Weekly Environmental Compliance Summary

Sudbury to Hudson Transmission Reliability Project (USEPA Tracking # MAR1003UW)

Sudbury, Hudson, and Stow, MA

Week of: October 24, 2022 through October 28, 2022

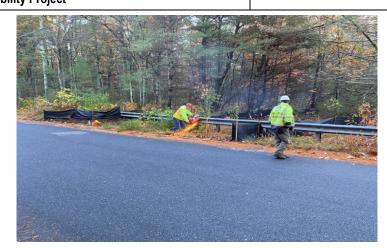
Photo No.: 1

White Pond Road crossing, silt fencing, looking eastward. Silt fencing is in good condition and operating properly. Contractor cutting guardrail preparing to build stabilized construction entrance.

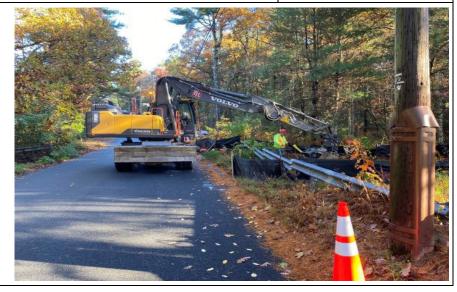
Photo No.: 2

White Pond Road crossing, silt fencing, looking northward. Silt fencing is in good condition and operating properly. Contractor removing guardrail preparing to build stabilized construction entrance.

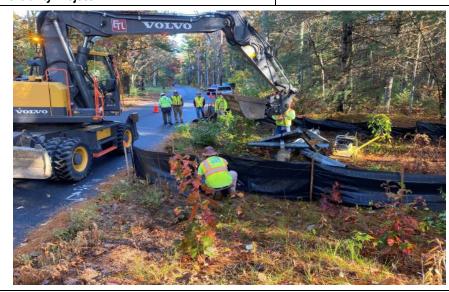
Photo No.: 3

White Pond Road crossing, silt fencing, looking northward. Silt fencing is in good condition and operating properly. Contractor removing preparing to build stabilized construction entrance.

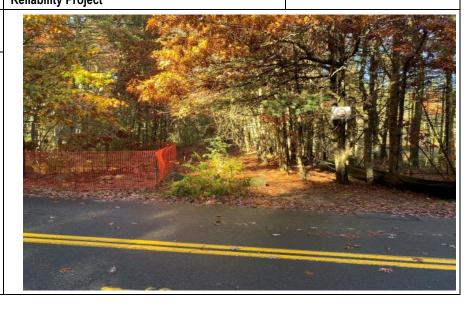
Photo No.: 4

Dutton Road crossing, silt fencing, looking westward. Silt fencing is in good condition and operating properly. Restrictive area fencing in place.

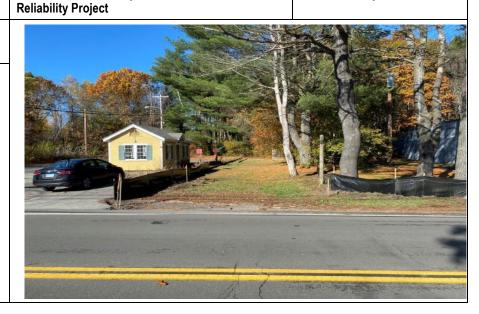
Photo No.: 5

Union Avenue crossing, silt fencing, looking westward. Silt fencing is in good condition and operating properly.

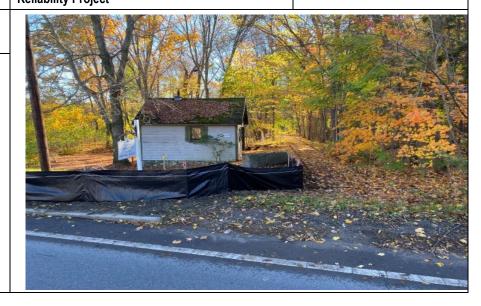
Photo No.: 6

Boston Post Road crossing, silt fencing, looking eastward. Silt fencing is in good condition and operating properly.

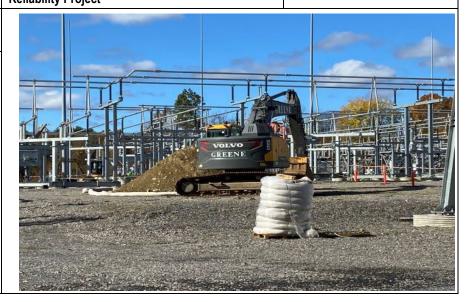
Photo No.: 7

Sudbury Substation, stockpile with filter tubes surrounding stockpile, looking westward. Filter tubes are in good condition and operating properly.

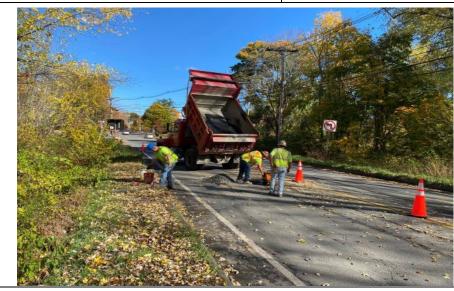
Photo No.: 8

Test pit # 4 in Forest Road, near intersection with Glendale, looking northward.

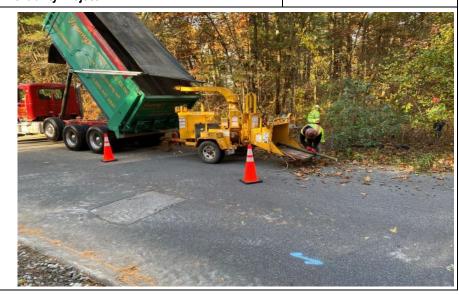
Photo No.: 1

White Pond Road crossing, looking westward, chipping of removed brush in preparation for construction of stabilized site entrance.

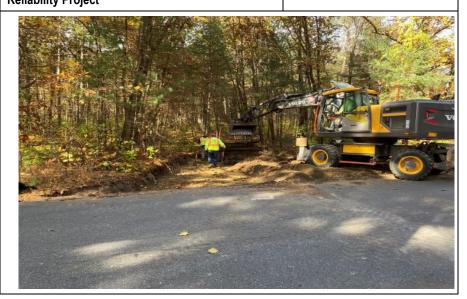
Photo No.: 2

White Pond Road crossing, looking westward, area excavated in preparation for construction of stabilized site entrance.

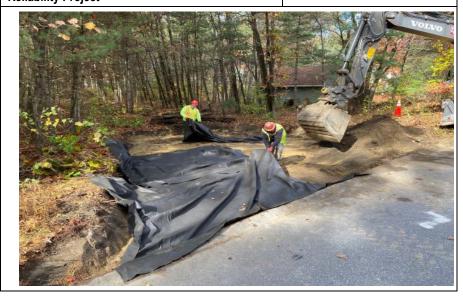
Photo No.: 3

White Pond Road crossing, looking westward, area excavated and fabric laid down below stone in preparation for construction of stabilized site entrance.

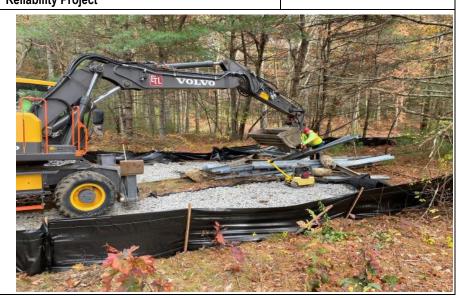
Photo No.: 4

White Pond Road crossing, looking eastward, removal of cut guard rail left on eastern stabilized construction entrance (developed 10-27-22).

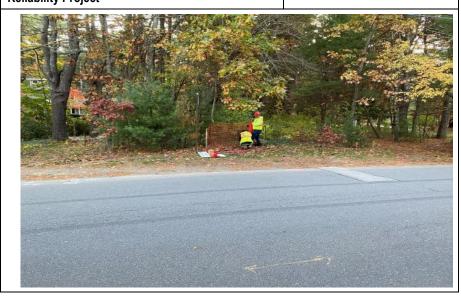
Parmenter Road crossing, archeological fencing installation, looking eastward. Fencing is in good condition and operating properly.

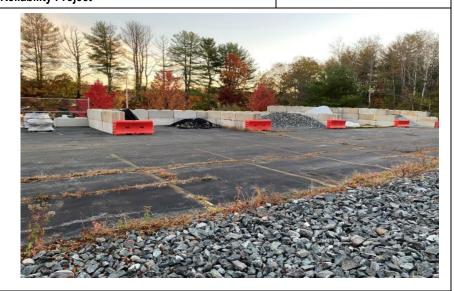
ETL laydown yard, looking eastward. Storage bin areas established to store project materials. Laydown yard located at 555 Main Street in Hudson.

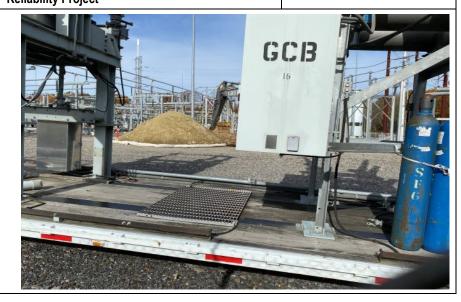
Photo No.: 7

Sudbury Substation, stockpile with filter tubes surrounding stockpile, looking northward. Filter tubes are in good condition and operating properly.

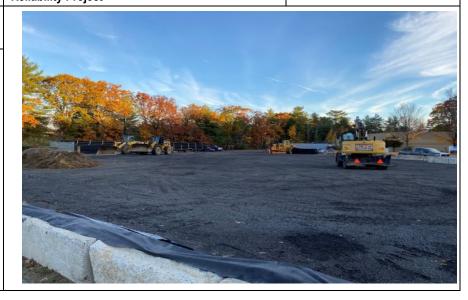
Bond laydown yard, looking north. Storage bin areas to be established for storage of project materials. Laydown yard located at 17 Robert Bonazzoli Avenue in Hudson.
