## Weekly Environmental Compliance Summary

**Sudbury to Hudson Transmission Reliability Project (USEPA Tracking # MAR1003UW)**

Week of: November 7 to November 11, 2022 (no work on Nov. 11 – Veterans Day)

# CONSTRUCTION MONITORING REPORT

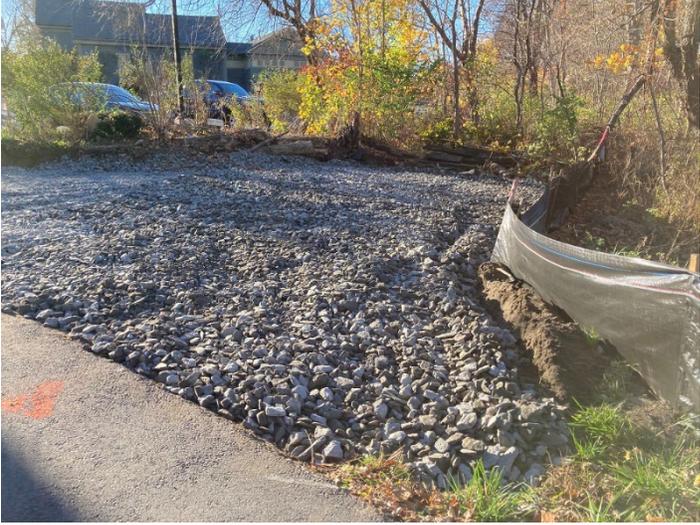
<b>PHOTOGRAPHIC LOG</b>	
<b>Client Name:</b> Eversource		<b>Site Location:</b> Sudbury to Hudson Transmission Reliability Project	
<b>Town:</b> Sudbury			
<b>Photo No.:</b> 1	<b>Date:</b> 11/07/2022

<b>Description:</b> View of stabilized construction entrance at Boston Post Road, facing west.

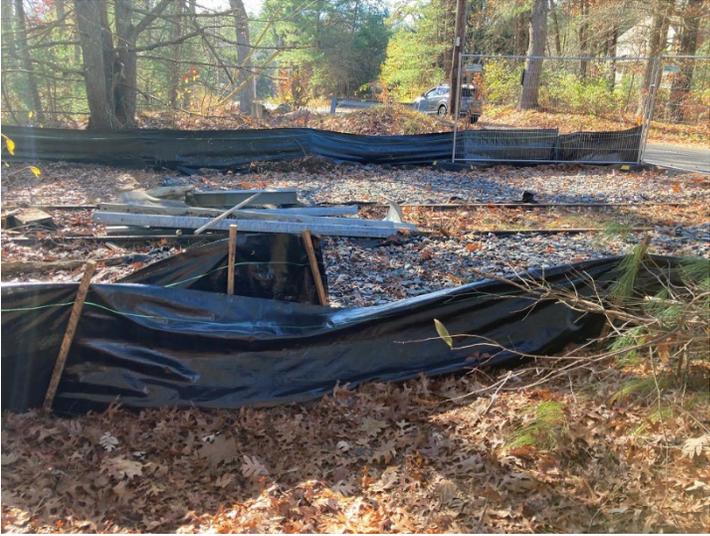
<b>PHOTOGRAPHIC LOG</b>	
<b>Client Name:</b> Eversource		<b>Site Location:</b> Sudbury to Hudson Transmission Reliability Project	
<b>Town:</b> Hudson			
<b>Photo No.:</b> 2	<b>Date:</b> 11/07/2022

<b>Description:</b> View of sagging silt fence at White Pond Rd, facing north.

- Repair/reset sagging silt fence at Stowe Ct laydown yard.**
- Repair/reset sagging silt fence at White Pond Rd.**
-

**-Silt fence repaired at White Pond Rd and Stowe Ct laydown yard.**

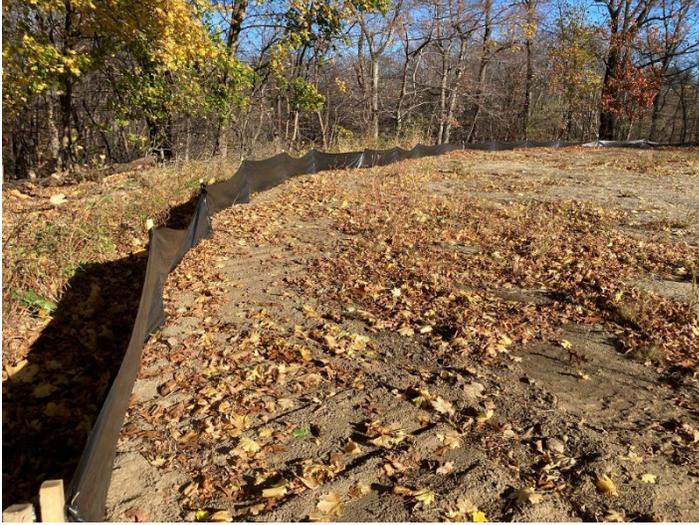
<b>PHOTOGRAPHIC LOG</b>	
<b>Client Name:</b> Eversource		<b>Site Location:</b> Sudbury to Hudson Transmission Reliability Project	<b>Town:</b> Hudson
<b>Photo No.:</b> 1	<b>Date:</b> 11/08/2022

<b>Description:</b> View of repaired silt fence at Stowe Ct laydown yard, facing east.

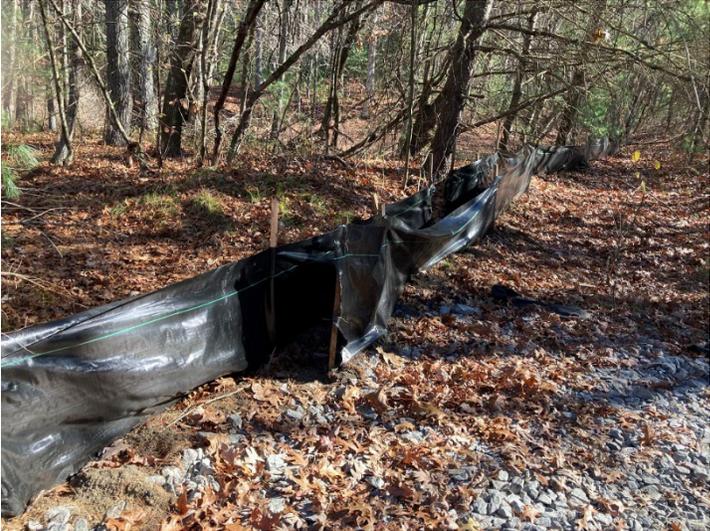
<b>PHOTOGRAPHIC LOG</b>	
<b>Client Name:</b> Eversource		<b>Site Location:</b> Sudbury to Hudson Transmission Reliability Project	<b>Town:</b> Hudson
<b>Photo No.:</b> 2	<b>Date:</b> 11/08/2022

<b>Description:</b> View of repaired silt fence at White Pond Rd, facing west.

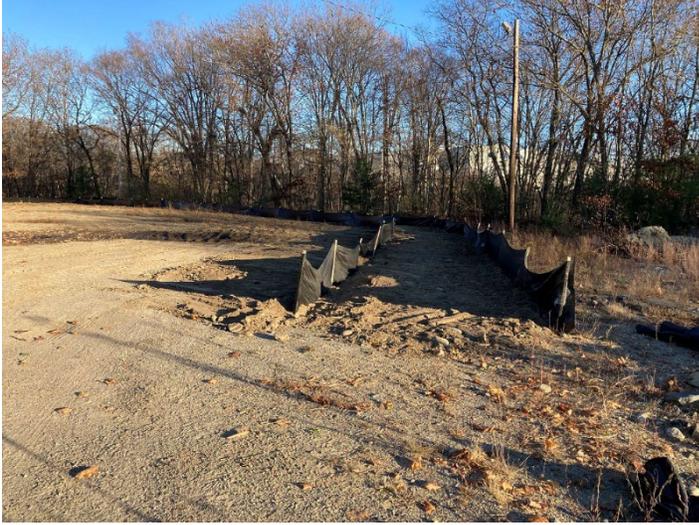
<b>PHOTOGRAPHIC LOG</b>	
<b>Client Name:</b> Eversource		<b>Site Location:</b> Sudbury to Hudson Transmission Reliability Project	<b>Town:</b> Hudson
<b>Photo No.:</b> 1	<b>Date:</b> 11/09/2022

<b>Description:</b> View of additional row of silt fence at Stowe Ct laydown yard, facing northeast.

**Attended meeting with Pam Helinek (Hudson agent) regarding Stowe Ct laydown yard. Additional row of silt fence was requested. Installation of silt fence in progress 11/09.**

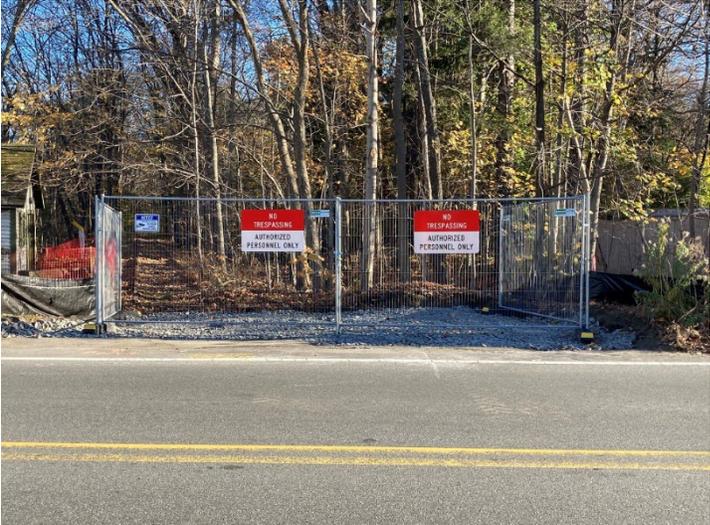
<b>PHOTOGRAPHIC LOG</b>	
<b>Client Name:</b> Eversource		<b>Site Location:</b> Sudbury to Hudson Transmission Reliability Project	<b>Town:</b> Sudbury
<b>Photo No.:</b> 2	<b>Date:</b> 11/09/2022

<b>Description:</b> View of completed construction entrance pad on east side of Boston Post Rd, facing east.

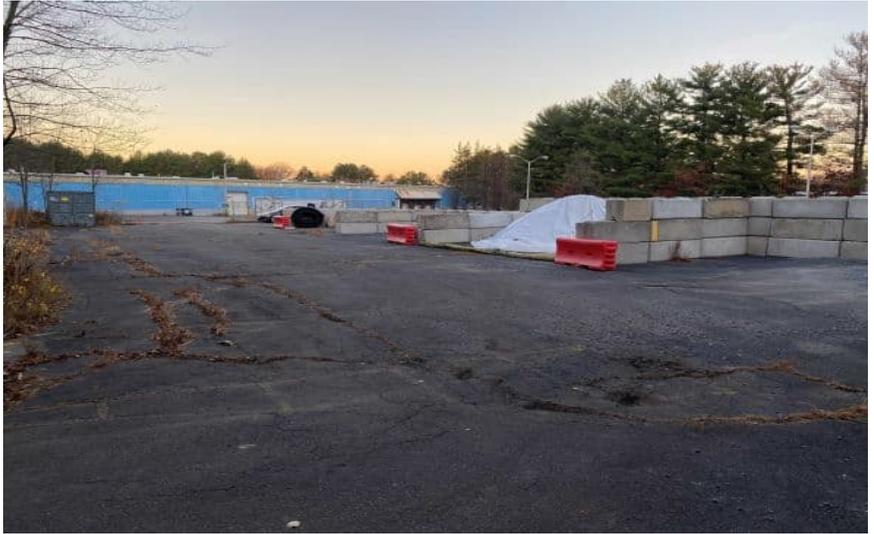
<b>PHOTOGRAPHIC LOG</b>	
Client Name: Eversource		Site Location: Sudbury to Hudson Transmission Reliability Project	Town: Hudson
Photo No.: 1	Date: 11-10-22

Description:  Bond laydown yard at 555 Main Street showing storage areas, looking northward, Storage bins in good condition and operating properly.

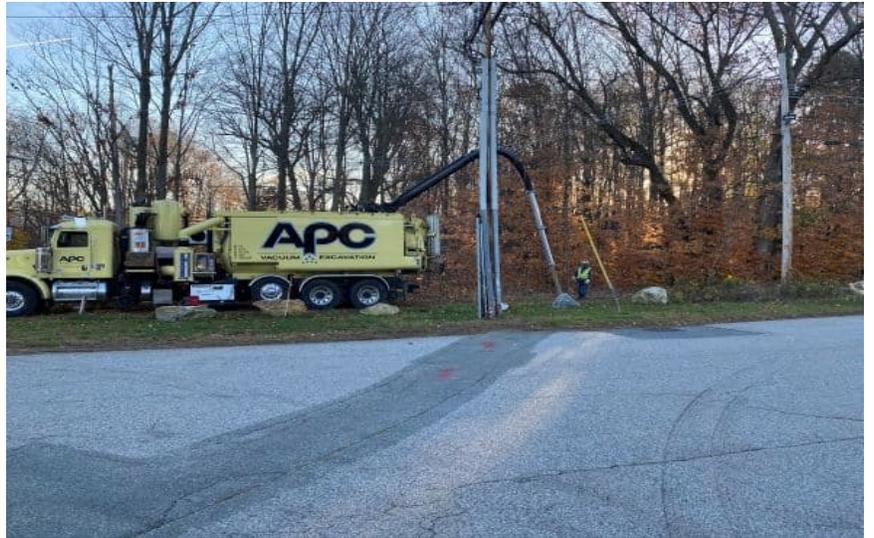
<b>PHOTOGRAPHIC LOG</b>	
Client Name: Eversource		Site Location: Sudbury to Hudson Transmission Reliability Project	Town: Hudson
Photo No.: 2	Date: 11-10-22

Description:  Test pitting for MH#1 off Forest Avenue near Station 0+00, looking Northward.

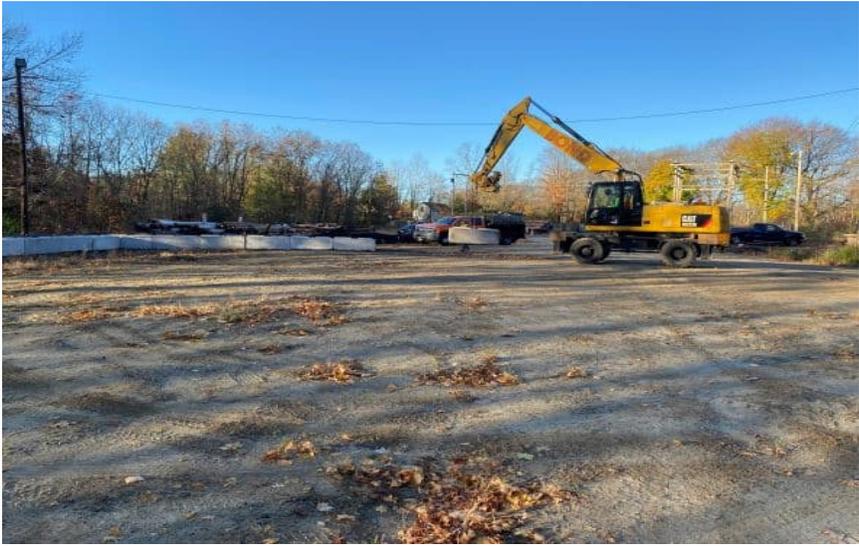
<b>PHOTOGRAPHIC LOG</b>	
Client Name: Eversource		Site Location: Sudbury to Hudson Transmission Reliability Project	Town: Hudson
Photo No.: 3	Date: 11-10-22

Description:  Bond laydown yard at 25 Stowe Court showing placement of concrete blocks for storage areas, looking southward.

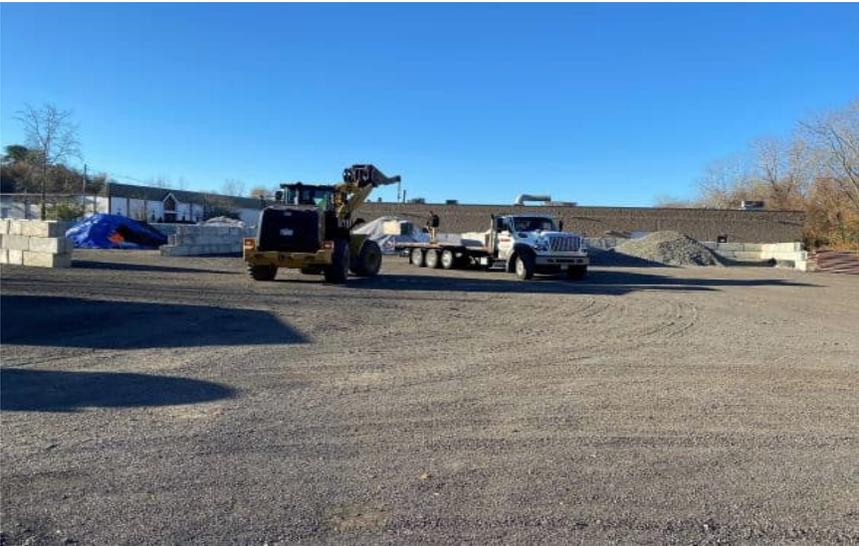
<b>PHOTOGRAPHIC LOG</b>	
Client Name: Eversource		Site Location: Sudbury to Hudson Transmission Reliability Project	Town: Hudson
Photo No.: 4	Date: 11-10-22

Description:  Bond laydown yard at 17 Bonazzoli Avenue showing movement of concrete blocks for use in creating storage areas at Stowe Court laydown yard, looking southward.

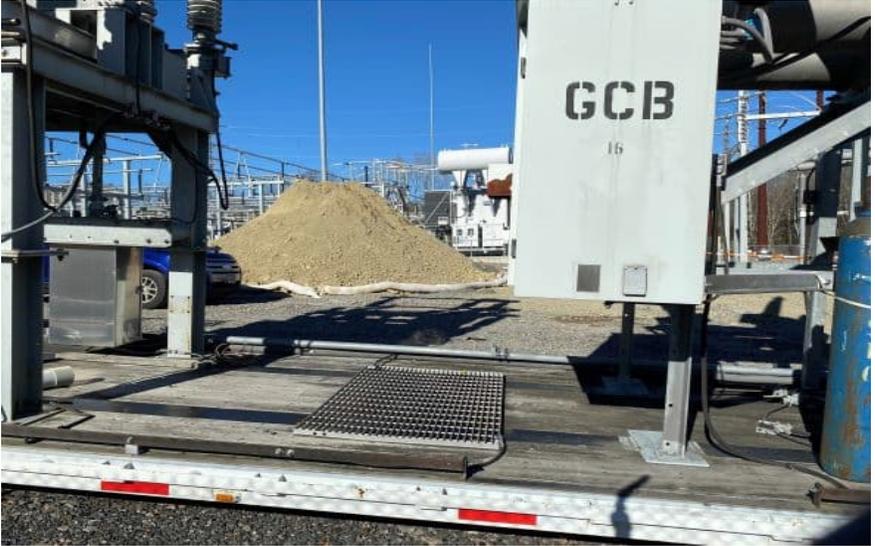
<b>PHOTOGRAPHIC LOG</b>	
Client Name: Eversource		Site Location: Sudbury to Hudson Transmission Reliability Project	Town: Sudbury
Photo No.: 6	Date: 11-10-22

Description:  Sudbury Substation, stockpile with filter tubes surrounding stockpile, looking northward. Filter tubes are in good condition and operating properly. Stockpile in compliance.

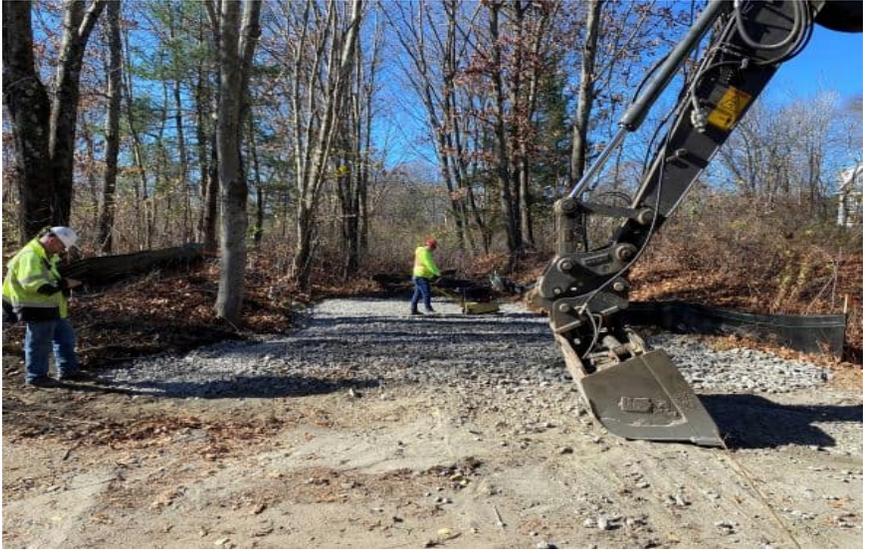
<b>PHOTOGRAPHIC LOG</b>	
Client Name: Eversource		Site Location: Sudbury to Hudson Transmission Reliability Project	Town: Sudbury
Photo No.: 7	Date: 11-10-22

Description:  Sudbury Substation area, finalizing stabilized construction entrance of Right-of-way at intersection with Sudbury Substation access driveway at <b>approximate Station #767+00, looking westward.</b>

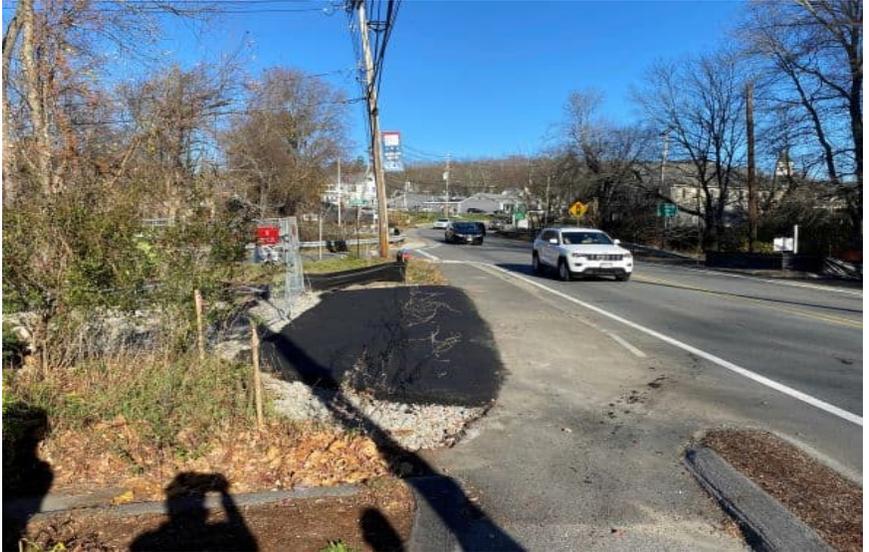
<b>PHOTOGRAPHIC LOG</b>	
Client Name: Eversource		Site Location: Sudbury to Hudson Transmission Reliability Project	Town: Sudbury
Photo No.: 8	Date: 11-10-22

Description:  Finalized paved apron at stabilized construction entrance off Boston Post Road, looking southward.
