Weekly Environmental Compliance Summary

Sudbury to Hudson Transmission Reliability Project (USEPA Tracking # MAR1003UW)

Sudbury, Hudson, and Stow, MA

Week of: November 14 to November 18, 2022

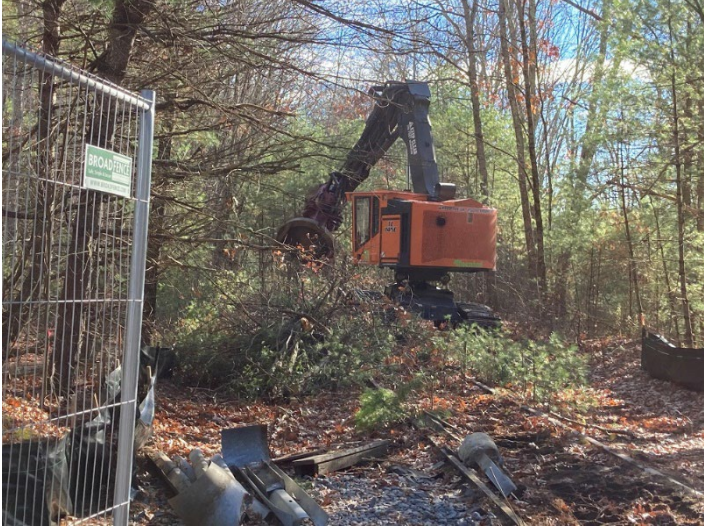
PHOTOGRAPHIC LOG	
Client Name: Eversource		Site Location: Sudbury to Hudson Transmission Reliability Project	
Town: Hudson			
Photo No.: 1	Date: 11/15/2022

Description: View of clearing activities at White Pond Rd (Segment 6), facing southeast.

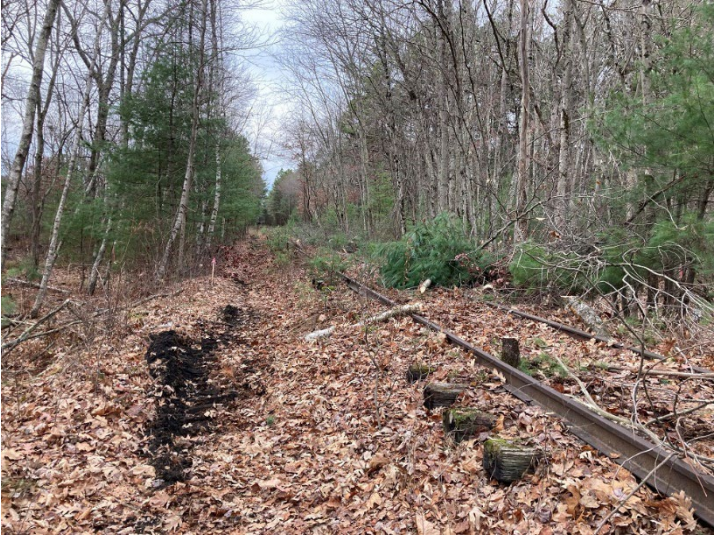
PHOTOGRAPHIC LOG	
Client Name: Eversource		Site Location: Sudbury to Hudson Transmission Reliability Project	
Town: Hudson			
Photo No.: 2	Date: 11/15/2022

Description: View of cut trees in Segment 6, facing northwest.

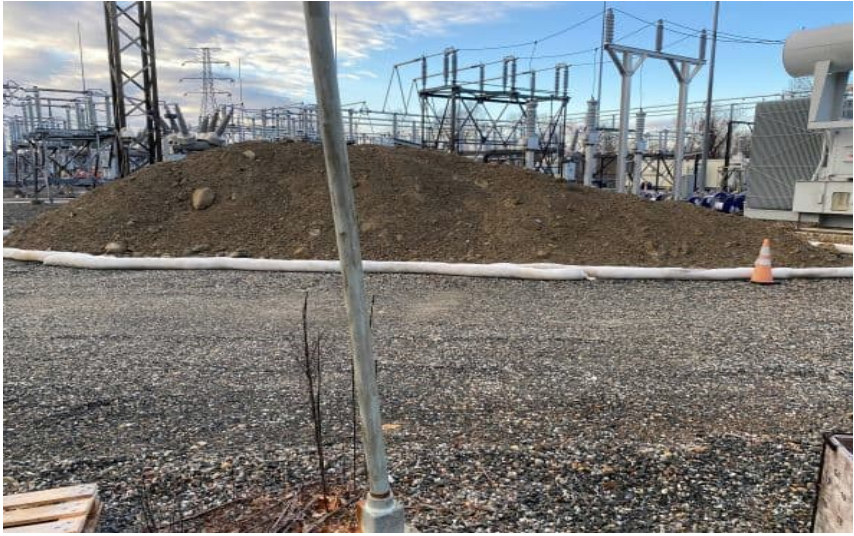
<p>PHOTOGRAPHIC LOG</p>	
<p>Client Name: Eversource</p>		<p>Site Location: Sudbury to Hudson Transmission Reliability Project</p>	<p>Town: Sudbury</p>
<p>Photo No.: 1</p>	<p>Date: 11-17-22</p>

<p>Description:</p> <p>Spoil pile within Sudbury substation looking southward. Spoil pile surrounded by staked filter socks, installed correctly and functioning well.</p>

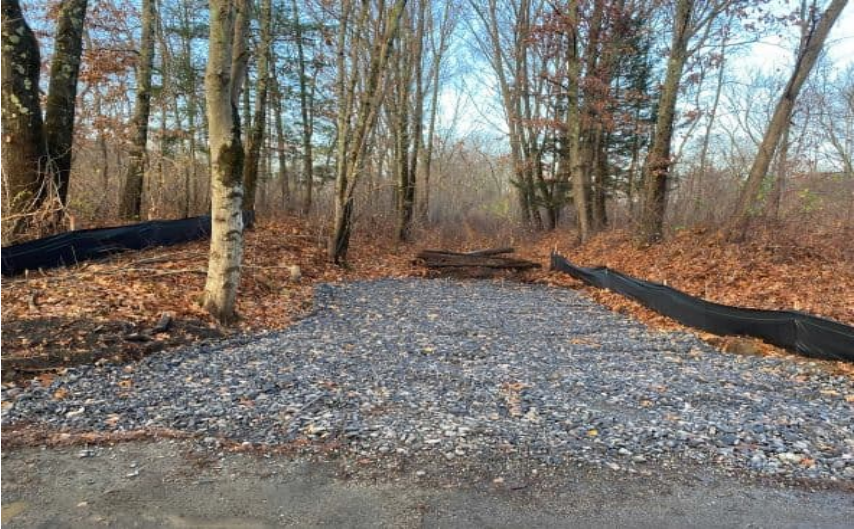
<p>PHOTOGRAPHIC LOG</p>	
<p>Client Name: Eversource</p>		<p>Site Location: Sudbury to Hudson Transmission Reliability Project</p>	<p>Town: Sudbury</p>
<p>Photo No.: 2</p>	<p>Date: 11-17-22</p>

<p>Description:</p> <p>Stabilized construction entrance off Sudbury substation entrance way, looking westward..</p>

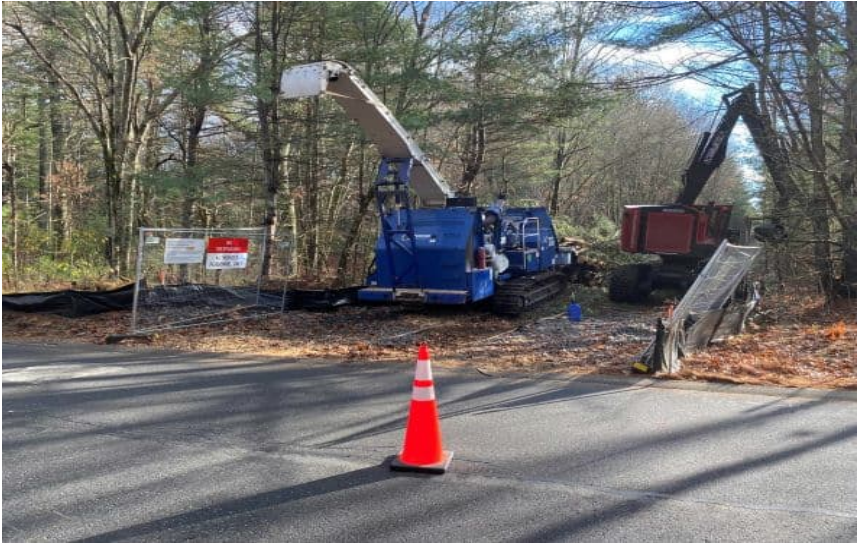
PHOTOGRAPHIC LOG	
Client Name: Eversource		Site Location: Sudbury to Hudson Transmission Reliability Project	Town: Hudson
Photo No.: 3	Date: 11-17-22

Description: Clearing operation at White Pond Road (chipper & forwarder on-site), looking eastward.

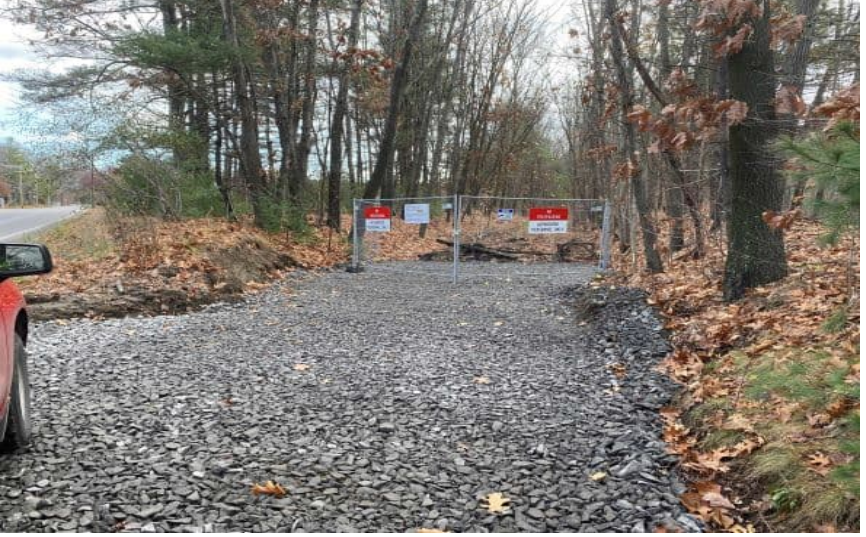
PHOTOGRAPHIC LOG	
Client Name: Eversource		Site Location: Sudbury to Hudson Transmission Reliability Project	Town: Hudson
Photo No.: 5	Date: 11-17-22

Description: New stabilized construction entrance off 566 Main Street in Hudson, looking eastward.

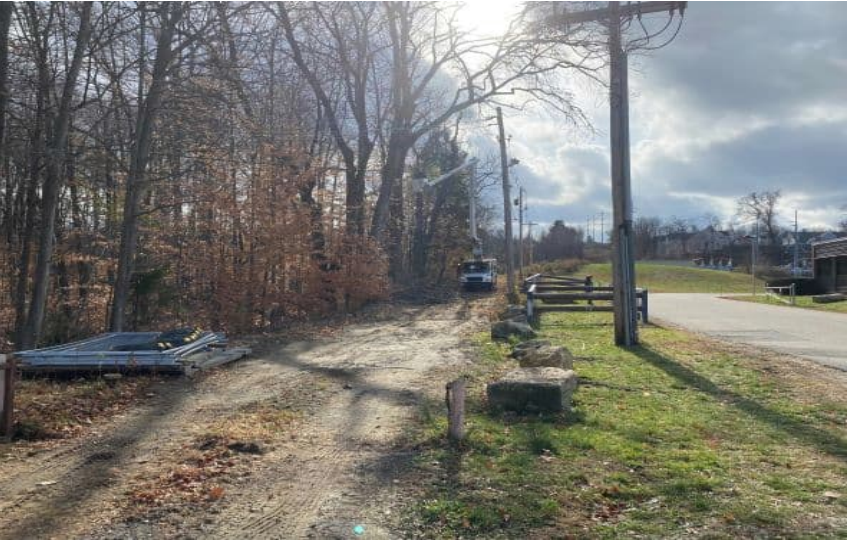
PHOTOGRAPHIC LOG	
Client Name: Eversource		Site Location: Sudbury to Hudson Transmission Reliability Project	Town: Hudson
Photo No.: 6	Date: 11-17-22

Description: Northeastern Tree trimming vegetation at area of MH#1 (49 Forest Avenue) in Hudson, looking eastward.

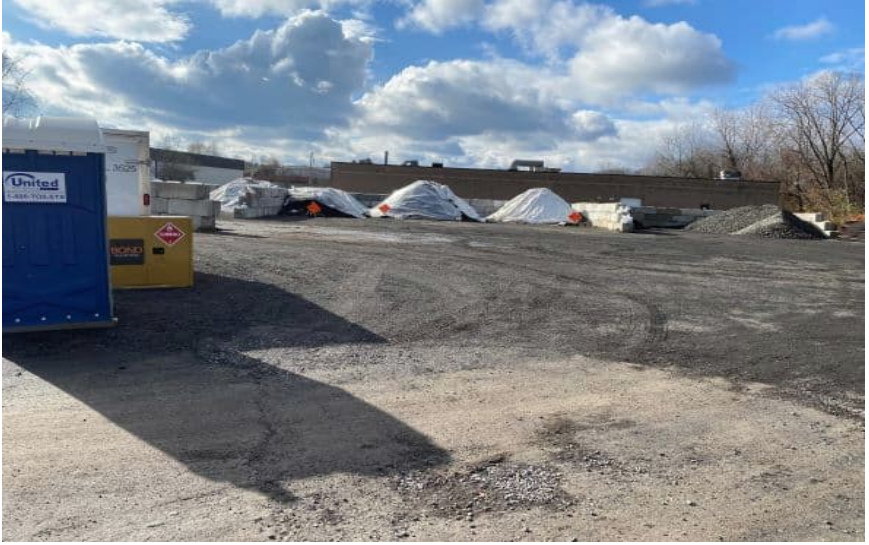
PHOTOGRAPHIC LOG	
Client Name: Eversource		Site Location: Sudbury to Hudson Transmission Reliability Project	Town: Hudson
Photo No.: 7	Date: 11-17-22

Description: Bond laydown yard at 17 Bonazzoli Avenue showing covered stockpiles, looking southward.

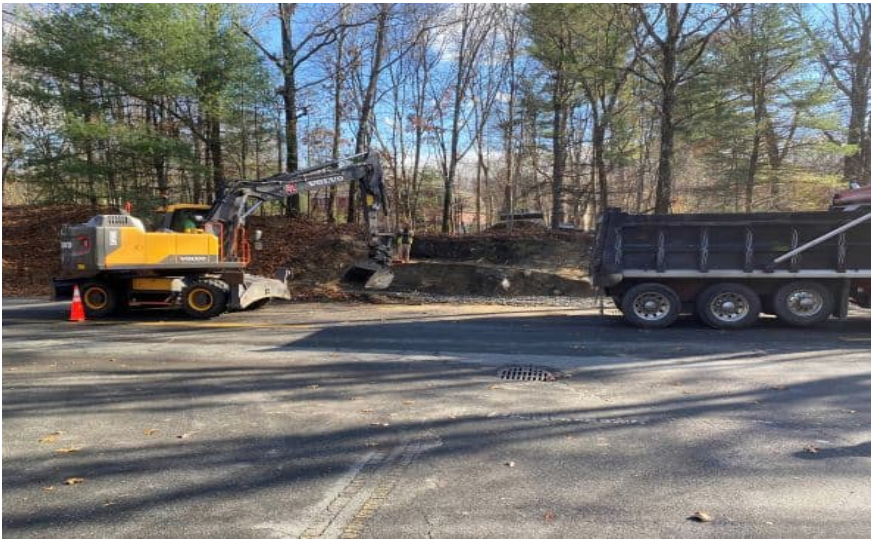
PHOTOGRAPHIC LOG	
Client Name: Eversource		Site Location: Sudbury to Hudson Transmission Reliability Project	Town: Hudson
Photo No.: 8	Date: 11-17-22

Description: ETL working on new stabilized construction entrance off Wilkins Avenue, looking eastward.

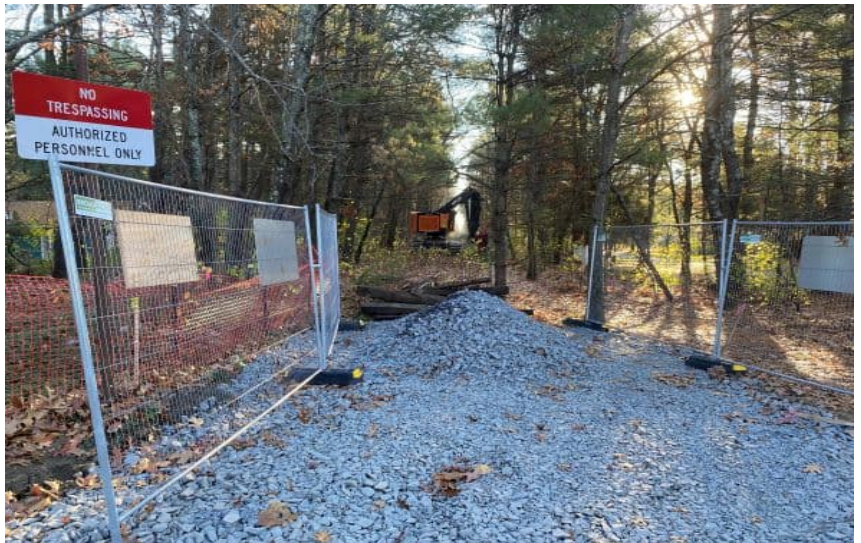
PHOTOGRAPHIC LOG	
Client Name: Eversource		Site Location: Sudbury to Hudson Transmission Reliability Project	Town: Hudson
Photo No.: 2	Date: 11-18-22

Description: Feller buncher removing vegetation (trees) off Parmenter Road, looking eastward..

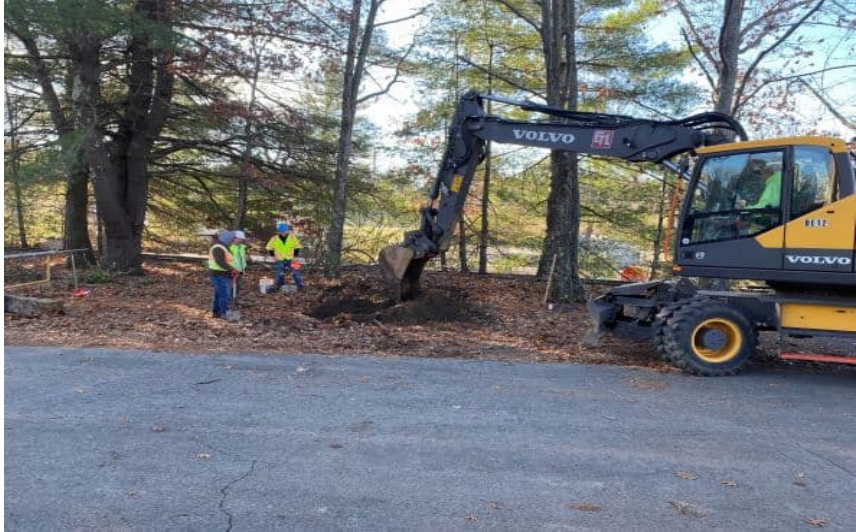
<p>PHOTOGRAPHIC LOG</p>	
<p>Client Name: Eversource</p>		<p>Site Location: Sudbury to Hudson Transmission Reliability Project</p>	<p>Town: Hudson</p>
<p>Photo No.: 3</p>	<p>Date: 11-18-22</p>

<p>Description:</p> <p>ETL excavating old railroad feature near station # 167+00. Commonwealth Heritage Group individual (David Gutbrod) overseeing work, looking westward.</p>

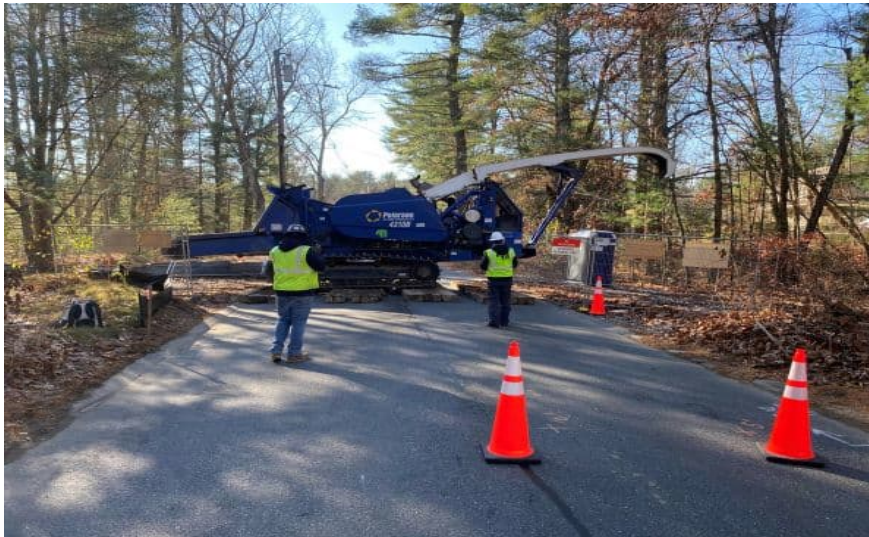
<p>PHOTOGRAPHIC LOG</p>	
<p>Client Name: Eversource</p>		<p>Site Location: Sudbury to Hudson Transmission Reliability Project</p>	<p>Town: Hudson</p>
<p>Photo No.: 4</p>	<p>Date: 11-18-22</p>

<p>Description:</p> <p>Crossing of White Pond Road with chipper (on wood mats across the road), looking southward.</p>

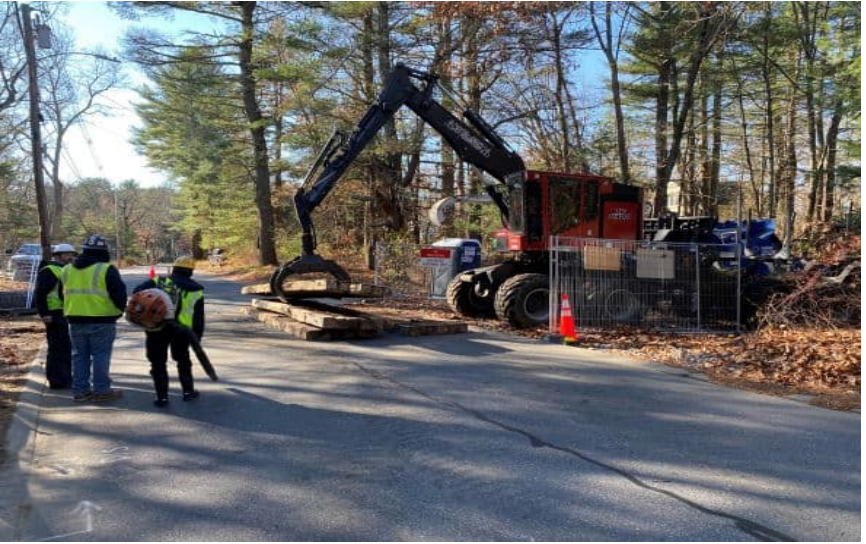
<p>PHOTOGRAPHIC LOG</p>	
<p>Client Name: Eversource</p>		<p>Site Location: Sudbury to Hudson Transmission Reliability Project</p>	<p>Town: Hudson</p>
<p>Photo No.: 5</p>	<p>Date: 11-18-22</p>

<p>Description:</p> <p>Crossing of White Pond Road with chipper (removal of wood mats on the road), looking southward..</p>

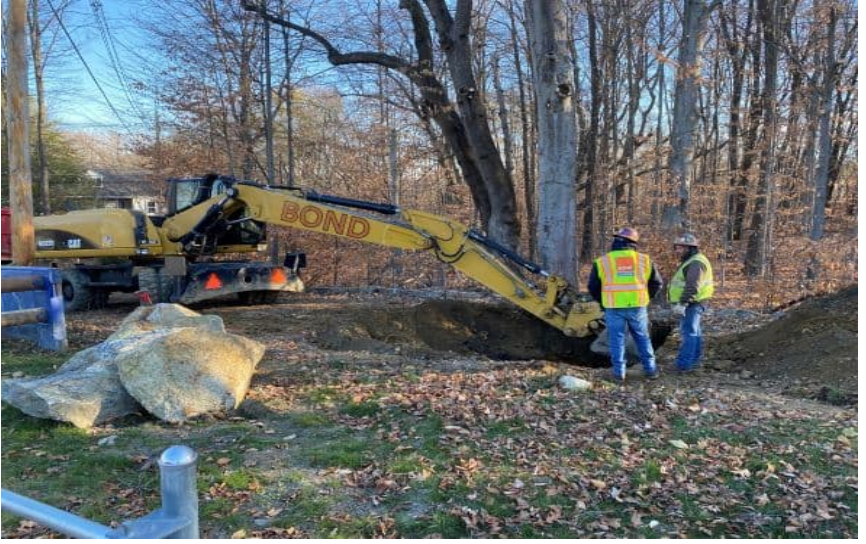
<p>PHOTOGRAPHIC LOG</p>	
<p>Client Name: Eversource</p>		<p>Site Location: Sudbury to Hudson Transmission Reliability Project</p>	<p>Town: Hudson</p>
<p>Photo No.: 6</p>	<p>Date: 11-18-22</p>

<p>Description:</p> <p>Bond conducting excavation at area of MH#1 (49 Forest Avenue) in Hudson, looking northward.</p>

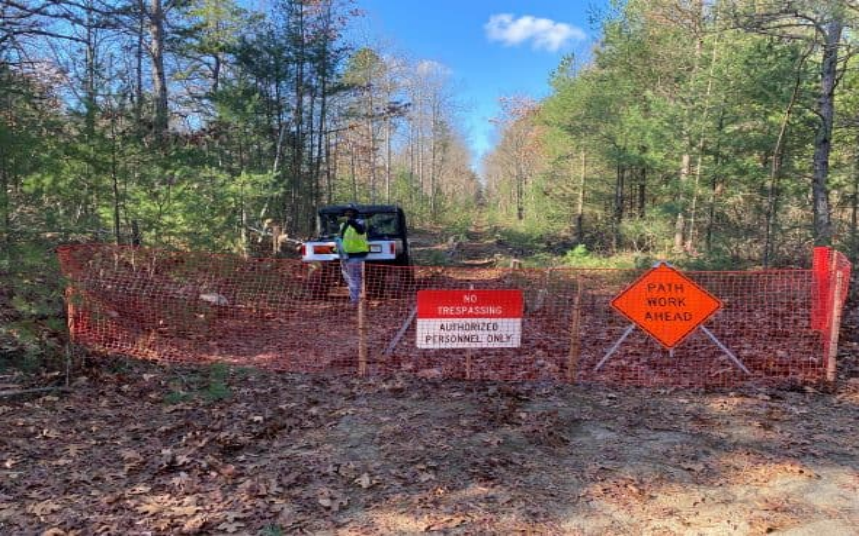
<p>PHOTOGRAPHIC LOG</p>	
<p>Client Name: Eversource</p>		<p>Site Location: Sudbury to Hudson Transmission Reliability Project</p>	<p>Town: Hudson</p>
<p>Photo No.: 8</p>	<p>Date: 11-18-22</p>

<p>Description:</p> <p>Bond personnel established right-of-way barricade near town line (Hudson-Sudbury) to prevent entrance by unauthorized individuals at approximate Station # 360+75, looking westward.</p>

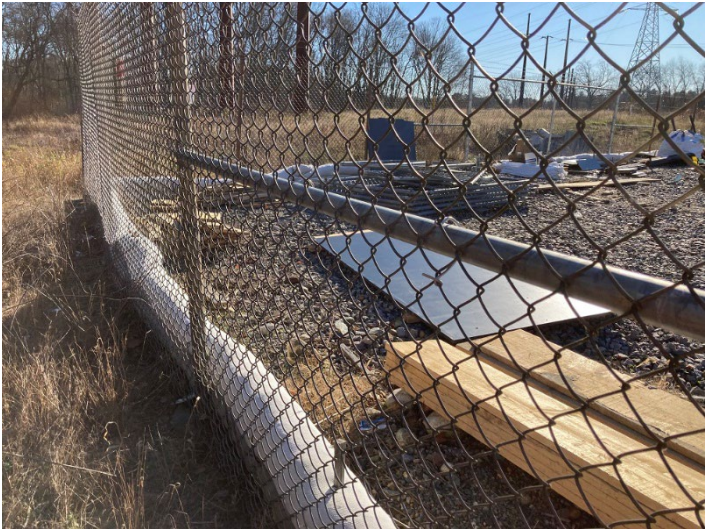
PHOTOGRAPHIC LOG	
Client Name: Eversource		Site Location: Sudbury to Hudson Transmission Reliability Project	Town: Sudbury
Photo No.: 2	Date: 11-14-2022

Description: View of filter socks at Sudbury Substation. Filter socks are in good condition and operating properly, facing south.

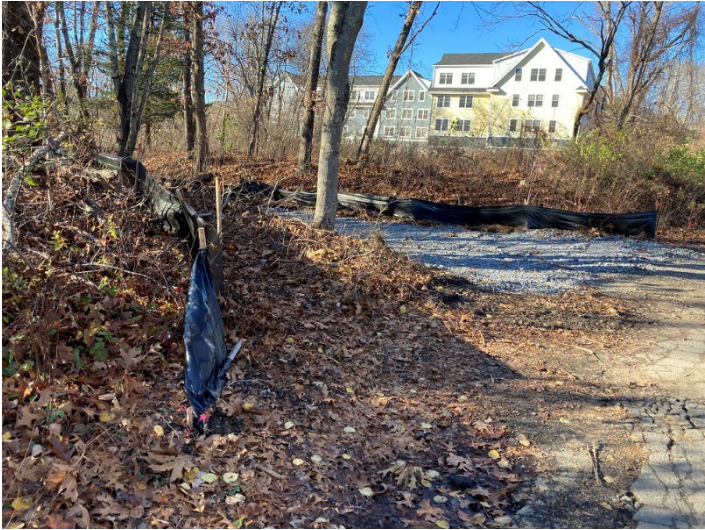
PHOTOGRAPHIC LOG	
Client Name: Eversource		Site Location: Sudbury to Hudson Transmission Reliability Project	Town: Sudbury
Photo No.: 3	Date: 11-14-2022

Description: View of construction entrance pad and silt fence at Sudbury Substation terminus. Repair damaged stake at silt fence (routine maintenance), facing northwest.

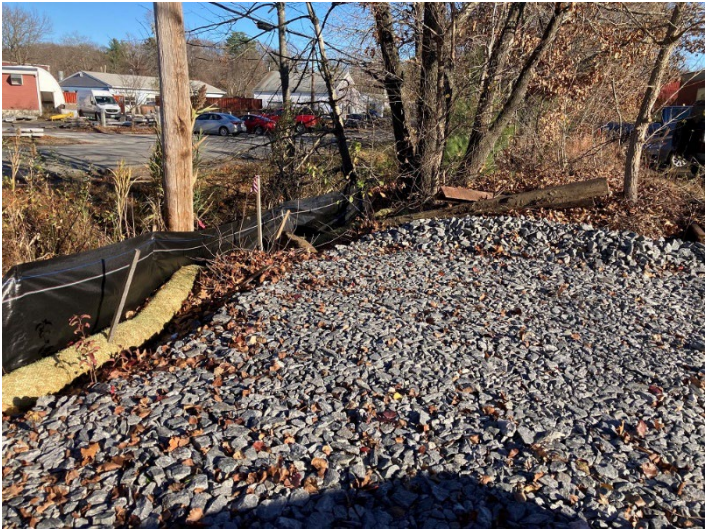
PHOTOGRAPHIC LOG	
Client Name: Eversource		Site Location: Sudbury to Hudson Transmission Reliability Project	Town: Sudbury
Photo No.: 4	Date: 11-14-2022

Description: View of construction entrance pad at Union Ave. Silt fence and straw wattles are operating properly. It is recommended that straw wattles with plastic netting be replaced with biodegradable compost filter tubes (per Eversource requirement), facing west.

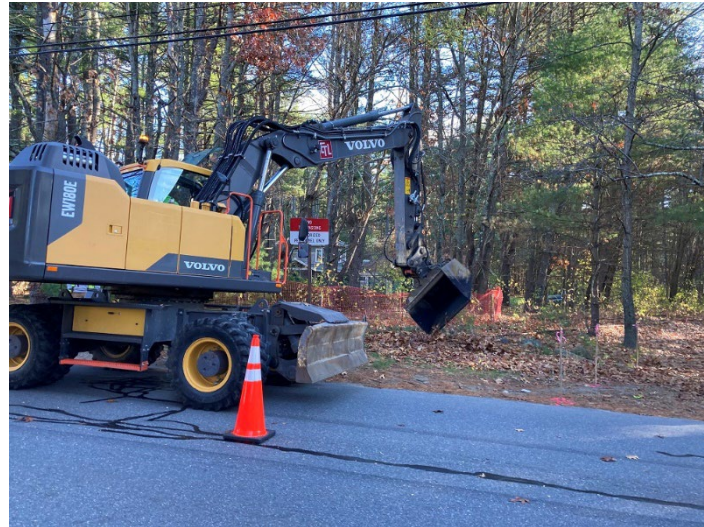
Installation of construction entrance pads at Parmenter Rd was in progress at time of inspection, facing east.

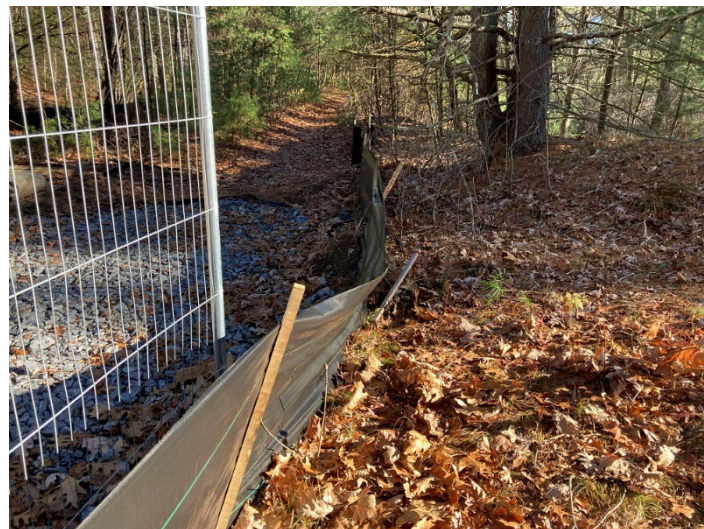
1. Silt Fencing at ROW (White Pond Rd., Dutton Rd., Peakham Rd., Union Ave, Boston Post Rd. & Sudbury Substation)	<input checked="" type="checkbox"/> Yes <input type="checkbox"/> No	1	<input type="checkbox"/> Yes <input checked="" type="checkbox"/> No	11/14/2022	-Silt fence is installed per the plan and operating properly. -Repair damaged stake at silt fence along construction entrance pad at Sudbury Substation terminus (routine maintenance). -Repair/reset sagging silt fence at construction entrance pad at White Pond Rd (routine maintenance).

View of construction entrance pad and silt fence at White Pond Rd. Repair/reset sagging silt fence at construction entrance pad at White Pond Rd (routine maintenance), facing east.

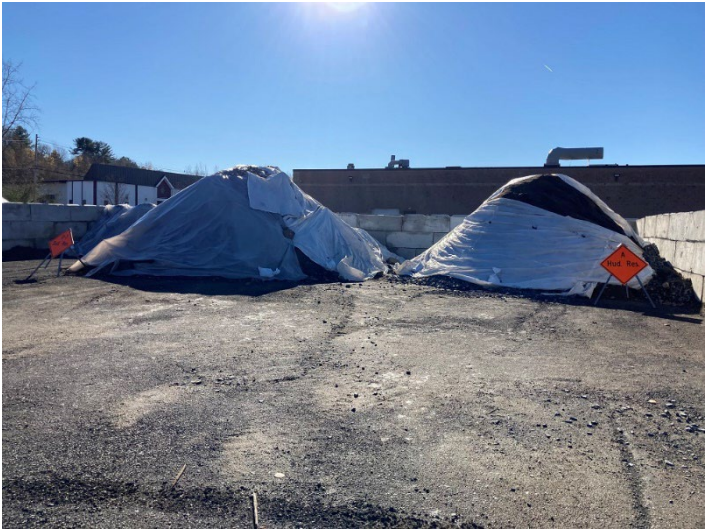
Epsilon ASSOCIATES INC.		PHOTOGRAPHIC LOG	
Client Name: Eversource		Site Location: Sudbury to Hudson Transmission Reliability Project	Town: Hudson
Photo No.: 7	Date: 11-14-2022

Description: View of laydown yard at Robert Bonazzoli Ave. No issues observed. Stockpiles are being covered at the end of each day, facing south.

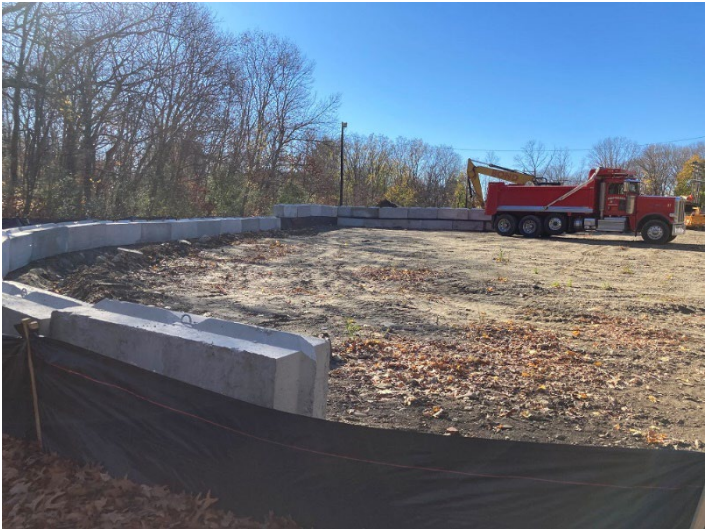
Epsilon ASSOCIATES INC.		PHOTOGRAPHIC LOG	
Client Name: Eversource		Site Location: Sudbury to Hudson Transmission Reliability Project	Town: Hudson
Photo No.: 8	Date: 11-14-2022

Description: View of laydown yard at Stowe Ct. Silt fence is operating properly. Soil storage begun in this location today. Please ensure yard is being managed per conservation agent's request, facing south.

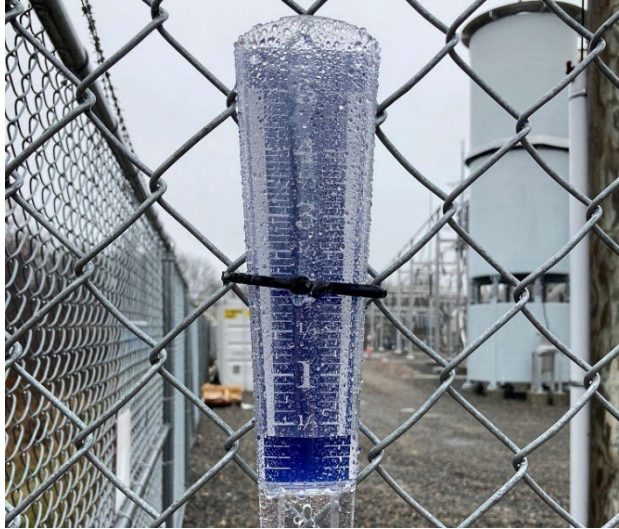
PHOTOGRAPHIC LOG	
Client Name: Eversource		Site Location: Sudbury to Hudson Transmission Reliability Project	
		Town: Sudbury	
Photo No.: 1	Date: 11-16-2022

Description: View of onsite rain gauge at 10:30am on 11-16-2022 (showing rain from past 14 hours), facing north.

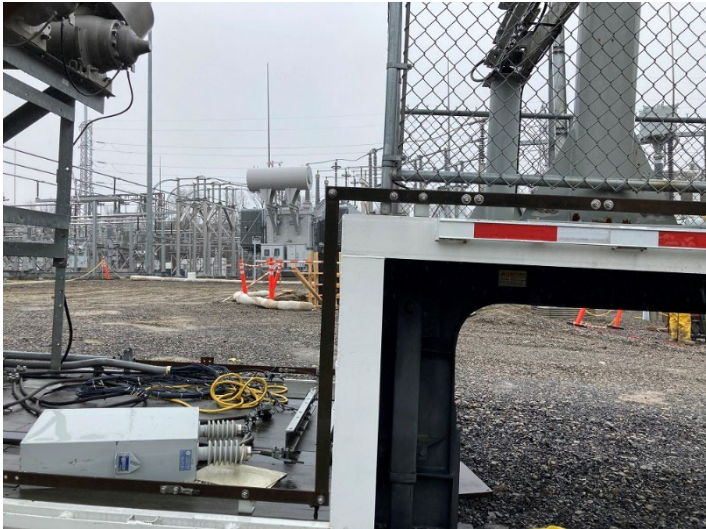
PHOTOGRAPHIC LOG	
Client Name: Eversource		Site Location: Sudbury to Hudson Transmission Reliability Project	
		Town: Sudbury	
Photo No.: 2	Date: 11-16-2022

Description: View of active work area at Sudbury Substation. Stockpile appears to have been removed. Filter socks are in good condition and operating properly, facing northwest.

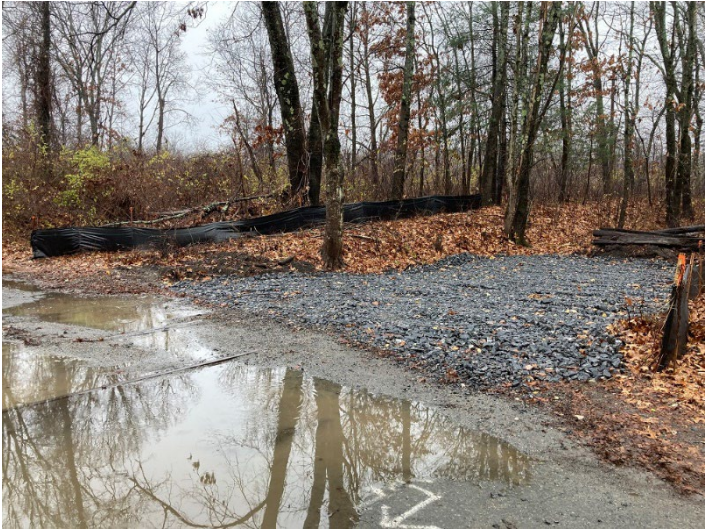
PHOTOGRAPHIC LOG	
Client Name: Eversource		Site Location: Sudbury to Hudson Transmission Reliability Project	Town: Sudbury
Photo No.: 3	Date: 11-16-2022

Description: View of construction entrance pad and silt fence at Sudbury Substation terminus. Damaged stake at silt fence has been repaired (routine maintenance has been completed), facing southwest.

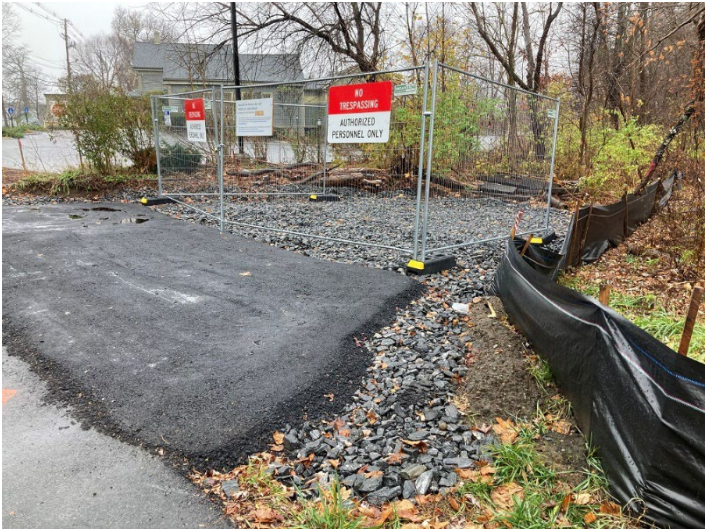
PHOTOGRAPHIC LOG	
Client Name: Eversource		Site Location: Sudbury to Hudson Transmission Reliability Project	Town: Sudbury
Photo No.: 4	Date: 11-16-2022

Description: View of construction entrance pad at Boston Post Rd. Silt fence is operating properly, facing southwest.

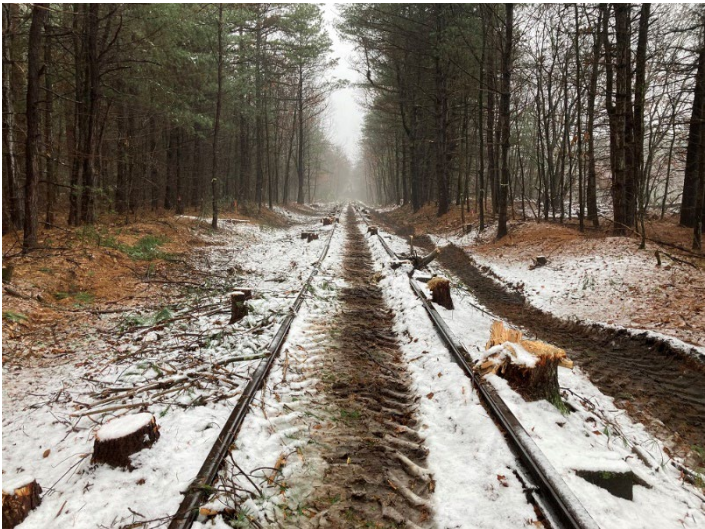
Epsilon ASSOCIATES INC.		PHOTOGRAPHIC LOG	
Client Name: Eversource		Site Location: Sudbury to Hudson Transmission Reliability Project	Town: Hudson
Photo No.: 5	Date: 11-16-2022

Description: View of cleared area on segment 6 from White Pond Rd, facing east.

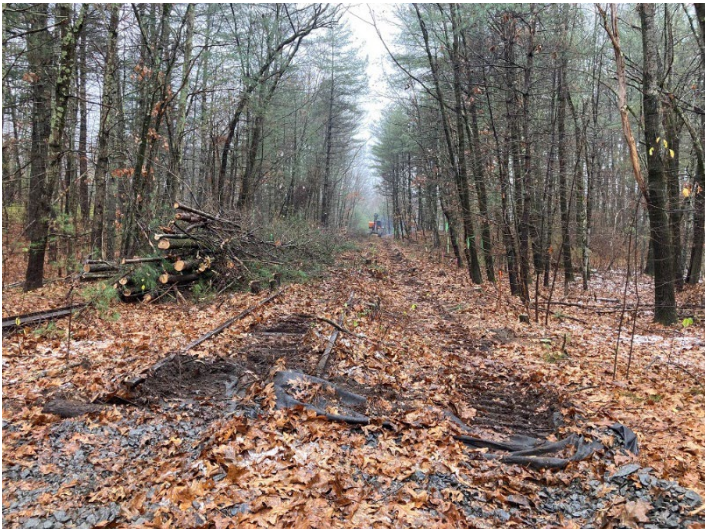
Epsilon ASSOCIATES INC.		PHOTOGRAPHIC LOG	
Client Name: Eversource		Site Location: Sudbury to Hudson Transmission Reliability Project	Town: Hudson
Photo No.: 6	Date: 11-16-2022

Description: View of clearing activities on Segment 5 from White Pond Rd, facing west.

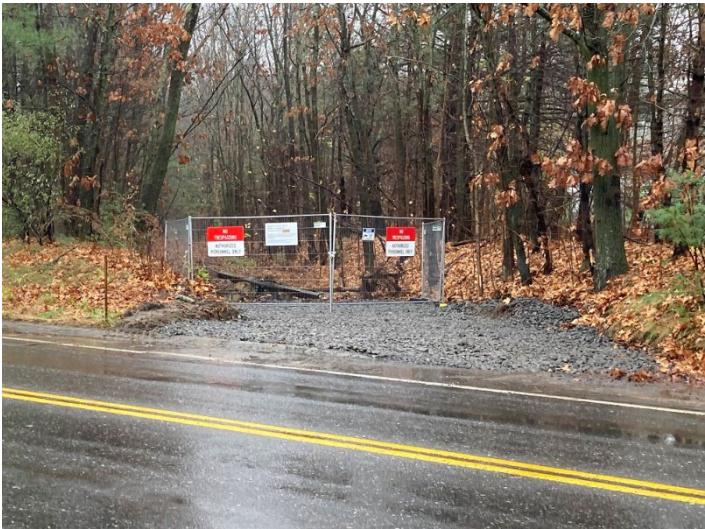
Epsilon ASSOCIATES INC.		PHOTOGRAPHIC LOG	
Client Name: Eversource		Site Location: Sudbury to Hudson Transmission Reliability Project	Town: Hudson
Photo No.: 7	Date: 11-16-2022

Description: View of entrance pad at Main St (completed 11/16/2022), facing east.

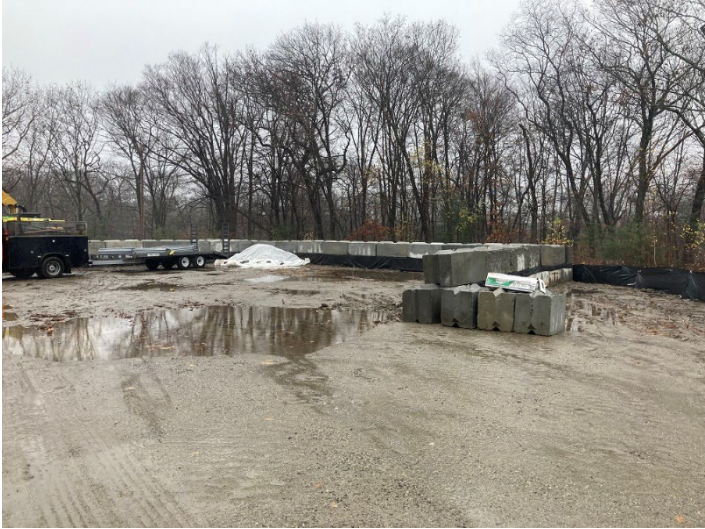
Epsilon ASSOCIATES INC.		PHOTOGRAPHIC LOG	
Client Name: Eversource		Site Location: Sudbury to Hudson Transmission Reliability Project	Town: Hudson
Photo No.: 8	Date: 11-16-2022

Description: View of laydown yard at Stowe Ct. Silt fence is operating properly. Inactive pile is covered. Additional cement barriers were delivered and placed today. Facing northeast.
