## Weekly Environmental Compliance Summary

**Sudbury to Hudson Transmission Reliability Project (USEPA Tracking # MAR1003UW)**

Sudbury, Hudson, and Stow, MA

Week of: November 21 to November 25, 2022

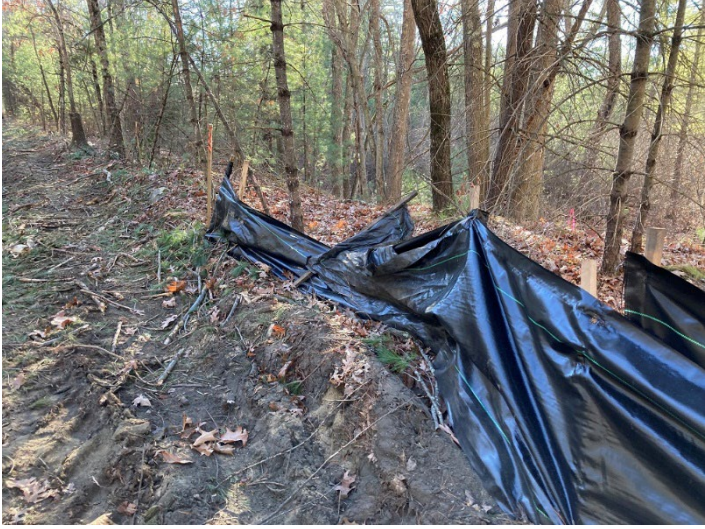
<p><b>Description:</b> View of silt fence at White Pond Road (Segment 6). Routine maintenance needed. Facing northwest.</p>

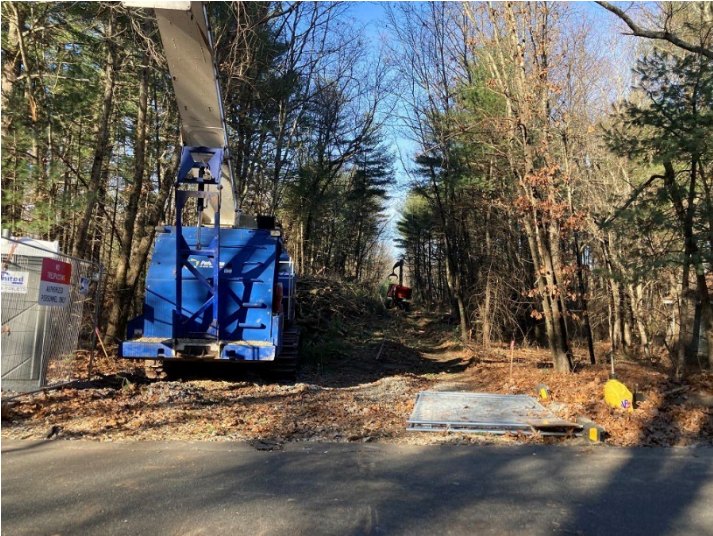
<p><b>Description:</b> View of bunching and chipping activities in Segment 5, facing east.</p>

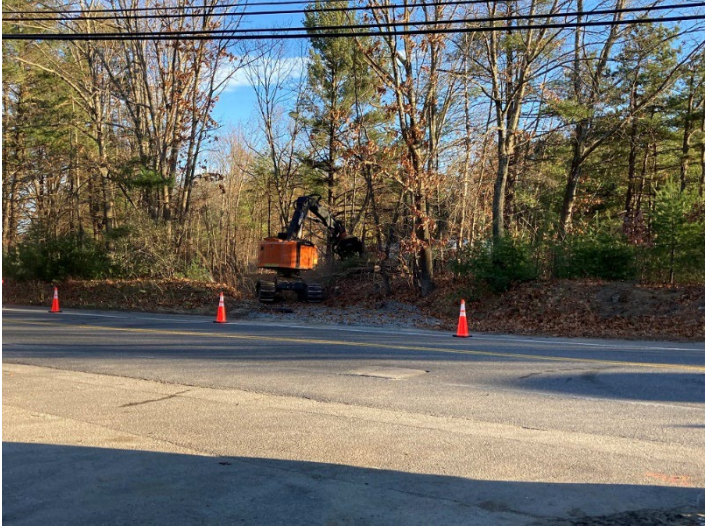
<b>Description:</b> View of clearing activities at Main St (Segment 4), facing northwest.

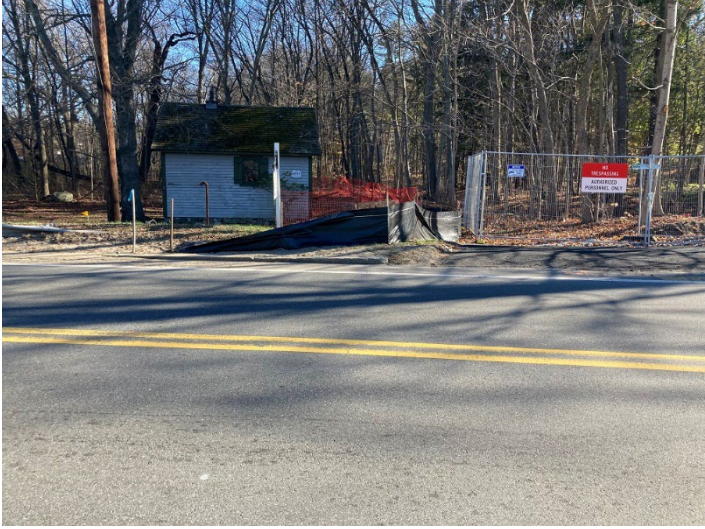
<b>Description:</b> View of damaged silt fence at Boston Post Rd. Routine maintenance needed, facing southwest.

**-Silt fence at Boston Post Rd (segment 13) has been repaired.**

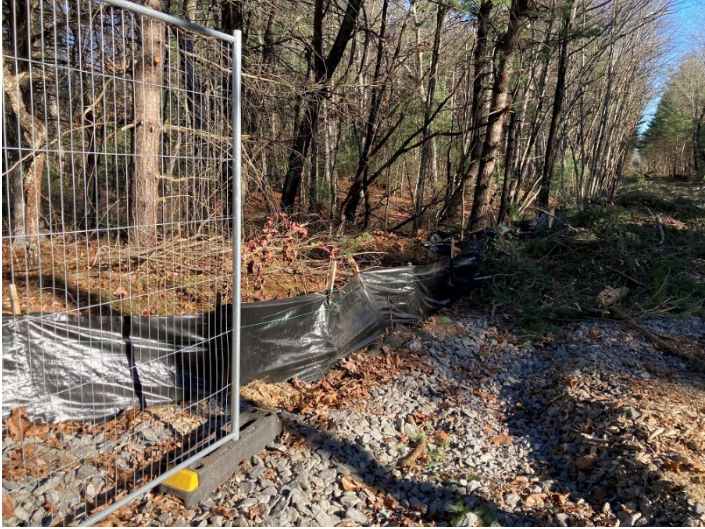
<b>Description:</b> Silt fence at White Pond Road has been repaired. Installation of silt fence along remainder of Segment 6 is in progress. Facing northeast.

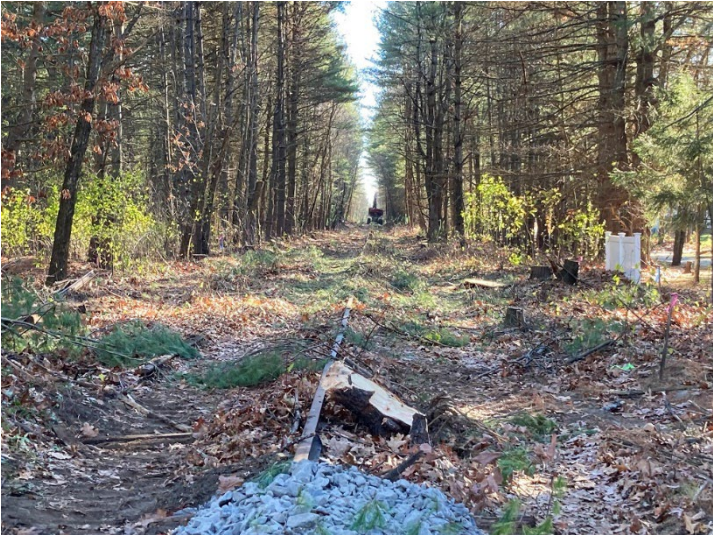
<b>Description:</b> View of forwarder on Segment 4, facing west.

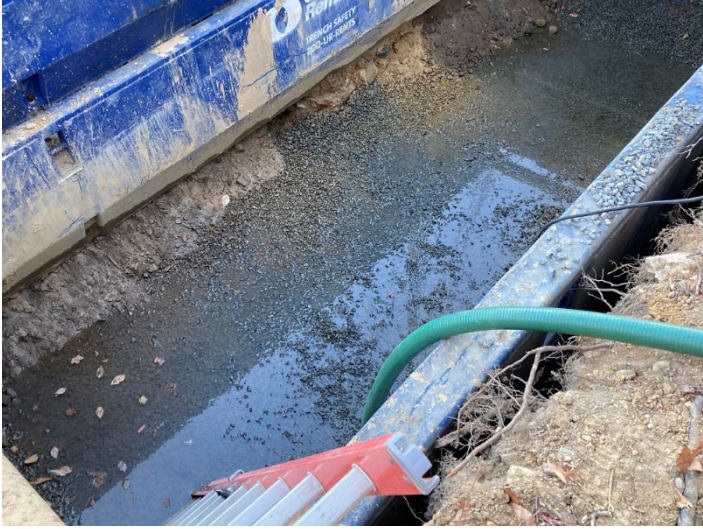
Inspection Notes:
Any Significant Discharges of Sediment (or other) or Non-Compliance Actions?
Discharge of turbid water and sedimentation occurred during dewatering operation at MH#1. See dewatering inspection report for details.
Identify presence of stockpiles and document when placed and when removed (week maximum for stockpiles)
Stockpile present at substation. Week maximum requirement does not apply to stockpiles outside of ROW.
Compliance with Previous Observations?
Previous observation that needs attention- Repair/reset silt fence where damaged at entrance pad at Boston Post Rd (segment 13). Previous observation that was addressed- Syncopated silt fencing at White Pond Road crossing has been repaired (segment 6).
New Corrective Action Recommendations
Address turbidity and sedimentation discharge at MH#1.
New Routine Maintenance Recommendations

<b>Description:</b> View of work at MH#1. Dewatering occurred and corrective action is needed. See dewatering inspection report for details.

**-Turbidity and sedimentation discharges at MH#1 have been addressed. See corrective action log.**

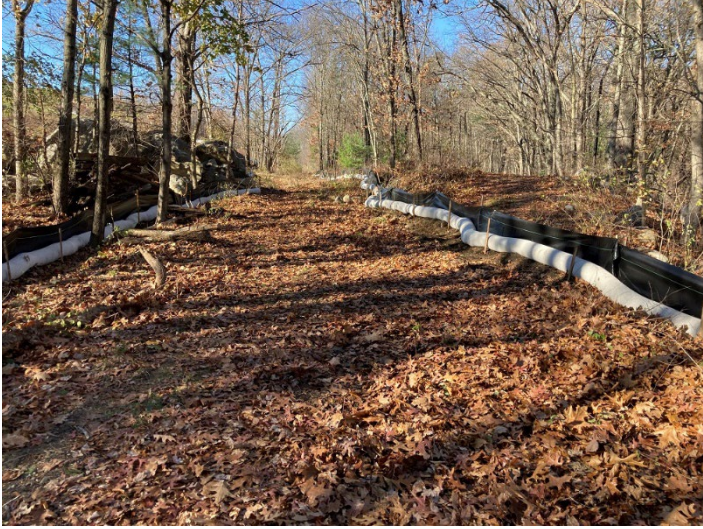
<b>Description:</b> View of E&S controls installed along Stow portion of project in segment 1, facing west.

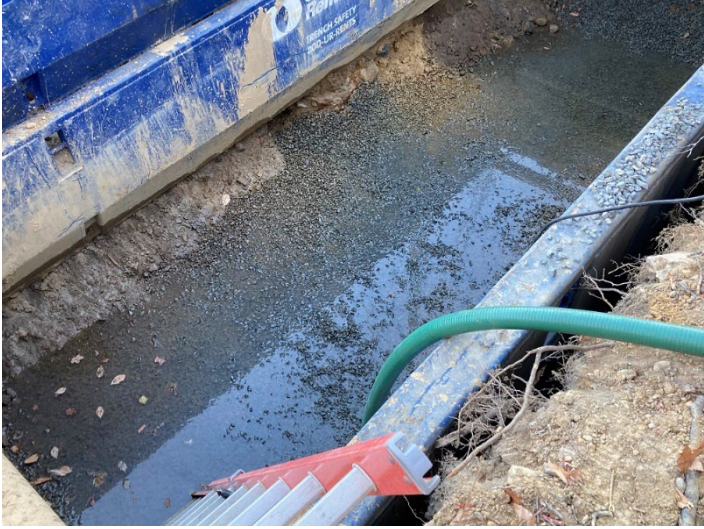
<b>Description:</b> View of dewatering water prior to treatment. Unable to safely collect turbidity samples at this location.

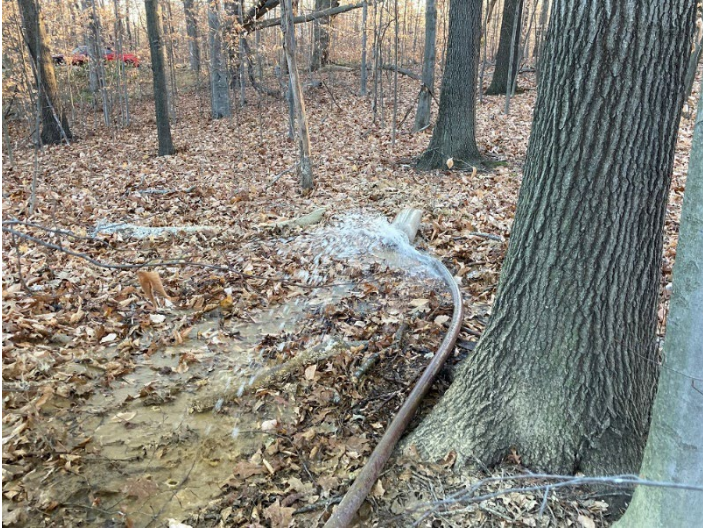
<b>Description:</b> View of dewatering discharge location. Sediment deposition observed. Facing east.

Specific location where problem identified: MH #1	
Provide a description of the specific condition that triggered the need for corrective action and the cause (if identifiable): Turbidity reading for 11/22/2022 exceeded 50 NTUs and sediment plume was deposited below discharge point and was at risk of reaching drainage structure.	
Section C – Corrective Action Completion (CGP Part 5.4.1.b)	
Complete this section <u>within 24 hours</u> after completing the corrective action.	
For site condition # 1, 2, 3, 4, or 6 (those not related to a dewatering discharge) confirm that you met the following deadlines (CGP Part 5.2.1):	
<input type="checkbox"/> Immediately took all reasonable steps to address the condition, including cleaning up any contaminated surfaces so the material will not discharge in subsequent storm events. <b>AND</b>	
<input type="checkbox"/> Completed corrective action by the close of the next business day, unless a new or replacement control, or significant repair, was required. <b>OR</b>

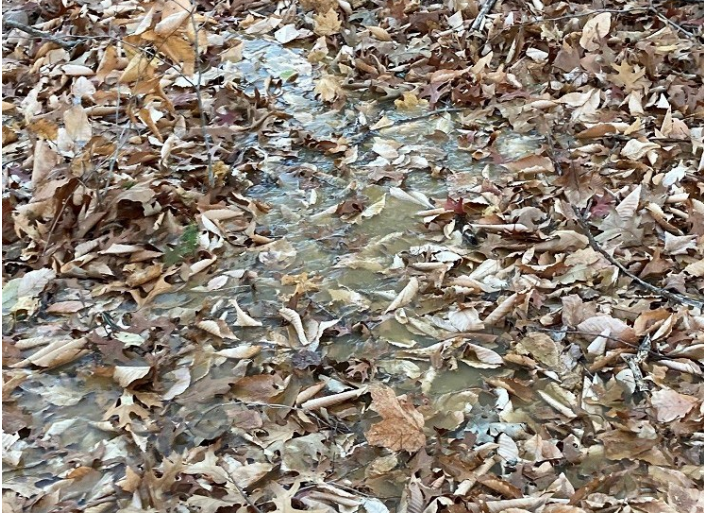
<b>Description:</b> View of final discharge after treatment. Turbid water observed. Turbidity samples taken at this location.

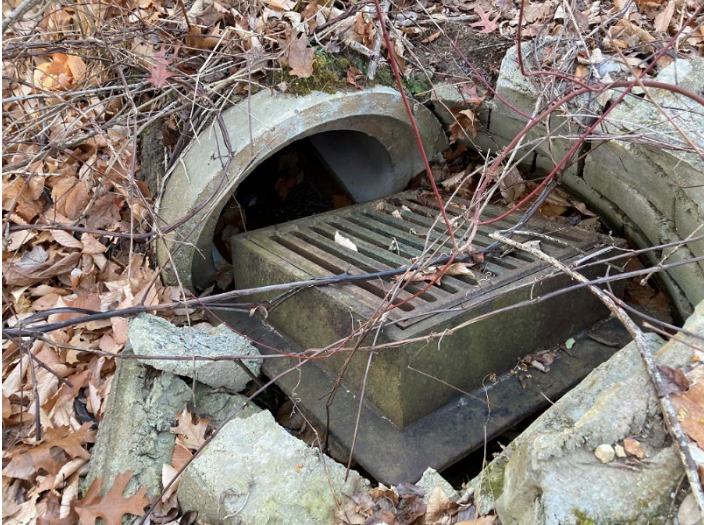
<b>Description:</b> View of storm drain inlet and culvert downstream of dewatering discharge. Turbidity samples taken at this location. Unable to determine discharge location of inlet and culvert. Turbidity monitoring was conducted as a precaution. Facing north.

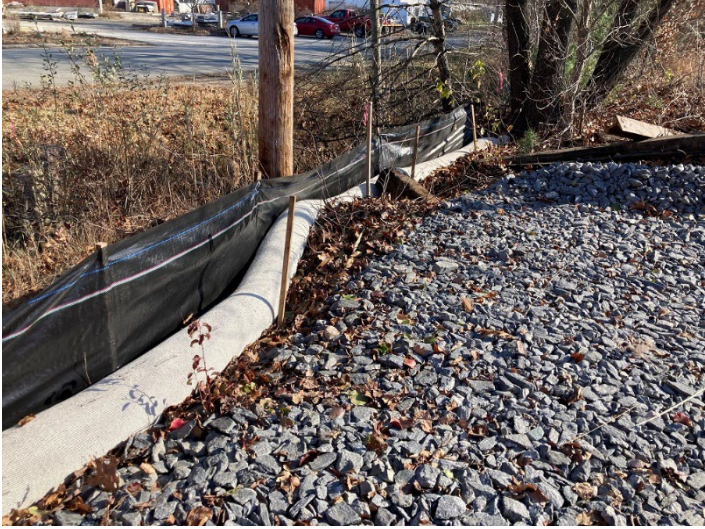
<b>Description:</b> View of E&S controls at Union Ave entrance pad. Controls are in good condition and operating properly. Straw wattles have been replaced with filter tubes. Facing east.

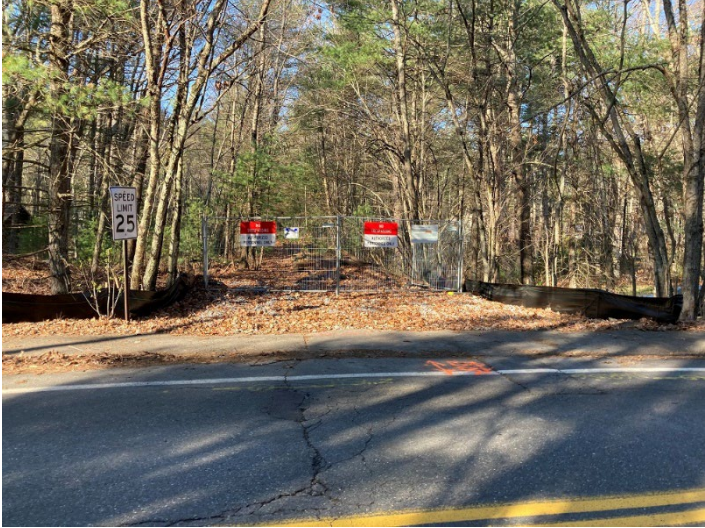
<b>Description:</b> View of construction entrance pad and silt fence at Peakham Rd. Silt fence is in good condition and operating properly. Facing west.

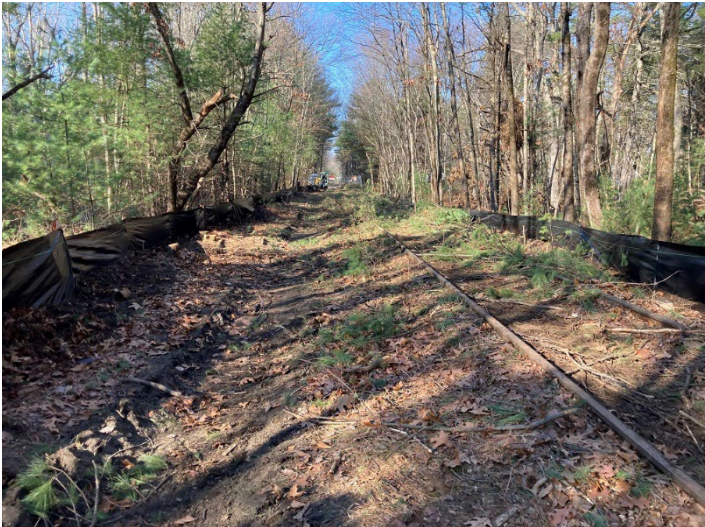
<b>Description:</b> Installation of syncopated silt fence is in progress in Segment 6 off White Pond Rd. Facing east.

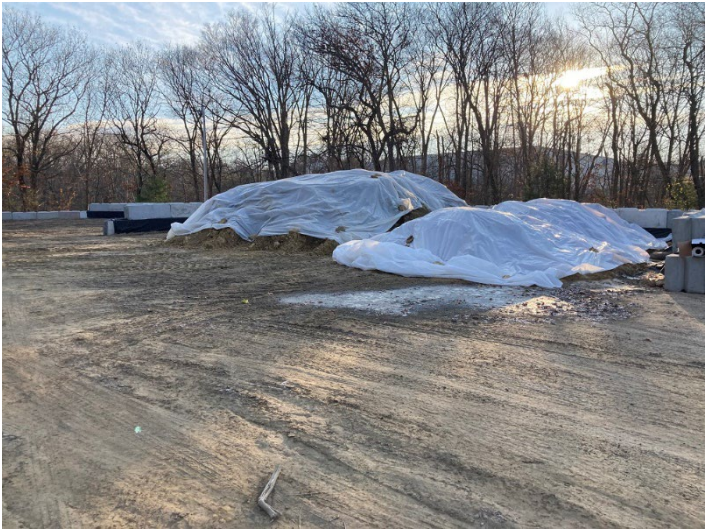
<b>Description:</b> View of laydown yard at Stowe Ct. Silt fence is operating properly. Inactive pile is covered. Additional cement barriers are scheduled to be delivered next week. Facing northeast.

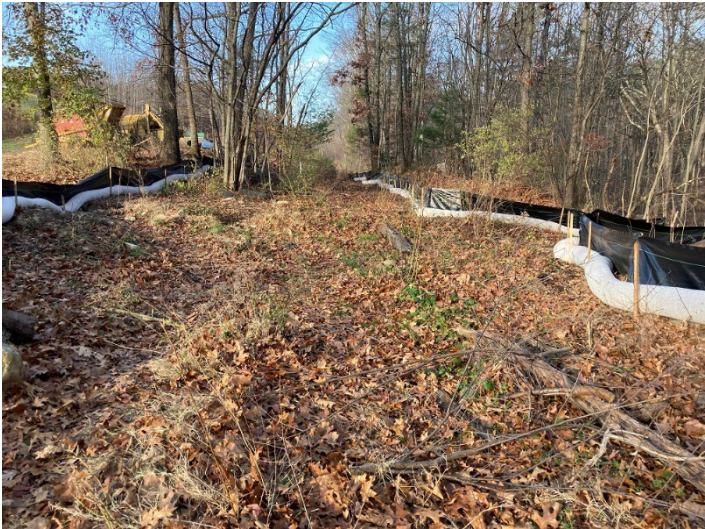
<b>Description:</b> View of E&S controls in Stow portion of project (Segment 1). Controls are in good condition and operating properly. Facing west.

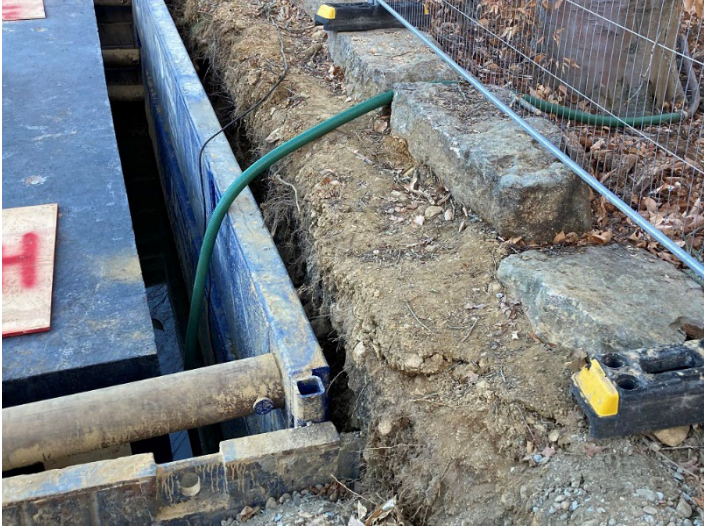
<b>Description:</b> View of dewatering water prior to treatment. Unable to safely collect turbidity samples at this location.

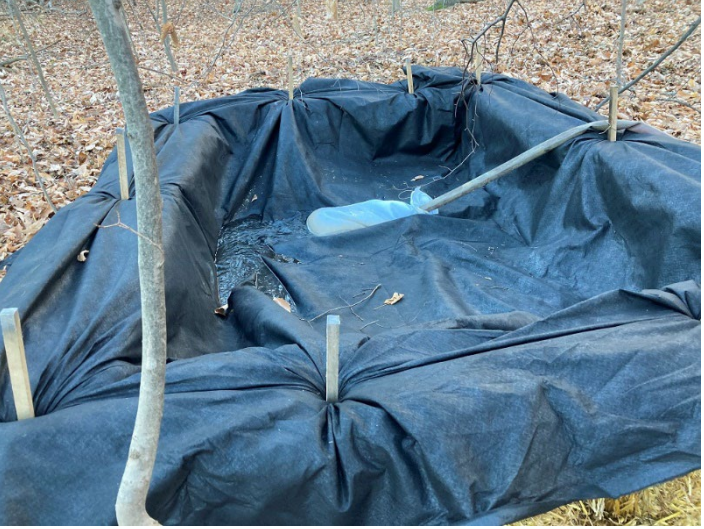
<b>Description:</b> View of dewatering discharge and controls. Facing east.

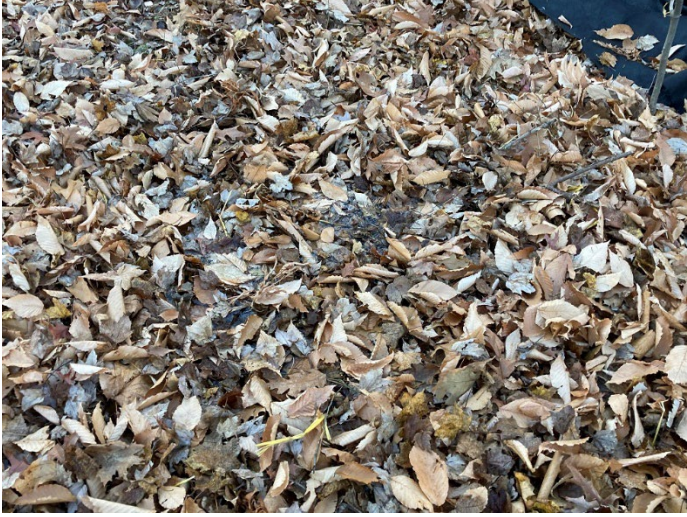
<b>Description:</b> View of final discharge after treatment. Water appeared to be clear. Turbidity samples taken at this location.

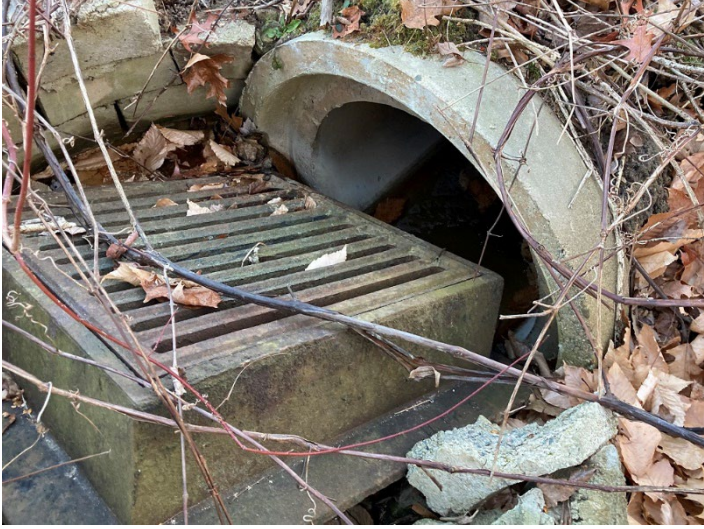
<b>Description:</b> View of storm drain inlet and culvert downstream of dewatering discharge. Turbidity samples taken at this location. Unable to determine discharge location of inlet and culvert. Turbidity monitoring was conducted as a precaution. Facing north.
