## Weekly Environmental Compliance Summary

**Sudbury to Hudson Transmission Reliability Project (USEPA Tracking # MAR1003UW)**

Week of: November 28 to December 2, 2022

# CONSTRUCTION MONITORING REPORT Sudbury to Hudson Transmission Project

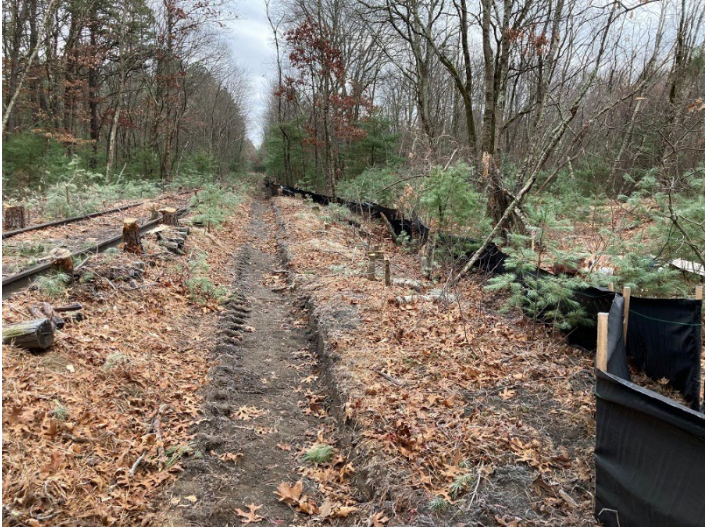
<b>PHOTOGRAPHIC LOG</b>	
<b>Client Name: Eversource</b>		<b>Site Location: Sudbury to Hudson Transmission Reliability Project</b>	<b>Town: Hudson</b>
<b>Photo No.: 1</b>	<b>Date:</b> 11/29/2022

<b>Description:</b> View of silt fence along Segment 6. Conduct maintenance to silt fence as requested by Hudson agent (routine maintenance). Facing east.

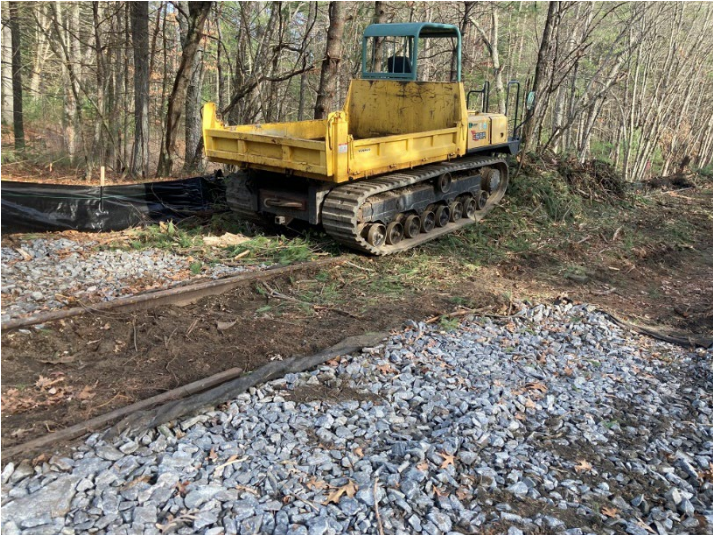
<b>PHOTOGRAPHIC LOG</b>	
<b>Client Name: Eversource</b>		<b>Site Location: Sudbury to Hudson Transmission Reliability Project</b>	<b>Town: Hudson</b>
<b>Photo No.: 2</b>	<b>Date:</b> 11/29/2022

<b>Description:</b> View of section of rail removed in Segment 6, facing northeast.

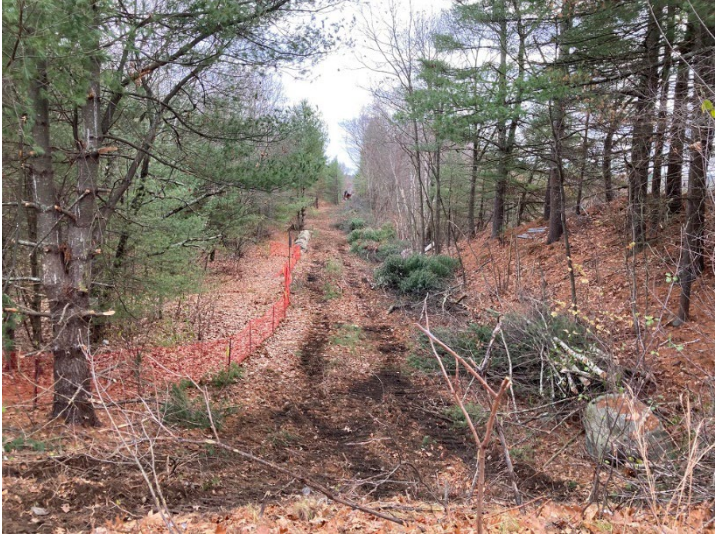
<b>PHOTOGRAPHIC LOG</b>	
<b>Client Name:</b> Eversource		<b>Site Location:</b> Sudbury to Hudson Transmission Reliability Project	<b>Town:</b> Hudson
<b>Photo No.:</b> 3	<b>Date:</b> 11/29/2022

<b>Description:</b> View of clearing activities in Segment 2, facing east.

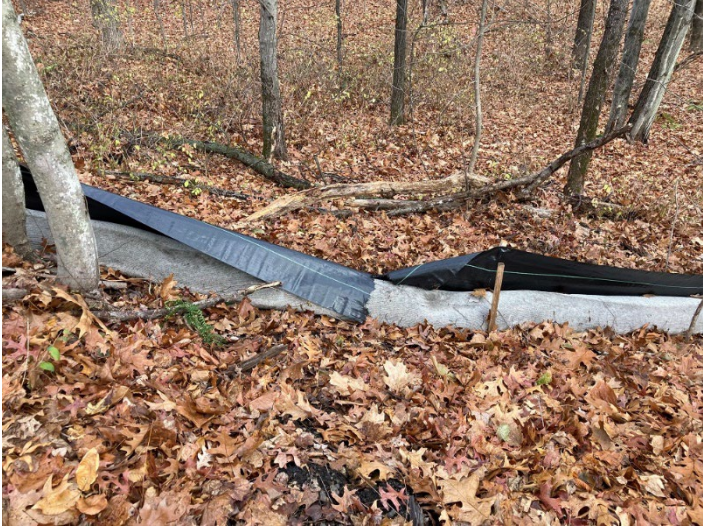
<b>PHOTOGRAPHIC LOG</b>	
<b>Client Name:</b> Eversource		<b>Site Location:</b> Sudbury to Hudson Transmission Reliability Project	<b>Town:</b> Stow
<b>Photo No.:</b> 4	<b>Date:</b> 11/29/2022

Compliance with Previous Observations?  
**Previous observations that needs attention:**  
**-Repair damaged/torn silt fence in Stow portion of project (between Stations 125 and 126 left in segment 1).**  
**-Conduct maintenance to silt fence as requested by Hudson agent.**

<b>Description:</b> Repair damaged/torn silt fence in Stow portion of project (between Station 125 and 126 left in segment 1) (routine maintenance). Facing north.

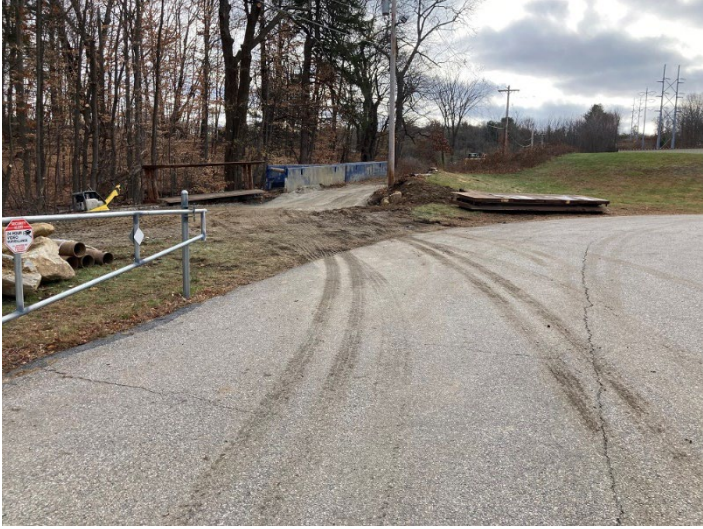
<b>PHOTOGRAPHIC LOG</b>	
<b>Client Name:</b> Eversource		<b>Site Location:</b> Sudbury to Hudson Transmission Reliability Project	<b>Town:</b> Hudson
<b>Photo No.:</b> 5	<b>Date:</b> 11/29/2022

<b>Description:</b> View of sediment tracking at MH#1/Hudson substation. Please address sediment tracking noted in multiple locations onsite (routine maintenance). Facing southeast.

- Address sediment tracking noted in multiple areas of project.**
- 
-

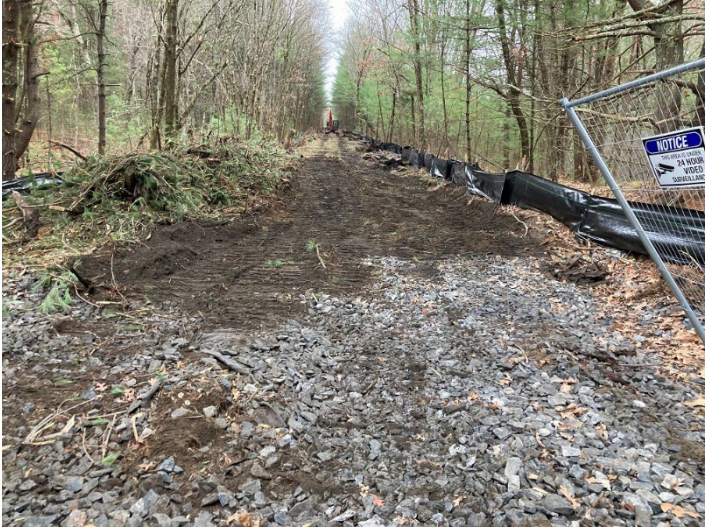
<p align="center"><b>PHOTOGRAPHIC LOG</b></p>	
<p><b>Client Name:</b> Eversource</p>		<p><b>Site Location:</b> Sudbury to Hudson Transmission Reliability Project</p>	<p><b>Town:</b> Hudson</p>
<p><b>Photo No.:</b> 1</p>	<p><b>Date:</b> 11/30/2022</p>

<p><b>Description:</b> View of rain and tie removal in Segment 6, facing east.</p>

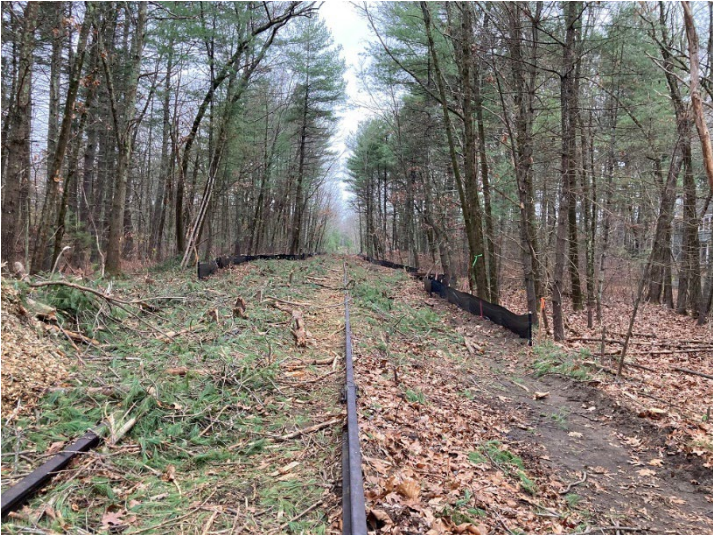
<p align="center"><b>PHOTOGRAPHIC LOG</b></p>	
<p><b>Client Name:</b> Eversource</p>		<p><b>Site Location:</b> Sudbury to Hudson Transmission Reliability Project</p>	<p><b>Town:</b> Hudson</p>
<p><b>Photo No.:</b> 2</p>	<p><b>Date:</b> 11/30/2022</p>

<p><b>Description:</b> View of E&amp;S controls installed in Segment 5, facing west.</p>

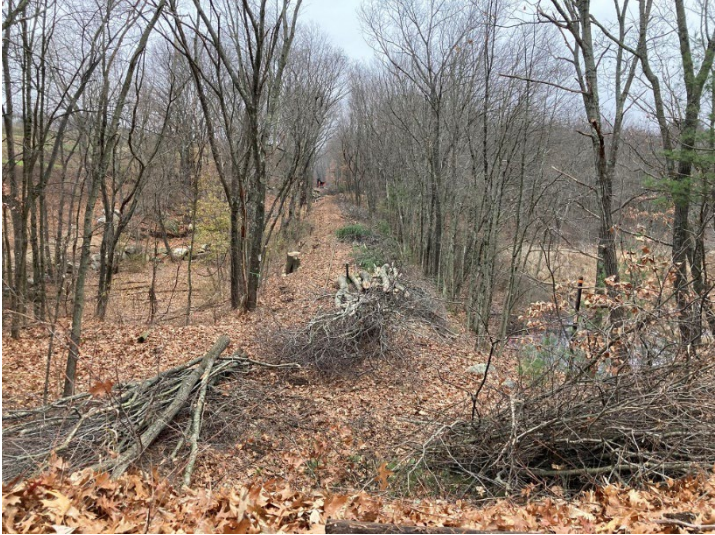
<b>PHOTOGRAPHIC LOG</b>	
<b>Client Name:</b> Eversource		<b>Site Location:</b> Sudbury to Hudson Transmission Reliability Project	<b>Town:</b> Hudson
<b>Photo No.:</b> 3	<b>Date:</b> 11/30/2022

<b>Description:</b> View of cleared section of Segment 1, facing west.

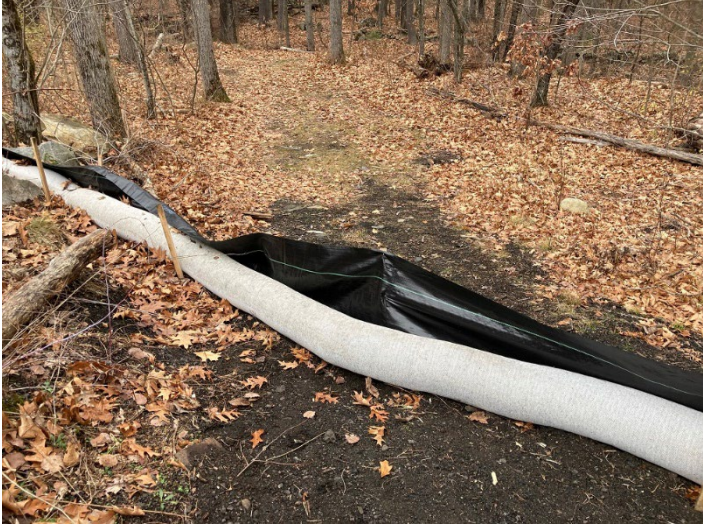
<b>PHOTOGRAPHIC LOG</b>	
<b>Client Name:</b> Eversource		<b>Site Location:</b> Sudbury to Hudson Transmission Reliability Project	<b>Town:</b> Stow
<b>Photo No.:</b> 4	<b>Date:</b> 11/30/2022

<b>Description:</b> Damaged/torn silt fence in Stow portion of project (between Station 125 and 126 left in segment 1) has been repaired (routine maintenance has been addressed). Facing north.

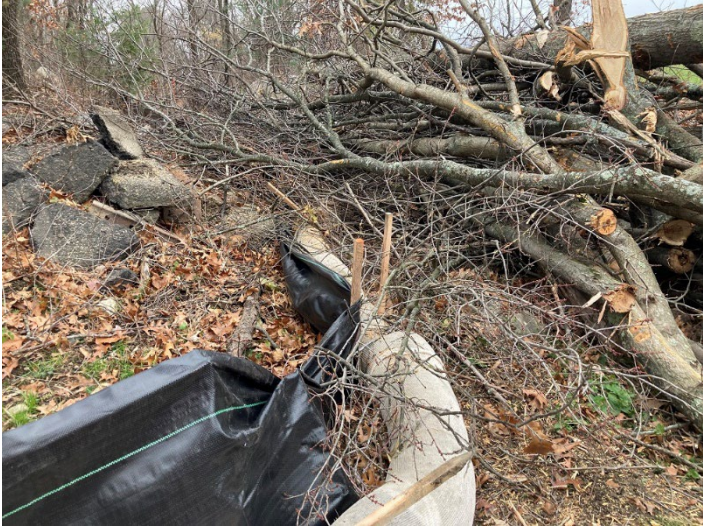
<p align="right"><b>PHOTOGRAPHIC LOG</b></p>	
<p><b>Client Name:</b> Eversource</p>		<p><b>Site Location:</b> Sudbury to Hudson Transmission Reliability Project</p>	<p><b>Town:</b> Stow</p>
<p><b>Photo No.:</b> 5</p>	<p><b>Date:</b> 11/30/2022</p>

**-Portion of silt fence is damaged in Stow (Segment 1) due to tree piles. Silt fence will be repaired once tree piles have been removed.**

<p><b>Description:</b>                  Portion of silt fence is damaged in Stow (Segment 1) due to tree piles. Silt fence will be repaired once tree piles have been removed. Facing east.</p>

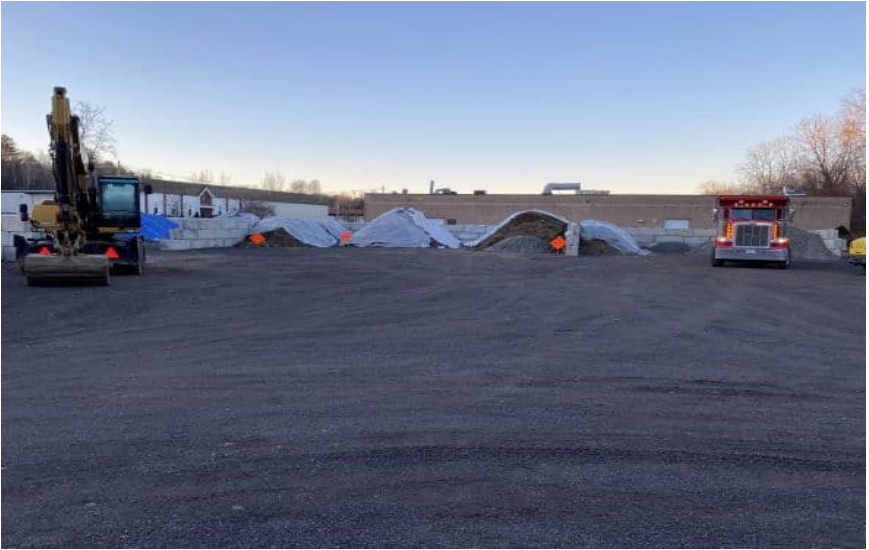
<p>PHOTOGRAPHIC LOG</p>	
<p>Client Name: Eversource</p>		<p>Site Location: Sudbury to Hudson Transmission Reliability Project</p>	<p>Town: Hudson</p>
<p>Photo No.: 1</p>	<p>Date: 12-02-22</p>

<p>Description:</p> <p>Bond laydown yard at 17 Bonazzoli Avenue showing covered stockpiles and categorized by soil type (orange signs), looking southward.</p>

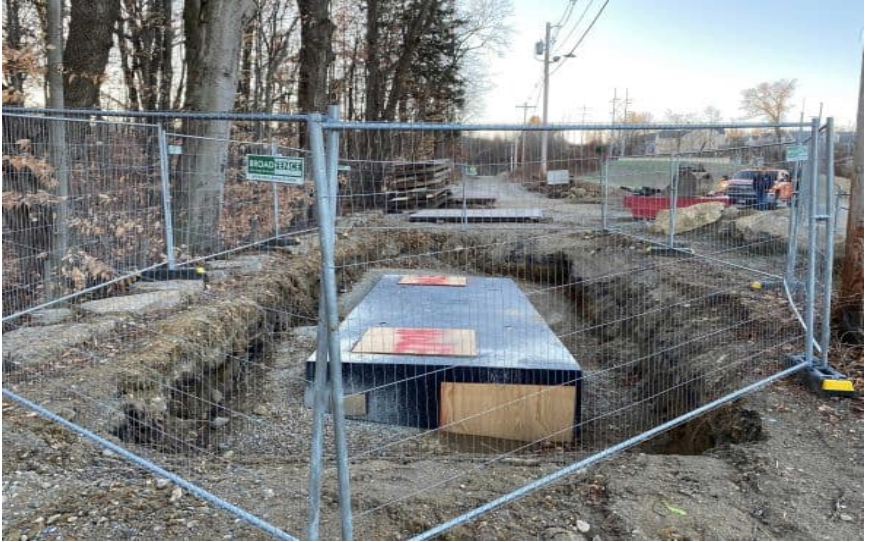
<p>PHOTOGRAPHIC LOG</p>	
<p>Client Name: Eversource</p>		<p>Site Location: Sudbury to Hudson Transmission Reliability Project</p>	<p>Town: Hudson</p>
<p>Photo No.: 2</p>	<p>Date: 12-02-22</p>

<p>Description:</p> <p>MH#1 work area at 49 Forest Avenue, looking eastward.</p>

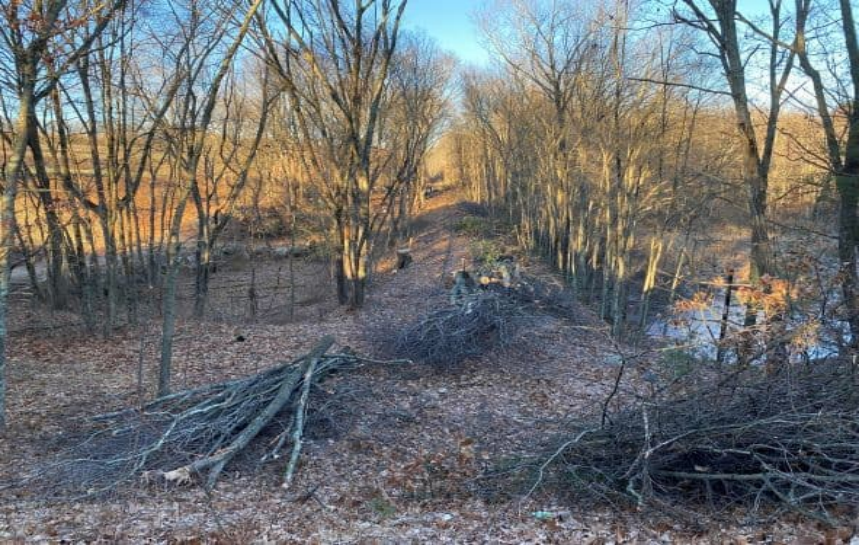
<p>PHOTOGRAPHIC LOG</p>	
<p>Client Name: Eversource</p>		<p>Site Location: Sudbury to Hudson Transmission Reliability Project</p>	<p>Town: Hudson</p>
<p>Photo No.: 4</p>	<p>Date: 12-02-22</p>

<p>Description:</p> <p>Chestnut Street, future placement of silt fencing left side of area, looking westward.</p>

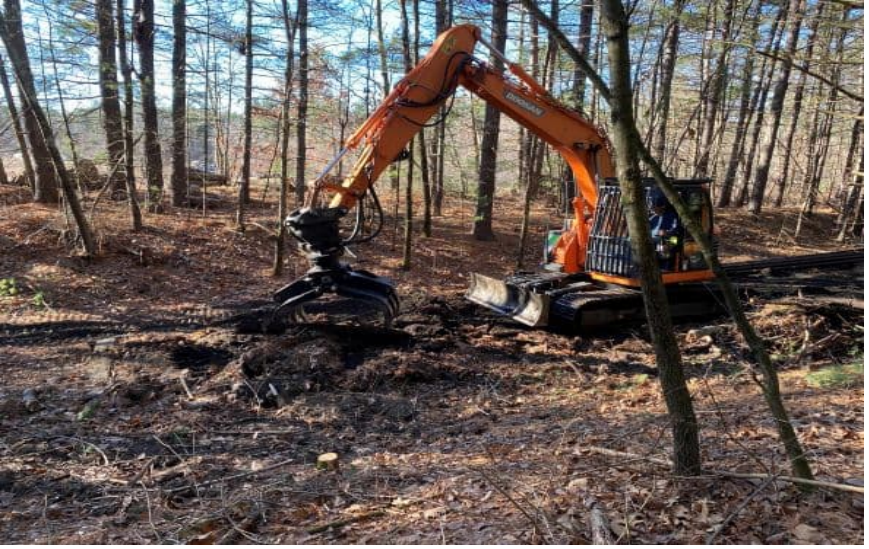
<p>PHOTOGRAPHIC LOG</p>	
<p>Client Name: Eversource</p>		<p>Site Location: Sudbury to Hudson Transmission Reliability Project</p>	<p>Town: Hudson</p>
<p>Photo No.: 6</p>	<p>Date: 12-02-22</p>

<p>Description:</p> <p>Removal of old railroad ties east of White Pond Road at approximate Sta.#344+00, looking southward.</p>

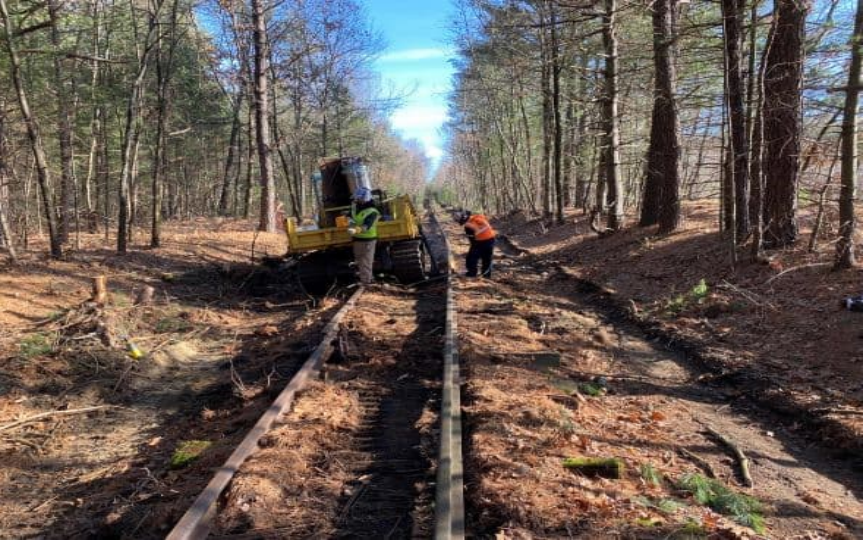
<p>PHOTOGRAPHIC LOG</p>	
<p>Client Name: Eversource</p>		<p>Site Location: Sudbury to Hudson Transmission Reliability Project</p>	<p>Town: Hudson</p>
<p>Photo No.: 8</p>	<p>Date: 12-02-22</p>

<p>Description:</p> <p>Cutting of rail east of White Pond Road at approximate Station # 349+50, looking eastward.</p>

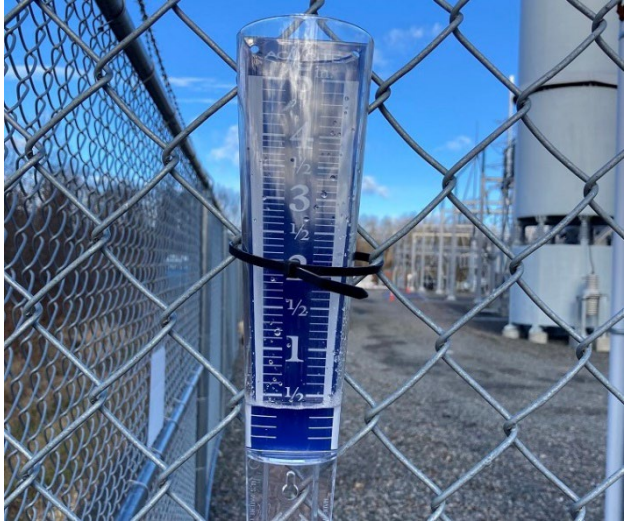
<b>PHOTOGRAPHIC LOG</b>	
<b>Client Name:</b> Eversource		<b>Site Location:</b> Sudbury to Hudson Transmission Reliability Project	
<b>Town:</b> Sudbury			
<b>Photo No.:</b> 1	<b>Date:</b> 11-28-2022

<b>Description:</b> View of rain gauge at Sudbury substation. Rainfall amount was 0.45" at 10:30am on 11-28-2022. Facing north.

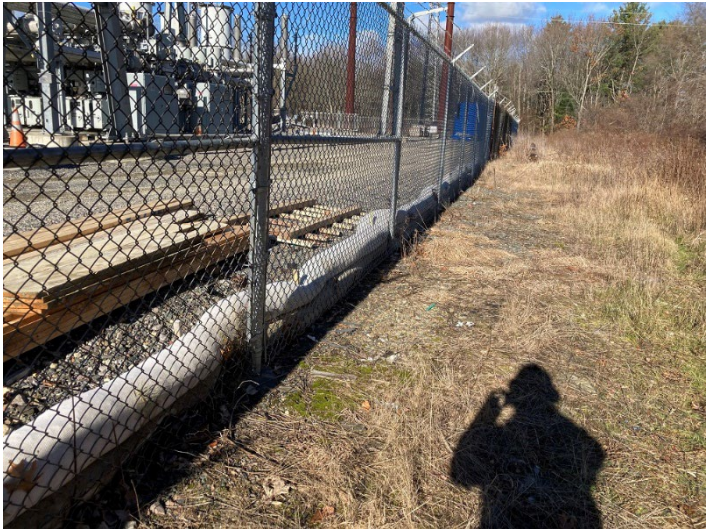
<b>PHOTOGRAPHIC LOG</b>	
<b>Client Name:</b> Eversource		<b>Site Location:</b> Sudbury to Hudson Transmission Reliability Project	
<b>Town:</b> Sudbury			
<b>Photo No.:</b> 2	<b>Date:</b> 11-28-2022

<b>Description:</b> View of E&S controls at Sudbury Substation. Controls are in good condition and operating properly. Facing northwest.

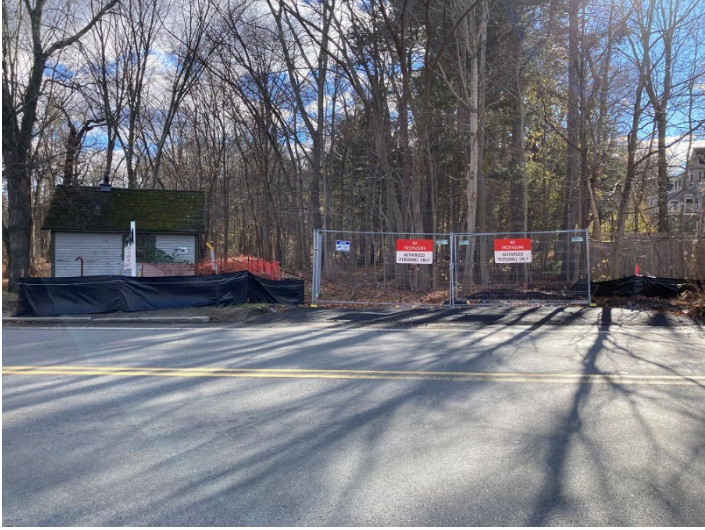
<b>PHOTOGRAPHIC LOG</b>	
<b>Client Name:</b> Eversource		<b>Site Location:</b> Sudbury to Hudson Transmission Reliability Project	<b>Town:</b> Sudbury
<b>Photo No.:</b> 3	<b>Date:</b> 11-28-2022

<b>Description:</b> View of construction entrance pad and silt fence at Boston Post Rd. Silt fence is in good condition and operating properly. Facing southeast.

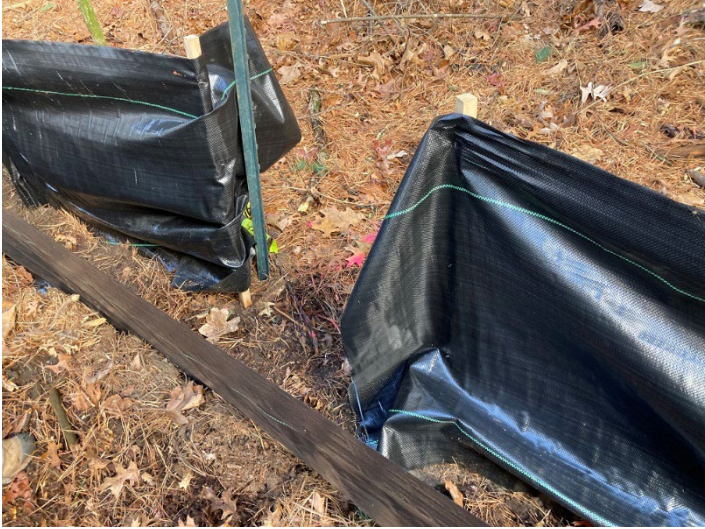
<b>PHOTOGRAPHIC LOG</b>	
<b>Client Name:</b> Eversource		<b>Site Location:</b> Sudbury to Hudson Transmission Reliability Project	<b>Town:</b> Hudson
<b>Photo No.:</b> 4	<b>Date:</b> 11-28-2022

<b>Description:</b> Installation of syncopated silt fence is in progress in Segment 6 off White Pond Rd. Conduct maintenance to silt fence as requested by Hudson agent (routine maintenance). Facing north.

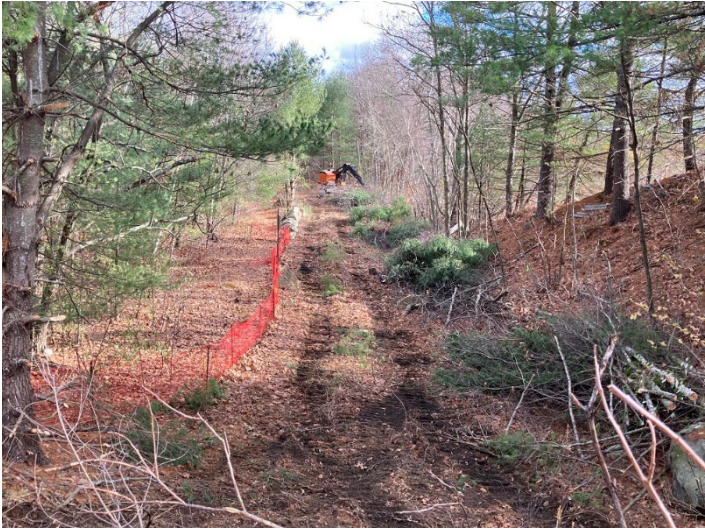
<b>PHOTOGRAPHIC LOG</b>	
<b>Client Name:</b> Eversource		<b>Site Location:</b> Sudbury to Hudson Transmission Reliability Project	<b>Town:</b> Hudson
<b>Photo No.:</b> 5	<b>Date:</b> 11-28-2022

<b>Description:</b> View of clearing activities in Segment 2, off Chesnut St, facing east.

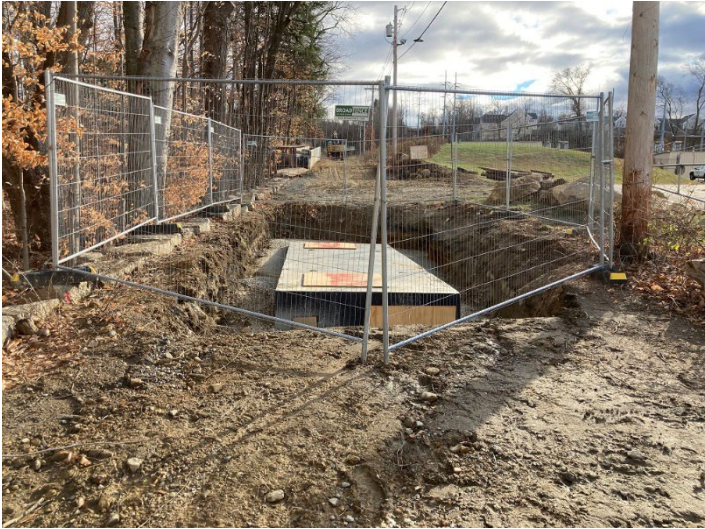
<b>PHOTOGRAPHIC LOG</b>	
<b>Client Name:</b> Eversource		<b>Site Location:</b> Sudbury to Hudson Transmission Reliability Project	<b>Town:</b> Hudson
<b>Photo No.:</b> 6	<b>Date:</b> 11-28-2022

<b>Description:</b> View of active work at MH#1. No issues observed. Facing south.

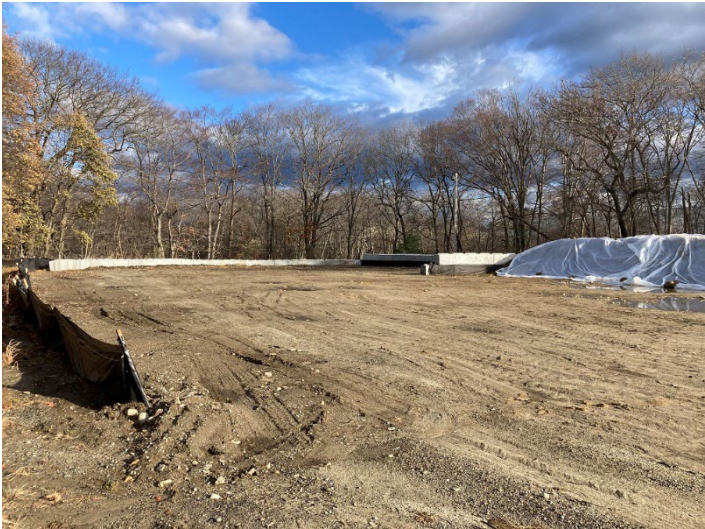
<b>Epsilon</b> ASSOCIATES INC.		<b>PHOTOGRAPHIC LOG</b>	
Client Name: Eversource		Site Location: Sudbury to Hudson Transmission Reliability Project	Town: Hudson
Photo No.: 7	Date: 11-28-2022

<b>Description:</b> View of laydown yard at Stowe Ct. Silt fence is operating properly. Inactive pile is covered. Additional cement barriers are scheduled to be delivered this week. Facing northeast.

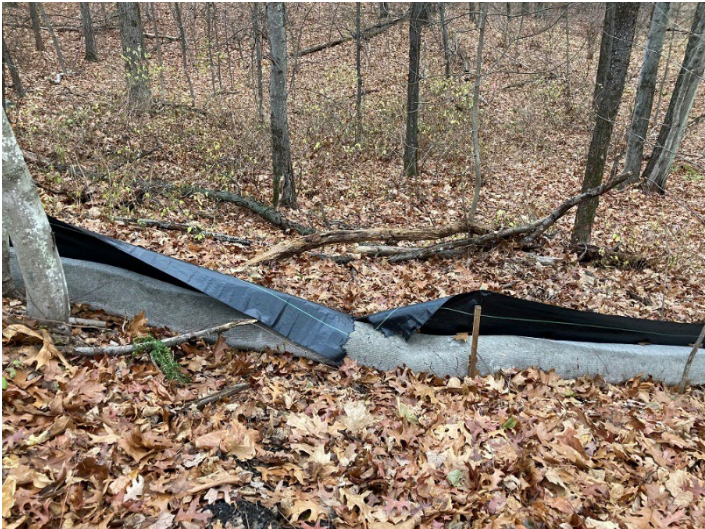
<b>Epsilon</b> ASSOCIATES INC.		<b>PHOTOGRAPHIC LOG</b>	
Client Name: Eversource		Site Location: Sudbury to Hudson Transmission Reliability Project	Town: Stow
Photo No.: 8	Date: 11-28-2022

8. Silt Fencing and filter tubes in Stow (Segment 1 off Chesnut Dr)	<input checked="" type="checkbox"/> Yes <input type="checkbox"/> No	1	<input type="checkbox"/> Yes <input checked="" type="checkbox"/> No	11/28/2022	-Repair silt fence where damaged/torn in Stow portion of project (between Stations 125 and 126 left in segment 1) (routine maintenance). -Filter tubes are installed per the plan and operating properly.

<b>Description:</b> View of E&S controls in Stow portion of project (Segment 1). Repair silt fence where damaged/torn between Stations 125 and 126 left (routine maintenance). Facing north.

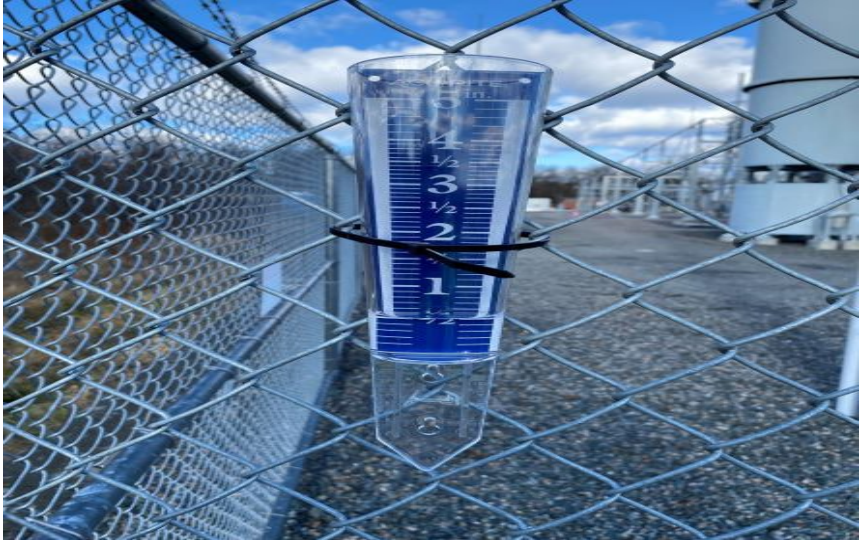
<b>PHOTOGRAPHIC LOG</b>	
<b>Client Name:</b> Eversource		<b>Site Location:</b> Sudbury to Hudson Transmission Reliability Project	<b>Town:</b> Sudbury
<b>Photo No.:</b> 1	<b>Date:</b> 12-01-22

<b>Description:</b>  Rain gauge at Sudbury Substation showing approximately 0.60", looking northward. Rain from event on 11-30-22.

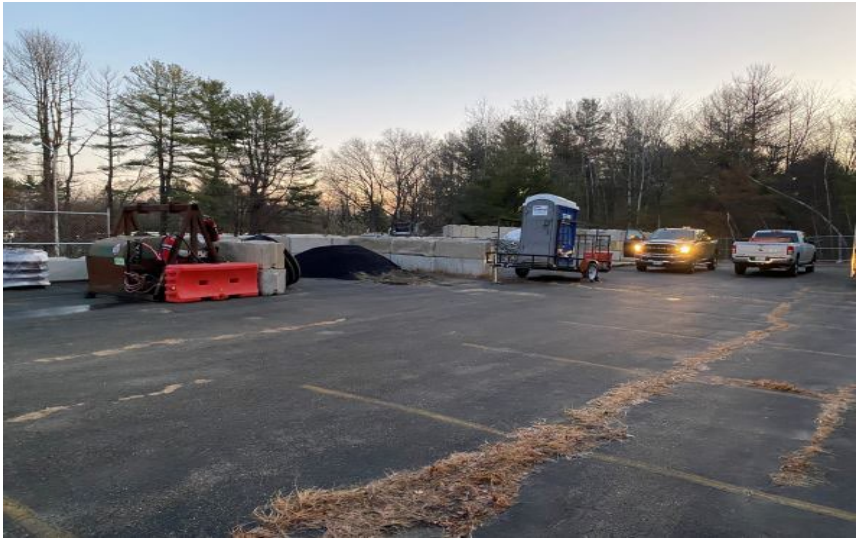
<b>PHOTOGRAPHIC LOG</b>	
<b>Client Name:</b> Eversource		<b>Site Location:</b> Sudbury to Hudson Transmission Reliability Project	<b>Town:</b> Hudson
<b>Photo No.:</b> 2	<b>Date:</b> 12-01-22

<b>Description:</b>  Bond laydown yard at 555 Main Street showing storage areas, looking southward, storage bins in good condition and operating properly.

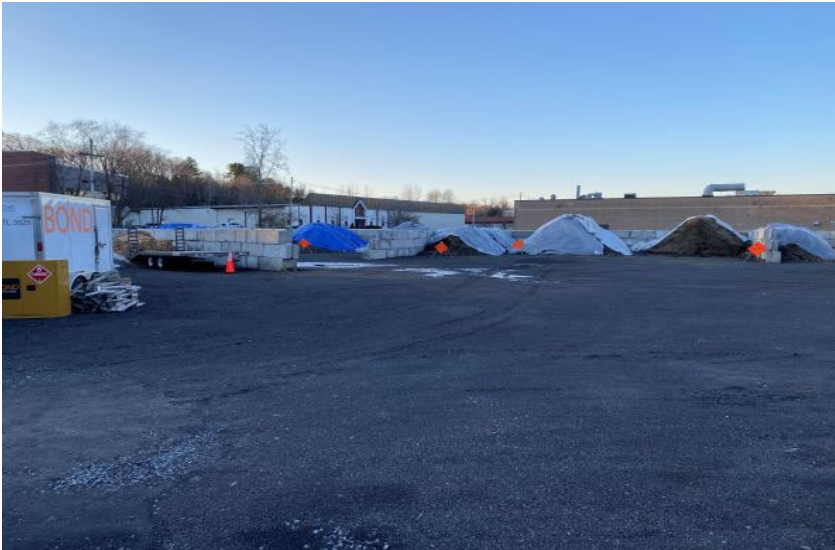
<b>Epsilon</b> ASSOCIATES INC.		<b>PHOTOGRAPHIC LOG</b>	
Client Name: Eversource		Site Location: Sudbury to Hudson Transmission Reliability Project	Town: Hudson
Photo No.: 4	Date: 12-01-22

<b>Description:</b>  Bond laydown yard at 17 Bonazzoli Avenue showing storage areas, looking southward, storage bins in good condition and operating properly.

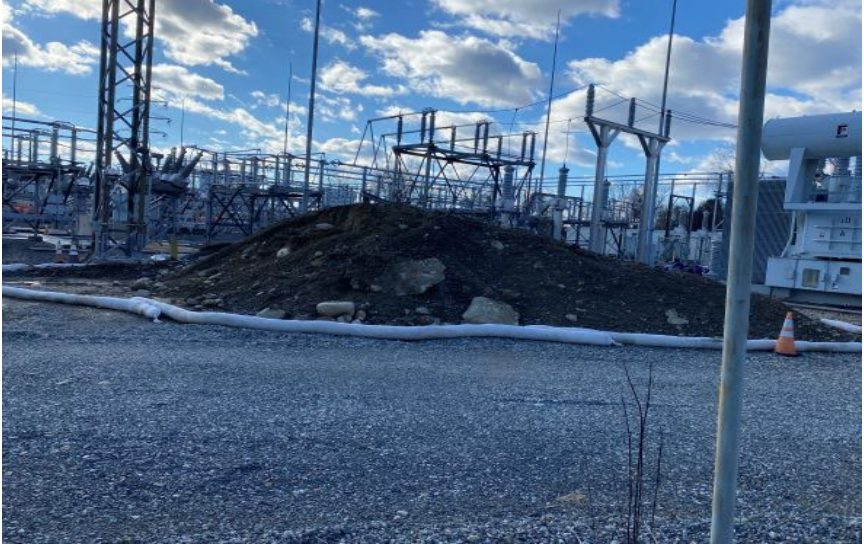
<b>PHOTOGRAPHIC LOG</b>	
<b>Client Name:</b> Eversource		<b>Site Location:</b> Sudbury to Hudson Transmission Reliability Project	<b>Town:</b> Sudbury
<b>Photo No.:</b> 5	<b>Date:</b> 12-01-22

<b>Description:</b>  Sudbury Substation, stockpile with filter tubes surrounding stockpile, looking southward. Filter tubes are in good condition and operating properly. Stockpile in compliance.

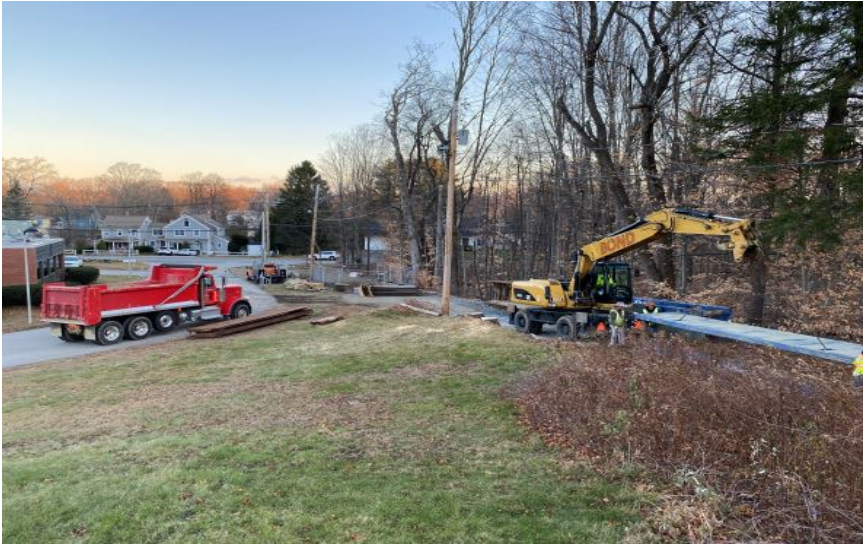
<b>PHOTOGRAPHIC LOG</b>	
<b>Client Name:</b> Eversource		<b>Site Location:</b> Sudbury to Hudson Transmission Reliability Project	<b>Town:</b> Hudson
<b>Photo No.:</b> 6	<b>Date:</b> 12-01-22

<b>Description:</b>  Site work at MH#1 area off Forest Avenue, looking westward.

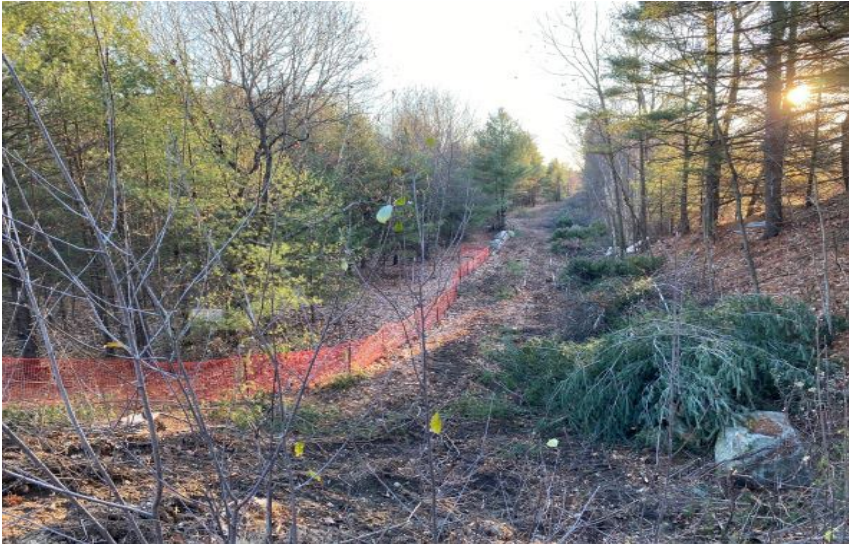
<b>Epsilon</b> ASSOCIATES INC.		<b>PHOTOGRAPHIC LOG</b>	
Client Name: Eversource		Site Location: Sudbury to Hudson Transmission Reliability Project	Town: Hudson
Photo No.: 7	Date: 12-01-22

<b>Description:</b>  Recently clearing along right-of-way off Chestnut Street, looking eastward.

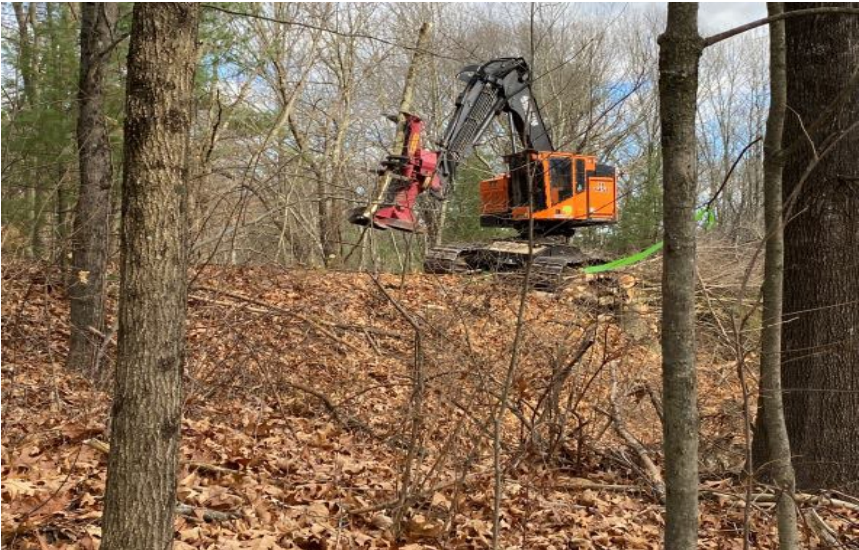
<b>Epsilon</b> ASSOCIATES INC.		<b>PHOTOGRAPHIC LOG</b>	
Client Name: Eversource		Site Location: Sudbury to Hudson Transmission Reliability Project	Town: Hudson
Photo No.: 8	Date: 12-01-22

<b>Description:</b>  Clearing operations using feller buncher off Wilkins Avenue, looking northward.
