Weekly Environmental Compliance Summary

Sudbury to Hudson Transmission Reliability Project (USEPA Tracking # MAR1003UW)

Sudbury, Hudson, and Stow, MA

Week of: December 5 to December 9, 2022

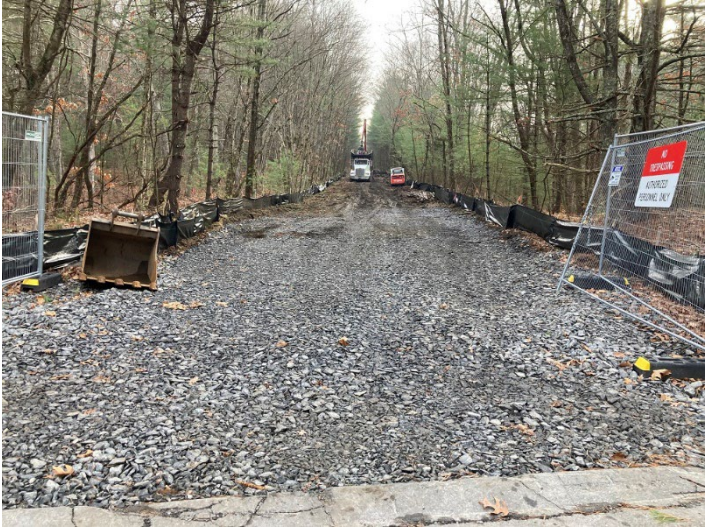
<p align="right">PHOTOGRAPHIC LOG</p>	
Client Name: Eversource		Site Location: Sudbury to Hudson Transmission Reliability Project	Town: Hudson
Photo No.: 1	Date: 12/06/2022

Description: View of construction entrance pad and rail and tie removal in Segment 6, facing east.

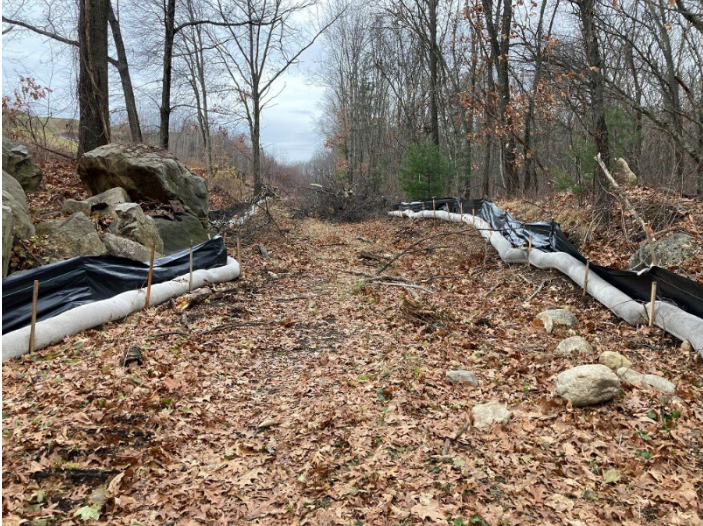
<p align="right">PHOTOGRAPHIC LOG</p>	
Client Name: Eversource		Site Location: Sudbury to Hudson Transmission Reliability Project	Town: Stow
Photo No.: 4	Date: 12/06/2022

-Portion of silt fence is damaged in Stow (Segment 1) due to tree piles. Silt fence will be repaired once tree piles have been removed.

Description: View of Stow portion of project in Segment 1. Portion of silt fence is damaged due to tree piles. Silt fence will be repaired once tree piles have been removed. Facing west.

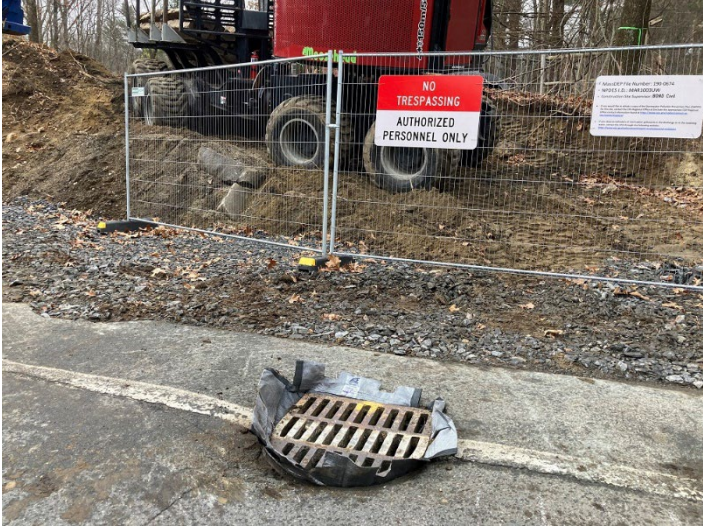
<p align="right">PHOTOGRAPHIC LOG</p>	
<p>Client Name: Eversource</p>		<p>Site Location: Sudbury to Hudson Transmission Reliability Project</p>	<p>Town: Hudson</p>
<p>Photo No.: 5</p>	<p>Date: 12/06/2022</p>

<p>Description: View of construction entrance pad at Wilkins Street. Forwarding and chipping work will begin here 12/07/22. Silt sack inlet protection has been installed in catch basin. Facing east.</p>

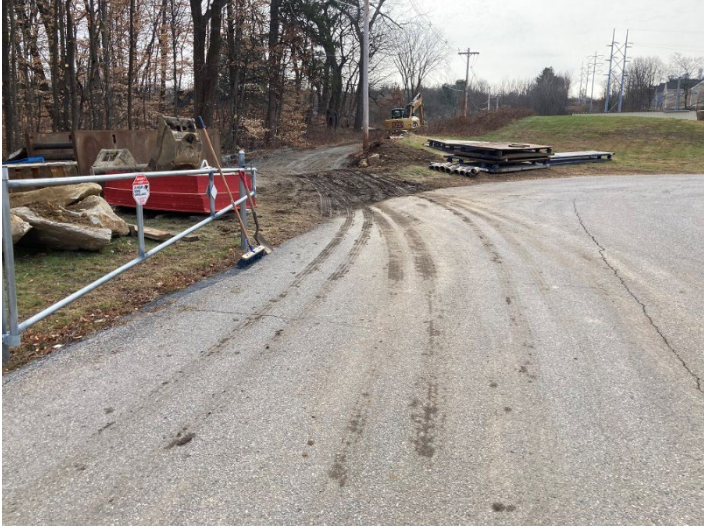
<p align="right">PHOTOGRAPHIC LOG</p>	
<p>Client Name: Eversource</p>		<p>Site Location: Sudbury to Hudson Transmission Reliability Project</p>	<p>Town: Hudson</p>
<p>Photo No.: 6</p>	<p>Date: 12/06/2022</p>

-Sediment tracking noted at MH#1/Hudson substation work area. Sweeping is scheduled for this week.

<p>Description: View of MH#1/Hudson Substation work area. Sediment tracking observed. Sweeping is scheduled for this week. Facing southeast.</p>

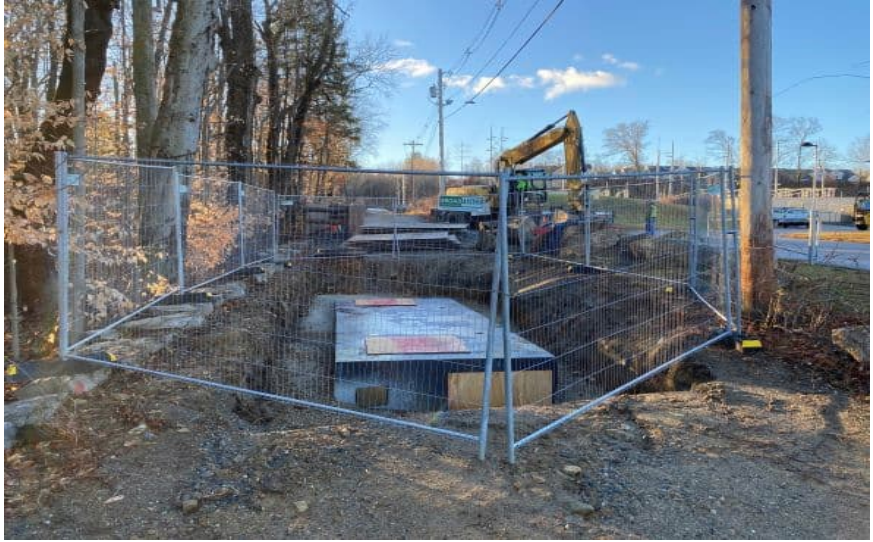
<p>PHOTOGRAPHIC LOG</p>	
<p>Client Name: Eversource</p>		<p>Site Location: Sudbury to Hudson Transmission Reliability Project</p>	<p>Town: Hudson</p>
<p>Photo No.: 2</p>	<p>Date: 12-08-22</p>

<p>Description:</p> <p>MH#1 work area at 49 Forest Avenue, looking eastward.</p>

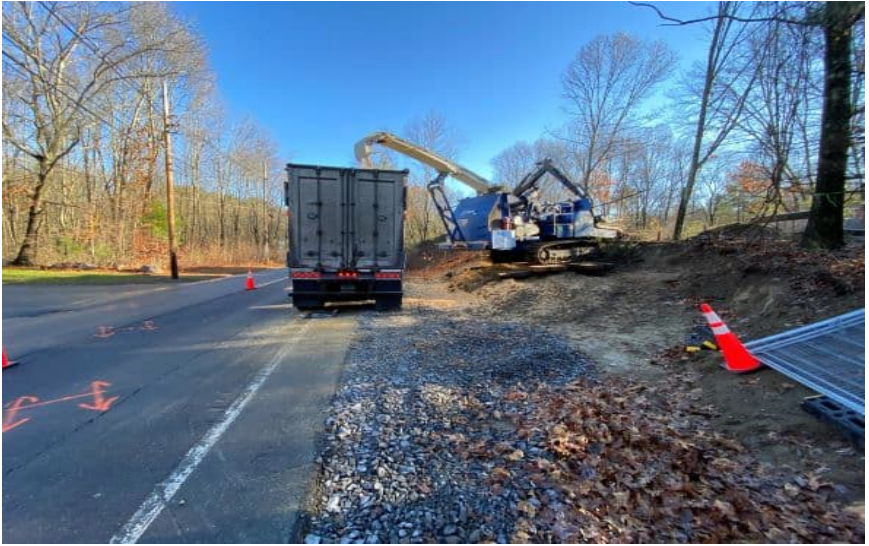
<p>PHOTOGRAPHIC LOG</p>	
<p>Client Name: Eversource</p>		<p>Site Location: Sudbury to Hudson Transmission Reliability Project</p>	<p>Town: Hudson</p>
<p>Photo No.: 3</p>	<p>Date: 12-08-22</p>

<p>Description: Chipping operations at Wilkins Avenue, looking eastward.</p>

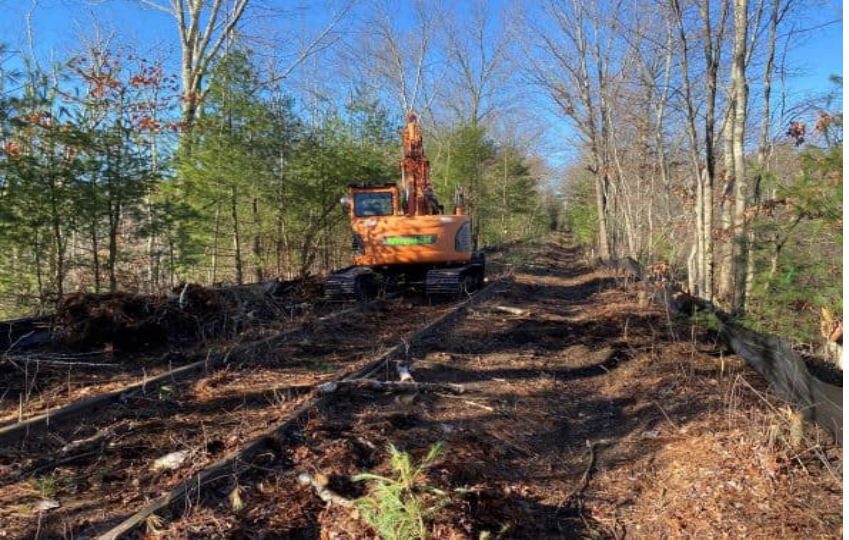
<p>PHOTOGRAPHIC LOG</p>	
<p>Client Name: Eversource</p>		<p>Site Location: Sudbury to Hudson Transmission Reliability Project</p>	<p>Town: Hudson</p>
<p>Photo No.: 6</p>	<p>Date: 12-08-22</p>

<p>Description: Stump removal west of White Pond Road at approximate Sta.#330+50, looking westward.</p>

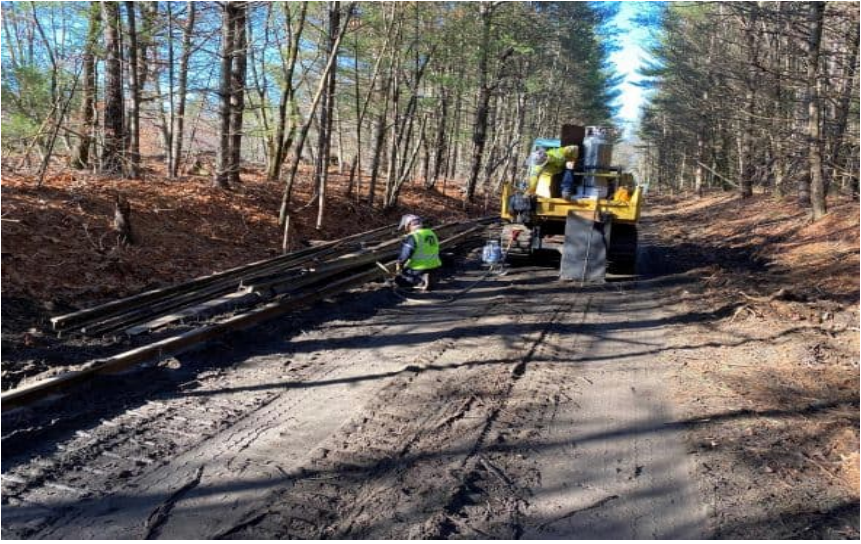
<p>PHOTOGRAPHIC LOG</p>	
<p>Client Name: Eversource</p>		<p>Site Location: Sudbury to Hudson Transmission Reliability Project</p>	<p>Town: Hudson</p>
<p>Photo No.: 7</p>	<p>Date: 12-08-22</p>

<p>Description:</p> <p>Rail cutting east of White Pond Road at approximate Sta.#344+50, looking westward.</p>

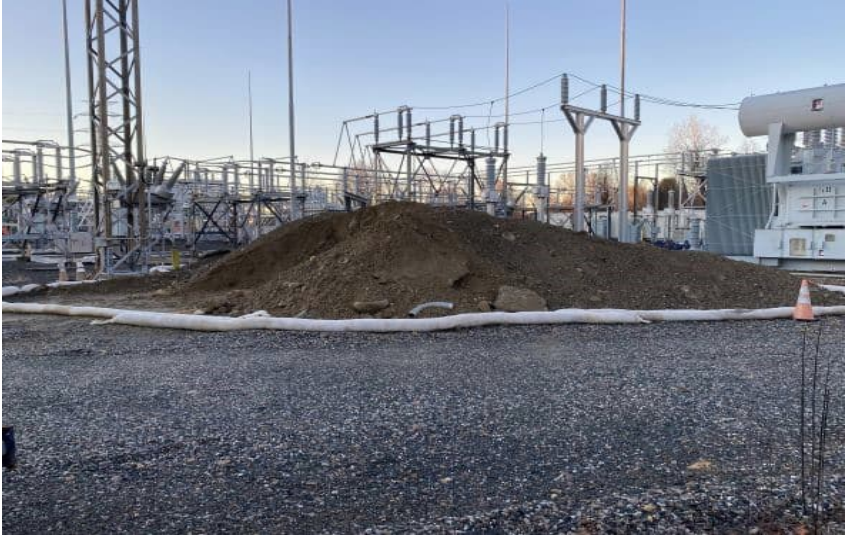
<p>PHOTOGRAPHIC LOG</p>	
<p>Client Name: Eversource</p>		<p>Site Location: Sudbury to Hudson Transmission Reliability Project</p>	<p>Town: Sudbury</p>
<p>Photo No.: 8</p>	<p>Date: 12-08-22</p>

<p>Description:</p> <p>Spoil pile within Sudbury substation, looking southward. Compost filter tube socks surrounding pile, in good condition.</p>

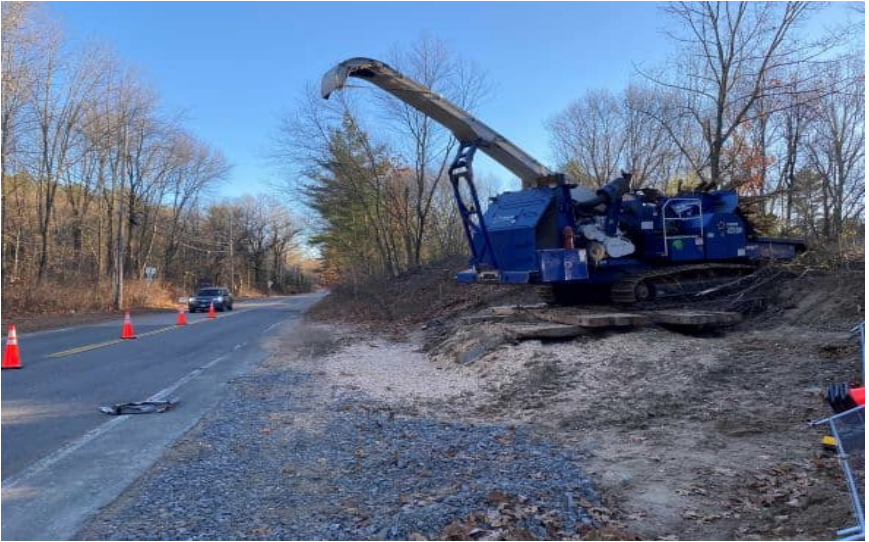
<p>PHOTOGRAPHIC LOG</p>	
<p>Client Name: Eversource</p>		<p>Site Location: Sudbury to Hudson Transmission Reliability Project</p>	<p>Town: Hudson</p>
<p>Photo No.: 3</p>	<p>Date: 12-09-22</p>

<p>Description:</p> <p>Chipping operations at Wilkins Avenue, looking eastward. New filter bag in catch basin on edge of the road.</p>

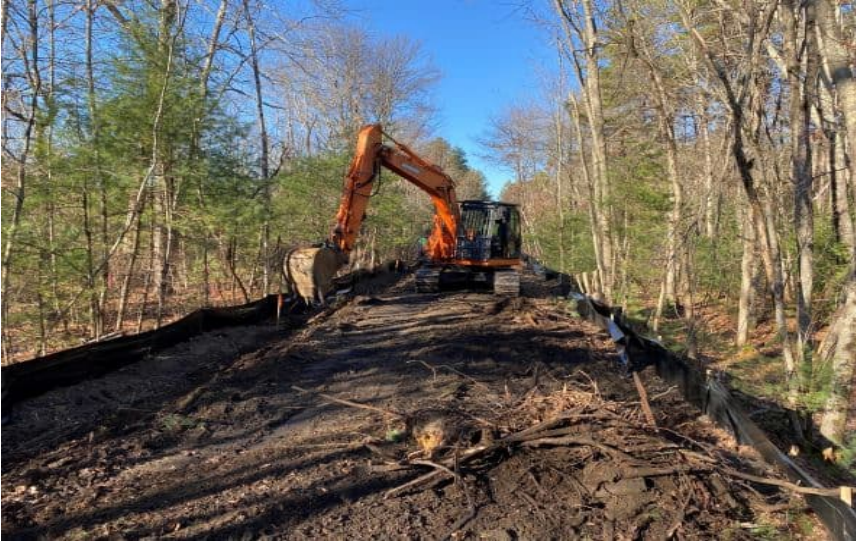
<p>PHOTOGRAPHIC LOG</p>	
<p>Client Name: Eversource</p>		<p>Site Location: Sudbury to Hudson Transmission Reliability Project</p>	<p>Town: Hudson</p>
<p>Photo No.: 6</p>	<p>Date: 12-09-22</p>

<p>Description: Stump removal east of White Pond Road at approximate Sta.#353+50, looking westward.</p>

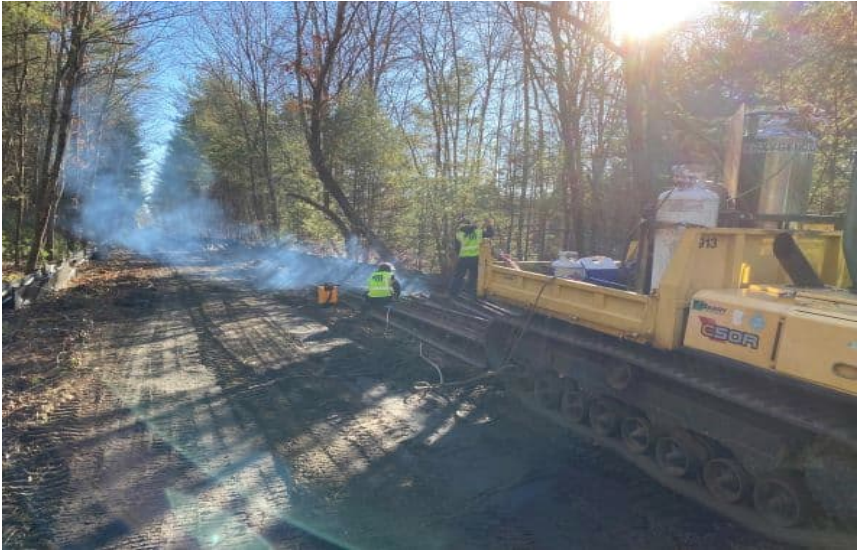
<p>PHOTOGRAPHIC LOG</p>	
<p>Client Name: Eversource</p>		<p>Site Location: Sudbury to Hudson Transmission Reliability Project</p>	<p>Town: Hudson</p>
<p>Photo No.: 7</p>	<p>Date: 12-09-22</p>

<p>Description:</p> <p>Rail cutting east of White Pond Road at approximate Sta.#339+50, looking eastward.</p>

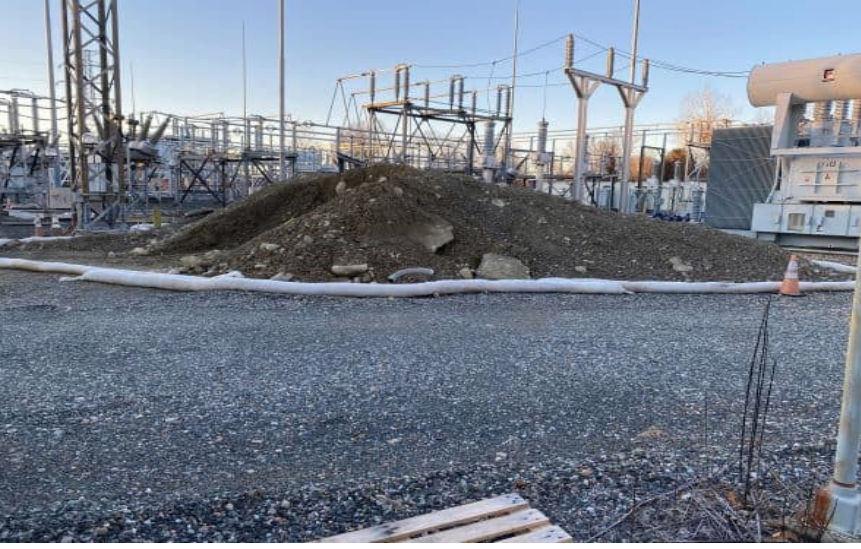
<p>PHOTOGRAPHIC LOG</p>	
<p>Client Name: Eversource</p>		<p>Site Location: Sudbury to Hudson Transmission Reliability Project</p>	<p>Town: Sudbury</p>
<p>Photo No.: 8</p>	<p>Date: 12-09-22</p>

<p>Description:</p> <p>Spoil pile within Sudbury substation, looking southward. Compost filter tube socks surrounding pile, in good condition.</p>

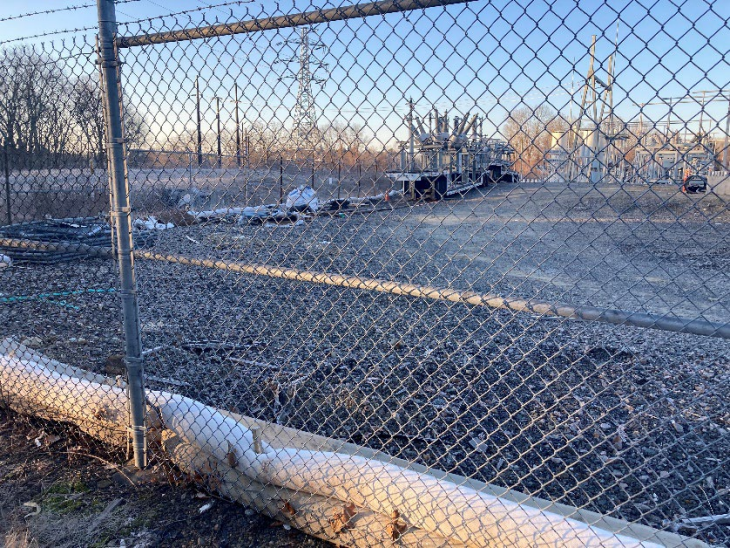
PHOTOGRAPHIC LOG	
Client Name: Eversource		Site Location: Sudbury to Hudson Transmission Reliability Project	Town: Sudbury
Photo No.: 1	Date: 12-05-22

Description: Erosion Control Barrier at existing Substation

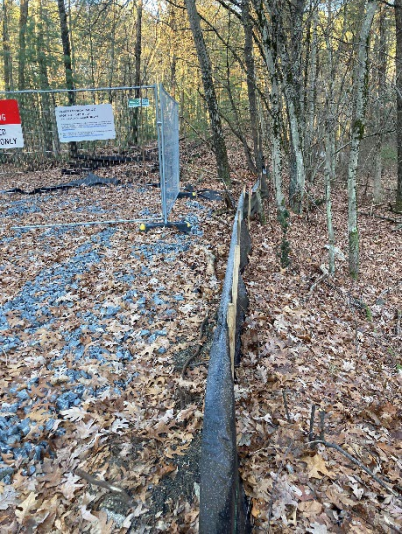
PHOTOGRAPHIC LOG	
Client Name: Eversource		Site Location: Sudbury to Hudson Transmission Reliability Project	Town: Sudbury
Photo No.: 2	Date: 12-05-22

Description: Existing erosion control barrier at Dutton Rd. construction entrance

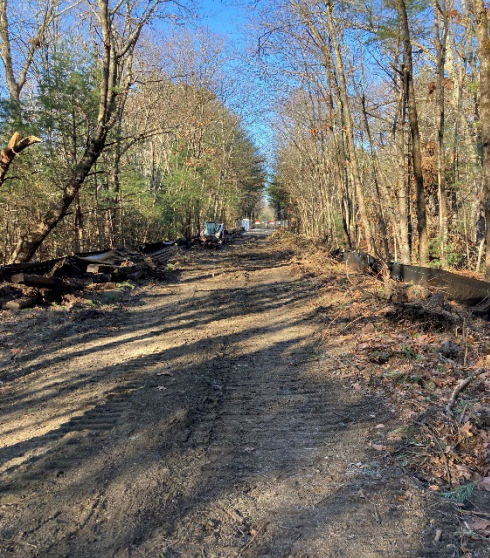
PHOTOGRAPHIC LOG	
Client Name: Eversource		Site Location: Sudbury to Hudson Transmission Reliability Project	Town: Hudson
Photo No.: 3	Date: 12-05-22

Description: Rail Removal activities in Segment 6 (White Pond Rd. to the Town Line)

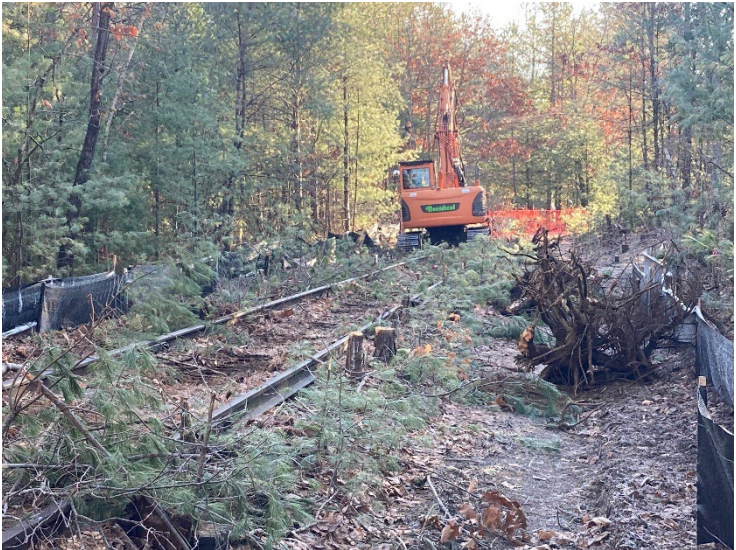
PHOTOGRAPHIC LOG	
Client Name: Eversource		Site Location: Sudbury to Hudson Transmission Reliability Project	Town: Hudson
Photo No.: 4	Date: 12-05-22

Description: Rail Removal activities in Segment 6 (White Pond Rd. to the Town Line)

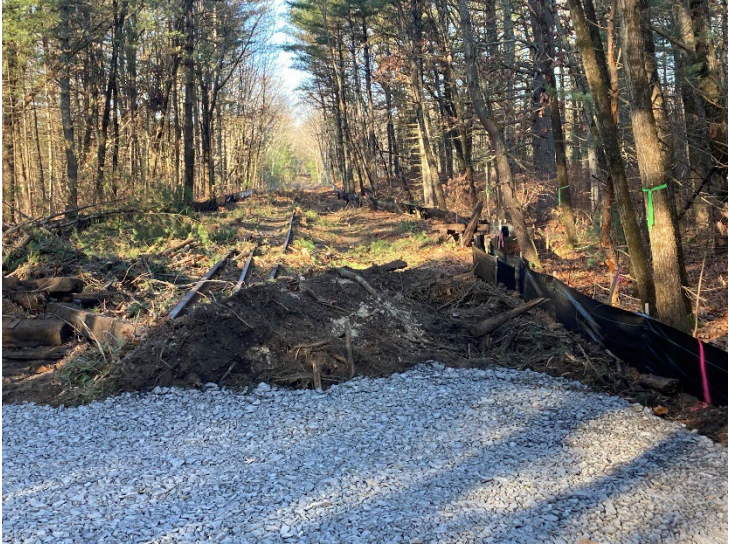
PHOTOGRAPHIC LOG	
Client Name: Eversource		Site Location: Sudbury to Hudson Transmission Reliability Project	Town: Hudson
Photo No.: 5	Date: 12-05-22

Description: Newly installed erosion control barriers in Segment 4 (looking west from Parmenter Road)

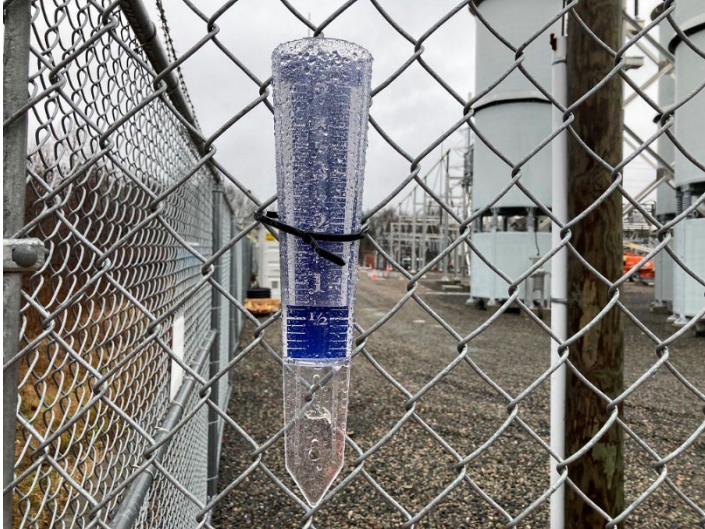
PHOTOGRAPHIC LOG	
Client Name: Eversource		Site Location: Sudbury to Hudson Transmission Reliability Project	Town: Sudbury
Photo No.: 1	Date: 12-07-2022

Description: View of rain gauge at Sudbury substation. Rainfall amount was 0.65" at 1:45pm on 12-07-2022. Facing north.

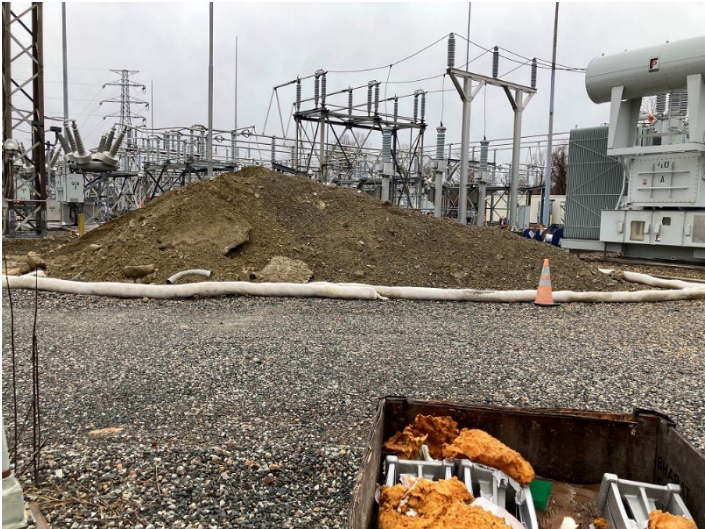
PHOTOGRAPHIC LOG	
Client Name: Eversource		Site Location: Sudbury to Hudson Transmission Reliability Project	Town: Sudbury
Photo No.: 2	Date: 12-07-2022

Description: View of stockpile at Sudbury Substation. E&S controls are in good condition and operating properly. Facing south.

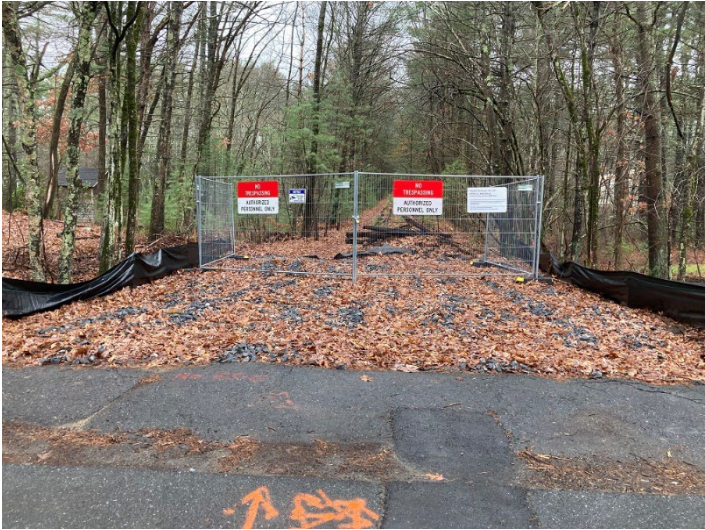
PHOTOGRAPHIC LOG	
Client Name: Eversource		Site Location: Sudbury to Hudson Transmission Reliability Project	Town: Sudbury
Photo No.: 3	Date: 12-07-2022

Description: View of construction entrance pad and silt fence Peakham Rd. Silt fence is in good condition and operating properly. Facing west.

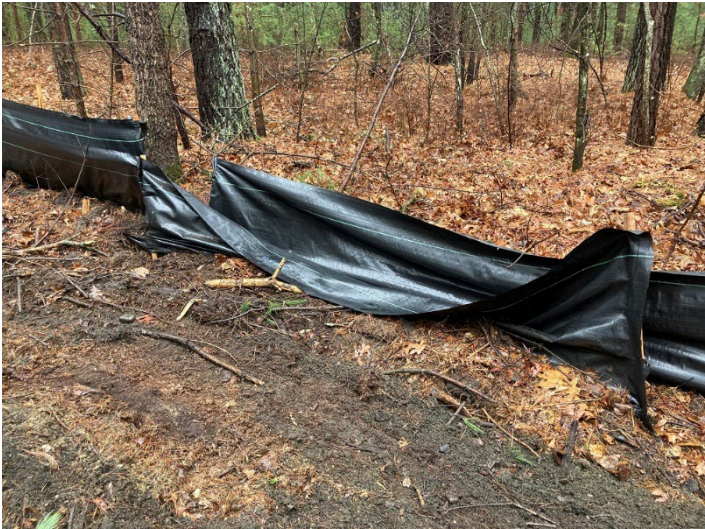
PHOTOGRAPHIC LOG	
Client Name: Eversource		Site Location: Sudbury to Hudson Transmission Reliability Project	Town: Hudson
Photo No.: 4	Date: 12-07-2022

6. Silt Fencing on ROW in Hudson	<input checked="" type="checkbox"/> Yes <input type="checkbox"/> No	1	<input type="checkbox"/> Yes <input checked="" type="checkbox"/> No	12//2022	-Repair silt fence where damaged in multiple places along Segment 6 off White Pond Rd (routine maintenance). -Silt fence is installed and operating properly in Segment 5, Segment 4, and portion of Segment 2 (Station 142+00 to Bridge 130). Silt fence installation in process in Segment 3.

Description: View of of syncopated silt fence installed in Segment 6 off White Pond Rd. Repair silt fence where damaged in multiple places along Segment 6 (routine maintenance). Facing northeast.

-Repair silt fence where damaged in multiple places along Segment 6 off White Pond Rd.

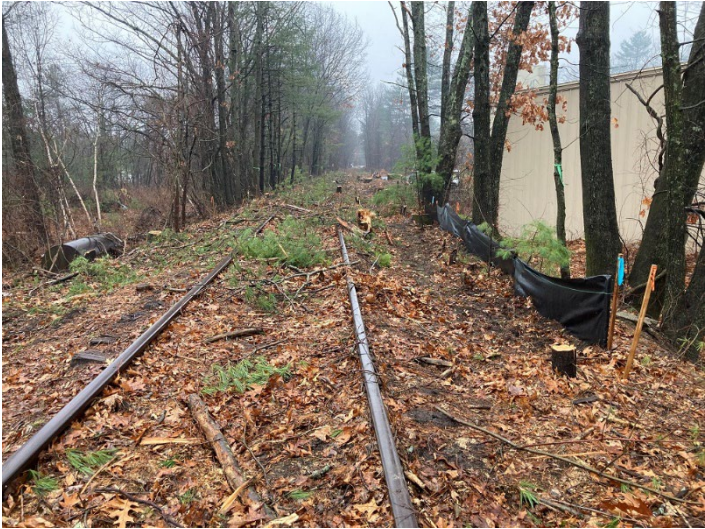
Epsilon ASSOCIATES INC.		PHOTOGRAPHIC LOG	
Client Name: Eversource		Site Location: Sudbury to Hudson Transmission Reliability Project	Town: Hudson
Photo No.: 6	Date: 12-07-2022

Description: Silt fence installation in progress in Segment 3 off of Main St at time of inspection. Facing east.

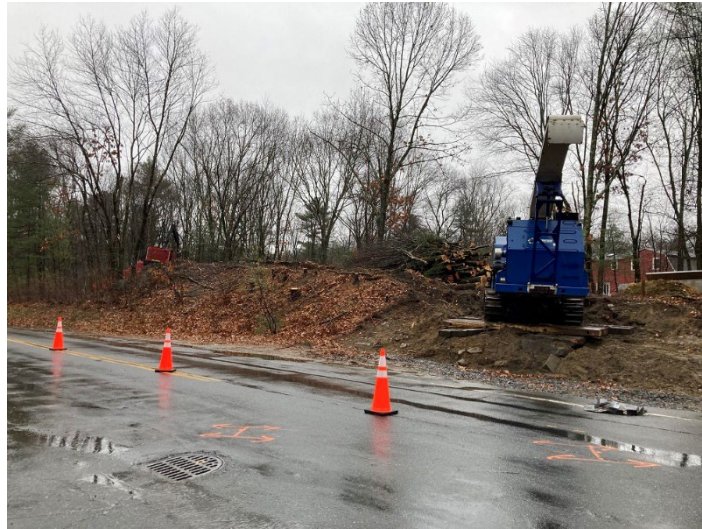
View of forwarding and chipping activities in Segment 1 off Wilkins St. Silt sack inlet protection is installed properly and in good condition. Facing east.

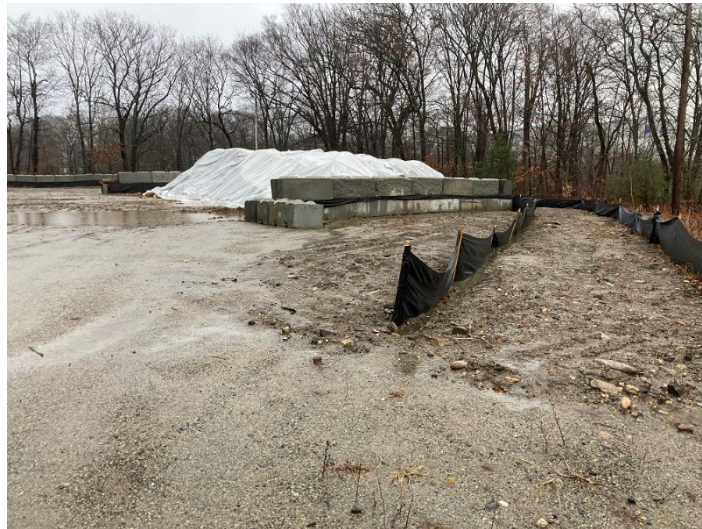
View of laydown yard at Stowe Ct. Additional cement barriers have been installed. Silt fence is operating properly. Inactive pile is covered. Facing east.
