Weekly Environmental Compliance Summary

Sudbury to Hudson Transmission Reliability Project (USEPA Tracking # MAR1003UW)

Sudbury, Hudson, and Stow, MA

Week of: December 12 to December 16, 2022

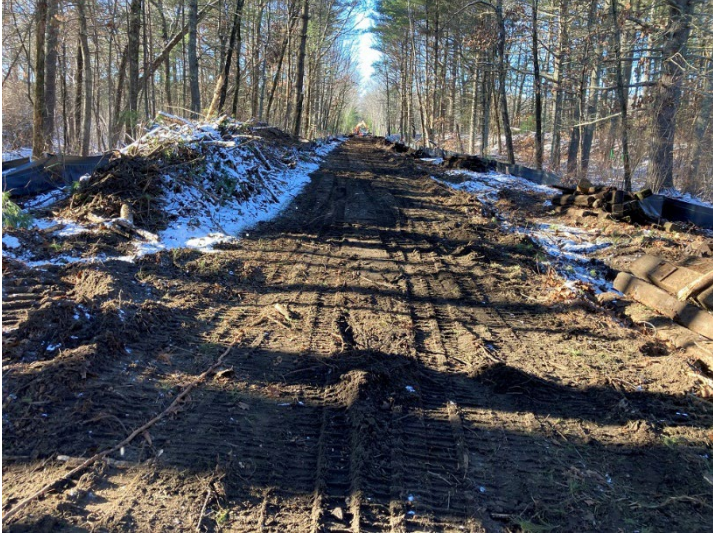
| <p>Photo No.: 3</p> | <p>Date: 12/12/2022</p> | | |

| <p>Description: View of rail and tie removal in Segment 5 (off White Pond Rd), facing west.</p> | | | |

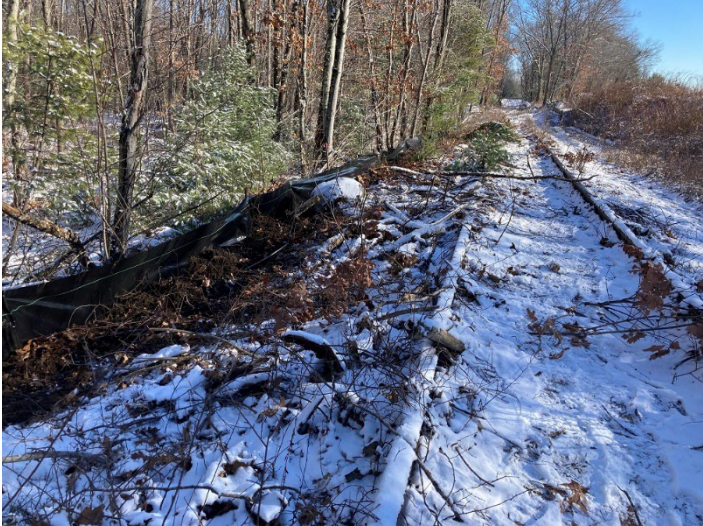
| <p>Photo No.: 4</p> | <p>Date: 12/12/2022</p> | | |

| <p>Description: Silt fence installation is in progress in Segment 1. Fence is being installed westward from Stow. Facing east.</p> | | | |

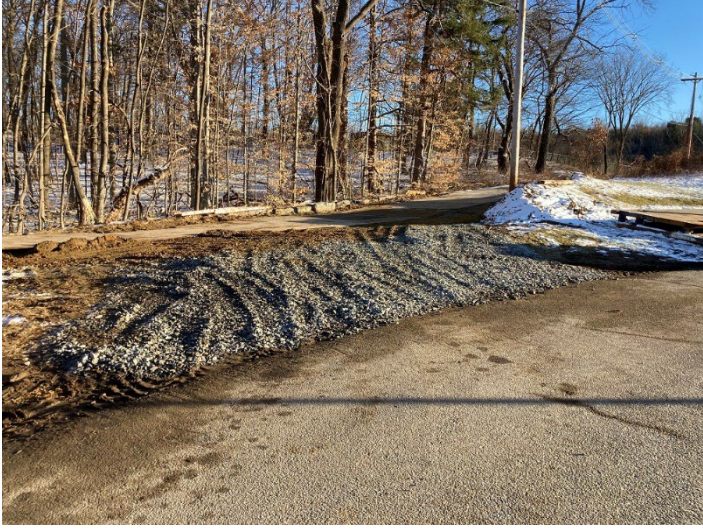
| Photo No.: 5 | Date: 12/12/2022 | | |

| Description: Stone construction entrance pad has been installed at MH#1/Hudson Substation work area. Facing southeast. | | | |

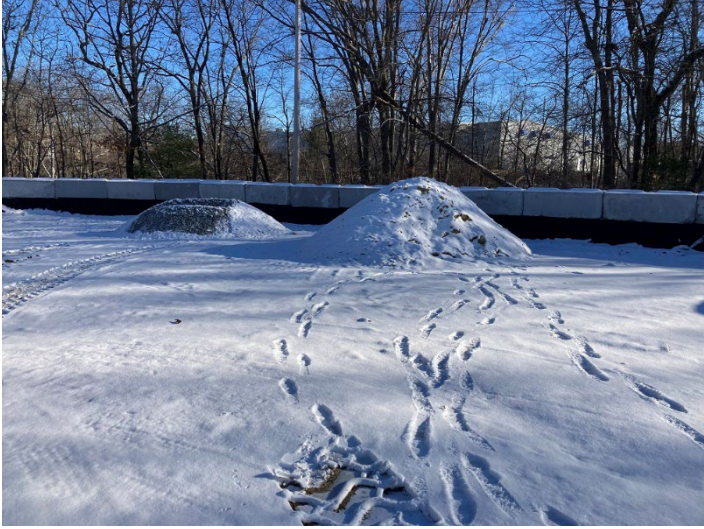
| Photo No.: 6 | Date: 12/12/2022 | | |

| Description: View of small stockpiles at Stowe Ct laydown yard. Ensure that soil stockpiles are getting covered at the end of each workday. Facing east. | | | |

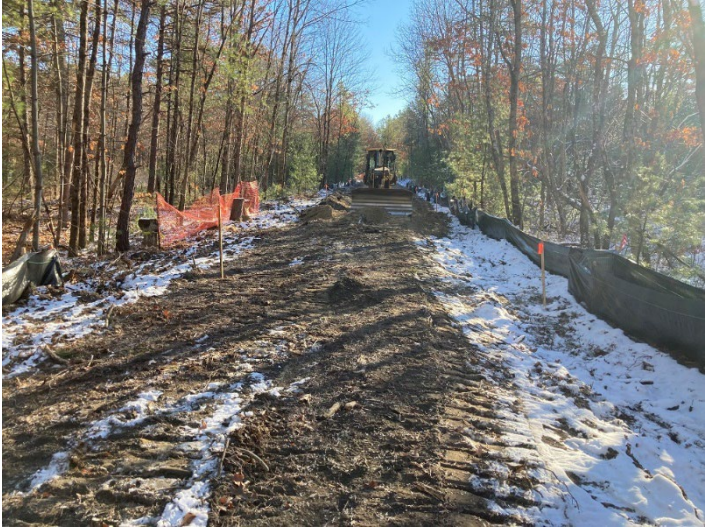
| Photo No.: 1 | Date: 12/13/2022 | | |

| Description: View of grading activities in Segment 6 off white Pond Rd, facing east. | | | |

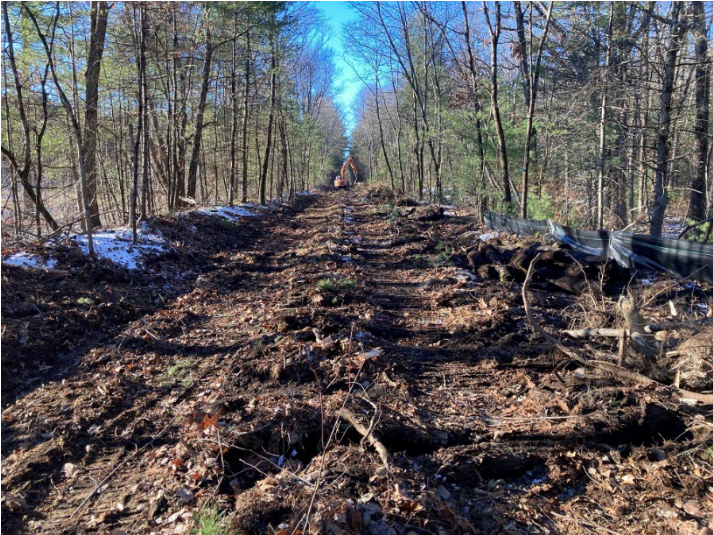
| Photo No.: 2 | Date: 12/13/2022 | | |

| Description: View of rail and tie removal in Segment 5 off White Pond Rd, facing west. | | | |

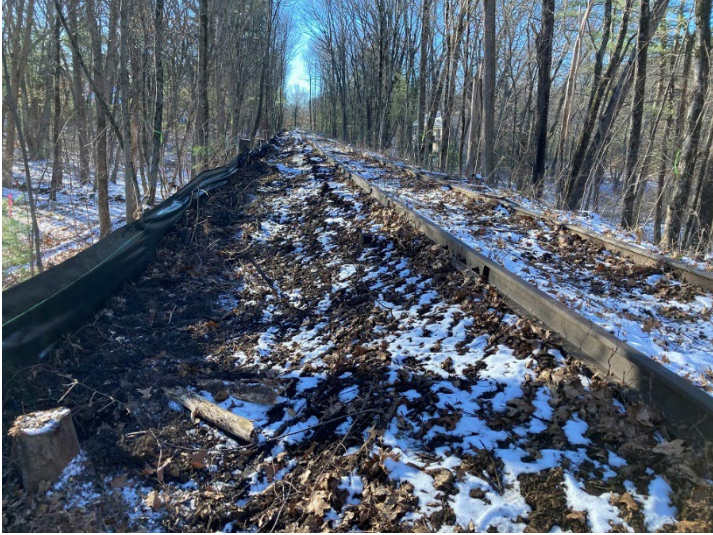
| <p>Photo No.: 3</p> | <p>Date: 12/13/2022</p> | | |

| <p>Description: View of newly installed silt fence in Segment 1 off Wilkins St, facing west.</p> | | | |

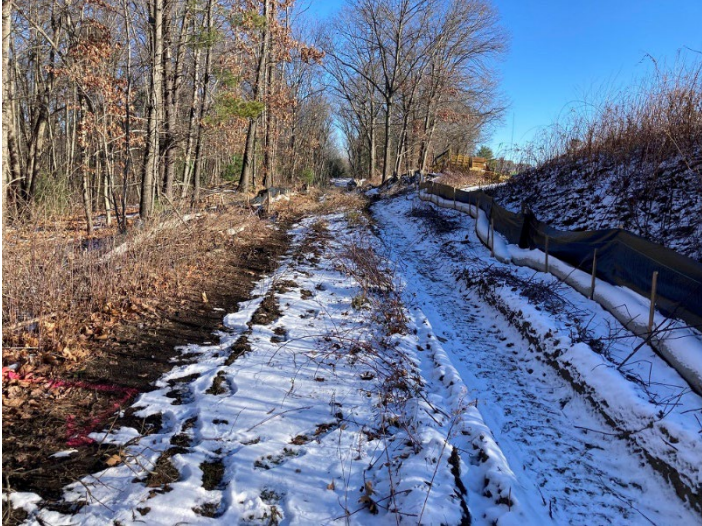
| <p>Photo No.: 4</p> | <p>Date: 12/13/2022</p> | | |

| <p>Description: View of Stow portion of project, facing east.</p> | | | |

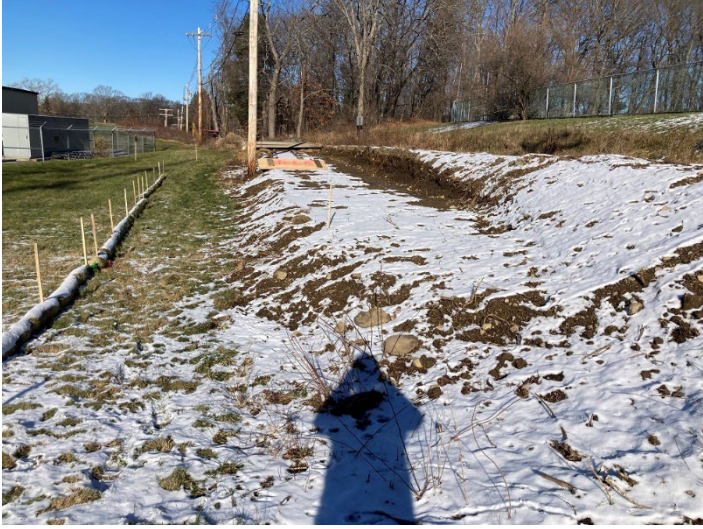
| <p>Photo No.: 5</p> | <p>Date: 12/13/2022</p> | | |

| <p>Description: View of MH#1/Hudson Substation work area. Straw wattles are in good condition and operating properly. Recommend replacing straw wattles with biodegradable controls. Facing north.</p> | | | |

-Recommend replacing straw wattles with biodegradable controls.

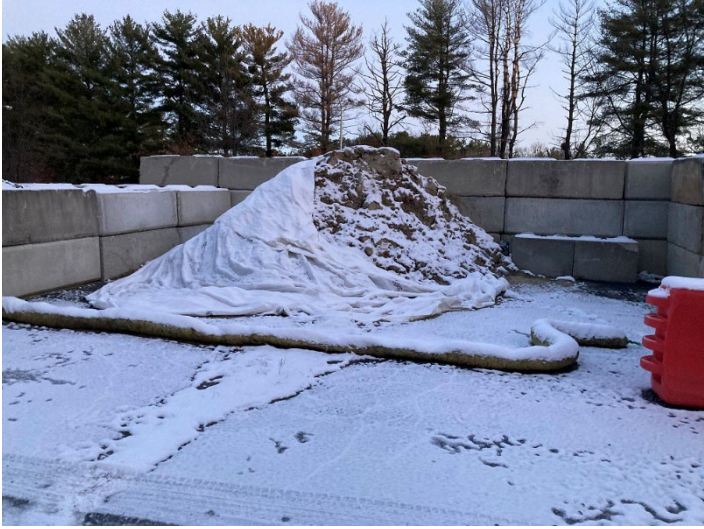
| <p>Photo No.: 6</p> | <p>Date: 12/13/2022</p> | | |

| <p>Description: View of stockpile at laydown yard at 555 Main St. Ensure that soil stockpiles are getting covered at the end of each workday and that covers are being adjusted as needed. Recommend replacing straw wattles with biodegradable controls. Facing north.</p> | | | |

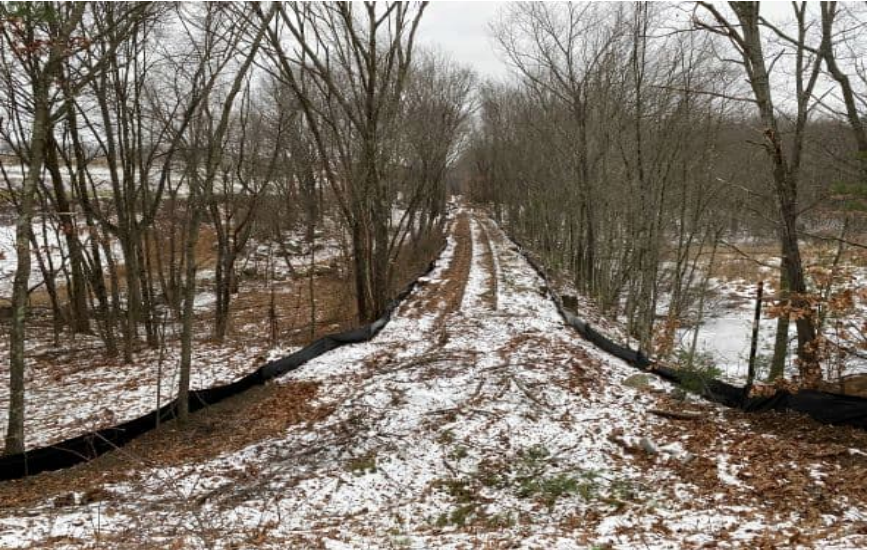
| <p>Photo No.: 1</p> | <p>Date: 12-15-22</p> | | |

| <p>Description:</p> <p>Right-of-way west off Chestnut Road with newly placed erosion control, looking westward.</p> | | | |

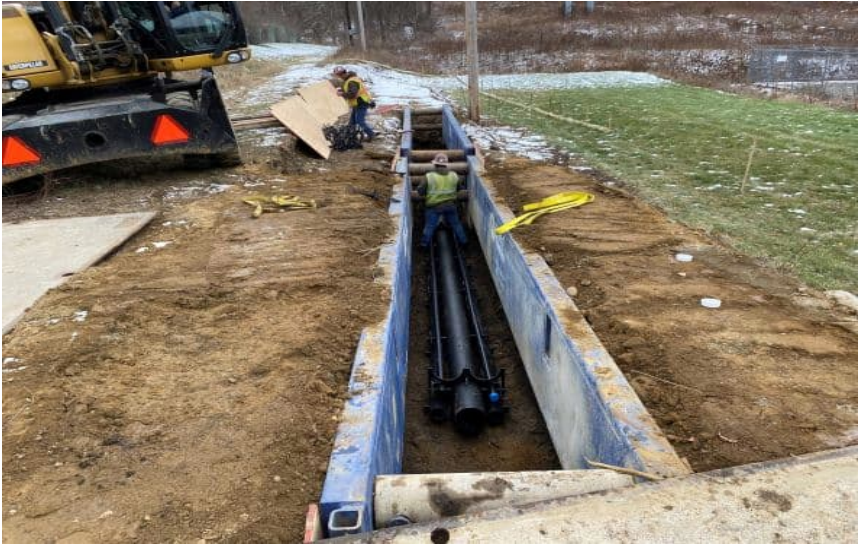
| <p>Photo No.: 3</p> | <p>Date: 12-15-22</p> | | |

| <p>Description:</p> <p>Site work at MH#1 area off Forest Avenue, first conduit placed, looking eastward.</p> | | | |

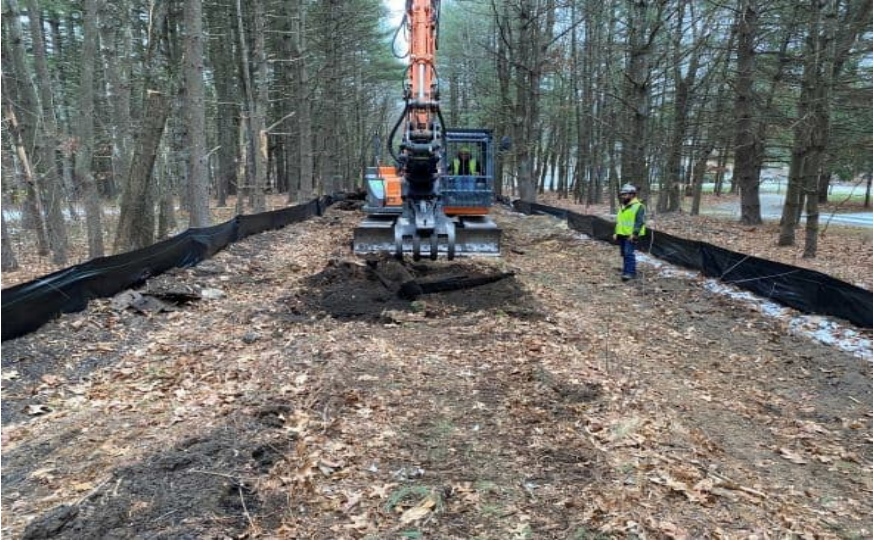
| <p>Photo No.: 4</p> | <p>Date: 12-15-22</p> | | |

| <p>Description:</p> <p>Railroad tie removal at approximate Sta.#301+00, Segment 5 off Parmenter Road, looking eastward.</p> | | | |

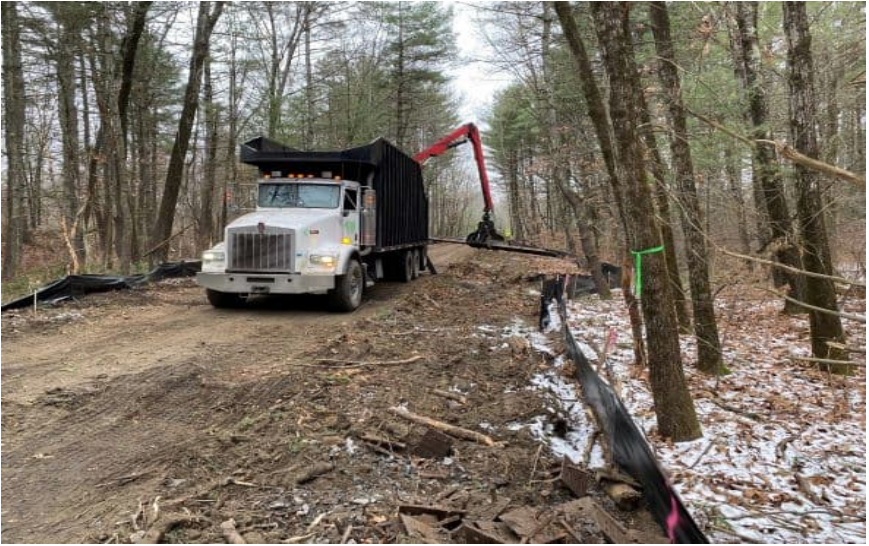
| <p>Photo No.: 5</p> | <p>Date: 12-15-22</p> | | |

| <p>Description:</p> <p>Steel rail removal at approximate Sta.# 335+50, Segment 5 off White Pond Road, looking westward.</p> | | | |

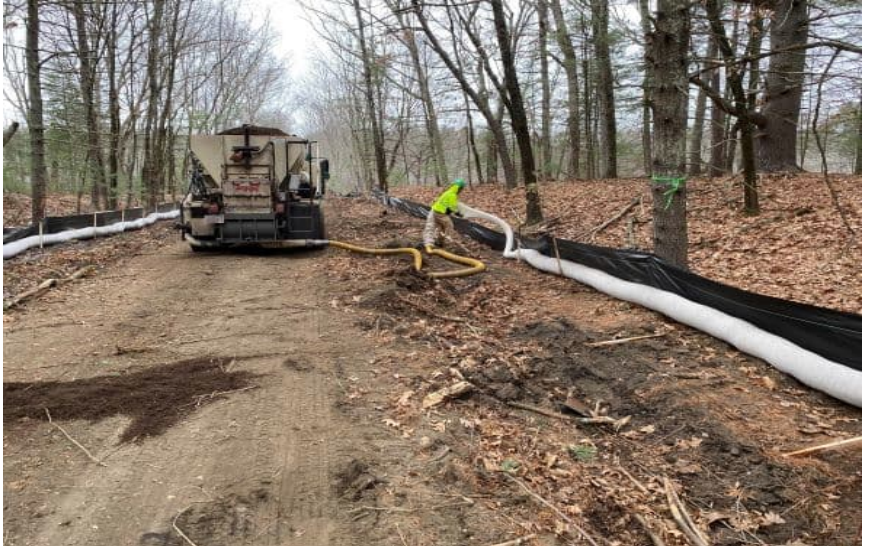
| <p>Photo No.: 6</p> | <p>Date: 12-15-22</p> | | |

| <p>Description:</p> <p>Compost filled tube placement at approximate Sta.#333+50, Segment 5 off White Pond Road, looking westward.</p> | | | |

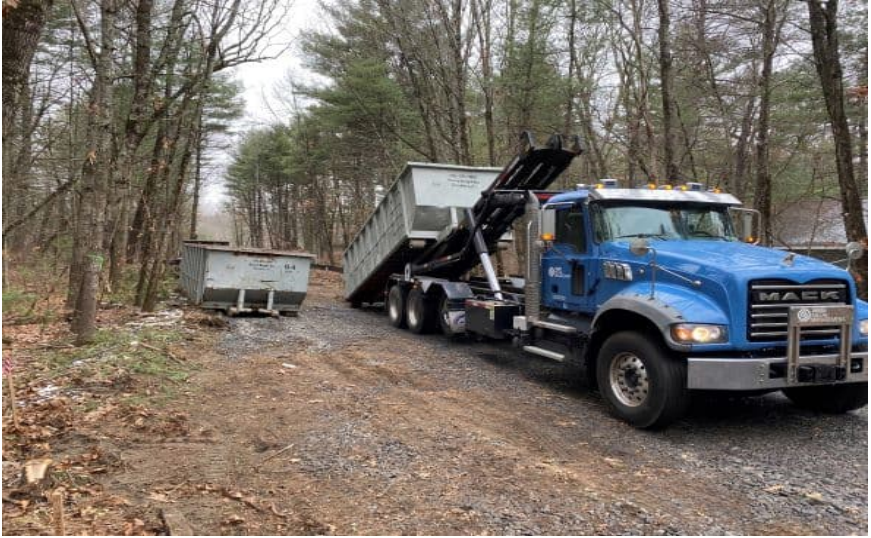
| <p>Photo No.: 8</p> | <p>Date: 12-15-22</p> | | |

| <p>Description:</p> <p>Loading/unloading dumpsters off White Pond Road, looking westward.</p> | | | |

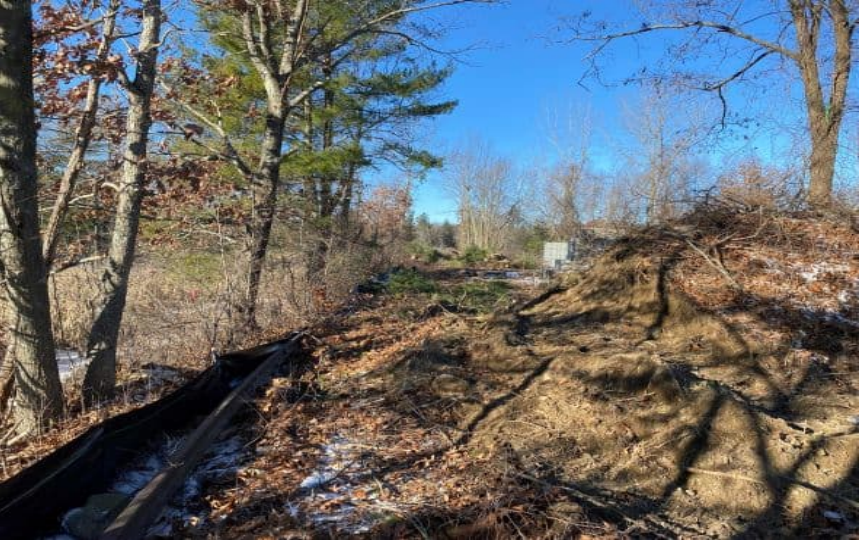
| Photo No.: 2 | Date: 12-14-22 | | |

| Description: Recently clearing along right-of-way Sta.# 156+00 westward toward bridge 130, looking westward. | | | |

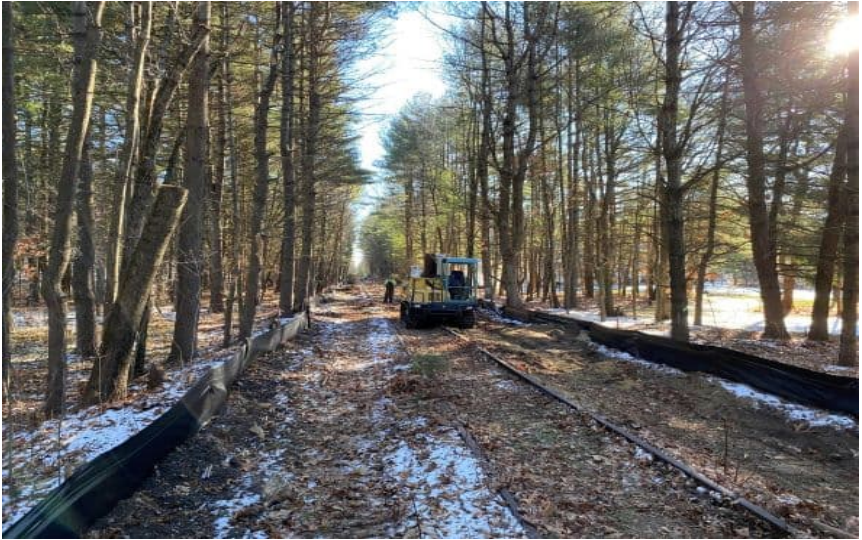
| Photo No.: 3 | Date: 12-14-22 | | |

| Description: Stump removal at approximate Sta.# 301+50, looking E. | | | |

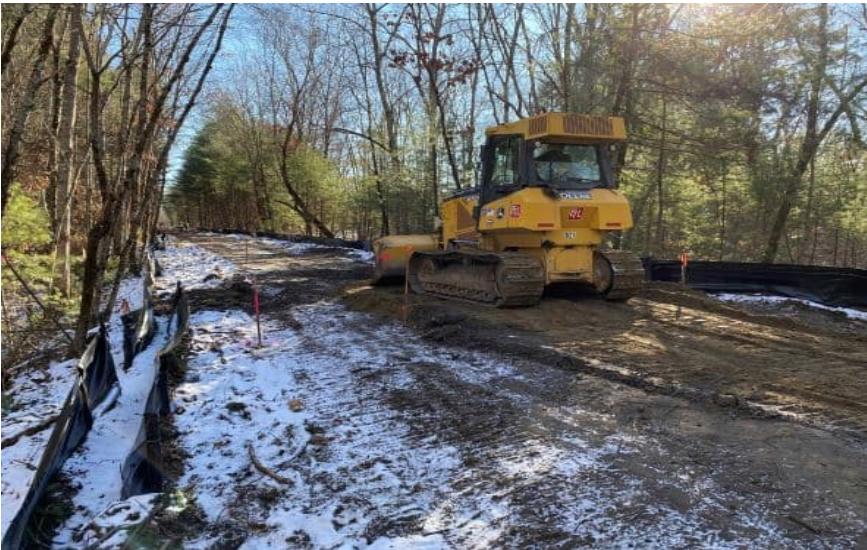
| Photo No.: 4 | Date: 12-14-22 | | |

| Description: Site grading along right-of-way off White Pond Road at approximate Sta.# 338+00, looking eastward. | | | |

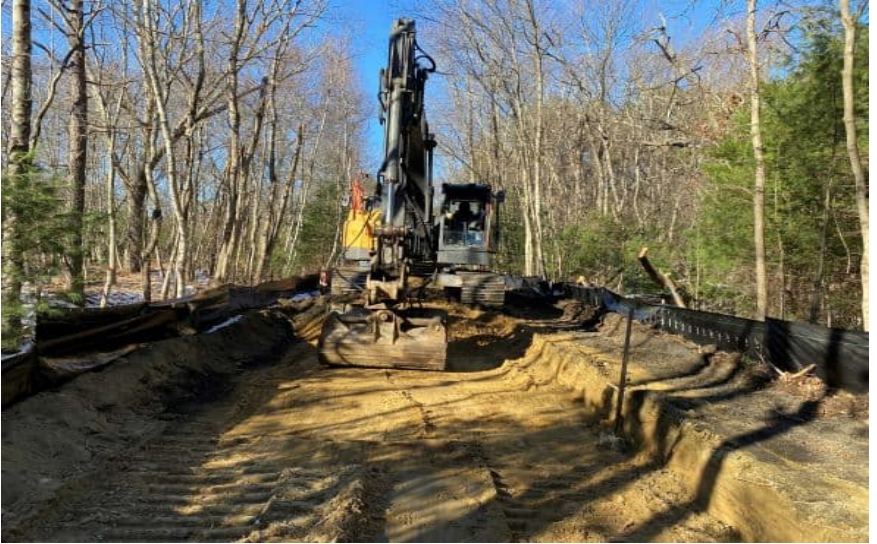
| Photo No.: 5 | Date: 12-14-22 | | |

| Description: Site grading along right-of-way off White Pond Road at approximate Sta.# 357+00, looking eastward. | | | |

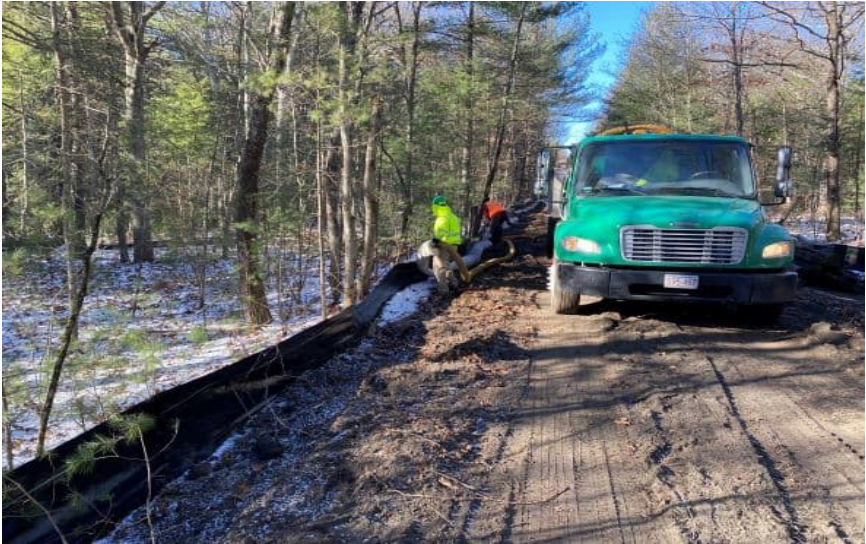
| Photo No.: 7 | Date: 12-14-22 | | |

| Description: Installation of compost filter sock off White Pond Road at approximate Sta.# 323+50, looking westward. | | | |

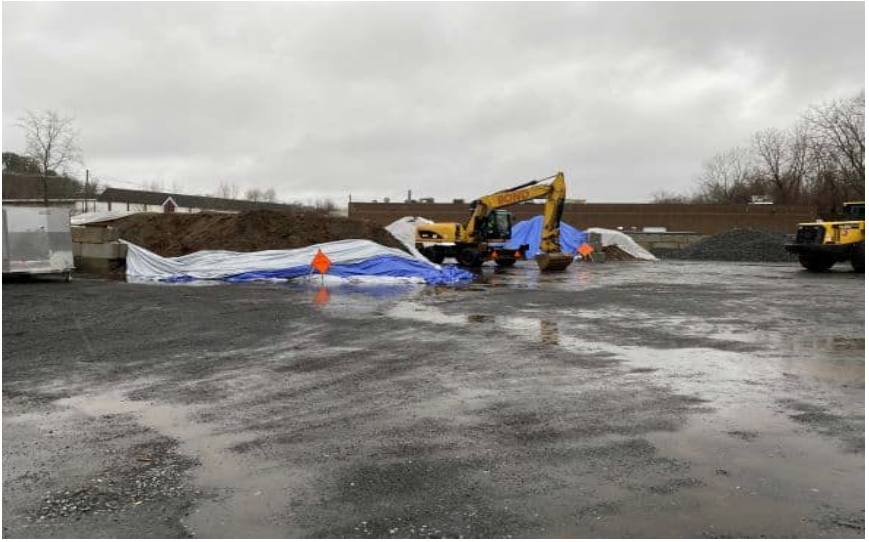
| Photo No.: 1 | Date: 12-16-22 | | |

| Description: Bond laydown yard at 17 Bonazzoli Avenue showing storage areas, looking southward, storage bins in good condition and operating properly. | | | |

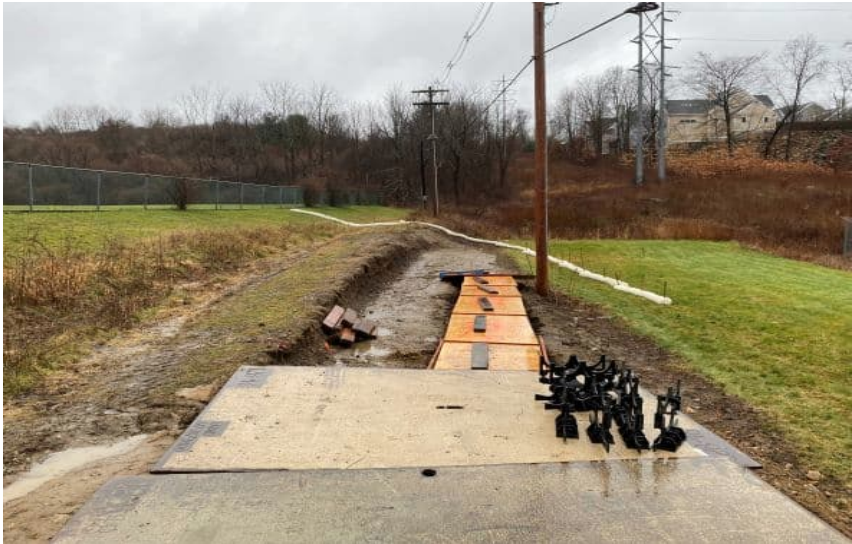
| Photo No.: 2 | Date: 12-16-22 | | |

| Description: MH#1 area, newly placed compost filter tubes, looking eastward. | | | |

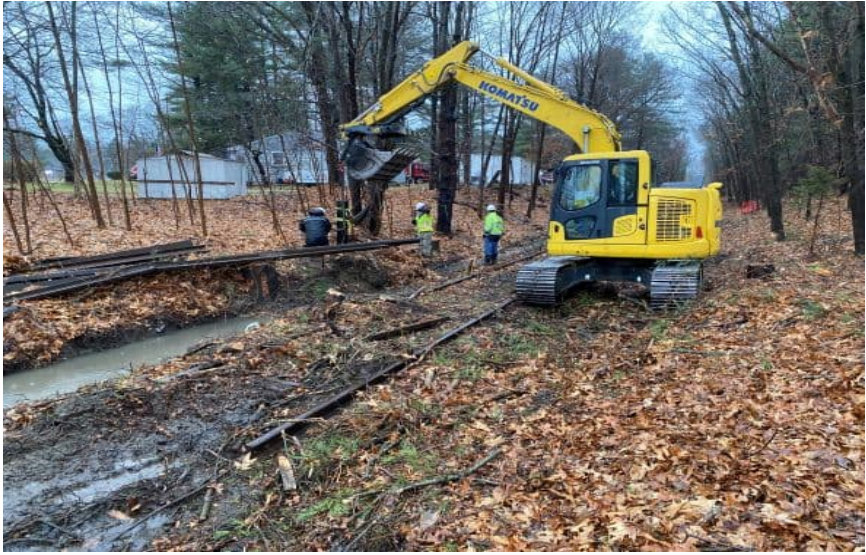
| Photo No.: 3 | Date: 12-16-22 | | |

| Description: Railroad artifact removal off Main Street (west), work observed/inspected by Marty Dudek (Commonwealth Heritage Group), looking westward. | | | |

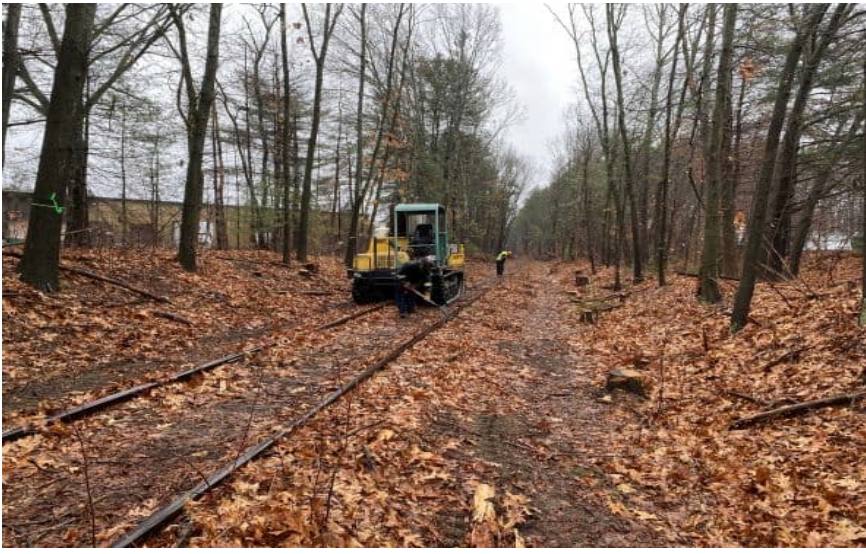
| Photo No.: 4 | Date: 12-16-22 | | |

| Description: Rail cutting off Main Street (east) at approximate Sta.# 185+00, looking eastward. | | | |

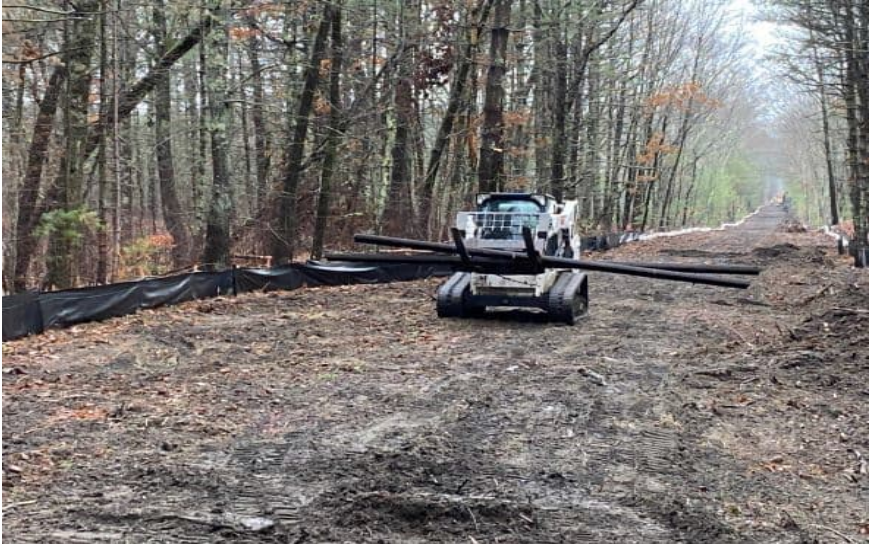
| Photo No.: 5 | Date: 12-16-22 | | |

| Description: Rail removal off White Pond Road (west) (Segment 5), looking westward. | | | |

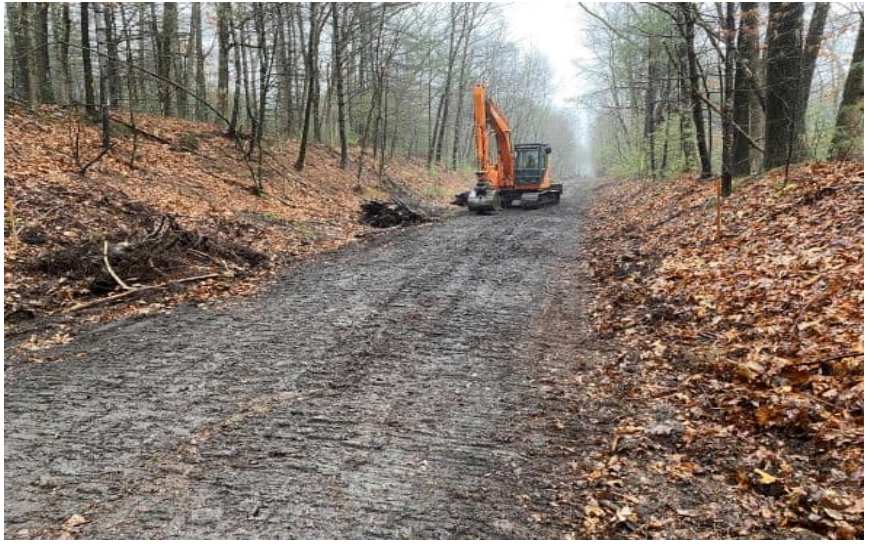
| Photo No.: 6 | Date: 12-16-22 | | |

| Description: Right-of-way cleanup of debris off White Pond Road at approximate Sta.# 311+00, looking eastward. | | | |

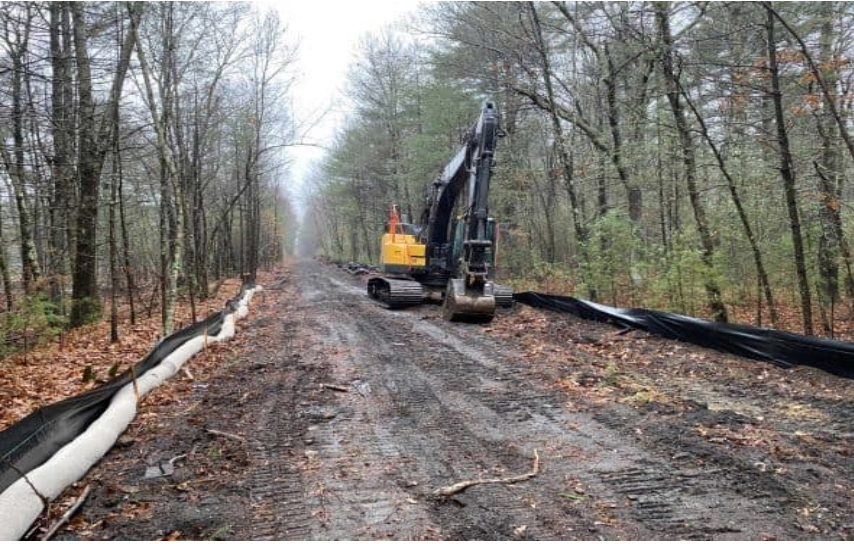
| Photo No.: 7 | Date: 12-16-22 | | |

| Description: Right-of-way cleanup of debris off White Pond Road at approximate Sta.# 320+00, looking westward. | | | |

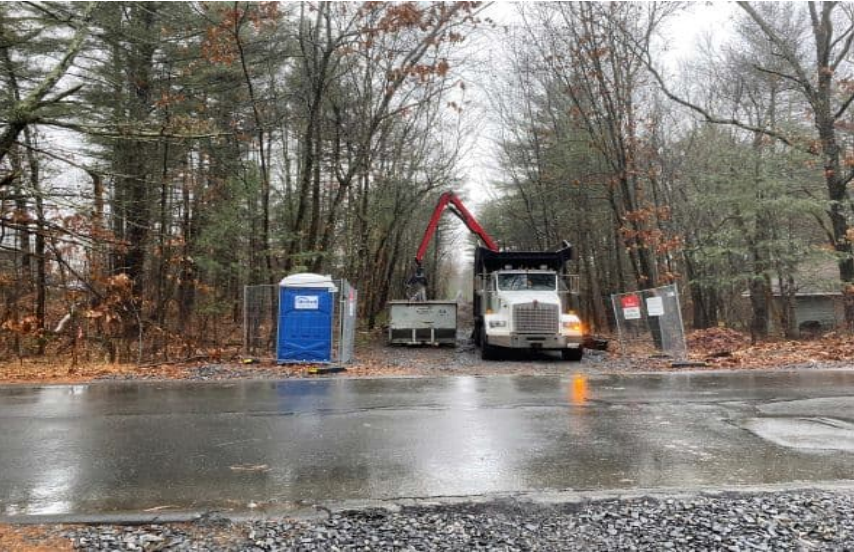
| Photo No.: 8 | Date: 12-16-22 | | |

| Description: Rail removal/disposal off White Pond Road (west), looking westward. | | | |
