Weekly Environmental Compliance Summary

Sudbury to Hudson Transmission Reliability Project (USEPA Tracking # MAR1003UW)

Sudbury, Hudson, and Stow, MA

Week of: December 19 to December 23, 2022

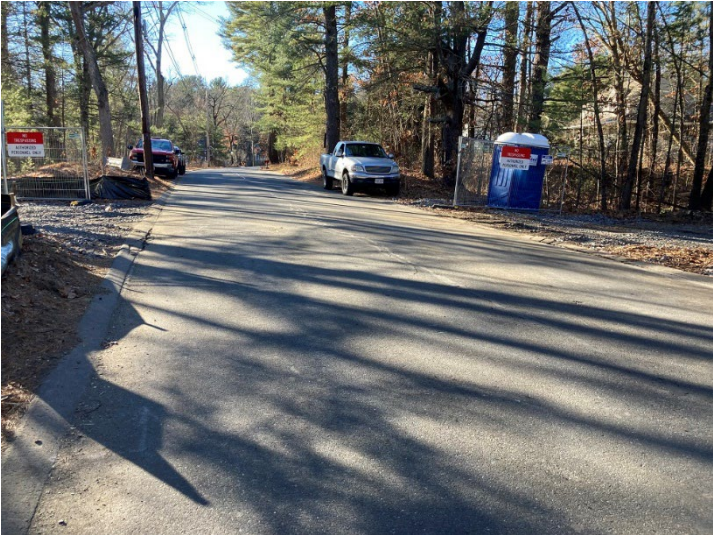
<p align="right">PHOTOGRAPHIC LOG</p>	
<p>Client Name: Eversource</p>		<p>Site Location: Sudbury to Hudson Transmission Reliability Project</p>	<p>Town: Hudson</p>
<p>Photo No.: 2</p>	<p>Date: 12/20/2022</p>

<p>Description: View of White Pond Rd. Street has been swept. No sediment tracking observed. Facing north.</p>

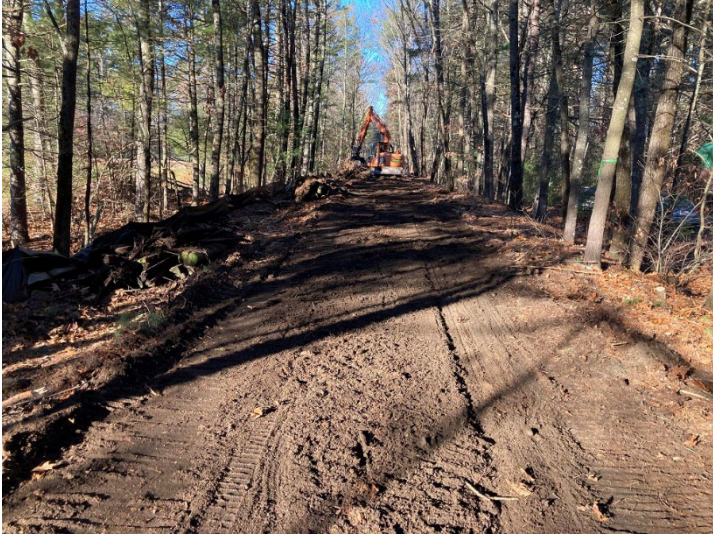
PHOTOGRAPHIC LOG	
Client Name: Eversource		Site Location: Sudbury to Hudson Transmission Reliability Project	Town: Hudson
Photo No.: 3	Date: 12/20/2022

Description: View of rail and tie removal in Segment 4 off Parmenter, facing west.

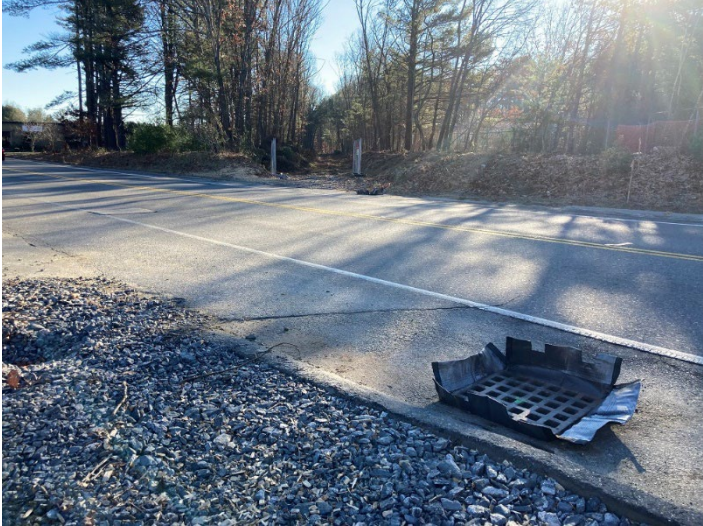
PHOTOGRAPHIC LOG	
Client Name: Eversource		Site Location: Sudbury to Hudson Transmission Reliability Project	Town: Hudson
Photo No.: 4	Date: 12/20/2022

Description: View of construction entrance at Main St. Silt sack inlet protection has been installed in two catch basins in this area. Facing east.

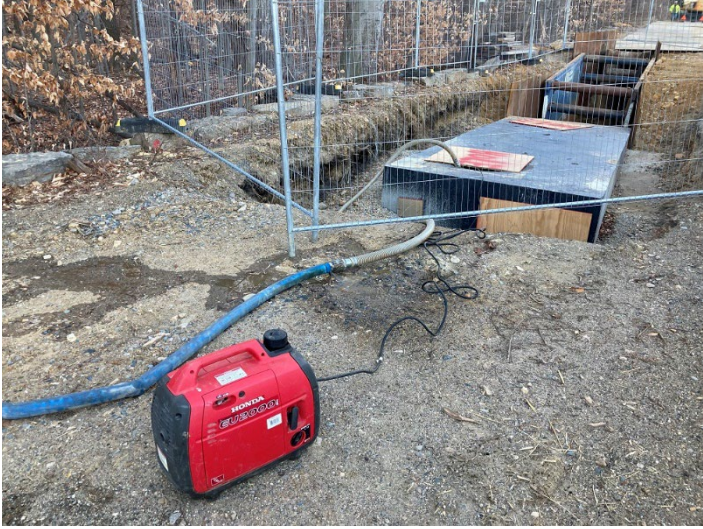
<p>PHOTOGRAPHIC LOG</p>	
<p>Client Name: Eversource</p>		<p>Site Location: Sudbury to Hudson Transmission Reliability Project</p>	<p>Town: Hudson</p>
<p>Photo No.: 5</p>	<p>Date: 12/20/2022</p>

<p>Description: View of pumping/dewatering operation at MH#1. See additional dewatering inspection report. Facing south.</p>

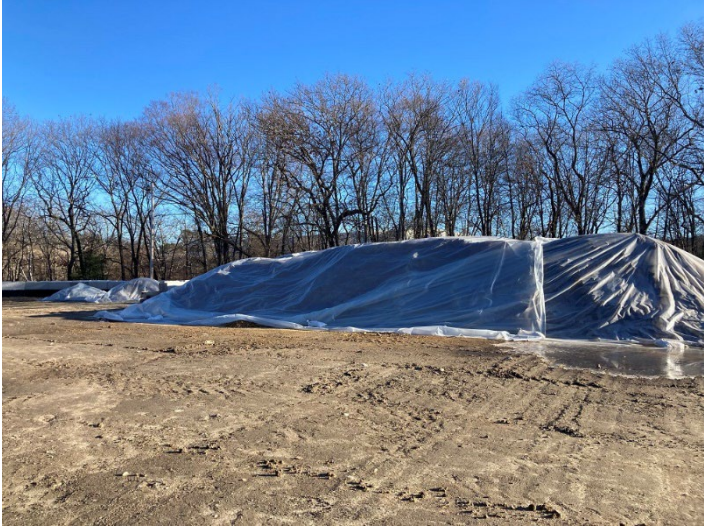
<p>PHOTOGRAPHIC LOG</p>	
<p>Client Name: Eversource</p>		<p>Site Location: Sudbury to Hudson Transmission Reliability Project</p>	<p>Town: Hudson</p>
<p>Photo No.: 6</p>	<p>Date: 12/20/2022</p>

<p>Description: View of stockpiles at Stowe Ct laydown yard. Plastic sheeting has been repaired. Facing southeast.</p>

2. Storage handling of materials at laydown yards	<input checked="" type="checkbox"/> Yes <input type="checkbox"/> No	1	<input type="checkbox"/> Yes <input checked="" type="checkbox"/> No	12/19/2022	Plastic sheeting over stockpiles at Stowe Ct laydown yard is in need of repair (routine maintenance).

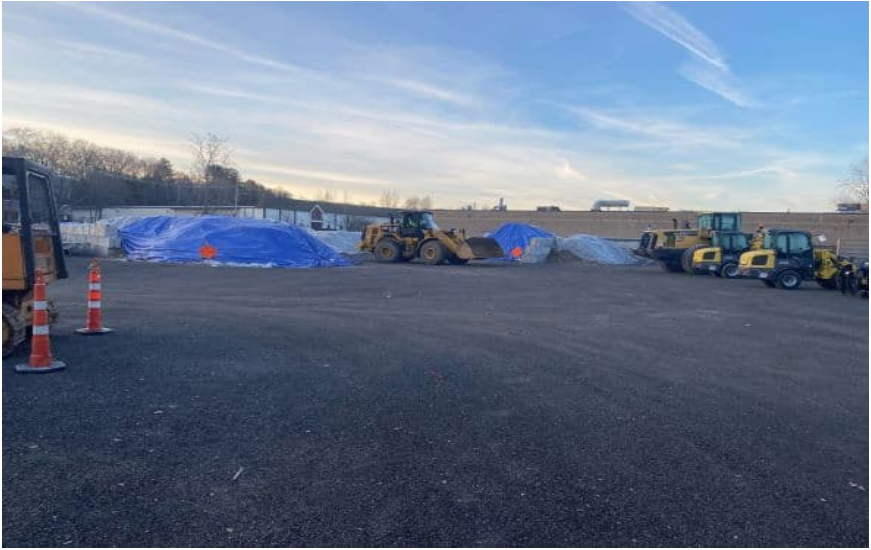
<p>PHOTOGRAPHIC LOG</p>	
<p>Client Name: Eversource</p>		<p>Site Location: Sudbury to Hudson Transmission Reliability Project</p>	<p>Town: Hudson</p>
<p>Photo No.: 1</p>	<p>Date: 12-21-22</p>

<p>Description: Laydown yard off Bonnazoli Avenue showing covered stockpiles, looking eastward.</p>

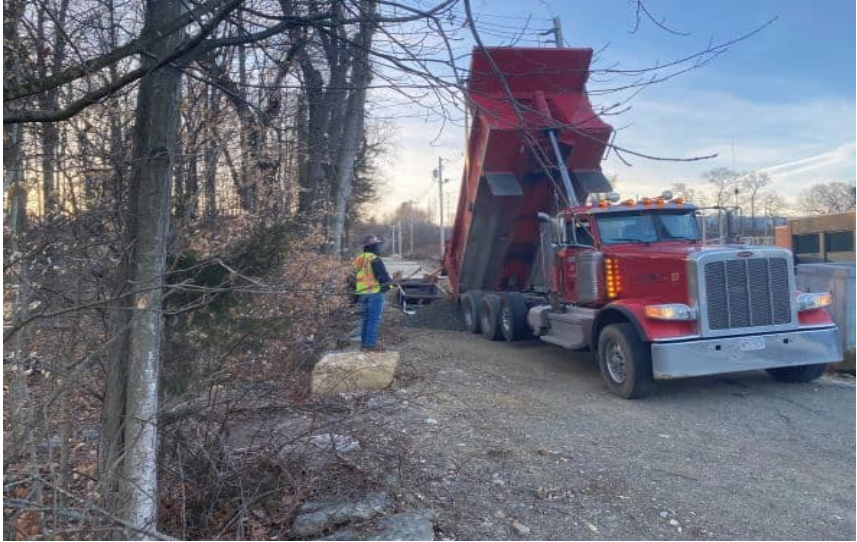
<p>PHOTOGRAPHIC LOG</p>	
<p>Client Name: Eversource</p>		<p>Site Location: Sudbury to Hudson Transmission Reliability Project</p>	<p>Town: Hudson</p>
<p>Photo No.: 2</p>	<p>Date: 12-21-22</p>

<p>Description: Site work at MH#1 off Forest Avenue, looking eastward.</p>

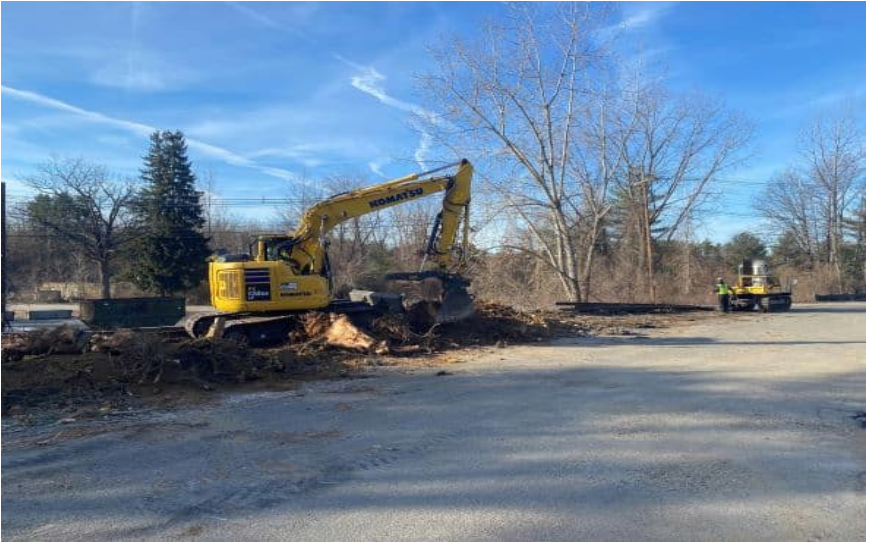
<p>PHOTOGRAPHIC LOG</p>	
<p>Client Name: Eversource</p>		<p>Site Location: Sudbury to Hudson Transmission Reliability Project</p>	<p>Town: Hudson</p>
<p>Photo No.: 3</p>	<p>Date: 12-21-22</p>

<p>Description:</p> <p>Stump removal at approximate Sta.#167+00, Segment 3, looking westward.</p>

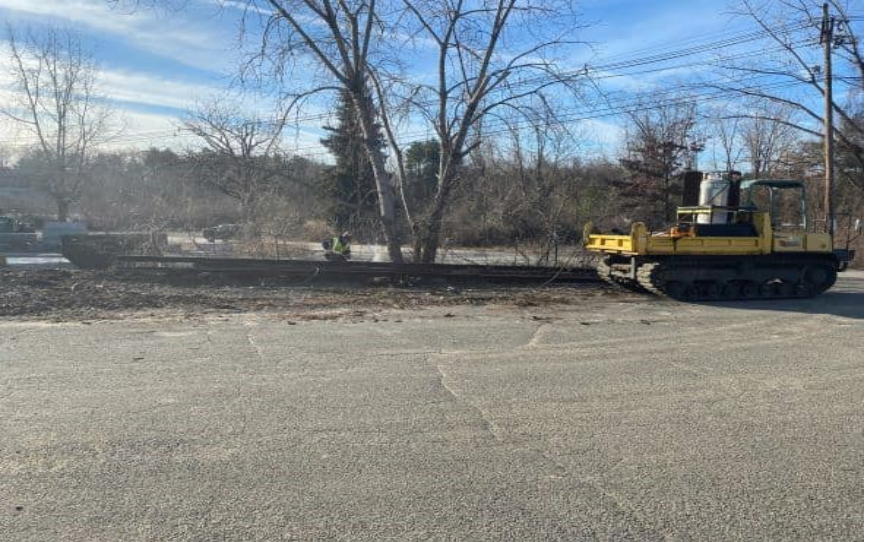
<p>PHOTOGRAPHIC LOG</p>	
<p>Client Name: Eversource</p>		<p>Site Location: Sudbury to Hudson Transmission Reliability Project</p>	<p>Town: Hudson</p>
<p>Photo No.: 4</p>	<p>Date: 12-21-22</p>

<p>Description:</p> <p>Rail cutting at approximate Sta.#167+00, Segment 3, looking westward.</p>

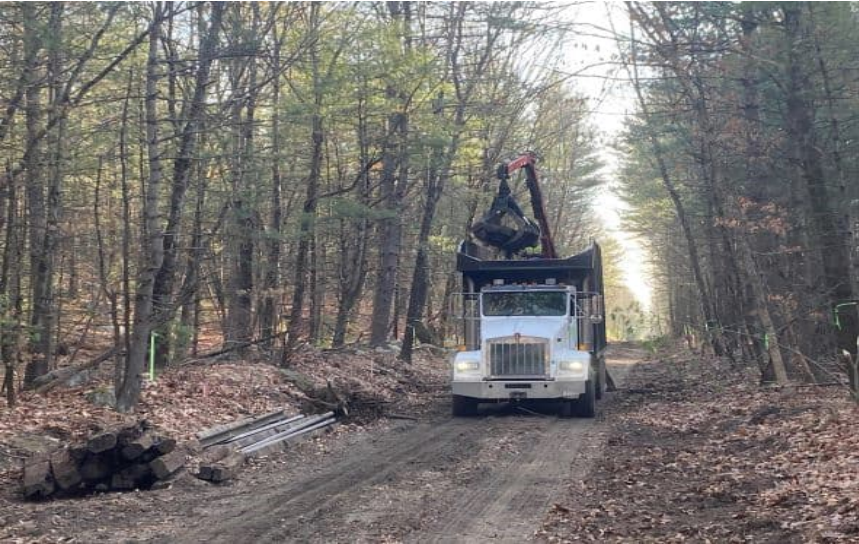
<p align="center">PHOTOGRAPHIC LOG</p>	
<p>Client Name: Eversource</p>		<p>Site Location: Sudbury to Hudson Transmission Reliability Project</p>	<p>Town: Hudson</p>
<p>Photo No.: 5</p>	<p>Date: 12-21-22</p>

<p>Description:</p> <p>Rail/tie removal at approximate Sta.# 306+00, Segment 5 off Parmenter Road, looking eastward.</p>

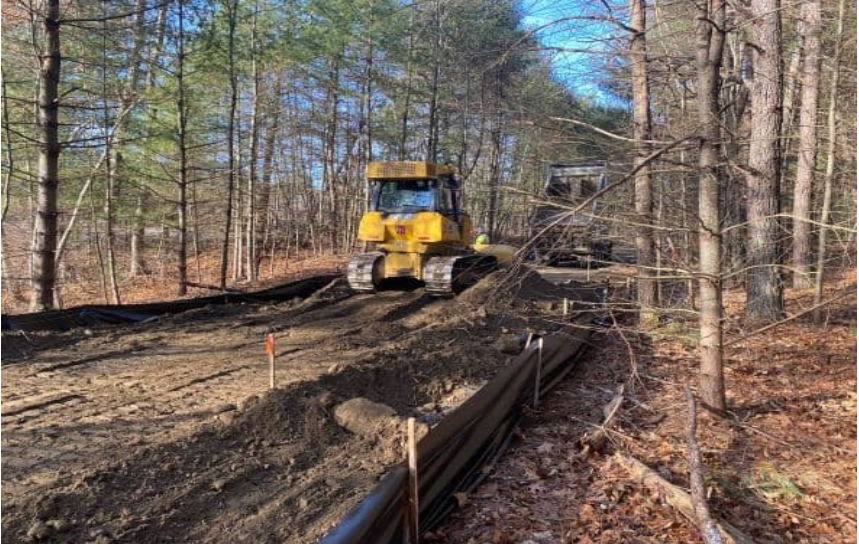
<p align="center">PHOTOGRAPHIC LOG</p>	
<p>Client Name: Eversource</p>		<p>Site Location: Sudbury to Hudson Transmission Reliability Project</p>	<p>Town: Hudson</p>
<p>Photo No.: 6</p>	<p>Date: 12-21-22</p>

<p>Description:</p> <p>Grading of ROW within Segment 5 off White Pond Road at approximate Sta.# 346+00, looking westward.</p>

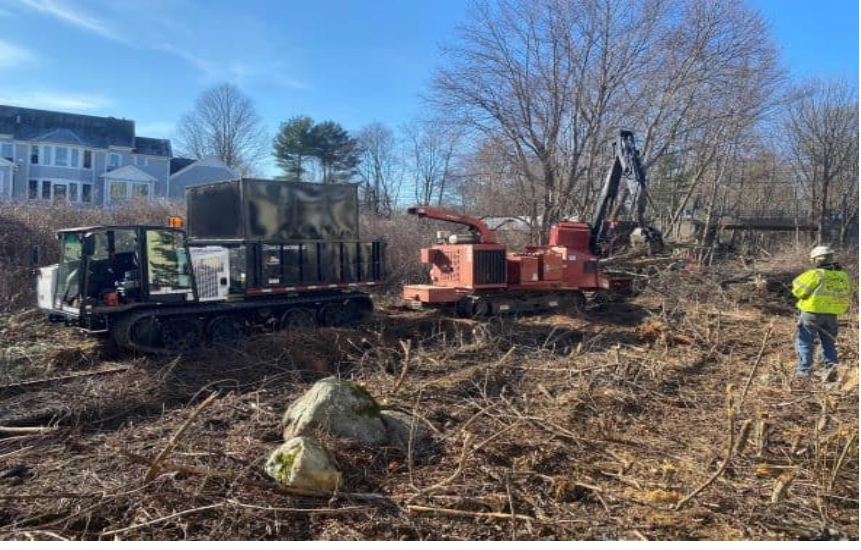
<p>PHOTOGRAPHIC LOG</p>	
<p>Client Name: Eversource</p>		<p>Site Location: Sudbury to Hudson Transmission Reliability Project</p>	<p>Town: Sudbury</p>
<p>Photo No.: 8</p>	<p>Date: 12-21-22</p>

<p>Description:</p> <p>Moosehead chipping operation within Segment 14 at approximate Sta.# 760+00, looking eastward.</p>

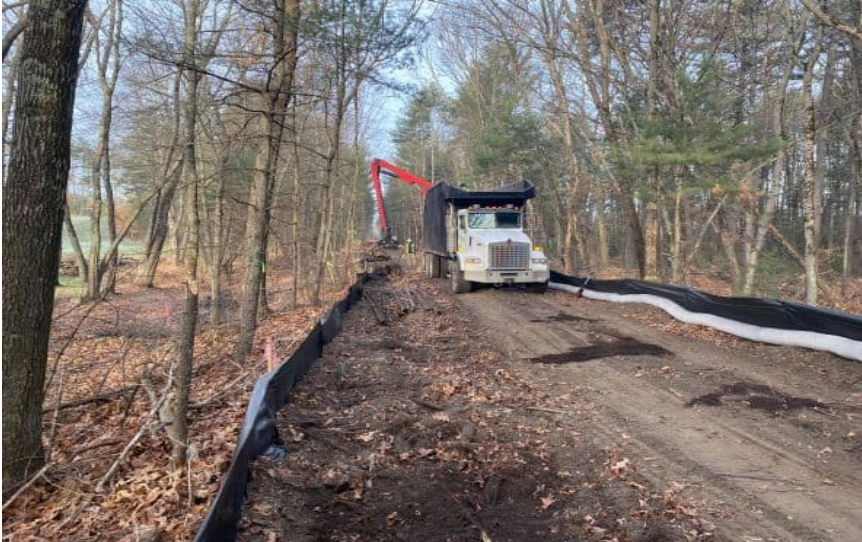
<p>PHOTOGRAPHIC LOG</p>	
<p>Client Name: Eversource</p>		<p>Site Location: Sudbury to Hudson Transmission Reliability Project</p>	<p>Town: Hudson</p>
<p>Photo No.: 2</p>	<p>Date: 12-22-22</p>

<p>Description:</p> <p>Debris removal at approximate Sta.#206+00, Segment 4, looking westward.</p>

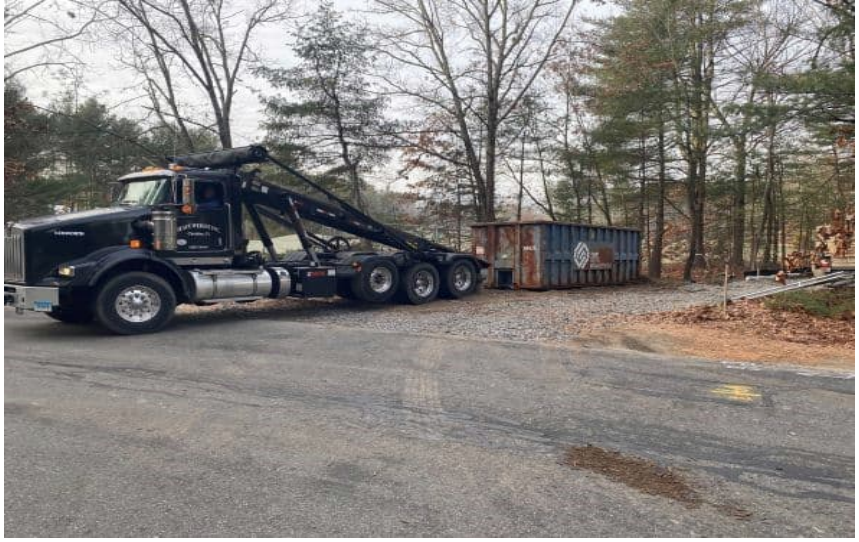
<p>PHOTOGRAPHIC LOG</p>	
<p>Client Name: Eversource</p>		<p>Site Location: Sudbury to Hudson Transmission Reliability Project</p>	<p>Town: Hudson</p>
<p>Photo No.: 4</p>	<p>Date: 12-22-22</p>

<p>Description:</p> <p>Debris (dumpster) removal from site off Parmenter Road (west), looking westward.</p>

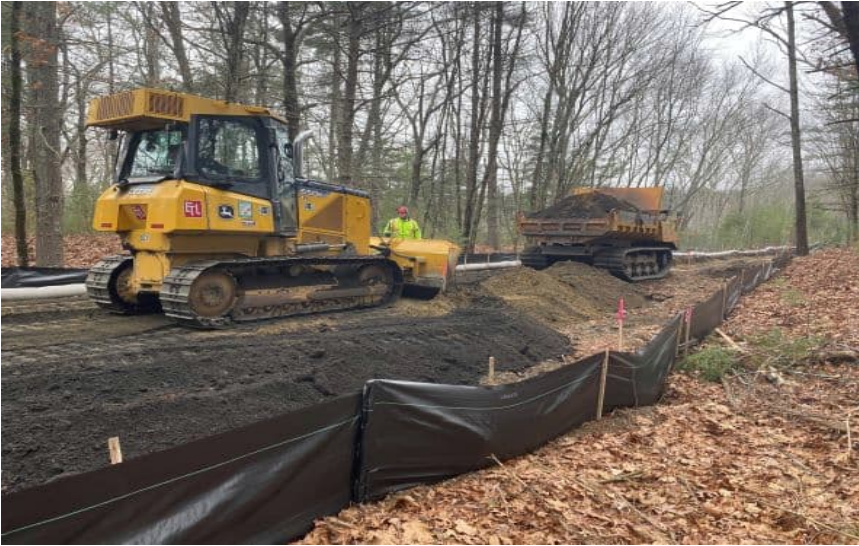
<p>PHOTOGRAPHIC LOG</p>	
<p>Client Name: Eversource</p>		<p>Site Location: Sudbury to Hudson Transmission Reliability Project</p>	<p>Town: Hudson</p>
<p>Photo No.: 5</p>	<p>Date: 12-22-22</p>

<p>Description:</p> <p>Grading of ROW within Segment 5 off White Pond Road at approximate Sta.# 333+00, looking westward.</p>

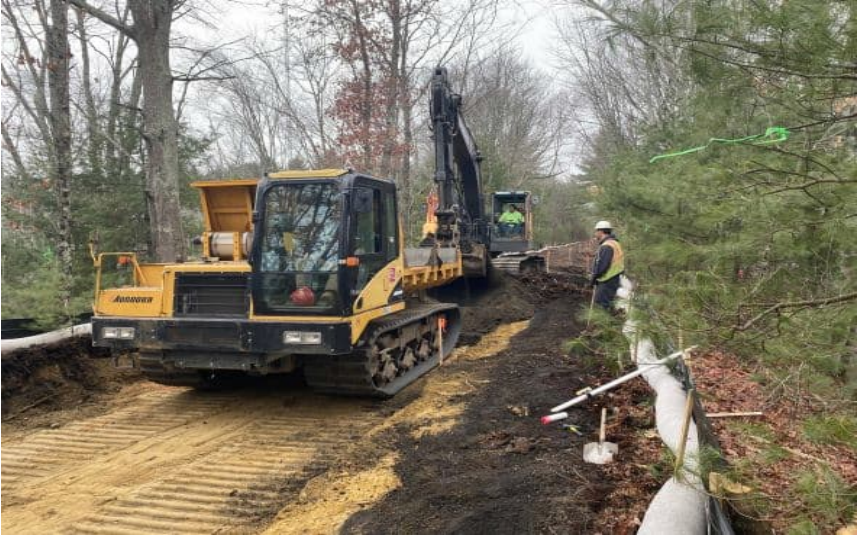
<p>PHOTOGRAPHIC LOG</p>	
<p>Client Name: Eversource</p>		<p>Site Location: Sudbury to Hudson Transmission Reliability Project</p>	<p>Town: Hudson</p>
<p>Photo No.: 6</p>	<p>Date: 12-22-22</p>

<p>Description:</p> <p>Grading of ROW within Segment 5 off White Pond Road at approximate Sta.# 327+50, looking westward.</p>

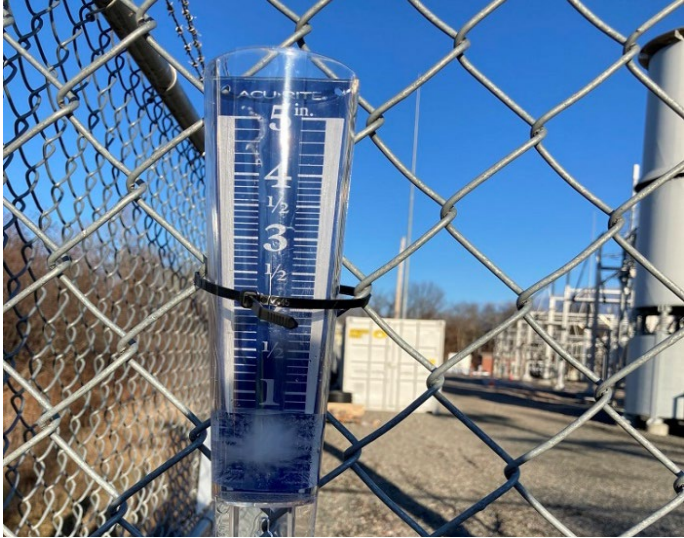
PHOTOGRAPHIC LOG	
Client Name: Eversource		Site Location: Sudbury to Hudson Transmission Reliability Project	Town: Sudbury
Photo No.: 1	Date: 12-19-2022

Description: View of rain gauge at Sudbury substation. Rainfall amount was 0.80" (frozen) at 9:00am on 12-19-2022. Facing north.

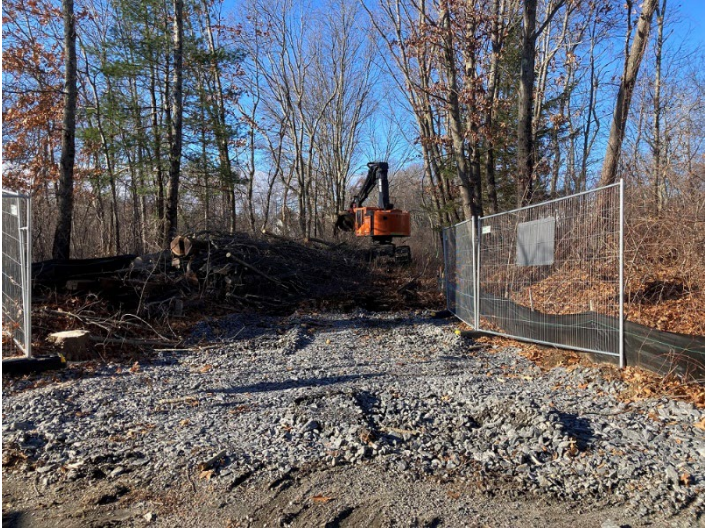
PHOTOGRAPHIC LOG	
Client Name: Eversource		Site Location: Sudbury to Hudson Transmission Reliability Project	Town: Sudbury
Photo No.: 2	Date: 12-19-2022

Description: View of construction entrance and clearing activities in Segment 14 near Sudbury Substation. Facing west.

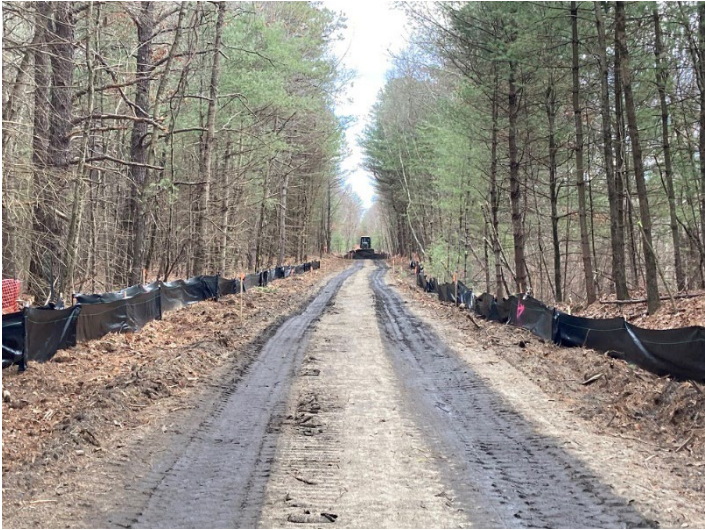
PHOTOGRAPHIC LOG	
Client Name: Eversource		Site Location: Sudbury to Hudson Transmission Reliability Project	Town: Hudson
Photo No.: 3	Date: 12-19-2022

Description: View of cut & fill activities and syncopated silt fence in segment 6 off White Pond Rd. Facing east.

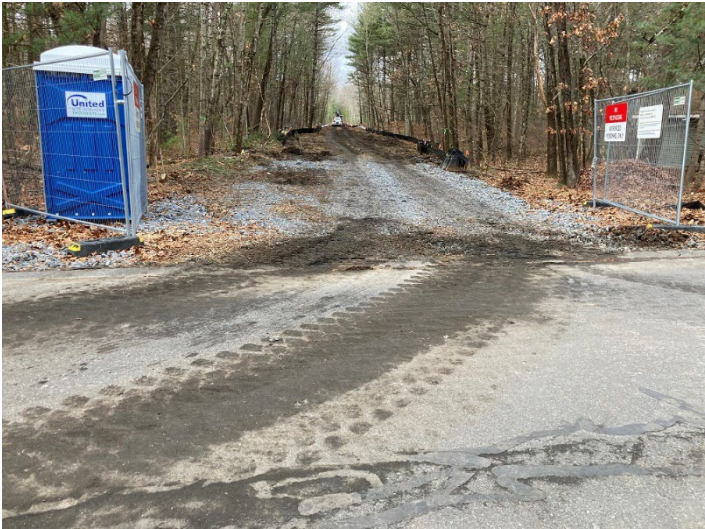
PHOTOGRAPHIC LOG	
Client Name: Eversource		Site Location: Sudbury to Hudson Transmission Reliability Project	Town: Hudson
Photo No.: 4	Date: 12-19-2022

3. Sediment tracking/street sweeping	<input checked="" type="checkbox"/> Yes <input type="checkbox"/> No	1	<input type="checkbox"/> Yes <input checked="" type="checkbox"/> No	12/19/2022	Sediment tracking observed on roadway at White Pond Rd and Parmenter Rd. Sweep streets as needed (routine maintenance).

Description: View of entrance pad at Segment 5 off White Pond Rd. Sediment tracking observed on roadway at White Pond Rd and Parmenter Rd. Sweet streets as needed (routine maintenance). Consider applying fresh stone to entrance pad shown. Facing west.

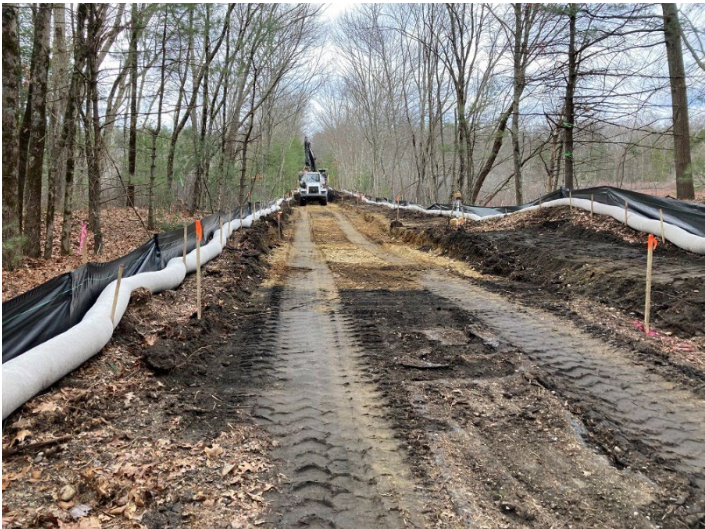
Epsilon ASSOCIATES INC.		PHOTOGRAPHIC LOG	
Client Name: Eversource		Site Location: Sudbury to Hudson Transmission Reliability Project	Town: Hudson
Photo No.: 5	Date: 12-19-2022

Description: View of cut & fill activities in Segment 5 off White Pond Rd. Compost filter tubes in this section of the segment have been installed and inspected by Hudson agent. Facing west.

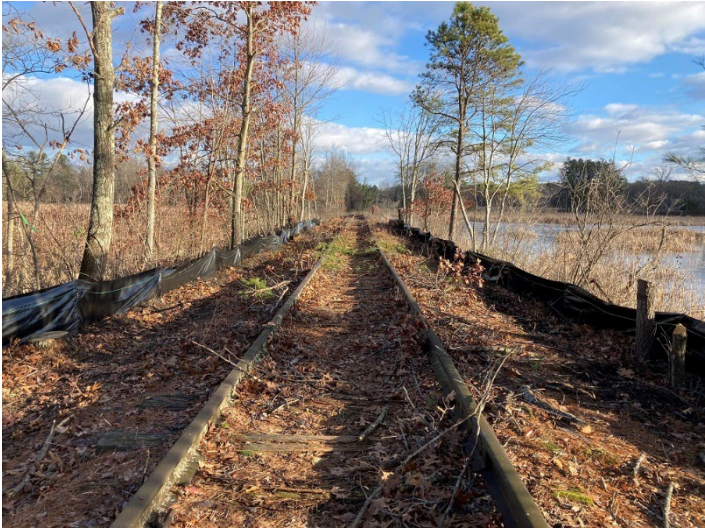
Epsilon ASSOCIATES INC.		PHOTOGRAPHIC LOG	
Client Name: Eversource		Site Location: Sudbury to Hudson Transmission Reliability Project	Town: Hudson
Photo No.: 6	Date: 12-19-2022

Description: View of silt fence in Segment 2 near Bridge 130. Fence is in good condition and operating properly. Facing east.

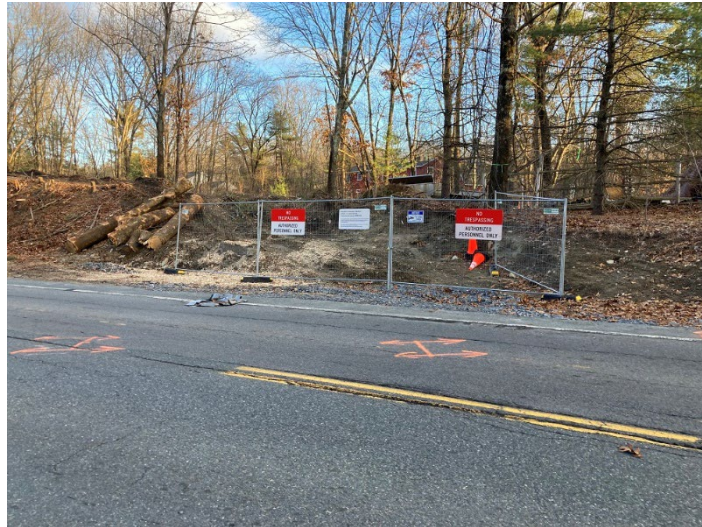
View of entrance pad at Segment 1 off Wilkins St. Silt sack inlet protection is installed properly and in good condition. Facing east.

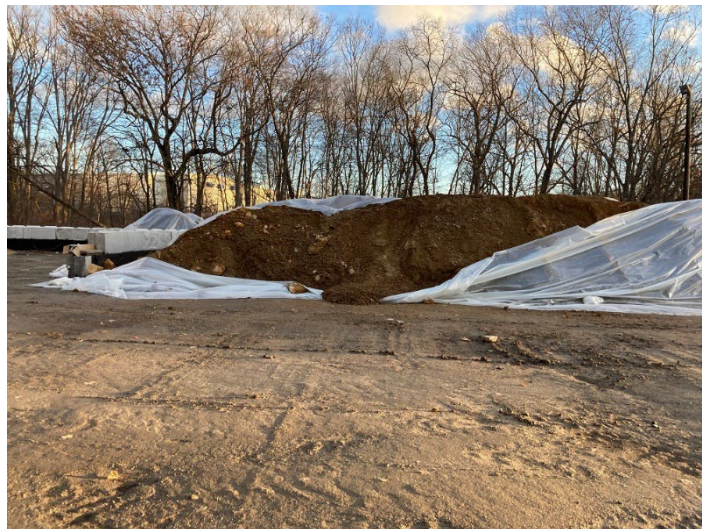
View of laydown yard at Stowe Ct. Plastic sheeting over stockpiles is in need of repair (routine maintenance). Facing east.

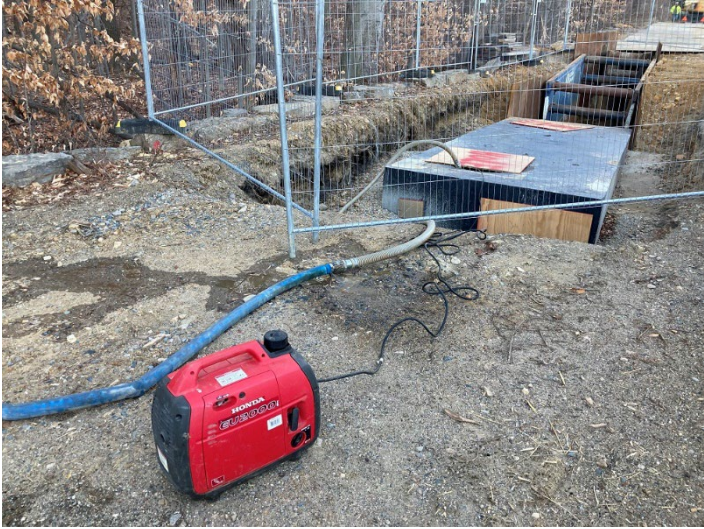
PHOTOGRAPHIC LOG		
Client Name: Eversource		Site Location: Sudbury to Hudson Transmission Reliability Project		Town: Hudson
Photo No.: 1	Date: 12/20/2022

Description: View of pumping operation at MH#1. This is the location of dewatering water prior to treatment. Unable to safely collect turbidity samples at this location. Facing southeast

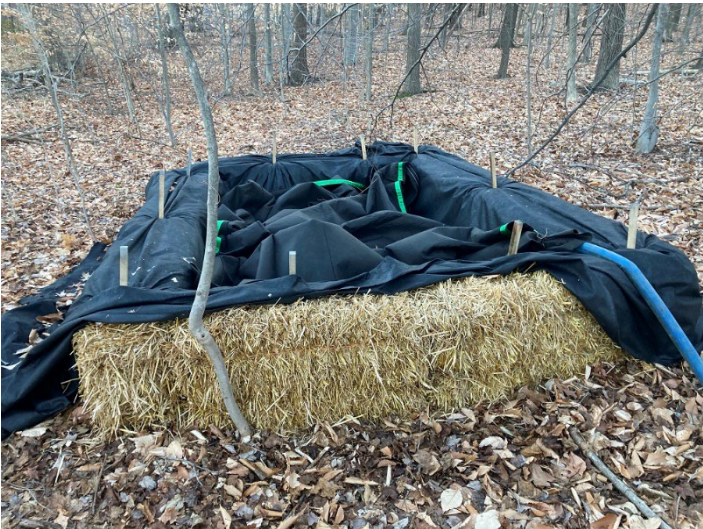
PHOTOGRAPHIC LOG		
Client Name: Eversource		Site Location: Sudbury to Hudson Transmission Reliability Project		Town: Hudson
Photo No.: 2	Date: 12/20/2022

Description: View of dewatering discharge and controls. Facing east.

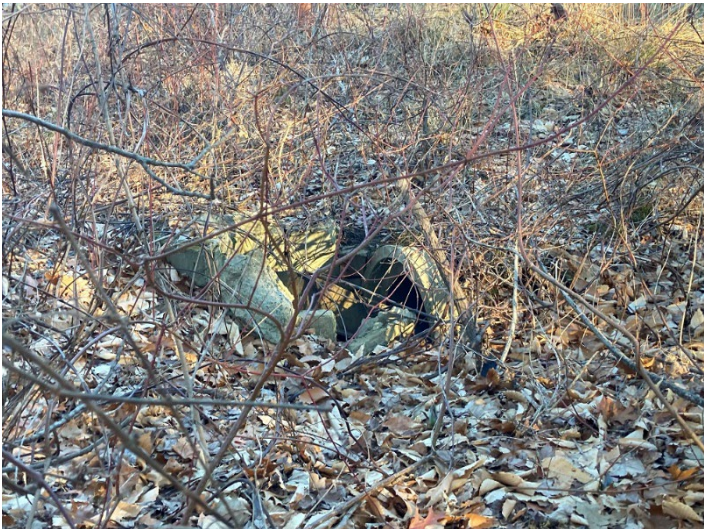
PHOTOGRAPHIC LOG	
Client Name: Eversource		Site Location: Sudbury to Hudson Transmission Reliability Project	
Town: Hudson			
Photo No.: 4	Date: 12/20/2022

Description: View of storm drain inlet and culvert downstream of dewatering discharge. Turbidity samples taken at this location. Unable to determine discharge location of inlet and culvert. Turbidity monitoring was conducted as a precaution. Facing north.

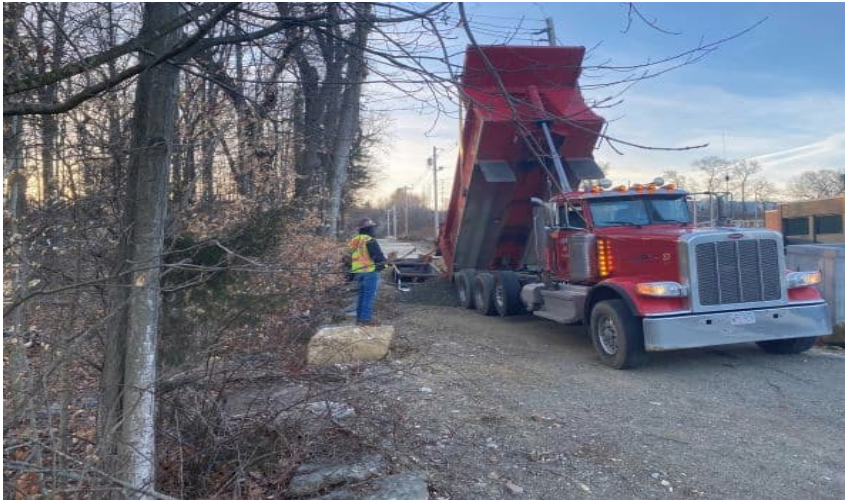
PHOTOGRAPHIC LOG	
Client Name: Eversource		Site Location: Sudbury to Hudson Transmission Reliability Project	Town: Hudson
Photo No.: 1	Date: 12/21/2022

Description: View of work operation at MH#1, facing eastward.

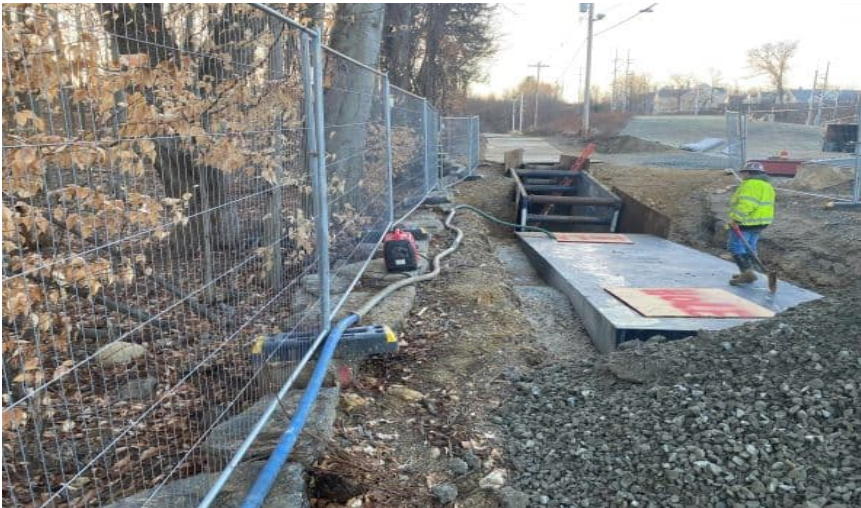
PHOTOGRAPHIC LOG	
Client Name: Eversource		Site Location: Sudbury to Hudson Transmission Reliability Project	Town: Hudson
Photo No.: 2	Date: 12/21/2022

Description: View of pumping operation at MH#1. This is the location of dewatering water prior to treatment, looking eastward.

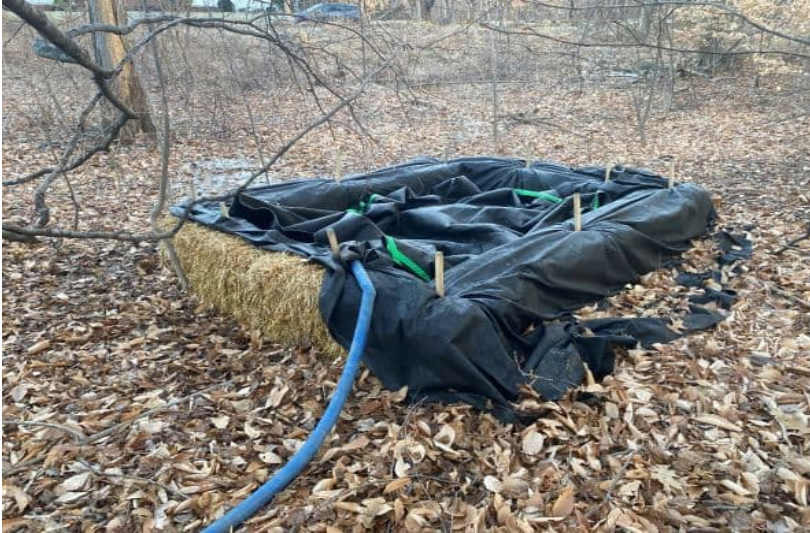
PHOTOGRAPHIC LOG	
Client Name: Eversource		Site Location: Sudbury to Hudson Transmission Reliability Project	Town: Hudson
Photo No.: 3	Date: 12/21/2022

Description: View of dewatering discharge area and controls, looking westward. Water appeared to be clear. Turbidity samples taken at this location.

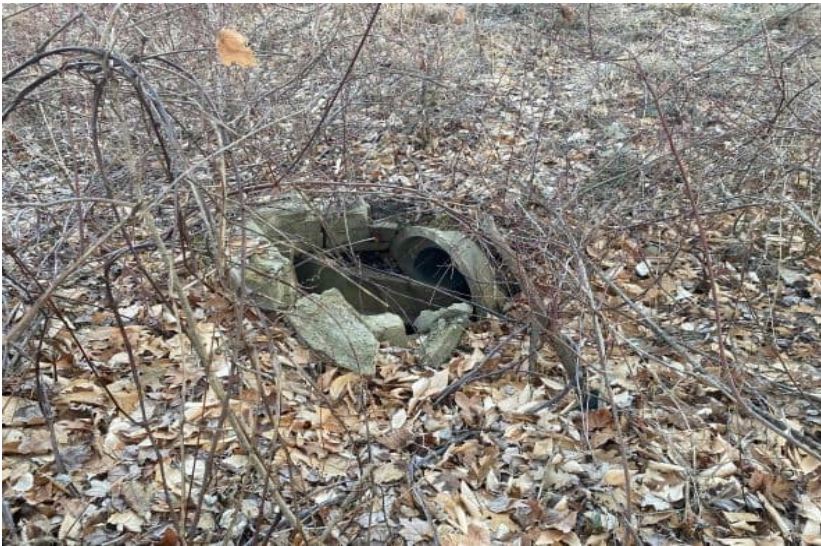
PHOTOGRAPHIC LOG	
Client Name: Eversource		Site Location: Sudbury to Hudson Transmission Reliability Project	Town: Hudson
Photo No.: 4	Date: 12/21/2022

Description: View of storm drain inlet and culvert downstream of dewatering discharge, looking westward. Water appeared to be clear. Turbidity samples taken at this location.

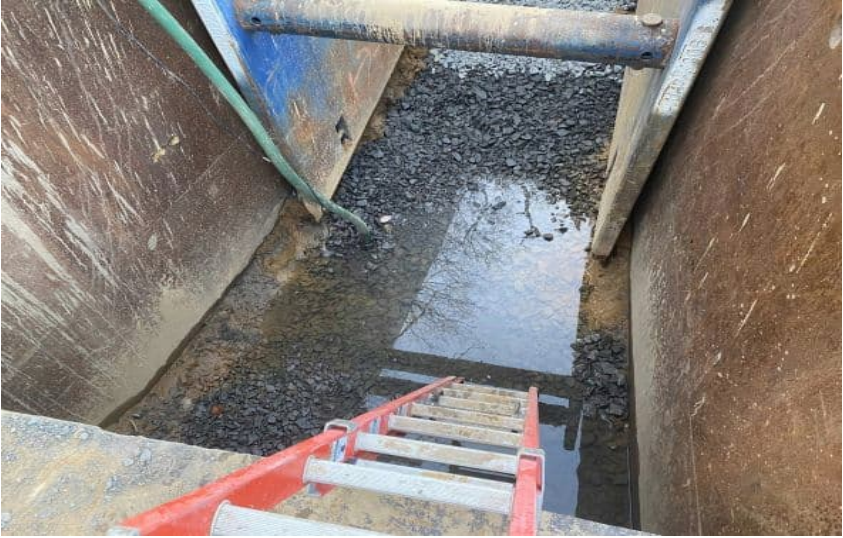
PHOTOGRAPHIC LOG	
Client Name: Eversource		Site Location: Sudbury to Hudson Transmission Reliability Project	Town: Hudson
Photo No.: 1	Date: 12/22/2022

Description: View of area being pumped at work operation at MH#1.

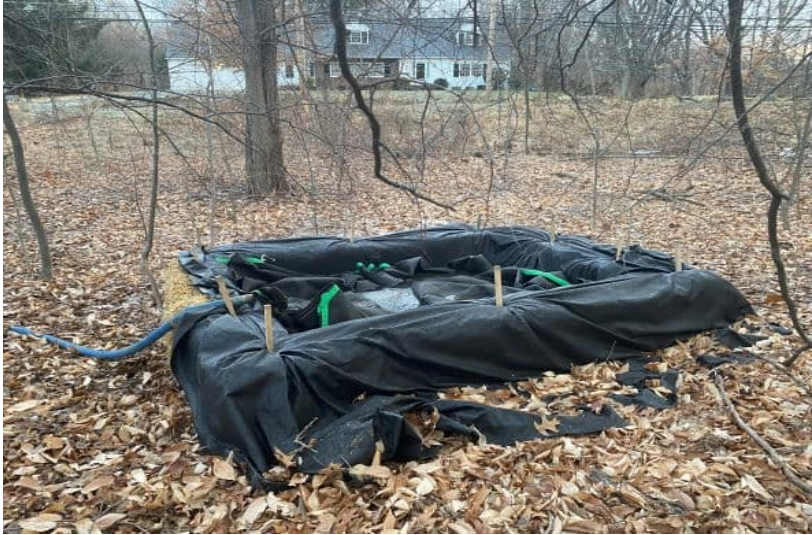
PHOTOGRAPHIC LOG	
Client Name: Eversource		Site Location: Sudbury to Hudson Transmission Reliability Project	Town: Hudson
Photo No.: 3	Date: 12/22/2022

Description: View of dewatering discharge area and controls, looking westward. Water appeared to be clear. Turbidity samples taken at this location.

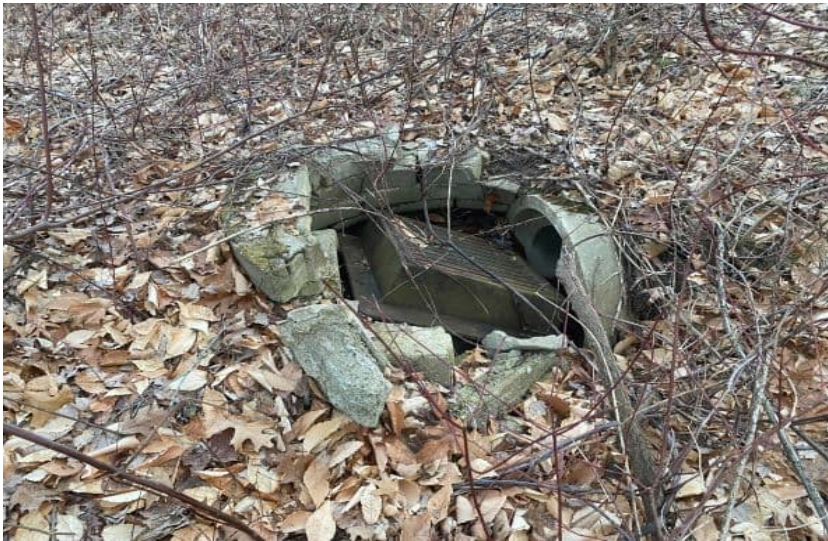
PHOTOGRAPHIC LOG	
Client Name: Eversource		Site Location: Sudbury to Hudson Transmission Reliability Project	Town: Hudson
Photo No.: 4	Date: 12/22/2022

Description: View of storm drain inlet and culvert downstream of dewatering discharge, looking westward. Water appeared to be clear. Turbidity samples taken at this location.

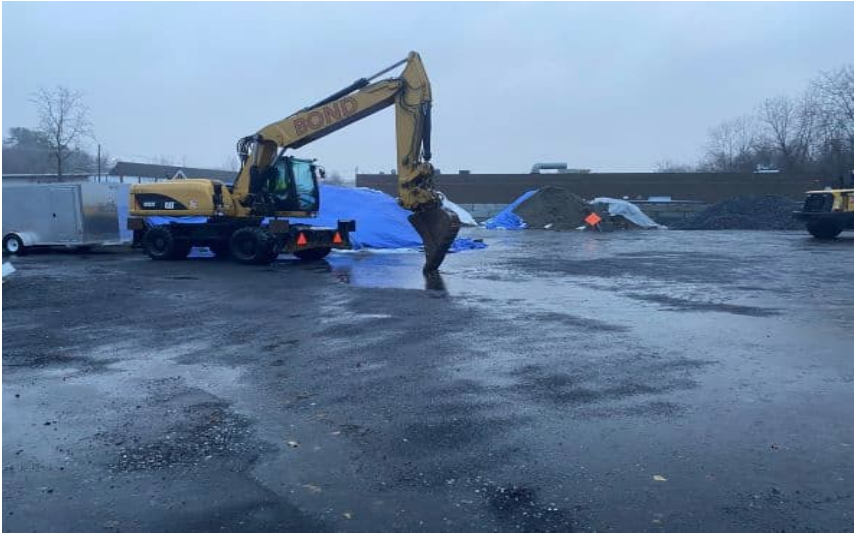
PHOTOGRAPHIC LOG	
Client Name: Eversource		Site Location: Sudbury to Hudson Transmission Reliability Project	Town: Hudson
Photo No.: 1	Date: 12-23-22

Description: Bond laydown yard at 17 Bonazzoli Avenue showing storage areas, looking southward, storage bins in good condition and operating properly.

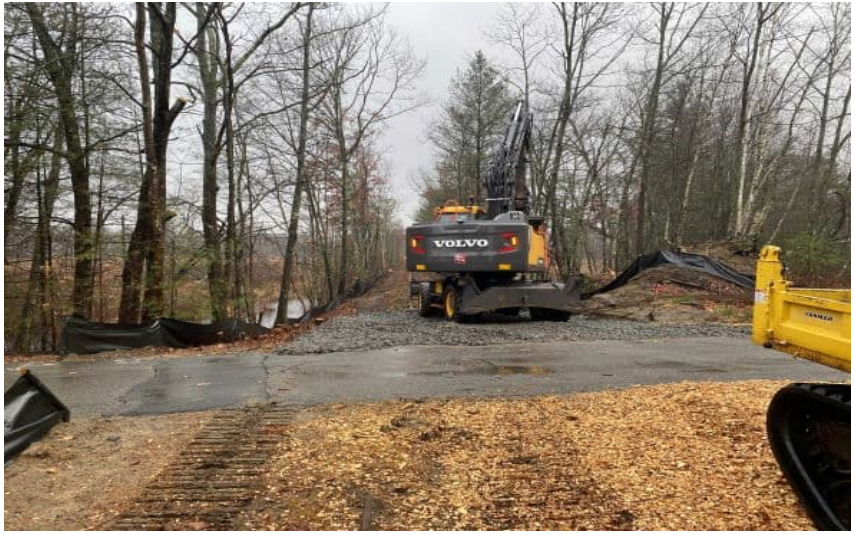
PHOTOGRAPHIC LOG	
Client Name: Eversource		Site Location: Sudbury to Hudson Transmission Reliability Project	Town: Hudson
Photo No.: 2	Date: 12-23-22

Description: Addition of new stabilized construction entrance off Hudson DPW road at approximate Sta.# 142+00, looking westward.

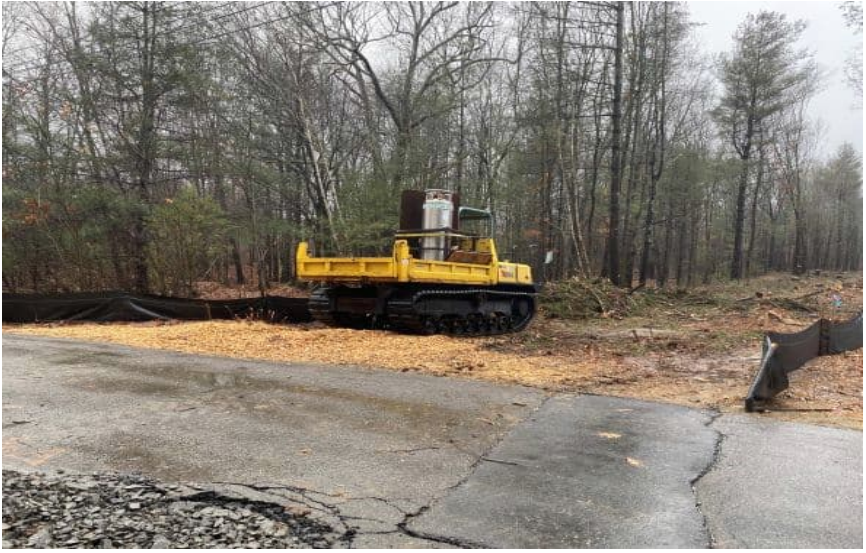
<p>Description:</p> <p>Addition of new stabilized construction entrance off Hudson DPW road at approximate Sta.# 142+00, looking eastward.</p>

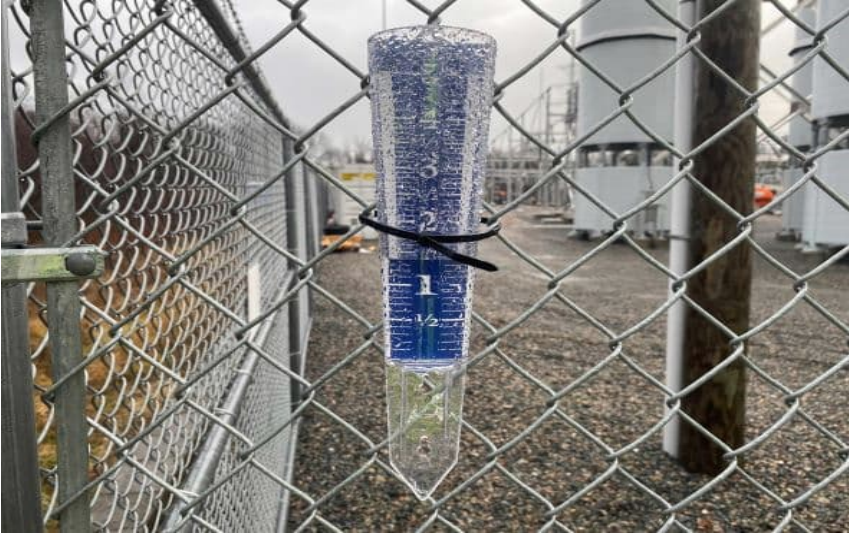
PHOTOGRAPHIC LOG	
Client Name: Eversource		Site Location: Sudbury to Hudson Transmission Reliability Project	Town: Sudbury
Photo No.: 5	Date: 12-23-22

Description: Rain gauge at Sudbury substation showing approximately 1.60" of rainfall, looking northward.

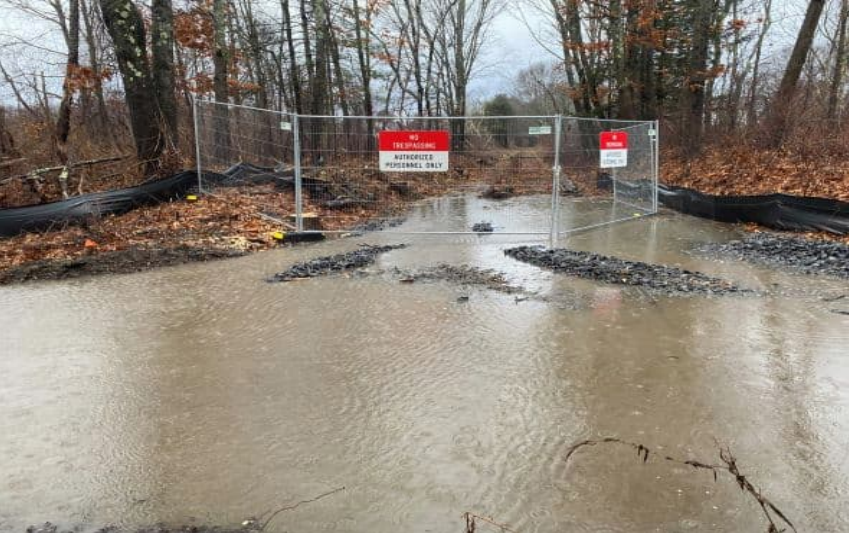
Description: Right-of-way entrance to Segment 14 near substation, flooded, looking westward.

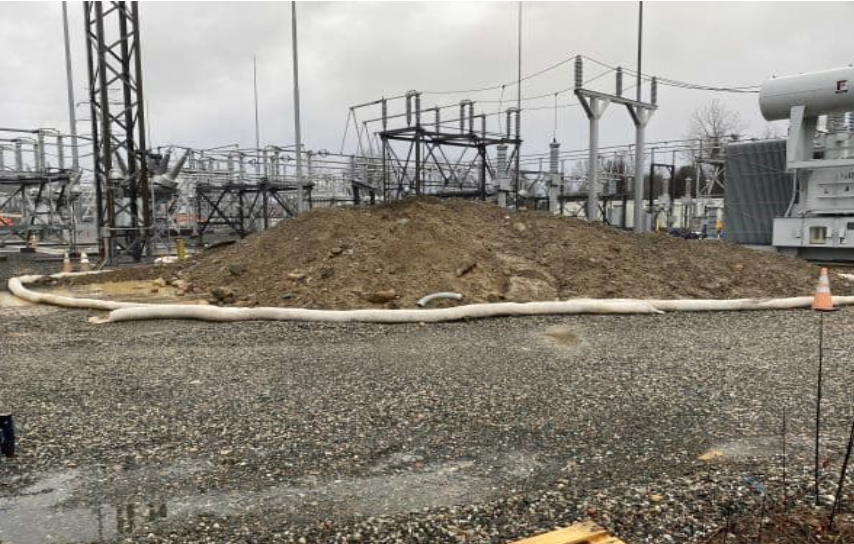
Description: Spoil pile within substation, surrounded by compost filter tubes (installed & operating properly), looking southward.
