Weekly Environmental Compliance Summary

Sudbury to Hudson Transmission Reliability Project (USEPA Tracking # MAR1003UW)

CONSTRUCTION MONITORING REPORT

Sudbury to Hudson Transmission Project

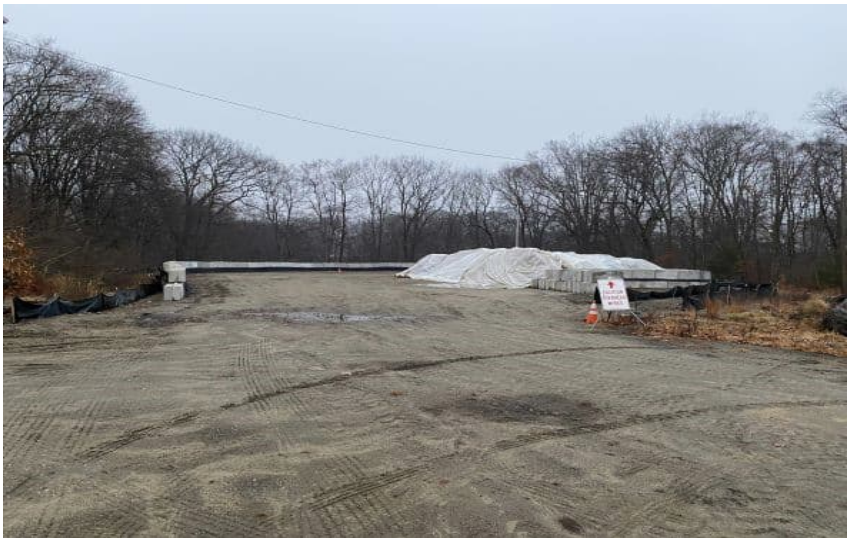
PHOTOGRAPHIC LOG	
Client Name: Eversource		Site Location: Sudbury to Hudson Transmission Reliability Project	
Photo No.: 2		Date: 1-3-23	
Description: Laydown Yard at Stowe Court, covered spoil pile, looking northward.

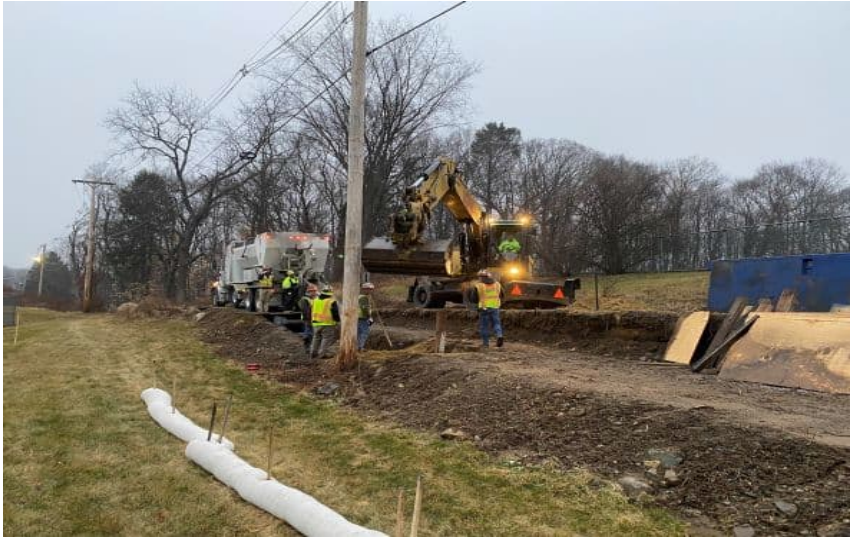
PHOTOGRAPHIC LOG	
Client Name: Eversource		Site Location: Sudbury to Hudson Transmission Reliability Project	
Photo No.: 3		Date: 1-3-23	
Description: Bond performing MH#1 site work off Forest Avenue, looking westward.

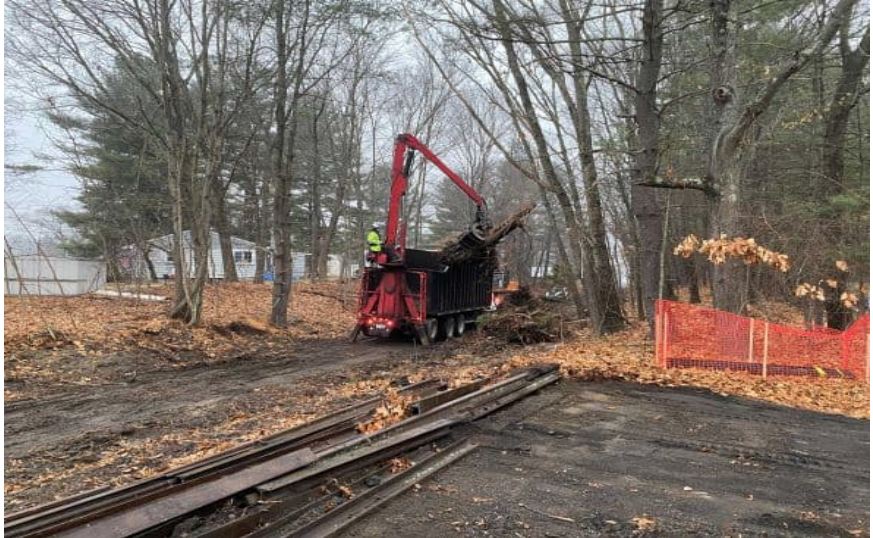
PHOTOGRAPHIC LOG	
Client Name: Eversource		Site Location: Sudbury to Hudson Transmission Reliability Project	
Photo No.: 4		Date: 1-3-23	
Description: Moosehead removing rails/ties within Segment 3 at approximate Sta.# 179+50, looking westward.

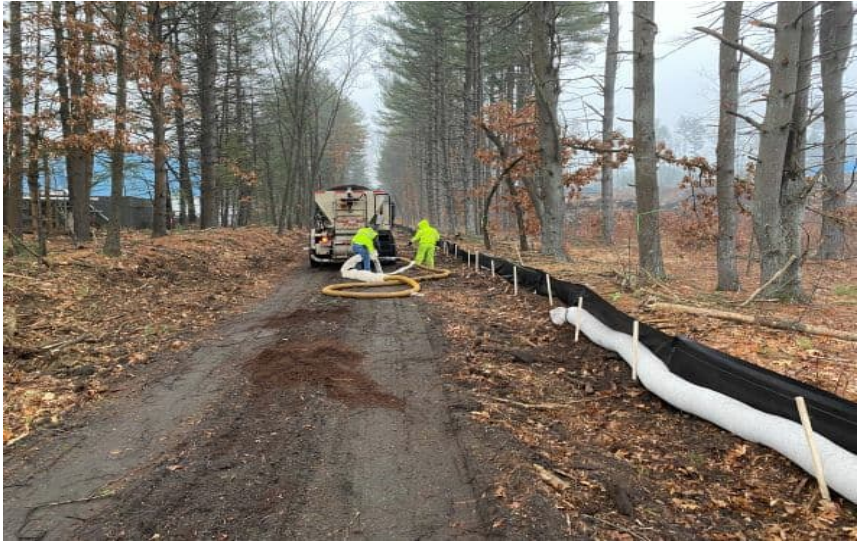
PHOTOGRAPHIC LOG	
Client Name: Eversource		Site Location: Sudbury to Hudson Transmission Reliability Project	
Photo No.: 5		Town: Hudson	
Date: 1-3-23

Description: MON adding compost filter tubes within Segment 4 at approximate Sta.# 191+00, looking eastward.

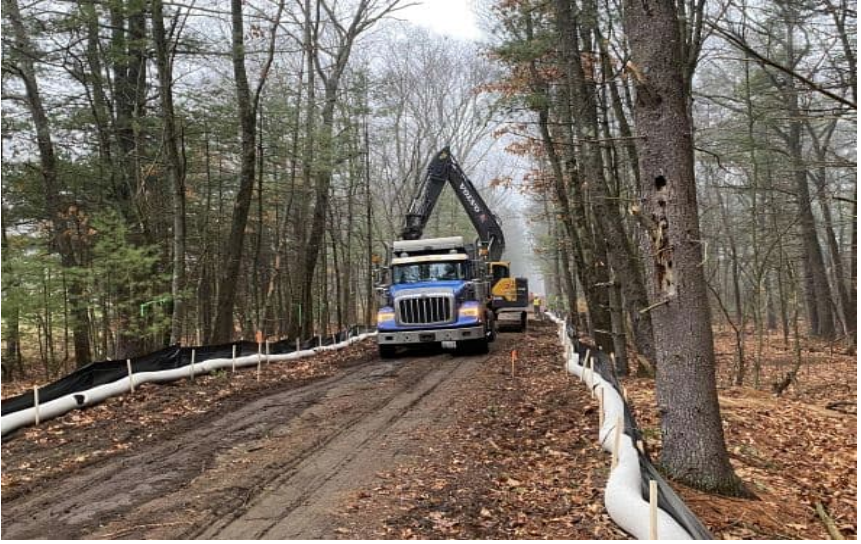
PHOTOGRAPHIC LOG	
Client Name: Eversource		Site Location: Sudbury to Hudson Transmission Reliability Project	
Photo No.: 6		Town: Hudson	
Date: 1-3-23

Description: ETL grading within Segment 4 at approximate Sta.# 208+00, looking westward.

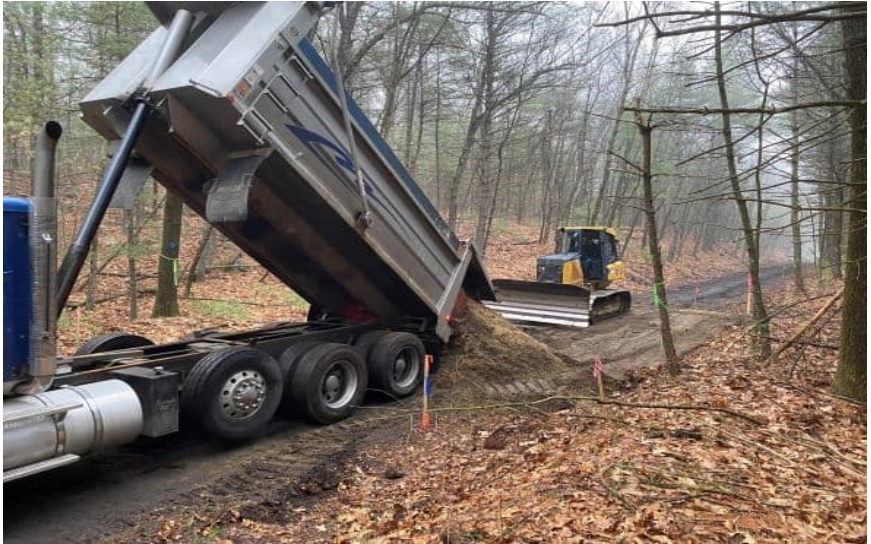
PHOTOGRAPHIC LOG	
Client Name: Eversource		Site Location: Sudbury to Hudson Transmission Reliability Project	
Photo No.: 7		Date: 1-3-23	
Description: ETL grading within Segment 5 at approximate Sta.# 301+50, looking eastward.

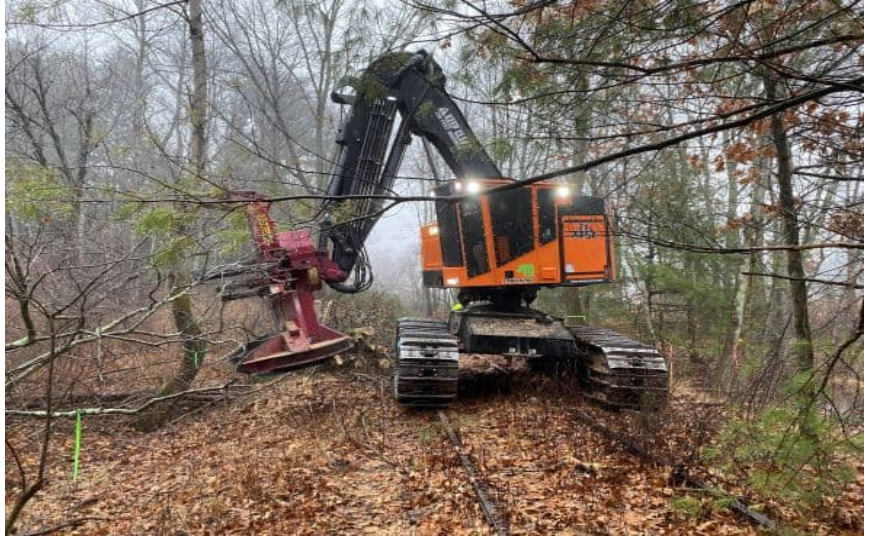
PHOTOGRAPHIC LOG	
Client Name: Eversource		Site Location: Sudbury to Hudson Transmission Reliability Project	
Photo No.: 8		Date: 1-3-23	
Description: Moosehead clearing operation within Segment 14 at approximate Sta.# 727+00, looking westward.

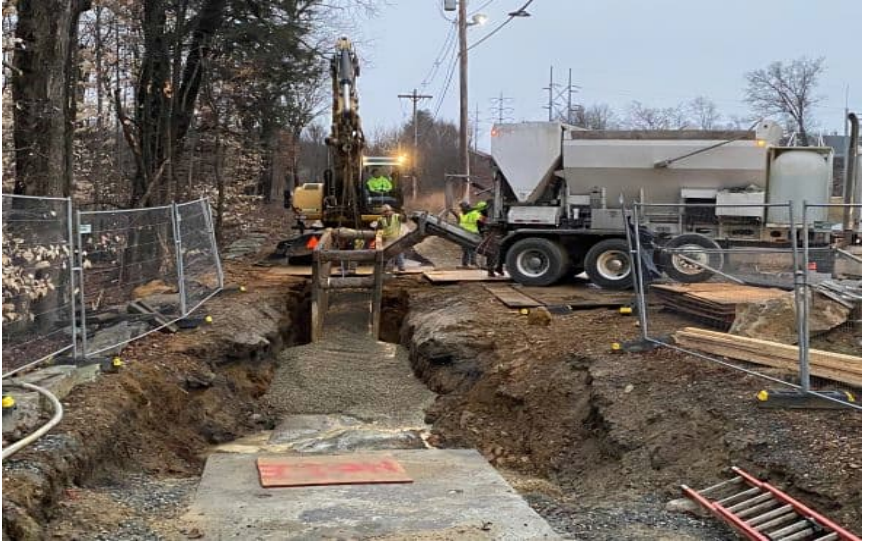
PHOTOGRAPHIC LOG	
Client Name: Eversource		Site Location: Sudbury to Hudson Transmission Reliability Project	
Photo No.: 2		Date: 1-6-23	
Description: Bond performing MH#1 site work (adding "flowable fill") off Forest Avenue, looking eastward.

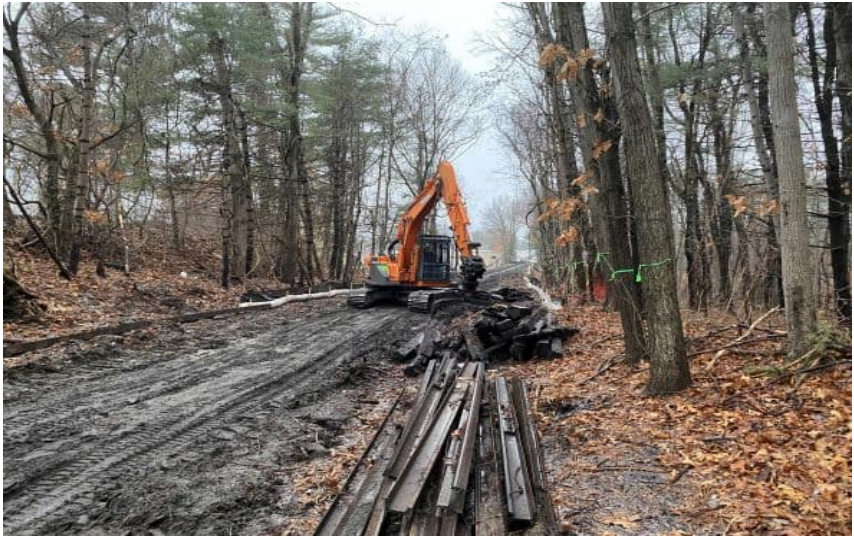
PHOTOGRAPHIC LOG	
Client Name: Eversource		Site Location: Sudbury to Hudson Transmission Reliability Project	
Photo No.: 4		Town: Hudson	
Date: 1-6-23

Description: Moosehead removing rails/ties within Segment 3 at approximate Sta.# 175+00, looking westward.

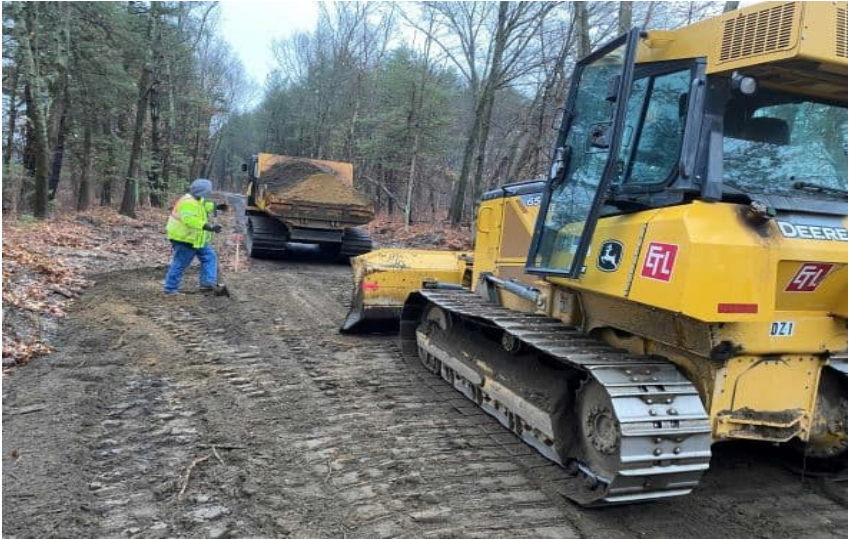
PHOTOGRAPHIC LOG	
Client Name: Eversource		Site Location: Sudbury to Hudson Transmission Reliability Project	
Photo No.: 5		Date: 1-6-23	
Description: ET&L grading within Segment 4 at approximate Sta.# 185+00, looking eastward.

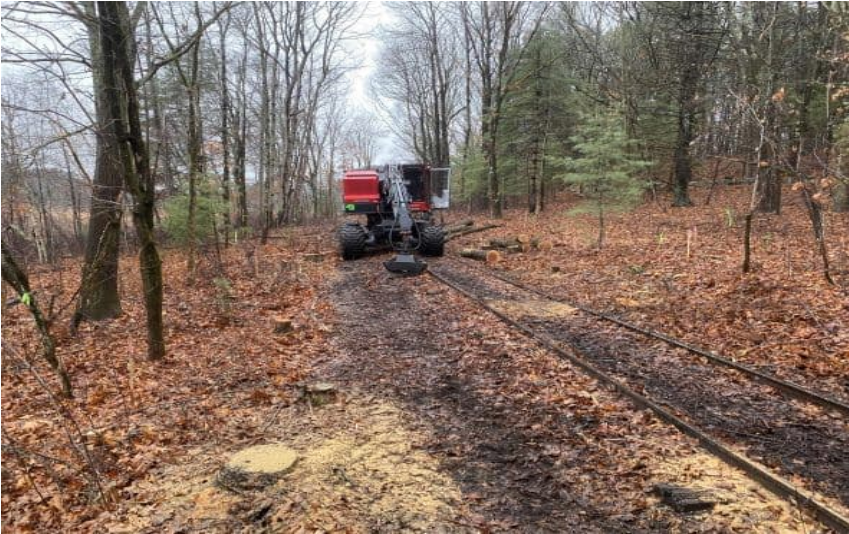
PHOTOGRAPHIC LOG	
Client Name: Eversource		Site Location: Sudbury to Hudson Transmission Reliability Project	
Photo No.: 7		Date: 1-6-23	
Description: Moosehead chipping operation within Segment 14 at approximate Sta.# 737+00, looking westward.

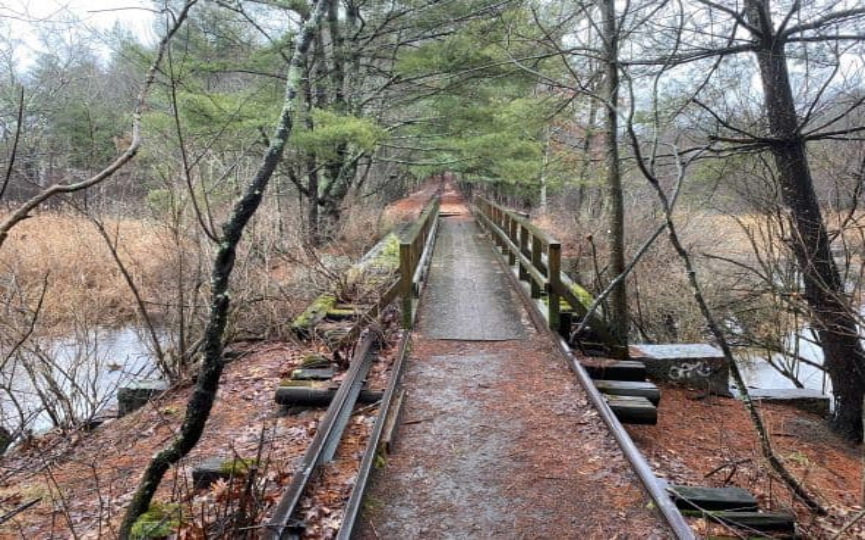
PHOTOGRAPHIC LOG	
Client Name: Eversource		Site Location: Sudbury to Hudson Transmission Reliability Project	
Photo No.: 8		Date: 1-6-23	
Description: Bridge 128 (eastern extent of segment 7), looking eastward.

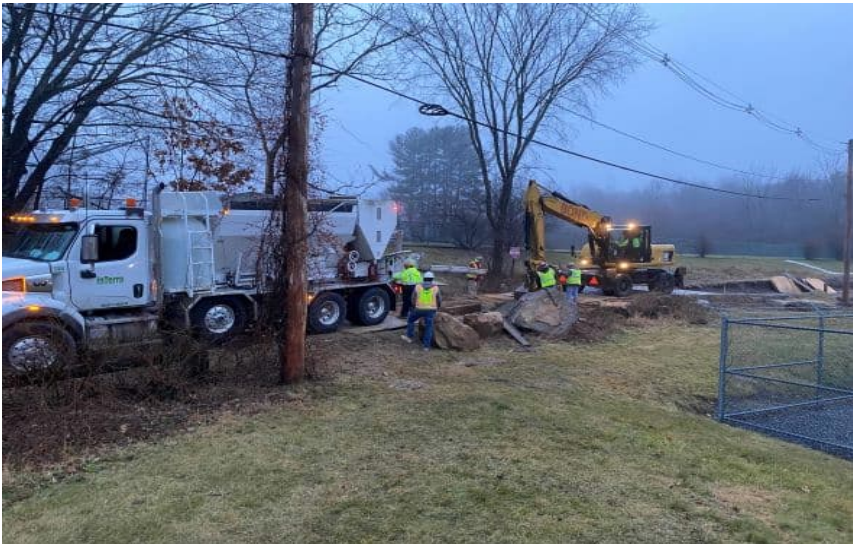
PHOTOGRAPHIC LOG	
Client Name: Eversource		Site Location: Sudbury to Hudson Transmission Reliability Project	
Photo No.: 1 Date: 1-4-23		Town: Hudson	
Description: Site work at MH#1 off Forest Avenue, placing flowable fill, looking eastward.

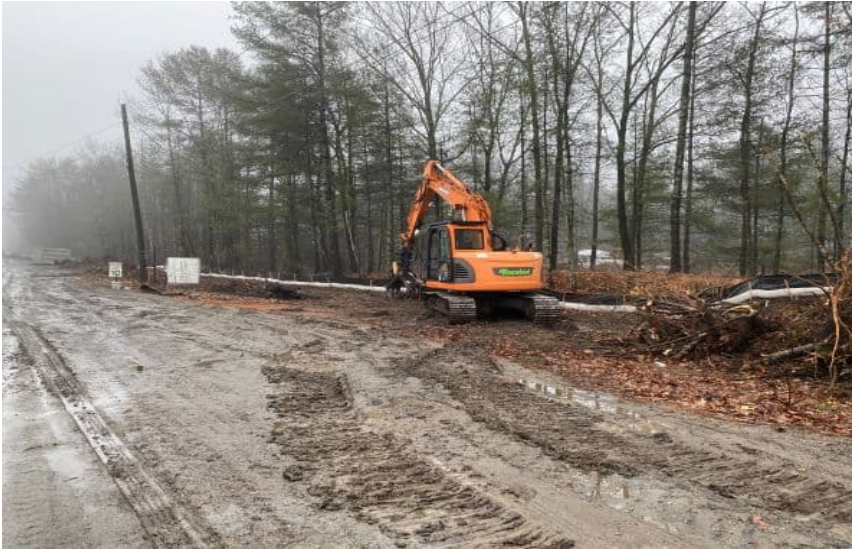
PHOTOGRAPHIC LOG	
Client Name: Eversource		Site Location: Sudbury to Hudson Transmission Reliability Project	
Town: Hudson			
Photo No.: 3	Date: 1-4-23

Description: Clearing of debris within Segment 3 at approximate Sta.# 158+00, looking eastward.

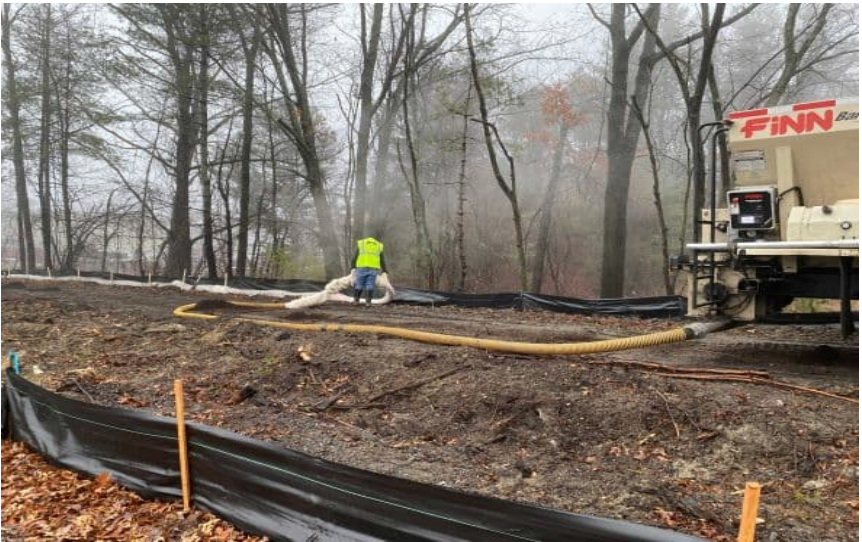
PHOTOGRAPHIC LOG	
Client Name: Eversource		Site Location: Sudbury to Hudson Transmission Reliability Project	
Town: Hudson			
Photo No.: 4	Date: 1-4-23

Description: MON adding compost filter tubes within Segment 3 at approximate Sta.# 171+00, looking westward.

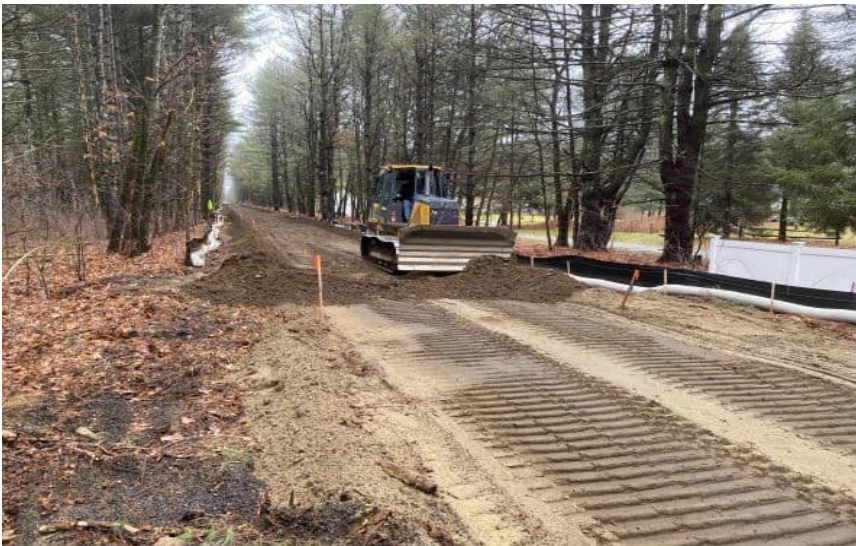
PHOTOGRAPHIC LOG	
Client Name: Eversource		Site Location: Sudbury to Hudson Transmission Reliability Project	
Town: Hudson			
Photo No.: 5	Date: 1-4-23

Description: Grading work in Segment 5 at approximate Sta.# 300+75, looking eastward.

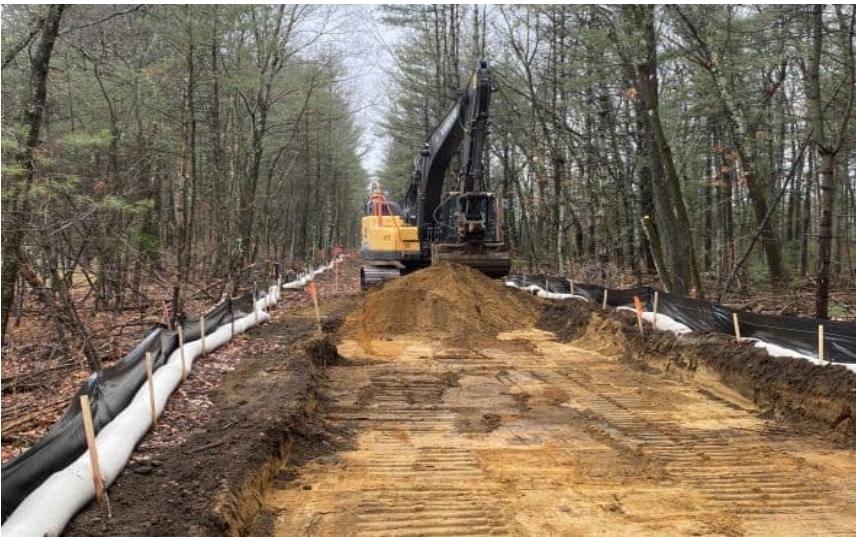
PHOTOGRAPHIC LOG	
Client Name: Eversource		Site Location: Sudbury to Hudson Transmission Reliability Project	
Town: Hudson			
Photo No.: 6	Date: 1-4-23

Description: Grading work in Segment 4 at approximate Sta.# 205+50, looking westward.

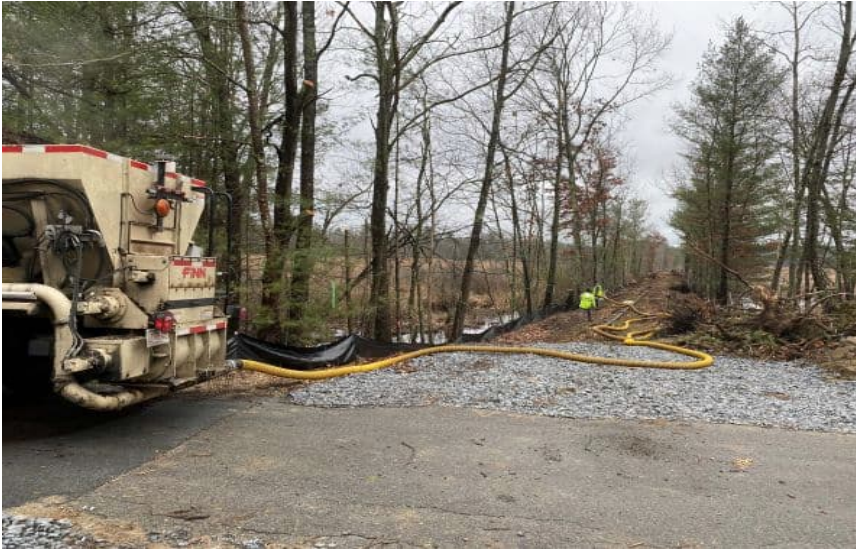
PHOTOGRAPHIC LOG	
Client Name: Eversource		Site Location: Sudbury to Hudson Transmission Reliability Project	
Town: Hudson			
Photo No.: 7	Date: 1-4-23

Description: MON installing compost filter tubes within Segment 2 near Sta.# 142+00, looking eastward.

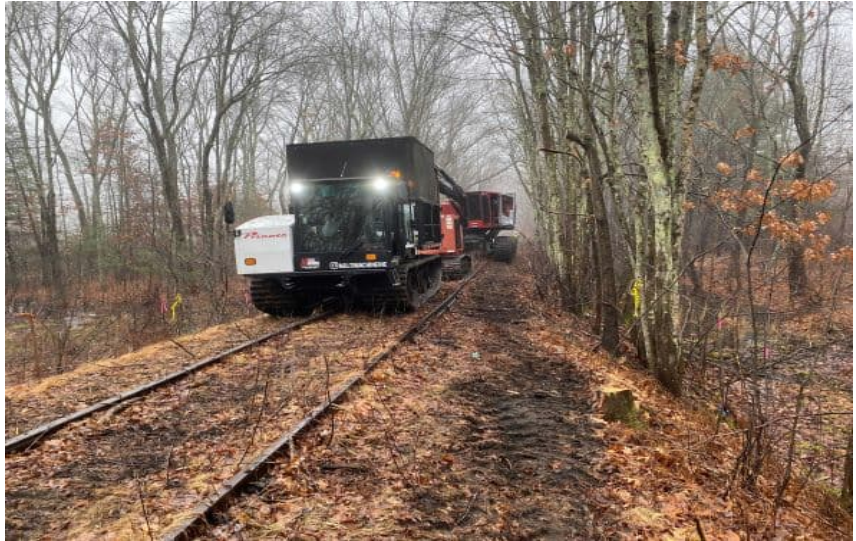
PHOTOGRAPHIC LOG	
Client Name: Eversource		Site Location: Sudbury to Hudson Transmission Reliability Project	
Town: Sudbury			
Photo No.: 8	Date: 1-4-23

Description: Chipping by Moosehead within Segment 14 at approximate Sta.# 747+00, looking westward.

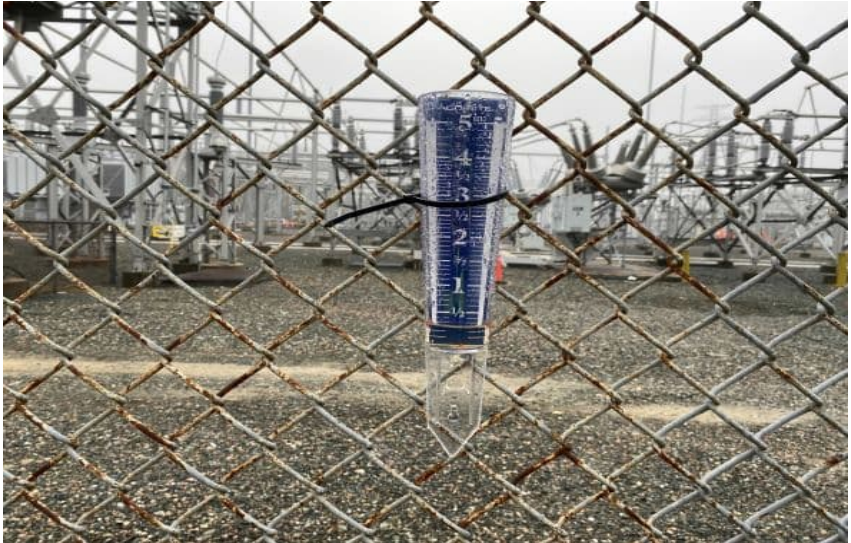
PHOTOGRAPHIC LOG	
Client Name: Eversource		Site Location: Sudbury to Hudson Transmission Reliability Project	
Photo No.: 9		Town: Sudbury	
Date: 1-4-23

Description: Rain gauge at Sudbury substation, showing approximately 0.35" of rainfall, looking southward.

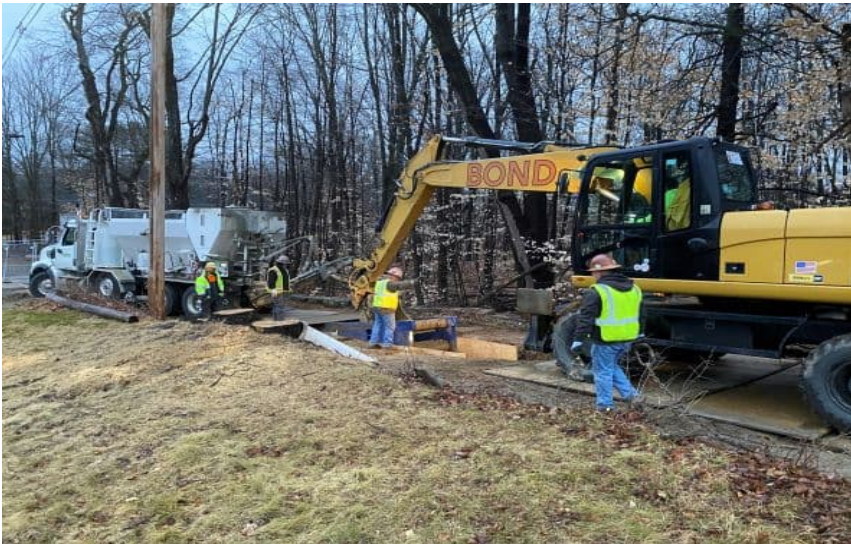
PHOTOGRAPHIC LOG	
Client Name: Eversource		Site Location: Sudbury to Hudson Transmission Reliability Project	
Photo No.: 1 Date: 1-5-23		Town: Hudson	
Description: Site work at MH#1 off Forest Avenue, placing flowable fill, looking westward.

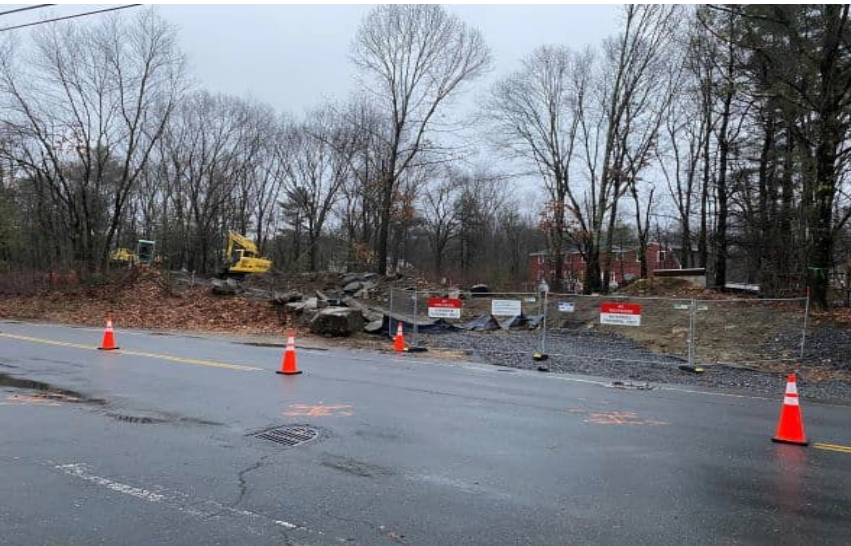
PHOTOGRAPHIC LOG	
Client Name: Eversource		Site Location: Sudbury to Hudson Transmission Reliability Project	
Photo No.: 2 Date: 1-5-23		Town: Hudson	
Description: Site work off Wilkins, looking eastward.

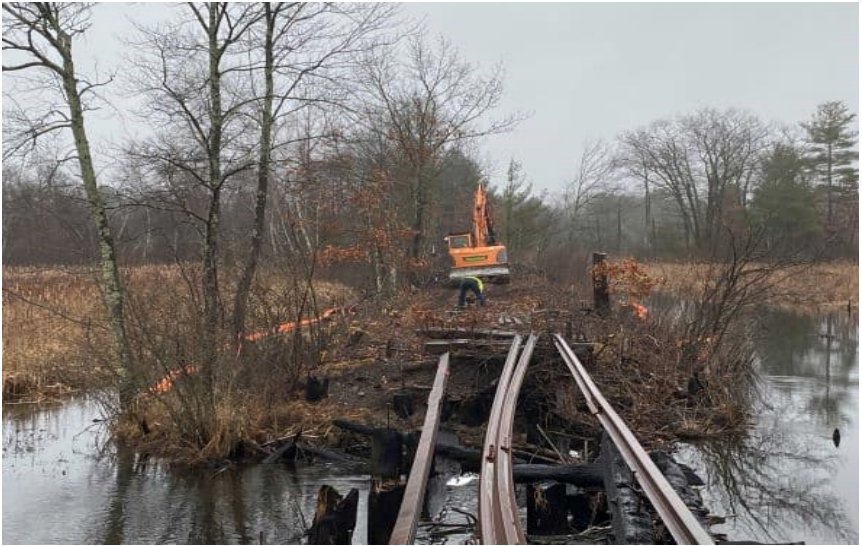
PHOTOGRAPHIC LOG	
Client Name: Eversource		Site Location: Sudbury to Hudson Transmission Reliability Project	
Town: Hudson			
Photo No.: 3	Date: 1-5-23

Description: Clearing of debris within Segment 2 at approximate Sta.# 149+50, looking westward.

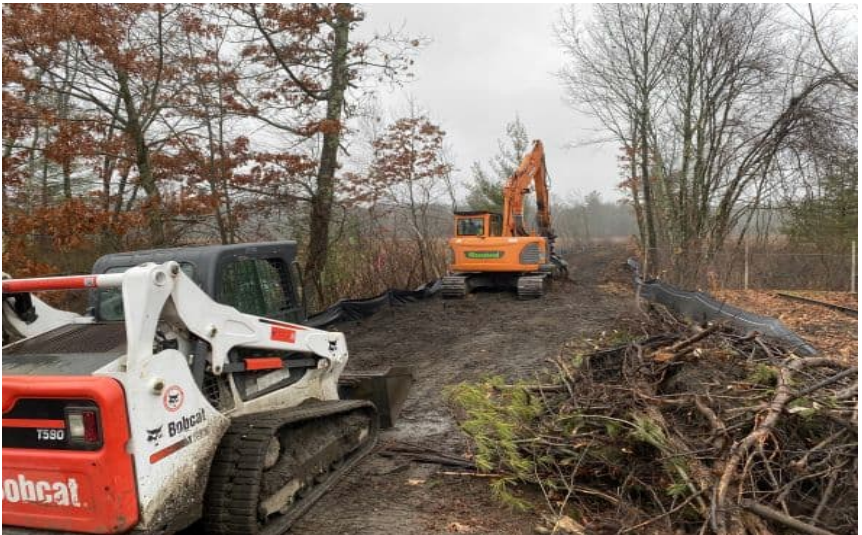
PHOTOGRAPHIC LOG	
Client Name: Eversource		Site Location: Sudbury to Hudson Transmission Reliability Project	
Town: Hudson			
Photo No.: 4	Date: 1-5-23

Description: Clearing of debris within Segment 3 at approximate Sta.# 155+00, looking westward.

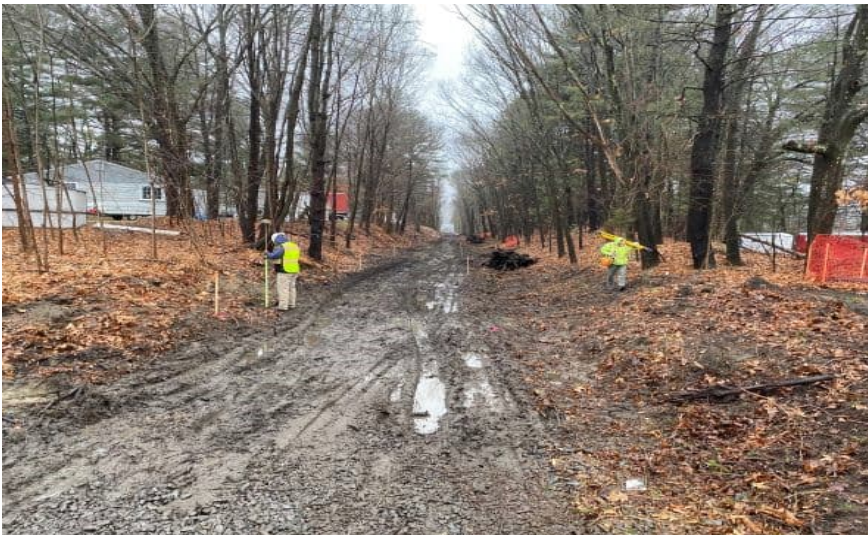
PHOTOGRAPHIC LOG	
Client Name: Eversource		Site Location: Sudbury to Hudson Transmission Reliability Project	
Town: Hudson			
Photo No.: 5	Date: 1-5-23

Description: ET&L establishing grade stakes off Main Street withing Segment 3, looking westward.

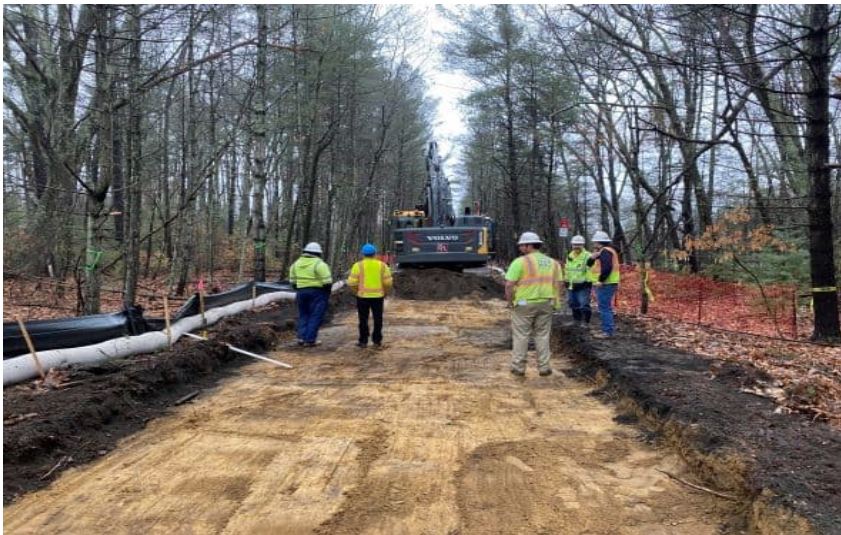
PHOTOGRAPHIC LOG	
Client Name: Eversource		Site Location: Sudbury to Hudson Transmission Reliability Project	
Town: Hudson			
Photo No.: 6	Date: 1-5-23

Description: Grading work in Segment 4 at approximate Sta.# 207+00, oversight by Commonwealth Heritage & Wampanoag Representative, looking westward.

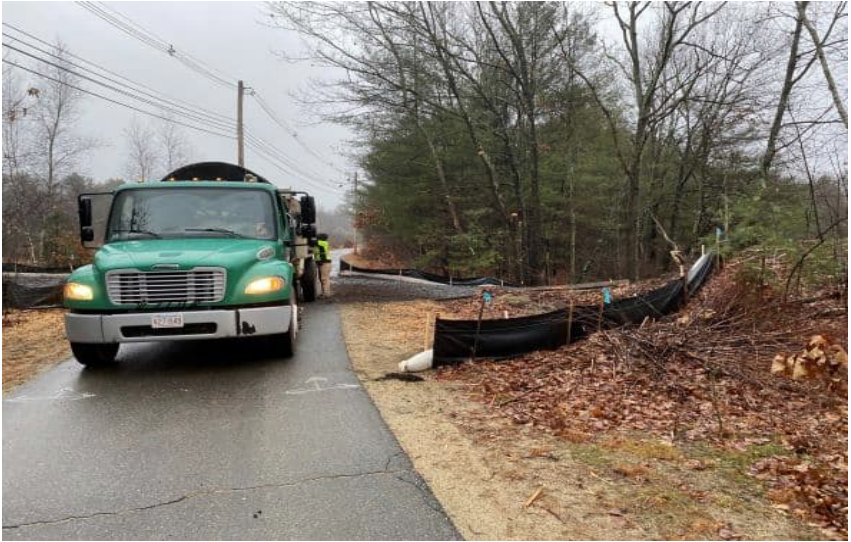
PHOTOGRAPHIC LOG	
Client Name: Eversource		Site Location: Sudbury to Hudson Transmission Reliability Project	
Town: Hudson			
Photo No.: 7	Date: 1-5-23

Description: MON installing compost filter tubes within Segment 2 near Sta.# 142+00, looking eastward.

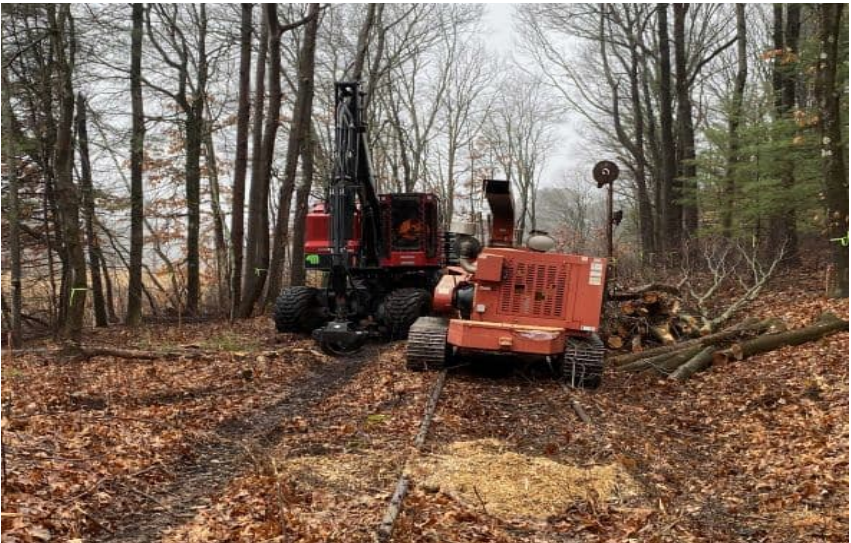
PHOTOGRAPHIC LOG	
Client Name: Eversource		Site Location: Sudbury to Hudson Transmission Reliability Project	
Town: Sudbury			
Photo No.: 8	Date: 1-5-23

Description: Chipping by Moosehead within Segment 14 at approximate Sta.# 737+50, looking westward.

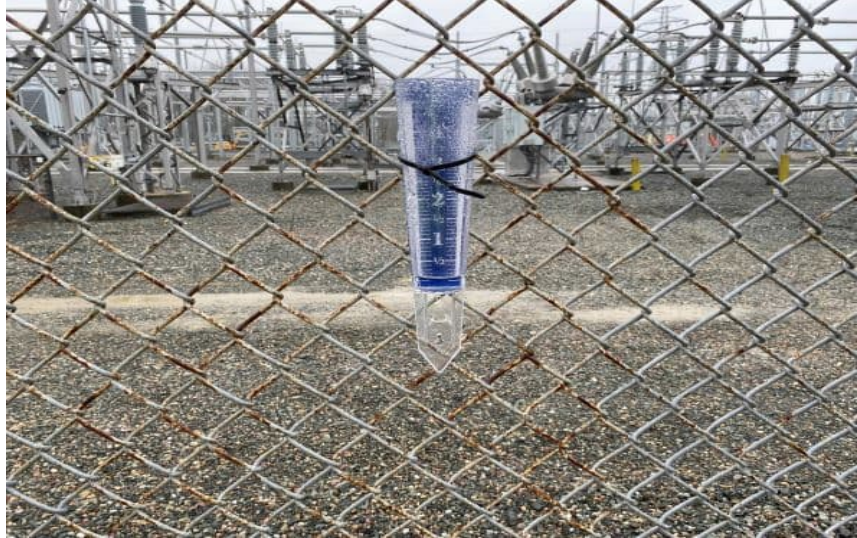
Rain gauge at Sudbury substation, showing approximately 0.30" of rainfall, looking southward.
