Weekly Environmental Compliance Summary

Sudbury to Hudson Transmission Reliability Project (USEPA Tracking # MAR1003UW)

Week of: January 9 to January 13, 2023

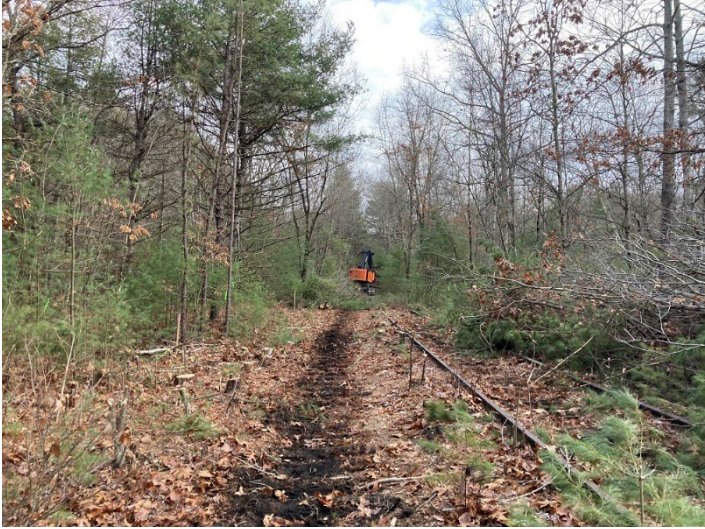
PHOTOGRAPHIC LOG	
Client Name: Eversource		Site Location: Sudbury to Hudson Transmission Reliability Project	Town: Sudbury
Photo No.: 1	Date: 1/09/2023

Description: View of clearing activities in Segment 7 from town line, facing east.

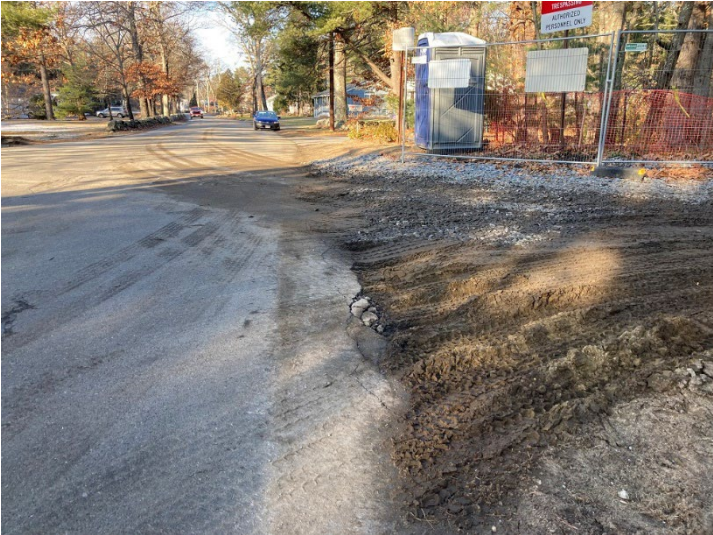
PHOTOGRAPHIC LOG	
Client Name: Eversource		Site Location: Sudbury to Hudson Transmission Reliability Project	Town: Hudson
Photo No.: 2	Date: 1/09/2023

Description: View of entrance to Segment 5 off Parmenter Rd. Fresh stone is needed on tracking pad to ensure sediment is not tracked into roadway (routine maintenance). Facing north.

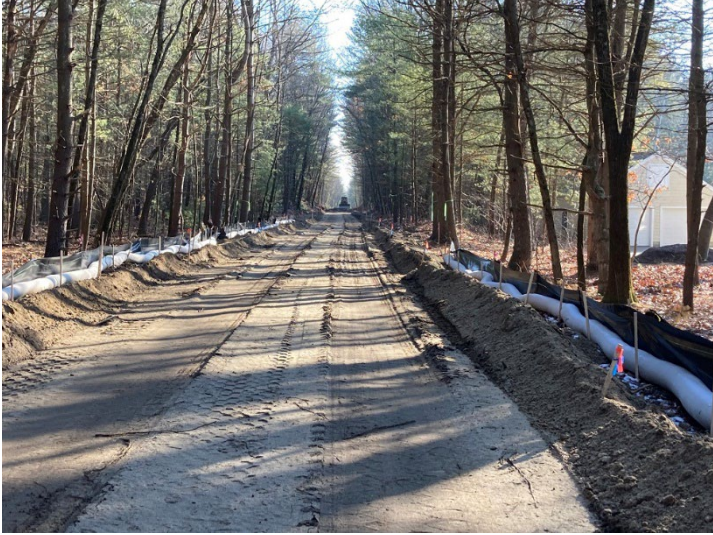
PHOTOGRAPHIC LOG	
Client Name: Eversource		Site Location: Sudbury to Hudson Transmission Reliability Project	Town: Hudson
Photo No.: 3	Date: 1/09/2023

Description: View of Segment 5 from Parmenter Rd. Erosion controls are in good condition and operating properly. Facing east.

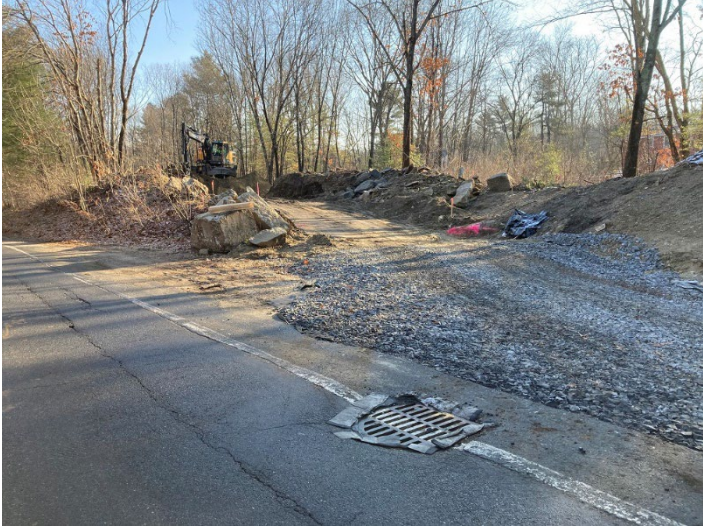
PHOTOGRAPHIC LOG	
Client Name: Eversource		Site Location: Sudbury to Hudson Transmission Reliability Project	Town: Hudson
Photo No.: 4	Date: 1/09/2023

Description: View of cut & fill activities in Segment 1 off Wilkins St. Facing northeast.

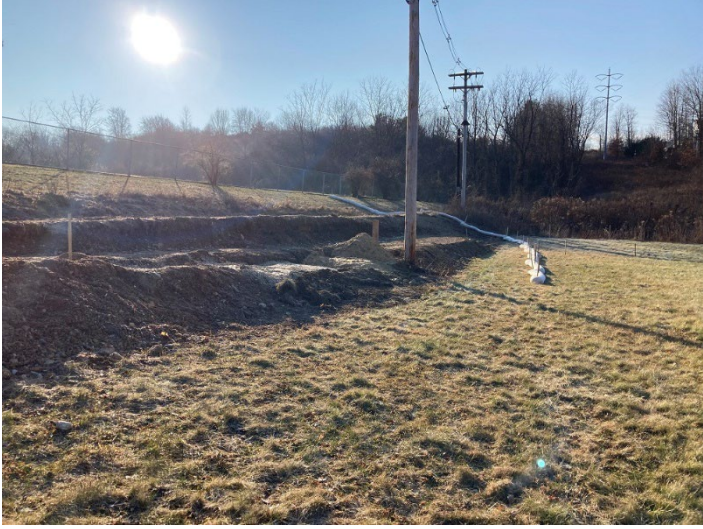
PHOTOGRAPHIC LOG	
Client Name: Eversource		Site Location: Sudbury to Hudson Transmission Reliability Project	Town: Hudson
Photo No.: 5	Date: 1/09/2023

Description: View of E&S controls near MH #1. Controls are in good condition and operating properly. Facing south.

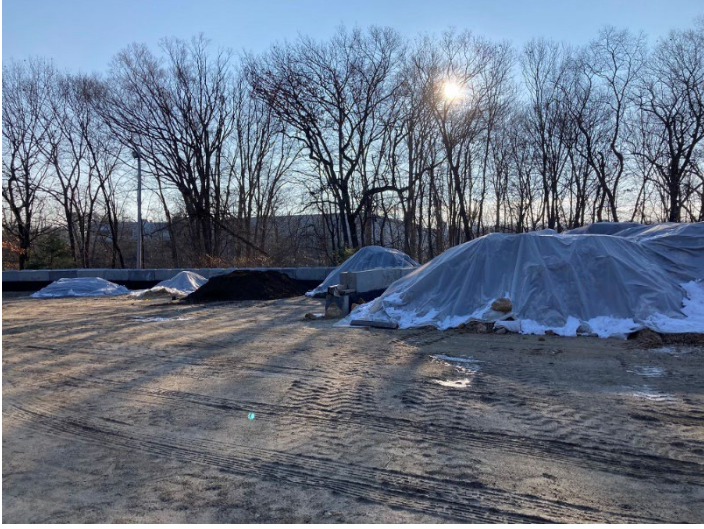
PHOTOGRAPHIC LOG	
Client Name: Eversource		Site Location: Sudbury to Hudson Transmission Reliability Project	Town: Hudson
Photo No.: 6	Date: 1/09/2023

Description: View of Stowe Ct laydown yard. Please ensure stockpiles are being covered at the end of each workday. Facing southeast.

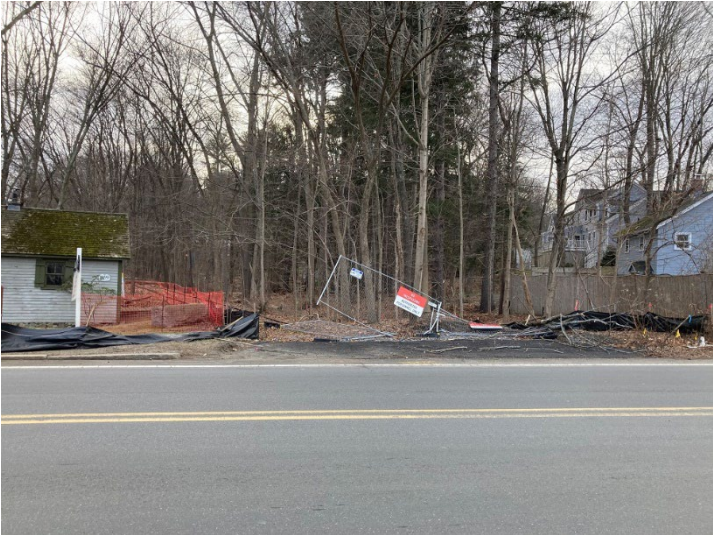
PHOTOGRAPHIC LOG	
Client Name: Eversource		Site Location: Sudbury to Hudson Transmission Reliability Project	Town: Sudbury
Photo No.: 2	Date: 1/10/2023

Description: View of construction entrance to Segment 13 on Boston Post Rd. An auto incident appears to have occurred and caused damage to site fence and silt fence. Repairs are needed (routine maintenance). Facing east.

- Repair silt fence where damaged at construction entrance to segment 13 at Boston Post Rd.**
-
-

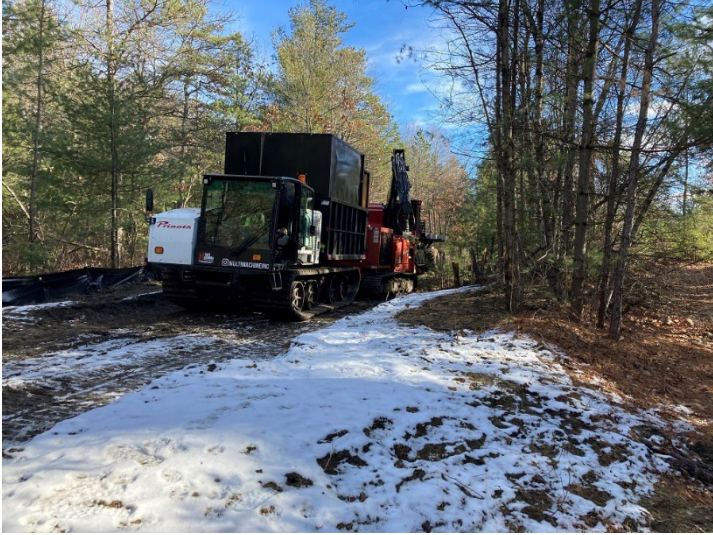
<p>PHOTOGRAPHIC LOG</p>	
<p>Client Name: Eversource</p>		<p>Site Location: Sudbury to Hudson Transmission Reliability Project</p>	<p>Town: Hudson near Sudbury town line</p>
<p>Photo No.: 3</p>	<p>Date: 1/10/2023</p>

<p>Description: View of chipping activities at end of Segment 6 in Hudson just before town line. Chipping operation continued into Segment 7 in Sudbury. Facing northeast.</p>

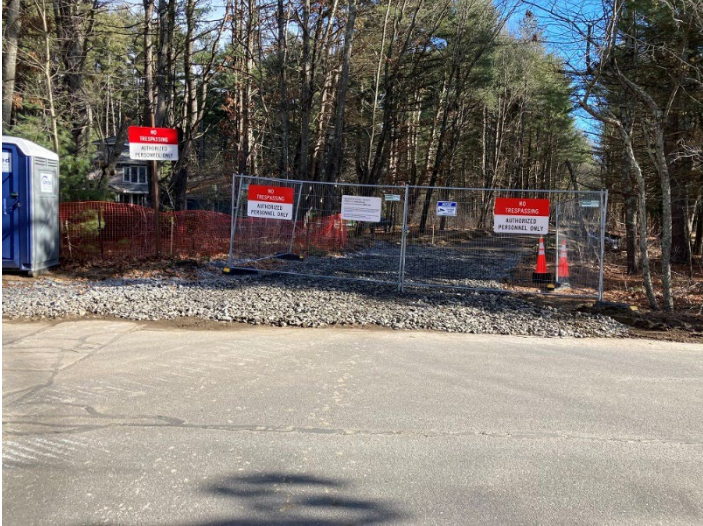
<p>PHOTOGRAPHIC LOG</p>	
<p>Client Name: Eversource</p>		<p>Site Location: Sudbury to Hudson Transmission Reliability Project</p>	<p>Town: Hudson</p>
<p>Photo No.: 4</p>	<p>Date: 1/10/2023</p>

<p>Description: View of construction entrance at Segment 5 at Parmenter Rd. Fresh stone has been applied to pad. Facing east.</p>

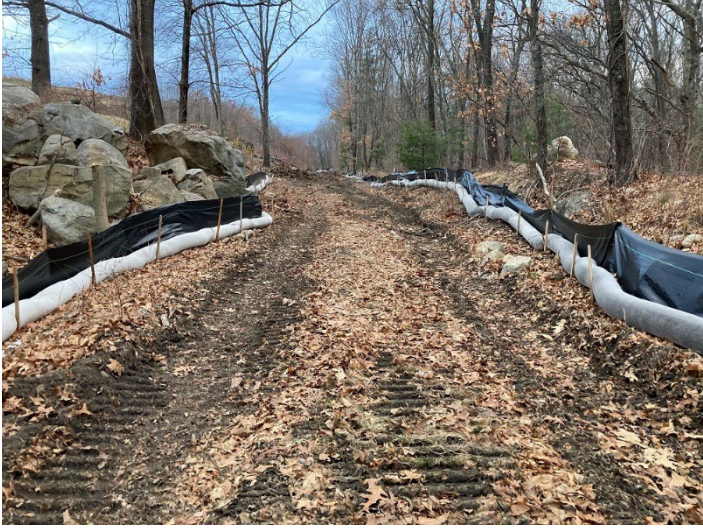
PHOTOGRAPHIC LOG	
Client Name: Eversource		Site Location: Sudbury to Hudson Transmission Reliability Project	Town: Stow
Photo No.: 5	Date: 1/10/2023

Description: View of E&S controls in Stow portion of project in Segment 1. Controls are in good condition and operating properly. Facing west.

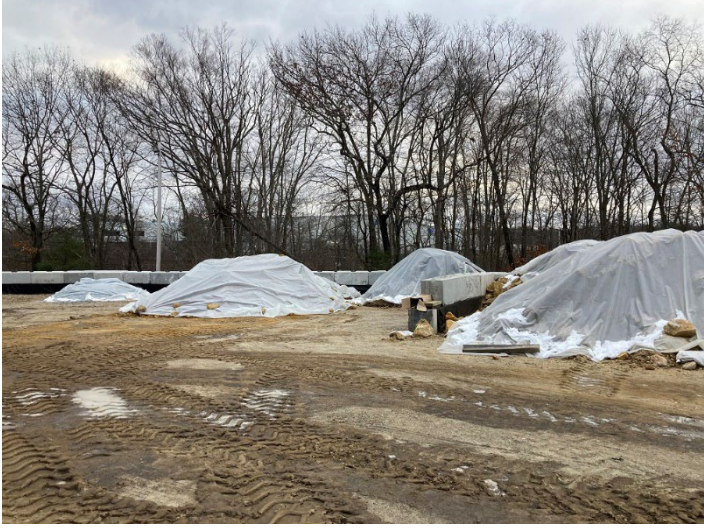
PHOTOGRAPHIC LOG	
Client Name: Eversource		Site Location: Sudbury to Hudson Transmission Reliability Project	Town: Hudson
Photo No.: 6	Date: 1/10/2023

Description: View of Stowe Ct laydown yard. All stockpiles were covered at time of inspection. Facing southeast.

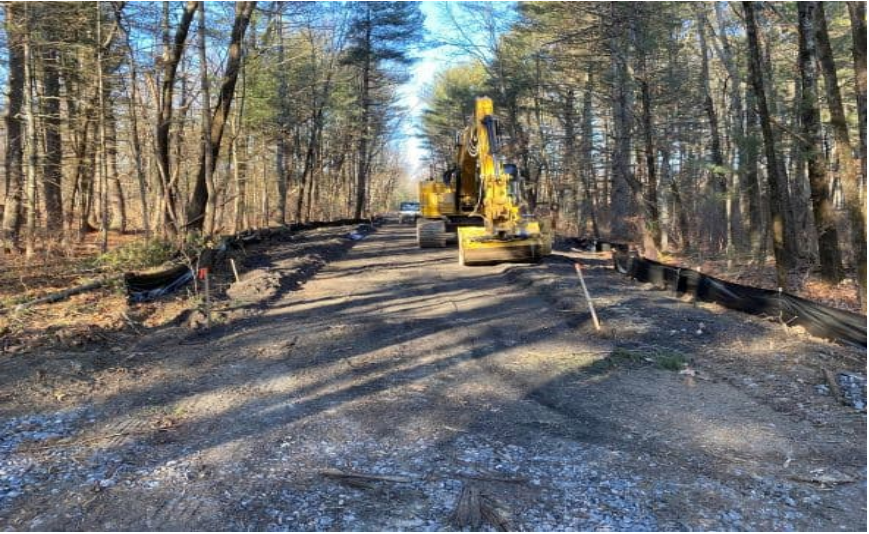
<p>PHOTOGRAPHIC LOG</p>	
<p>Client Name: Eversource</p>		<p>Site Location: Sudbury to Hudson Transmission Reliability Project</p>	<p>Town: Hudson</p>
<p>Photo No.: 1</p>	<p>Date: 1-11-23</p>

<p>Description:</p> <p>Bond setting up for installation of manhole off White Pond Road, looking westward.</p>

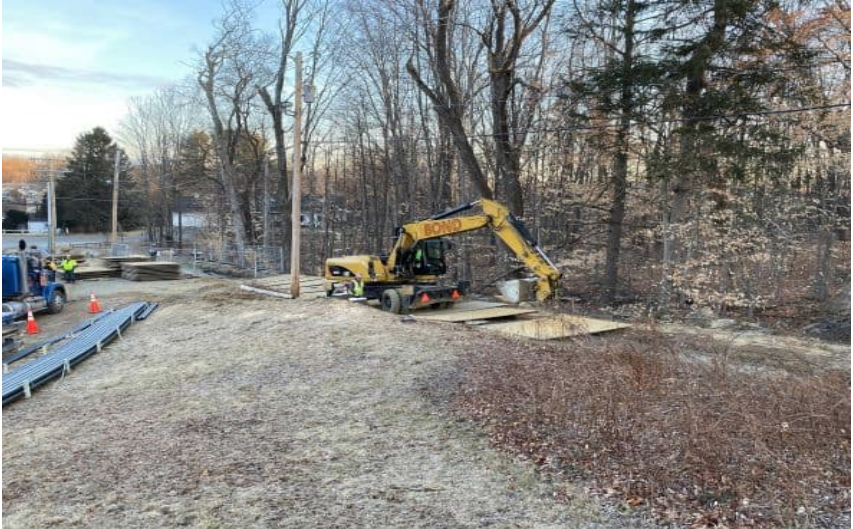
<p>PHOTOGRAPHIC LOG</p>	
<p>Client Name: Eversource</p>		<p>Site Location: Sudbury to Hudson Transmission Reliability Project</p>	<p>Town: Hudson</p>
<p>Photo No.: 2</p>	<p>Date: 1-11-23</p>

<p>Description:</p> <p>Bond performing MH#1 site work (backfilling) off Forest Avenue, looking westward.</p>

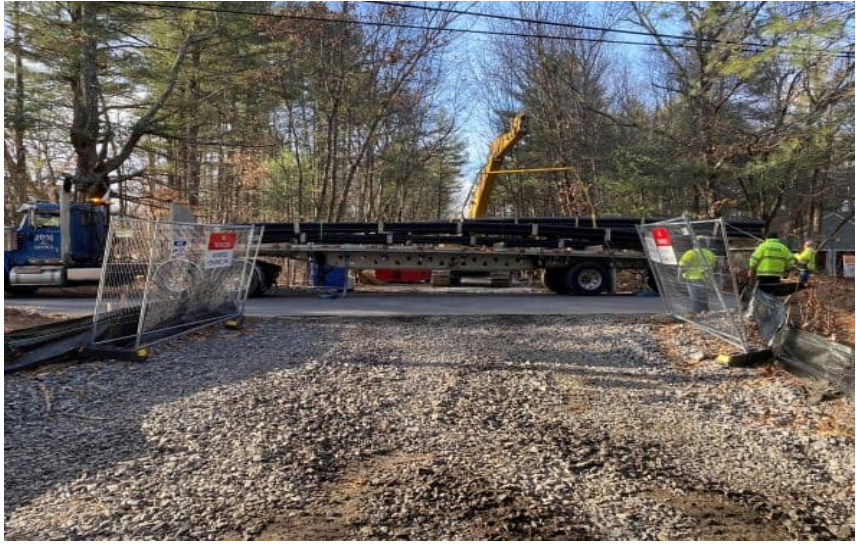
<p align="center">PHOTOGRAPHIC LOG</p>	
<p>Client Name: Eversource</p>		<p>Site Location: Sudbury to Hudson Transmission Reliability Project</p>	<p>Town: Hudson</p>
<p>Photo No.: 3</p>	<p>Date: 1-11-23</p>

<p>Description:</p> <p>Bond unloading conduit for future use in manhole off White Pond Road, looking westward.</p>

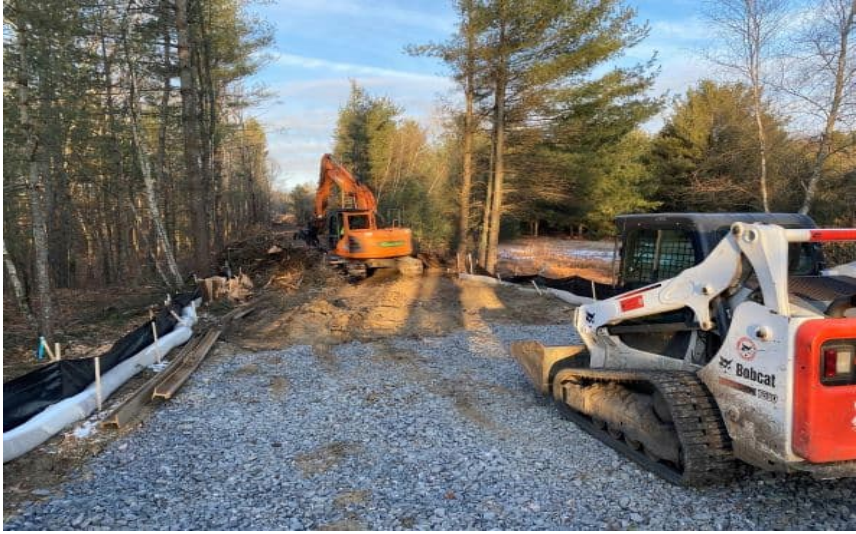
<p align="center">PHOTOGRAPHIC LOG</p>	
<p>Client Name: Eversource</p>		<p>Site Location: Sudbury to Hudson Transmission Reliability Project</p>	<p>Town: Hudson</p>
<p>Photo No.: 4</p>	<p>Date: 1-11-23</p>

<p>Description:</p> <p>Moosehead removing materials within Segment 2 at approximate Sta.# 142+00, looking westward.</p>

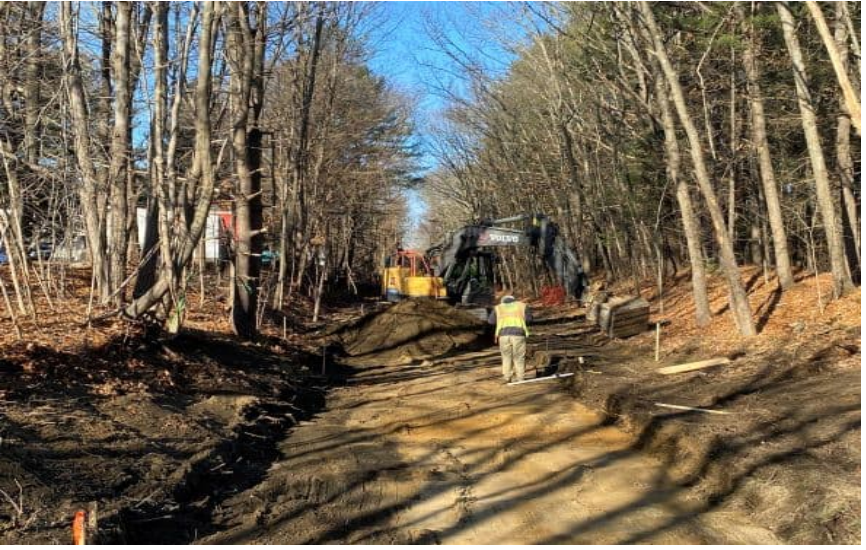
<p>PHOTOGRAPHIC LOG</p>	
<p>Client Name: Eversource</p>		<p>Site Location: Sudbury to Hudson Transmission Reliability Project</p>	<p>Town: Hudson</p>
<p>Photo No.: 5</p>	<p>Date: 1-11-23</p>

<p>Description:</p> <p>ET&L grading within Segment 4 just off Main Street, looking westward.</p>

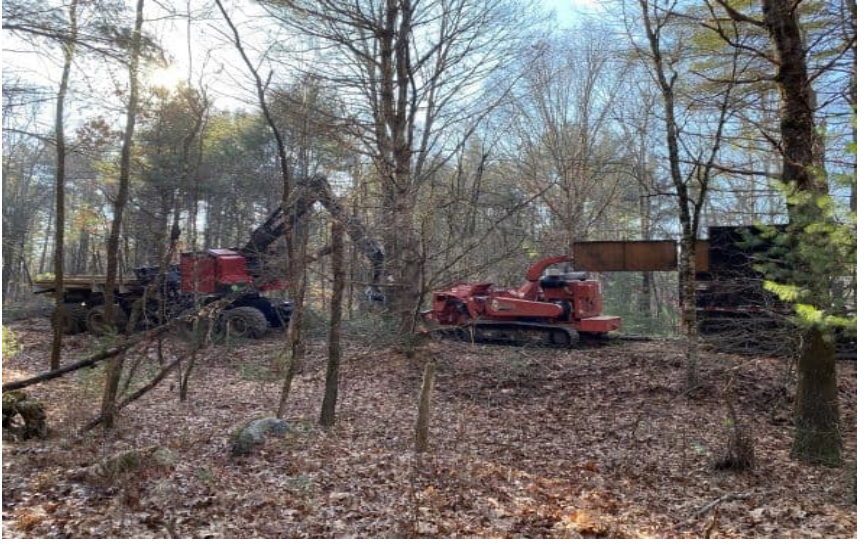
<p>PHOTOGRAPHIC LOG</p>	
<p>Client Name: Eversource</p>		<p>Site Location: Sudbury to Hudson Transmission Reliability Project</p>	<p>Town: Sudbury</p>
<p>Photo No.: 6</p>	<p>Date: 1-11-23</p>

<p>Description:</p> <p>Moosehead chipping operation within Segment 7 at approximate Sta.# 370+00, looking southward.</p>

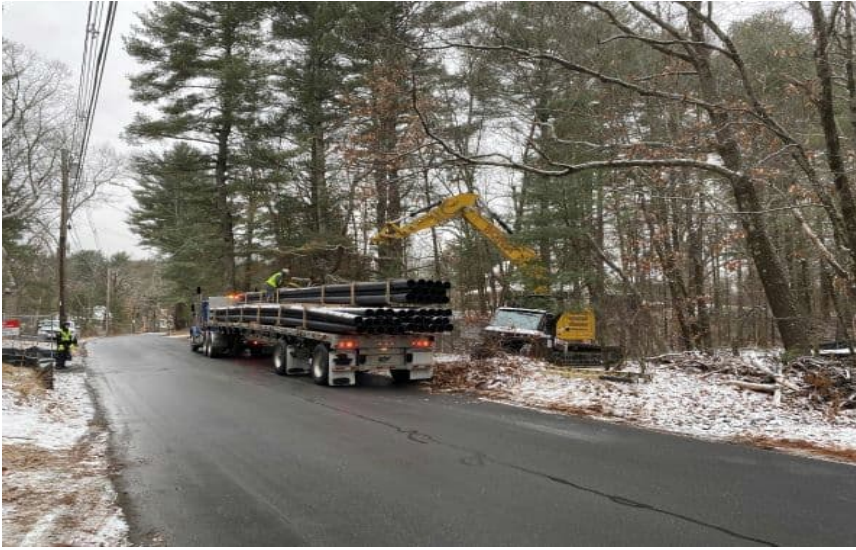
PHOTOGRAPHIC LOG	
Client Name: Eversource		Site Location: Sudbury to Hudson Transmission Reliability Project	Town: Hudson
Photo No.: 1	Date: 1-12-23

Description: Unloading conduit at White Pond Road (east), looking southward.

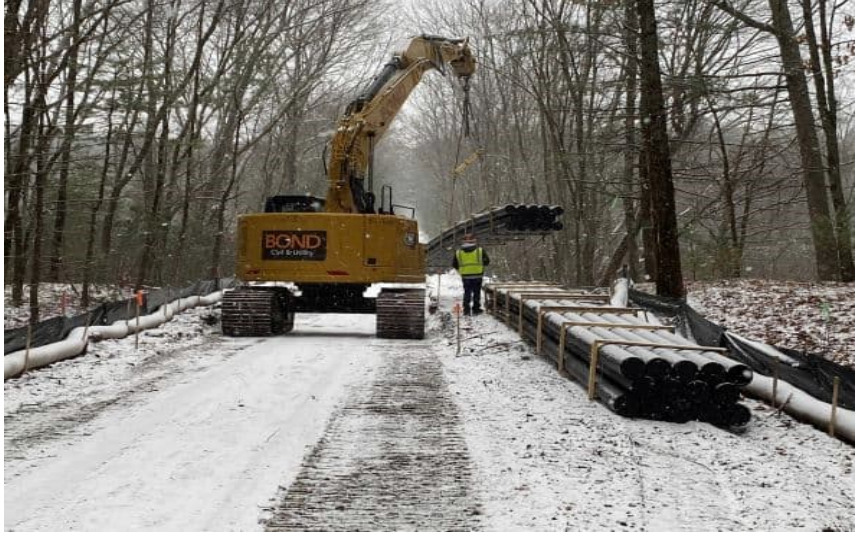
PHOTOGRAPHIC LOG	
Client Name: Eversource		Site Location: Sudbury to Hudson Transmission Reliability Project	Town: Hudson
Photo No.: 2	Date: 1-12-23

Description: Staging of conduit within Segment 5 just off White Pond road (east side), looking eastward.

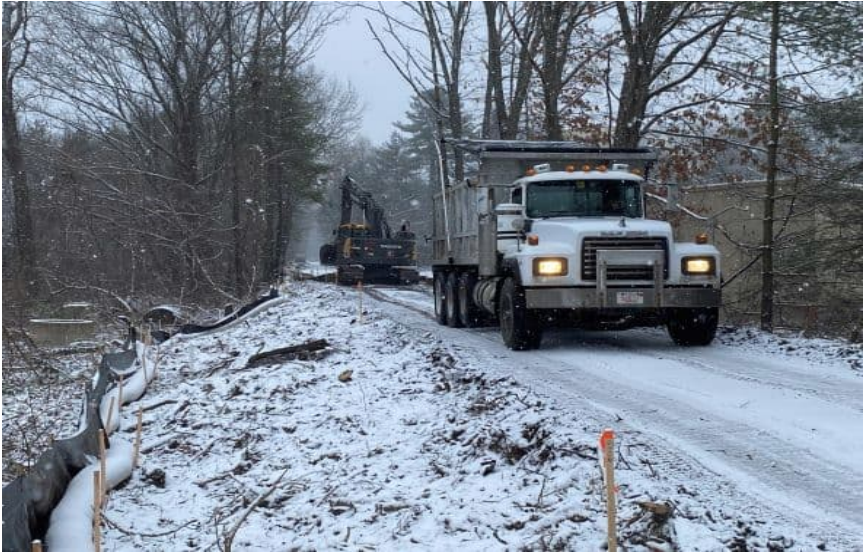
PHOTOGRAPHIC LOG	
Client Name: Eversource		Site Location: Sudbury to Hudson Transmission Reliability Project	Town: Hudson
Photo No.: 3	Date: 1-12-23

Description: Grading of ROW within Segment 3 near approximate Sta.# 170+00, looking westward.

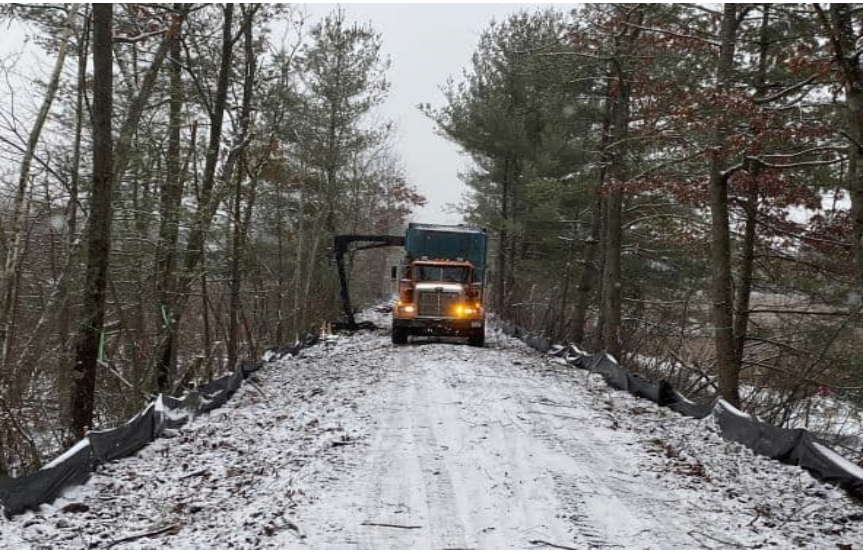
PHOTOGRAPHIC LOG	
Client Name: Eversource		Site Location: Sudbury to Hudson Transmission Reliability Project	Town: Hudson
Photo No.: 4	Date: 1-12-23

Description: Clearing of debris within Segment 2 at approximate Sta.# 144+00, looking eastward.

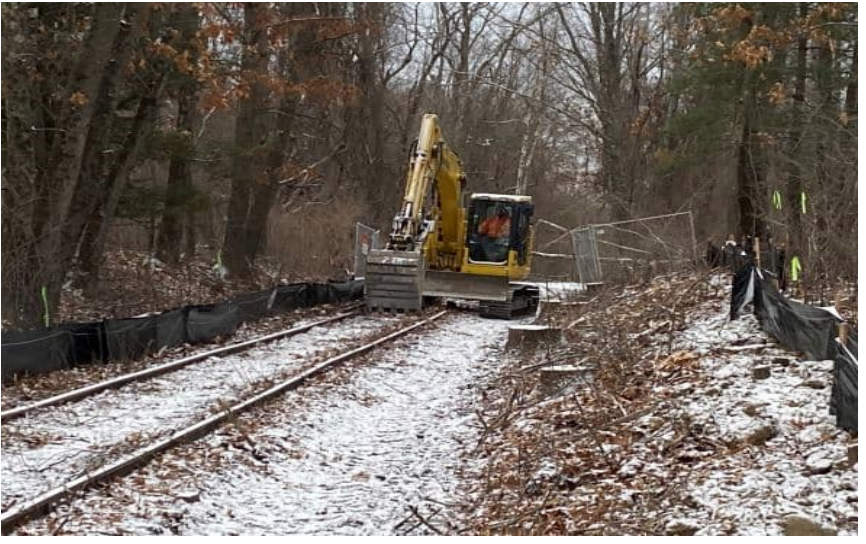
PHOTOGRAPHIC LOG	
Client Name: Eversource		Site Location: Sudbury to Hudson Transmission Reliability Project	Town: Sudbury
Photo No.: 6	Date: 1-12-23

Description: Rail removal at end of segment 14 near approximate Sta.# 767+00, looking eastward.

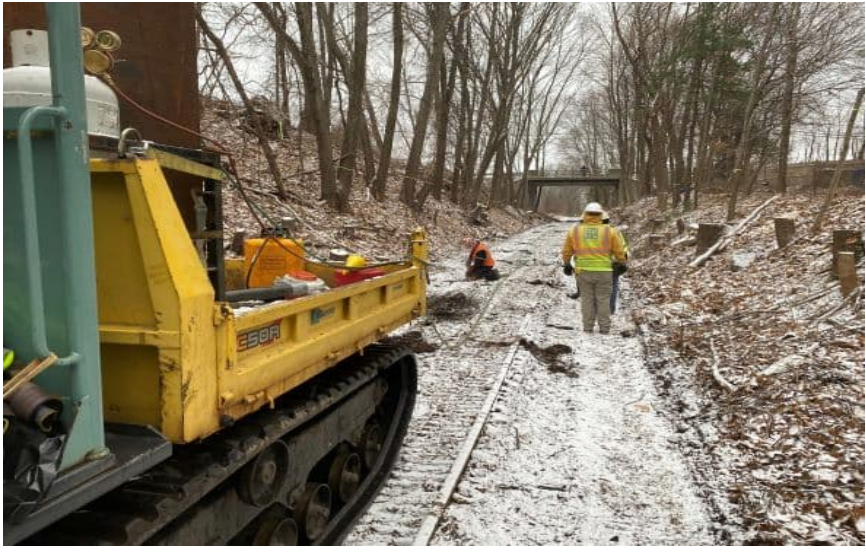
PHOTOGRAPHIC LOG	
Client Name: Eversource		Site Location: Sudbury to Hudson Transmission Reliability Project	Town: Sudbury
Photo No.: 7	Date: 1-12-23

Description: Rail cutting within Segment 14 near approximate Sta.# 760+00, looking eastward.

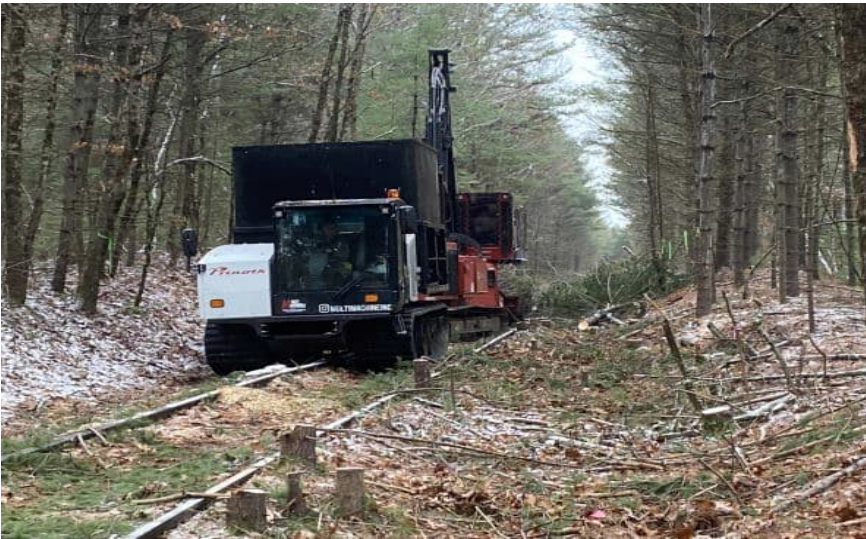
PHOTOGRAPHIC LOG	
Client Name: Eversource		Site Location: Sudbury to Hudson Transmission Reliability Project	Town: Sudbury
Photo No.: 8	Date: 1-12-23

Description: Chipping by Moosehead within Segment 7 near approximate Sta.# 375+50, looking eastward.

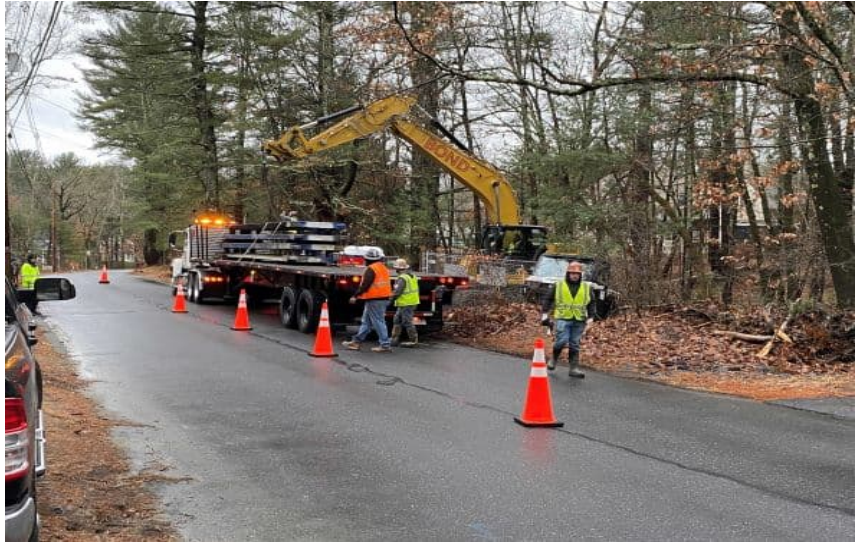
PHOTOGRAPHIC LOG	
Client Name: Eversource		Site Location: Sudbury to Hudson Transmission Reliability Project	Town: Hudson
Photo No.: 1	Date: 1-13-23

Description: Unloading trench boxes at White Pond Road (east), Segment 5, looking southward.

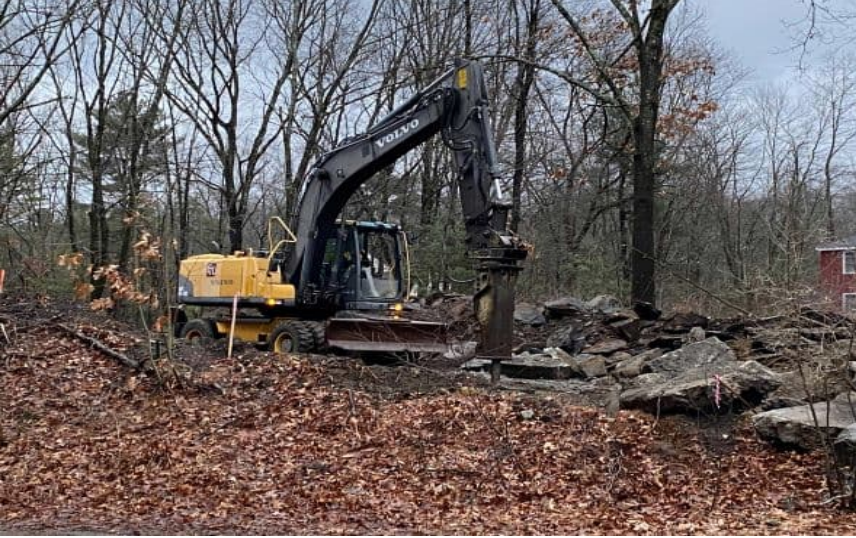
PHOTOGRAPHIC LOG	
Client Name: Eversource		Site Location: Sudbury to Hudson Transmission Reliability Project	Town: Hudson
Photo No.: 2	Date: 1-13-23

Description: Rock breakup off Wilkins Avenue, looking eastward.

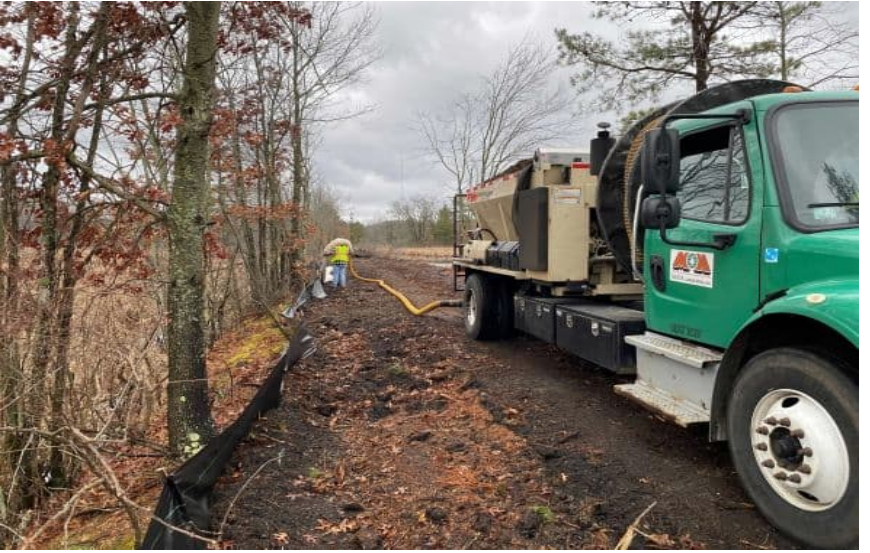
PHOTOGRAPHIC LOG	
Client Name: Eversource		Site Location: Sudbury to Hudson Transmission Reliability Project	Town: Hudson
Photo No.: 3	Date: 1-13-23

Description: MON adding compost filter tubes within Segment 2 near approximate Sta.# 147+00, looking eastward.

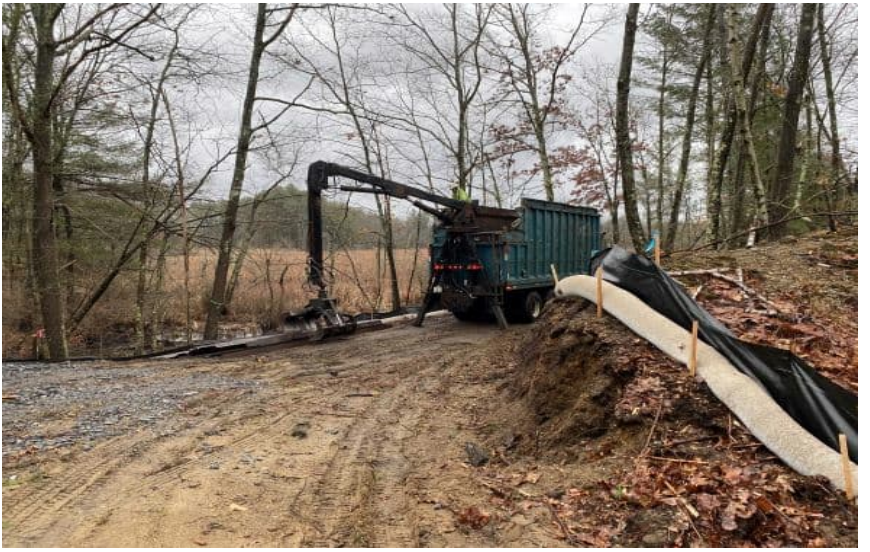
PHOTOGRAPHIC LOG	
Client Name: Eversource		Site Location: Sudbury to Hudson Transmission Reliability Project	Town: Hudson
Photo No.: 4	Date: 1-13-23

Description: Moosehead removing rail/tie within segment 2 near approximate Sta.# 142+00, looking eastward.

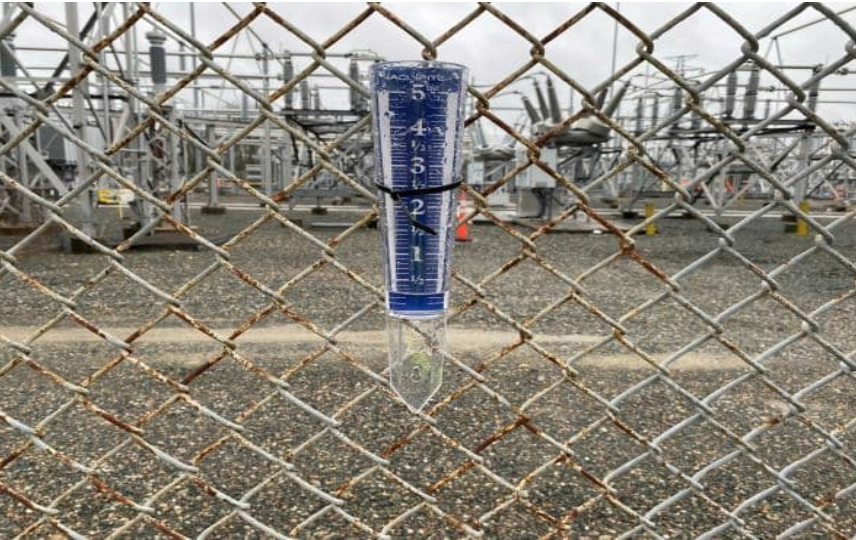
PHOTOGRAPHIC LOG	
Client Name: Eversource		Site Location: Sudbury to Hudson Transmission Reliability Project	Town: Sudbury
Photo No.: 6	Date: 1-13-23

Description: Rain gauge at Sudbury Substation with approximately 0.40", looking southward.

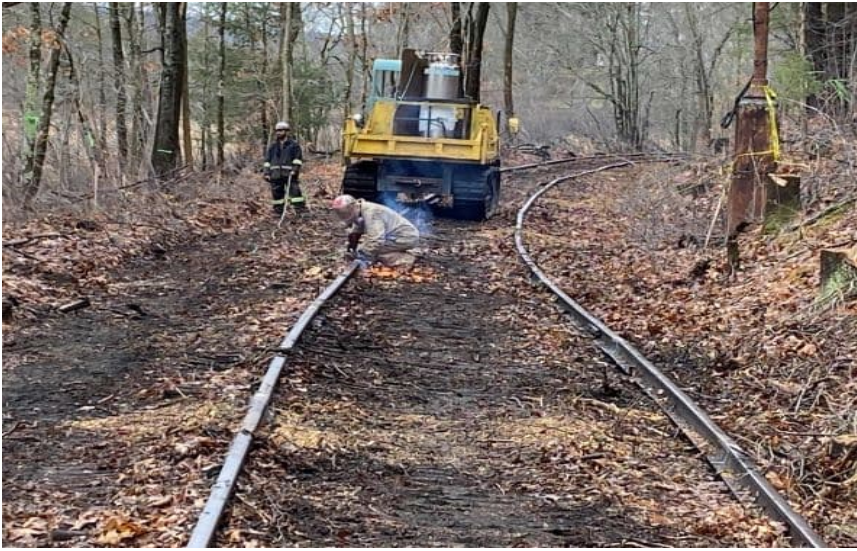
PHOTOGRAPHIC LOG	
Client Name: Eversource		Site Location: Sudbury to Hudson Transmission Reliability Project	Town: Sudbury
Photo No.: 7	Date: 1-13-23

Description: Rail cutting within Segment 14 near approximate Sta.# 736+00, looking westward.

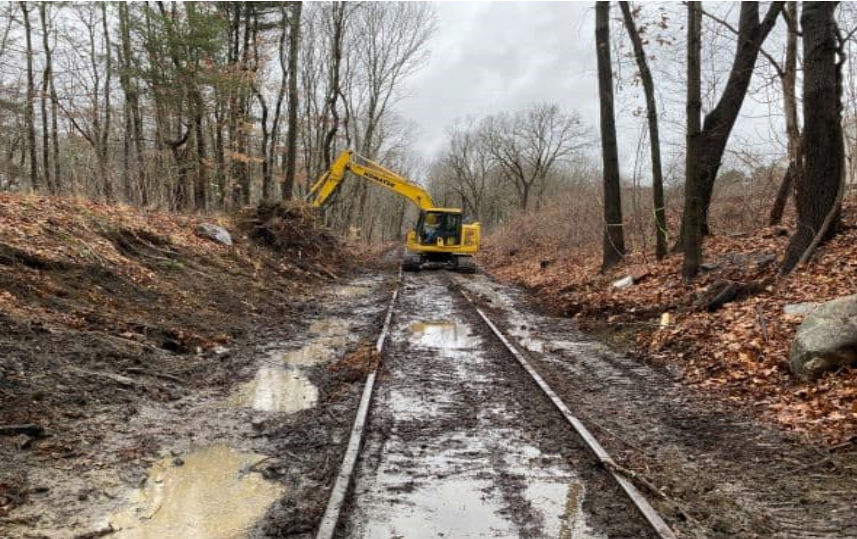
PHOTOGRAPHIC LOG	
Client Name: Eversource		Site Location: Sudbury to Hudson Transmission Reliability Project	Town: Sudbury
Photo No.: 8	Date: 1-13-23

Description: Rail/tie removal within Segment 14 at approximate Sta.#753+50, looking westward.

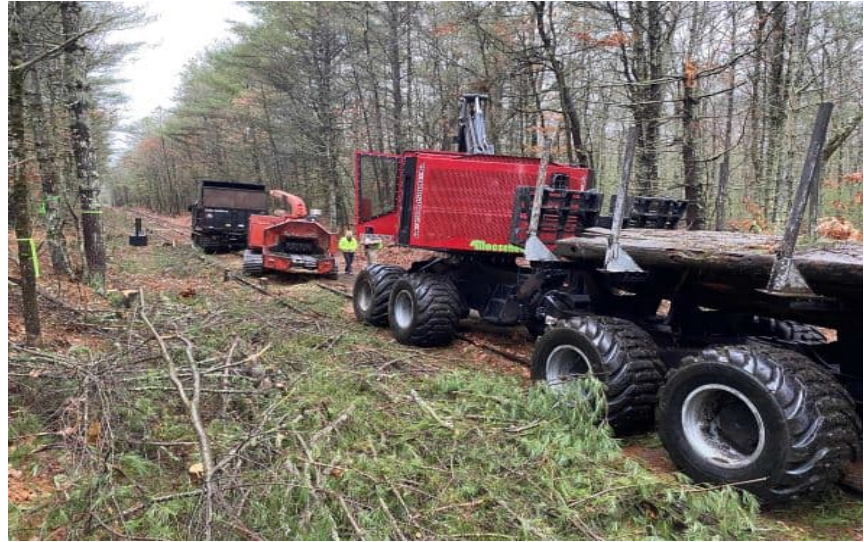
Chipping by Moosehead within Segment 7 near approximate Sta.# 383+00, looking eastward.
