Weekly Environmental Compliance Summary

Sudbury to Hudson Transmission Reliability Project (USEPA Tracking # MAR1003UW)

Week of: January 16 to January 20, 2023

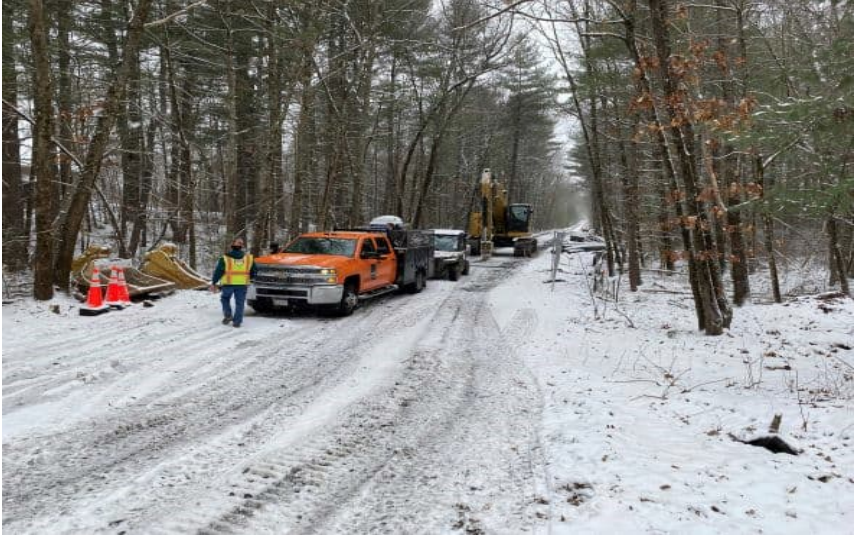
<p>PHOTOGRAPHIC LOG</p>	
<p>Client Name: Eversource</p>		<p>Site Location: Sudbury to Hudson Transmission Reliability Project</p>	<p>Town: Hudson</p>
<p>Photo No.: 1</p>	<p>Date: 1-16-23</p>

<p>Description:</p> <p>Bond setting up for installation of manhole work off White Pond Road, looking westward.</p>

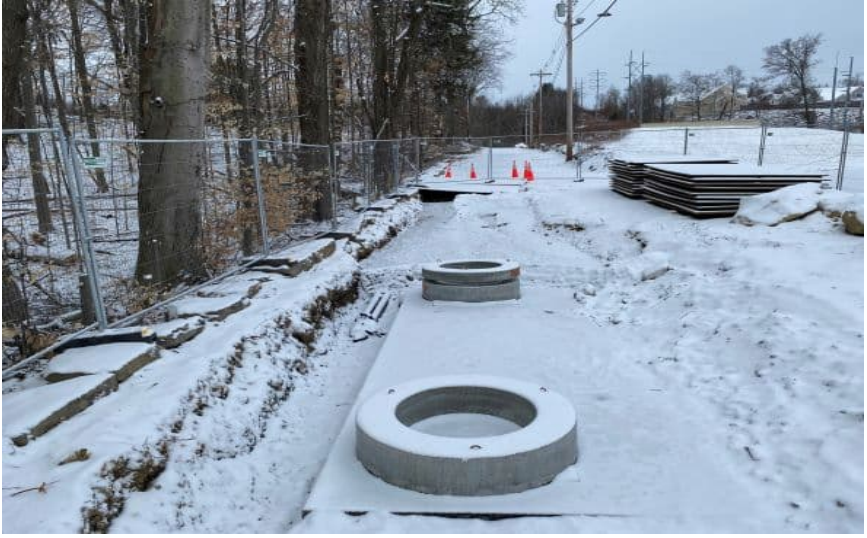
<p>PHOTOGRAPHIC LOG</p>	
<p>Client Name: Eversource</p>		<p>Site Location: Sudbury to Hudson Transmission Reliability Project</p>	<p>Town: Hudson</p>
<p>Photo No.: 2</p>	<p>Date: 1-16-23</p>

<p>Description:</p> <p>MH#1 work area off Forest Avenue, looking eastward.</p>

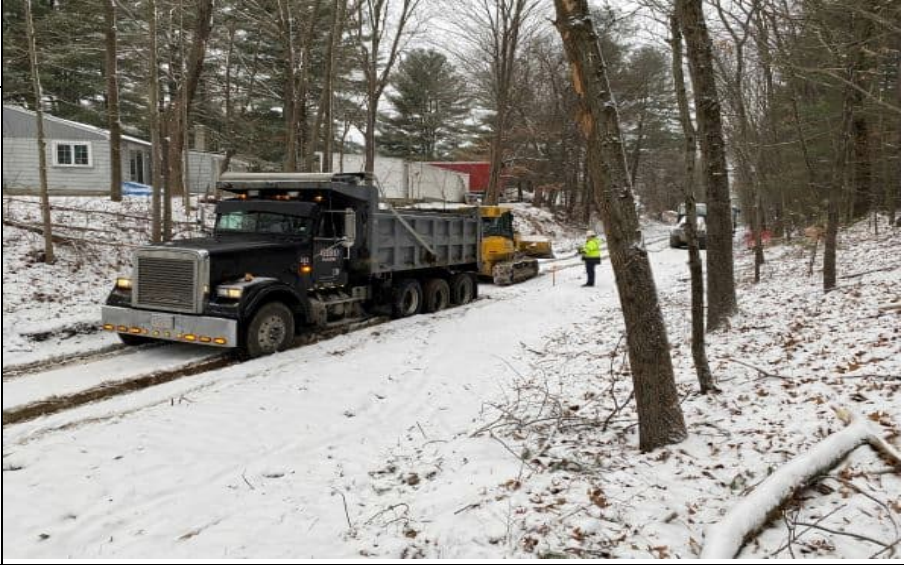
<p>PHOTOGRAPHIC LOG</p>	
<p>Client Name: Eversource</p>		<p>Site Location: Sudbury to Hudson Transmission Reliability Project</p>	<p>Town: Hudson</p>
<p>Photo No.: 3</p>	<p>Date: 1-16-23</p>

<p>Description: ET&L grading work within Segment 3, looking westward.</p>

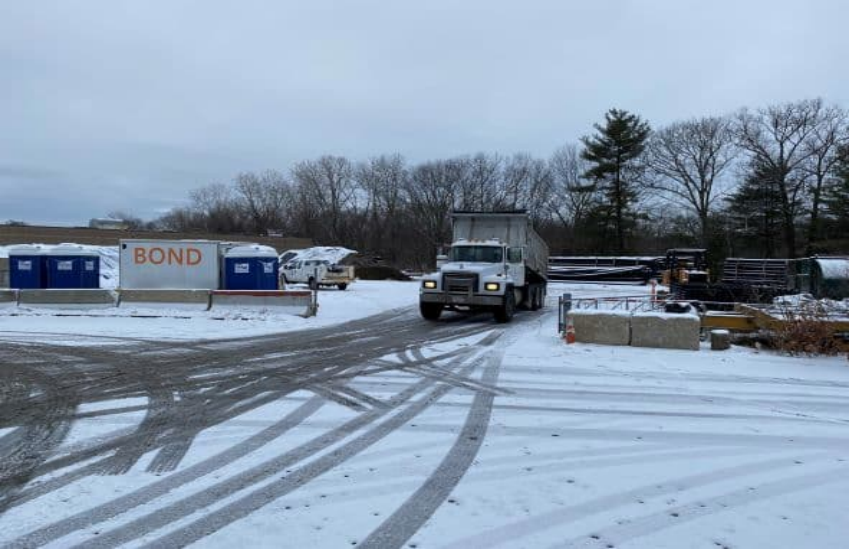
<p>PHOTOGRAPHIC LOG</p>	
<p>Client Name: Eversource</p>		<p>Site Location: Sudbury to Hudson Transmission Reliability Project</p>	<p>Town: Hudson</p>
<p>Photo No.: 4</p>	<p>Date: 1-16-23</p>

<p>Description: Bonazzoli laydown yard, spoil stockpiling, looking southward.</p>

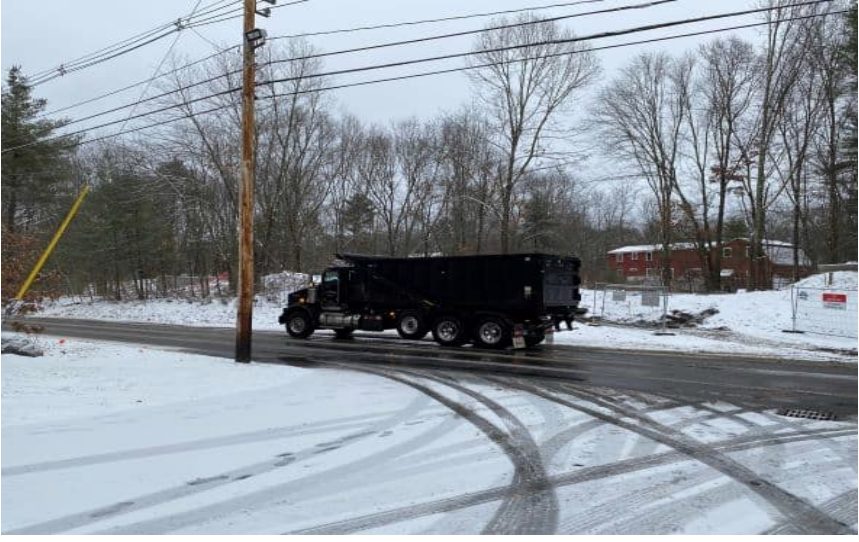
<p>PHOTOGRAPHIC LOG</p>	
<p>Client Name: Eversource</p>		<p>Site Location: Sudbury to Hudson Transmission Reliability Project</p>	<p>Town: Hudson</p>
<p>Photo No.: 6</p>	<p>Date: 1-16-23</p>

<p>Description:</p> <p>Moosehead conducting site work off Wilkins Avenue, looking southward.</p>

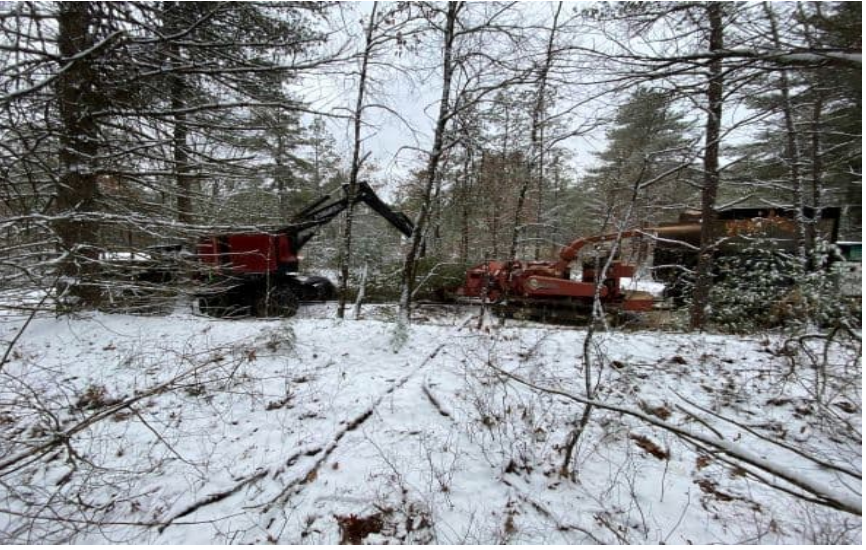
<p>PHOTOGRAPHIC LOG</p>	
<p>Client Name: Eversource</p>		<p>Site Location: Sudbury to Hudson Transmission Reliability Project</p>	<p>Town: Sudbury</p>
<p>Photo No.: 7</p>	<p>Date: 1-16-23</p>

<p>Description:</p> <p>Moosehead chipping within Segment 7 at approximate Sta.# 386+50, looking southward.</p>

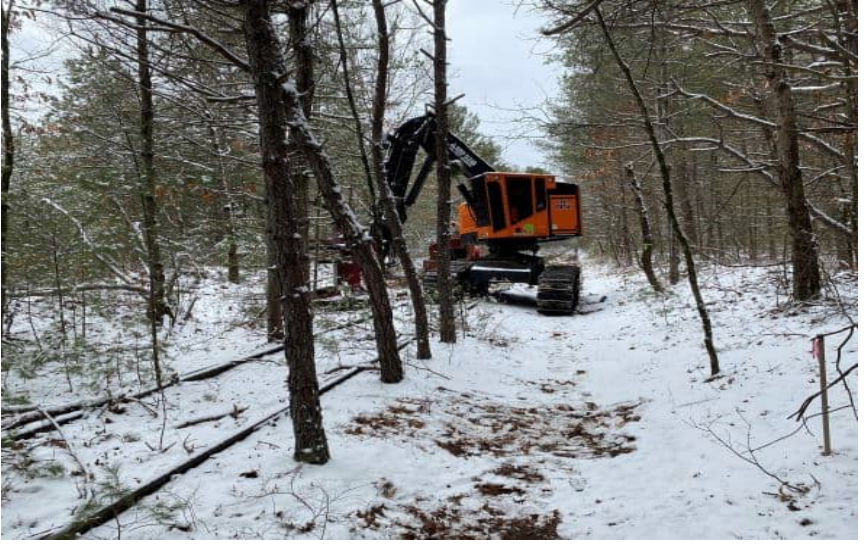
<p>PHOTOGRAPHIC LOG</p>	
<p>Client Name: Eversource</p>		<p>Site Location: Sudbury to Hudson Transmission Reliability Project</p>	<p>Town: Sudbury</p>
<p>Photo No.: 8</p>	<p>Date: 1-16-23</p>

<p>Description:</p> <p>Moosehead clearing within Segment 7 at approximate Sta.# 386+50, looking westward.</p>

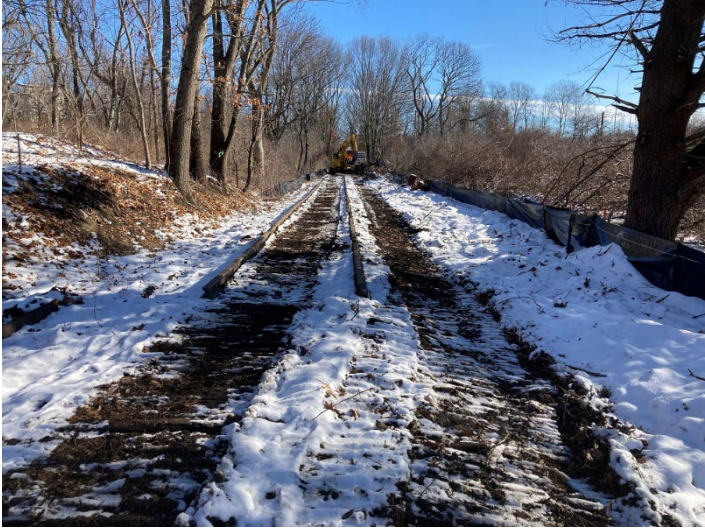
<p>PHOTOGRAPHIC LOG</p>	
<p>Client Name: Eversource</p>		<p>Site Location: Sudbury to Hudson Transmission Reliability Project</p>	<p>Town: Sudbury</p>
<p>Photo No.: 1</p>	<p>Date: 1/17/2023</p>

<p>Description: View of silt fence and rail & tie removal in Segment 14. Silt fence installation continues. Facing east.</p>

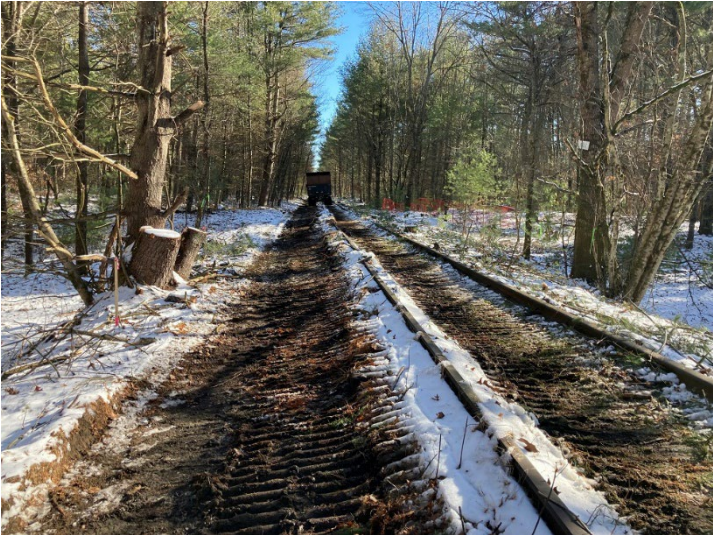
<p>PHOTOGRAPHIC LOG</p>	
<p>Client Name: Eversource</p>		<p>Site Location: Sudbury to Hudson Transmission Reliability Project</p>	<p>Town: Sudbury</p>
<p>Photo No.: 2</p>	<p>Date: 1/17/2023</p>

<p>Description: View of chipping activities in segment 7. Facing east.</p>

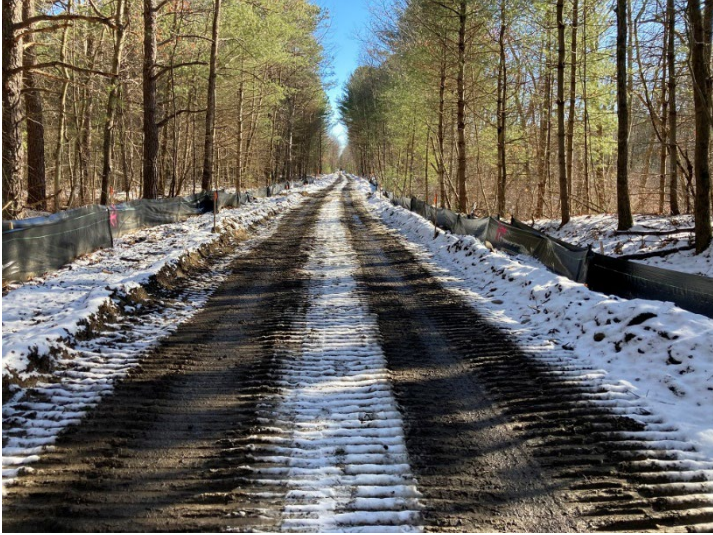
PHOTOGRAPHIC LOG	
Client Name: Eversource		Site Location: Sudbury to Hudson Transmission Reliability Project	Town: Hudson
Photo No.: 3	Date: 1/17/2023

Description: View of syncopated silt fence in segment 6. Silt fence is in good condition and operating properly. Facing east.

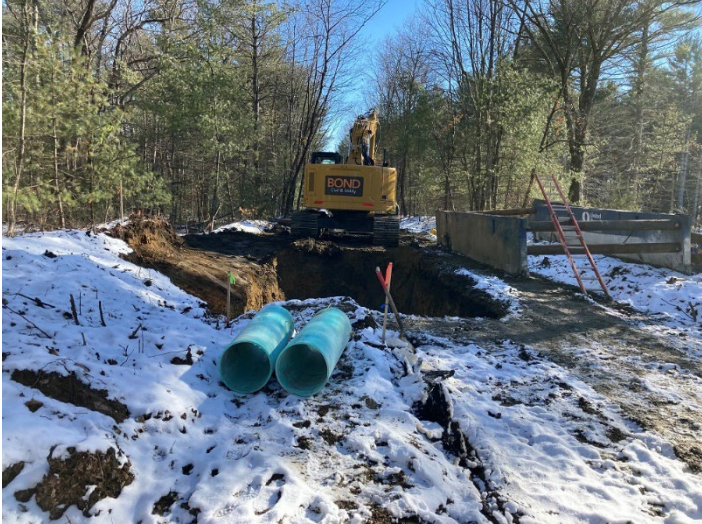
PHOTOGRAPHIC LOG	
Client Name: Eversource		Site Location: Sudbury to Hudson Transmission Reliability Project	Town: Hudson
Photo No.: 4	Date: 1/17/2023

Description: View of trenching work for MH # 12 in Segment 5. Facing east.

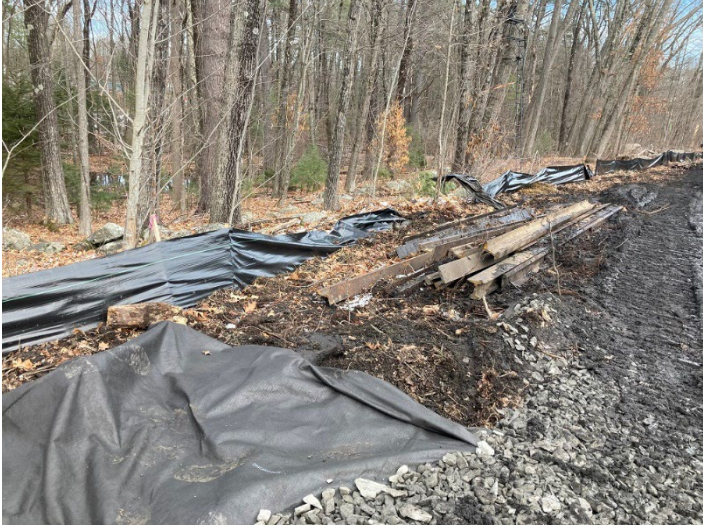
PHOTOGRAPHIC LOG	
Client Name: Eversource		Site Location: Sudbury to Hudson Transmission Reliability Project	
Town: Hudson			
Photo No.: 5	Date: 1/17/2023

-Following rainfall and snowmelt, silt fence became overwhelmed at station 116 in segment 1 in Hudson and sediment was discharged beyond the silt fence. Sediment was not released into wetland or jurisdictional area. Crews began to address the issue immediately. Silt fence was repaired and stone was added to the area in an attempt to reduce erosion and sedimentation in the future. The sediment that was deposited is being removed by hand.

Description: View of silt fence in segment 1. Repairs are needed (routine maintenance). Facing northeast.

- Repair silt fence where damaged in multiple places along segment 1.**
-
-

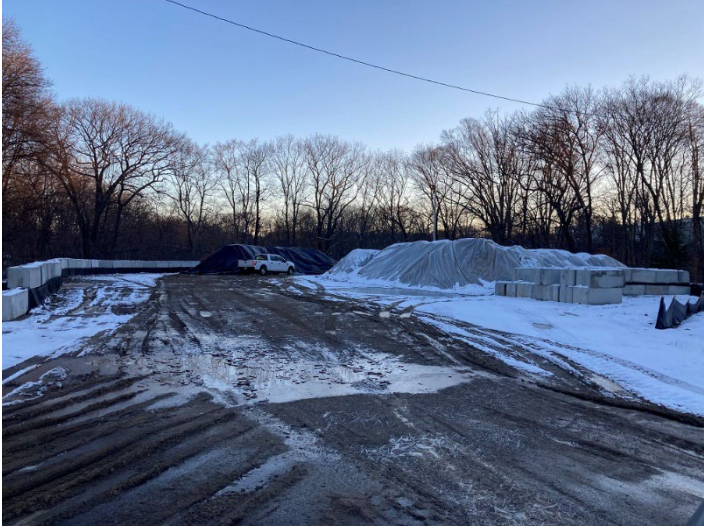
PHOTOGRAPHIC LOG	
Client Name: Eversource		Site Location: Sudbury to Hudson Transmission Reliability Project	
Town: Hudson			
Photo No.: 6	Date: 1/17/2023

Description: View of Stowe Ct laydown yard. All stockpiles were covered at time of inspection. Facing southeast.

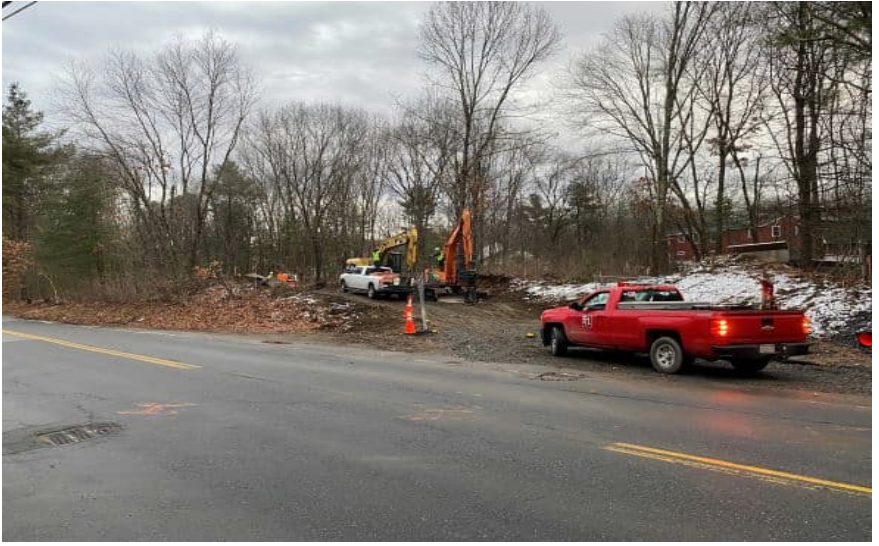
PHOTOGRAPHIC LOG	
Client Name: Eversource		Site Location: Sudbury to Hudson Transmission Reliability Project	Town: Hudson
Photo No.: 1	Date: 1-18-23

Description: Site work off Wilkins Avenue, looking eastward.

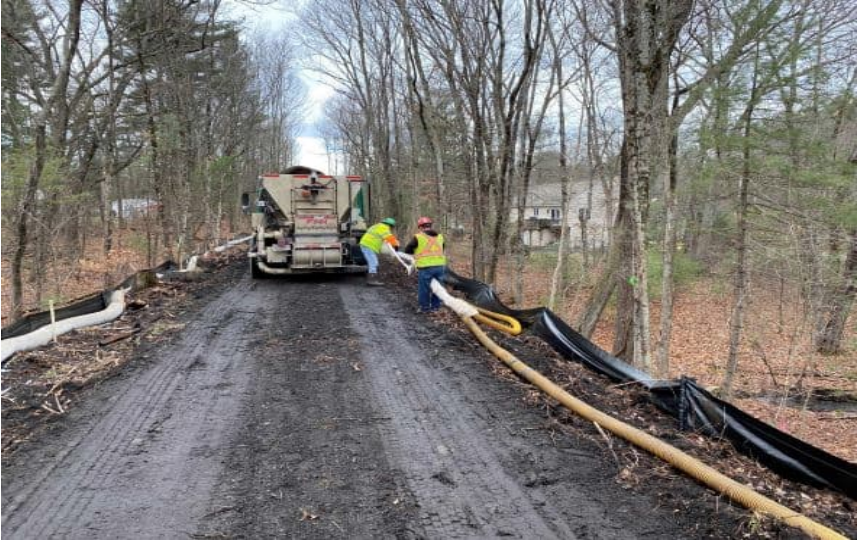
PHOTOGRAPHIC LOG	
Client Name: Eversource		Site Location: Sudbury to Hudson Transmission Reliability Project	Town: Hudson
Photo No.: 2	Date: 1-18-23

Description: MON adding compost filter tubes within Segment 1 near approximate Sta.# 108+50, looking westward.

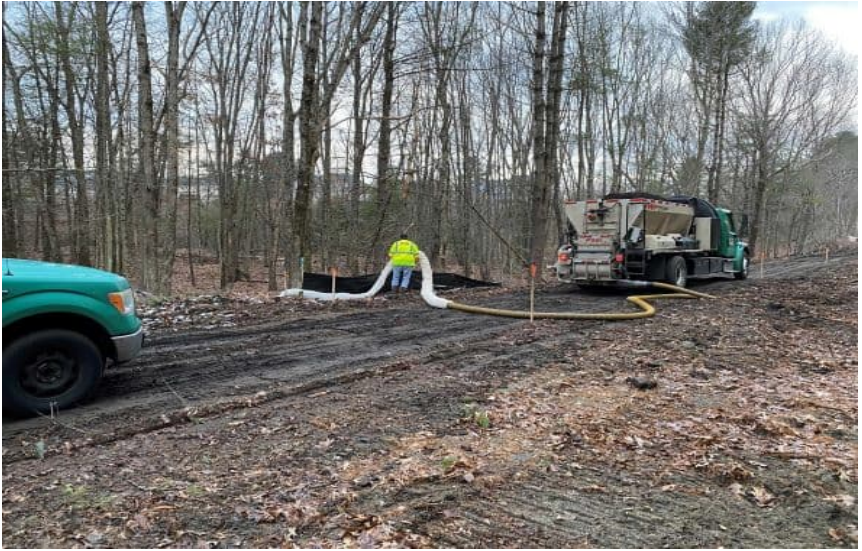
PHOTOGRAPHIC LOG	
Client Name: Eversource		Site Location: Sudbury to Hudson Transmission Reliability Project	Town: Hudson
Photo No.: 3	Date: 1-18-23

Description: MON adding compost filter tubes within Segment 2 near approximate Sta.# 139+00, looking westward.

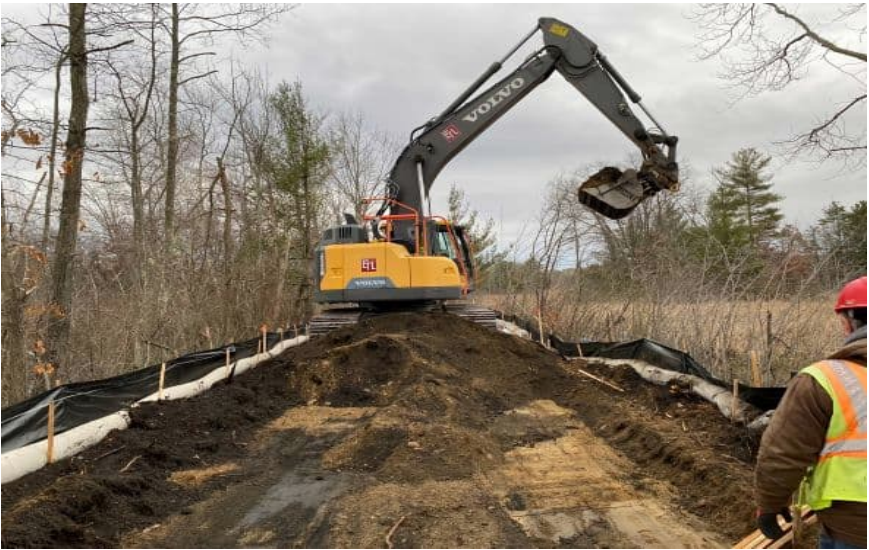
PHOTOGRAPHIC LOG	
Client Name: Eversource		Site Location: Sudbury to Hudson Transmission Reliability Project	Town: Hudson
Photo No.: 4	Date: 1-18-23

Description: Grading by ET&L within segment 2 near approximate Sta.# 151+00, looking eastward.

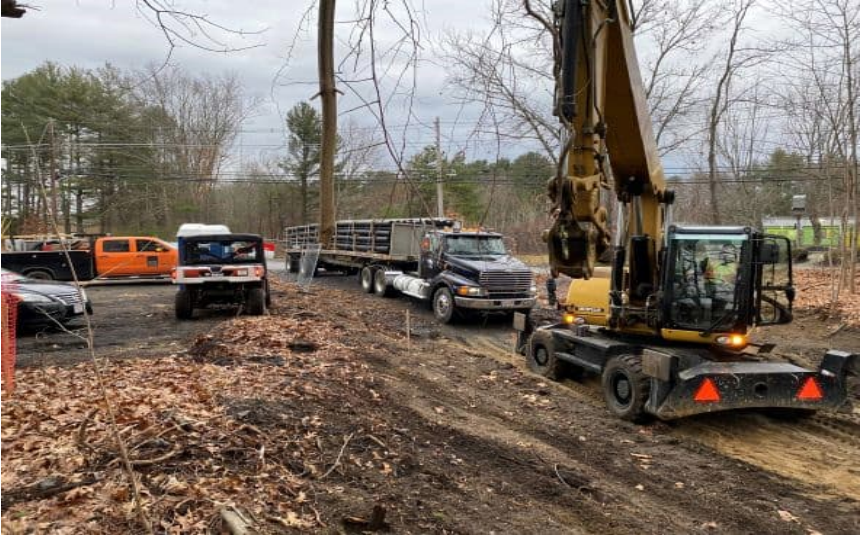
PHOTOGRAPHIC LOG	
Client Name: Eversource		Site Location: Sudbury to Hudson Transmission Reliability Project	Town: Hudson
Photo No.: 5	Date: 1-18-23

Description: Bond staging conduit at Main Street within Segment 3, looking eastward.

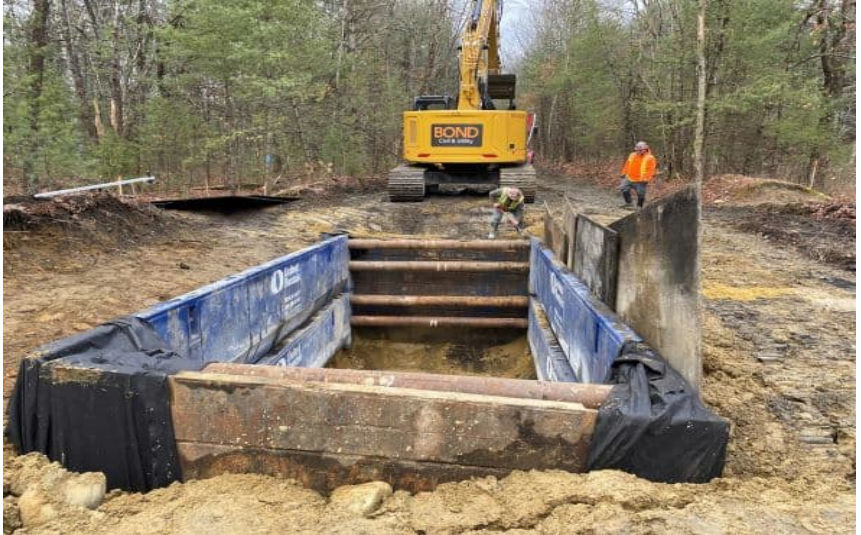
PHOTOGRAPHIC LOG	
Client Name: Eversource		Site Location: Sudbury to Hudson Transmission Reliability Project	Town: Hudson
Photo No.: 6	Date: 1-18-23

Description: Bond working on MH#12 within Segment 5 at approximate Sta.# 316+50, looking eastward.

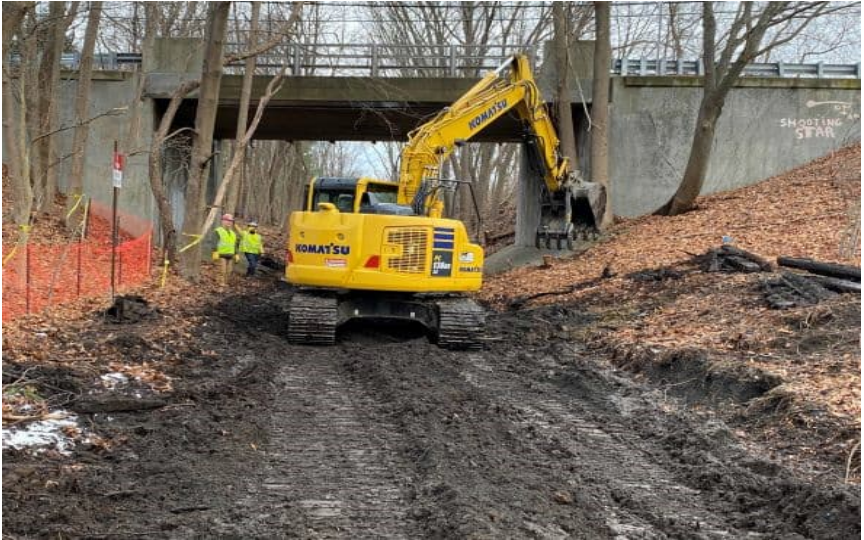
PHOTOGRAPHIC LOG	
Client Name: Eversource		Site Location: Sudbury to Hudson Transmission Reliability Project	Town: Sudbury
Photo No.: 7	Date: 1-18-23

Description: Rail/tie removal by Moosehead within Segment 14 near approximate Sta.# 738+00, looking westward.

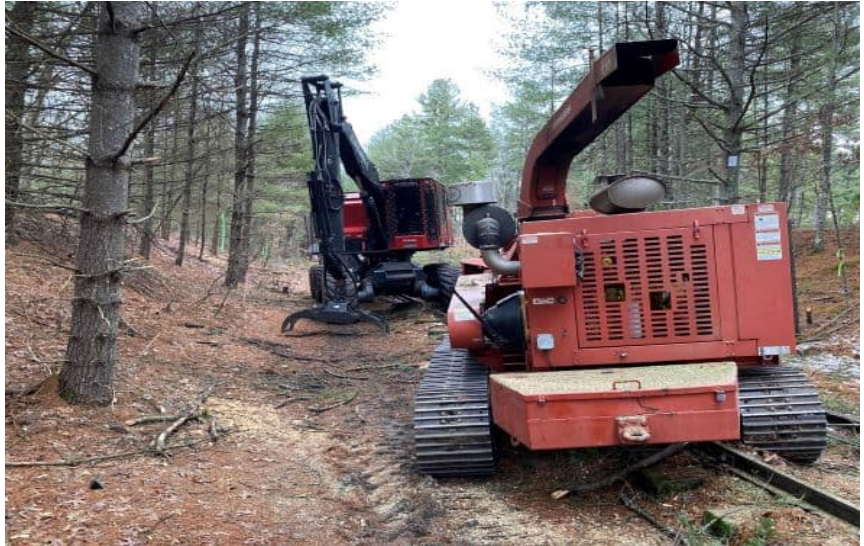
PHOTOGRAPHIC LOG	
Client Name: Eversource		Site Location: Sudbury to Hudson Transmission Reliability Project	Town: Sudbury
Photo No.: 8	Date: 1-18-23

Description: Chipping by Moosehead within Segment 7 at approximate Sta.#394+00, looking eastward.

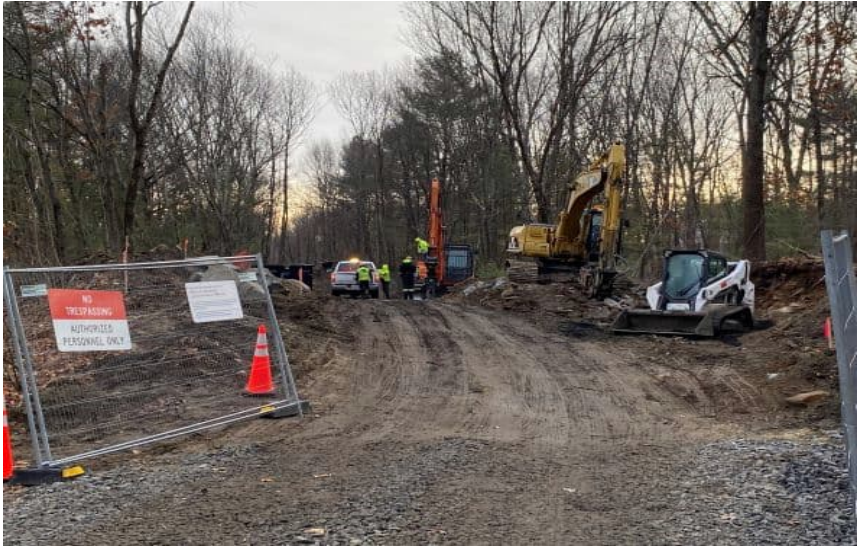
PHOTOGRAPHIC LOG	
Client Name: Eversource		Site Location: Sudbury to Hudson Transmission Reliability Project	Town: Hudson
Photo No.: 1	Date: 1-19-23

Description: Site work off Wilkins Avenue, looking eastward.

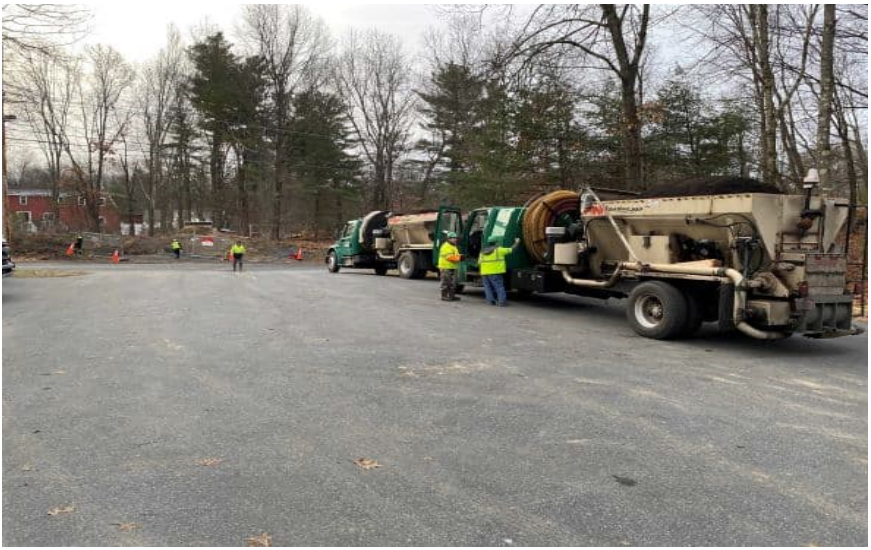
PHOTOGRAPHIC LOG	
Client Name: Eversource		Site Location: Sudbury to Hudson Transmission Reliability Project	Town: Hudson
Photo No.: 2	Date: 1-19-23

Description: MON on-site to add compost filter tubes within Segment 1, looking southward.

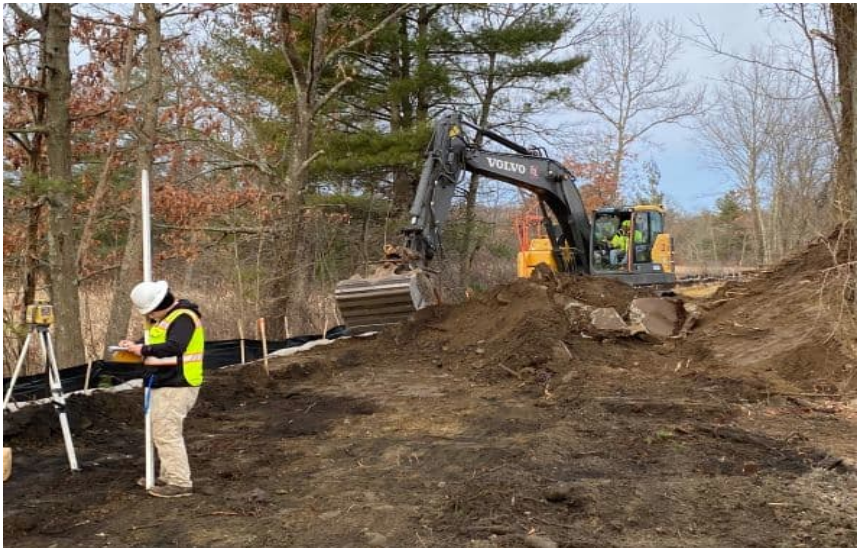
PHOTOGRAPHIC LOG	
Client Name: Eversource		Site Location: Sudbury to Hudson Transmission Reliability Project	Town: Hudson
Photo No.: 4	Date: 1-19-23

Description: Grading by ET&L within segment 2 near approximate Sta.# 150+00, looking eastward.

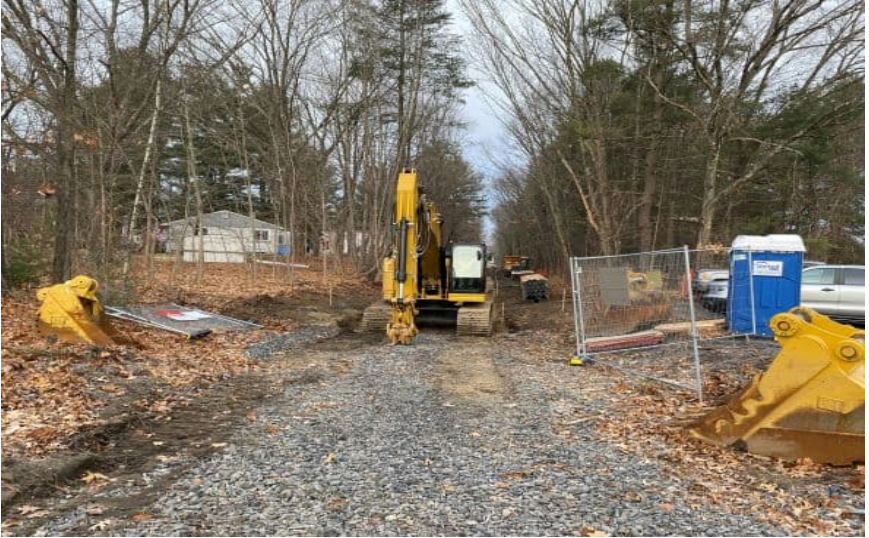
PHOTOGRAPHIC LOG	
Client Name: Eversource		Site Location: Sudbury to Hudson Transmission Reliability Project	
Town: Hudson			
Photo No.: 5	Date: 1-19-23

Description: Bond on-site to stage conduit at Main Street within Segment 3, looking westward.

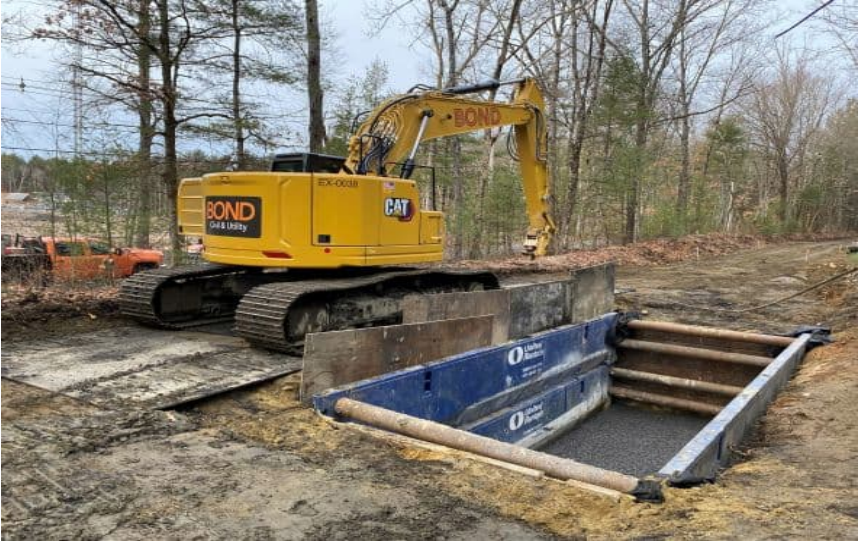
PHOTOGRAPHIC LOG	
Client Name: Eversource		Site Location: Sudbury to Hudson Transmission Reliability Project	
Town: Hudson			
Photo No.: 6	Date: 1-19-23

Description: Bond working on MH#12 within Segment 5 at approximate Sta.# 316+50, looking eastward.

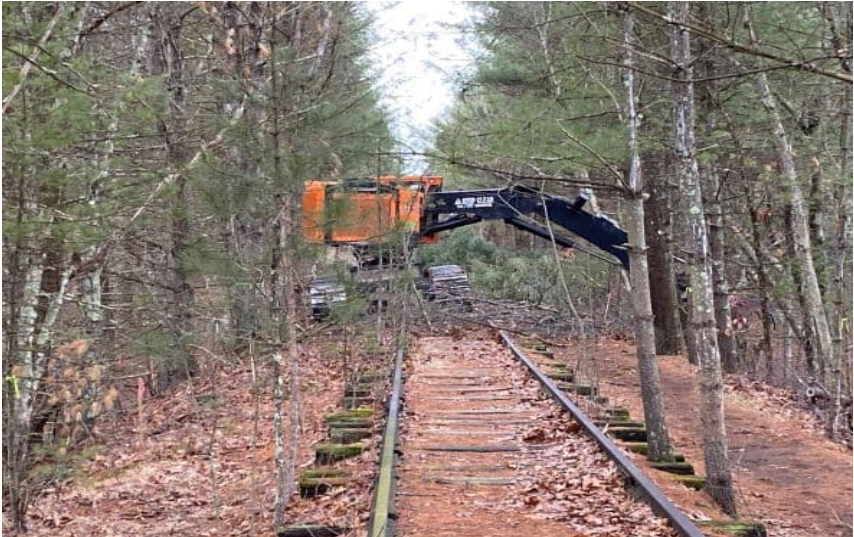
PHOTOGRAPHIC LOG	
Client Name: Eversource		Site Location: Sudbury to Hudson Transmission Reliability Project	Town: Sudbury
Photo No.: 8	Date: 1-19-23

Description: Clearing by Moosehead within Segment 7 at approximate Sta.#398+00, looking eastward.

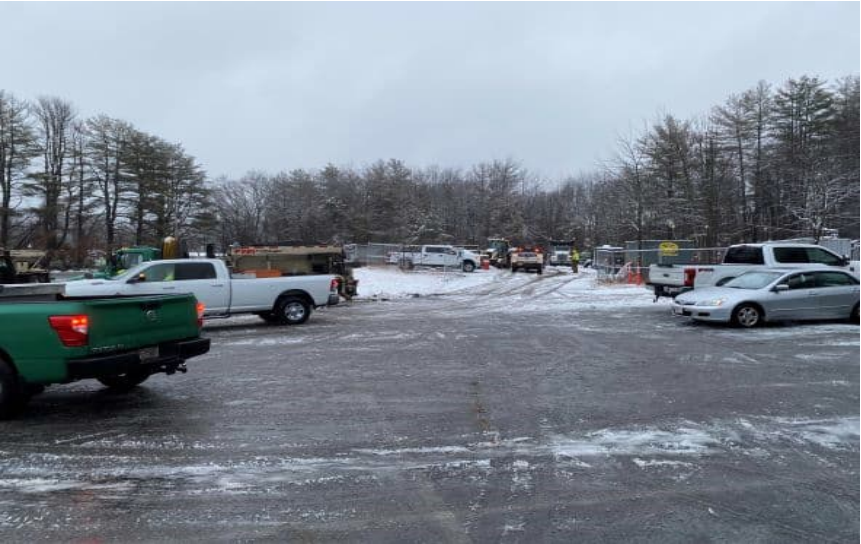
PHOTOGRAPHIC LOG	
Client Name: Eversource		Site Location: Sudbury to Hudson Transmission Reliability Project	Town: Hudson
Photo No.: 1	Date: 1-20-23

Description: Main Street laydown yard, looking southward.

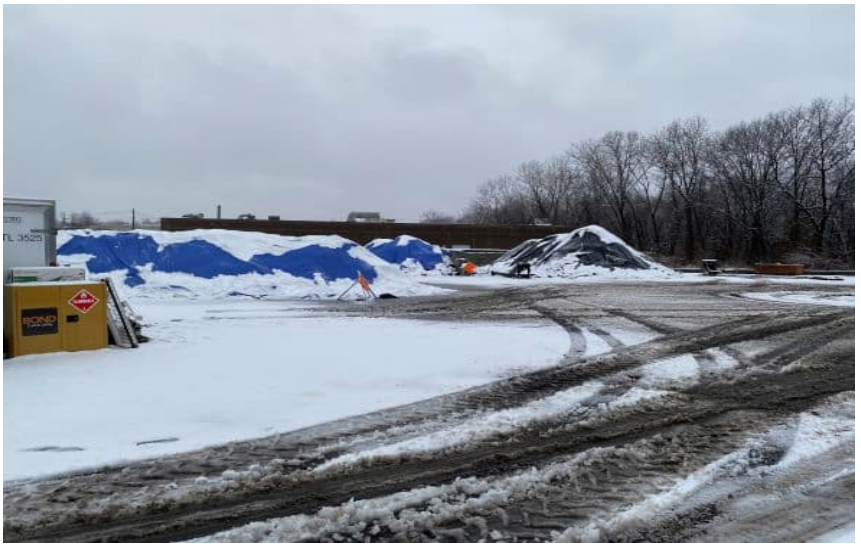
PHOTOGRAPHIC LOG	
Client Name: Eversource		Site Location: Sudbury to Hudson Transmission Reliability Project	Town: Hudson
Photo No.: 2	Date: 1-20-23

Description: Bonazzoli laydown yard, covered spoil storage, looking northward.

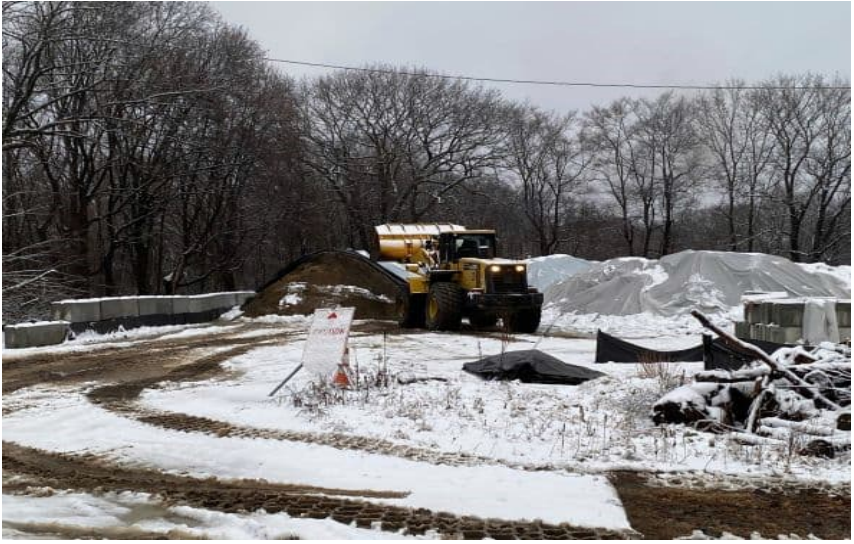
PHOTOGRAPHIC LOG	
Client Name: Eversource		Site Location: Sudbury to Hudson Transmission Reliability Project	Town: Hudson
Photo No.: 3	Date: 1-20-23

Description: ET&L working at Stowe Court laydown yard, covered spoil storage, looking northward.

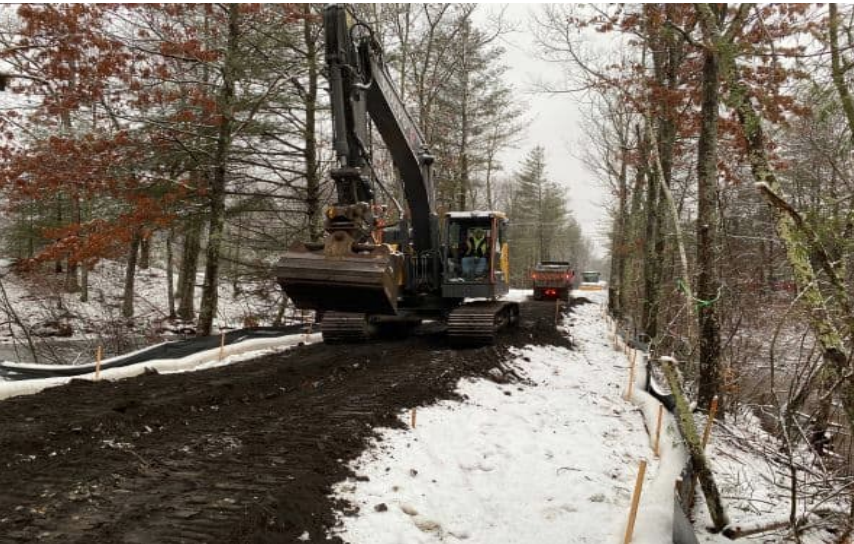
PHOTOGRAPHIC LOG	
Client Name: Eversource		Site Location: Sudbury to Hudson Transmission Reliability Project	Town: Hudson
Photo No.: 4	Date: 1-20-23

Description: Grading by ET&L within segment 2 near approximate Sta.# 144+00, looking westward.

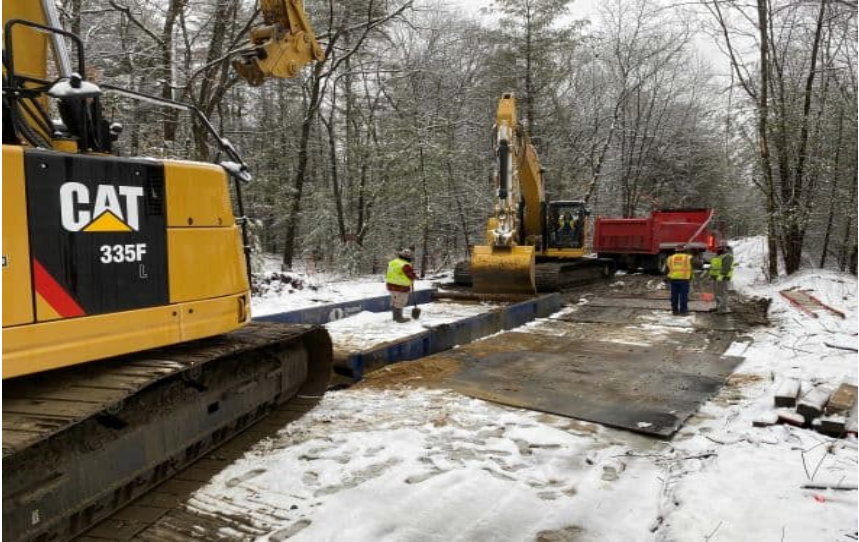
PHOTOGRAPHIC LOG	
Client Name: Eversource		Site Location: Sudbury to Hudson Transmission Reliability Project	Town: Hudson
Photo No.: 5	Date: 1-20-23

Description: Bond working on MH#12 within Segment 5 at approximate Sta.# 316+50, looking westward.

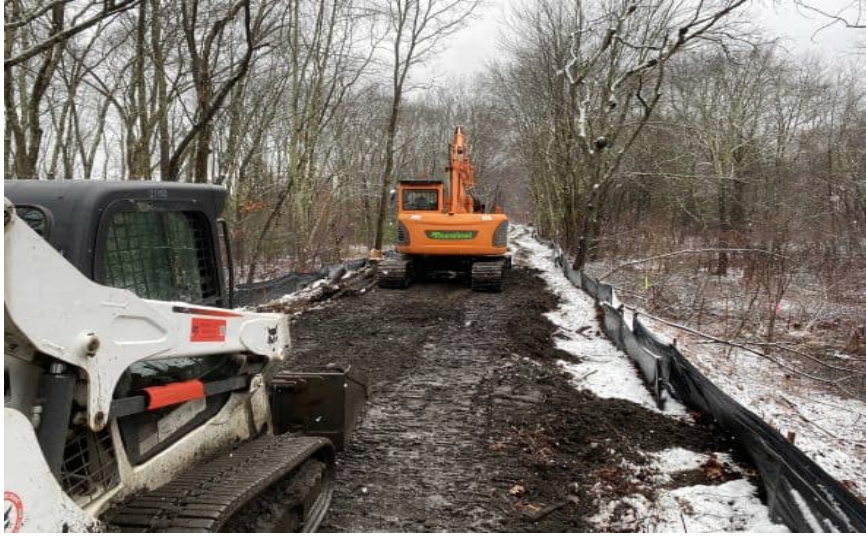
PHOTOGRAPHIC LOG	
Client Name: Eversource		Site Location: Sudbury to Hudson Transmission Reliability Project	Town: Sudbury
Photo No.: 6	Date: 1-20-23

Description: Moosehead working within Segment 14 removing rail/ties at approximate Sta.# 749+00, looking westward.

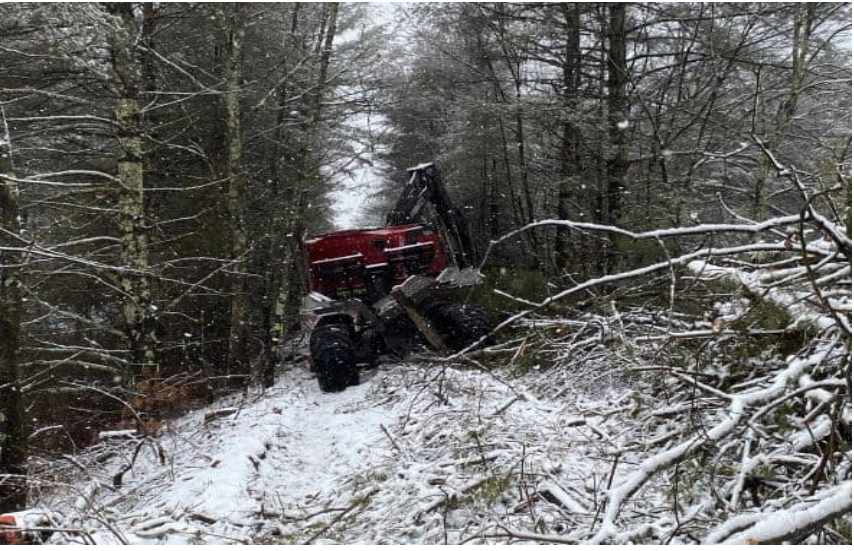
PHOTOGRAPHIC LOG	
Client Name: Eversource		Site Location: Sudbury to Hudson Transmission Reliability Project	Town: Sudbury
Photo No.: 7	Date: 1-20-23

Description: Chipping by Moosehead within Segment 7 at approximate Sta.#398+00, looking westward.

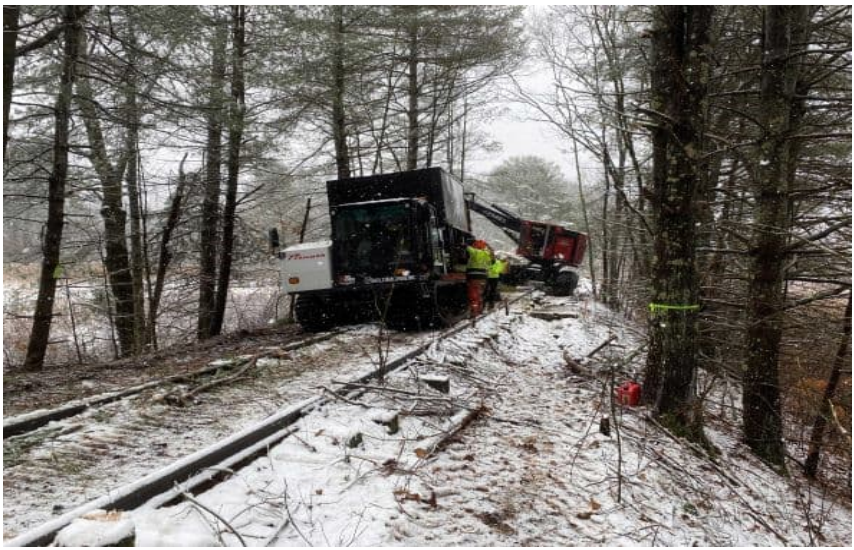
PHOTOGRAPHIC LOG	
Client Name: Eversource		Site Location: Sudbury to Hudson Transmission Reliability Project	Town: Sudbury
Photo No.: 8	Date: 1-20-23

Description: Chipping by Moosehead within Segment 7 at approximate Sta.#398+00, looking eastward.

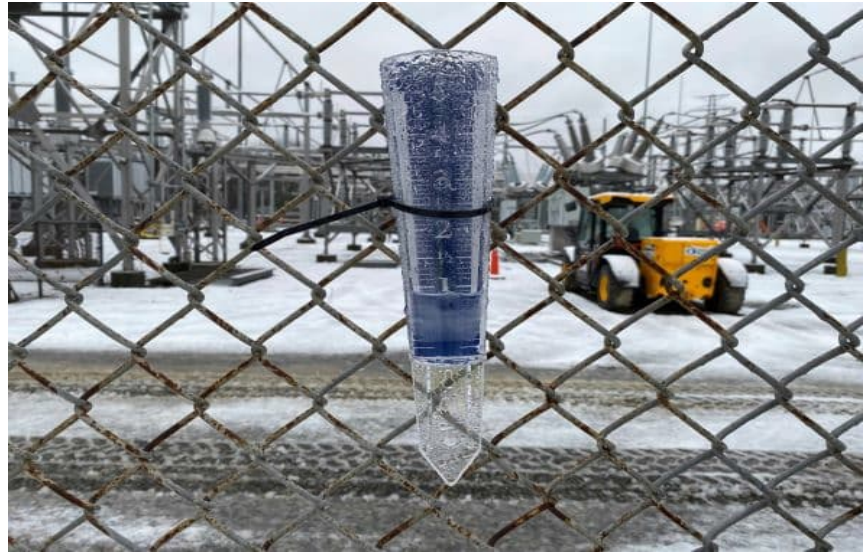
Rain gauge at Sudbury Substation
showing approximately 0.90" of
rainfall, looking southward.
