Weekly Environmental Compliance Summary

Sudbury to Hudson Transmission Reliability Project (USEPA Tracking # MAR1003UW)

Week of: January 23 to January 27, 2023

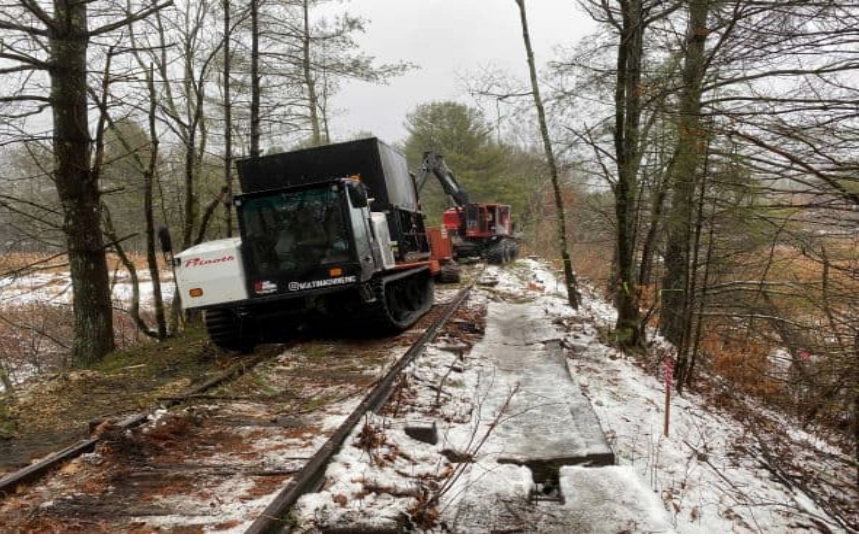
<p>PHOTOGRAPHIC LOG</p>	
<p>Client Name: Eversource</p>		<p>Site Location: Sudbury to Hudson Transmission Reliability Project</p>	<p>Town: Sudbury</p>
<p>Photo No.: 2</p>	<p>Date: 1-16-23</p>

<p>Description:</p> <p>Moosehead chipping within Segment 7 at approximate Sta.# 400+00, looking eastward.</p>

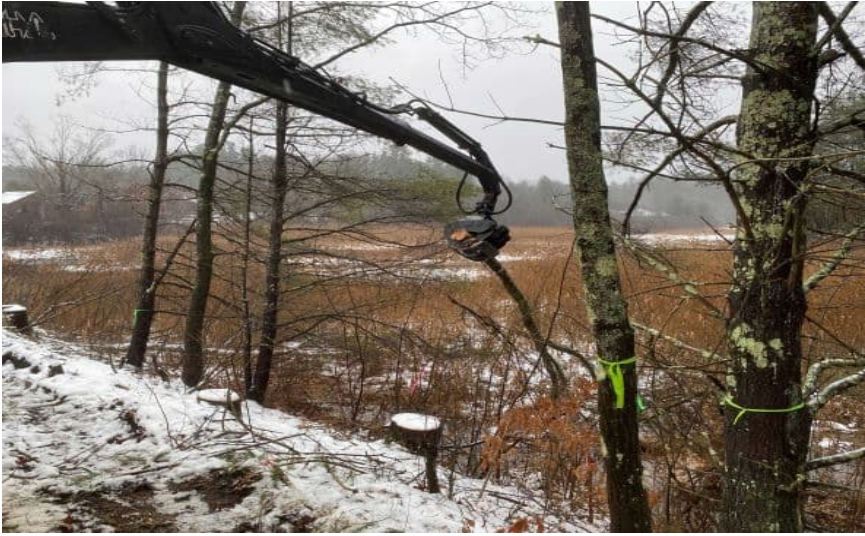
<p>PHOTOGRAPHIC LOG</p>	
<p>Client Name: Eversource</p>		<p>Site Location: Sudbury to Hudson Transmission Reliability Project</p>	<p>Town: Sudbury</p>
<p>Photo No.: 3</p>	<p>Date: 1-16-23</p>

<p>Description:</p> <p>Moosehead placing snags within Segment 7 at approximate Sta.# 398+00, looking eastward.</p>

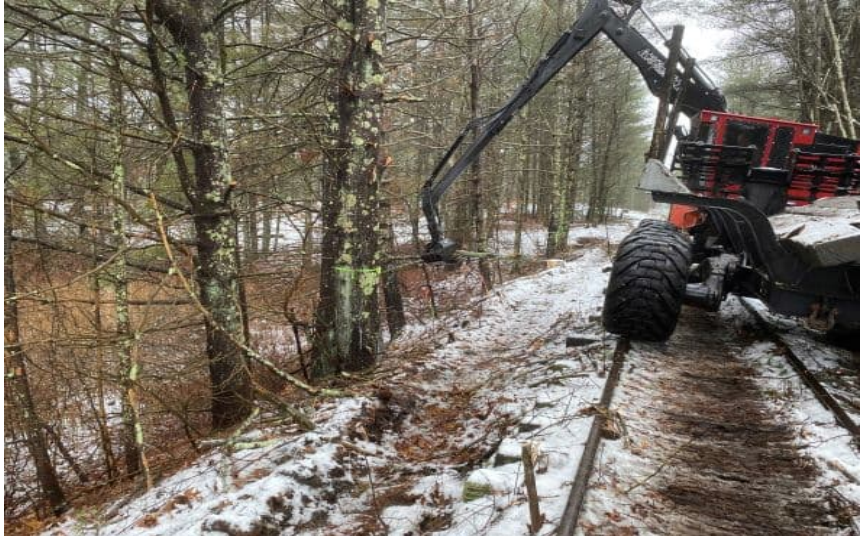
<p>PHOTOGRAPHIC LOG</p>	
<p>Client Name: Eversource</p>		<p>Site Location: Sudbury to Hudson Transmission Reliability Project</p>	<p>Town: Sudbury</p>
<p>Photo No.: 4</p>	<p>Date: 1-16-23</p>

<p>Description:</p> <p>Moosehead placing snags within Segment 7 at approximate Sta.# 398+00, looking westward.</p>

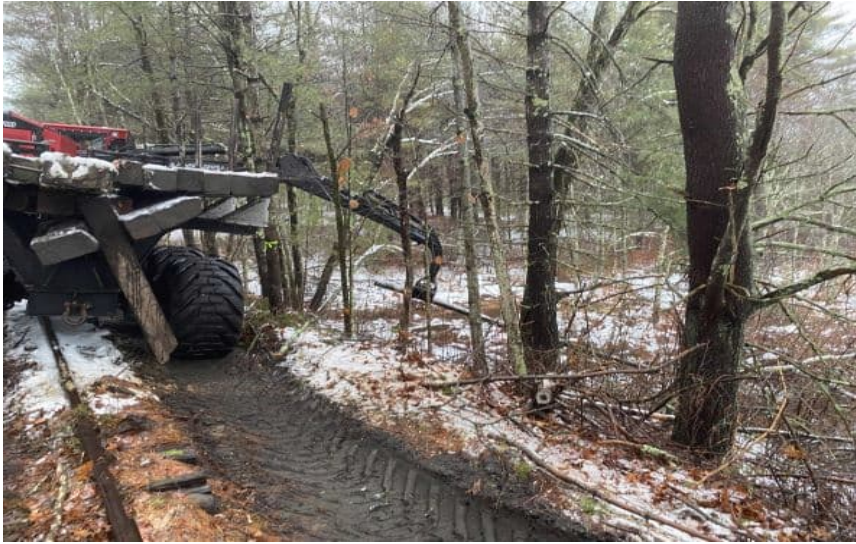
<p>PHOTOGRAPHIC LOG</p>	
<p>Client Name: Eversource</p>		<p>Site Location: Sudbury to Hudson Transmission Reliability Project</p>	<p>Town: Sudbury</p>
<p>Photo No.: 5</p>	<p>Date: 1-16-23</p>

<p>Description:</p> <p>Moosehead placing snags within Segment 7 at approximate Sta.# 398+00, looking westward.</p>

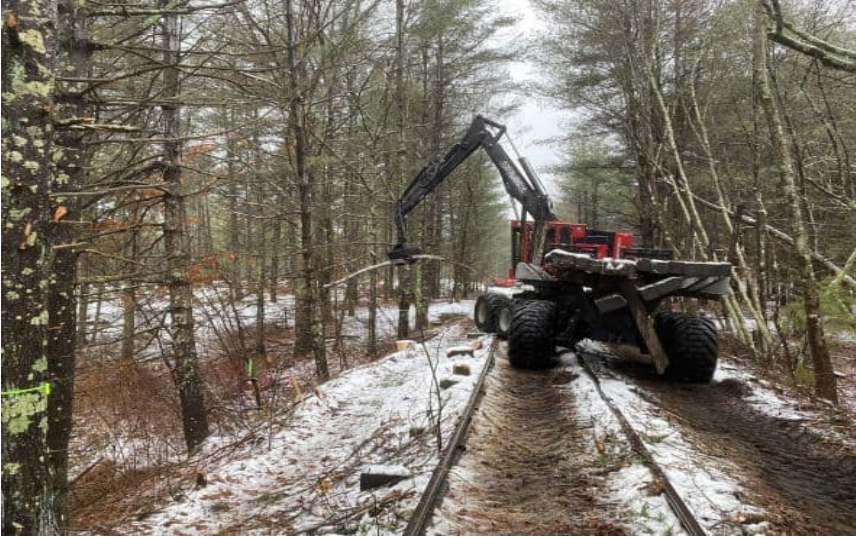
<p>PHOTOGRAPHIC LOG</p>	
<p>Client Name: Eversource</p>		<p>Site Location: Sudbury to Hudson Transmission Reliability Project</p>	<p>Town: Sudbury</p>
<p>Photo No.: 6</p>	<p>Date: 1-16-23</p>

<p>Description:</p> <p>Moosehead placing snags within Segment 7 at approximate Sta.# 398+00, looking westward.</p>

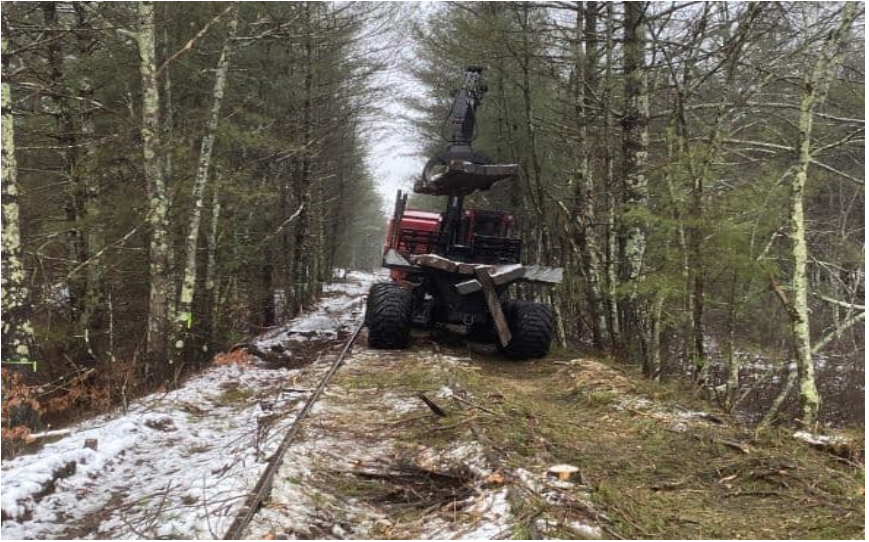
<p>PHOTOGRAPHIC LOG</p>	
<p>Client Name: Eversource</p>		<p>Site Location: Sudbury to Hudson Transmission Reliability Project</p>	<p>Town: Sudbury</p>
<p>Photo No.: 7</p>	<p>Date: 1-16-23</p>

<p>Description: Moosehead leaving Segment 7 at approximate Sta.# 398+00, looking westward.</p>

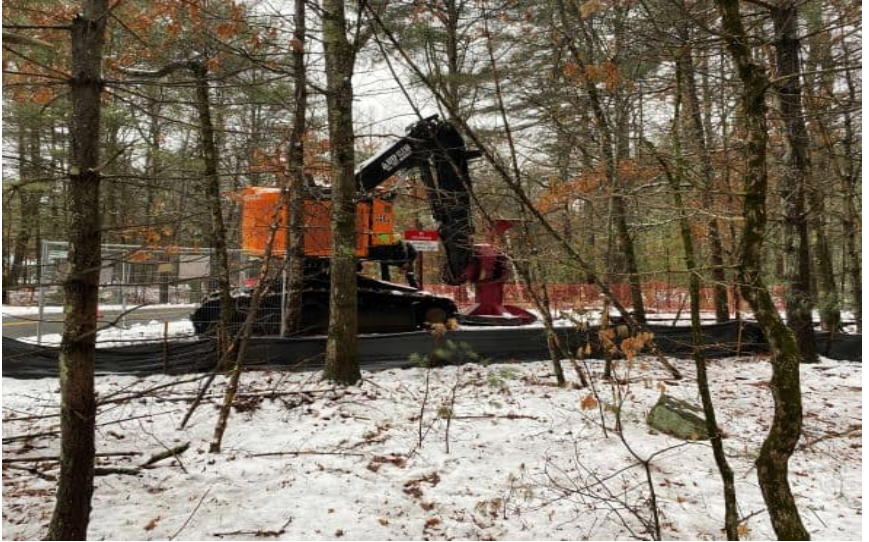
<p>PHOTOGRAPHIC LOG</p>	
<p>Client Name: Eversource</p>		<p>Site Location: Sudbury to Hudson Transmission Reliability Project</p>	<p>Town: Sudbury</p>
<p>Photo No.: 8</p>	<p>Date: 1-16-23</p>

<p>Description: Moosehead started clearing within Segment 8 at Dutton Road, looking eastward.</p>

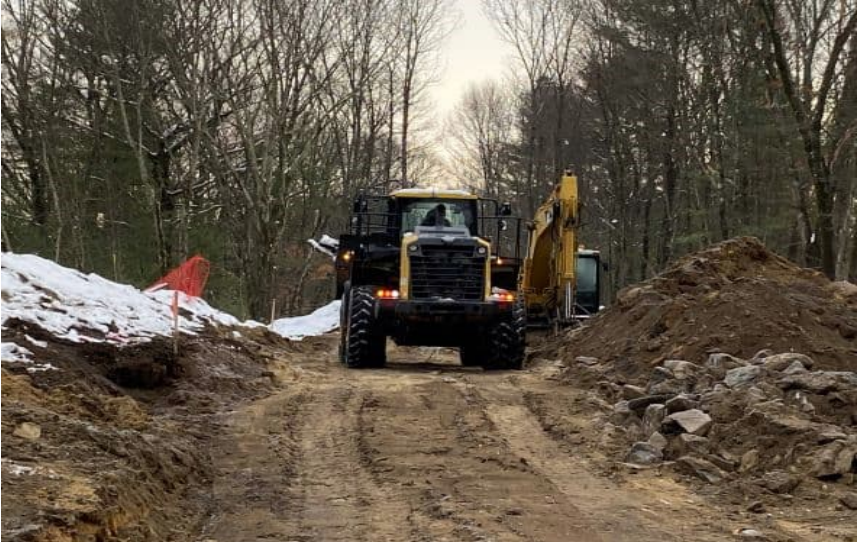
<p>PHOTOGRAPHIC LOG</p>	
<p>Client Name: Eversource</p>		<p>Site Location: Sudbury to Hudson Transmission Reliability Project</p>	<p>Town: Hudson</p>
<p>Photo No.: 2</p>	<p>Date: 1-25-23</p>

<p>Description:</p> <p>Moosehead removing rail/ties within Segment 1 just off Wilkins Avenue, looking eastward.</p>

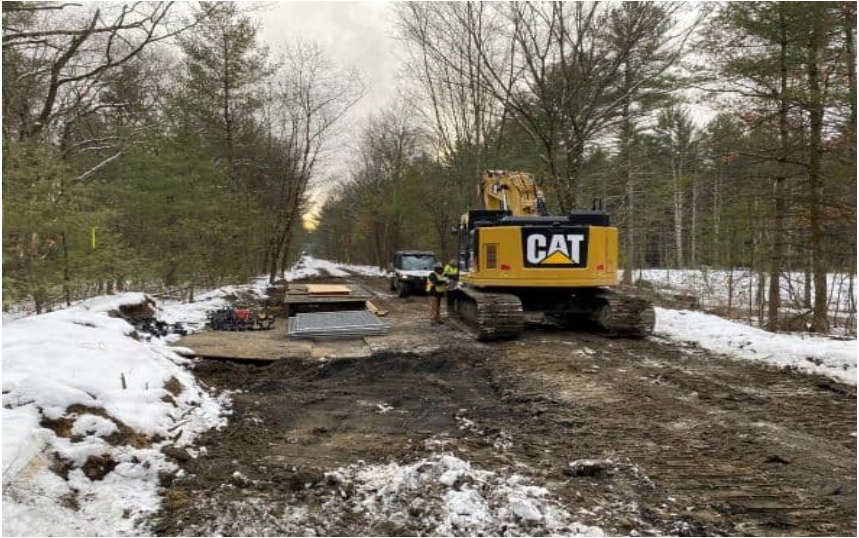
<p>PHOTOGRAPHIC LOG</p>	
<p>Client Name: Eversource</p>		<p>Site Location: Sudbury to Hudson Transmission Reliability Project</p>	<p>Town: Hudson</p>
<p>Photo No.: 3</p>	<p>Date: 1-25-23</p>

<p>Description:</p> <p>Bond conducting site work at MH#12 at approximate Sta.# 316+50 Segment 5, looking eastward.</p>

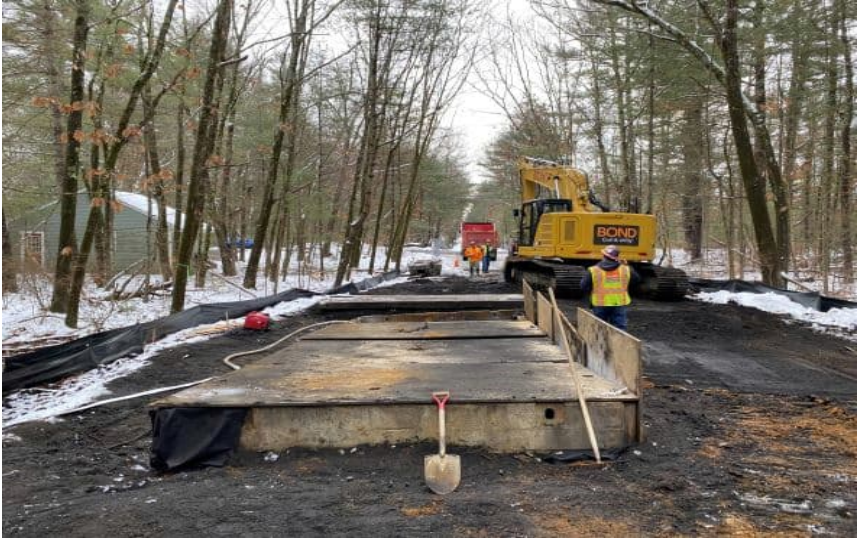
<p>PHOTOGRAPHIC LOG</p>	
<p>Client Name: Eversource</p>		<p>Site Location: Sudbury to Hudson Transmission Reliability Project</p>	<p>Town: Hudson</p>
<p>Photo No.: 4</p>	<p>Date: 1-25-23</p>

<p>Description:</p> <p>Bond conducting site work at MH#13 at approximate Sta.# 336+00 Segment 5, looking eastward.</p>

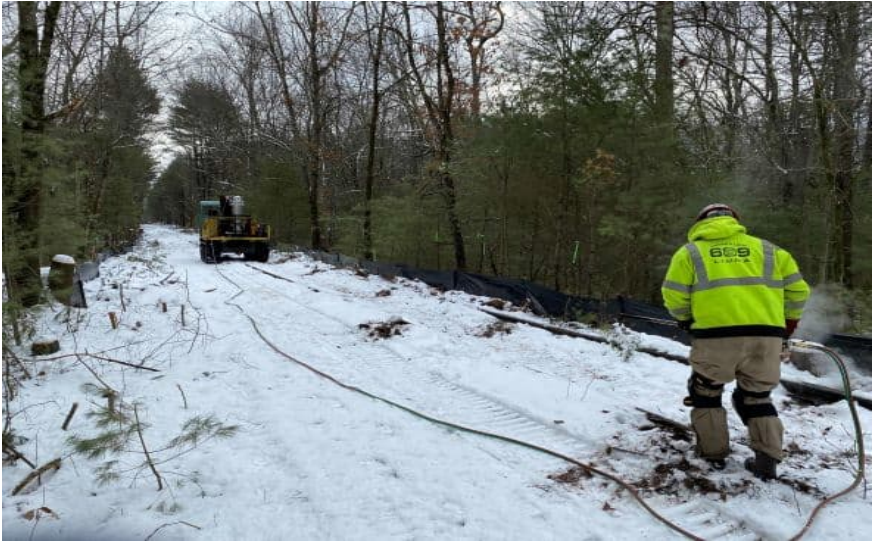
<p>PHOTOGRAPHIC LOG</p>	
<p>Client Name: Eversource</p>		<p>Site Location: Sudbury to Hudson Transmission Reliability Project</p>	<p>Town: Sudbury</p>
<p>Photo No.: 5</p>	<p>Date: 1-25-23</p>

<p>Description:</p> <p>Moosehead cutting rail within Segment 7 at approximate Sta.# 365+00, looking eastward.</p>

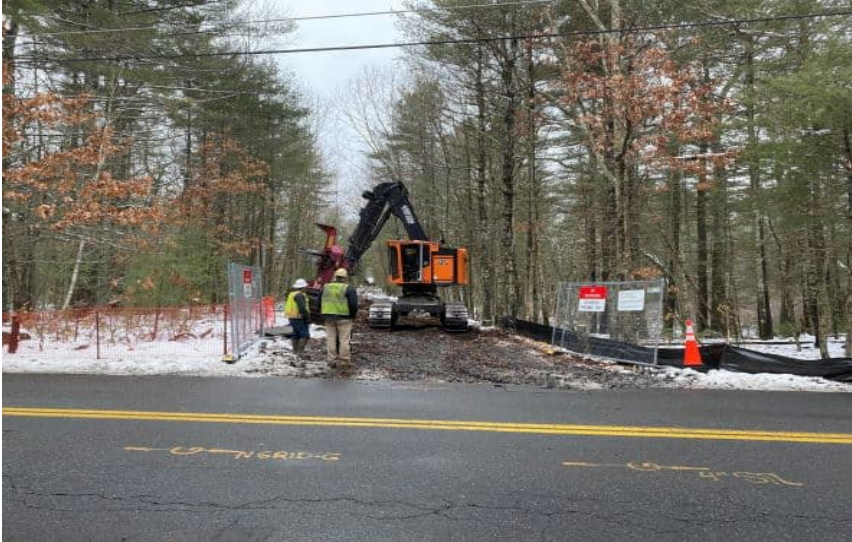
<p>PHOTOGRAPHIC LOG</p>	
<p>Client Name: Eversource</p>		<p>Site Location: Sudbury to Hudson Transmission Reliability Project</p>	<p>Town: Sudbury</p>
<p>Photo No.: 6</p>	<p>Date: 1-25-23</p>

<p>Description:</p> <p>Moosehead finished clearing of Segment 8 at Dutton Road, looking westward.</p>

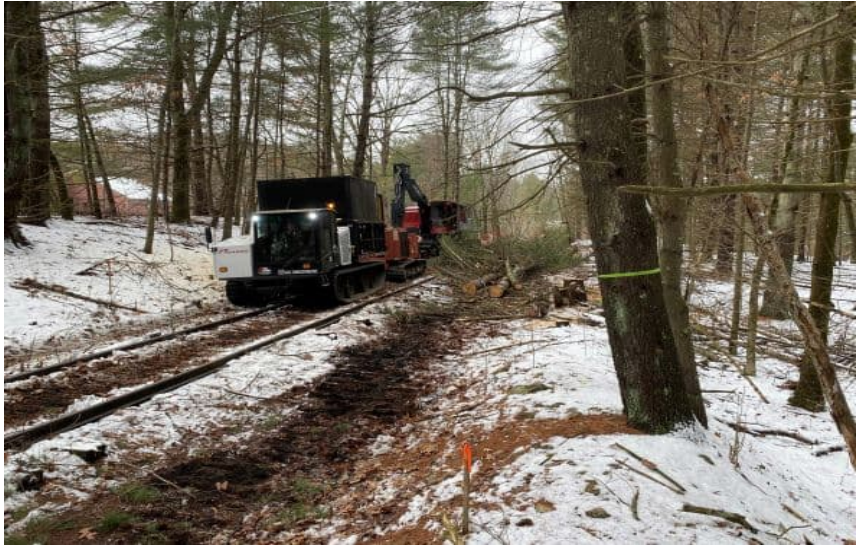
<p>PHOTOGRAPHIC LOG</p>	
<p>Client Name: Eversource</p>		<p>Site Location: Sudbury to Hudson Transmission Reliability Project</p>	<p>Town: Sudbury</p>
<p>Photo No.: 7</p>	<p>Date: 1-25-23</p>

<p>Description: Moosehead chipping within Segment 8 at approximate Sta.# 404+00, looking eastward.</p>

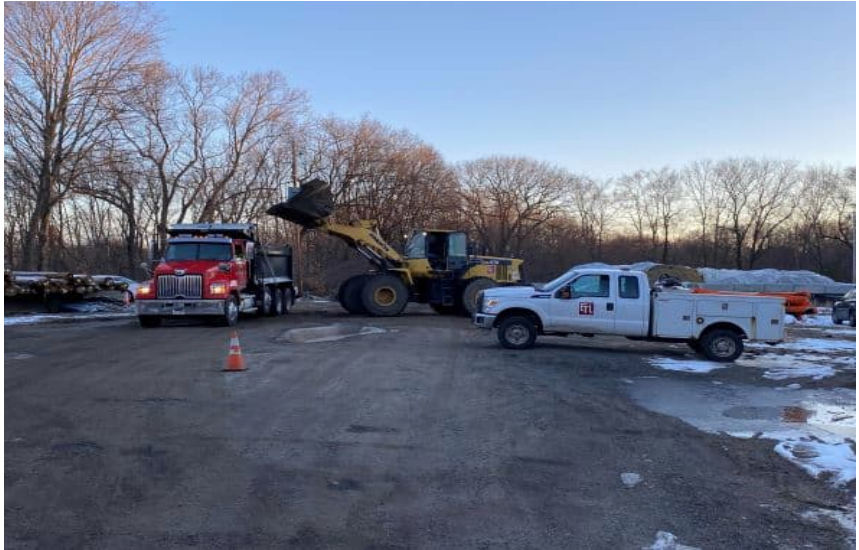
<p>PHOTOGRAPHIC LOG</p>	
<p>Client Name: Eversource</p>		<p>Site Location: Sudbury to Hudson Transmission Reliability Project</p>	<p>Town: Hudson</p>
<p>Photo No.: 1</p>	<p>Date: 1-27-23</p>

<p>Description:</p> <p>Stowe Court laydown yard, spoil removal by ET&L, looking northward.</p>

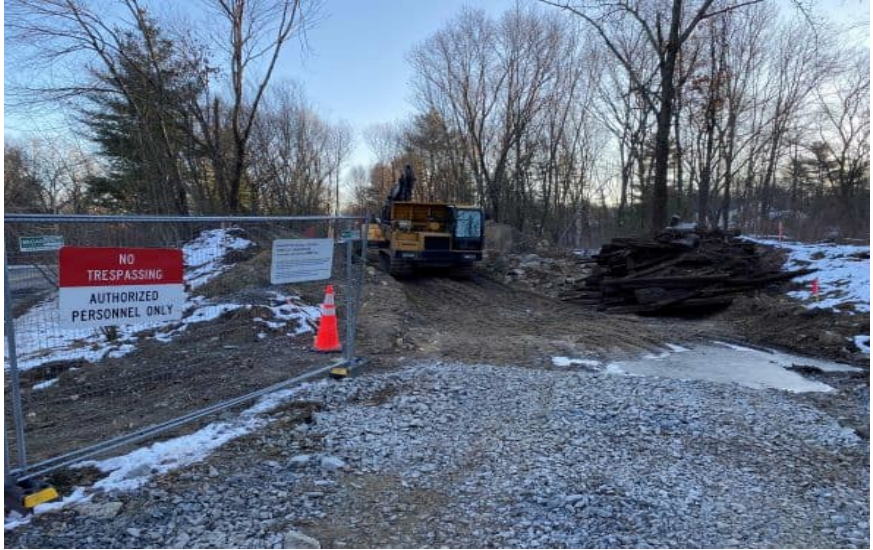
<p>PHOTOGRAPHIC LOG</p>	
<p>Client Name: Eversource</p>		<p>Site Location: Sudbury to Hudson Transmission Reliability Project</p>	<p>Town: Hudson</p>
<p>Photo No.: 2</p>	<p>Date: 1-27-23</p>

<p>Description:</p> <p>Moosehead conducting site work off Wilkins Avenue, looking eastward.</p>

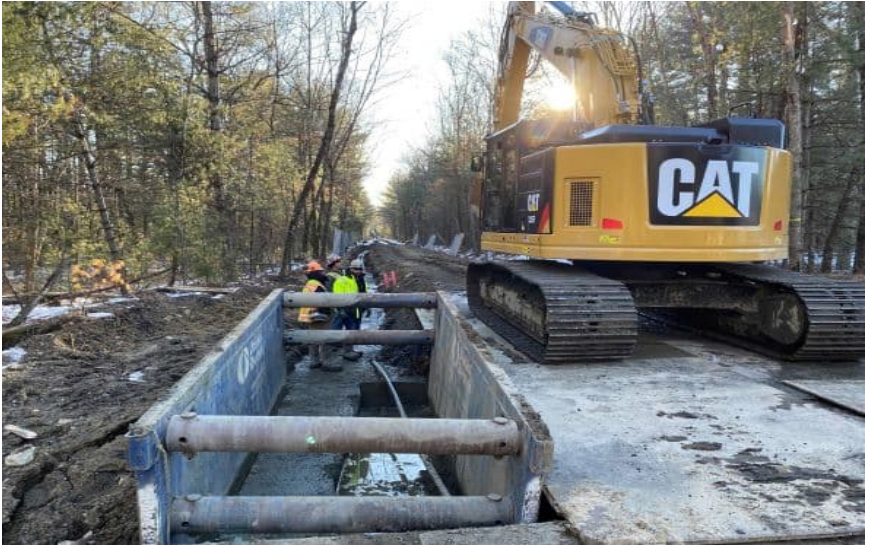
<p>PHOTOGRAPHIC LOG</p>	
<p>Client Name: Eversource</p>		<p>Site Location: Sudbury to Hudson Transmission Reliability Project</p>	<p>Town: Hudson</p>
<p>Photo No.: 3</p>	<p>Date: 1-27-23</p>

<p>Description:</p> <p>Bond conducting site work at MH#12 within Segment 5 at approximate Sta#316+50, looking eastward.</p>

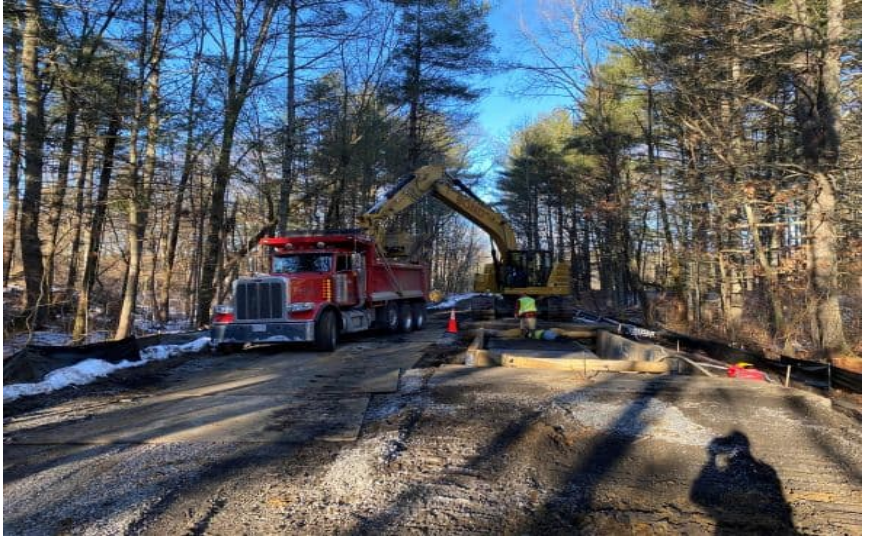
<p>PHOTOGRAPHIC LOG</p>	
<p>Client Name: Eversource</p>		<p>Site Location: Sudbury to Hudson Transmission Reliability Project</p>	<p>Town: Hudson</p>
<p>Photo No.: 4</p>	<p>Date: 1-27-23</p>

<p>Description:</p> <p>Bond conducting site work at MH#13 within Segment 5 at approximate Sta#336+00, looking westward.</p>

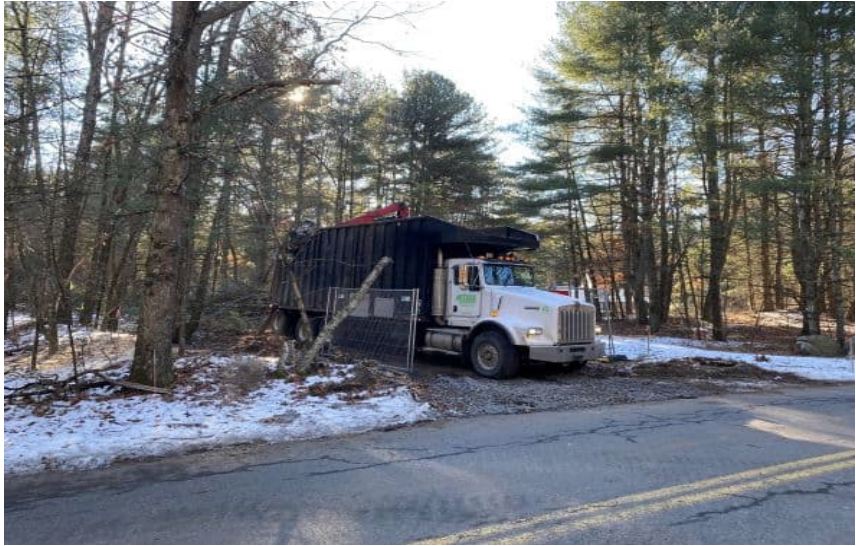
<p>PHOTOGRAPHIC LOG</p>	
<p>Client Name: Eversource</p>		<p>Site Location: Sudbury to Hudson Transmission Reliability Project</p>	<p>Town: Sudbury</p>
<p>Photo No.: 5</p>	<p>Date: 1-27-23</p>

<p>Description: Moosehead removing debris within Segment 9 off Dutton Road, looking eastward.</p>

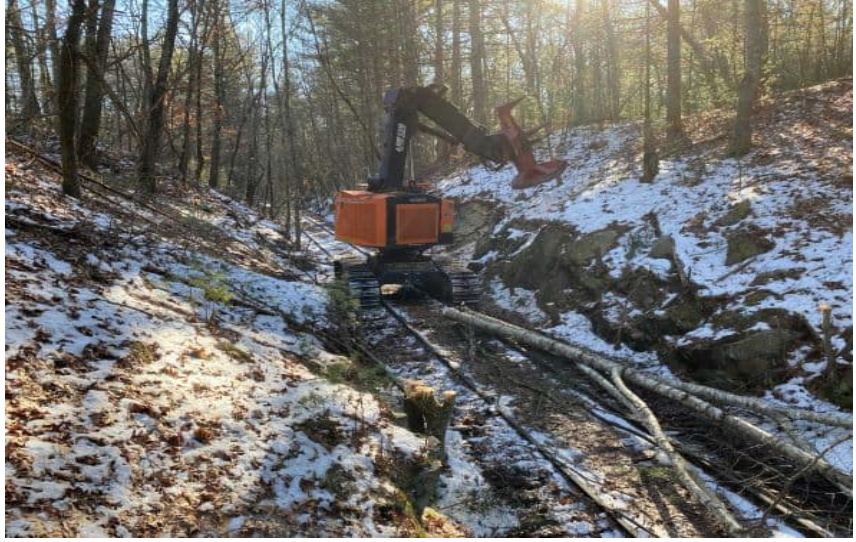
<p>PHOTOGRAPHIC LOG</p>	
<p>Client Name: Eversource</p>		<p>Site Location: Sudbury to Hudson Transmission Reliability Project</p>	<p>Town: Sudbury</p>
<p>Photo No.: 6</p>	<p>Date: 1-27-23</p>

<p>Description: Moosehead clearing within Segment 9 at approximate Sta# 508+00, looking eastward.</p>

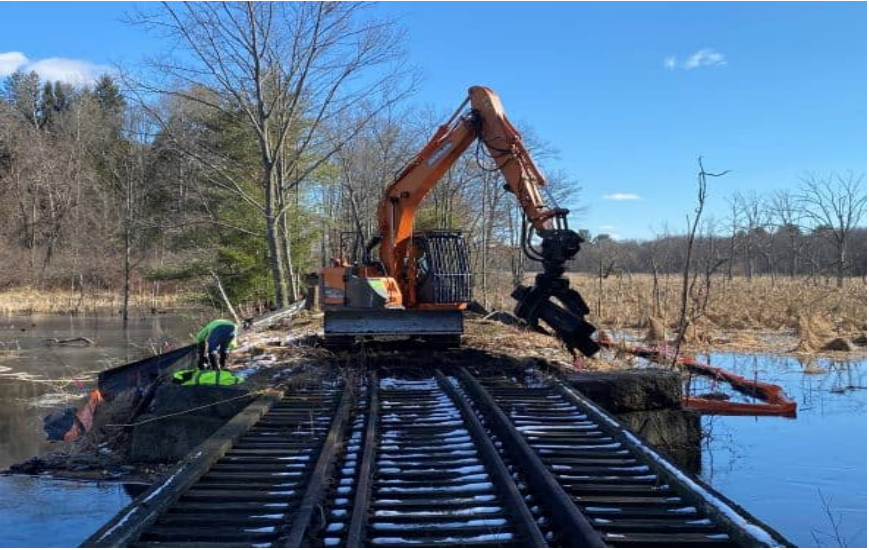
<p>PHOTOGRAPHIC LOG</p>	
<p>Client Name: Eversource</p>		<p>Site Location: Sudbury to Hudson Transmission Reliability Project</p>	<p>Town: Sudbury</p>
<p>Photo No.: 7</p>	<p>Date: 1-27-23</p>

<p>Description:</p> <p>Moosehead removing debris within Segment 14 at bridge 127/ET&L installing erosion control (silt fencing & floating silt fencing), looking eastward.</p>

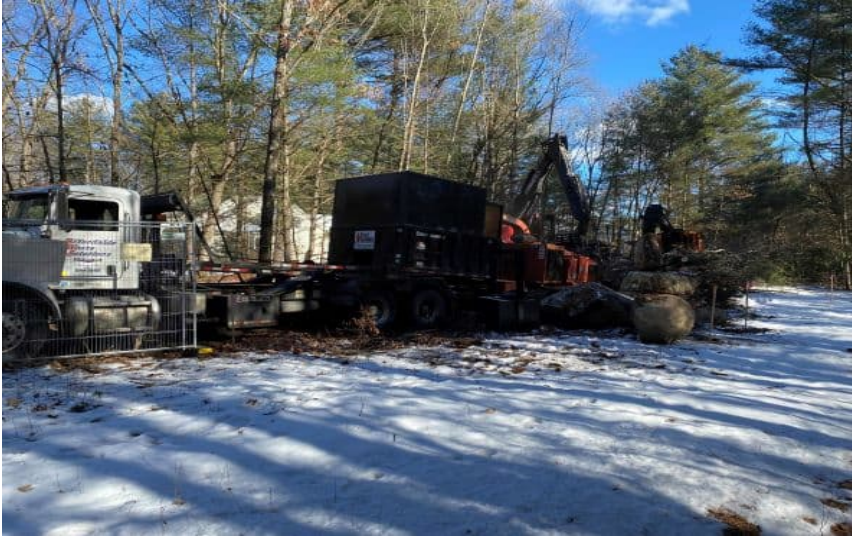
<p>PHOTOGRAPHIC LOG</p>	
<p>Client Name: Eversource</p>		<p>Site Location: Sudbury to Hudson Transmission Reliability Project</p>	<p>Town: Sudbury</p>
<p>Photo No.: 8</p>	<p>Date: 1-27-23</p>

<p>Description:</p> <p>Moosehead chipping within Segment 9 at Dutton Road, looking eastward.</p>

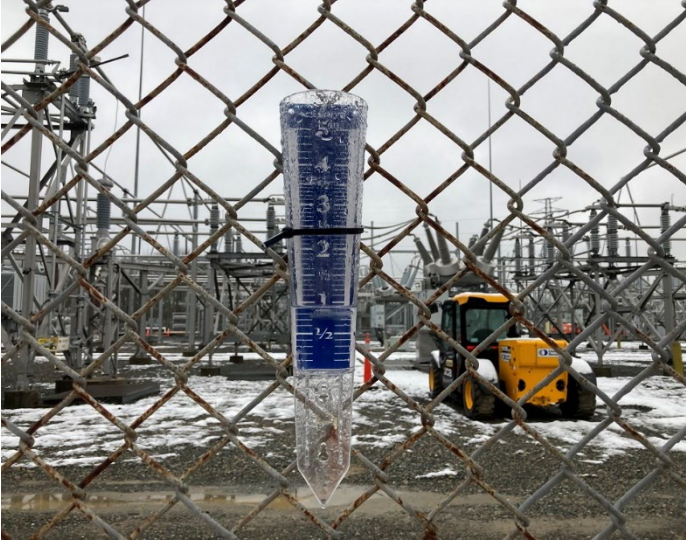
PHOTOGRAPHIC LOG	
Client Name: Eversource		Site Location: Sudbury to Hudson Transmission Reliability Project	Town: Sudbury
Photo No.: 1	Date: 1-23-2023

Description: View of rain gauge at Sudbury substation. Rainfall amount was 0.90" at 7:45am on 1-23-2023. Facing south.

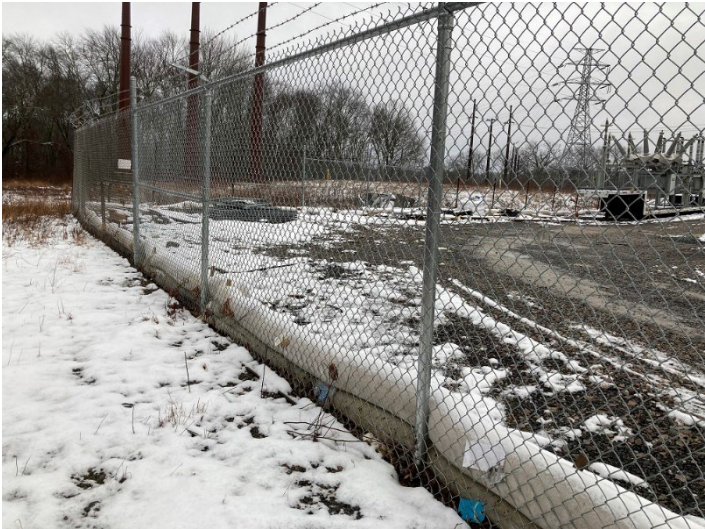
PHOTOGRAPHIC LOG	
Client Name: Eversource		Site Location: Sudbury to Hudson Transmission Reliability Project	Town: Sudbury
Photo No.: 2	Date: 1-23-2023

Description: View of filter tubes at Sudbury substation. Tubes are in good condition and operating properly. Facing southwest.

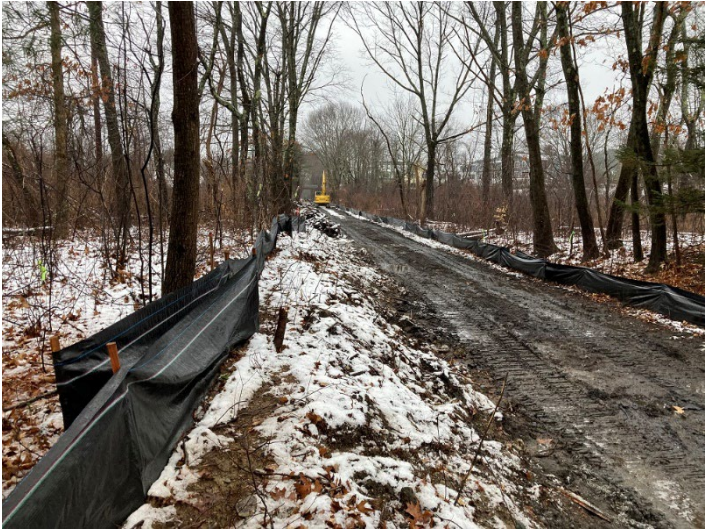
PHOTOGRAPHIC LOG	
Client Name: Eversource		Site Location: Sudbury to Hudson Transmission Reliability Project	Town: Sudbury
Photo No.: 3	Date: 1-23-2023

Description: View of rail & tie removal activities and silt fence in segment 14 near Sudbury substation. Facing west.

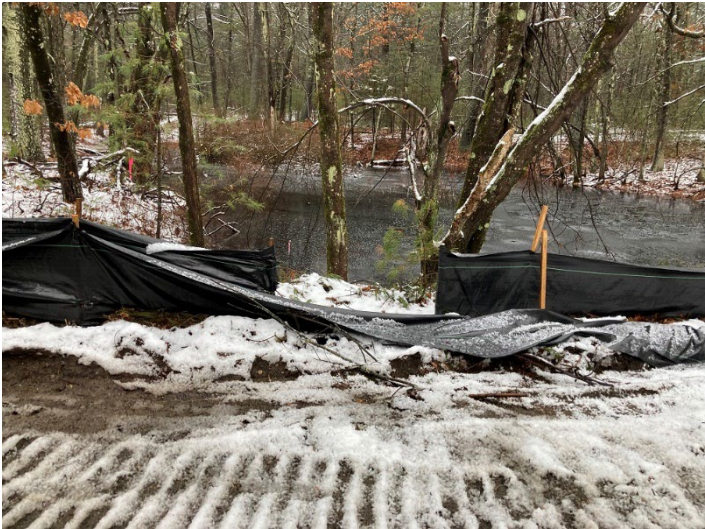
6. Silt Fencing on ROW in Hudson	<input checked="" type="checkbox"/> Yes <input type="checkbox"/> No	1	<input type="checkbox"/> Yes <input checked="" type="checkbox"/> No	1-23-2023	-Silt fence is installed in segments 1-6. -Repair silt fence where needed in segment 6 (routine maintenance).

Description: View syncopated silt fence in segment 6 off White Pond Rd. Repair silt fence where needed (routine maintenance). Facing northeast.

-Repair silt fence where needed in Segment 6.

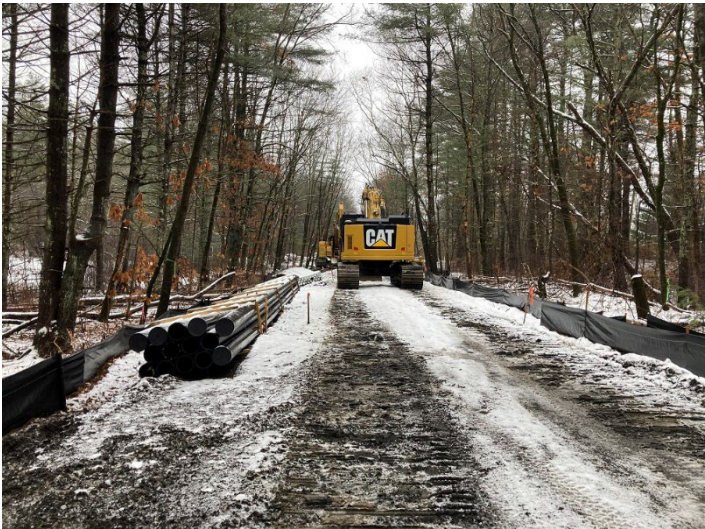
Description: View of work at MH #13 in segment 5 off White Pond Rd. Facing west.

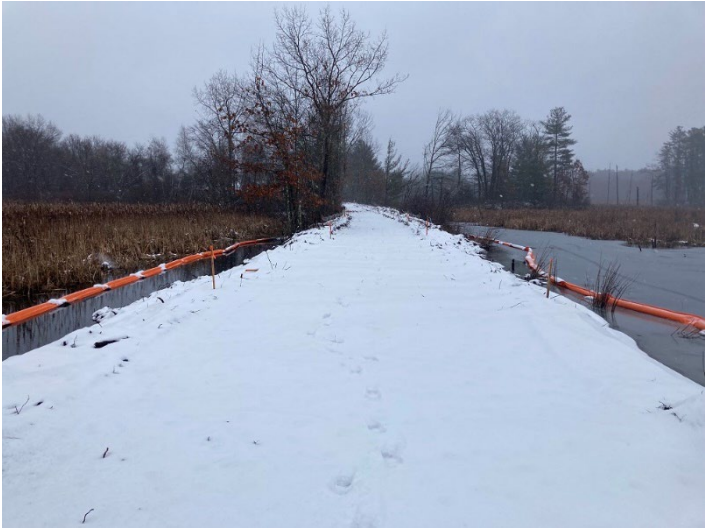
Description: View of turbidity curtain in segment 3 near Bridge 130. Curtain is in good condition and operating properly. Facing east.

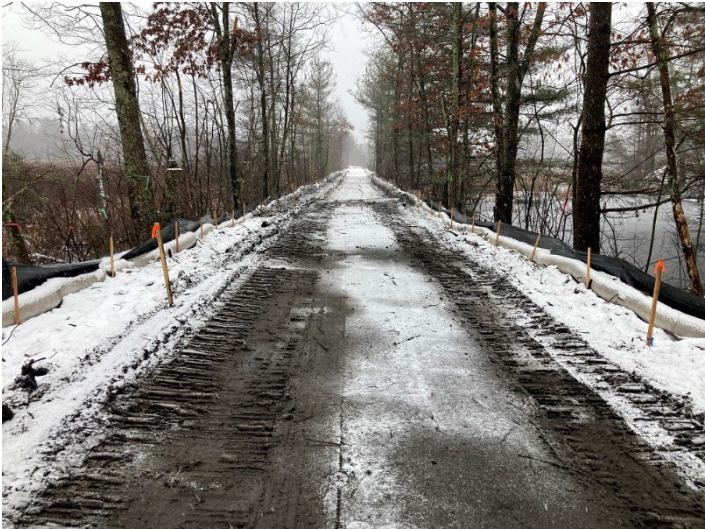
Description: View of erosion controls in segment 2 off Wilkins St. Controls are in good condition and operating properly. Facing east.

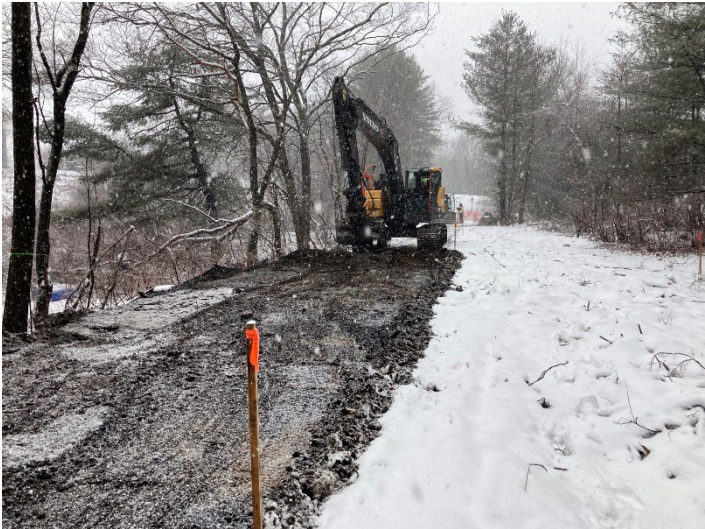
Description: View of grading activities in segment 2 off of Chestnut St. Facing west.

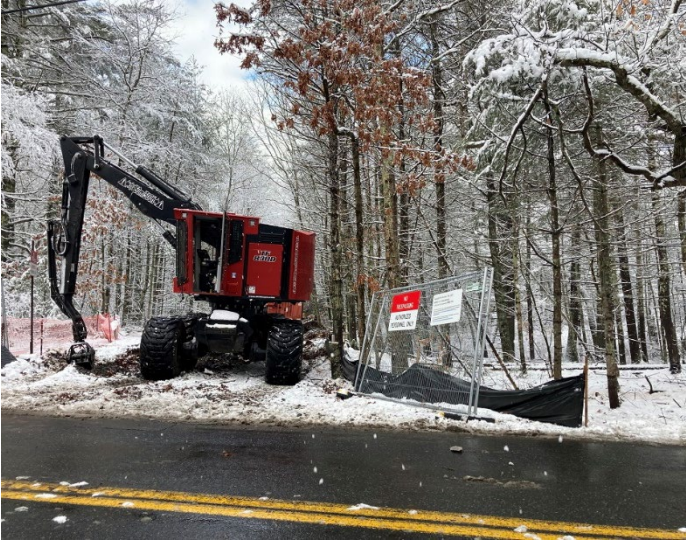
Description: View of chipping operation in segment 8 off Dutton Rd. Facing west.

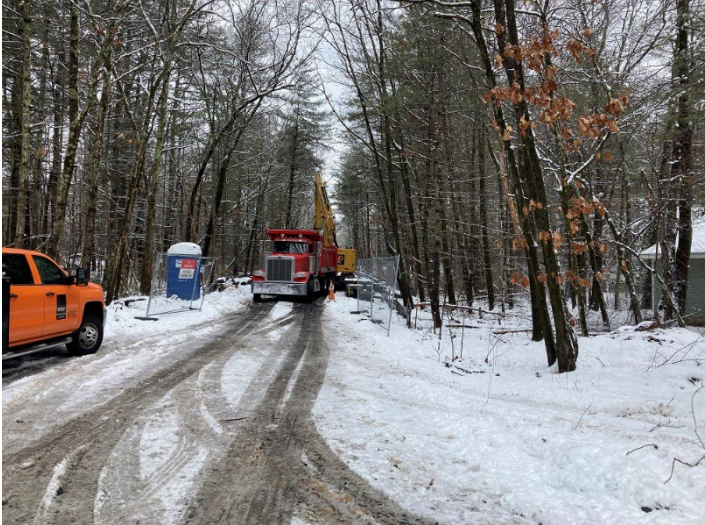
Description: View of work at MH #13 in segment 5 off White Pond Rd. Facing west.

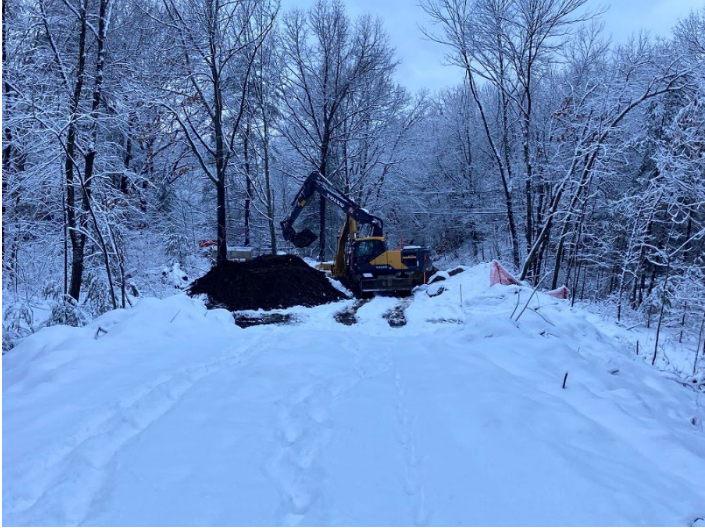
Description: View of ledge removal at entrance of segment 1 off Wilkins St. Facing west.

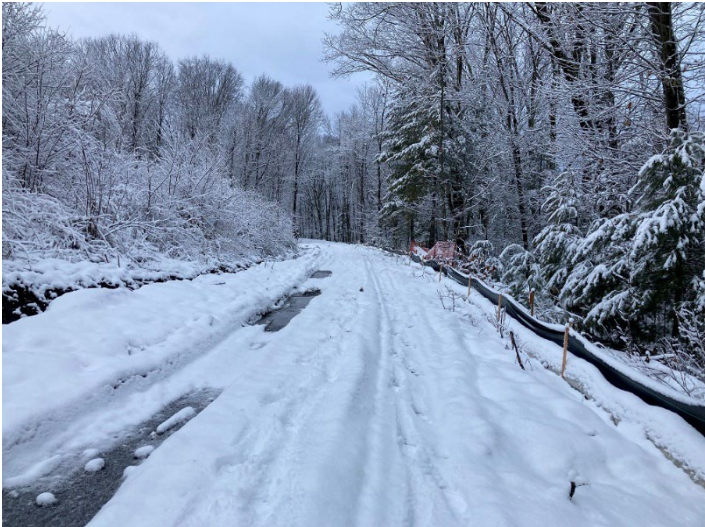
Other Comments & Observations
-Walked segment 1 with Pam Helinek (Hudson agent) and Andrew (ET&L). Pam requested a few silt fence repairs.
-Continuation of storm event inspection started on 1/23/2023.

Description: View of erosion controls in segment 1. Repair silt fence where needed per Con Com agent's request (routine maintenance). Facing west.

Inspection Notes:
Any Significant Discharges of Sediment (or other) or Non-Compliance Actions? <input type="checkbox"/> Yes <input checked="" type="checkbox"/> No
Identify presence of stockpiles and document when placed and when removed (week maximum for stockpiles) <input type="checkbox"/> Yes <input checked="" type="checkbox"/> No Stockpile present at substation. Week maximum requirement does not apply to stockpiles outside of ROW.
Compliance with Previous Observations? <input checked="" type="checkbox"/> Yes <input type="checkbox"/> No
New Corrective Action Recommendations? <input type="checkbox"/> Yes <input checked="" type="checkbox"/> No
New Routine Maintenance Recommendations? <input checked="" type="checkbox"/> Yes <input type="checkbox"/> No
-Repair silt fence where needed in segment 1 per Con Com agent's request.

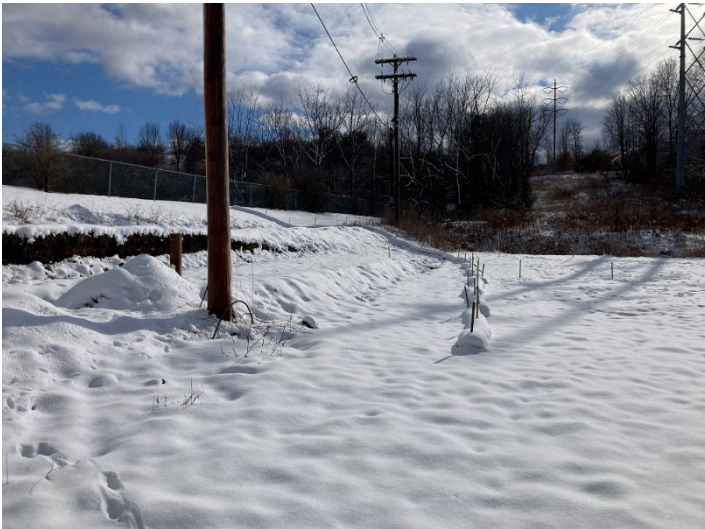
Description: View of filter tubes along work area at MH #1/Hudson substation. Facing south.

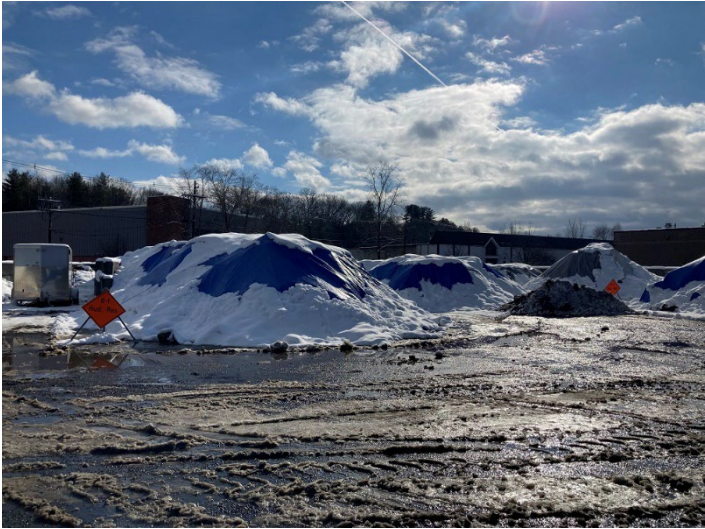
Description: View of laydown yard at Robert Bonazzoli Ave. Facing southeast.

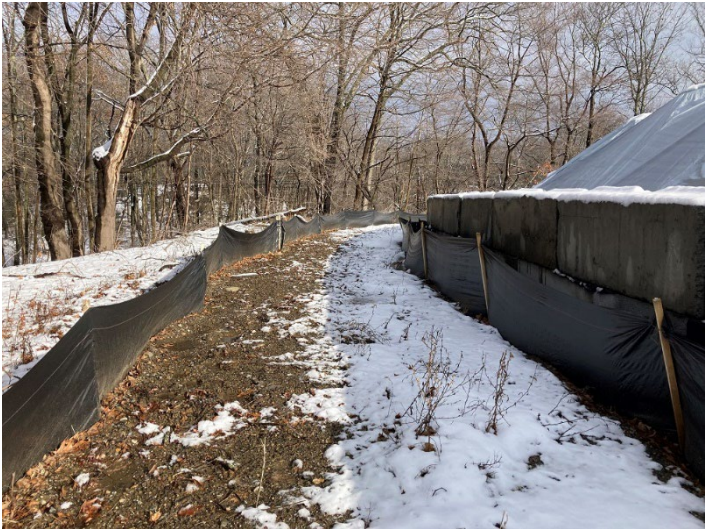
Description: View of silt fence at Stowe Ct laydown yard. Silt fence is in good condition and operating properly. Facing northeast.

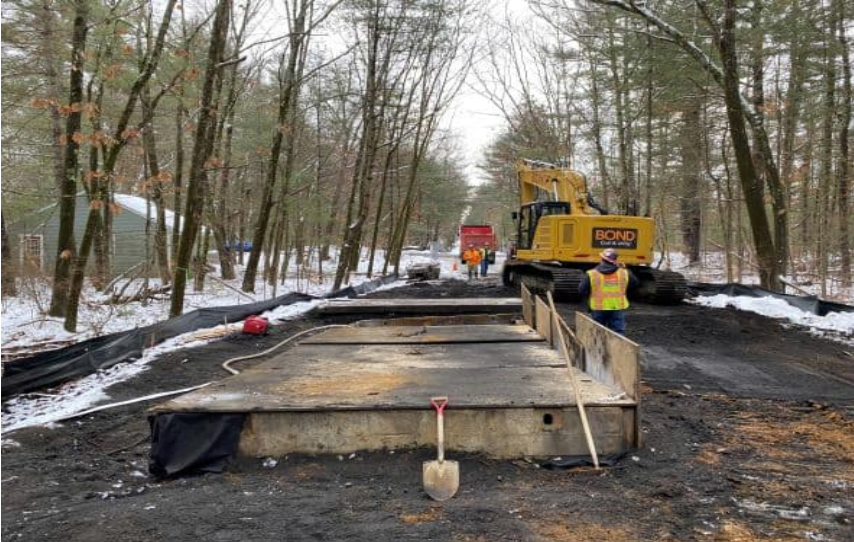
Description: View of area being pumped at work operation at MH#13, at approximate Sta.# 336+00 in Segment 5.

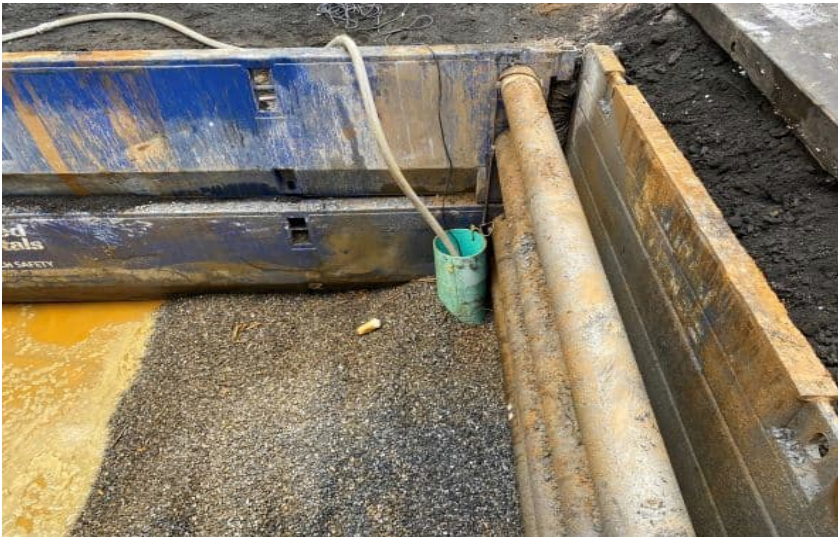
Description: View of pumping operation at MH#13. This is the location of dewatering water prior to treatment.

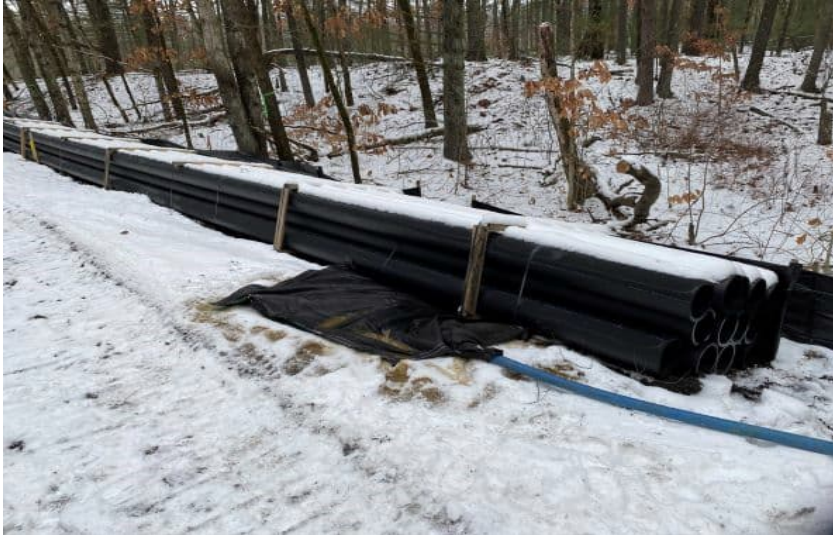
Description: MH#13. View of dewatering discharge bag, looking northward. Water appeared to be discolored exiting bag. Turbidity samples taken at this location.

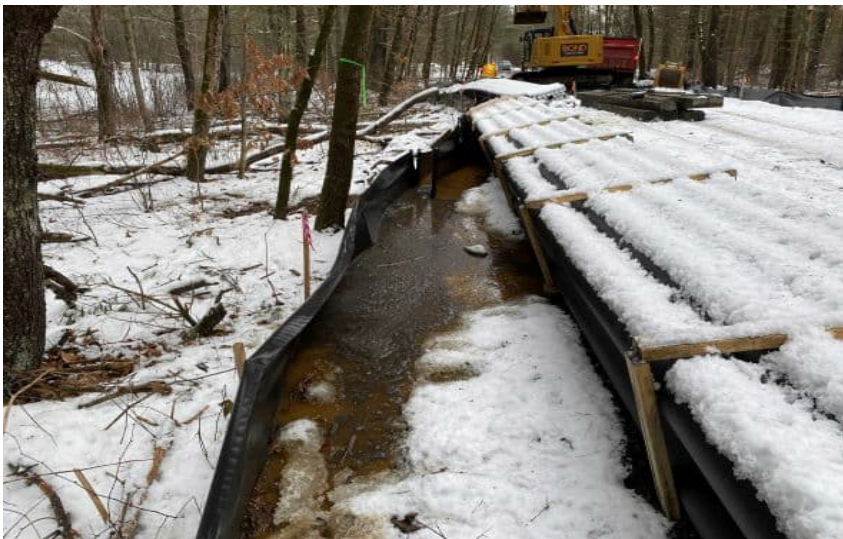
Description: MH13. View of accumulated discharge waters following treatment by discharge bag, looking eastward. Water appeared to be discolored.

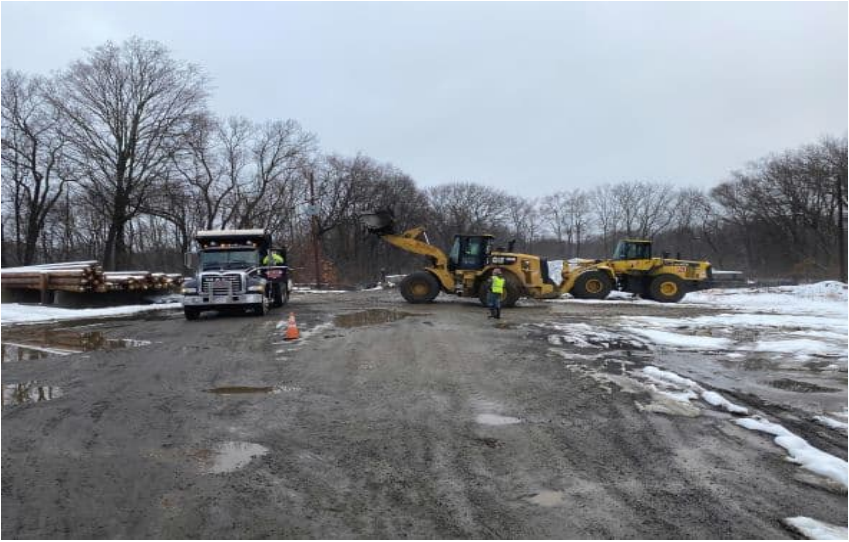
Description: Stowe Court laydown yard, spoil removal, looking northward.

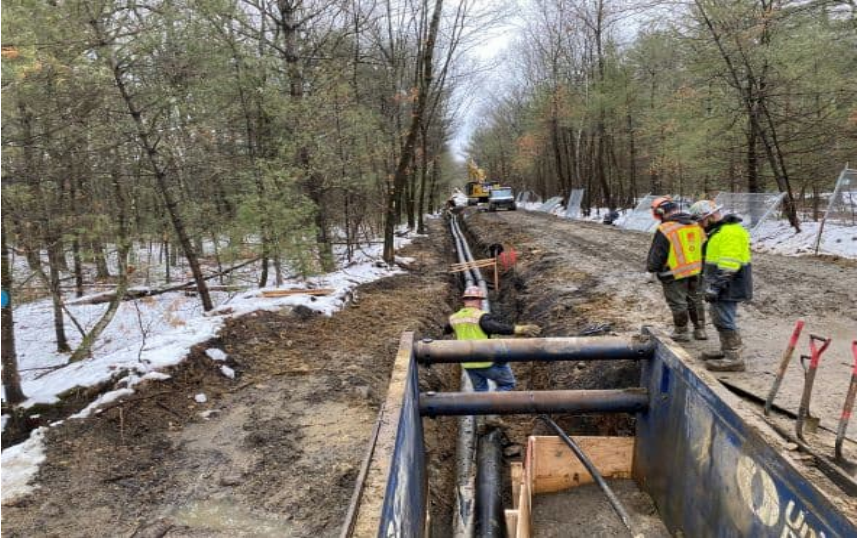
Description: Bond working at MH#12 (laying conduit) within Segment 5 at approximate Sta.# 316+50, looking eastward.

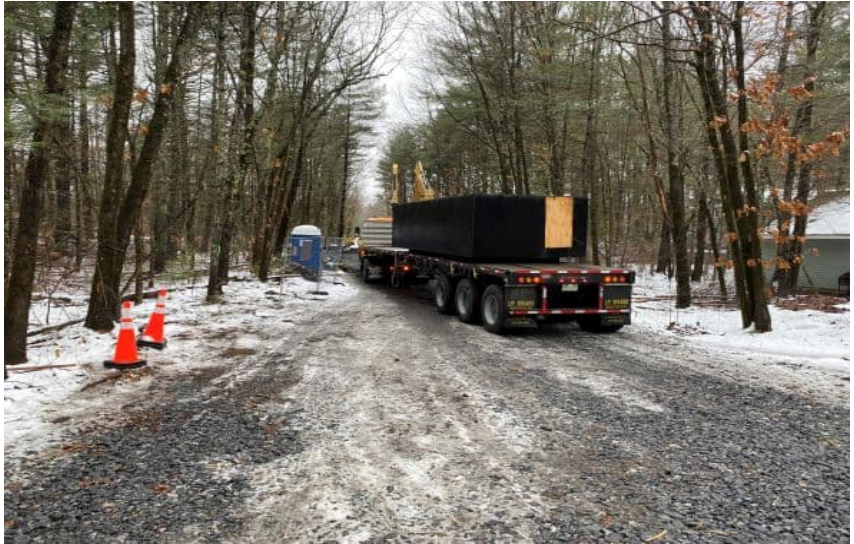
Description: Delivery of MH#13 structure at White Pond Road within Segment 5 at approximate Sta.# 316+50, looking westward.

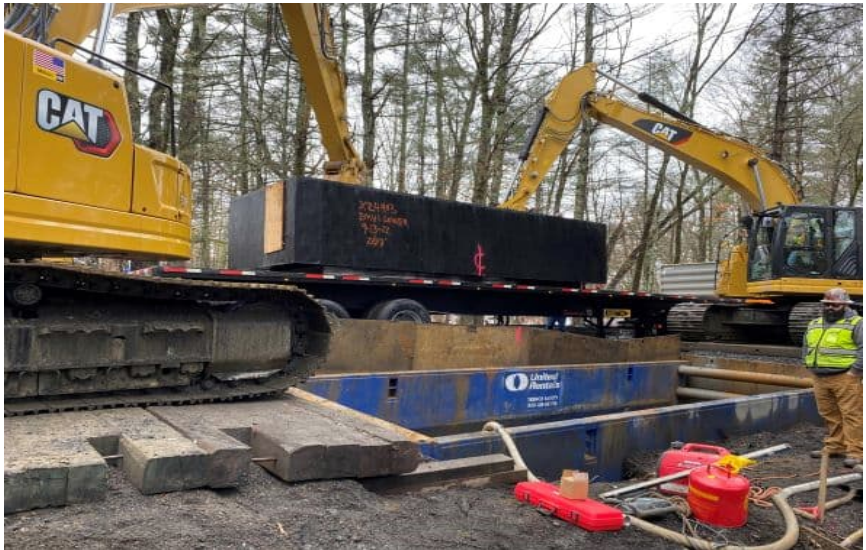
Description: Setting of MH#13 structure at within Segment 5 at approximate Sta.# 316+50, looking southward.

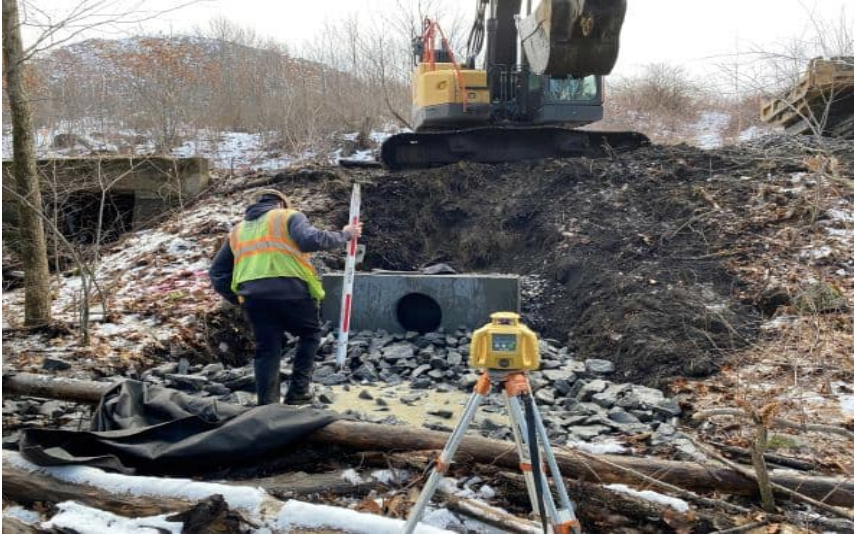
Description: ET&L working within Segment 1 installing new headwall at approximate Sta.# 119+00, looking westward.
