Weekly Environmental Compliance Summary

Sudbury to Hudson Transmission Reliability Project (USEPA Tracking # MAR1003UW)

Week of: January 23 to January 27, 2023

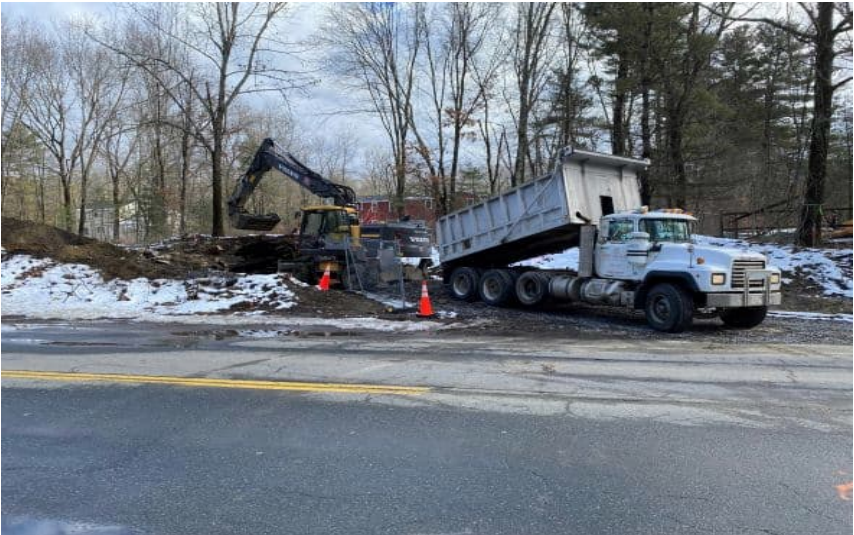
Description: ET&L working within Segment 1 delivering rock for work at approximate Sta.# 119+00, looking eastward.

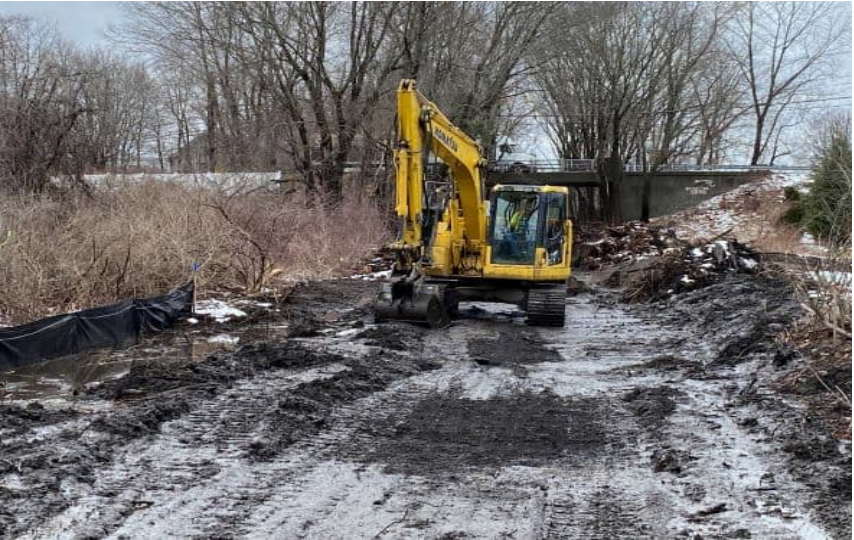
Description: Rail/Tie removal by Moosehead within Segment 14 at approximate Sta.#761+00, looking eastward.

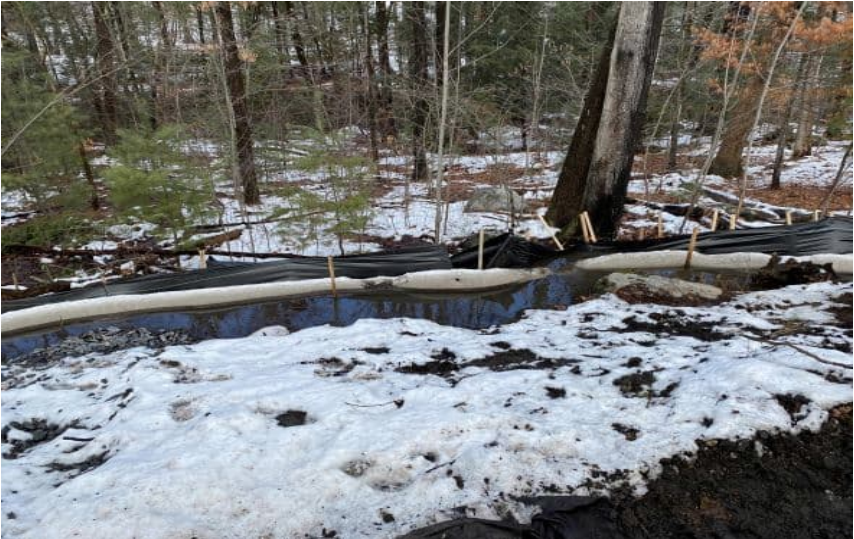
Description: Silt fencing within Segment 1 at approximate Sta.#116+50, looking northward.

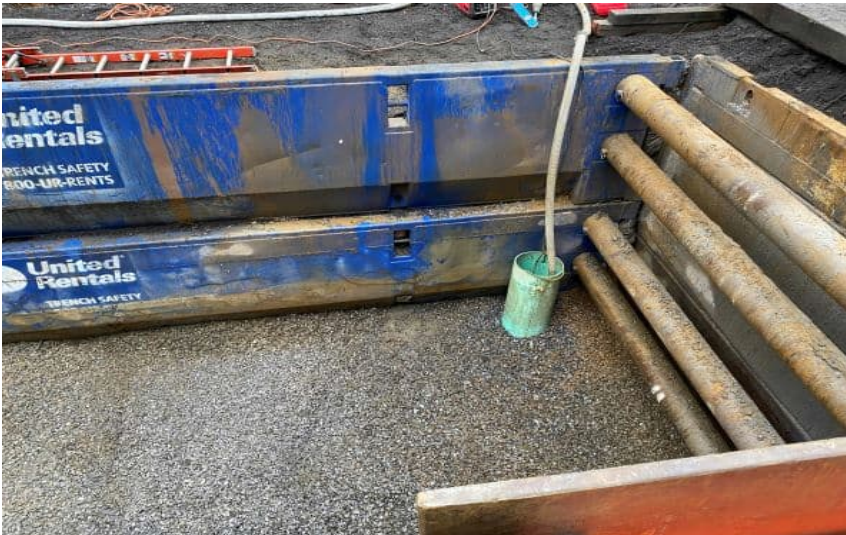
Description: View of pumping operation at MH#13. This is the location of dewatering water prior to treatment.

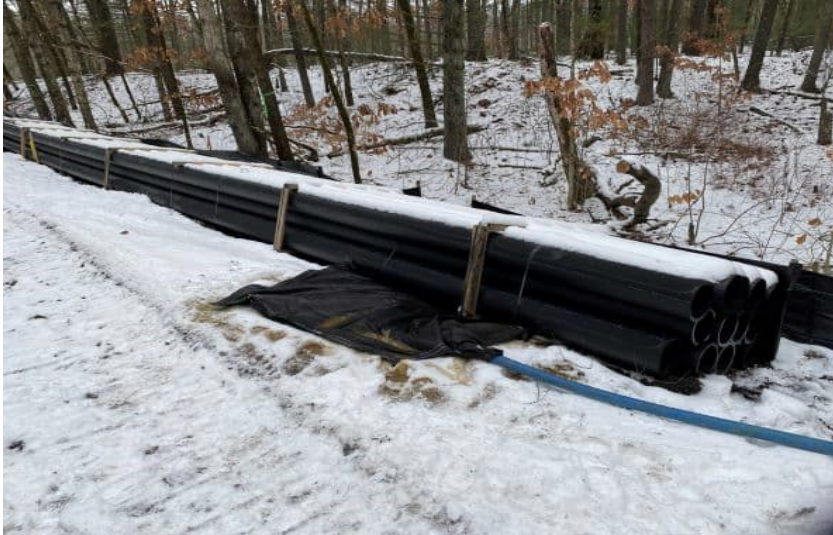
Description: MH#13. View of dewatering discharge bag, looking northward. Water appeared to be discolored exiting bag. Turbidity samples taken at this location. Photo taken 1-25-23.

Section A – Dewatering Discharges (CGP Part 4.6.3) Complete this section <u>within 24 hours</u> of completing the inspection. (If necessary, complete additional inspection reports for each separate inspection location.)	
Inspector Information	
Inspector Name: Terry Ramborger, CPSS, CPESC, SPWS & EPA Site Inspector	Title: Senior Environmental Scientist
Company Name: AECOM	Email: terry.ramborger@aecom.com
Address: 1155 Elm Street #401 Manchester, NH 03101	Phone Number: 603-557-0034
Inspection Details	
Inspection Date: 1/26/2023	Inspection Location: MH#13
Discharge Start Time: 9:00am	Discharge End Time: 2:00pm
Rate of Discharge (gallons per day): 50,400 (35 gallons per minute)	Corrective Action Required? ¹ <input type="checkbox"/> Yes <input checked="" type="checkbox"/> No
Describe Indicators of Pollutant Discharge at Point of Dewatering Discharge: ¹ Turbidity sampling conducted & exceeded 50 NTUs, but no discharge to within 100 feet of or directly to either impaired or sensitive waters associated with this project. Recommend additional controls for future events.

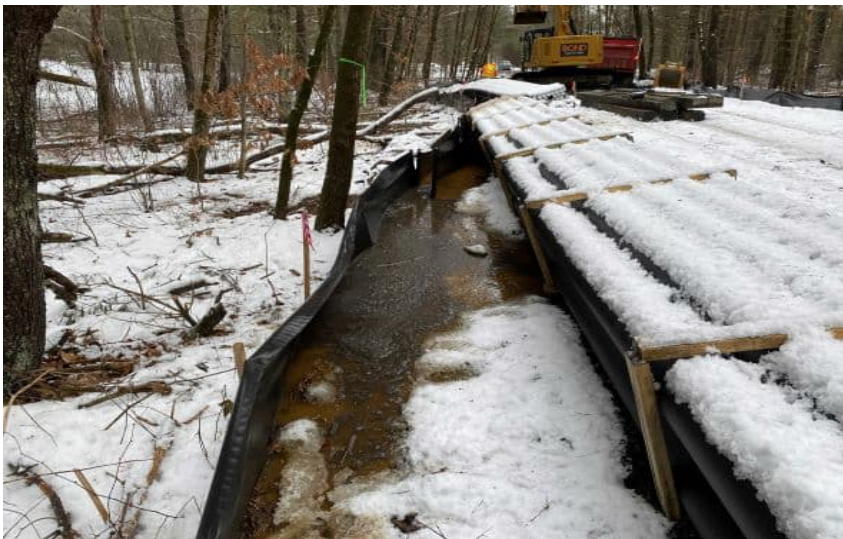
Description: MH13. View of accumulated discharge waters following treatment by discharge bag, looking eastward. Water appeared to be discolored. Photo taken 1-25-23.

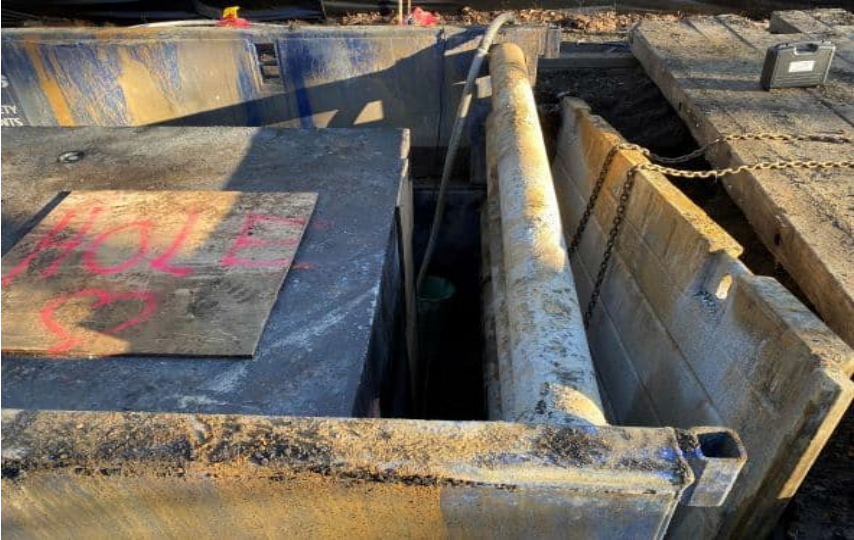
Description: View of area being pumped at work operation at MH#13, at approximate Sta.# 336+00 in Segment 5.

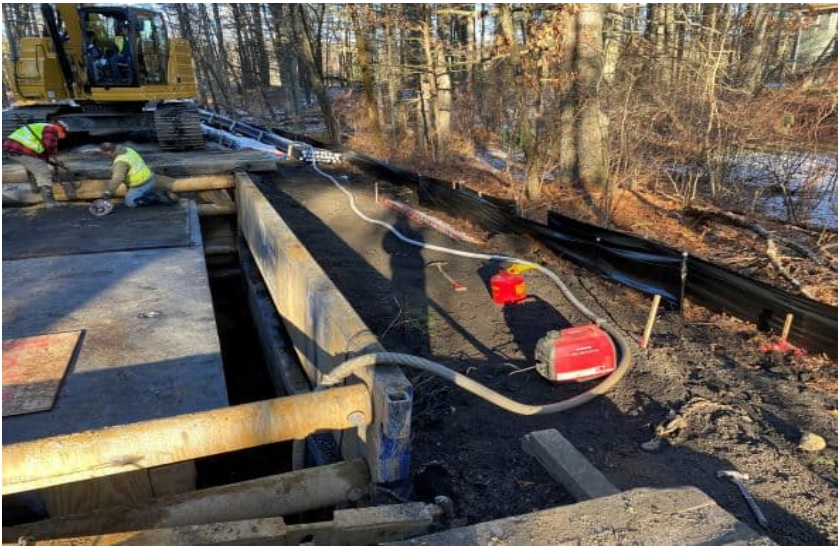
Description: View of pumping operation at MH#13. This is the location of dewatering water prior to treatment.

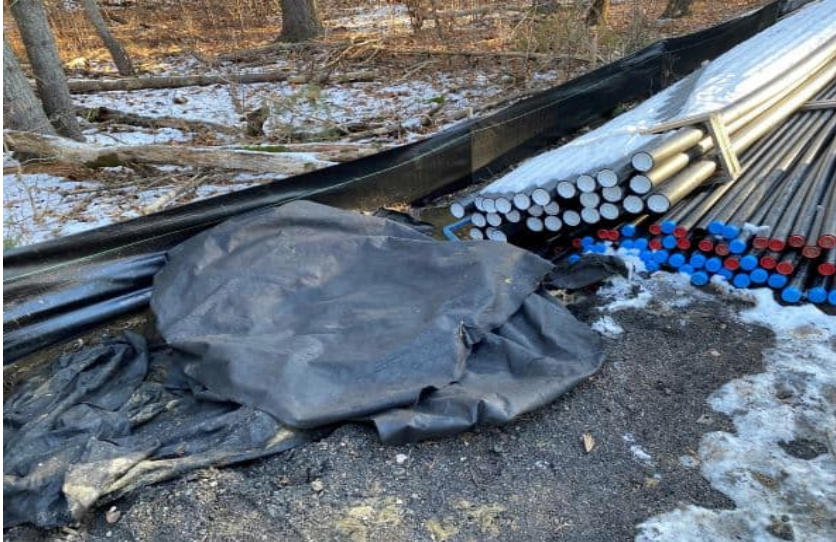
Description: MH#13. View of dewatering discharge bag, looking northward. Water appeared to be discolored exiting bag. Turbidity samples taken at this location.
