Weekly Environmental Compliance Summary

Sudbury to Hudson Transmission Reliability Project (USEPA Tracking # MAR1003UW)

Week of: December 26 to December 30, 2022

CONSTRUCTION MONITORING REPORT Sudbury to Hudson Transmission Project

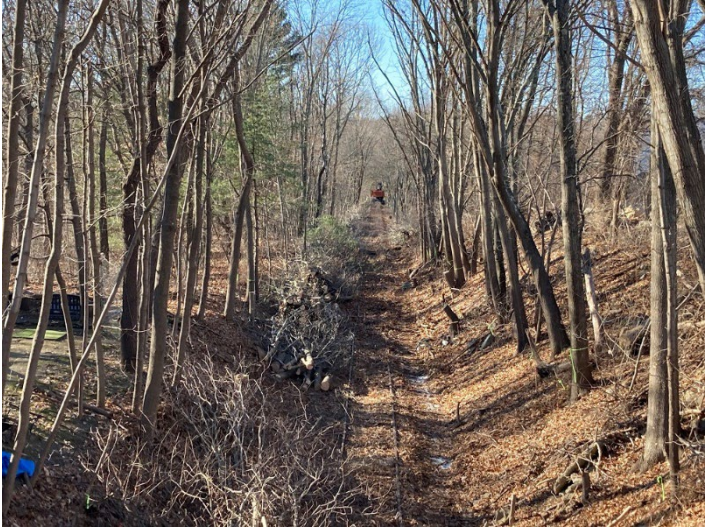
<p align="right">PHOTOGRAPHIC LOG</p>	
Client Name: Eversource		Site Location: Sudbury to Hudson Transmission Reliability Project	Town: Sudbury
Photo No.: 1	Date: 12/27/2022

Description: View of clearing activities in Segment 14 from overpass at Landham Rd, facing west.

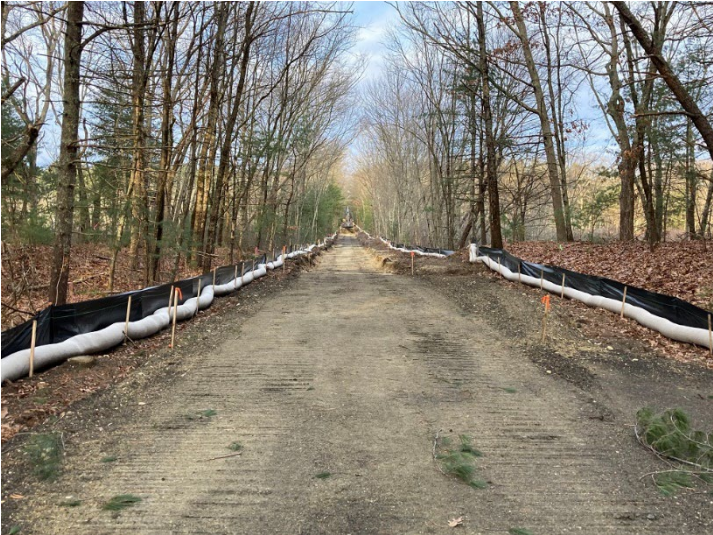
<p align="right">PHOTOGRAPHIC LOG</p>	
Client Name: Eversource		Site Location: Sudbury to Hudson Transmission Reliability Project	Town: Hudson
Photo No.: 2	Date: 12/27/2022

Description: View of Segment 5 off White Pond Rd. Grading is in progress. E&S controls are in good condition and operating properly. Facing west.

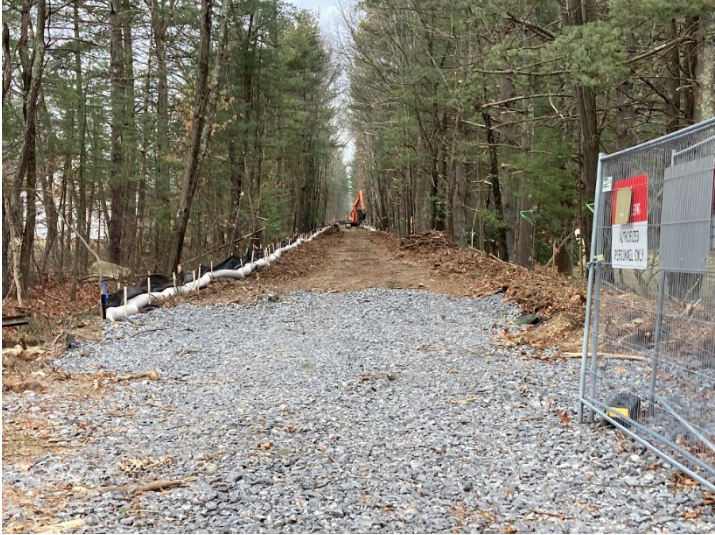
PHOTOGRAPHIC LOG	
Client Name: Eversource		Site Location: Sudbury to Hudson Transmission Reliability Project	Town: Hudson
Photo No.: 3	Date: 12/27/2022

Description: View of rail and tie removal in Segment 4 off Parmenter, facing west.

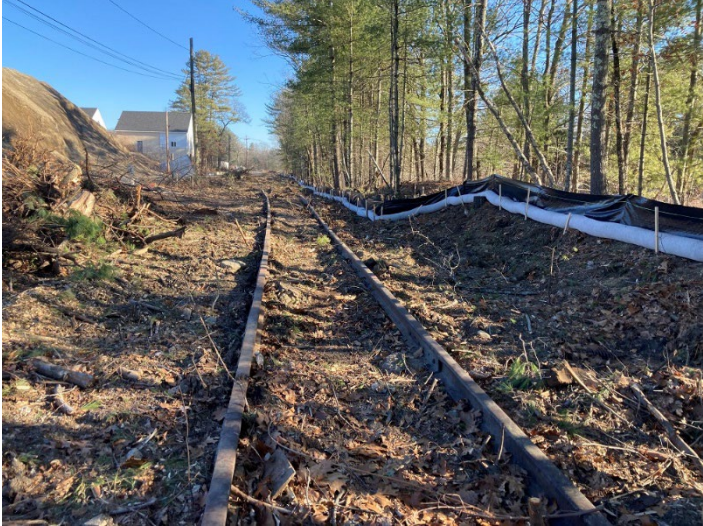
PHOTOGRAPHIC LOG	
Client Name: Eversource		Site Location: Sudbury to Hudson Transmission Reliability Project	Town: Hudson
Photo No.: 4	Date: 12/27/2022

Description: View of newly installed compost filter tubes in Segment 3. Facing east.

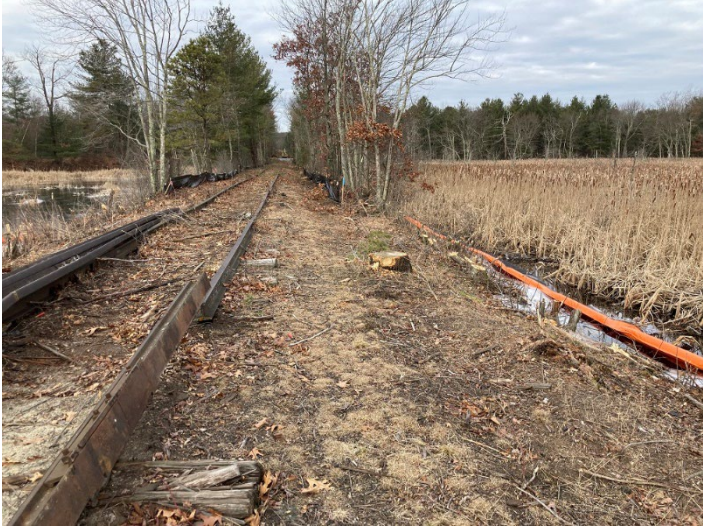
<p align="center">PHOTOGRAPHIC LOG</p>	
<p>Client Name: Eversource</p>		<p>Site Location: Sudbury to Hudson Transmission Reliability Project</p>	<p>Town: Hudson</p>
<p>Photo No.: 5</p>	<p>Date: 12/27/2022</p>

<p>Description: View of E&S controls near Bridge 130 in Segment 2. Controls are in good condition and operating properly. Facing west.</p>

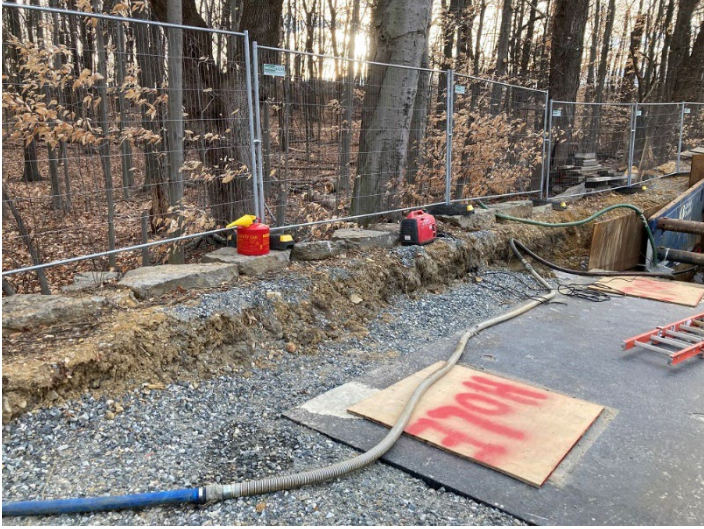
<p align="center">PHOTOGRAPHIC LOG</p>	
<p>Client Name: Eversource</p>		<p>Site Location: Sudbury to Hudson Transmission Reliability Project</p>	<p>Town: Hudson</p>
<p>Photo No.: 6</p>	<p>Date: 12/27/2022</p>

<p>Description: View of pumping/dewatering operation at MH#1. See additional dewatering inspection report. Facing southeast.</p>

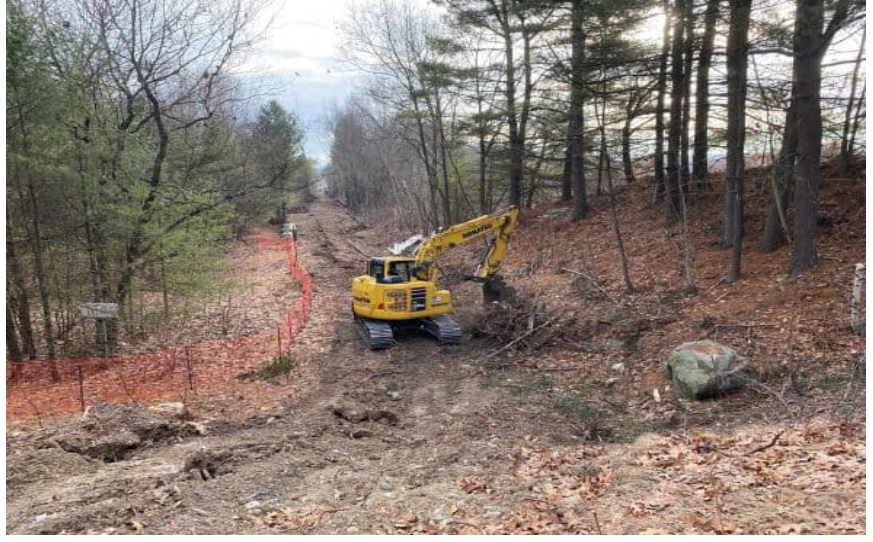
<p>PHOTOGRAPHIC LOG</p>	
<p>Client Name: Eversource</p>		<p>Site Location: Sudbury to Hudson Transmission Reliability Project</p>	<p>Town: Hudson</p>
<p>Photo No.: 2</p>	<p>Date: 12-28-22</p>

<p>Description:</p> <p>Debris removal off Chestnut Street, Segment 2, looking eastward.</p>

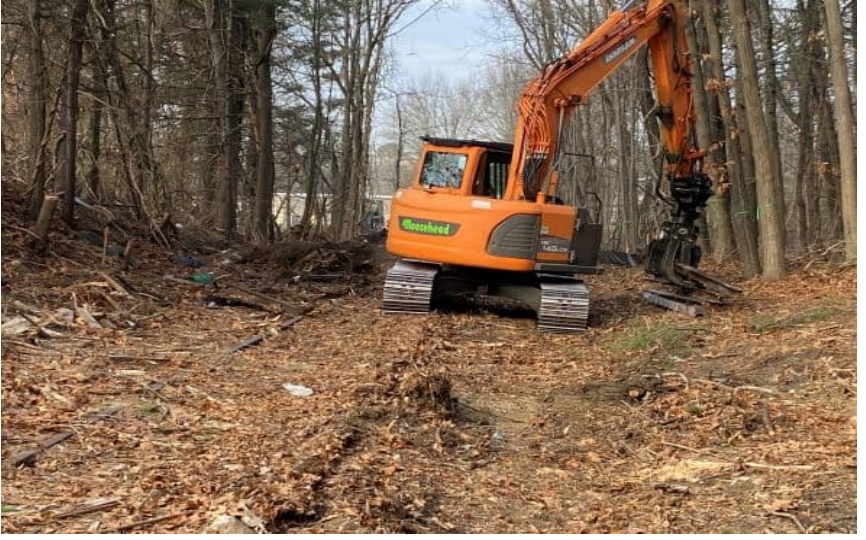
<p>PHOTOGRAPHIC LOG</p>	
<p>Client Name: Eversource</p>		<p>Site Location: Sudbury to Hudson Transmission Reliability Project</p>	<p>Town: Hudson</p>
<p>Photo No.: 4</p>	<p>Date: 12-28-22</p>

<p>Description:</p> <p>Cleanup of steel rail by Moosehead at approximate Sta# 176+00, Segment 3, looking westward.</p>

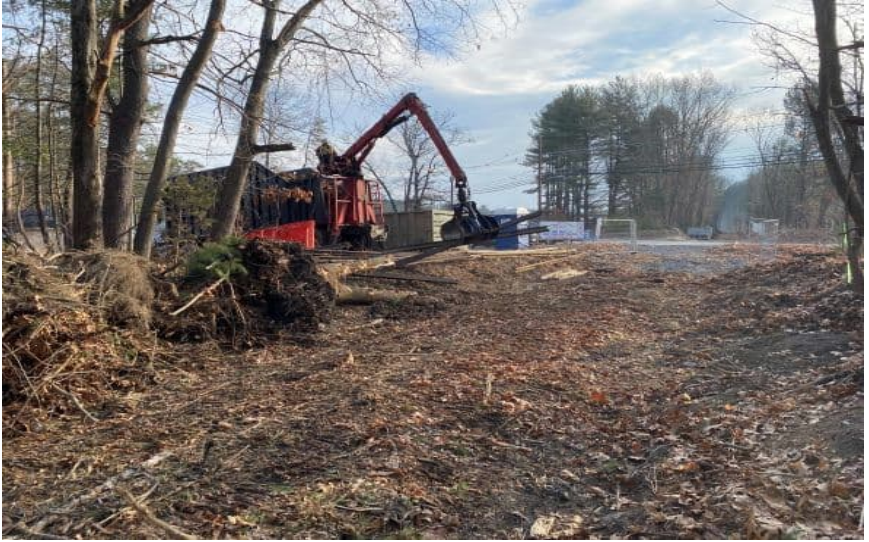
<p>PHOTOGRAPHIC LOG</p>	
<p>Client Name: Eversource</p>		<p>Site Location: Sudbury to Hudson Transmission Reliability Project</p>	<p>Town: Hudson</p>
<p>Photo No.: 6</p>	<p>Date: 12-28-22</p>

<p>Description:</p> <p>Cleanup of steel rail by Moosehead at approximate Sta# 180+00, Segment 3, looking eastward.</p>

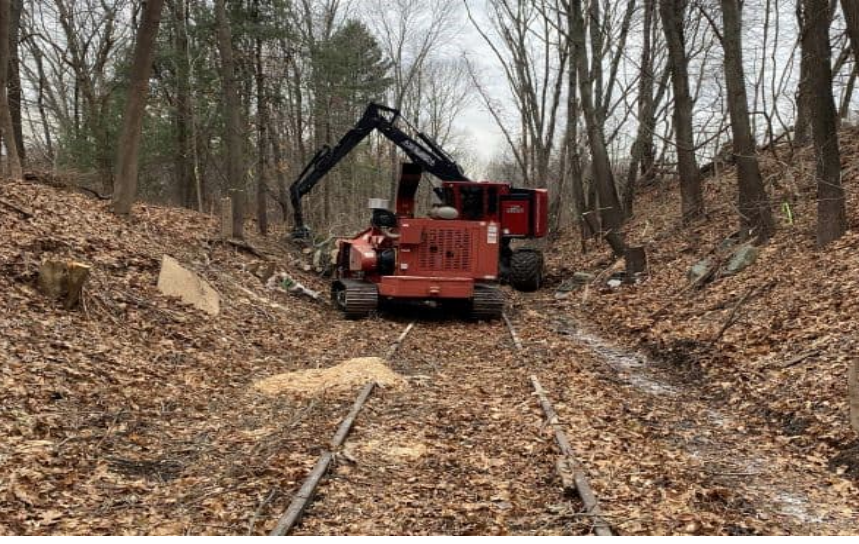
<p>PHOTOGRAPHIC LOG</p>	
<p>Client Name: Eversource</p>		<p>Site Location: Sudbury to Hudson Transmission Reliability Project</p>	<p>Town: Sudbury</p>
<p>Photo No.: 8</p>	<p>Date: 12-28-22</p>

<p>Description: Moosehead chipping operation within Segment 14 at approximate Sta.# 756+00, looking westward.</p>

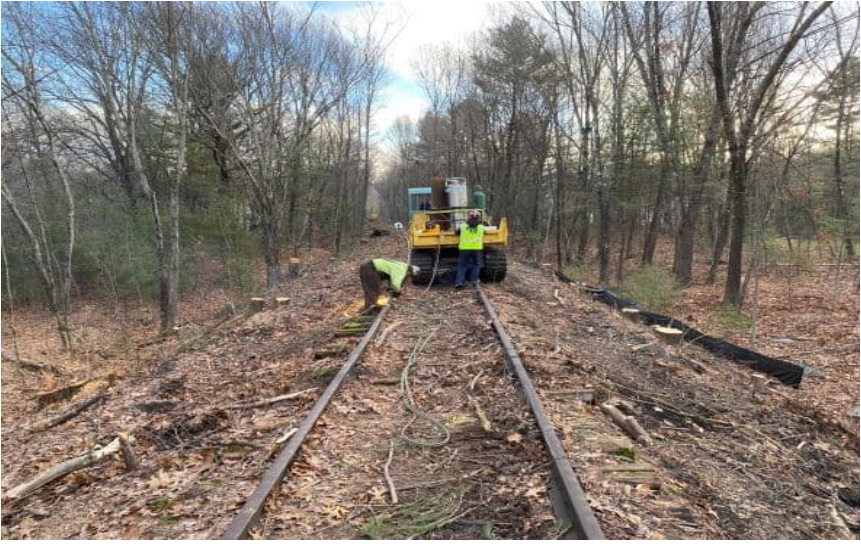
<p>PHOTOGRAPHIC LOG</p>	
<p>Client Name: Eversource</p>		<p>Site Location: Sudbury to Hudson Transmission Reliability Project</p>	<p>Town: Hudson</p>
<p>Photo No.: 1</p>	<p>Date: 12-29-22</p>

<p>Description:</p> <p>Rail cutting at approximate Sta.#102+50, Segment 1, looking eastward.</p>

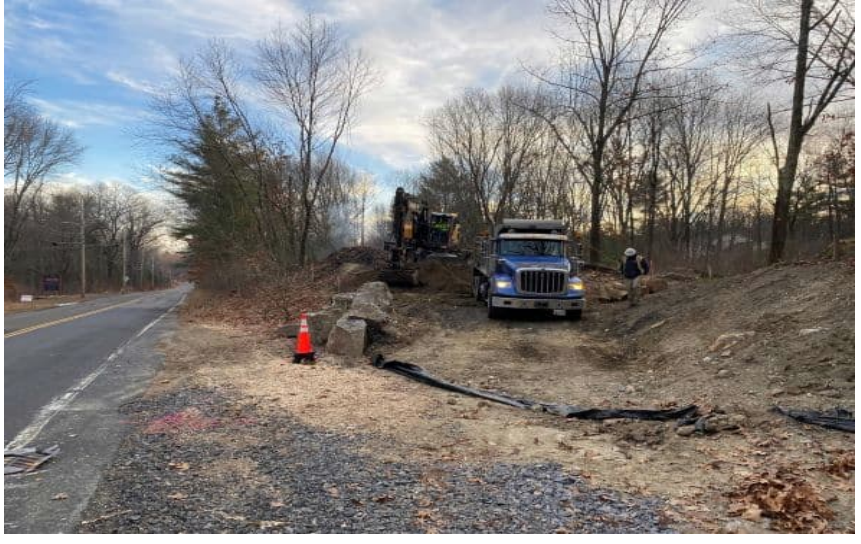
<p>PHOTOGRAPHIC LOG</p>	
<p>Client Name: Eversource</p>		<p>Site Location: Sudbury to Hudson Transmission Reliability Project</p>	<p>Town: Hudson</p>
<p>Photo No.: 2</p>	<p>Date: 12-29-22</p>

<p>Description:</p> <p>Site work (grading) off Wilkins Avenue, Segment 1, looking eastward.</p>

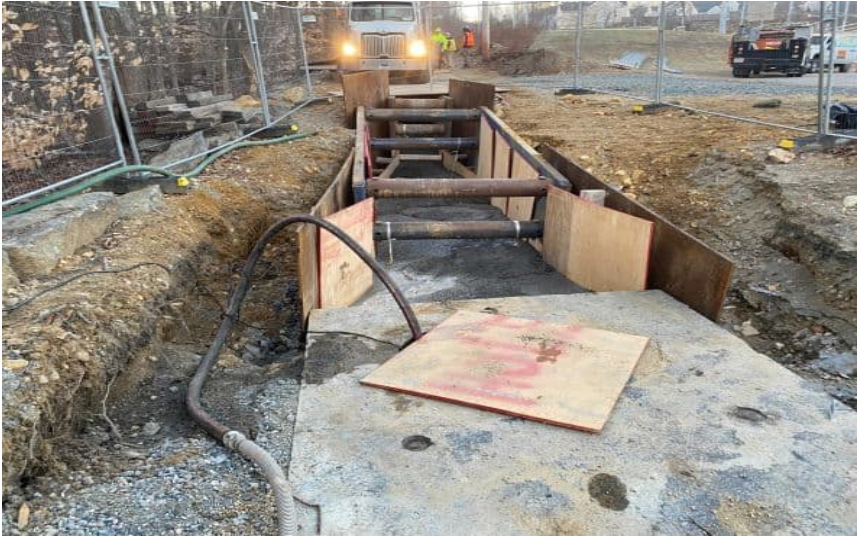
<p>PHOTOGRAPHIC LOG</p>	
<p>Client Name: Eversource</p>		<p>Site Location: Sudbury to Hudson Transmission Reliability Project</p>	<p>Town: Hudson</p>
<p>Photo No.: 3</p>	<p>Date: 12-29-22</p>

<p>Description:</p> <p>MH#1 site work off Forest Avenue, looking eastward.</p>

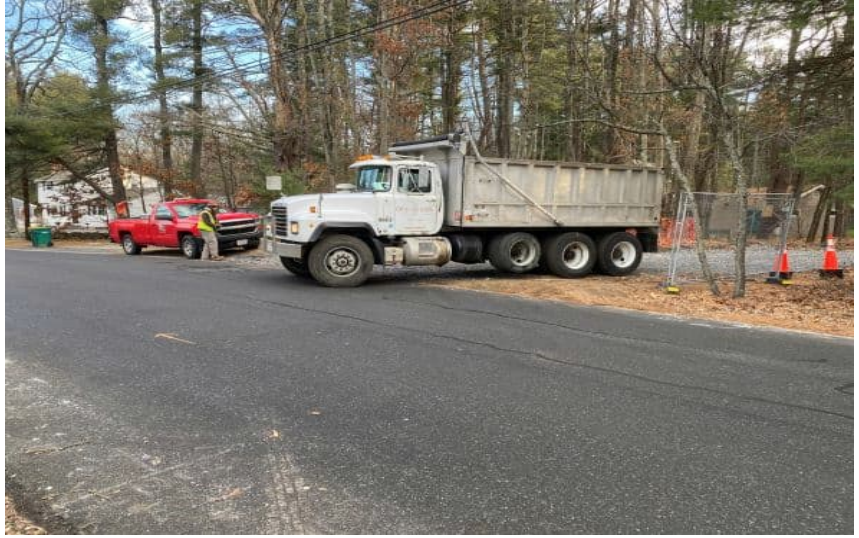
<p>PHOTOGRAPHIC LOG</p>	
<p>Client Name: Eversource</p>		<p>Site Location: Sudbury to Hudson Transmission Reliability Project</p>	<p>Town: Hudson</p>
<p>Photo No.: 4</p>	<p>Date: 12-29-22</p>

<p>Description:</p> <p>Soil delivery to Segment 5, at Parmenter Road, looking eastward.</p>

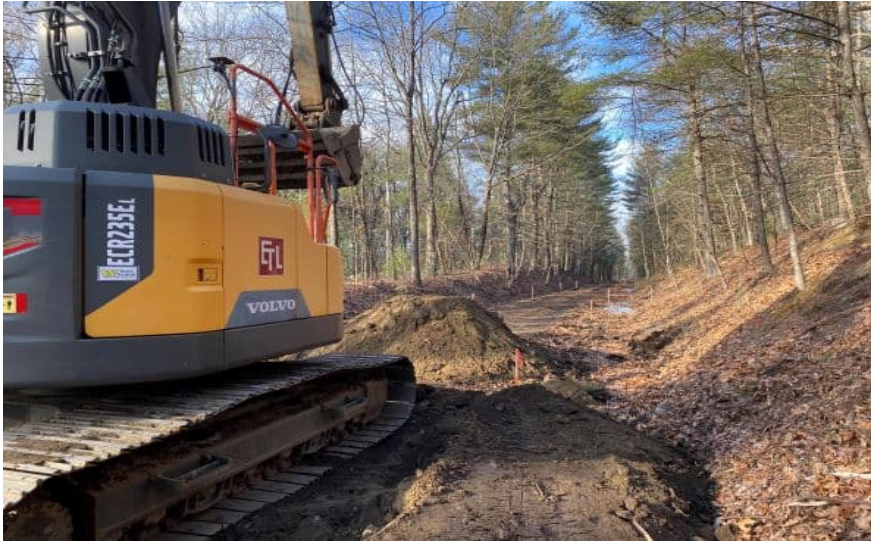
<p>PHOTOGRAPHIC LOG</p>	
<p>Client Name: Eversource</p>		<p>Site Location: Sudbury to Hudson Transmission Reliability Project</p>	<p>Town: Hudson</p>
<p>Photo No.: 5</p>	<p>Date: 12-29-22</p>

<p>Description:</p> <p>Grading of ROW by ETL within Segment 5 off Parmenter Road at approximate Sta.# 320+00, looking westward.</p>

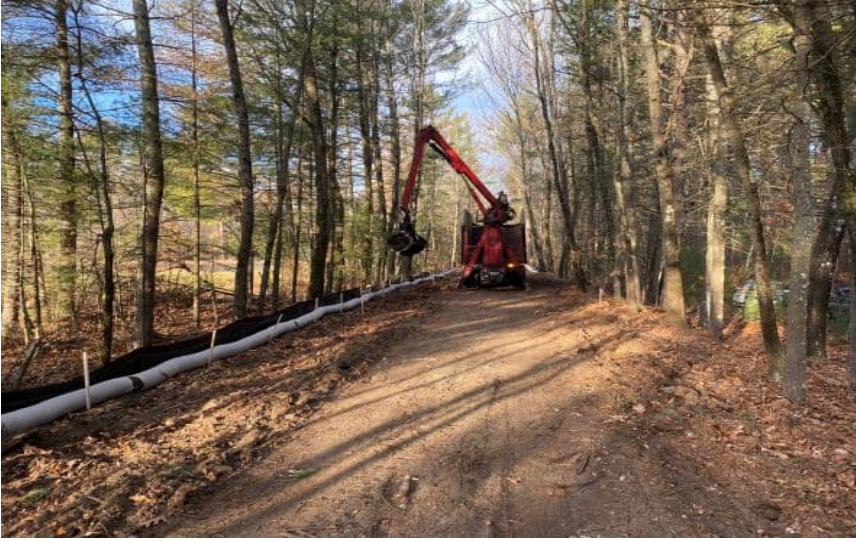
<p>PHOTOGRAPHIC LOG</p>	
<p>Client Name: Eversource</p>		<p>Site Location: Sudbury to Hudson Transmission Reliability Project</p>	<p>Town: Hudson</p>
<p>Photo No.: 6</p>	<p>Date: 12-29-22</p>

<p>Description:</p> <p>Cleanup of rail/tie by Moosehead at approximate Sta# 210+00, Segment 4, looking westward.</p>

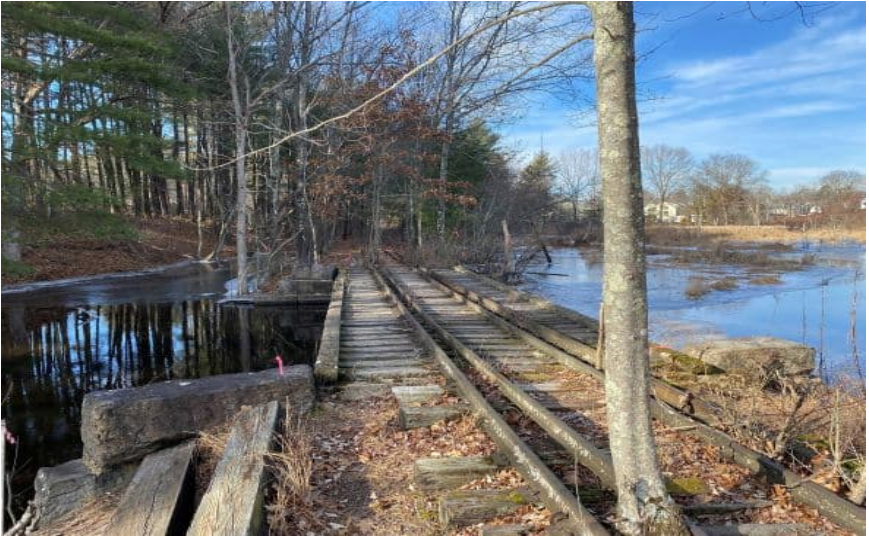
<p>PHOTOGRAPHIC LOG</p>	
<p>Client Name: Eversource</p>		<p>Site Location: Sudbury to Hudson Transmission Reliability Project</p>	<p>Town: Sudbury</p>
<p>Photo No.: 7</p>	<p>Date: 12-29-22</p>

<p>Description:</p> <p>Bridge 127, Segments 14-13, looking westward.</p>

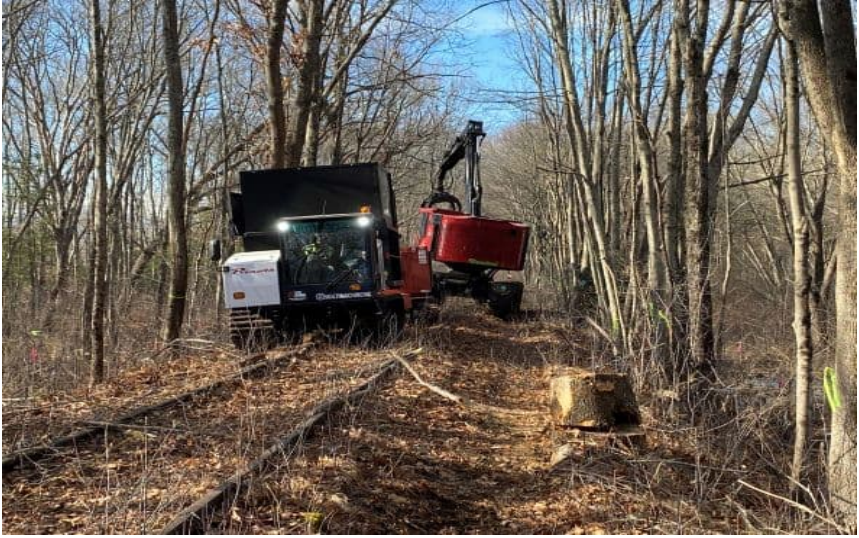
<p>PHOTOGRAPHIC LOG</p>	
<p>Client Name: Eversource</p>		<p>Site Location: Sudbury to Hudson Transmission Reliability Project</p>	<p>Town: Sudbury</p>
<p>Photo No.: 8</p>	<p>Date: 12-29-22</p>

<p>Description:</p> <p>Moosehead chipping operation within Segment 14 at approximate Sta.# 750+00, looking westward.</p>

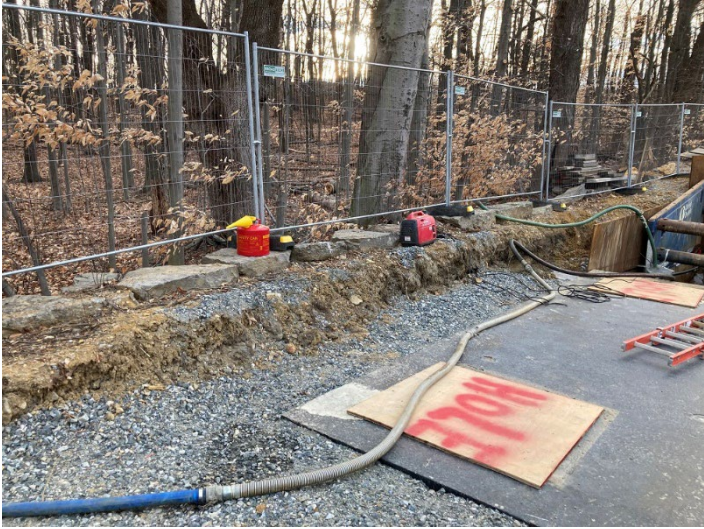
PHOTOGRAPHIC LOG		
Client Name: Eversource		Site Location: Sudbury to Hudson Transmission Reliability Project		Town: Hudson
Photo No.: 1	Date: 12/27/2022

Description: View of pumping operation at MH#1. This is the location of dewatering water prior to treatment. Unable to safely collect turbidity samples at this location. Facing southeast.

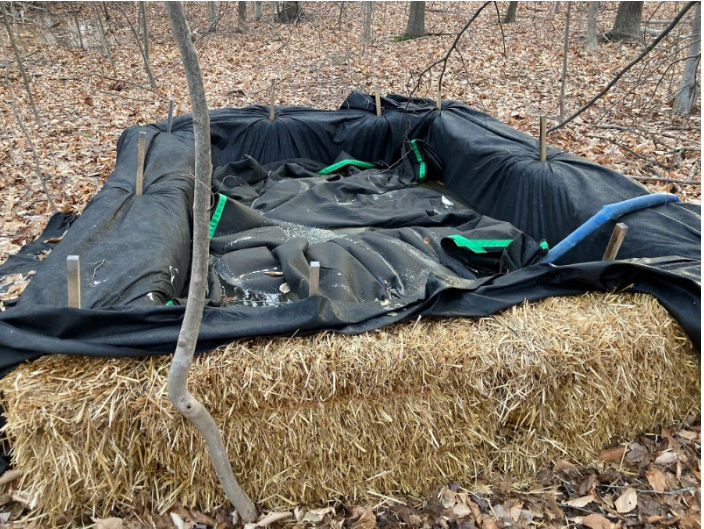
PHOTOGRAPHIC LOG		
Client Name: Eversource		Site Location: Sudbury to Hudson Transmission Reliability Project		Town: Hudson
Photo No.: 2	Date: 12/27/2022

Description: View of dewatering discharge controls. Facing east.

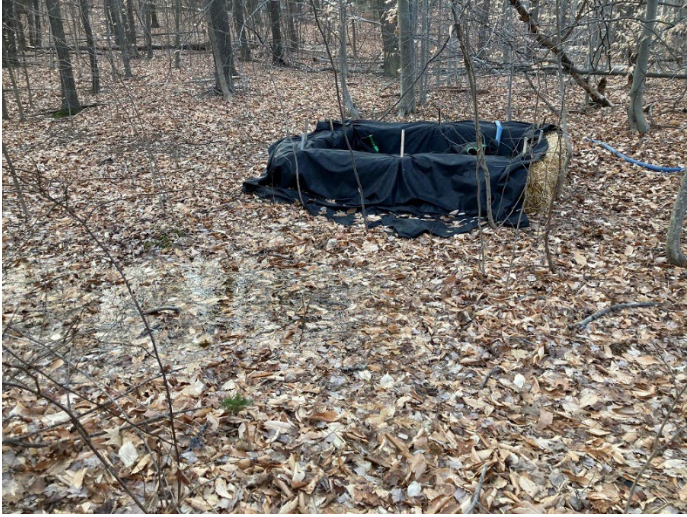
PHOTOGRAPHIC LOG	
Client Name: Eversource		Site Location: Sudbury to Hudson Transmission Reliability Project	
Town: Hudson			
Photo No.: 3	Date: 12/27/2022

Description: View of controls and discharge. Water appeared to be clear. Turbidity samples taken at this location. Facing southeast.

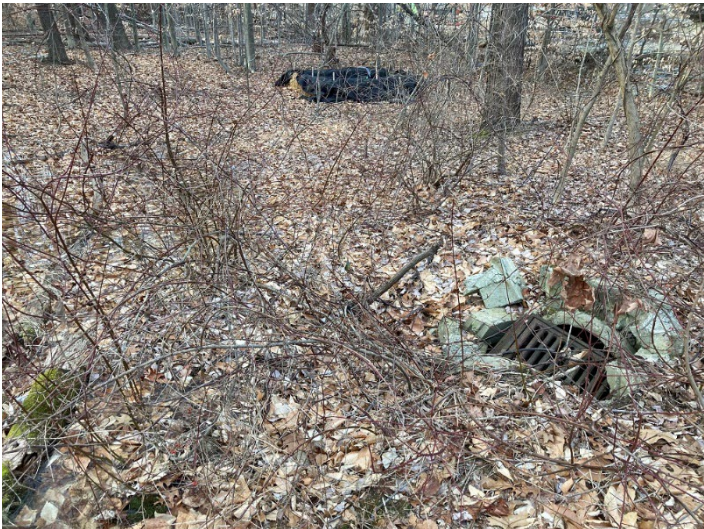
PHOTOGRAPHIC LOG	
Client Name: Eversource		Site Location: Sudbury to Hudson Transmission Reliability Project	
Town: Hudson			
Photo No.: 4	Date: 12/27/2022

Description: View of storm drain inlet and culvert downstream of dewatering discharge. Turbidity samples taken at this location. Facing south.

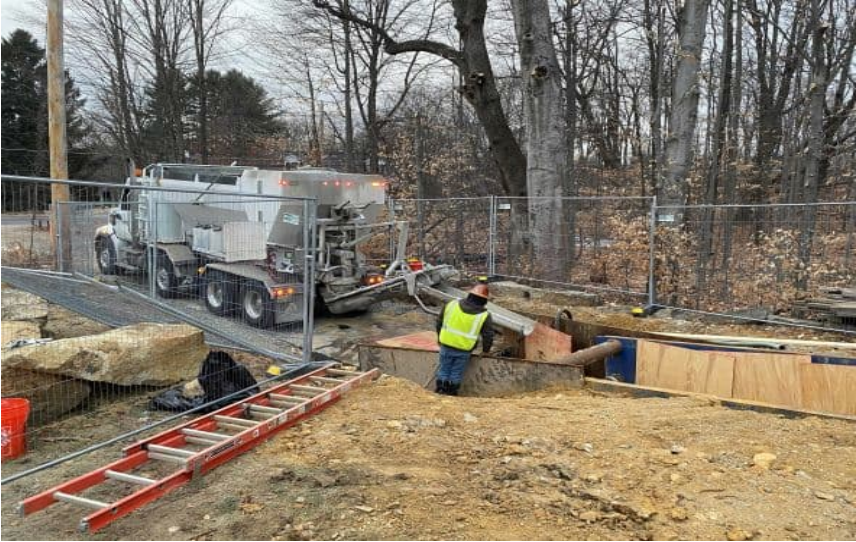
PHOTOGRAPHIC LOG	
Client Name: Eversource		Site Location: Sudbury to Hudson Transmission Reliability Project	Town: Hudson
Photo No.: 1	Date: 12/28/2022

Description: View of area being pumped at work operation at MH#1.

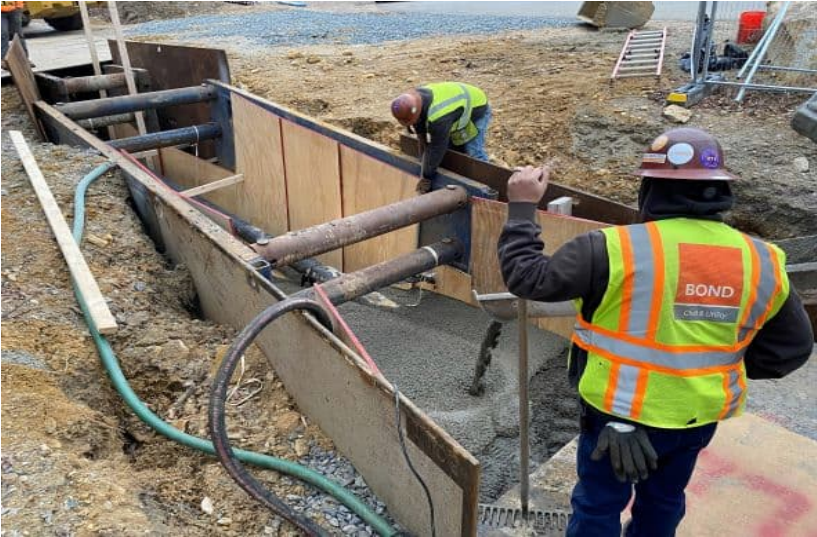
PHOTOGRAPHIC LOG	
Client Name: Eversource		Site Location: Sudbury to Hudson Transmission Reliability Project	Town: Hudson
Photo No.: 2	Date: 12/28/2022

Description: View of pumping operation at MH#1. This is the location of dewatering water prior to treatment, looking eastward.

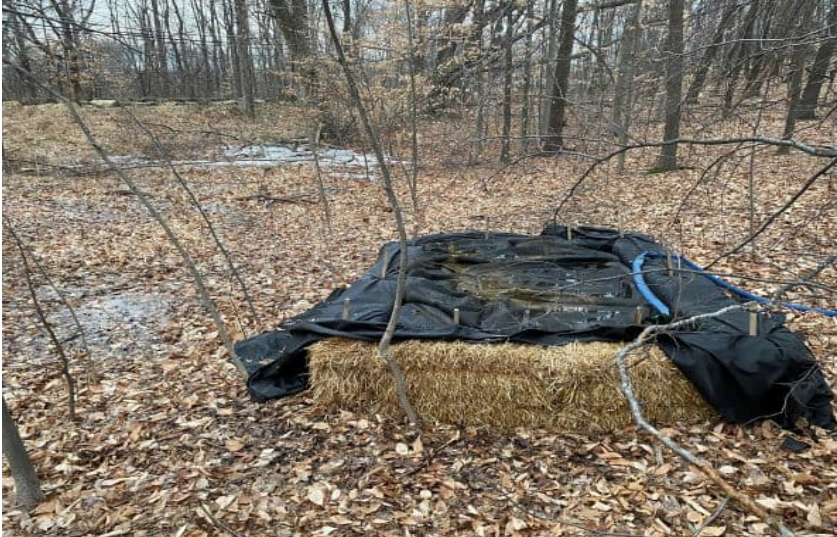
PHOTOGRAPHIC LOG	
Client Name: Eversource		Site Location: Sudbury to Hudson Transmission Reliability Project	Town: Hudson
Photo No.: 3	Date: 12/28/2022

Description: View of dewatering discharge area and controls, looking westward. Water appeared to be clear. Turbidity samples taken at this location.

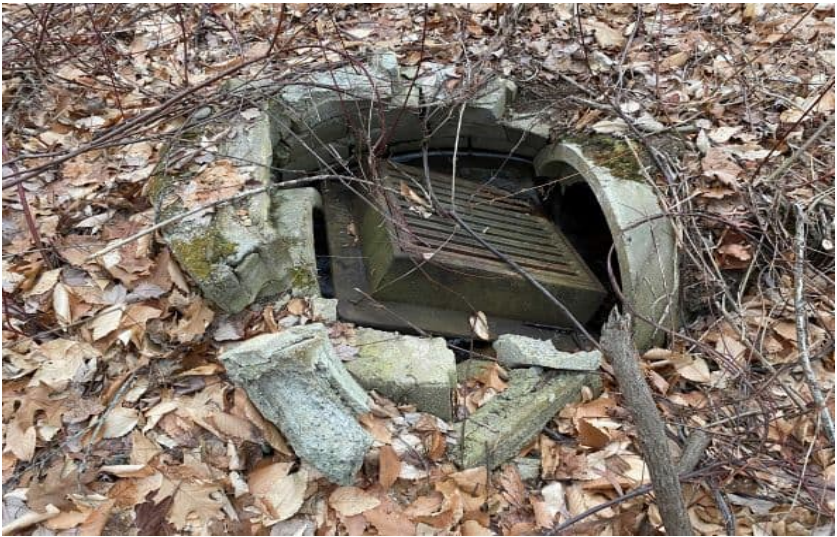
PHOTOGRAPHIC LOG	
Client Name: Eversource		Site Location: Sudbury to Hudson Transmission Reliability Project	Town: Hudson
Photo No.: 4	Date: 12/28/2022

Description: View of storm drain inlet and culvert downstream of dewatering discharge, looking westward. Water appeared to be clear. Turbidity samples taken at this location.

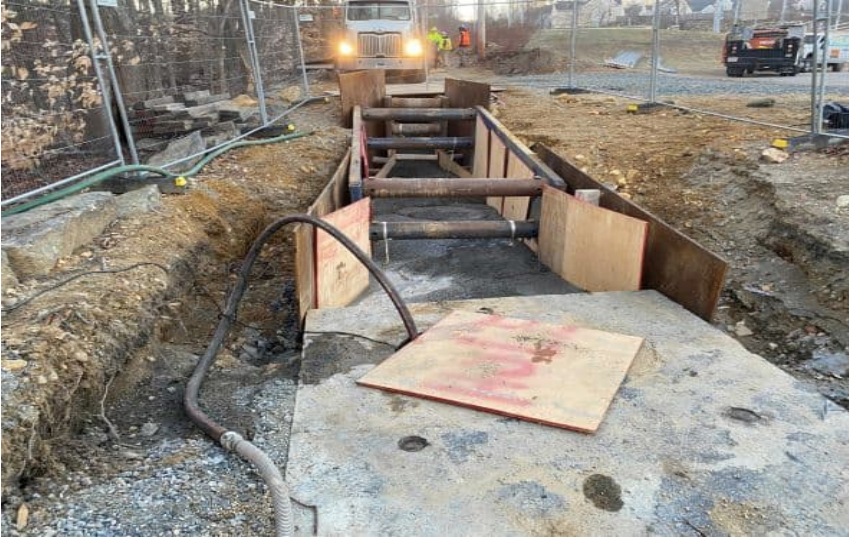
PHOTOGRAPHIC LOG	
Client Name: Eversource		Site Location: Sudbury to Hudson Transmission Reliability Project	Town: Hudson
Photo No.: 1	Date: 12/29/2022

Description: View of area being pumped at work operation at MH#1.

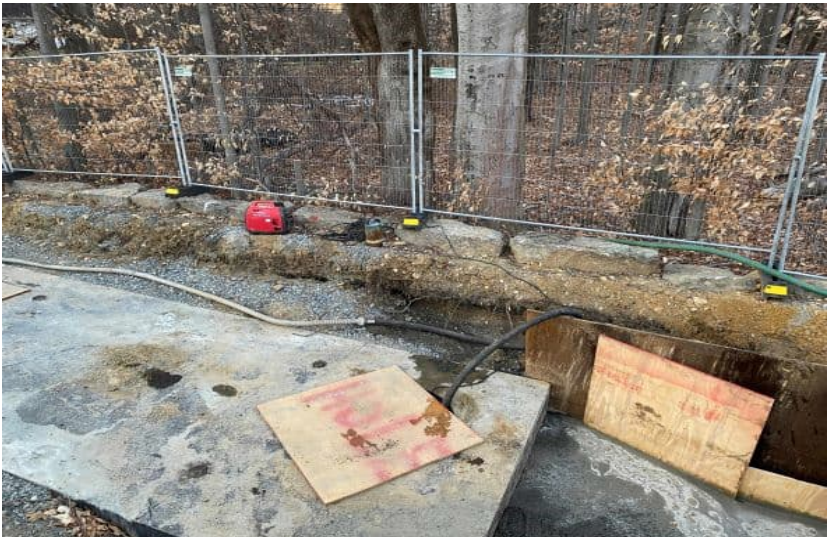
PHOTOGRAPHIC LOG	
Client Name: Eversource		Site Location: Sudbury to Hudson Transmission Reliability Project	Town: Hudson
Photo No.: 2	Date: 12/29/2022

Description: View of pumping operation at MH#1. This is the location of dewatering water prior to treatment, looking eastward.

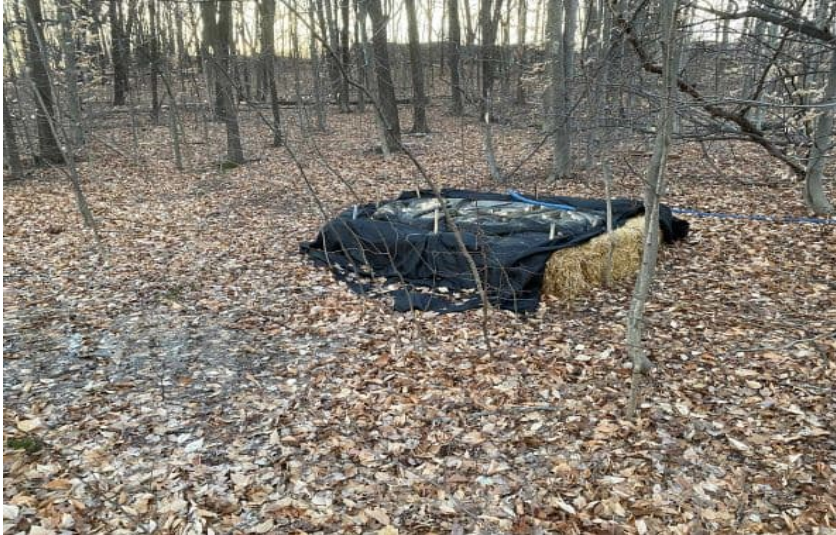
PHOTOGRAPHIC LOG	
Client Name: Eversource		Site Location: Sudbury to Hudson Transmission Reliability Project	Town: Hudson
Photo No.: 3	Date: 12/29/2022

Description: View of dewatering discharge area and controls, looking westward. Water appeared to be clear. Turbidity samples taken at this location.

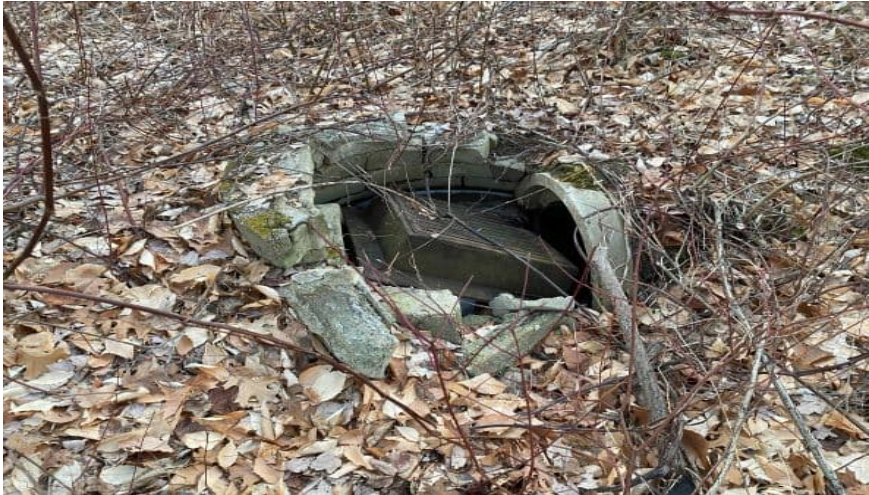
PHOTOGRAPHIC LOG	
Client Name: Eversource		Site Location: Sudbury to Hudson Transmission Reliability Project	Town: Hudson
Photo No.: 4	Date: 12/29/2022

Description: View of storm drain inlet and culvert downstream of dewatering discharge, looking westward. Water appeared to be clear. Turbidity samples taken at this location.

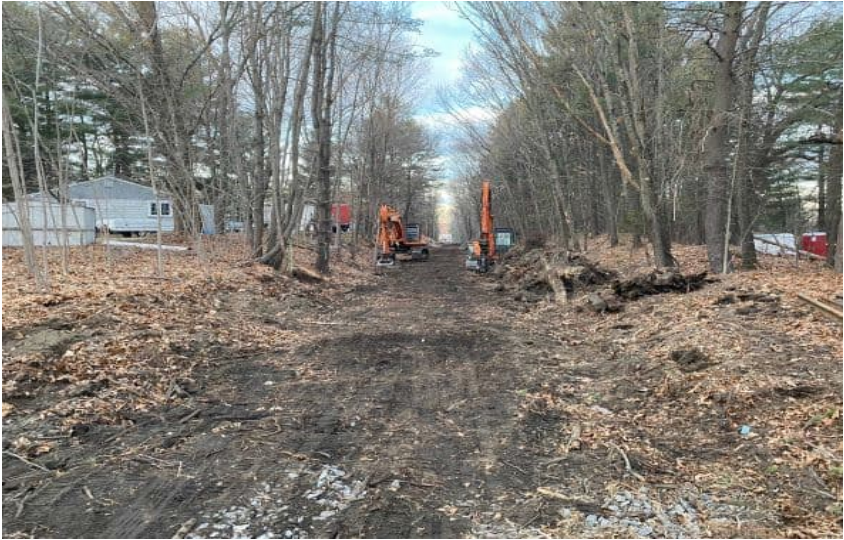
PHOTOGRAPHIC LOG	
Client Name: Eversource		Site Location: Sudbury to Hudson Transmission Reliability Project	Town: Hudson
Photo No.: 3	Date: 12-30-22

Description: Clearing of debris within Segment 3 at approximate Sta.# 180+00, looking westward.

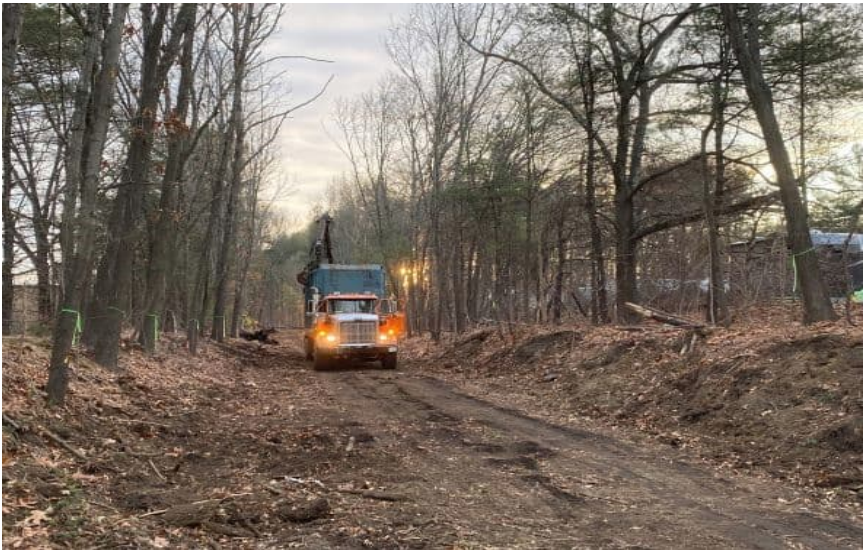
PHOTOGRAPHIC LOG	
Client Name: Eversource		Site Location: Sudbury to Hudson Transmission Reliability Project	Town: Hudson
Photo No.: 4	Date: 12-30-22

Description: Clearing of debris within Segment 4 at approximate Sta.# 182+00, looking eastward.

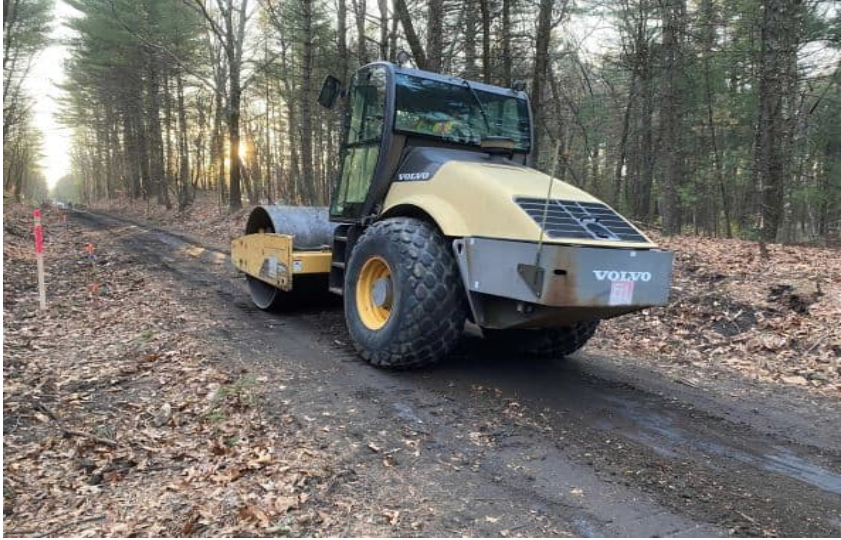
PHOTOGRAPHIC LOG	
Client Name: Eversource		Site Location: Sudbury to Hudson Transmission Reliability Project	Town: Hudson
Photo No.: 5	Date: 12-30-22

Description: Grading work (rolling) in Segment 5 at approximate Sta.# 307+50, looking westward.

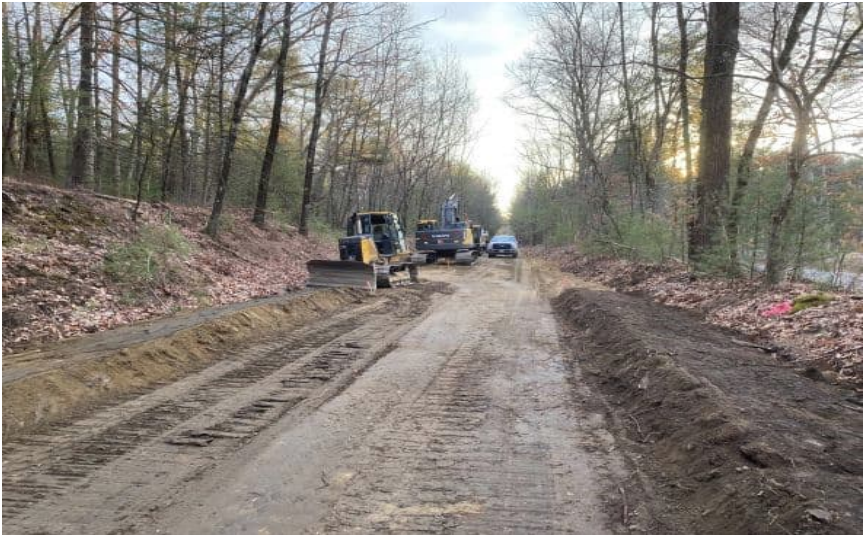
PHOTOGRAPHIC LOG	
Client Name: Eversource		Site Location: Sudbury to Hudson Transmission Reliability Project	Town: Hudson
Photo No.: 6	Date: 12-30-22

Description: Grading work in Segment 5 at approximate Sta.# 314+50, looking eastward.

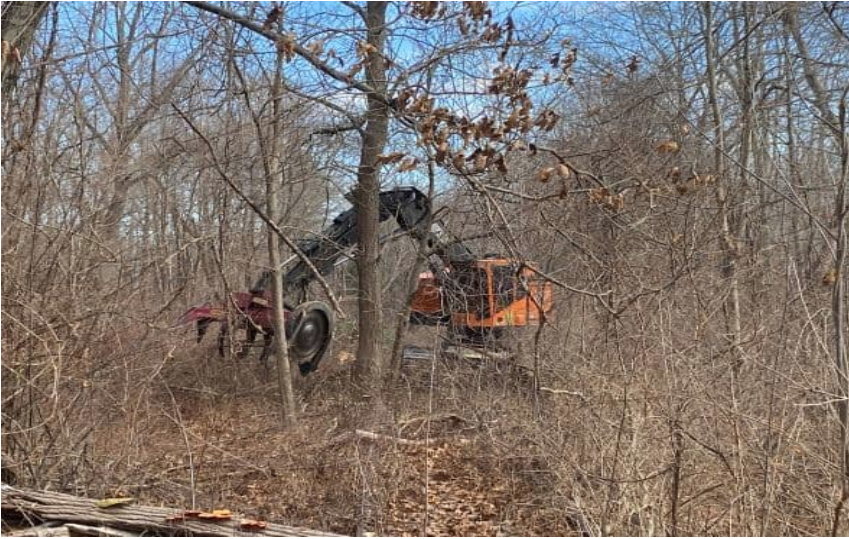
PHOTOGRAPHIC LOG	
Client Name: Eversource		Site Location: Sudbury to Hudson Transmission Reliability Project	Town: Sudbury
Photo No.: 8	Date: 12-30-22

Description: Clearing by Moosehead within Segment 14 at approximate Sta.# 741+00, looking eastward.
