**Weekly Environmental Compliance Summary**

**Sudbury to Hudson Transmission Reliability Project (USEPA Tracking # MAR1003UW)**

Week of: January 30 to February 3, 2023

# CONSTRUCTION MONITORING REPORT Sudbury to Hudson Transmission Project

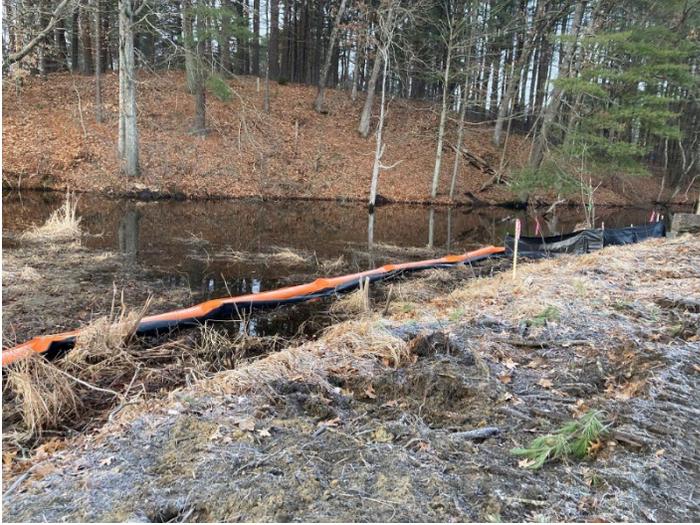
<b>PHOTOGRAPHIC LOG</b>	
<b>Client Name: Eversource</b>		<b>Site Location: Sudbury to Hudson Transmission Reliability Project</b>	<b>Town: Sudbury</b>
<b>Photo No.: 1</b>	<b>Date:</b> 1/30/2023

<b>Description:</b> View of turbidity curtain at station 726 at bridge 127 in segment 14. It was requested by Con. Com. agent that silt fence be installed to supplement turbidity curtains in this area. Facing northeast.

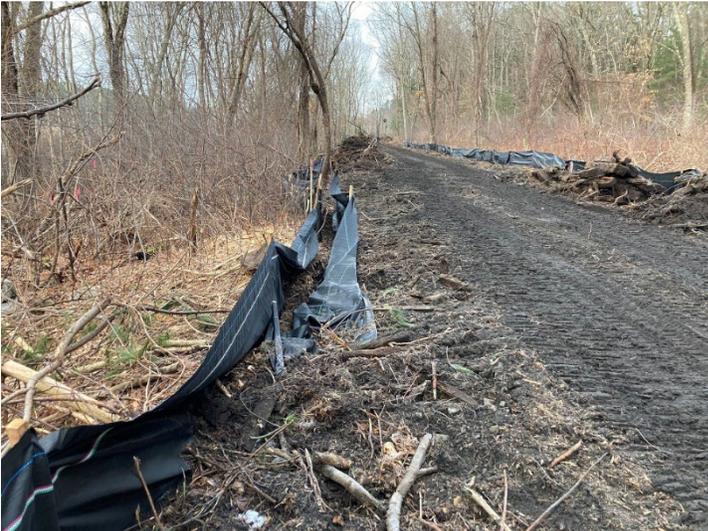
<b>PHOTOGRAPHIC LOG</b>	
<b>Client Name: Eversource</b>		<b>Site Location: Sudbury to Hudson Transmission Reliability Project</b>	<b>Town: Sudbury</b>
<b>Photo No.: 2</b>	<b>Date:</b> 1/30/2023

**-During recent rains and snowmelt, sediment was discharged beyond the syncopated silt fence at station 752-753 in segment 14. Sediment was not released into wetland. E&S controls in segment 14 were inspected by Lori Capone (Sudbury CC agent) on 1/30/2023. Some repairs were requested by Lori, in addition to needed repairs at station 752-753. It was requested that silt fence be installed at station 726 at bridge 127 to supplement turbidity curtains. Crews began to address the issues in segment 14 immediately. The sediment that was deposited is being removed by hand. -See additional dewatering inspection report.**

<b>Description:</b> View of syncopated silt fence in segment 14. Continue needed repairs to E&S controls in this segment (routine maintenance). Facing west.

- Continue E&S repairs where needed in multiple places along segment 14.**
- 
-

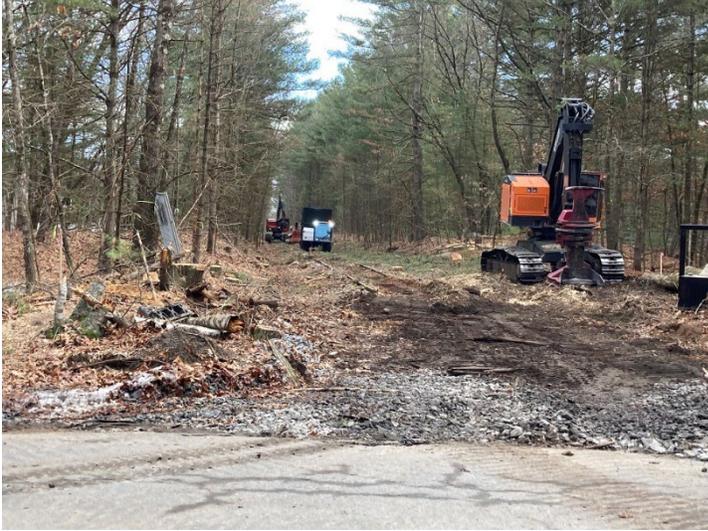
<b>PHOTOGRAPHIC LOG</b>	
<b>Client Name:</b> Eversource		<b>Site Location:</b> Sudbury to Hudson Transmission Reliability Project	
<b>Town:</b> Sudbury			
<b>Photo No.:</b> 3	<b>Date:</b> 1/30/2023

<b>Description:</b> View of Moosehead conducting chipping activities in segment 9. Facing east.

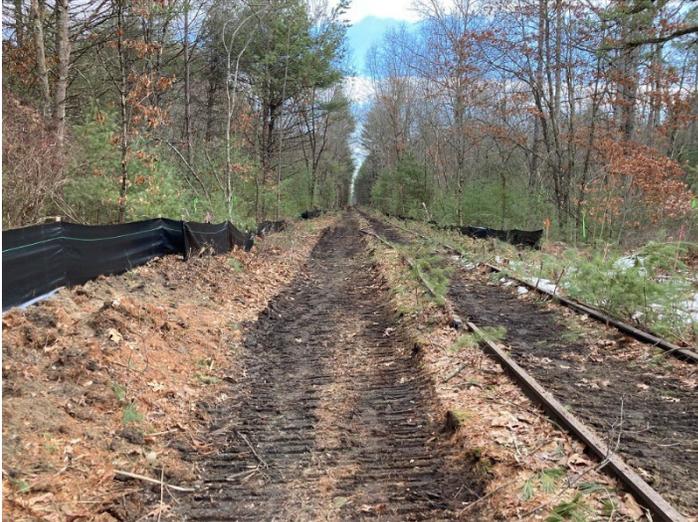
<b>PHOTOGRAPHIC LOG</b>	
<b>Client Name:</b> Eversource		<b>Site Location:</b> Sudbury to Hudson Transmission Reliability Project	
<b>Town:</b> Sudbury			
<b>Photo No.:</b> 4	<b>Date:</b> 1/30/2023

<b>Description:</b> View of silt fence installation in segment 7. Facing east.

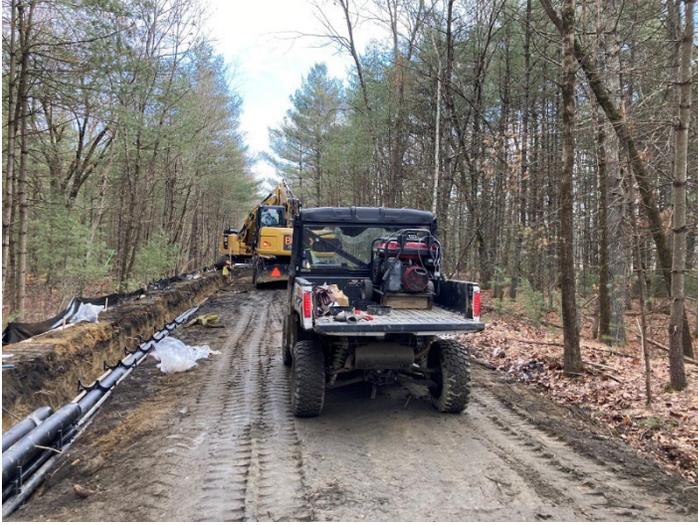
<b>PHOTOGRAPHIC LOG</b>	
<b>Client Name:</b> Eversource		<b>Site Location:</b> Sudbury to Hudson Transmission Reliability Project	<b>Town:</b> Hudson
<b>Photo No.:</b> 5	<b>Date:</b> 1/30/2023

<b>Description:</b> View of Bond conducting conduit work between MH#12 and MH#13 in segment 5. Facing east.

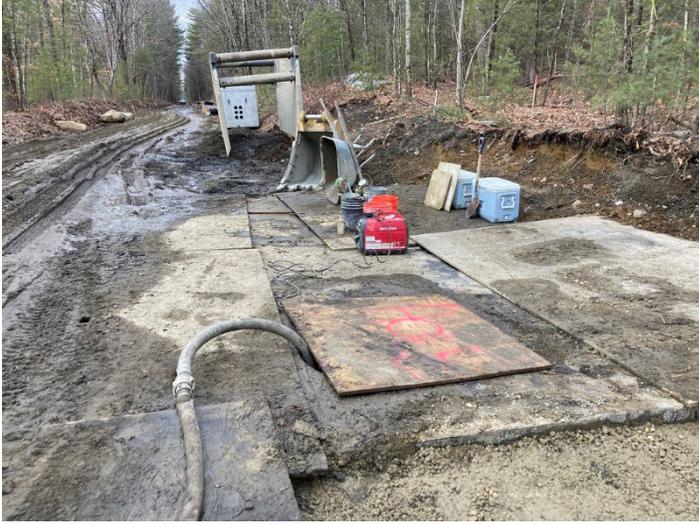
<b>PHOTOGRAPHIC LOG</b>	
<b>Client Name:</b> Eversource		<b>Site Location:</b> Sudbury to Hudson Transmission Reliability Project	<b>Town:</b> Hudson
<b>Photo No.:</b> 6	<b>Date:</b> 1/30/2023

<b>Description:</b> View of pumping operation at MH#12 in segment 5. See additional dewatering inspection report. Facing west.

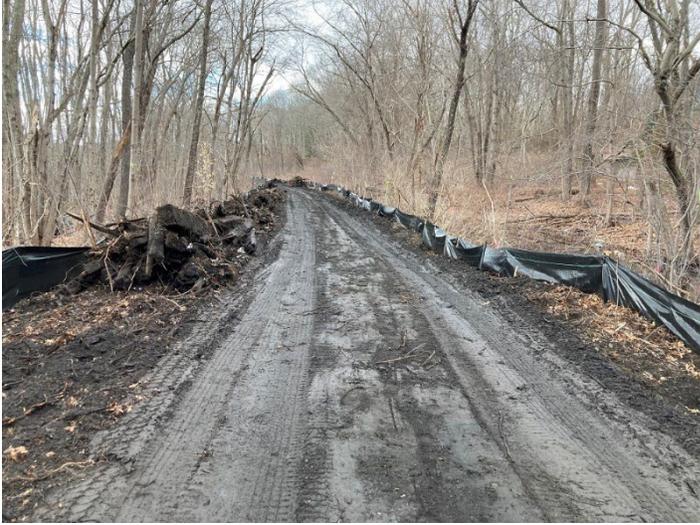
<b>PHOTOGRAPHIC LOG</b>	
<b>Client Name:</b> Eversource		<b>Site Location:</b> Sudbury to Hudson Transmission Reliability Project	<b>Town:</b> Sudbury
<b>Photo No.:</b> 1	<b>Date:</b> 1/31/2023

**-E&S controls in segment 14 were re-inspected by Lori Capone (Sudbury CC agent) on 1/31/2023. A few additional repairs were requested. Crews began to address additional repairs immediately. Lori also inspected E&S controls in segment 7. One repair was requested at bridge 128.**

<b>Description:</b> View of segment 14, facing west.

**Complete additional repairs needed in segments 7 and 14.**

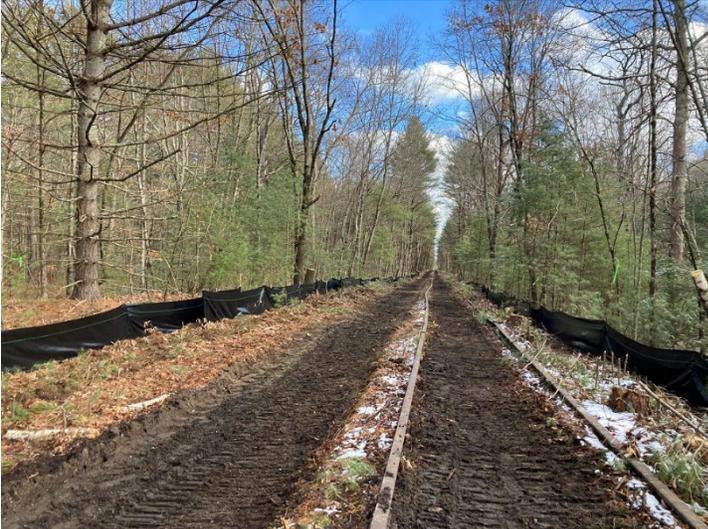
<b>PHOTOGRAPHIC LOG</b>	
<b>Client Name:</b> Eversource		<b>Site Location:</b> Sudbury to Hudson Transmission Reliability Project	<b>Town:</b> Sudbury
<b>Photo No.:</b> 2	<b>Date:</b> 1/31/2023

<b>Description:</b> View of silt fence installed in segment 7, facing west.

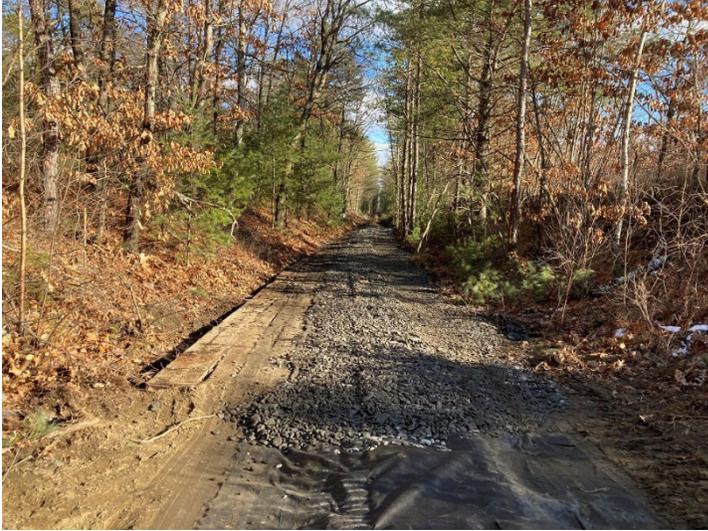
<b>PHOTOGRAPHIC LOG</b>	
<b>Client Name:</b> Eversource		<b>Site Location:</b> Sudbury to Hudson Transmission Reliability Project	<b>Town:</b> Sudbury
<b>Photo No.:</b> 3	<b>Date:</b> 1/31/2023

<b>Description:</b> View of Black Racer snake TOY restricted area at Sudbury/Hudson/Marlborough town line. Facing east.

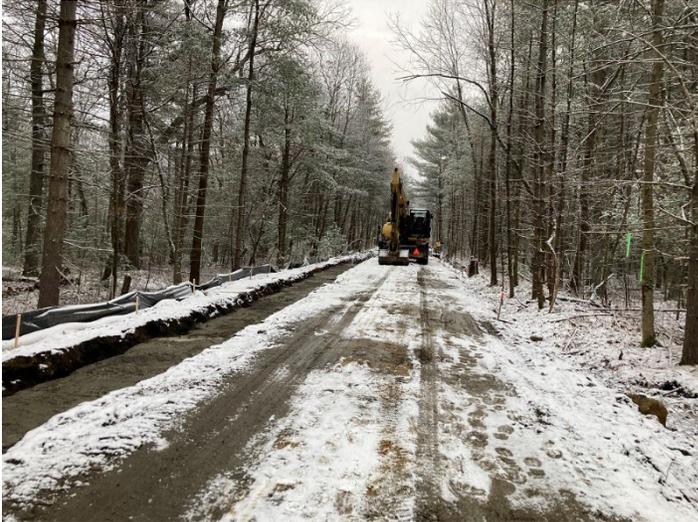
<b>PHOTOGRAPHIC LOG</b>	
<b>Client Name:</b> Eversource		<b>Site Location:</b> Sudbury to Hudson Transmission Reliability Project	<b>Town:</b> Hudson
<b>Photo No.:</b> 4	<b>Date:</b> 1/31/2023

<b>Description:</b> View of Bond conducting conduit work between MH#12 and MH#13 in segment 5. Facing east.

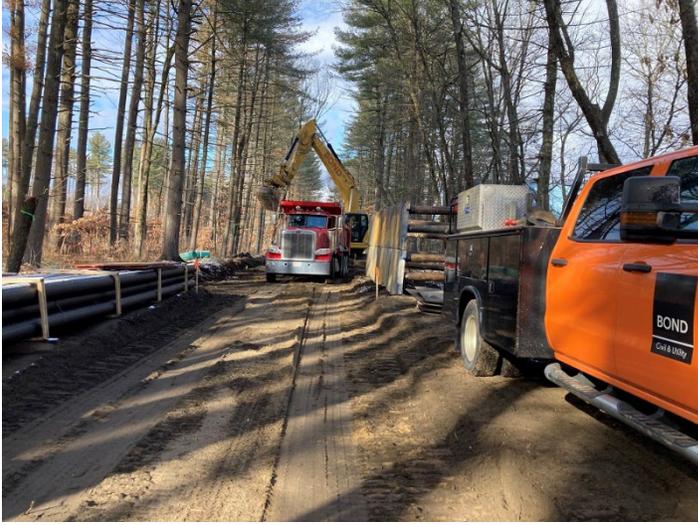
<b>PHOTOGRAPHIC LOG</b>	
<b>Client Name:</b> Eversource		<b>Site Location:</b> Sudbury to Hudson Transmission Reliability Project	<b>Town:</b> Hudson
<b>Photo No.:</b> 5	<b>Date:</b> 1/31/2023

<b>Description:</b> View of Bond conducting excavating work at MH#10 in segment 4. Facing west.

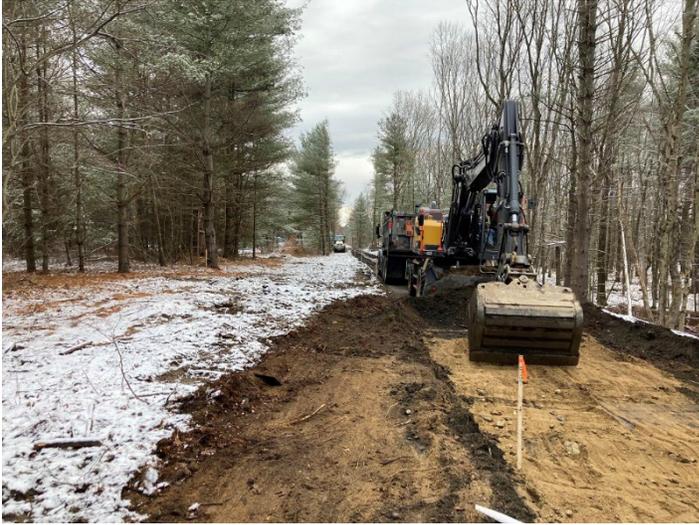
<b>PHOTOGRAPHIC LOG</b>	
<b>Client Name:</b> Eversource		<b>Site Location:</b> Sudbury to Hudson Transmission Reliability Project	<b>Town:</b> Hudson
<b>Photo No.:</b> 6	<b>Date:</b> 1/31/2023

<b>Description:</b> View of ET&L conducting grading activities in segment 2, facing east.

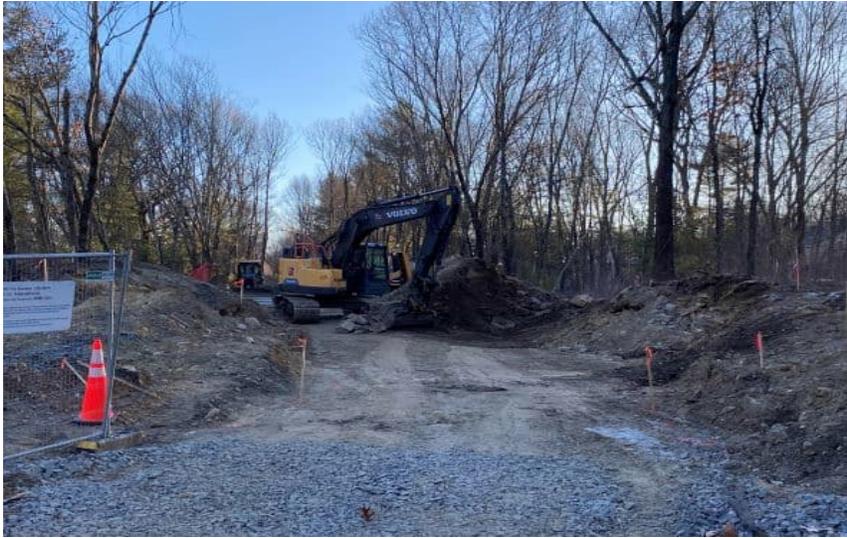
<p>PHOTOGRAPHIC LOG</p>	
<p>Client Name: Eversource</p>		<p>Site Location: Sudbury to Hudson Transmission Reliability Project</p>	<p>Town: Hudson</p>
<p>Photo No.: 1</p>	<p>Date: 2-3-23</p>

<p>Description:</p> <p>ET&amp;L conducting site work off Wilkins Avenue within Segment 1 at approximate Sta#103+00, looking eastward.</p>

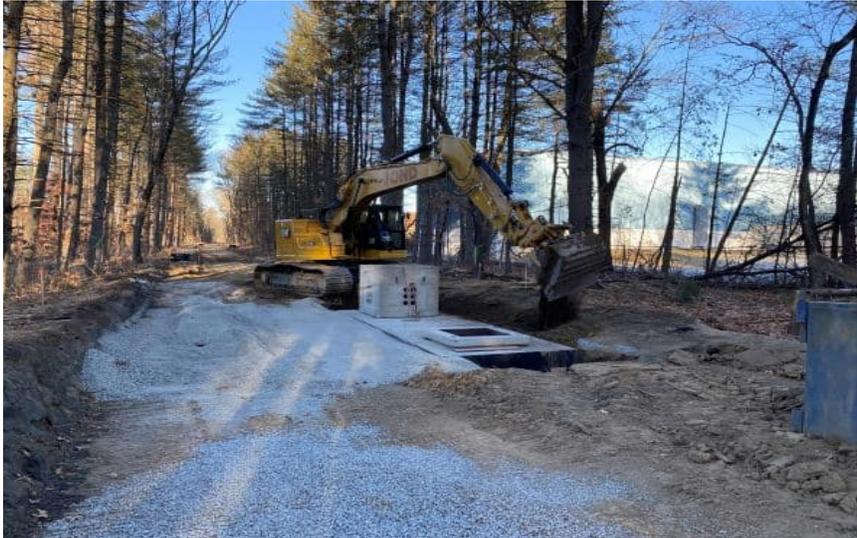
<p>PHOTOGRAPHIC LOG</p>	
<p>Client Name: Eversource</p>		<p>Site Location: Sudbury to Hudson Transmission Reliability Project</p>	<p>Town: Hudson</p>
<p>Photo No.: 2</p>	<p>Date: 2-3-23</p>

<p>Description:</p> <p>Bond conducting site work at MH#10 within Segment 4 at approximate Sta#196+00, looking westward.</p>

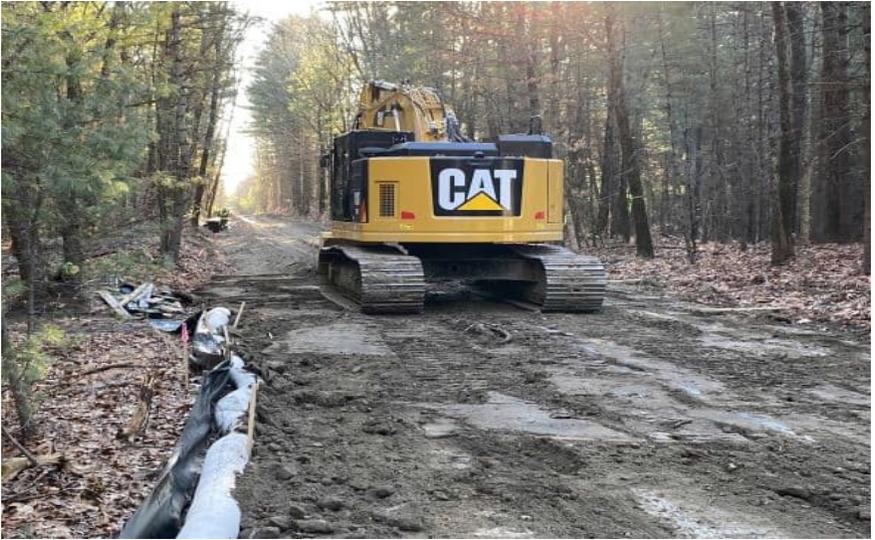
<p>PHOTOGRAPHIC LOG</p>	
<p>Client Name: Eversource</p>		<p>Site Location: Sudbury to Hudson Transmission Reliability Project</p>	<p>Town: Hudson</p>
<p>Photo No.: 3</p>	<p>Date: 2-3-23</p>

<p>Description:</p> <p>Bond conducting site work within Segment 5 at approximate Sta#308+00, looking eastward.</p>

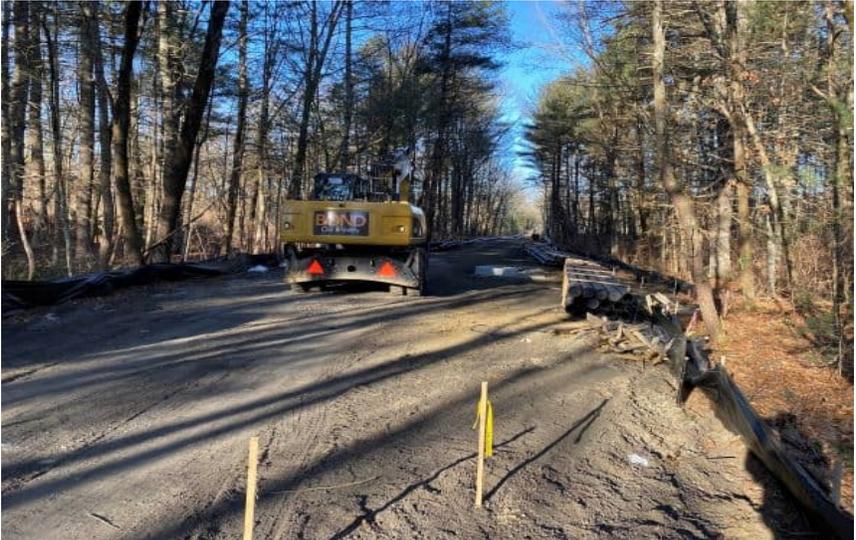
<p>PHOTOGRAPHIC LOG</p>	
<p>Client Name: Eversource</p>		<p>Site Location: Sudbury to Hudson Transmission Reliability Project</p>	<p>Town: Hudson</p>
<p>Photo No.: 4</p>	<p>Date: 2-3-23</p>

<p>Description:</p> <p>Bond conducting site work at MH#13 within Segment 5 at approximate Sta#336+00, looking westward.</p>

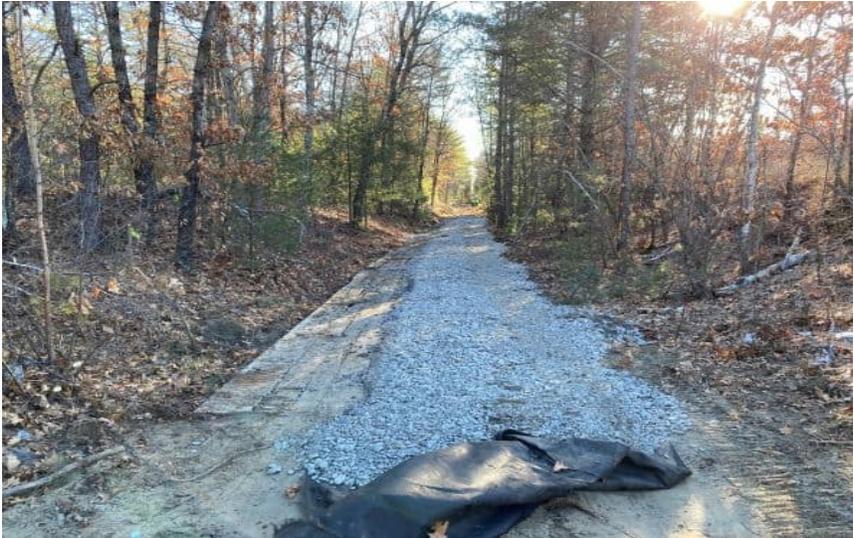
<p>PHOTOGRAPHIC LOG</p>	
<p>Client Name: Eversource</p>		<p>Site Location: Sudbury to Hudson Transmission Reliability Project</p>	<p>Town: Sudbury</p>
<p>Photo No.: 5</p>	<p>Date: 2-3-23</p>

<p>Description:                  Black Racer restrictive area (current condition), looking eastward.</p>

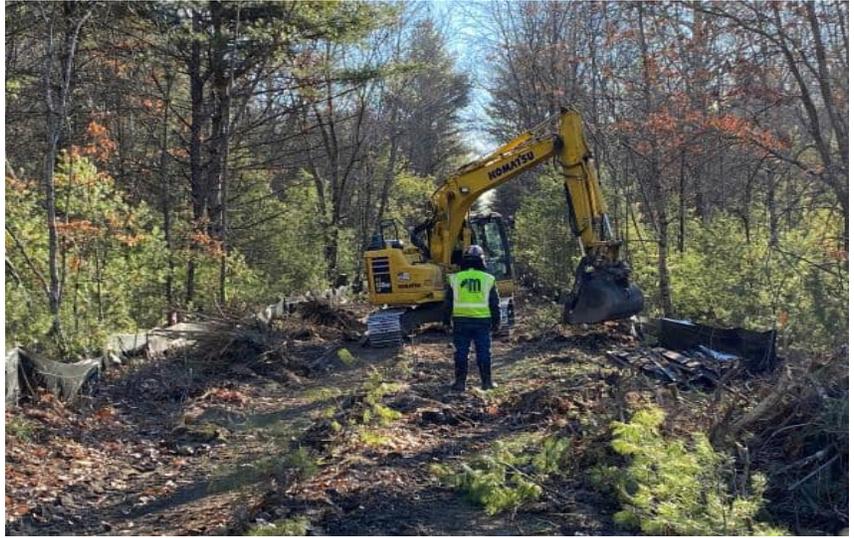
<p>PHOTOGRAPHIC LOG</p>	
<p>Client Name: Eversource</p>		<p>Site Location: Sudbury to Hudson Transmission Reliability Project</p>	<p>Town: Sudbury</p>
<p>Photo No.: 6</p>	<p>Date: 2-3-23</p>

<p>Description:                  Moosehead removing rails/ties within Segment 7 at approximate Sta# 358+00, looking eastward.</p>

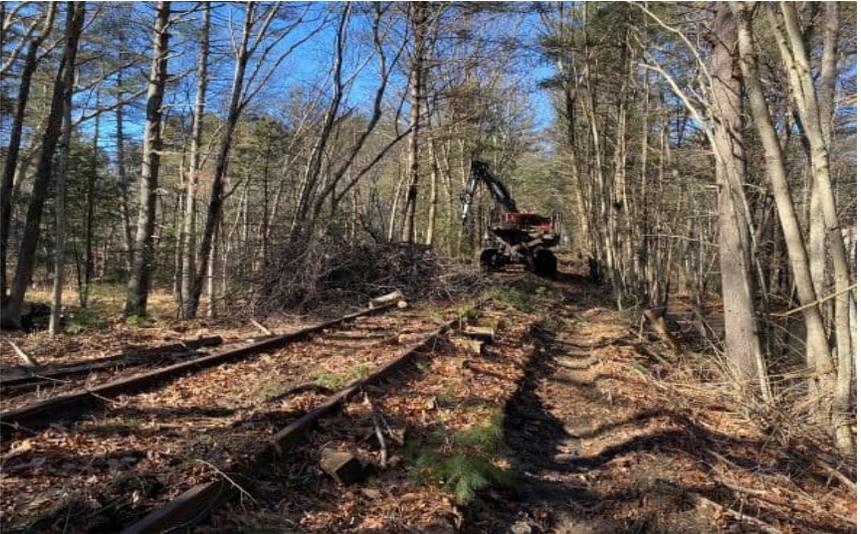
<p>PHOTOGRAPHIC LOG</p>	
<p>Client Name: Eversource</p>		<p>Site Location: Sudbury to Hudson Transmission Reliability Project</p>	<p>Town: Sudbury</p>
<p>Photo No.: 7</p>	<p>Date: 2-3-23</p>

<p>Description:                  Moosehead chipping within Segment 9 at approximate Sta# 529+00, looking westward.</p>

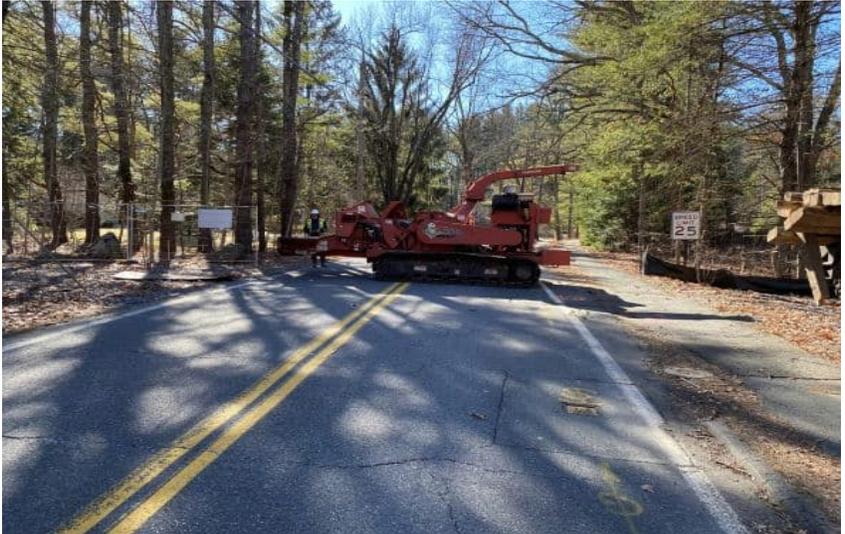
<p>PHOTOGRAPHIC LOG</p>	
<p>Client Name: Eversource</p>		<p>Site Location: Sudbury to Hudson Transmission Reliability Project</p>	<p>Town: Sudbury</p>
<p>Photo No.: 8</p>	<p>Date: 2-3-23</p>

<p>Description:                  Moosehead moving chipper across Peakham Road Segment 9 to 10 at Peakham Road, looking southward.</p>

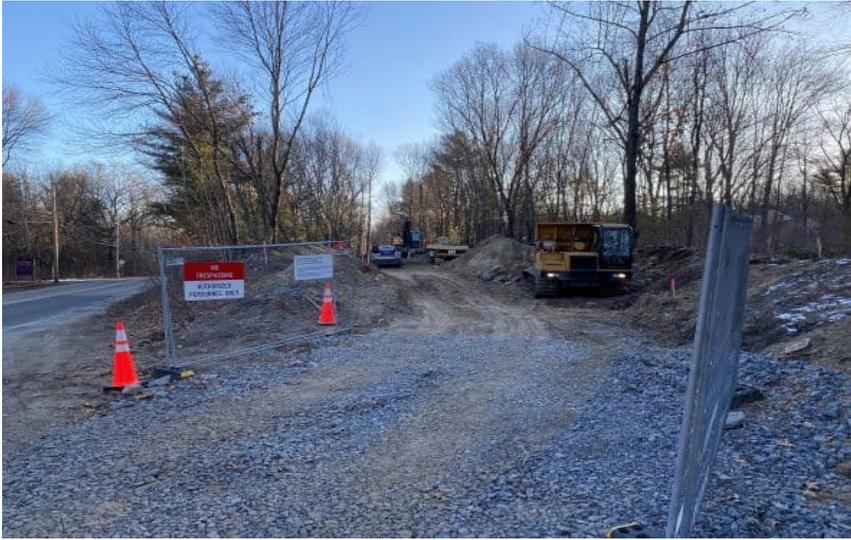
<b>PHOTOGRAPHIC LOG</b>	
Client Name: Eversource		Site Location: Sudbury to Hudson Transmission Reliability Project	Town: Hudson
Photo No.: 1	Date: 2-1-23

Description:  Site work at Wilkins Avenue, looking eastward.

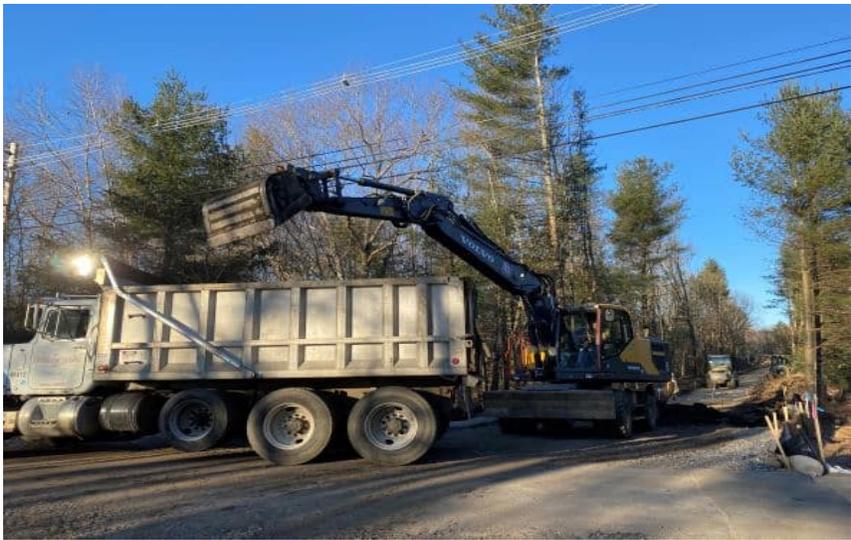
<b>PHOTOGRAPHIC LOG</b>	
Client Name: Eversource		Site Location: Sudbury to Hudson Transmission Reliability Project	Town: Hudson
Photo No.: 2	Date: 2-1-23

Description:  ET&L working at water supply road within Segment 2 at approximate Sta.# 142+00, looking westward.

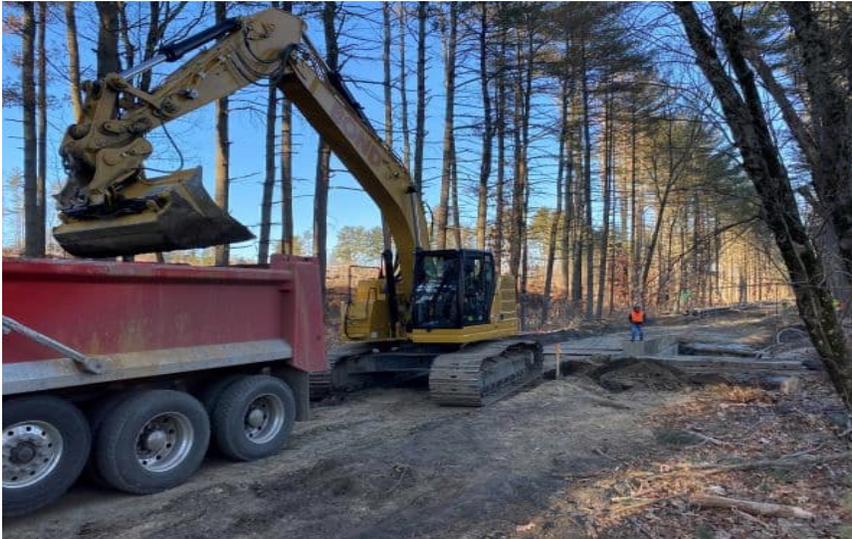
<b>PHOTOGRAPHIC LOG</b>	
Client Name: Eversource		Site Location: Sudbury to Hudson Transmission Reliability Project	Town: Hudson
Photo No.: 3	Date: 2-1-23

Description:  Bond working at MH#10 within Segment 4 at approximate Sta.# 196+00, looking westward.

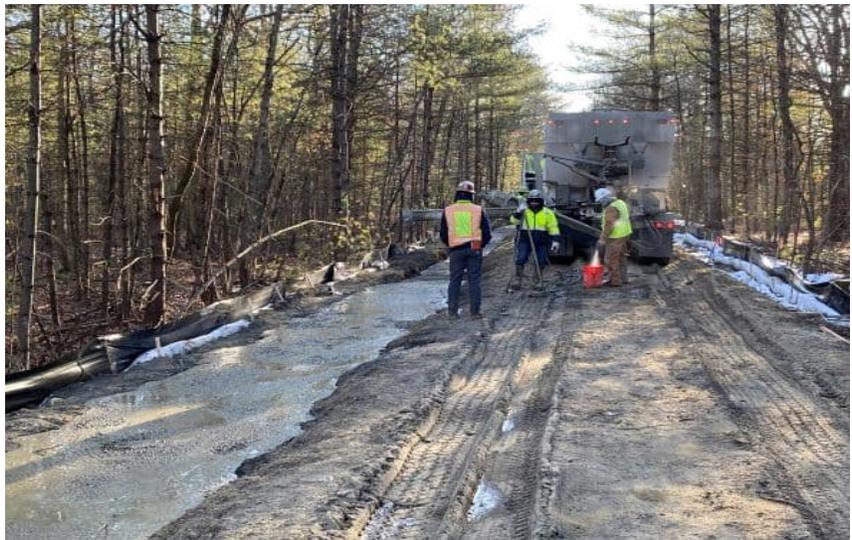
<b>PHOTOGRAPHIC LOG</b>	
Client Name: Eversource		Site Location: Sudbury to Hudson Transmission Reliability Project	Town: Hudson
Photo No.: 4	Date: 2-1-23

Description:  Filling of concrete & flowable fill within Segment 5 at approximate Sta.# 320+00, looking eastward.

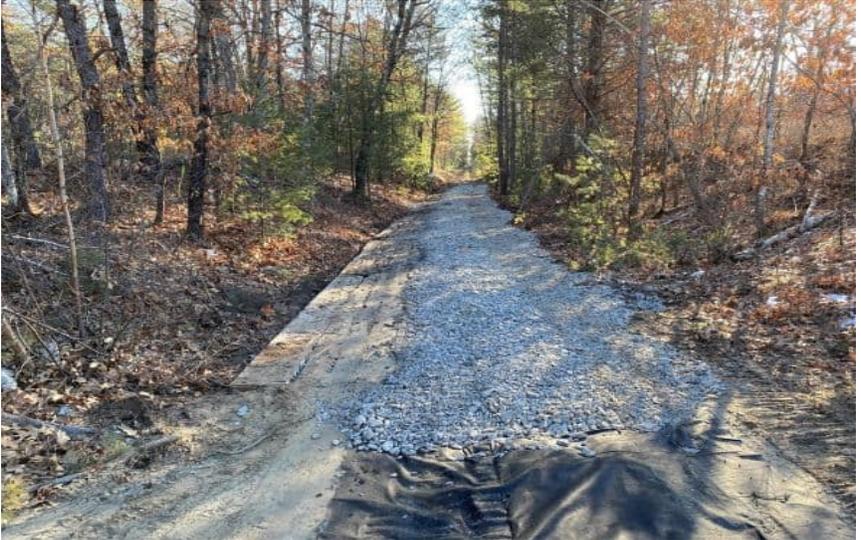
<b>PHOTOGRAPHIC LOG</b>	
Client Name: Eversource		Site Location: Sudbury to Hudson Transmission Reliability Project	Town: Sudbury
Photo No.: 5	Date: 2-1-23

Description:  Current state of 200' Black Racer time of year restrictive area with new stone access, looking eastward.

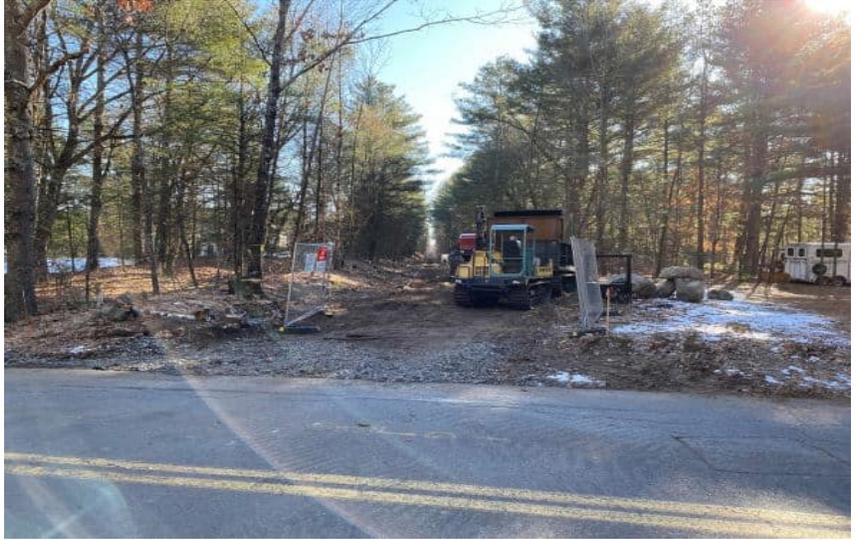
<b>PHOTOGRAPHIC LOG</b>	
Client Name: Eversource		Site Location: Sudbury to Hudson Transmission Reliability Project	Town: Sudbury
Photo No.: 6	Date: 2-1-23

Description:  Chipping operation by Moosehead off Dutton Road, looking eastward.

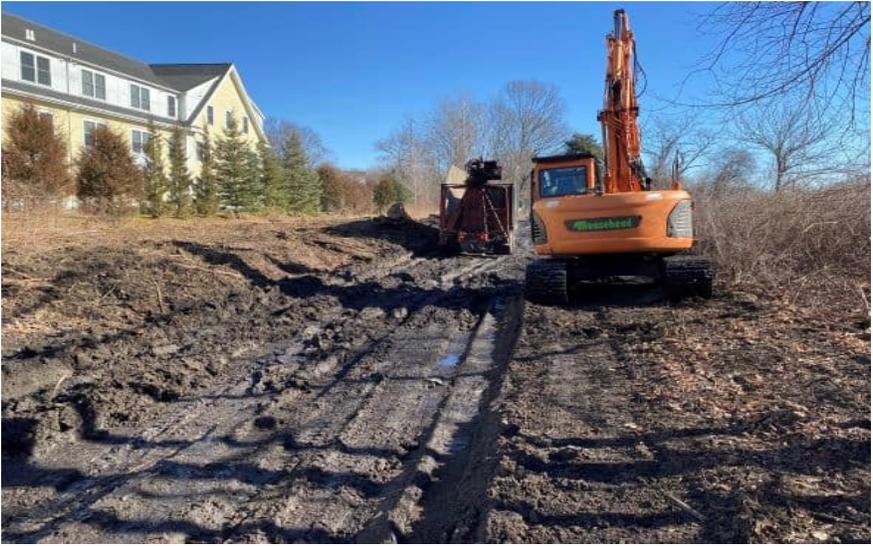
<b>PHOTOGRAPHIC LOG</b>	
Client Name: Eversource		Site Location: Sudbury to Hudson Transmission Reliability Project	Town: Sudbury
Photo No.: 7	Date: 2-1-23

Description:  Rail/Tie removal by Moosehead within Segment 14 at approximate Sta.#758+00, looking eastward.

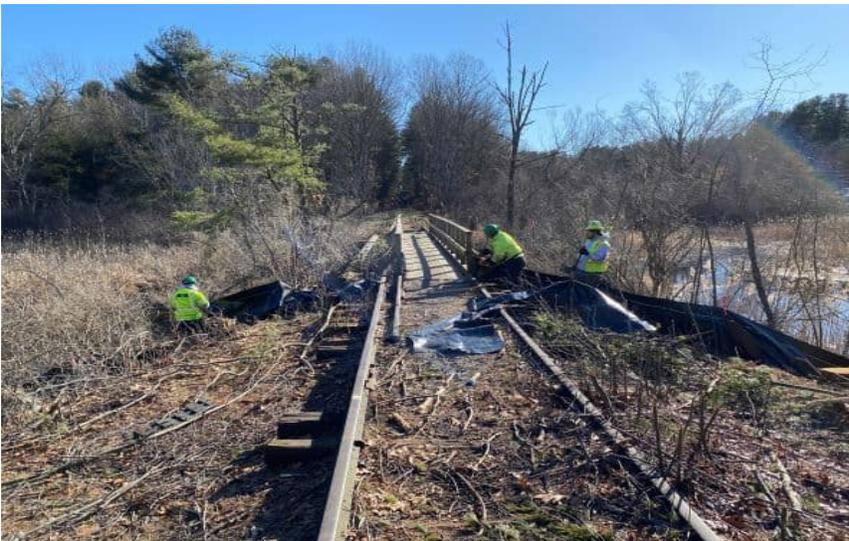
<b>PHOTOGRAPHIC LOG</b>	
Client Name: Eversource		Site Location: Sudbury to Hudson Transmission Reliability Project	Town: Sudbury
Photo No.: 8	Date: 2-1-23

Description:  Silt fencing placement by MON within Segment 7 at bridge 128, looking eastward.

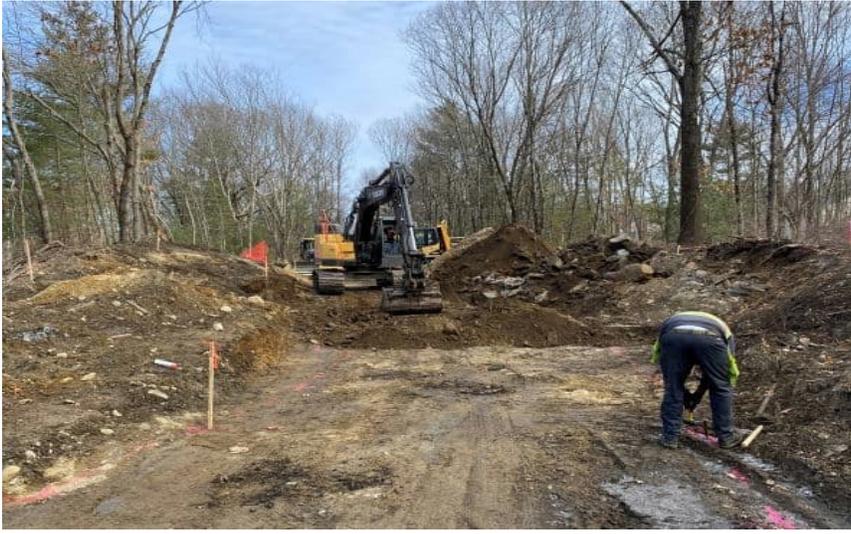
<b>PHOTOGRAPHIC LOG</b>	
Client Name: Eversource		Site Location: Sudbury to Hudson Transmission Reliability Project	Town: Hudson
Photo No.: 1	Date: 2-2-23

Description:  Site work (grading) at Wilkins Avenue, looking eastward.

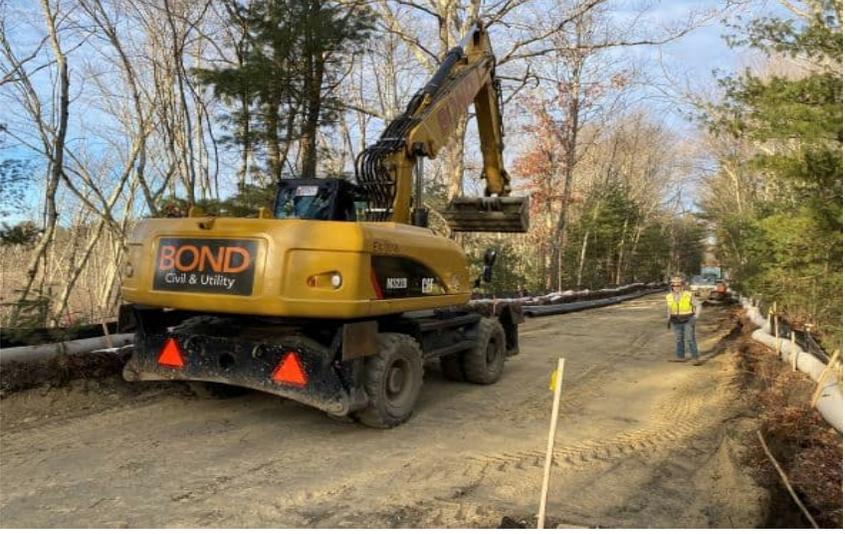
<b>PHOTOGRAPHIC LOG</b>	
Client Name: Eversource		Site Location: Sudbury to Hudson Transmission Reliability Project	Town: Hudson
Photo No.: 2	Date: 2-2-23

Description:  Bond working at conduit installation within Segment 5 at approximate Sta.# 328+00, looking westward.

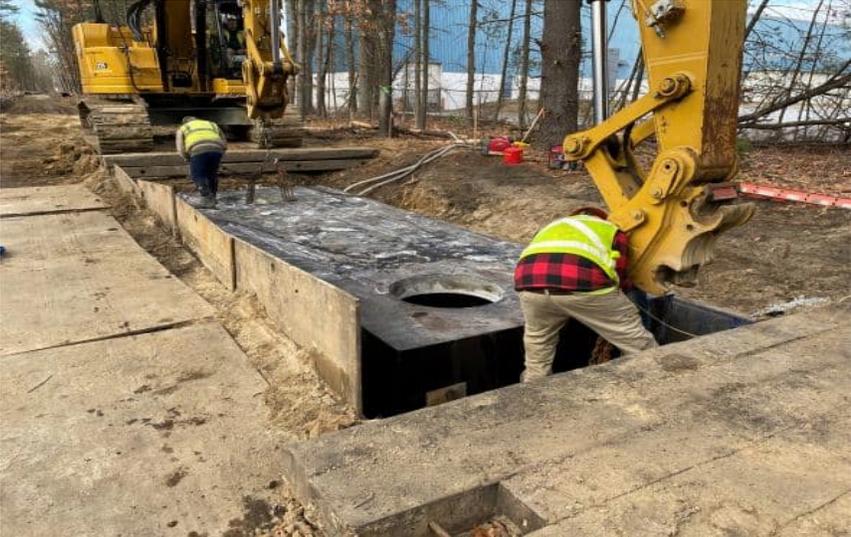
<b>PHOTOGRAPHIC LOG</b>	
Client Name: Eversource		Site Location: Sudbury to Hudson Transmission Reliability Project	Town: Hudson
Photo No.: 3	Date: 2-2-23

Description:  Bond working at MH#10 within Segment 4 at approximate Sta.# 196+00, looking westward.

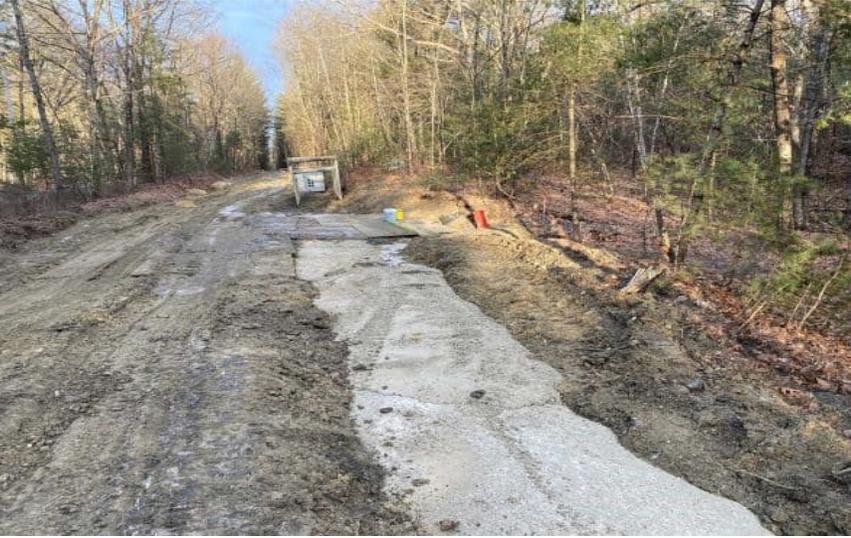
<b>PHOTOGRAPHIC LOG</b>	
Client Name: Eversource		Site Location: Sudbury to Hudson Transmission Reliability Project	Town: Hudson
Photo No.: 4	Date: 2-2-23

Description:  Filling of concrete & flowable fill within Segment 5 from MH#12 at approximate Sta.# 320+00, looking westward.

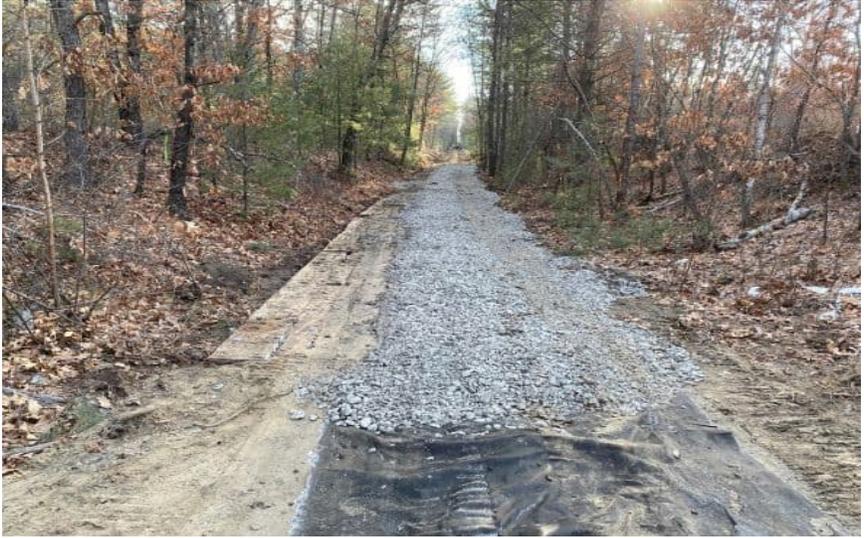
<b>PHOTOGRAPHIC LOG</b>	
Client Name: Eversource		Site Location: Sudbury to Hudson Transmission Reliability Project	Town: Sudbury
Photo No.: 5	Date: 2-2-23

Description:  Current state of 200' Black Racer time of year restrictive area with new stone access, looking eastward.

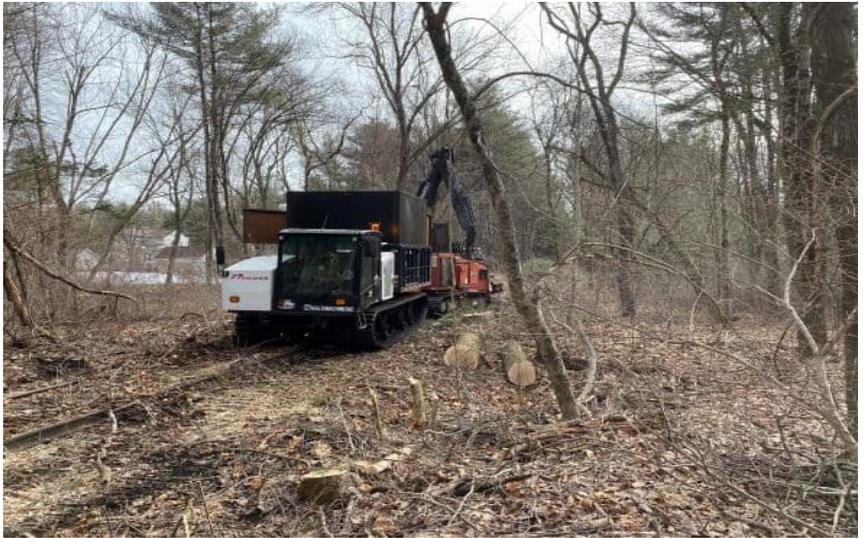
<b>PHOTOGRAPHIC LOG</b>	
Client Name: Eversource		Site Location: Sudbury to Hudson Transmission Reliability Project	Town: Sudbury
Photo No.: 6	Date: 2-2-23

Description:  Chipping operation by Moosehead within Segment 9 at approximately 516+00, looking eastward.

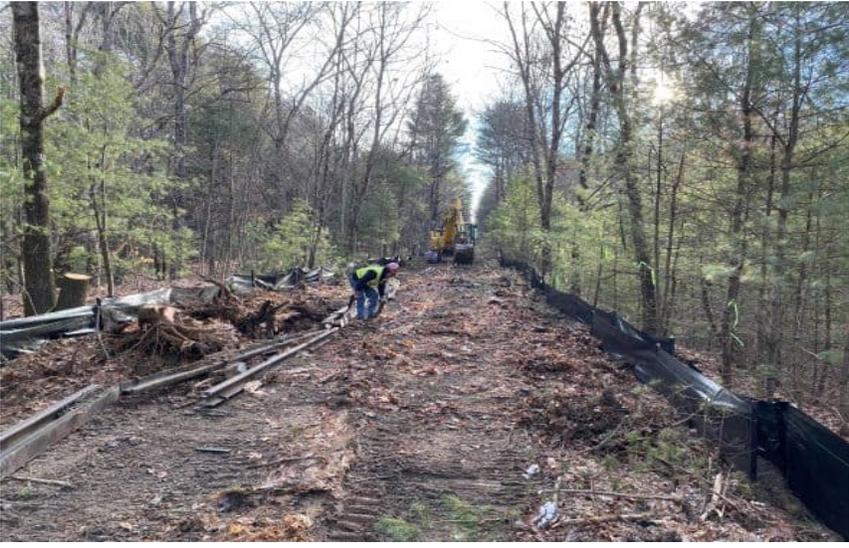
<b>PHOTOGRAPHIC LOG</b>	
Client Name: Eversource		Site Location: Sudbury to Hudson Transmission Reliability Project	Town: Sudbury
Photo No.: 7	Date: 2-2-23

Description:  Rail/Tie removal by Moosehead within Segment 7 at approximate Sta.#338+00, looking eastward.

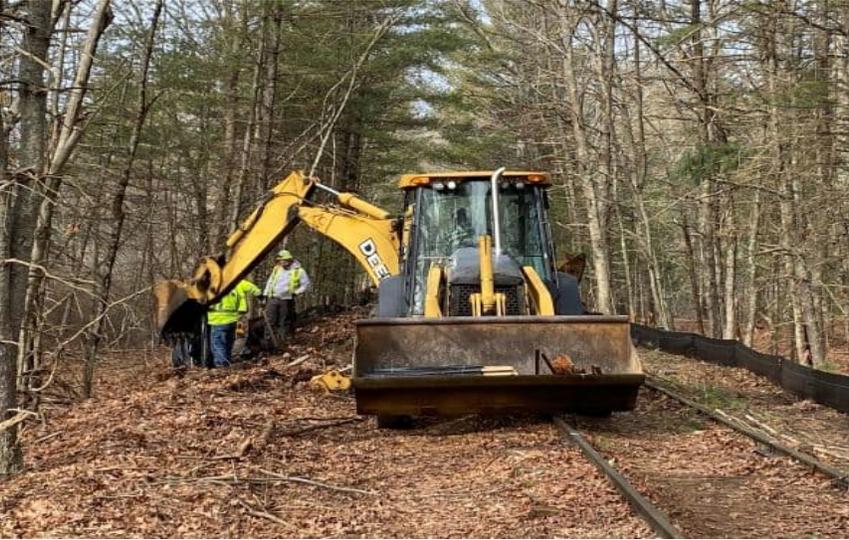
<b>PHOTOGRAPHIC LOG</b>	
Client Name: Eversource		Site Location: Sudbury to Hudson Transmission Reliability Project	Town: Sudbury
Photo No.: 8	Date: 2-2-23

Description:  Silt fencing placement by MON within Segment 8 at approximate Sta# 413+00, looking westward.
