**Weekly Environmental Compliance Summary**

**Sudbury to Hudson Transmission Reliability Project (USEPA Tracking # MAR1003UW)**

Sudbury, Hudson, and Stow, MA

Week of: February 13 to February 17, 2023

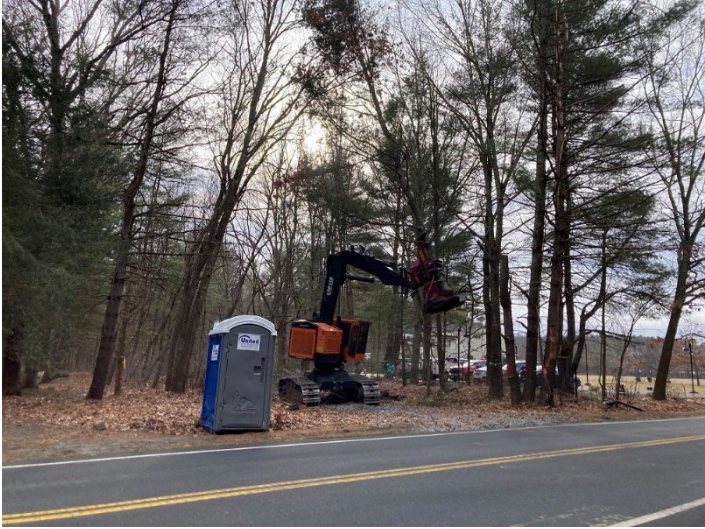
<p align="right"><b>PHOTOGRAPHIC LOG</b></p>	
<b>Client Name: Eversource</b>		<b>Site Location: Sudbury to Hudson Transmission Reliability Project</b>	<b>Town: Sudbury</b>
<b>Photo No.: 1</b>	<b>Date:</b> 2/13/2023

<b>Description:</b> View of Moosehead conducting tree cutting activities in segment 11 off Horse Pond Rd, facing southeast.

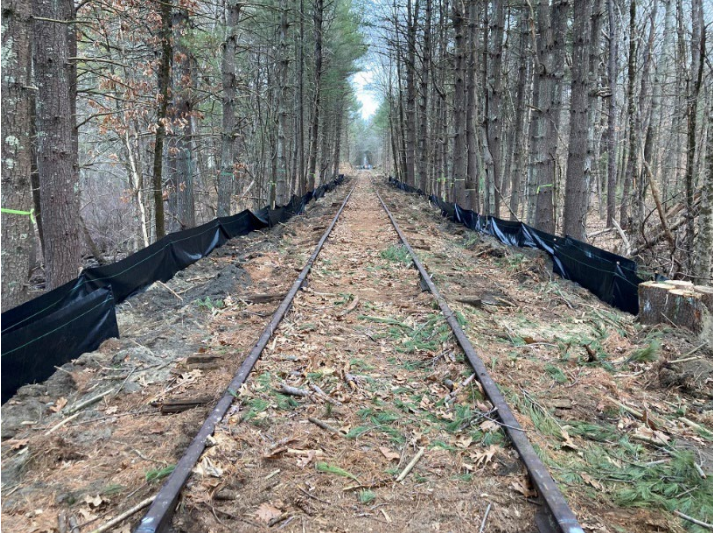
<p align="right"><b>PHOTOGRAPHIC LOG</b></p>	
<b>Client Name: Eversource</b>		<b>Site Location: Sudbury to Hudson Transmission Reliability Project</b>	<b>Town: Sudbury</b>
<b>Photo No.: 2</b>	<b>Date:</b> 2/13/2023

<b>Description:</b> View of silt fence installed in segment 10. Portion of silt fence (Peakham to Sta. 540+50) was inspected and approved by Zach Gallup (Pare). Facing west.

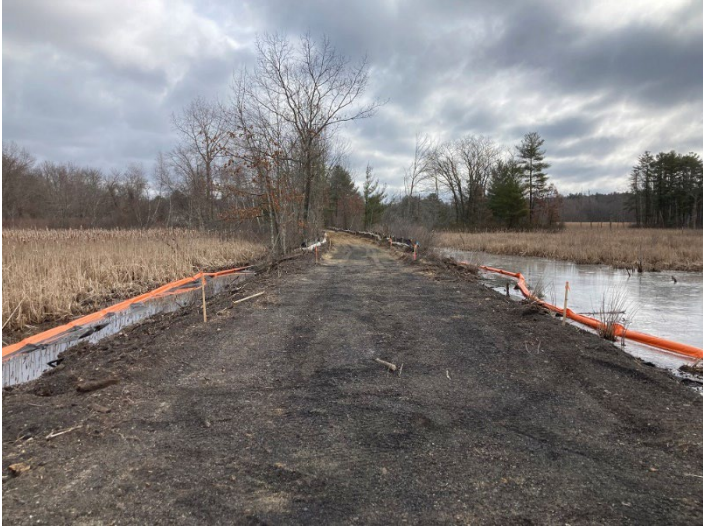
<p align="right"><b>PHOTOGRAPHIC LOG</b></p>	
<p><b>Client Name:</b> Eversource</p>		<p><b>Site Location:</b> Sudbury to Hudson Transmission Reliability Project</p>	<p><b>Town:</b> Hudson</p>
<p><b>Photo No.:</b> 4</p>	<p><b>Date:</b> 2/13/2023</p>

<p><b>Description:</b> View of turbidity curtains in segment 3 at bridge 130, facing east.</p>

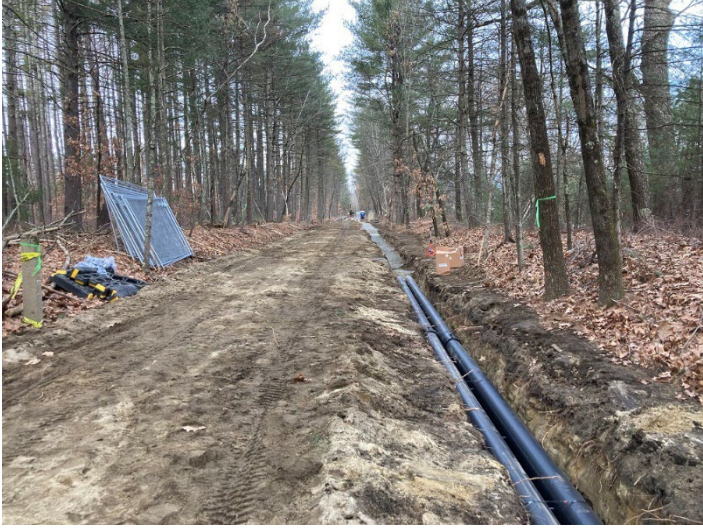
<b>PHOTOGRAPHIC LOG</b>	
<b>Client Name:</b> Eversource		<b>Site Location:</b> Sudbury to Hudson Transmission Reliability Project	<b>Town:</b> Hudson
<b>Photo No.:</b> 5	<b>Date:</b> 2/13/2023

<b>Description:</b> View of Bond conducting conduit work in segment 4. Please ensure that concrete is being managed properly during conduit installation. Facing west.

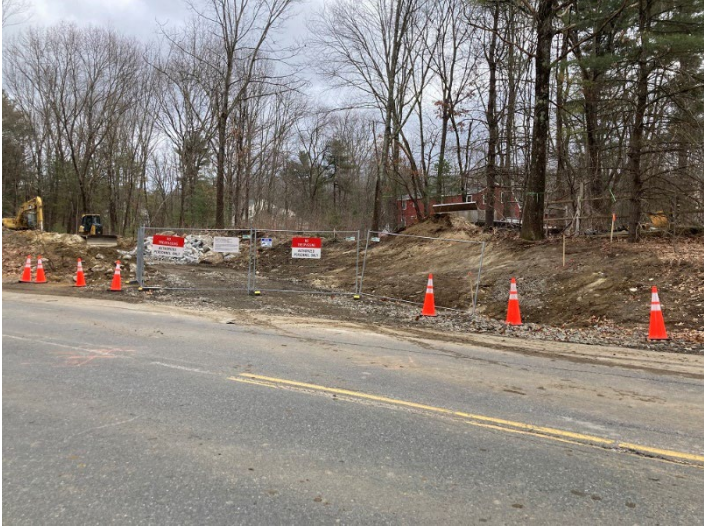
<b>PHOTOGRAPHIC LOG</b>	
<b>Client Name:</b> Eversource		<b>Site Location:</b> Sudbury to Hudson Transmission Reliability Project	<b>Town:</b> Hudson
<b>Photo No.:</b> 6	<b>Date:</b> 2/13/2023

<b>Description:</b> View of construction entrance to segment 1. Sediment tracking noted on Wilkins St. Sweep street and apply fresh stone to tracking pad (routine maintenance). Facing east.

**Sediment tracking noted on Wilkins St. Sweep street and apply fresh stone to tracking pad.**

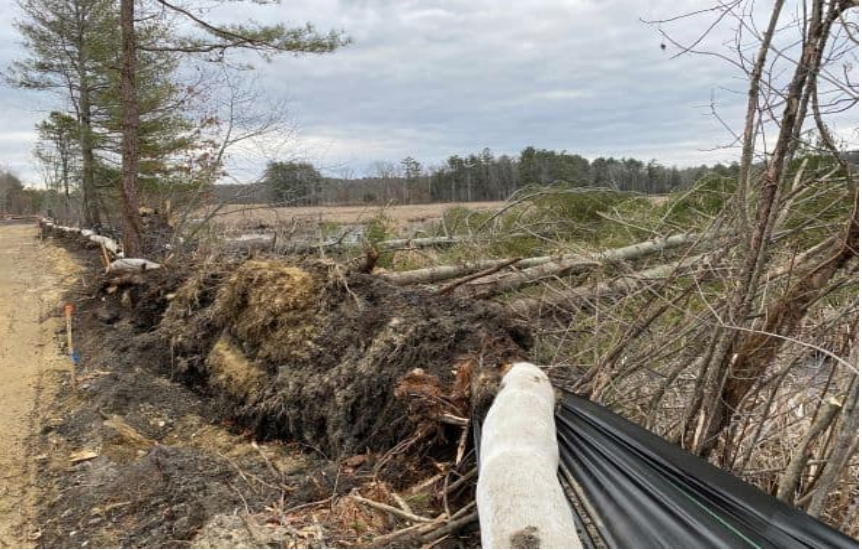
<p>PHOTOGRAPHIC LOG</p>	
<p>Client Name: Eversource</p>		<p>Site Location: Sudbury to Hudson Transmission Reliability Project</p>	<p>Town: Hudson</p>
<p>Photo No.: 6</p>	<p>Date: 2-14-23</p>

**Walked with Pam Helinek (Hudson CC) inspecting two (2) issues noted today: (1) downed trees within Segment 2 which had recently fallen down into adjacent wetlands and disturbed existing erosion control near Sta#145+50 (see photo 6) & (2) need for additional erosion control at the Bonazzoli laydown yard. Both issues will require improvements to on-site erosion control measures.**

<p>Description:                  Downed trees disturbing on-site erosion control measures, noted within Segment 2 at approximate Sta#145+50, looking eastward.</p>

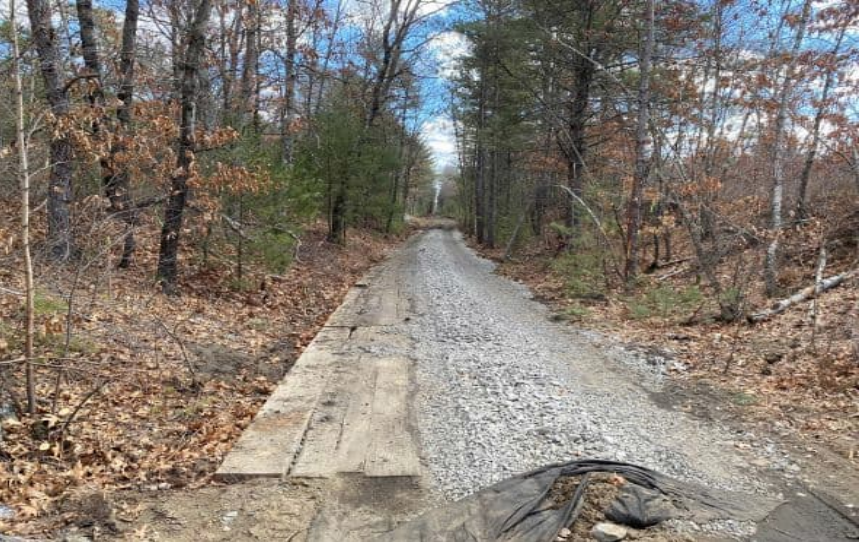
<p>PHOTOGRAPHIC LOG</p>	
<p>Client Name: Eversource</p>		<p>Site Location: Sudbury to Hudson Transmission Reliability Project</p>	<p>Town: Sudbury</p>
<p>Photo No.: 8</p>	<p>Date: 2-14-23</p>

<p>Description:</p> <p>Black Racer restrictive area (current condition), looking eastward.</p>

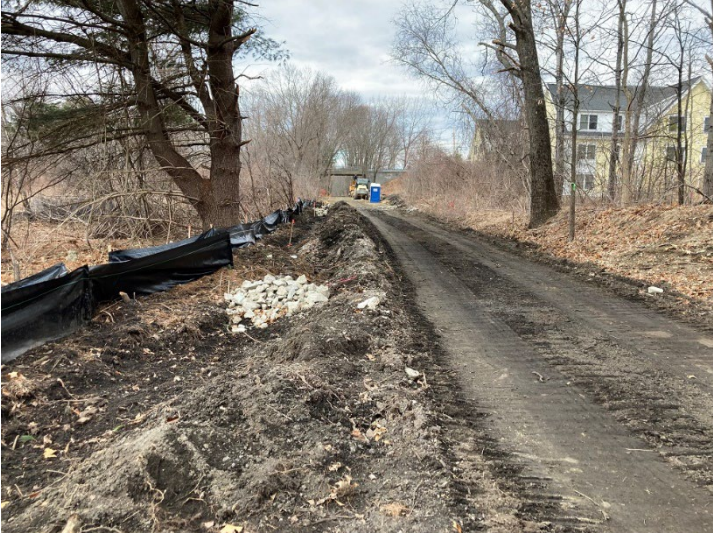
<p align="right"><b>PHOTOGRAPHIC LOG</b></p>	
<p><b>Client Name:</b> Eversource</p>		<p><b>Site Location:</b> Sudbury to Hudson Transmission Reliability Project</p>	<p><b>Town:</b> Sudbury</p>
<p><b>Photo No.:</b> 2</p>	<p><b>Date:</b> 2/14/2023</p>

<p><b>Description:</b> View of segment 14 at approximately Sta. #472. Swale and check dams have been installed along southern perimeter of ROW. Facing west.</p>

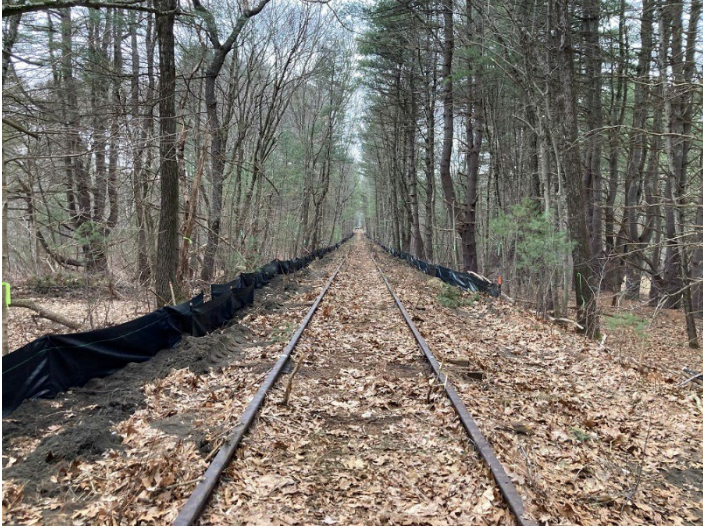
<b>PHOTOGRAPHIC LOG</b>	
<b>Client Name:</b> Eversource		<b>Site Location:</b> Sudbury to Hudson Transmission Reliability Project	<b>Town:</b> Sudbury
<b>Photo No.:</b> 4	<b>Date:</b> 2/14/2023

<b>Description:</b> View of silt fence in segment 10. Remainder of silt fence in this area (Sta. #540+50 to end of run) was inspected and approved by Lori Capone (Sudbury CC). Facing west.

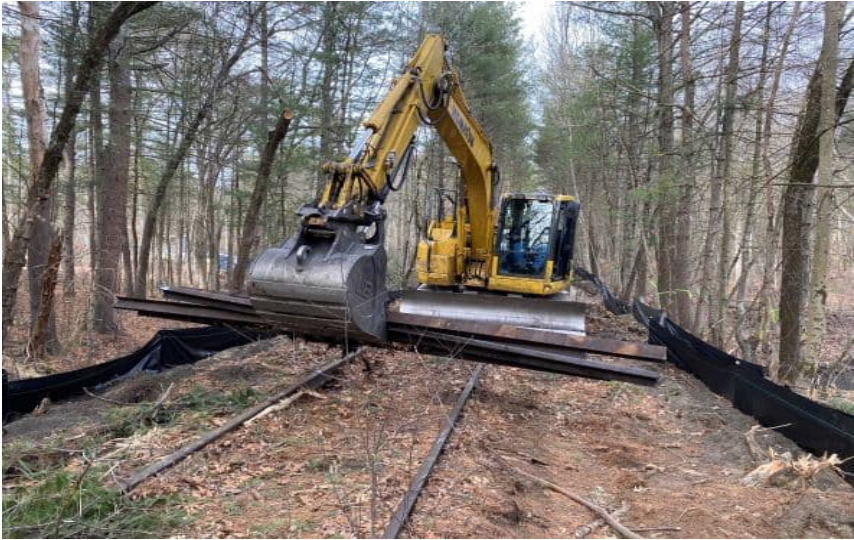
<p>Description:</p> <p>Moosehead removing debris within Segment 10 at approximate Sta#539+50 over culvert conveying Dudley Brook, looking eastward.</p>

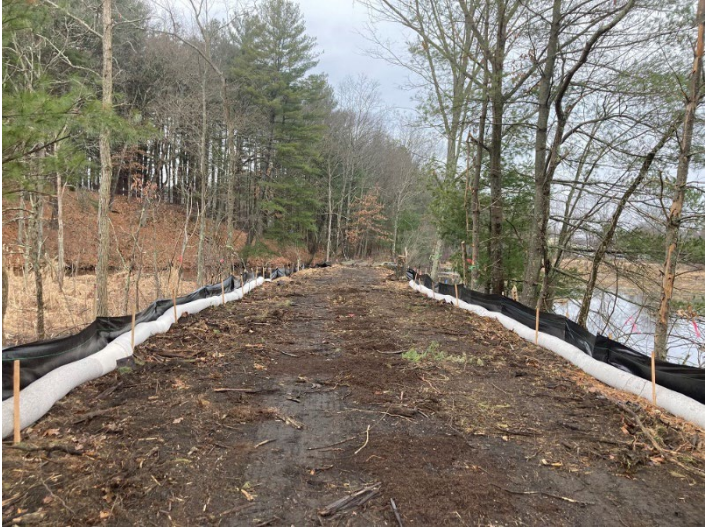
<p><b>Description:</b> View of silt fence and filter tube installed in segment 14. Controls are in good condition and operating properly. Facing west.</p>

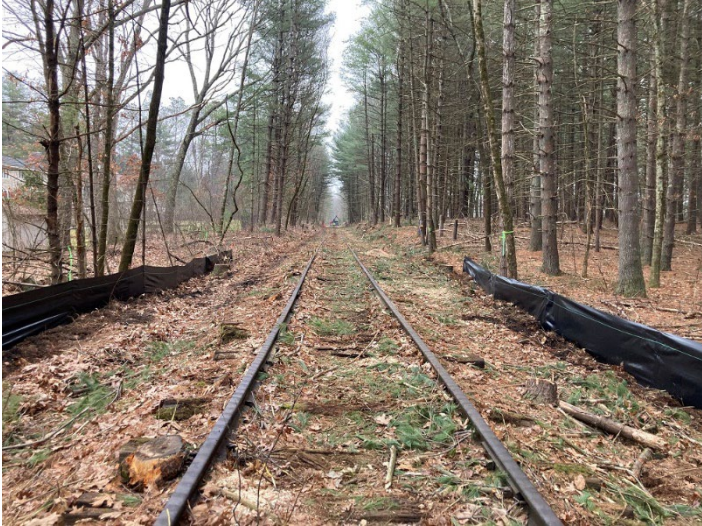
<b>Description:</b> View of newly installed silt fence in segment 11 off Horse Pond Rd. Silt fence in this area (approximately Sta. #363 - Sta. #370) was inspected and approved by Zach Gallup (Pare). Facing east.

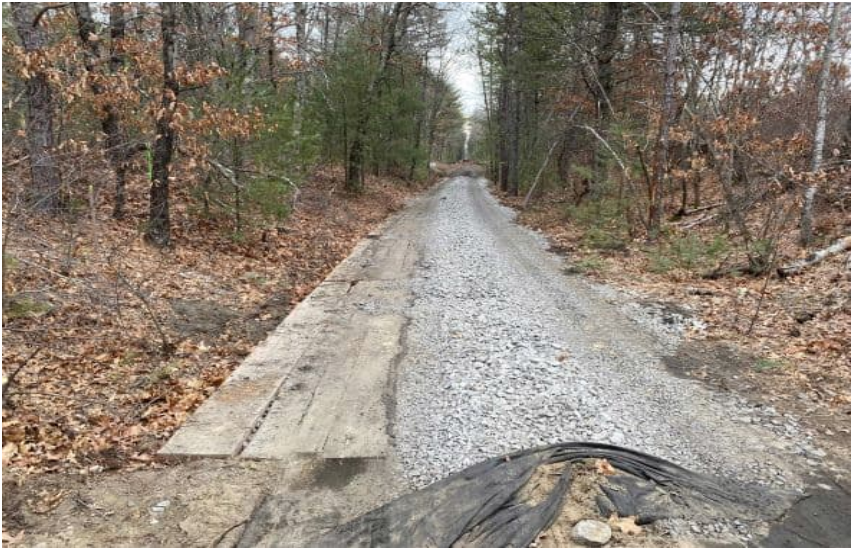
Description:  Current state of 200' Black Racer time of year restrictive area with new stone access, looking eastward.

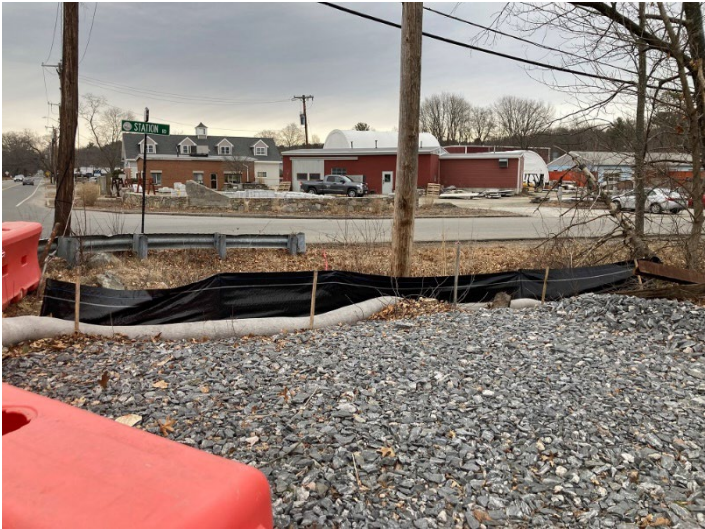
<b>Description:</b> View of construction entrance pad and erosion controls at entrance to segment 12 off Union Ave. Controls are in good condition and operating properly. Facing north.

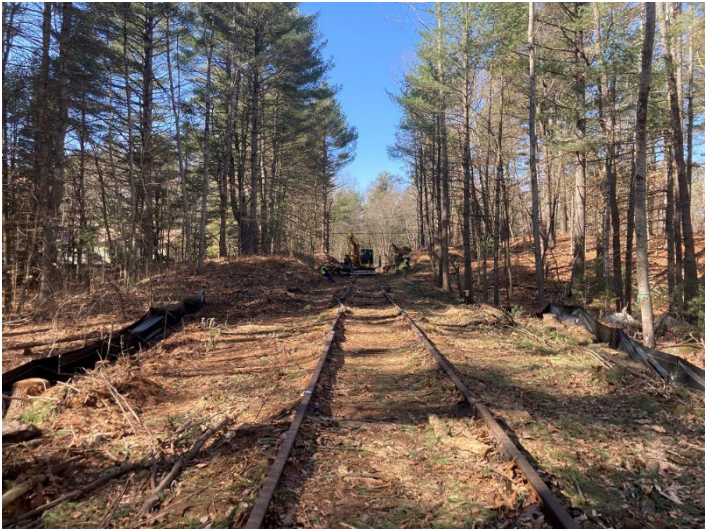
<b>Description:</b> View of segment 10 off of Peakham Rd. Moosehead is performing stump, rail, and tie removal. Silt fence in this area is in good condition and operating properly. Facing west.

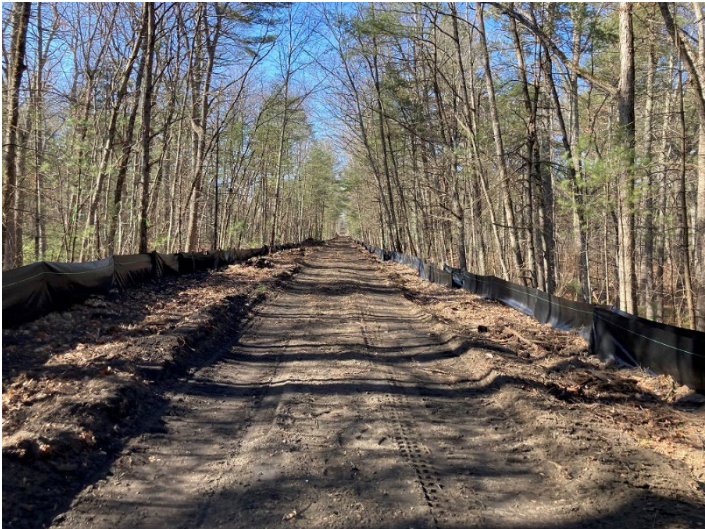
<b>Description:</b> View of silt fence in segment 8. Silt fence is in good condition and operating properly. Facing west.

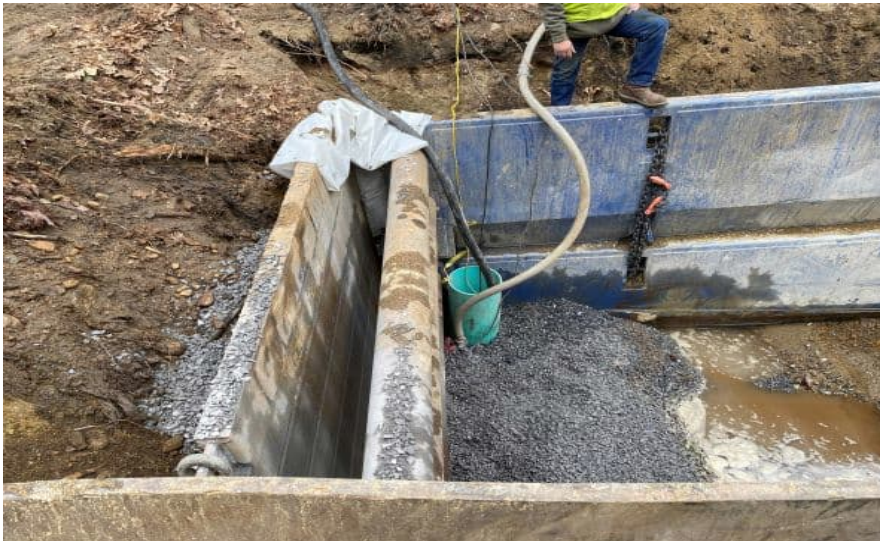
Description: View of pumping operation at MH#7. This is the location of dewatering water prior to treatment. Water appeared to be cloudy.

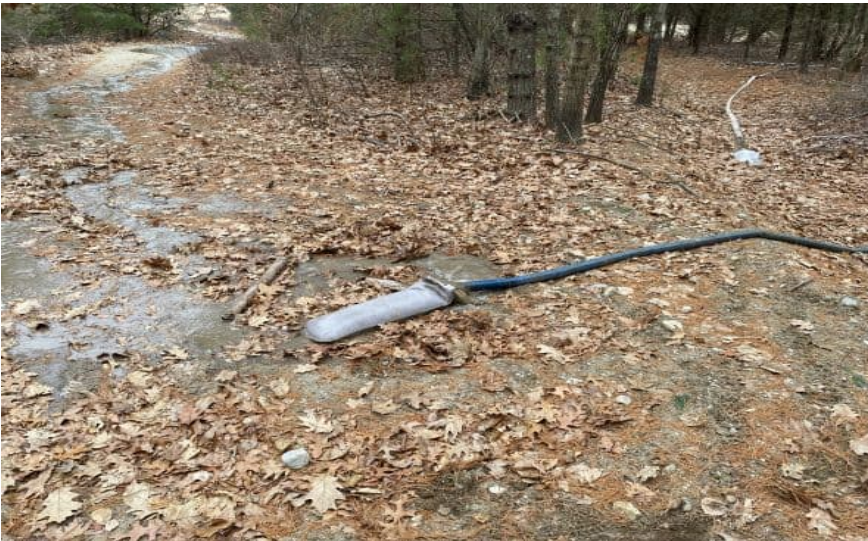
Description: MH#7. View of discharge bag, looking westward. Water appeared to be slightly clouded.

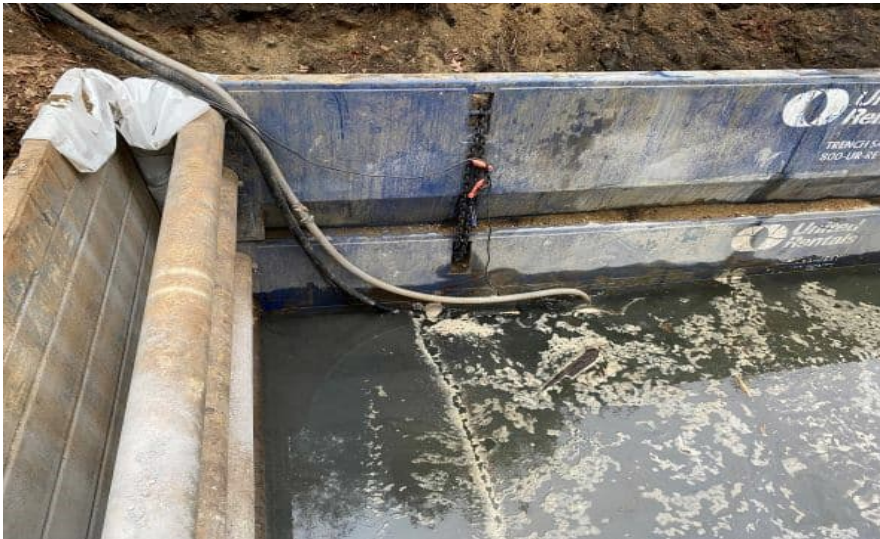
Description: View of pumping operation at MH#7. This is the location of dewatering water prior to treatment. Water appeared to be cloudy.

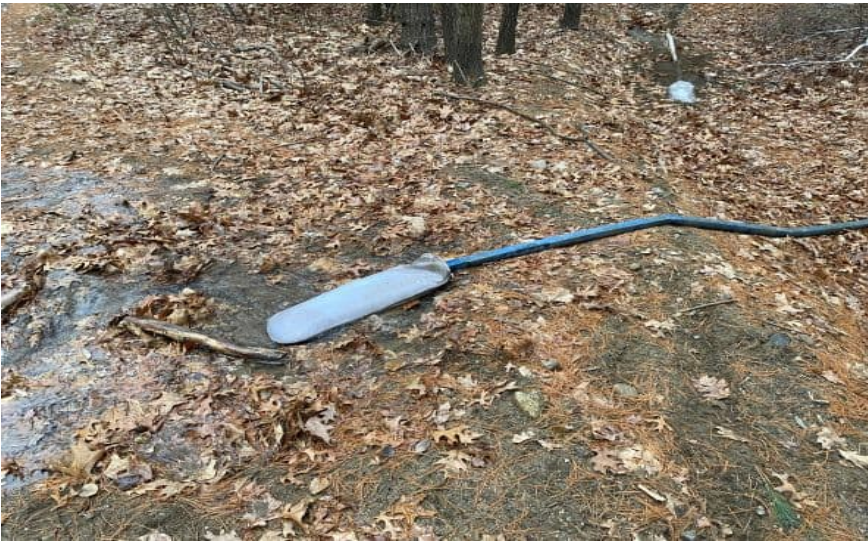
Description: MH#7. View of discharge bag, looking westward. Water appeared to be slightly clear.
