Bordering Vegetated Wetland & Buffer Zone Restoration Protocols

**Cavicchio Greenhouses Fire Site
110 Codjer Lane,
Sudbury, MA**

January 30, 2023

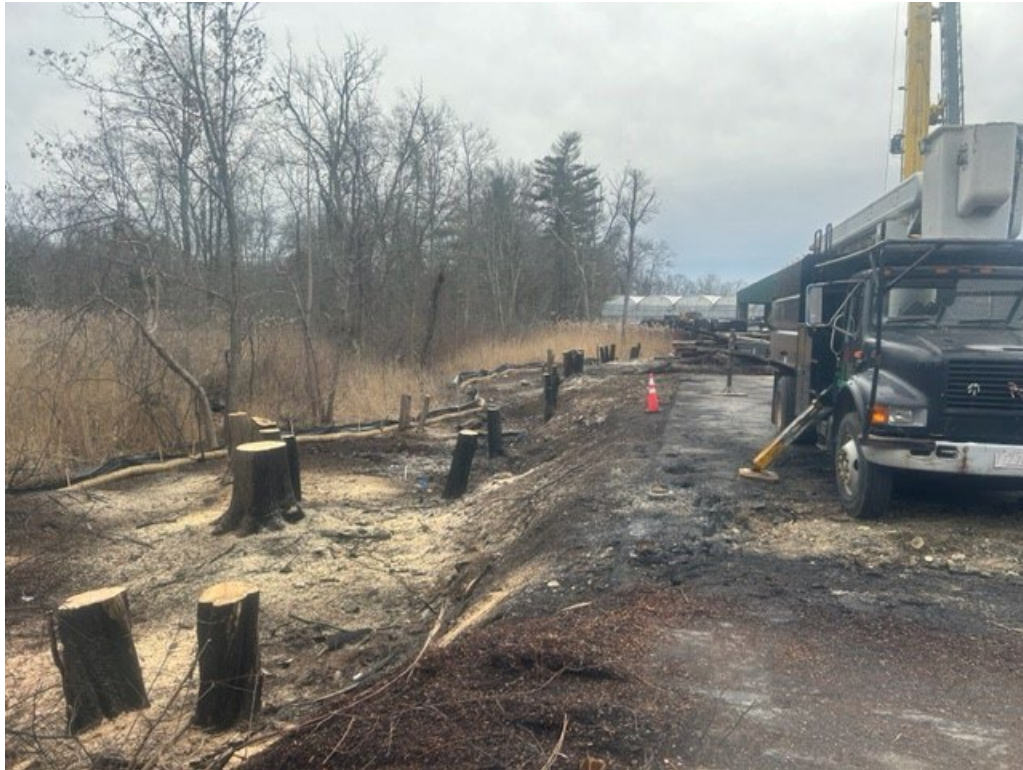
Photo 1. Southeasterly view of disturbed area. The delineated boundary of BVW is shown with the blue flags and the lower limit of the BVW to be restored is shown at the silt fence and straw wattle limits. The upper limit of the Buffer Zone to be restored is the edge of the existing pavement.

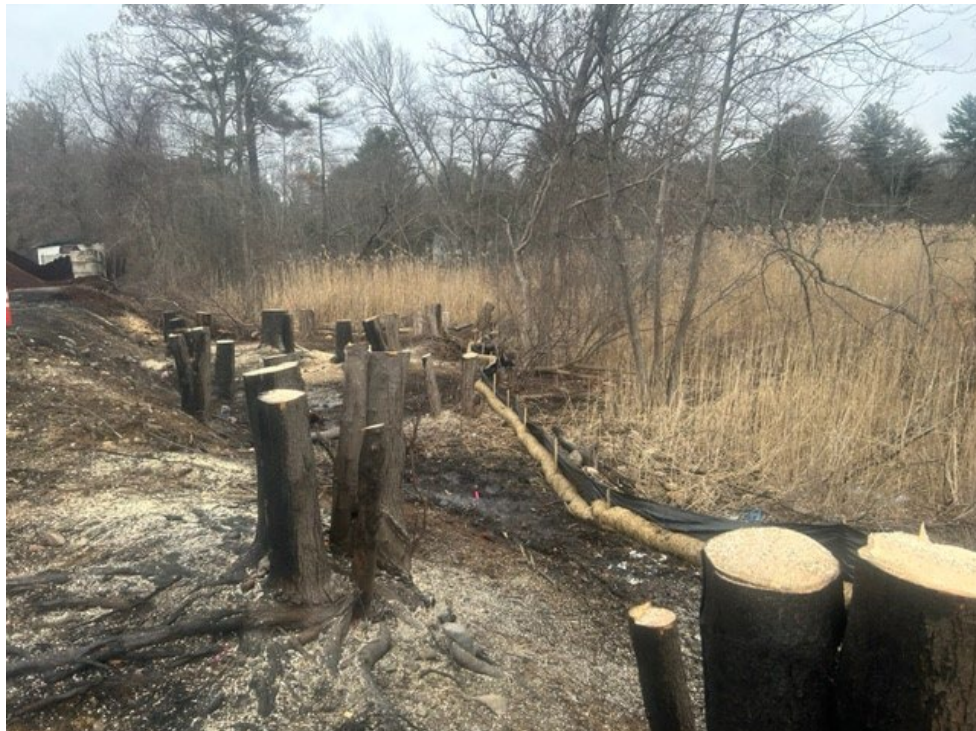
Photo 2. Northwesterly view of disturbed area. The delineated boundary of BVW is shown with the blue flags and the lower limit of the BVW to be restored is shown at the silt fence and straw wattle limits.
