Horsley Witten Group, Inc.

Client:	Town of Sudbury
Project Name:	Sudbury-Hudson Transmission Reliability
Inspector:	Jeffrey Polidor
Project No:	22012F
Inspection Date: 3/14/23	Arrival Time: 7:00 AM
Weather: Light flurries, 30°F	Departure Time: 11:00 AM

Sudbury to Hudson 115kV Underground Transmission Line Sudbury - Hudson, MA Date: November 16, 2018

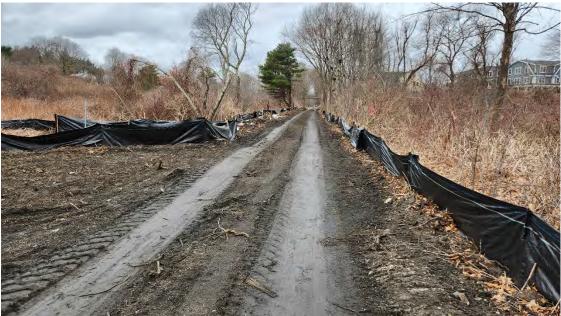
Photo 1: Silt fence operating properly along segment 14. Photo taken on 3/14/23

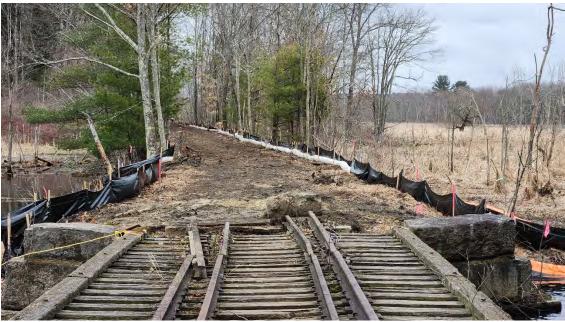
Photo 2: Turbidity curtain, filter tubes, and silt fence installed and operating properly at bridge 127.

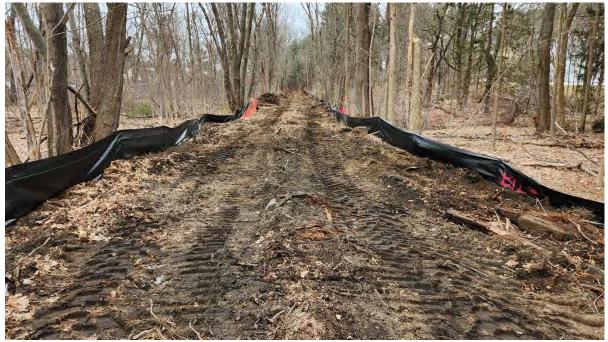
Photo 3: Silt fence operating properly along segment 13. Photo taken on 3/14/23

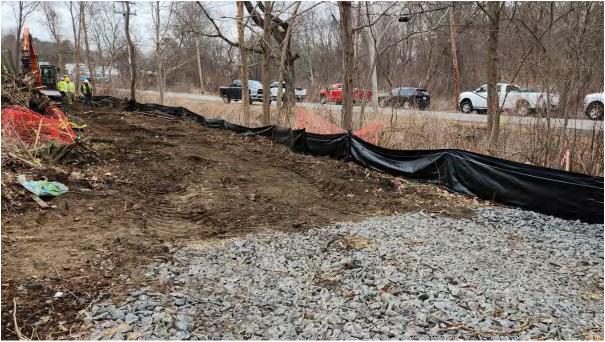
Photo 4: Silt fence operating properly along segment 12 while construction occurs. Photo taken on 3/14/23

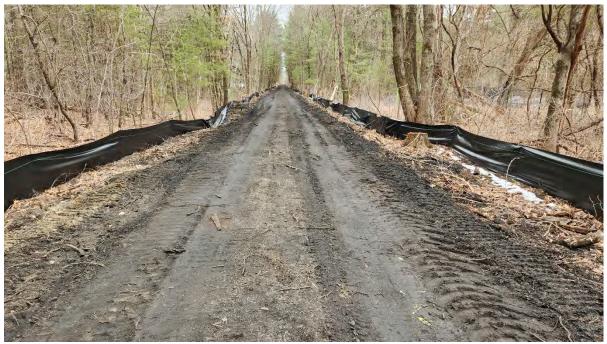
Photo 5: Silt fence operating properly along segment 11. Photo taken on 3/14/23

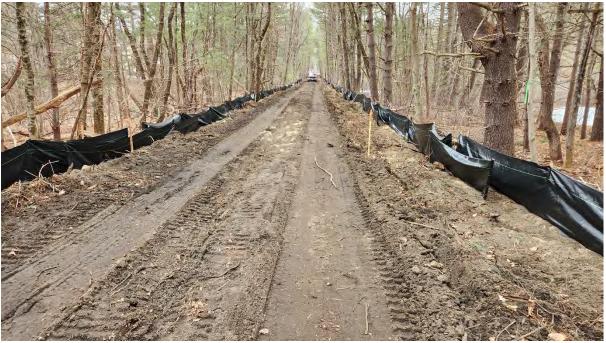
Photo 6: Silt fence operating properly along segment 10. Photo taken on 3/14/23

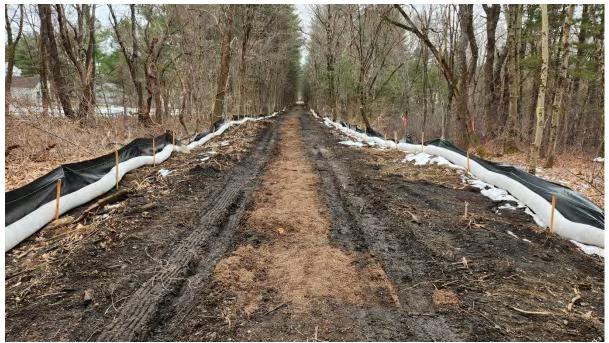
Photo 7: Silt fence and filter tube installed and operating properly along segment 9. Photo taken on 3/14/23

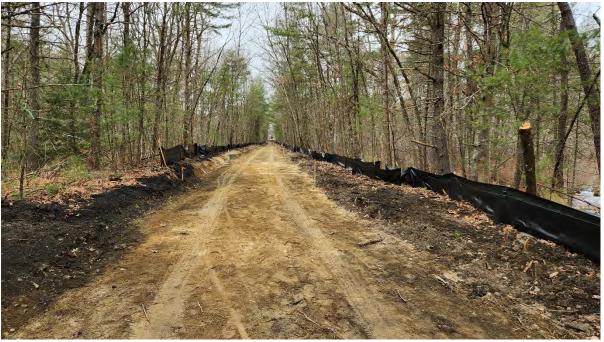
Photo 8: Silt fence operating properly along segment 8. Photo taken on 3/14/23

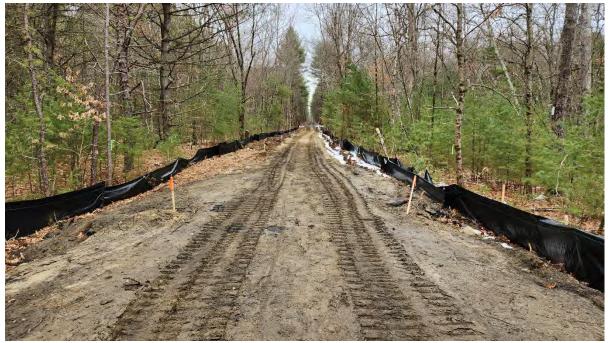
Photo 9: Silt fence operating properly along segment 7. Photo taken on 3/14/23
