**Weekly Environmental Compliance Summary**

**Sudbury to Hudson Transmission Reliability Project (USEPA Tracking # MAR1003UW)**

Week of: March 13 to March 17, 2023

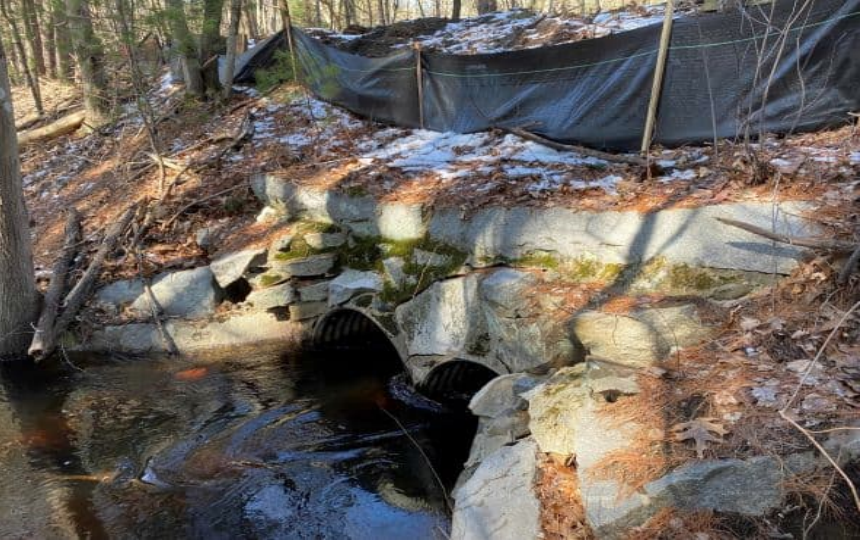
<p>PHOTOGRAPHIC LOG</p>	
<p>Client Name: Eversource</p>		<p>Site Location: Sudbury to Hudson Transmission Reliability Project</p>	<p>Town: Sudbury</p>
<p>Photo No.: 8</p>	<p>Date: 3-16-23</p>

**Walked in Segment 10 with Lori Capone (Sudbury CC); Ariel Leclerc (SWCA) & Ethan Wilkins (ET&L) reviewing the culverts conveying Dudley Brook within Segment 10 at approximate Sta# 539+50 for possible deterioration of outlet rock endwall (see photo 8).**

<p>Description:</p> <p>Dudley Brook culverts outlet endwall within Segment 10 at approximate Sta#739+50, looking eastward.</p>

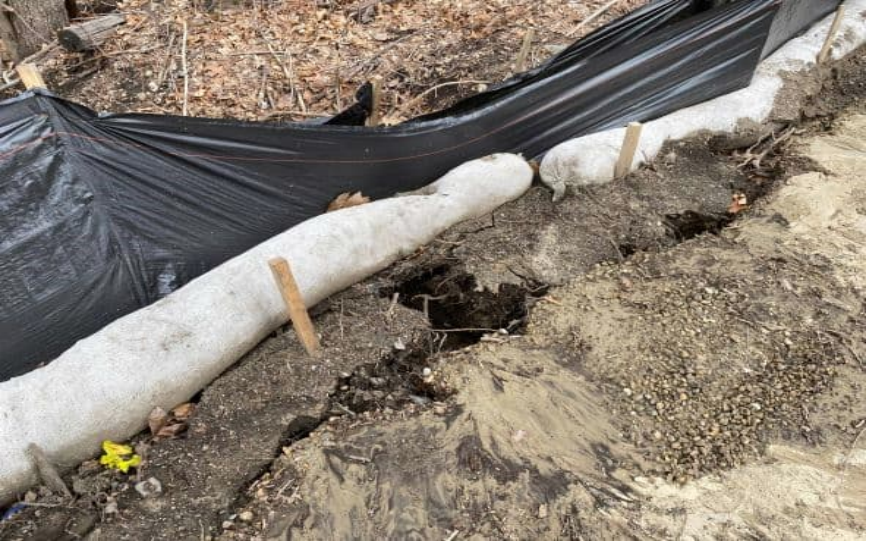
<p>PHOTOGRAPHIC LOG</p>	
<p>Client Name: Eversource</p>		<p>Site Location: Sudbury to Hudson Transmission Reliability Project</p>	<p>Town: Hudson</p>
<p>Photo No.: 2</p>	<p>Date: 3-17-23</p>

<p>Description:</p> <p>Newly developed erosion undermining silt fencing &amp; compost filter tubing north side of ROW within Segment 3 at approximate Sta# 173+00 necessitating additional controls, sedimentation to adjacent upland area, looking northward.</p>

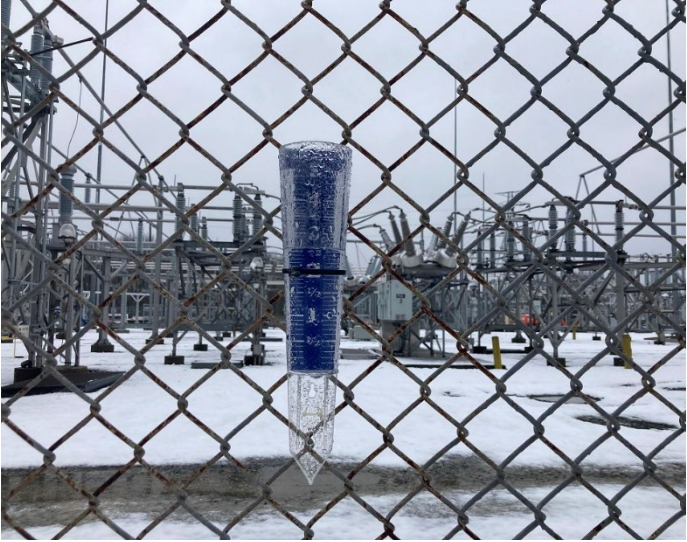
<b>PHOTOGRAPHIC LOG</b>	
<b>Client Name:</b> Eversource		<b>Site Location:</b> Sudbury to Hudson Transmission Reliability Project	<b>Town:</b> Sudbury
<b>Photo No.:</b> 1	<b>Date:</b> 3-14-2023

<b>Description:</b> View of rain gauge. 2.50" observed in gauge at 2:00pm. Facing south.

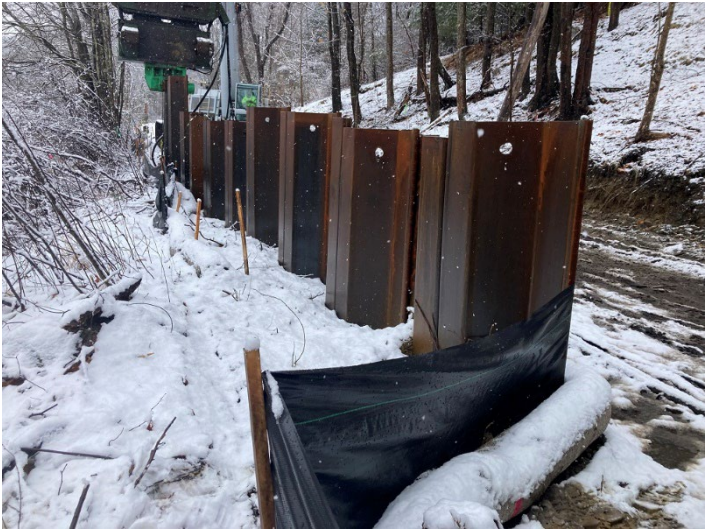
<b>PHOTOGRAPHIC LOG</b>	
<b>Client Name:</b> Eversource		<b>Site Location:</b> Sudbury to Hudson Transmission Reliability Project	<b>Town:</b> Sudbury
<b>Photo No.:</b> 4	<b>Date:</b> 3-14-2023

<b>Description:</b> With permission from Sudbury CC agent, E&S controls were moved for installation of sheetwall. E&S controls are being tied into sheet wall at the end of each work day. Facing northwest.

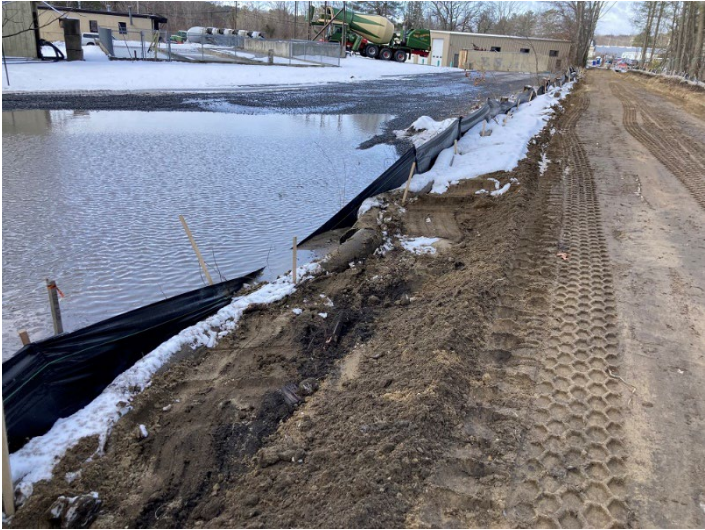
<b>PHOTOGRAPHIC LOG</b>	
<b>Client Name:</b> Eversource		<b>Site Location:</b> Sudbury to Hudson Transmission Reliability Project	<b>Town:</b> Hudson
<b>Photo No.:</b> 3	<b>Date:</b> 3-15-2023

**-E&S controls are in need of repair in multiple places in segment 3.**

<b>Description:</b> E&S controls are in need of repair in multiple places in segment 3 (routine maintenance). Facing west.

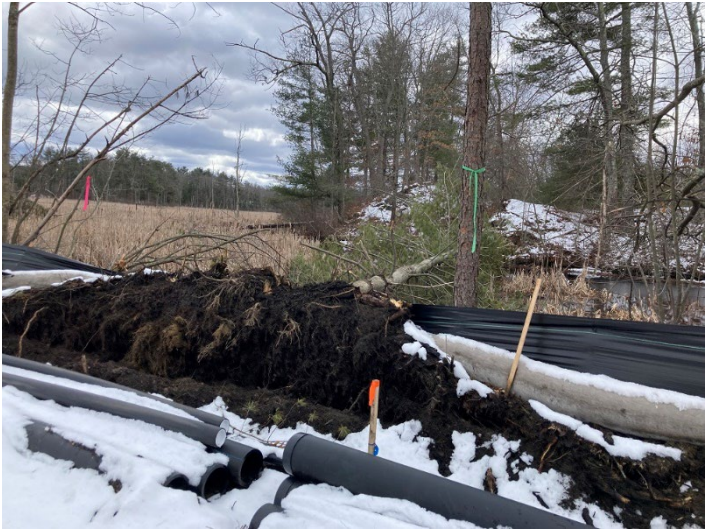
<b>PHOTOGRAPHIC LOG</b>	
<b>Client Name:</b> Eversource		<b>Site Location:</b> Sudbury to Hudson Transmission Reliability Project	<b>Town:</b> Hudson
<b>Photo No.:</b> 4	<b>Date:</b> 3-15-2023

**-E&S controls are in need of repair where additional tree has fallen into adjacent wetlands in segment 2 at approximately Sta. #144+50/ Sta. #118 rt.**

<b>Description:</b> Additional tree has fallen into adjacent wetlands in segment 2 at approximately Sta. #144+50/ Sta. #118 rt. Disturbed E&S controls are in need of repair (routine maintenance).

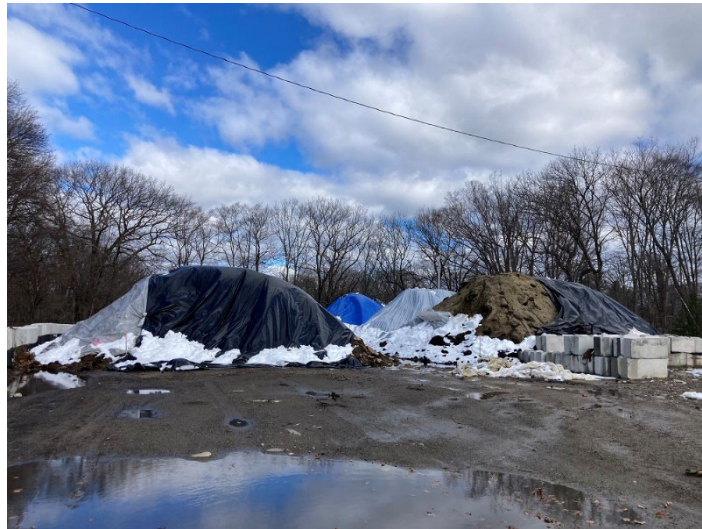
View of laydown yard at Stowe Ct. Covers appear to have blown off of piles in the storm. Please re-cover piles (routine maintenance). Facing northeast.
