**Weekly Environmental Compliance Summary**

**Sudbury to Hudson Transmission Reliability Project (USEPA Tracking # MAR1003UW)**

Sudbury, Hudson, and Stow, MA

Week of: March 20 to March 24, 2023

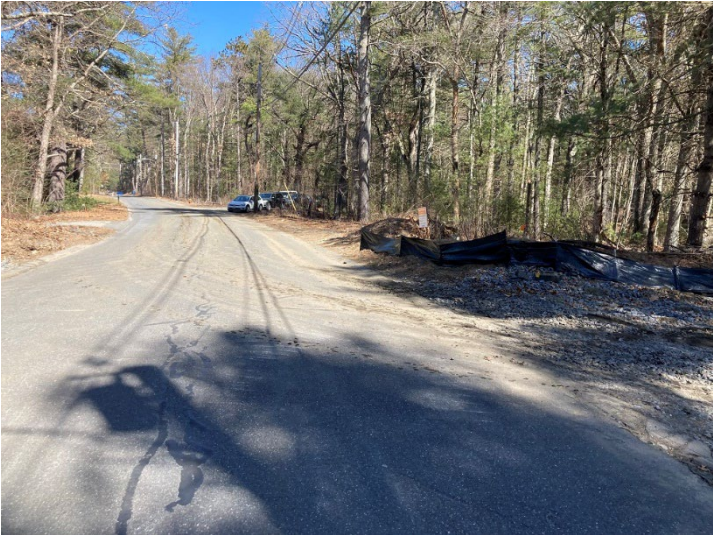
<b>PHOTOGRAPHIC LOG</b>	
<b>Client Name:</b> Eversource		<b>Site Location:</b> Sudbury to Hudson Transmission Reliability Project	<b>Town:</b> Hudson
<b>Photo No.:</b> 2	<b>Date:</b> 3/20/2023

- Sediment tracking observed on roadway from construction entrance to segments 6 and 7 at White Pond Rd.**
- 
-

<b>Description:</b> View of construction entrance to segments 6 and 7 at White Pond Rd. Sediment tracking observed on roadway (routine maintenance needed). Facing north.

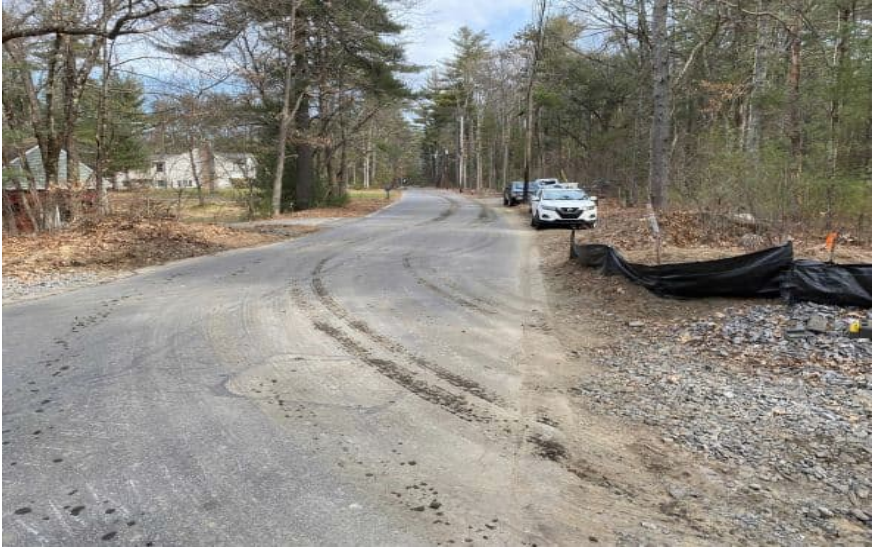
<p>PHOTOGRAPHIC LOG</p>	
<p>Client Name: Eversource</p>		<p>Site Location: Sudbury to Hudson Transmission Reliability Project</p>	<p>Town: Hudson</p>
<p>Photo No.: 4</p>	<p>Date: 3-21-23</p>

<p>Description:                  Debris deposited on White Pond Road, to be removed, looking northward.</p>

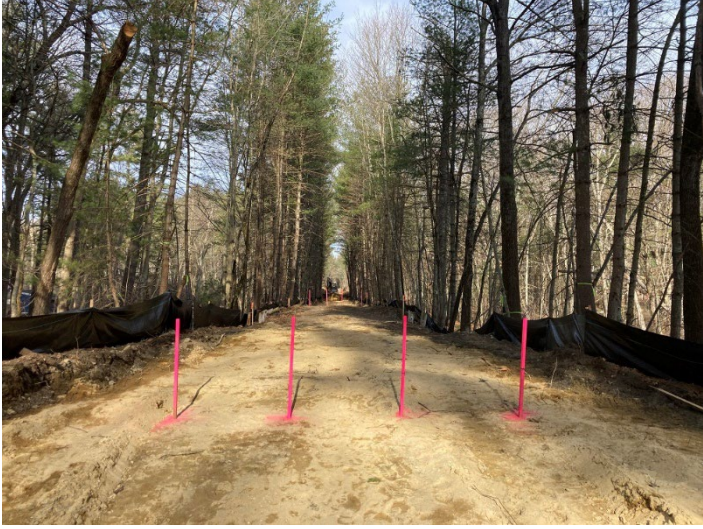
<b>PHOTOGRAPHIC LOG</b>	
<b>Client Name:</b> Eversource		<b>Site Location:</b> Sudbury to Hudson Transmission Reliability Project	
<b>Town:</b> Sudbury			
<b>Photo No.:</b> 5	<b>Date:</b> 3/21/2023

<b>Description:</b> View of Dudley Brook culvert area in segment 10. Barriers are in place to prevent traffic over the culvert. Facing west.

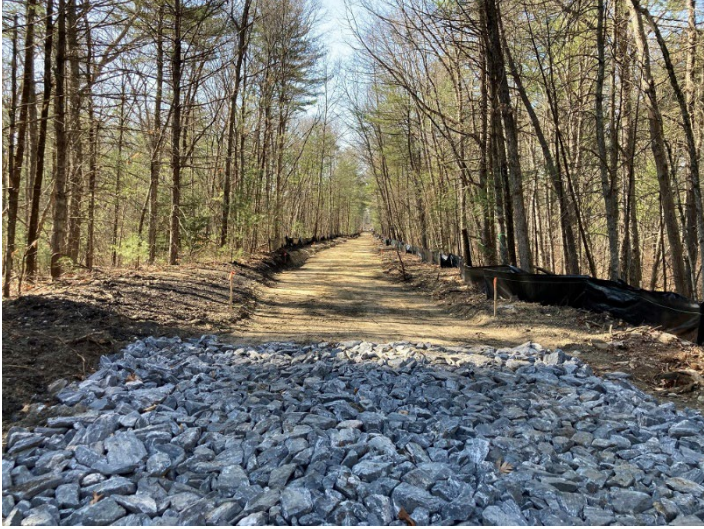
<b>PHOTOGRAPHIC LOG</b>	
<b>Client Name:</b> Eversource		<b>Site Location:</b> Sudbury to Hudson Transmission Reliability Project	
<b>Town:</b> Sudbury			
<b>Photo No.:</b> 6	<b>Date:</b> 3/21/2023

<b>Description:</b> View of segment 8 from construction entrance. E&S controls are operating properly. Facing west.

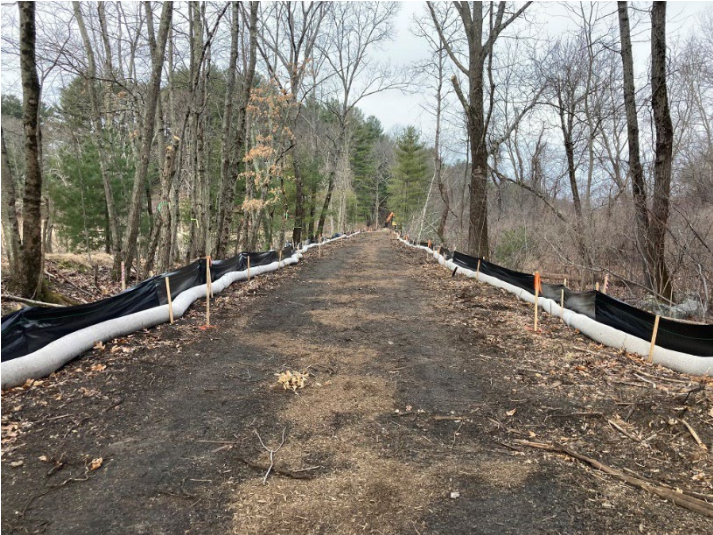
<b>Description:</b> View of west end of segment 14. E&S controls are operating properly. Facing west.

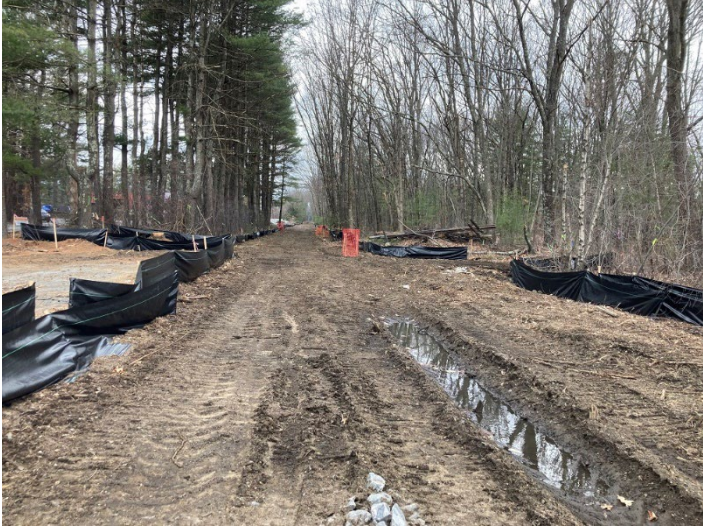
<b>Description:</b> View of segment 11 from construction entrance at Union Ave. E&S controls are operating properly. Facing west.

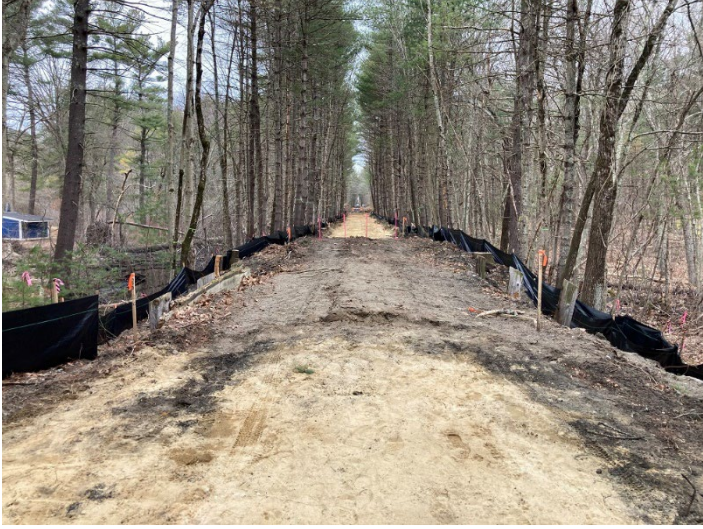
<b>Description:</b> View of Dudley Brook culvert area in segment 10. Barriers are in place to prevent traffic over the culvert. Facing west.

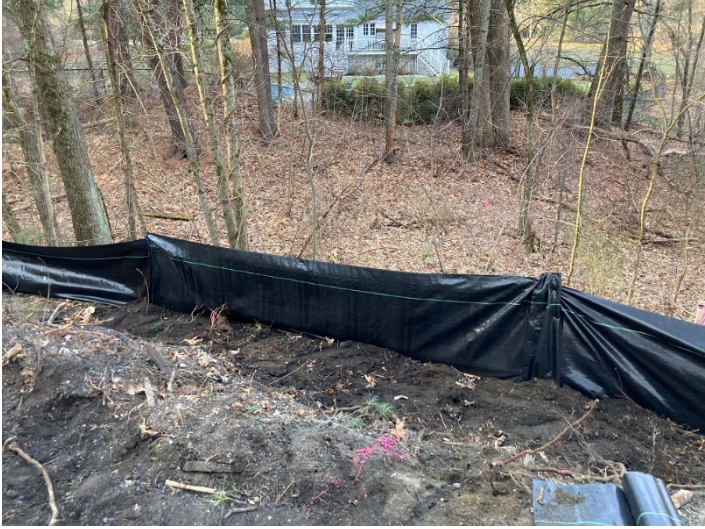
<b>Description:</b> View of silt fence repair made at Sta. #521+50/ Sta. #326+60 in segment 9 at request of Sudbury CC agent. Facing south.

-E&S repairs requested in segments 9, 11, and 12 by Lori Capone (Sudbury CC agent) were completed and approved.

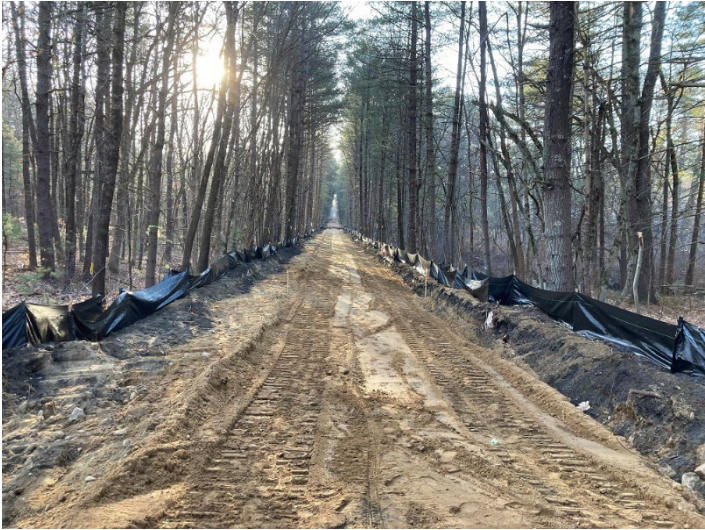
<b>Description:</b> View of syncopated silt fence in segment 10. Facing east.

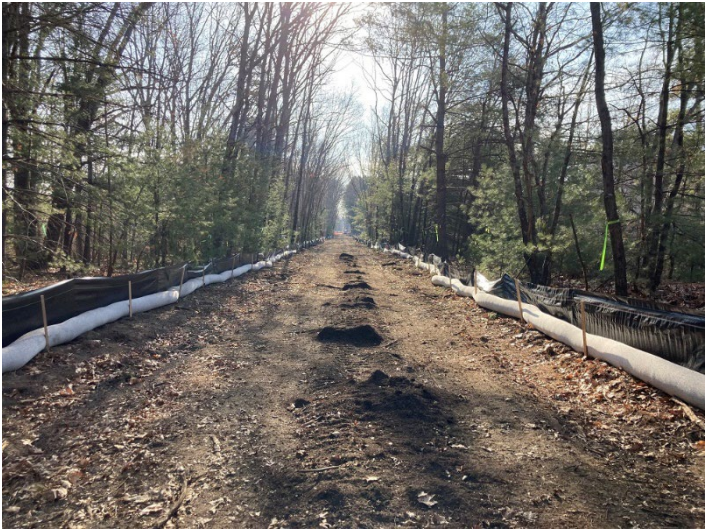
<b>Description:</b> View of E&S controls in segment 11. Facing west.

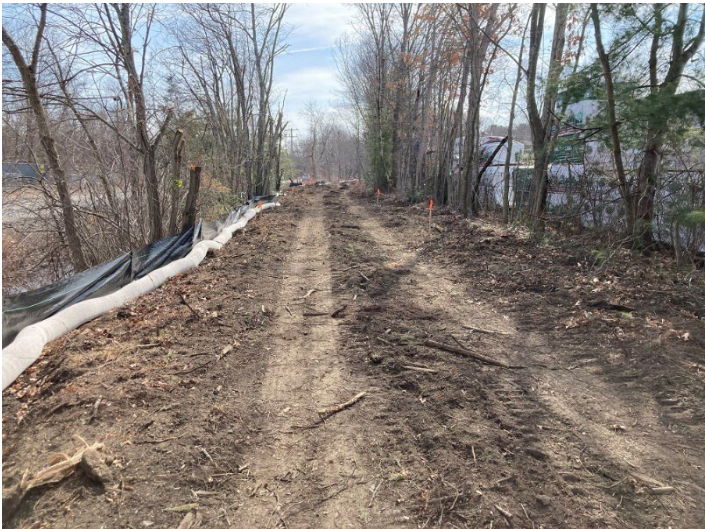
<b>Description:</b> View of E&S controls in segment 12. Facing east.

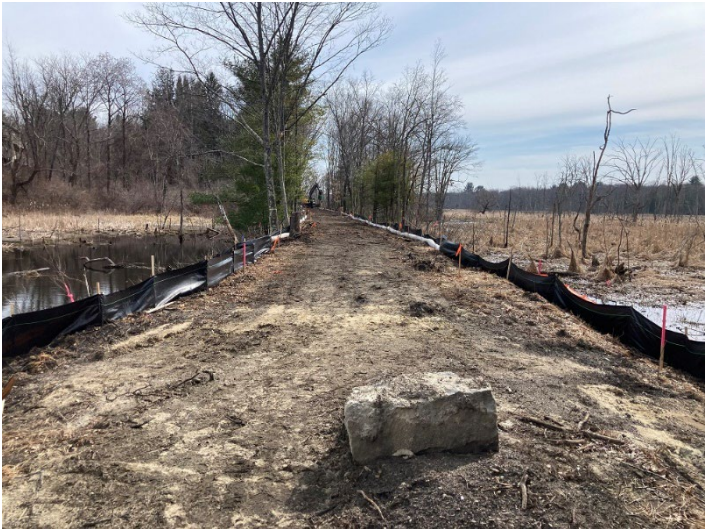
<b>Description:</b> View of E&S controls at west end of segment 14 from bridge 127. Facing east.

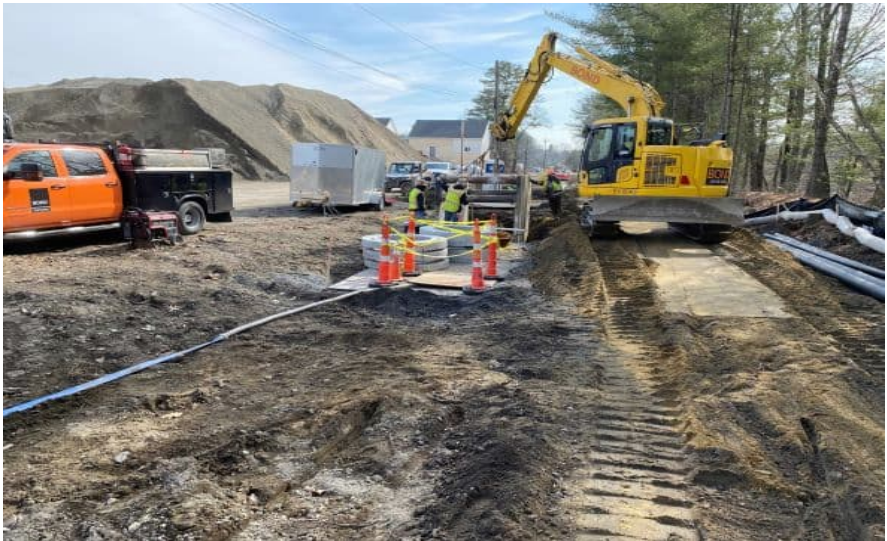
Description: View of pumping operation at MH#8, looking eastward. This is the location of dewatering water prior to treatment. Water appeared to be clear.

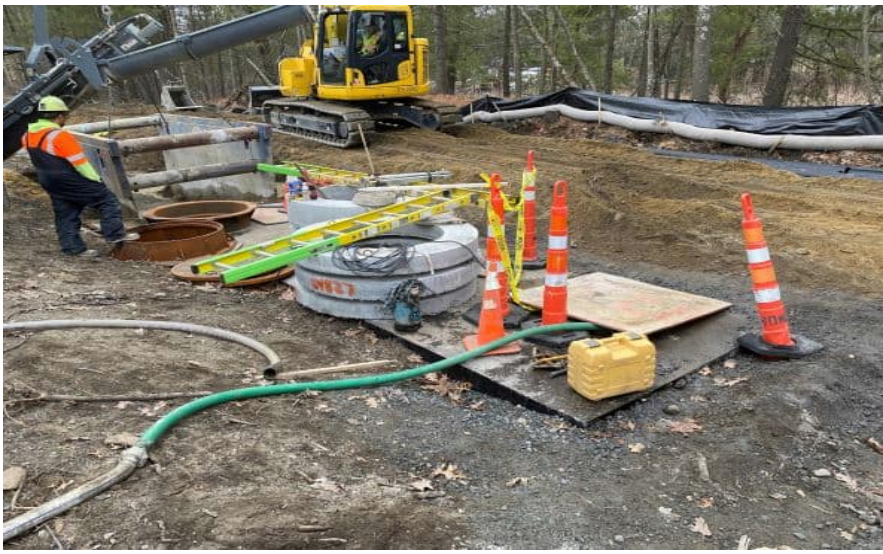
Description: View of pumping operation at MH#8, looking eastward. This is the location of dewatering water prior to treatment. Water appeared to be clear.

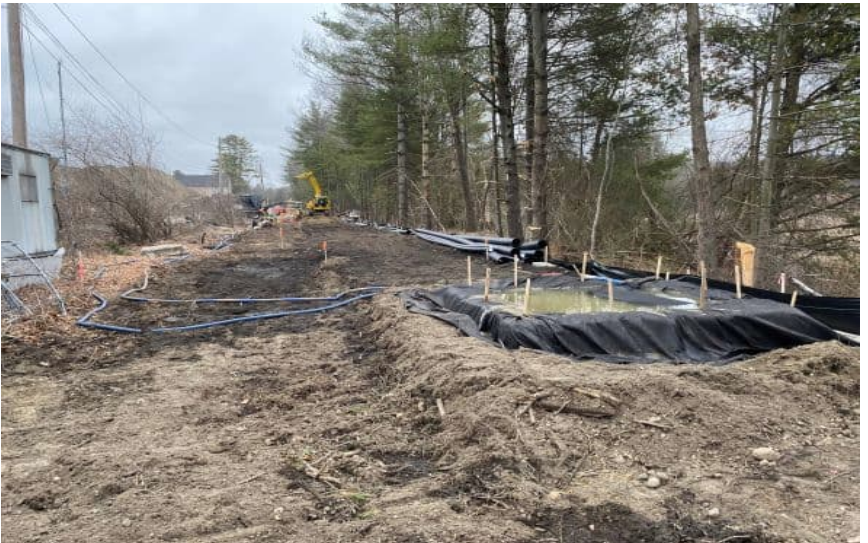
Description: MH#8. View of discharge location, looking eastward. Water appeared to be clear.

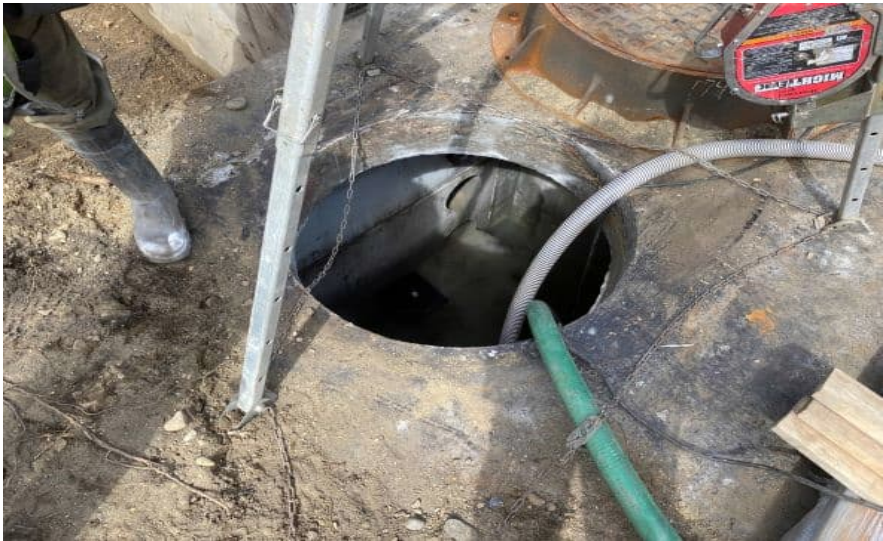
Description: View of pumping operation at MH#7. This is the location of dewatering water prior to treatment. Water appeared to be clear.

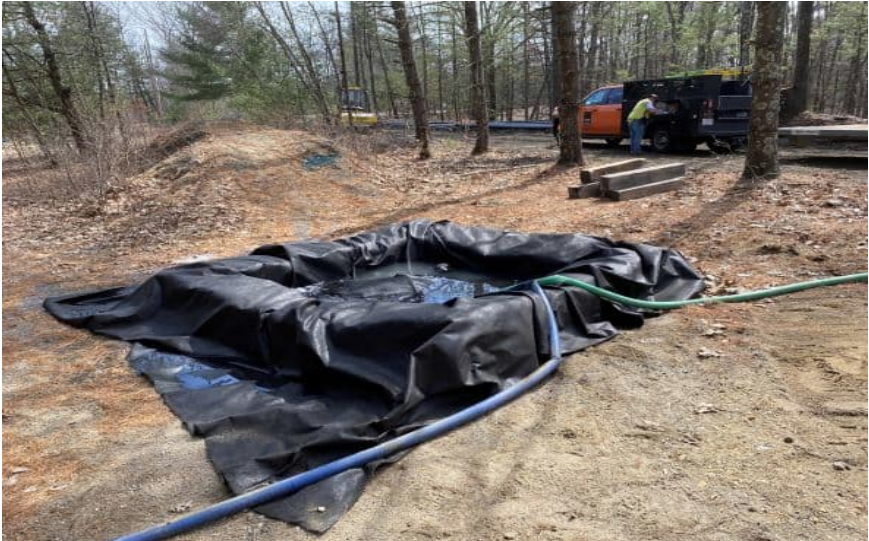
Description: MH#7. View of discharge bag/bale corral, looking eastward. Water appeared to be clear.
