Client: Town of Sudbury
 Project Name: Sudbury-Hudson Transmission Reliability
 Inspector: Jeffrey Polidor
 Project No: 22012F
 Inspection Date: 3/30/23 Arrival Time: 7:00 AM
 Weather: Clear, 35°F Departure Time: 10:30 AM

Sudbury to Hudson
 115kV Underground Transmission Line
 Sudbury - Hudson, MA
 Date: November 16, 2018

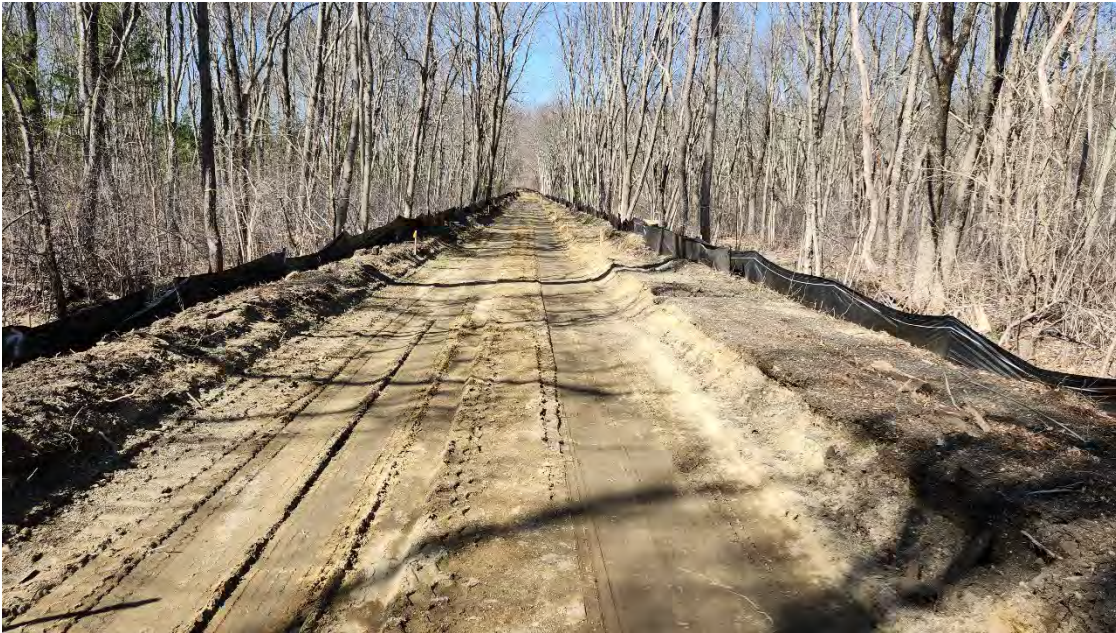
Photo 1: Silt fence functioning properly along segment 14.
Photo taken on 3/30/23

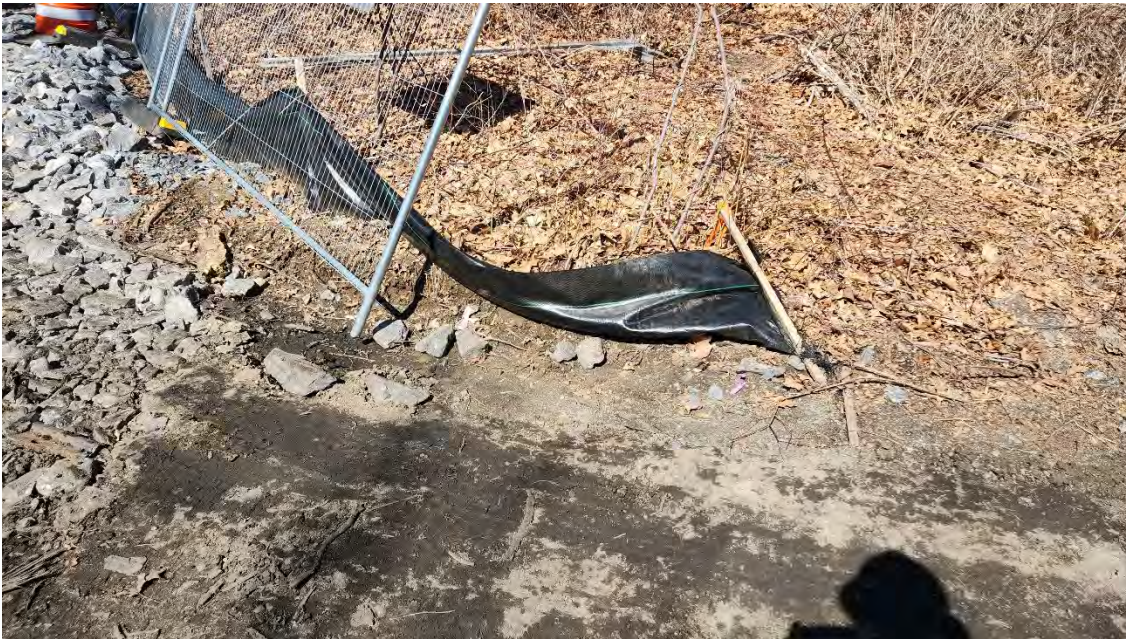
- Silt fence has been installed and is functioning properly along segments 7, 9, 10, 11, 13 and 14 (Photos 1, 3, 5-7, and 9).
- Stakes in the silt fence were broken and need to be replaced along segments 8 and 12, as well as at construction entrance STA476+00. (Photos 2, 4, and 8).
- Silt fence along segment 12 also has noticeable sagging in close proximity to Hop Brook (Photo 4).

Photo 2: Broken silt fence stake that needs to be replaced at construction entrance (SUB STATION).

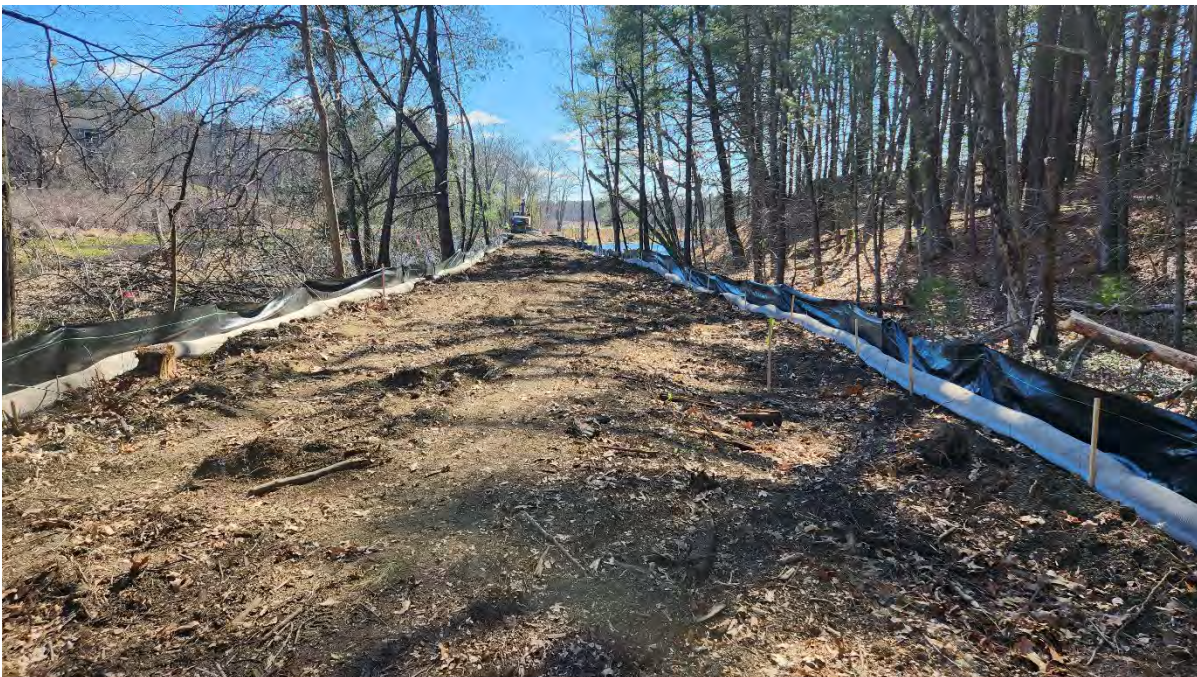
Photo 3: Silt fence and filter tubes functioning properly along segment 13.

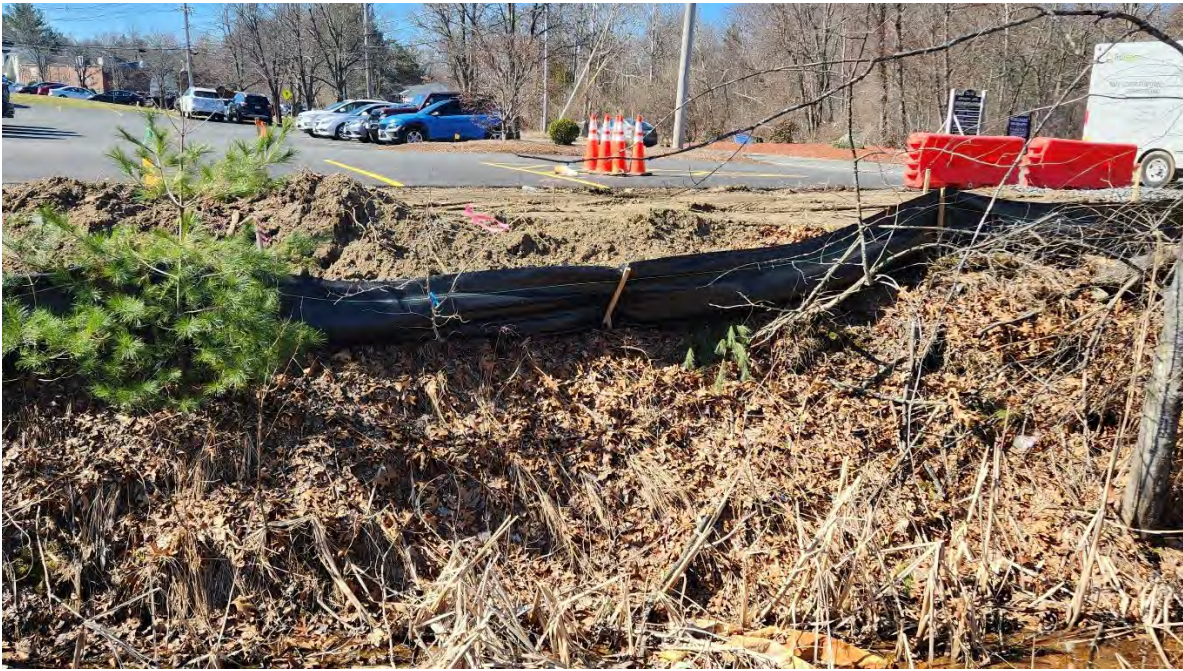
Photo 4: Broken silt fence stake and notable sagging in the fence along segment 12.
Photo taken on 3/30/23

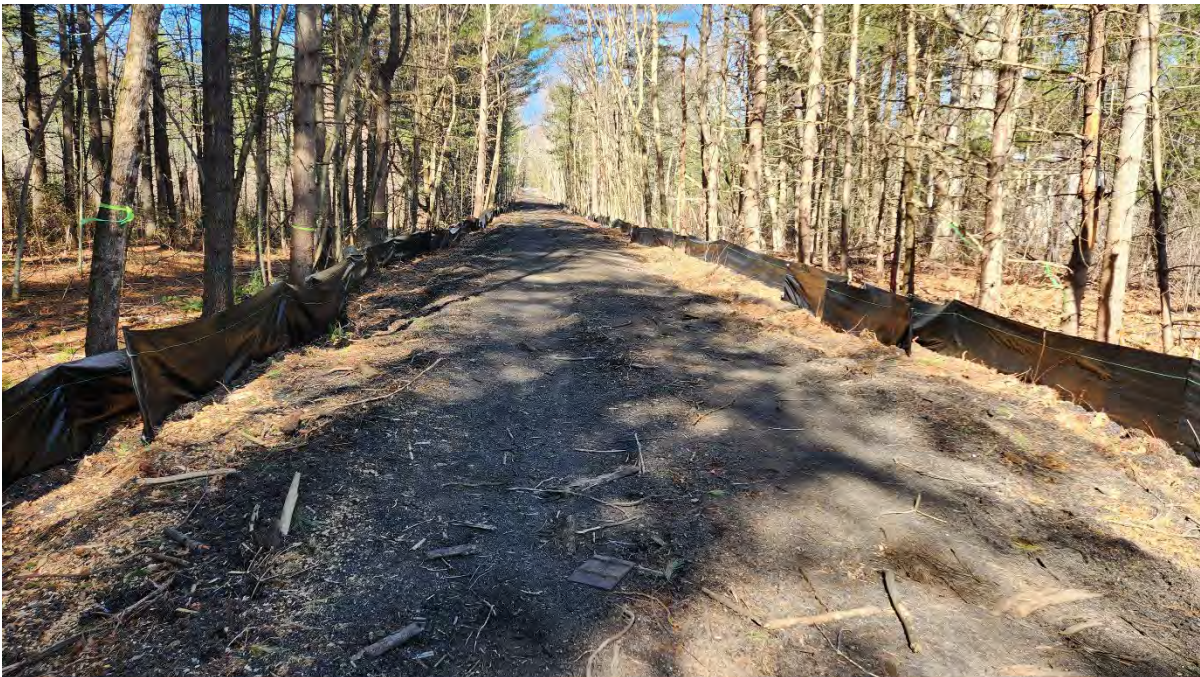
Photo 5: Silt fence functioning properly along segment 11.
Photo taken on 3/30/23

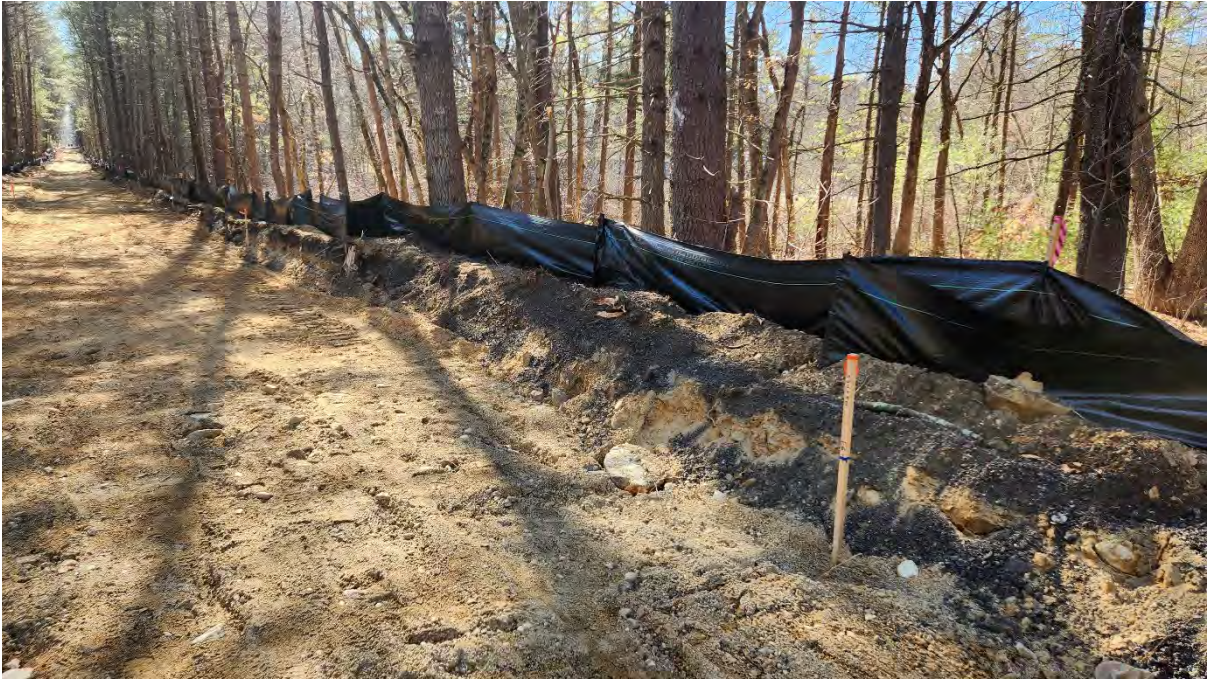
Photo 6: Silt fence functioning properly along segment 10.
Photo taken on 3/30/23

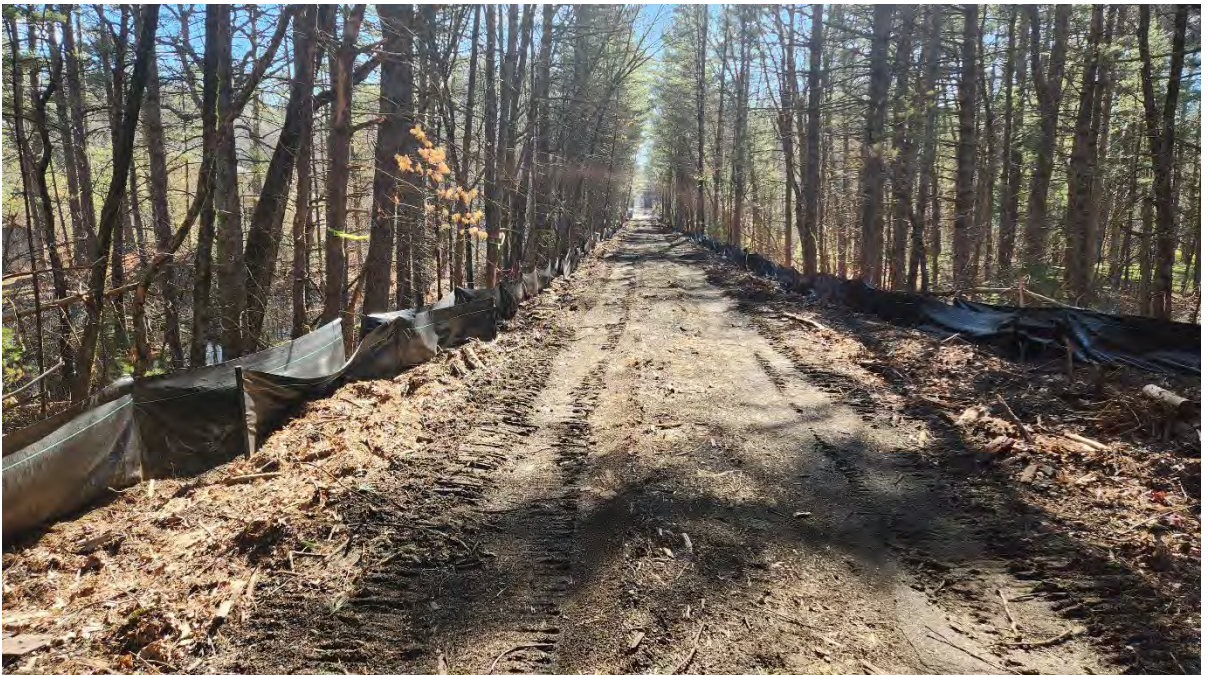
Photo 7: Silt fence functioning properly along segment 9.
Photo taken on 3/30/23

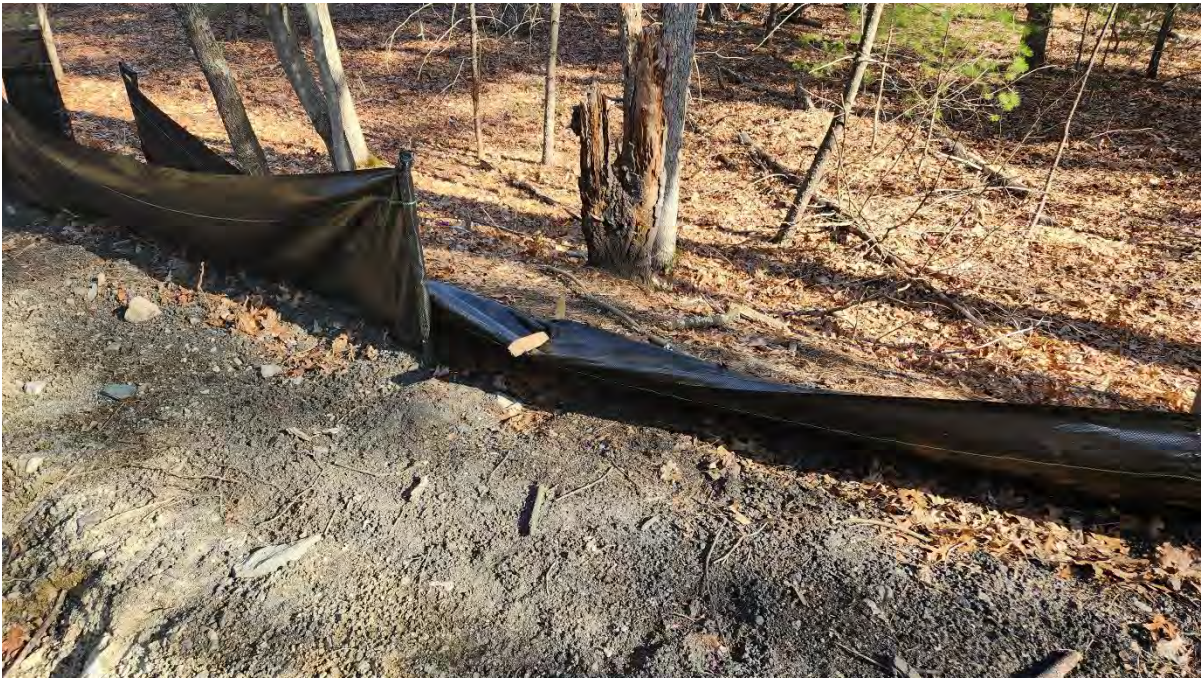
Photo 8: Broken stake in the silt fence along segment 8.
Photo taken on 3/30/23

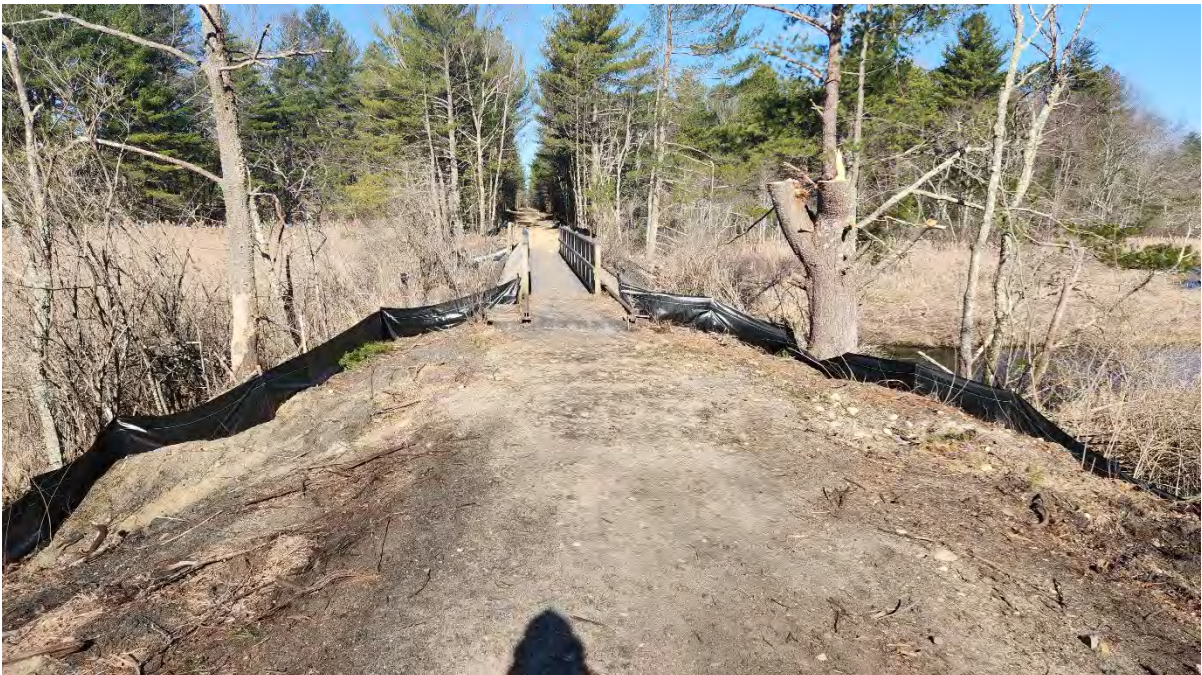
Photo 9: Silt fence functioning properly at Hop Brook Bridge along segment 7.
Photo taken on 3/30/23
