Horsley Witten Group, Inc.

Client: ..... Town of Sudbury  
 Project Name: ..... Sudbury-Hudson Transmission Reliability  
 Inspector: ..... Jeffrey Polidor  
 Project No: ..... 22012F  
 Inspection Date: 4/20/23 Arrival Time: ..... 2:00 PM  
 Weather: ..... Sunny, 60°F Departure Time: ..... 5:00 PM

Sudbury to Hudson  
 115kV Underground Transmission Line  
 Sudbury - Hudson, MA  
 Date: November 16, 2018

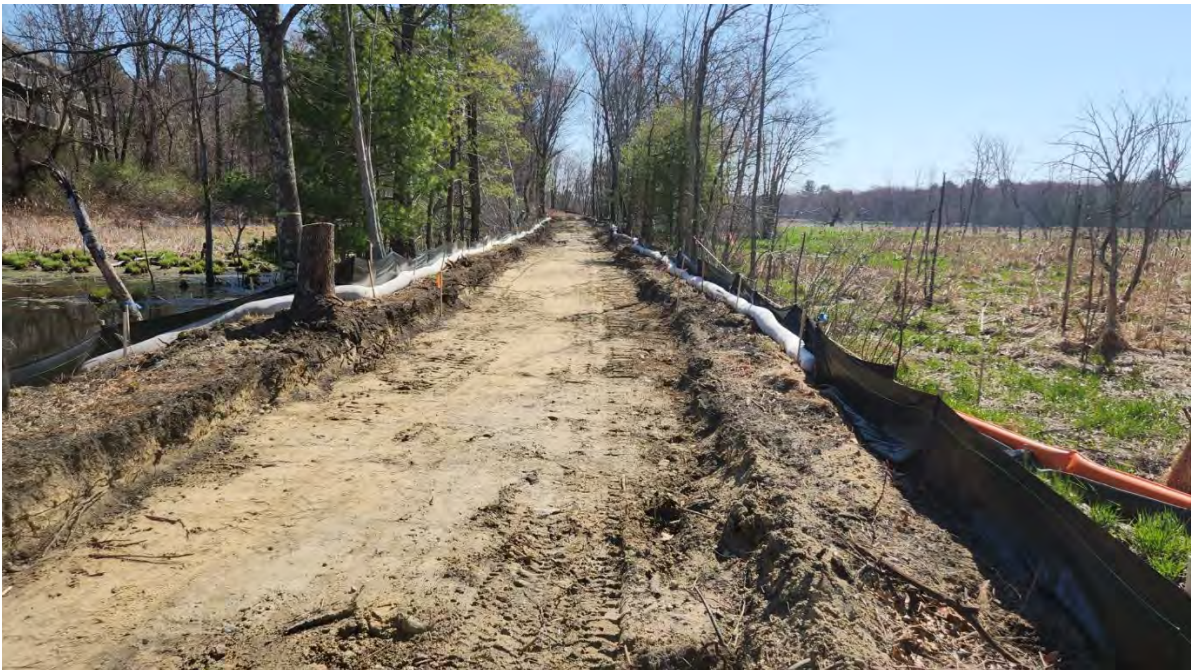
**Photo 1:** Silt fence and filter tube functioning properly along segment 14.  
Photo taken on 4/20/23

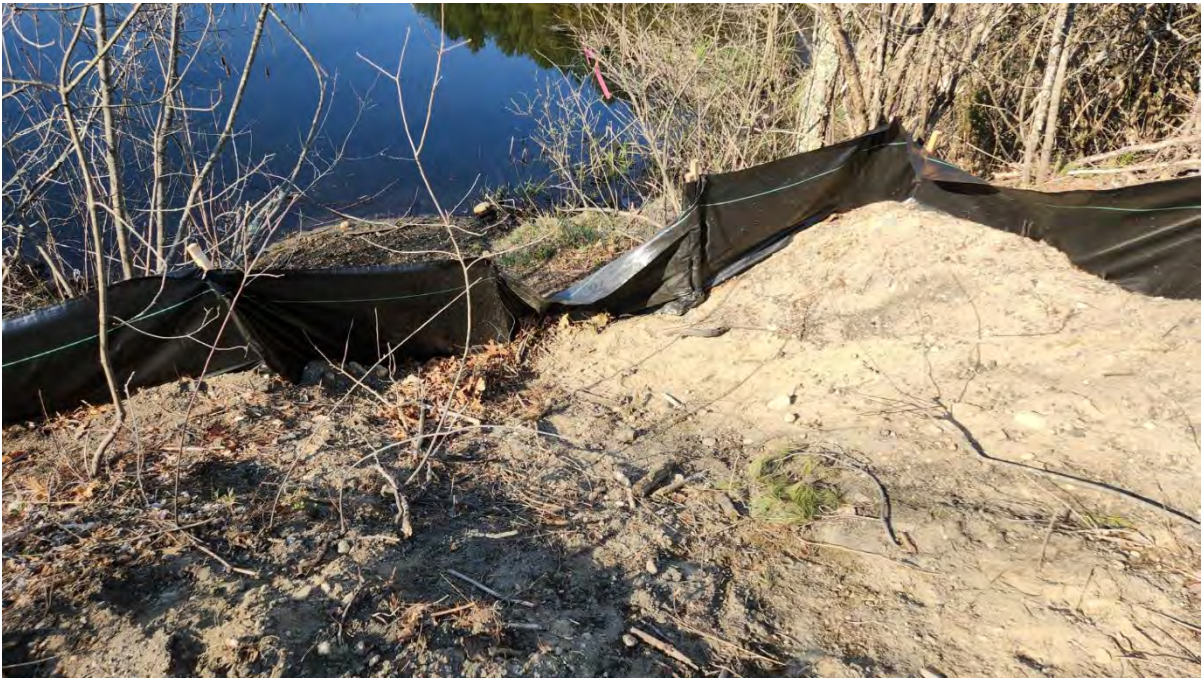
**Photo 2:** Notable sagging in the silt fence along segment 13 near Hop Brook Bridge.  
Photo taken on 4/20/23

1. Repair silt fence as noted above.
2. Monitor construction entrance STA407+50. If sediment is visible on roadway add stones to entrance areas.

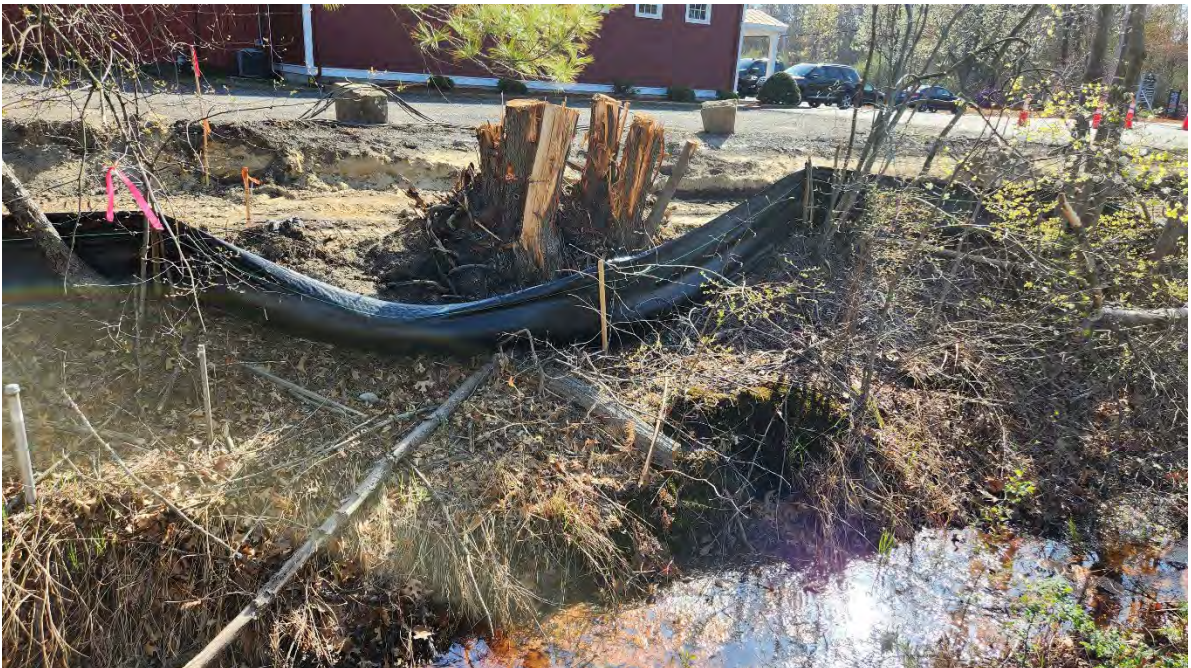
**Photo 3:** Notable sagging in the silt fence along segment 12.  
Photo taken on 4/20/23

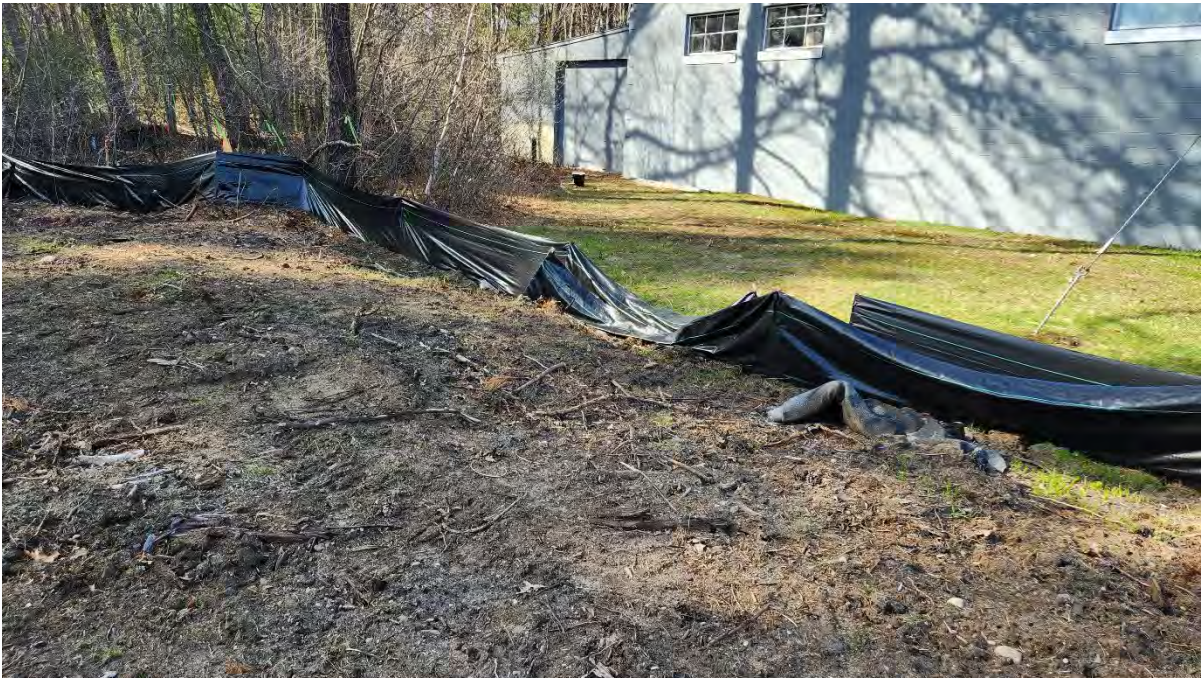
**Photo 4:** Broken stake in the silt fence along segment 11 near construction entrance STA407+50. Photo taken on 4/20/23

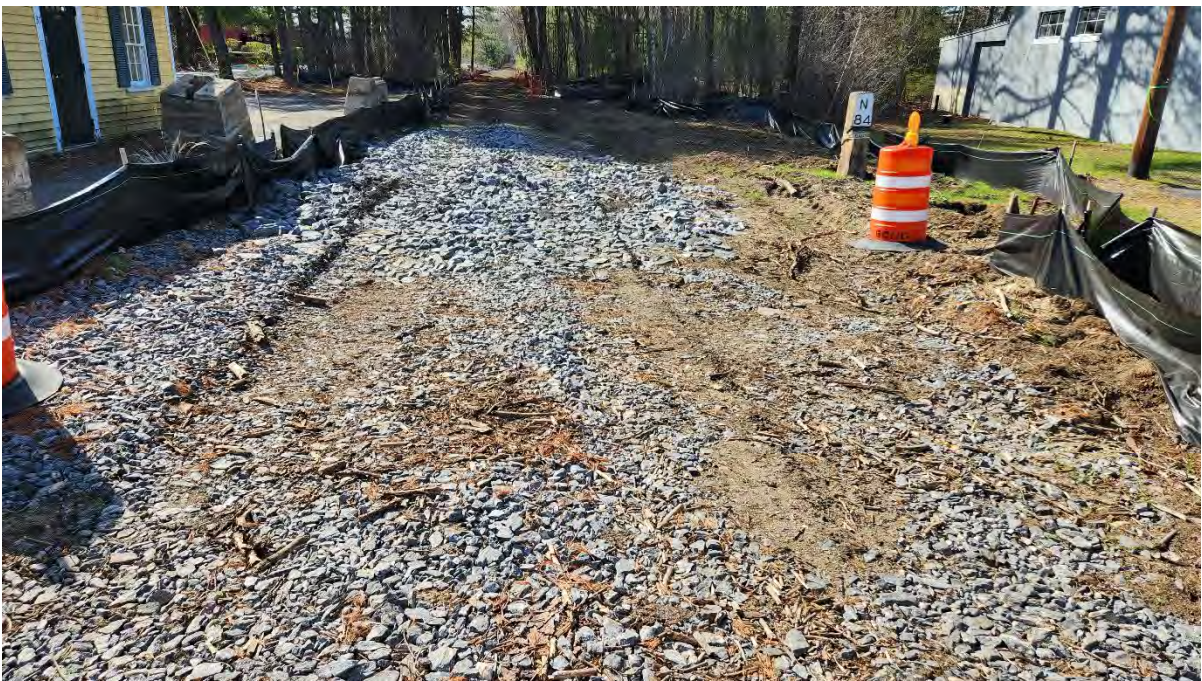
**Photo 5:** Construction entrance STA407+50 has visible dirt and should be monitored. Photo taken on 4/20/23

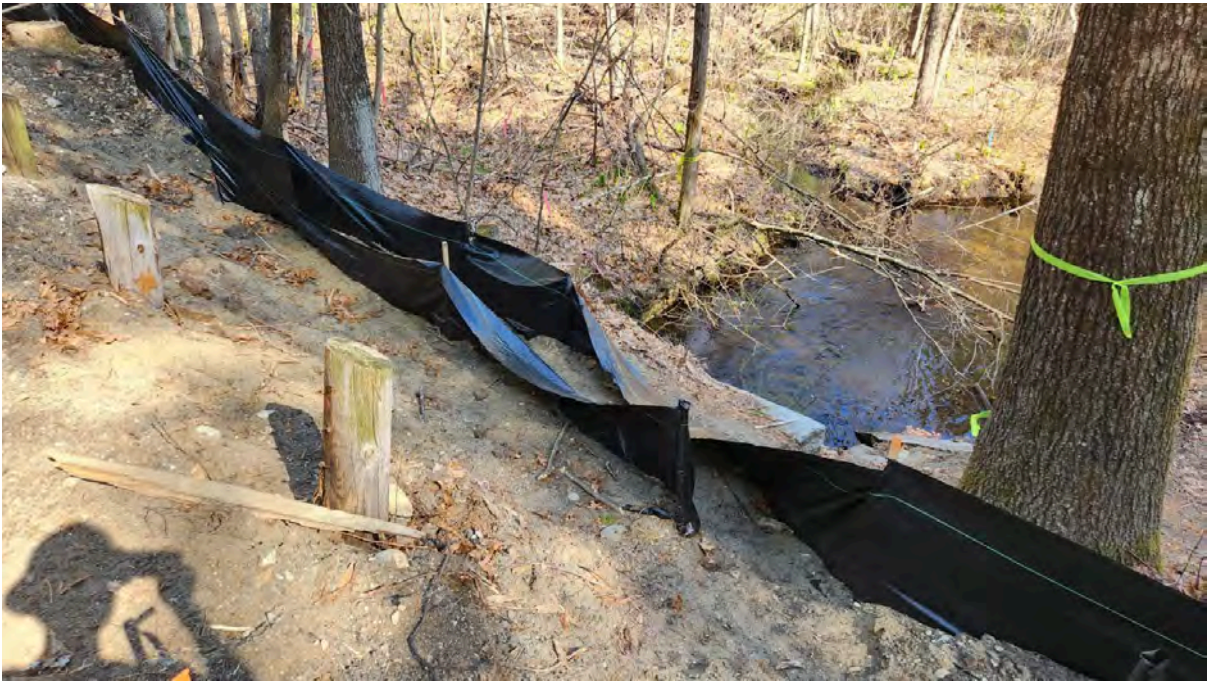
**Photo 6:** Silt fence sagging along segment 10 near Dudley Brook.  
Photo taken on 4/20/23

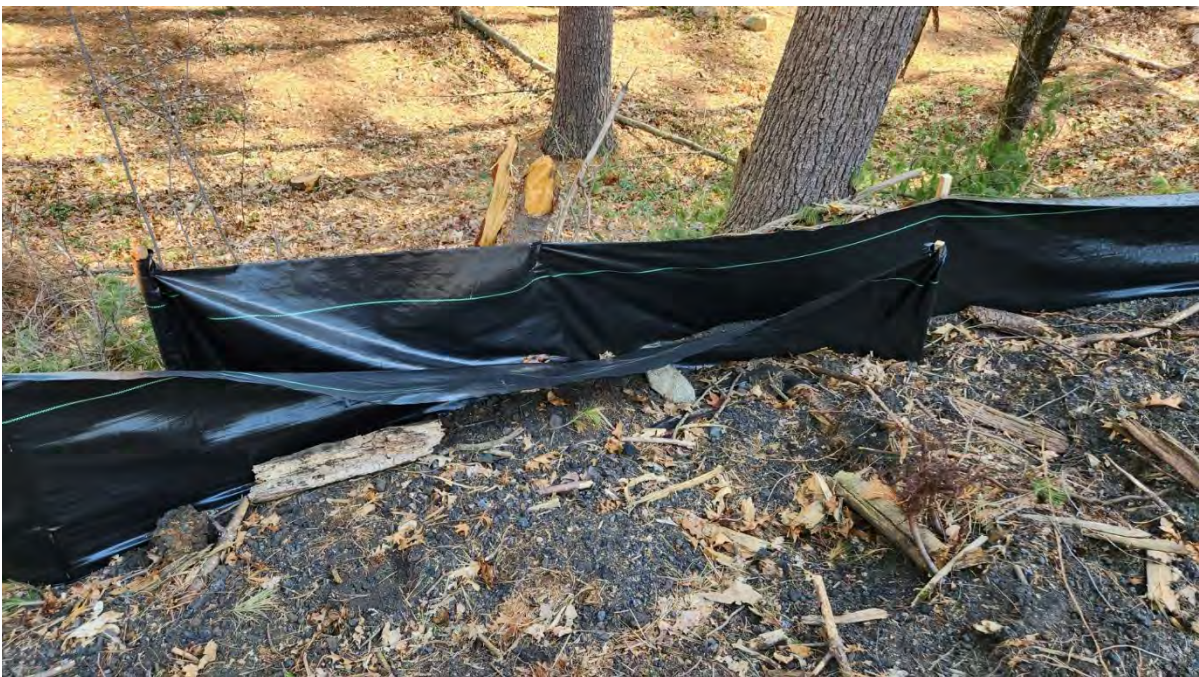
**Photo 7:** Silt fence sagging along segment 9 near construction entrance STA 335+50.  
Photo taken on 4/20/23

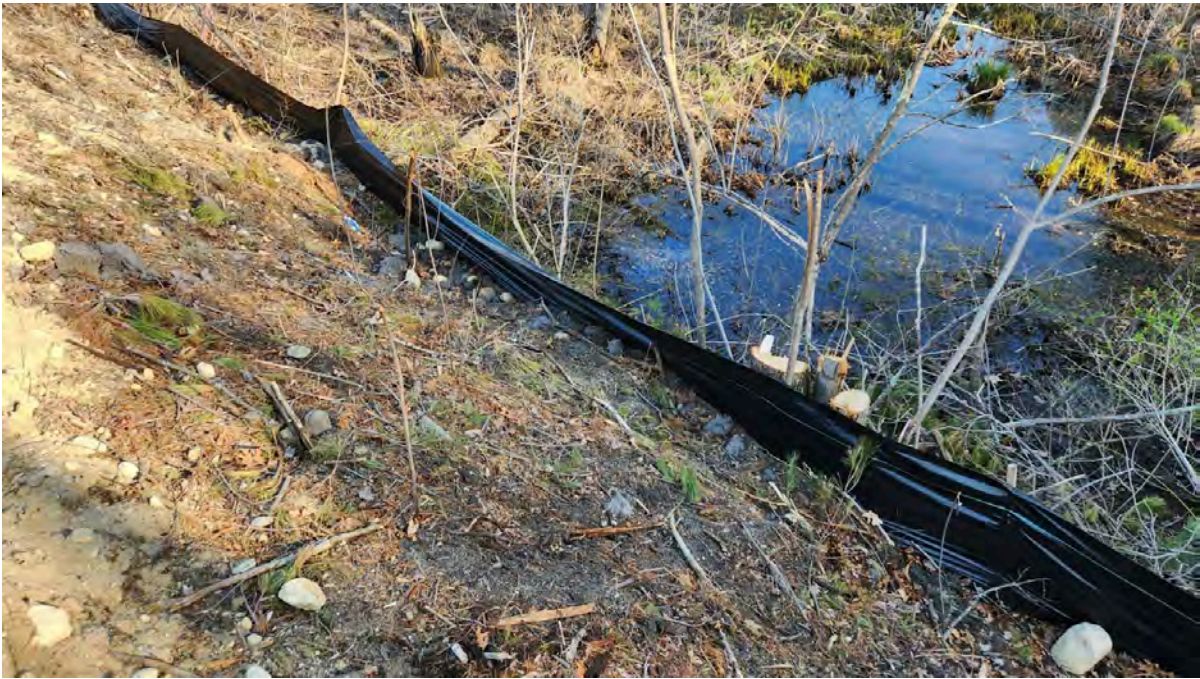
**Photo 8:** Silt fence sagging at Hop Brook Bridge along segment 8.  
Photo taken on 4/20/23

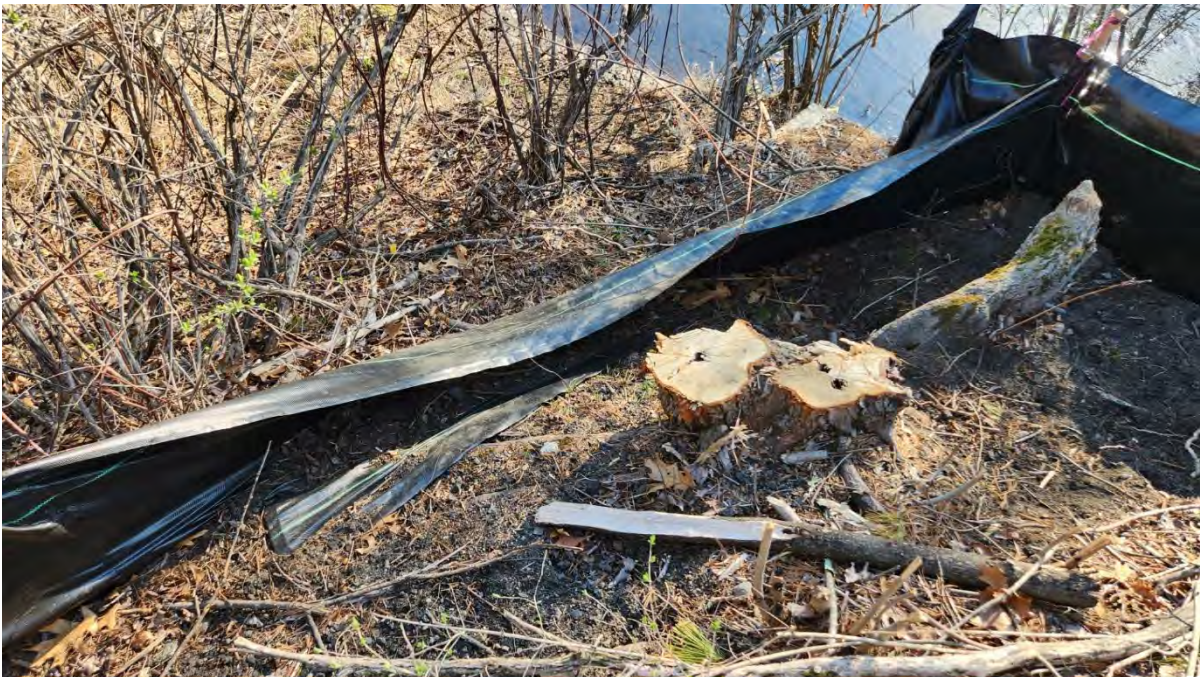
**Photo 9:** Silt fence sagging at Hop Brook Bridge along segment 7.  
Photo taken on 4/20/23
