Weekly Environmental Compliance Summary

Sudbury to Hudson Transmission Reliability Project (USEPA Tracking # MAR1003UW)

Week of: March 27 to March 31, 2023

CONSTRUCTION MONITORING REPORT
Sudbury to Hudson Transmission Project

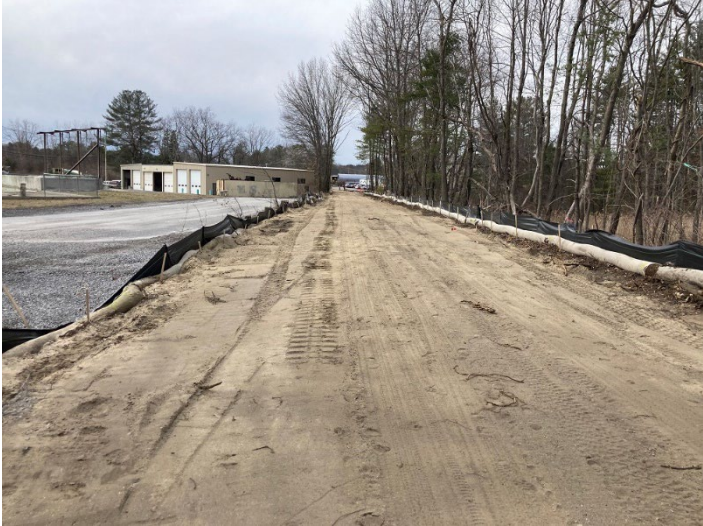
PHOTOGRAPHIC LOG	
Client Name: Eversource		Site Location: Sudbury to Hudson Transmission Reliability Project	Town: Hudson
Photo No.: 4	Date: 3/27/2023

Description: View of segment 3. Meeting is scheduled for 3/30/2023 to discuss drainage issue within the ROW in this segment. Erosion control repairs in this area are pending. Facing west.

-Meeting is scheduled for 3/30/2023 to discuss drainage issue within the ROW in Segment 3. Erosion control repairs in this area are pending.

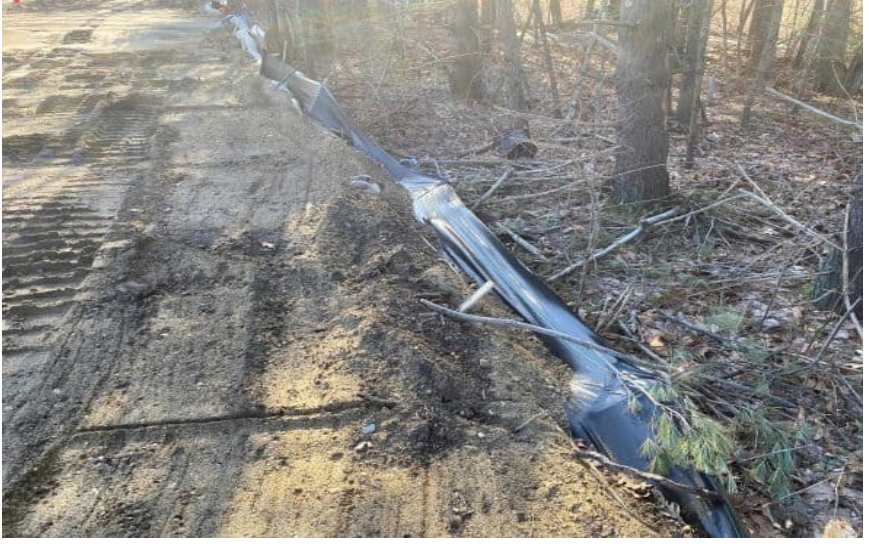
<p>PHOTOGRAPHIC LOG</p>	
<p>Client Name: Eversource</p>		<p>Site Location: Sudbury to Hudson Transmission Reliability Project</p>	<p>Town: Hudson</p>
<p>Photo No.: 6</p>	<p>Date: 3-29-23</p>

<p>Description:</p> <p>Erosion control damaged within Segment 3 from approximate Sta# 158+00 to Sta# 165+25, ET&L contacted to replace silt fencing & compost filter tubes, looking eastward.</p>

***Erosion control damaged within Segment 3 from approximate Sta# 158+00 to Sta# 165+25, ET&L contacted to replace silt fencing & compost filter tubes.**

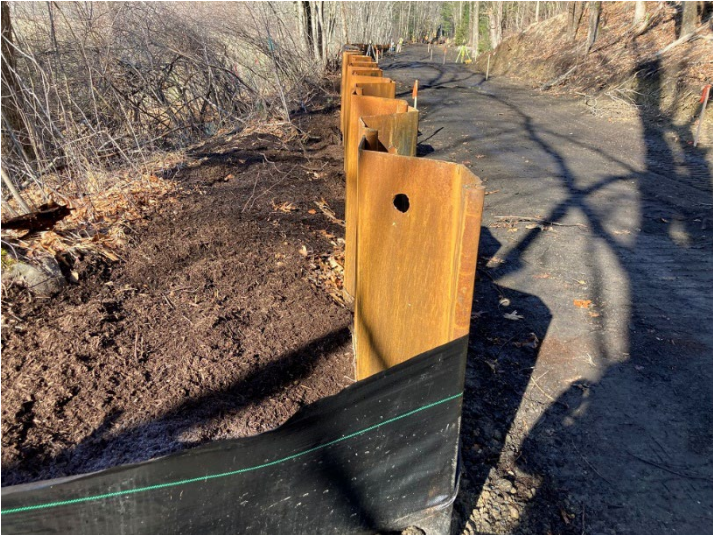
PHOTOGRAPHIC LOG	
Client Name: Eversource		Site Location: Sudbury to Hudson Transmission Reliability Project	Town: Sudbury
Photo No.: 2	Date: 3/29/2023

Description: View of eastern end of sheetwall #13 in segment 14. Mulch is being spread behind sheetwall for stabilization. Facing west.

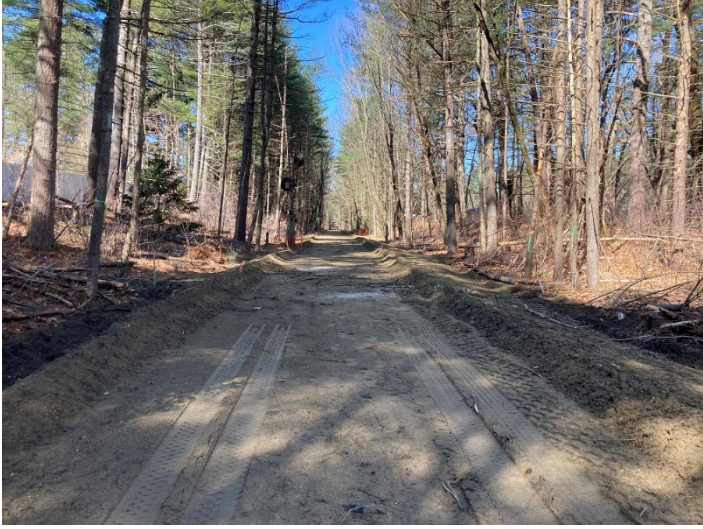
PHOTOGRAPHIC LOG	
Client Name: Eversource		Site Location: Sudbury to Hudson Transmission Reliability Project	Town: Sudbury
Photo No.: 5	Date: 3/29/2023

Description: View of eastern end of segment 10. Moosehead cut and removed a fallen tree at this location. Facing west.

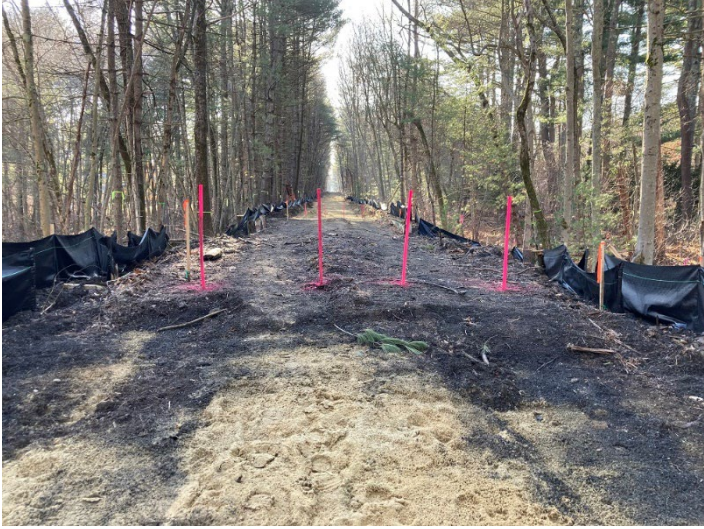
PHOTOGRAPHIC LOG	
Client Name: Eversource		Site Location: Sudbury to Hudson Transmission Reliability Project	Town: Sudbury
Photo No.: 6	Date: 3/29/2023

Description: View of Dudley Brook culvert area in segment 10. Barriers are in place to prevent traffic over the culvert. Facing west.

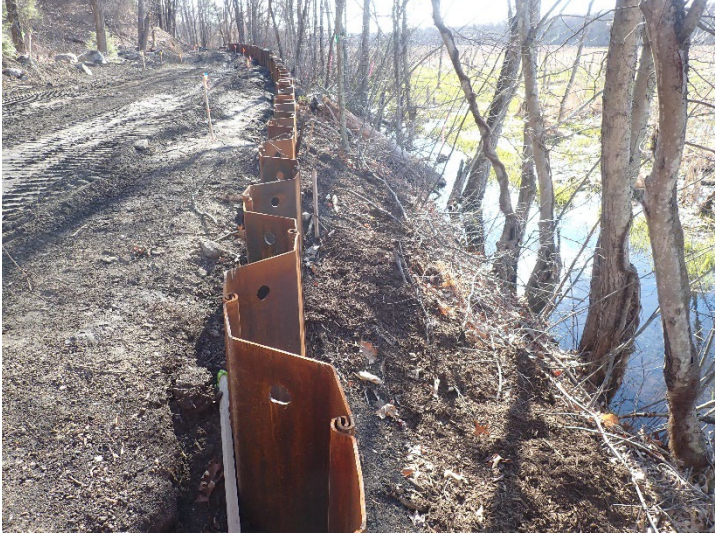
PHOTOGRAPHIC LOG	
Client Name: Eversource		Site Location: Sudbury to Hudson Transmission Reliability Project	Town: Sudbury
Photo No.: 3	Date: 3/30/2023

Description: View of eastern end of sheetwall #13 in segment 14. Mulch was partially spread behind sheetwall for stabilization. Additional mulch will be applied to this area. Facing east.

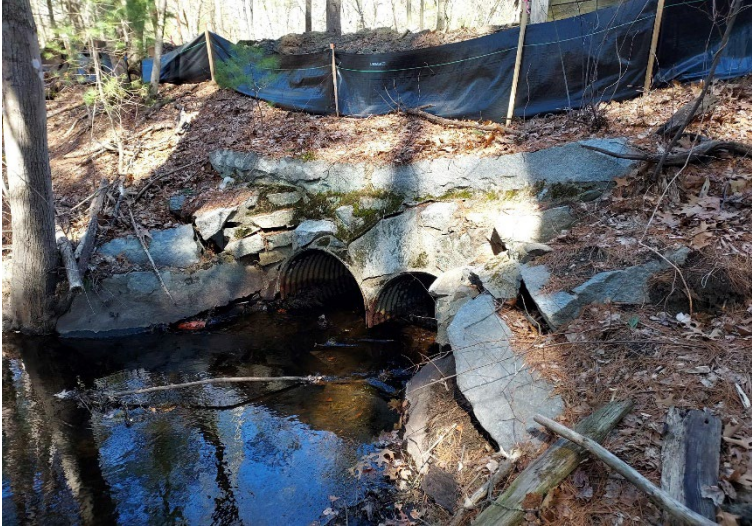
PHOTOGRAPHIC LOG	
Client Name: Eversource		Site Location: Sudbury to Hudson Transmission Reliability Project	Town: Sudbury
Photo No.: 6	Date: 3/30/2023

Description: View of Dudley Brook culvert in segment 10. Barriers are in place to prevent traffic over the culvert. Facing west.

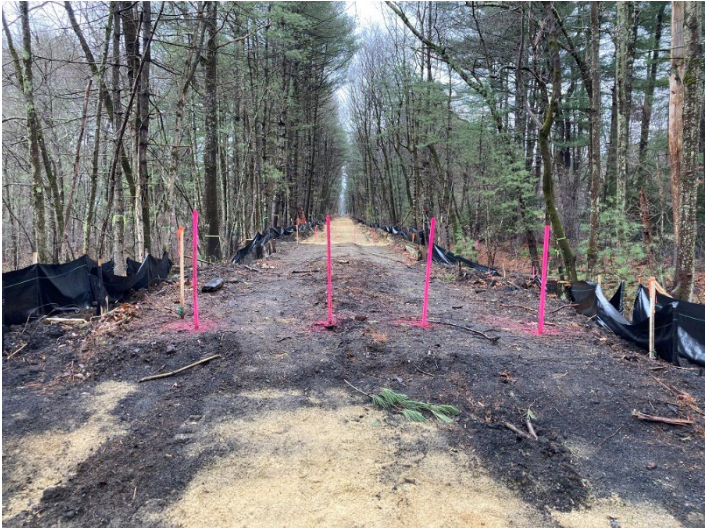
Description: View of Dudley Brook culvert area in segment 10. Barriers are in place to prevent traffic over culvert. Facing east.

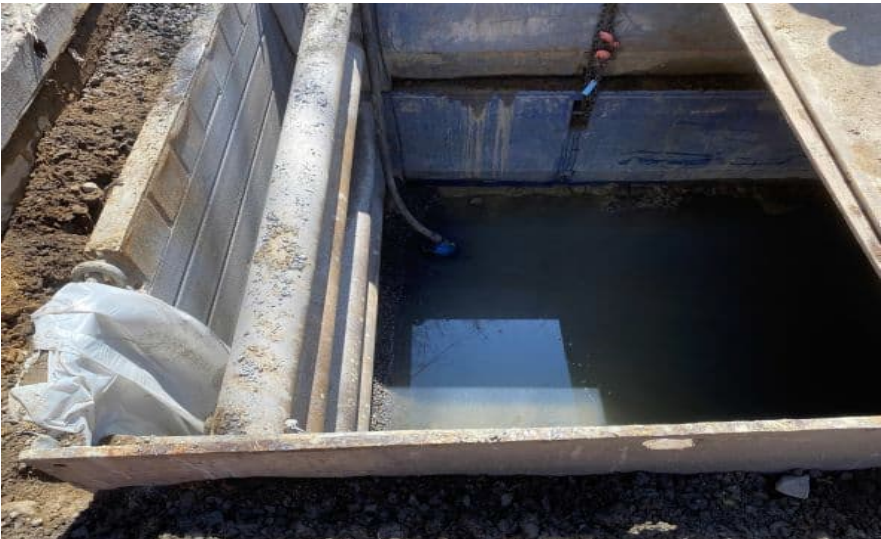
Description: View of pumping operation at MH#5. This is the location of dewatering water prior to treatment. Water appeared to be clear.

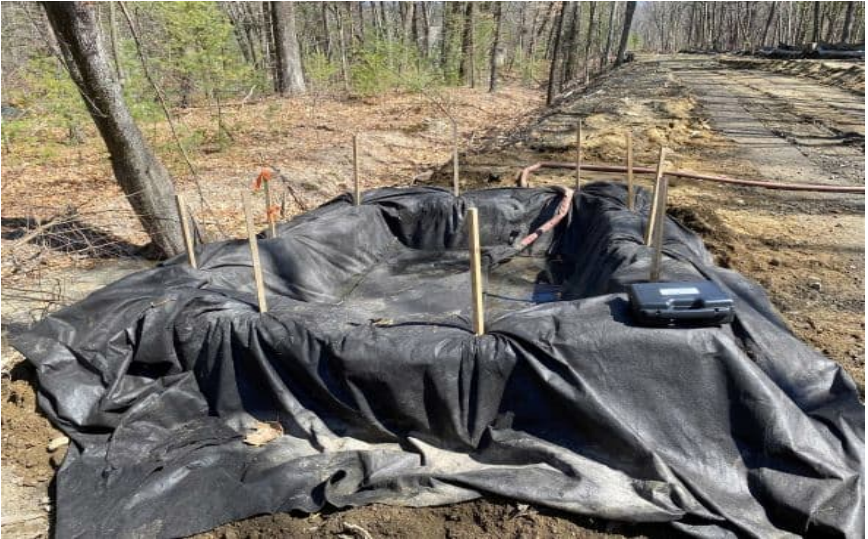
Description: MH#5. View of discharge bag/bale corral, looking eastward. Water appeared to be clear.

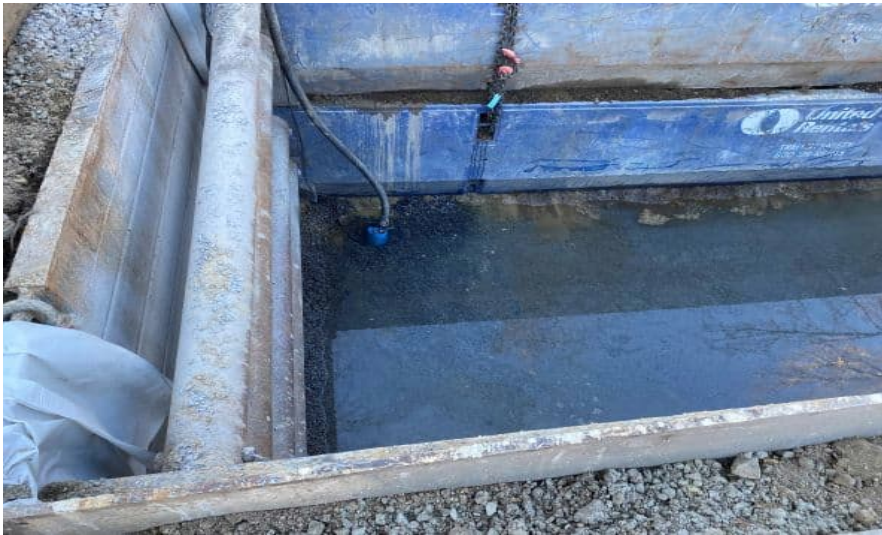
Description: View of pumping operation at MH#5. This is the location of dewatering water prior to treatment. Water appeared to be clear.

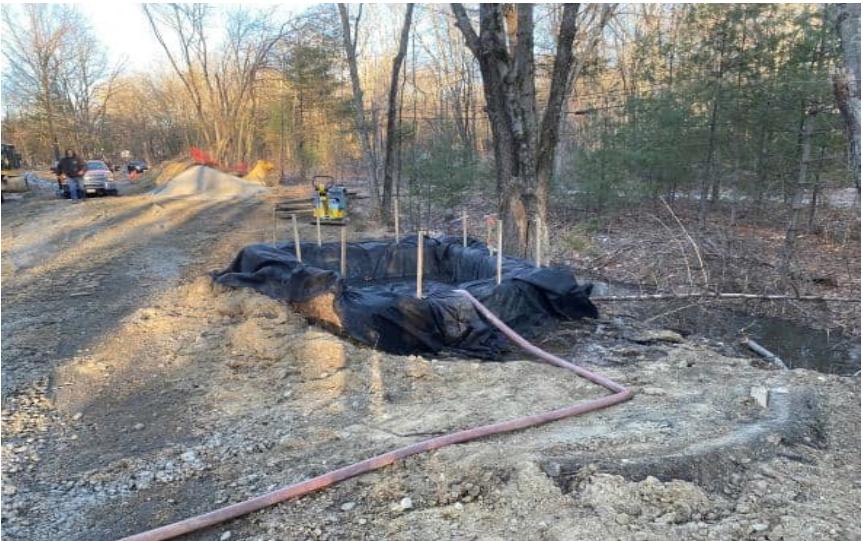
Description: MH#5. View of discharge bag/bale corral, looking eastward. Water appeared to be clear.
