Weekly Environmental Compliance Summary

Sudbury to Hudson Transmission Reliability Project (USEPA Tracking # MAR1003UW)

Week of: April 3 to April 7, 2023

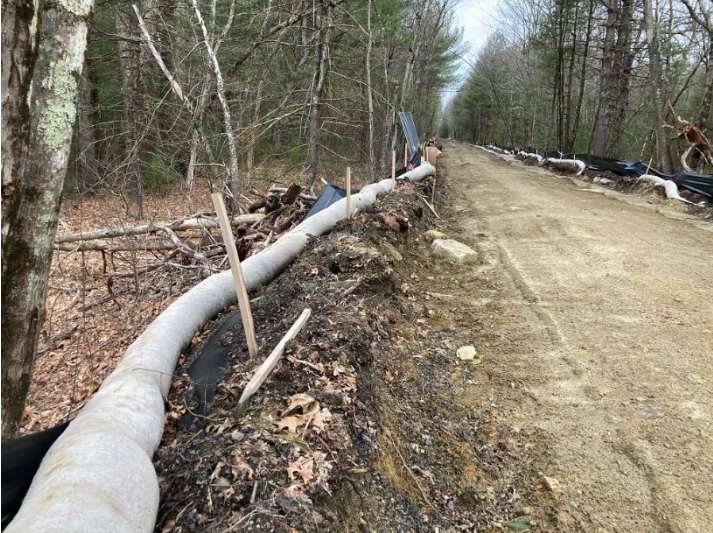
PHOTOGRAPHIC LOG	
Client Name: Eversource		Site Location: Sudbury to Hudson Transmission Reliability Project	Town: Hudson
Photo No.: 2	Date: 4/04/2023

Description: View of damaged E&S controls in segment 5. E&S control repairs needed in segments 2, 3, 4, and 5. Facing west.

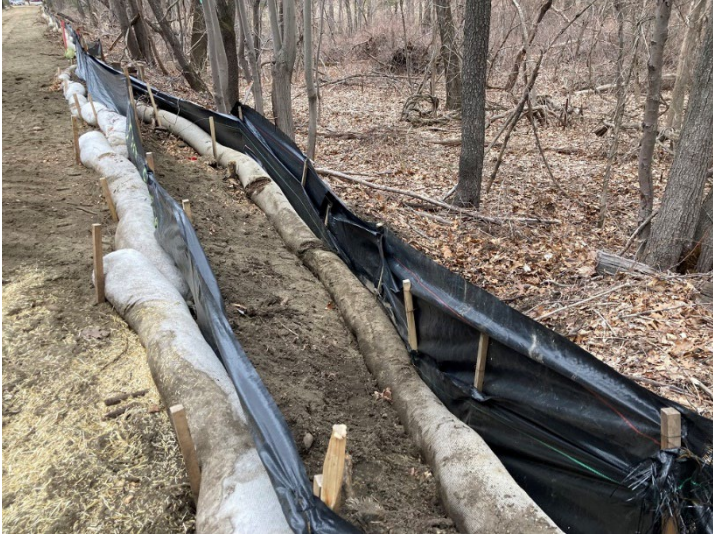
PHOTOGRAPHIC LOG	
Client Name: Eversource		Site Location: Sudbury to Hudson Transmission Reliability Project	Town: Hudson
Photo No.: 3	Date: 4/05/2023

Description: View of Sta. #174/ Sta. #147+75 in segment 3. E&S repairs have been completed in this location. Facing west.

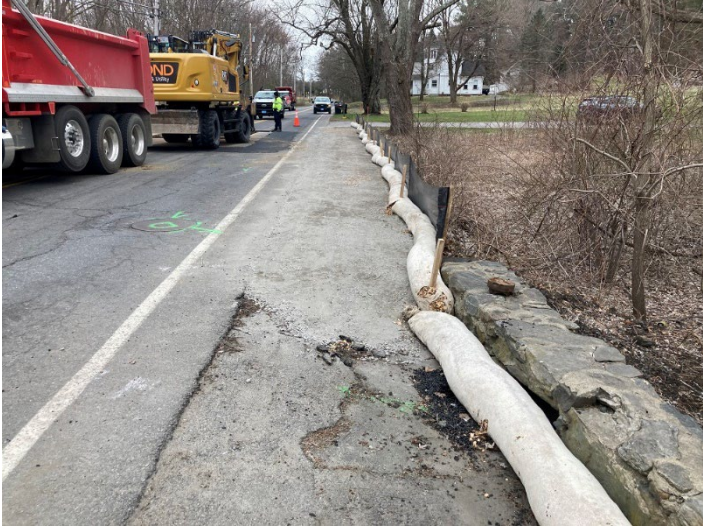
PHOTOGRAPHIC LOG	
Client Name: Eversource		Site Location: Sudbury to Hudson Transmission Reliability Project	
Town: Hudson			
Photo No.: 5	Date: 4/05/2023

Description: View of Bond performing work at MH #4 on Forest Ave. E&S controls are in good condition. Facing south.

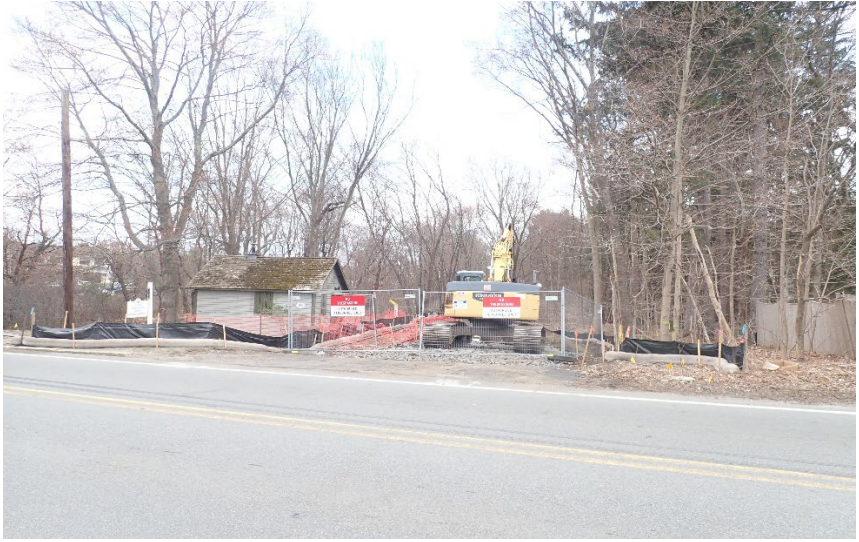
<p>Description:</p> <p>Construction entrance within segment 13. ET&L were working within the Segment 13 Right-of-Way. No sediment tracking observed on the roadway at the end of the workday. Facing east.</p>

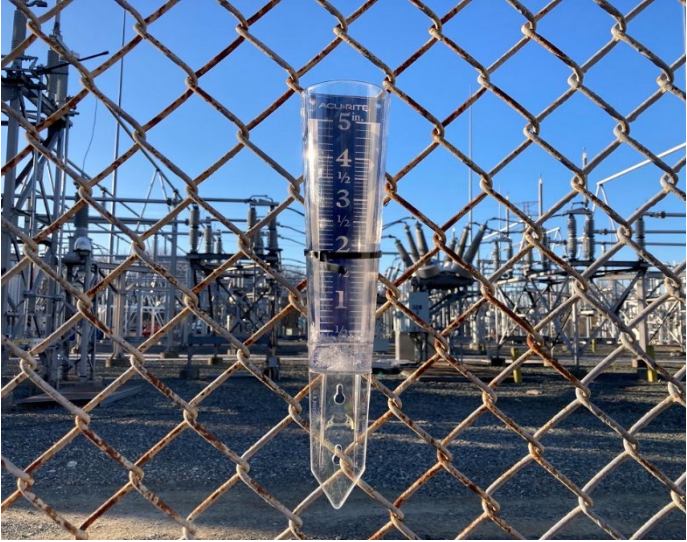
Description: View of rain gauge at Sudbury Substation. 0.30" (frozen) observed in gauge at 7:30am. Facing south.

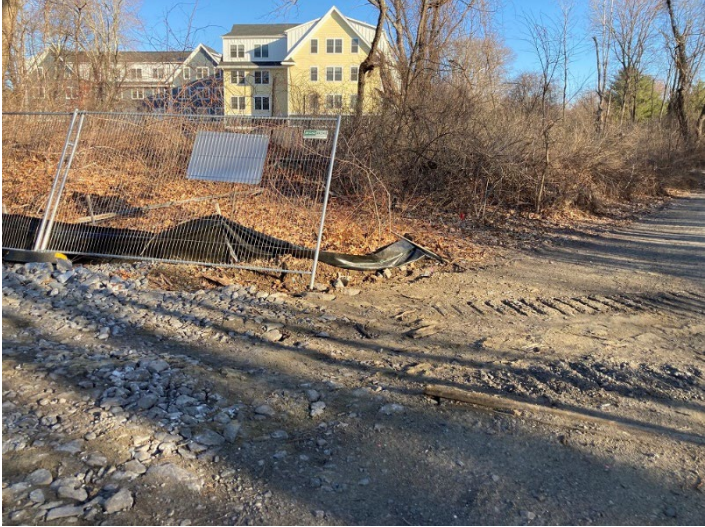
Description: View of construction entrance pad at segment 14. Repair silt fence where damaged (per Horsley Witten report) (routine maintenance). Facing north.

-Repair silt fence where needed in segments 8, 12, and 14 in Sudbury (per Horsley Witten report).

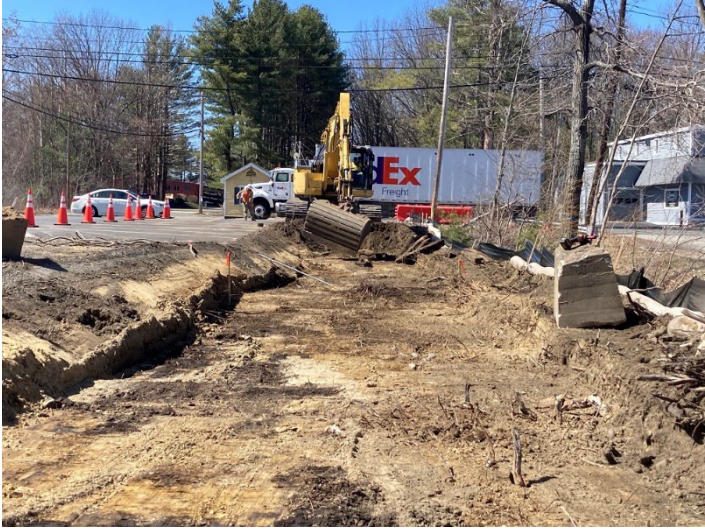
Description: View of ET&L performing cut & fill activities in segment 12. Repair silt fence where damaged in this area (per Horsley Witten report) (routine maintenance). Facing west.

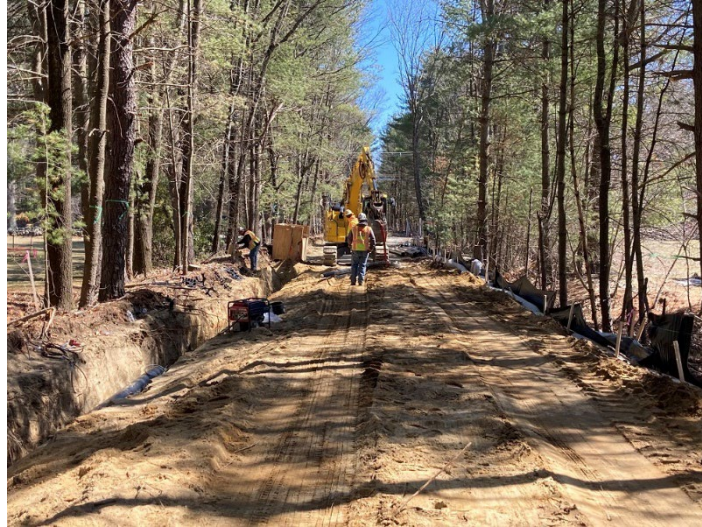
-During rainfall events, stormwater from adjacent property appears to be flowing onto project ROW and discharging through silt fence and filter tubes at approximately Sta. #174/ Sta. #147+75 in segment 3. Small amount of sediment appears to have deposited just beyond silt fence. Sediment did not reach any jurisdictional areas. Meeting was held with E. H. Perkins on 3/30/2023 and project was given permission to go outside of ROW to make repairs if necessary.

View of E&S controls at Sta. #174/ Sta. #147+75. Repair silt fence and filter tubes where damaged in multiple places in segment 3. Remove sediment that has deposited beyond controls at location pictured (corrective action). Facing west.

-Repair silt fence and filter tubes where damaged in multiple places in segment 3. Remove small amount of sediment that has deposited just beyond controls at Sta. #174/ Sta. #147+75.

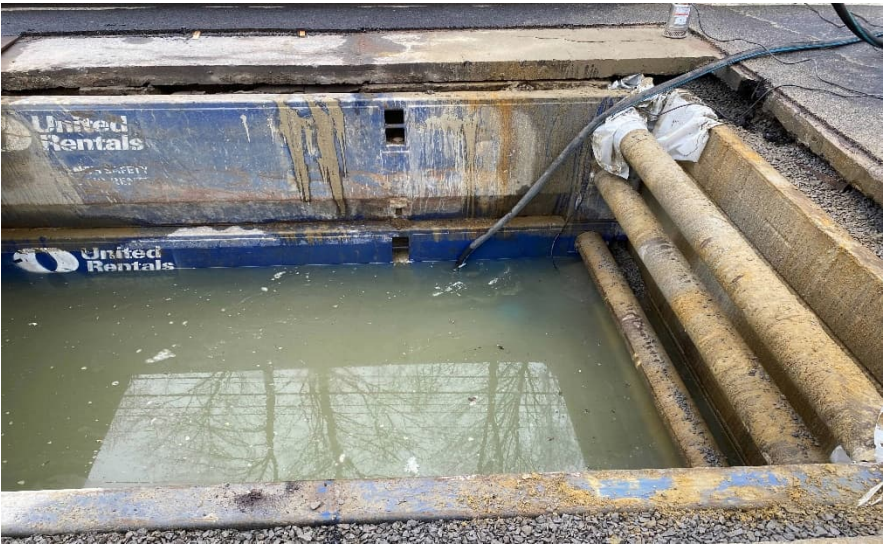
Description: View of pumping operation at MH#4. This is the location of dewatering water prior to treatment. Water appeared to be slightly turbid.

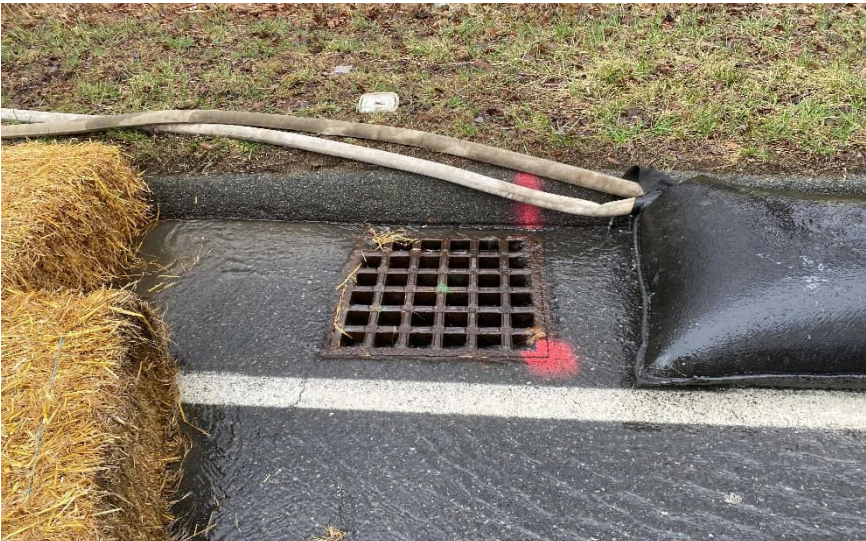
Description: MH#4. View of discharge bag/bales, looking eastward. Water appeared to be clear.

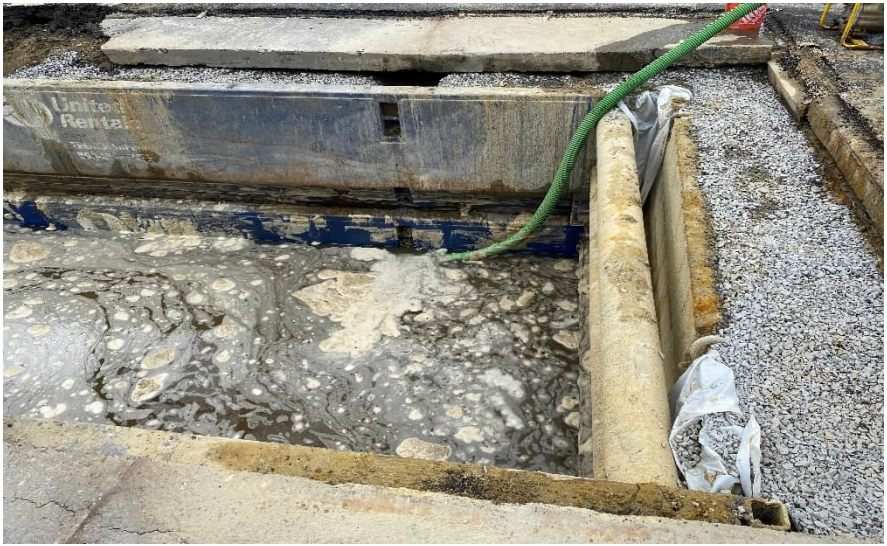
Description: View of pumping operation at MH#4. This is the location of dewatering water prior to treatment. Water appeared to be turbid.

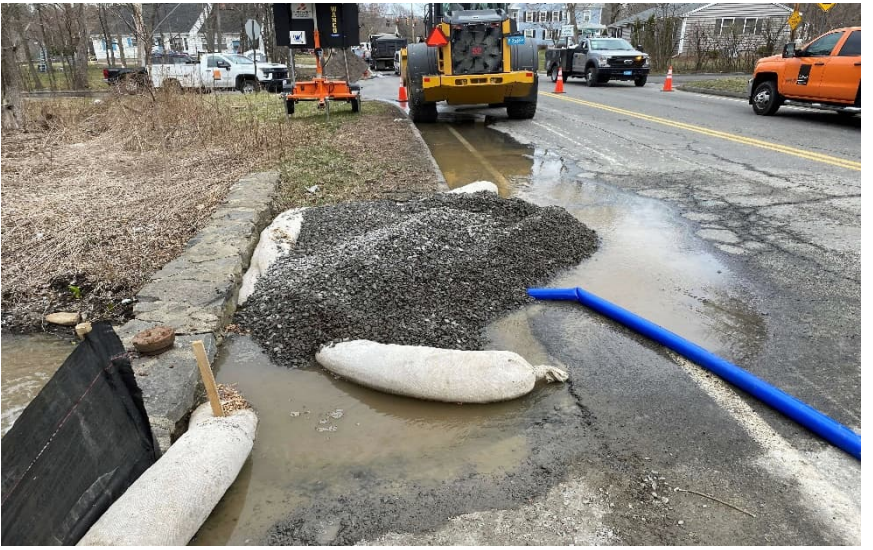
Description: MH#4. View of discharge bag/stone, looking northward. Water appeared to be slightly turbid.

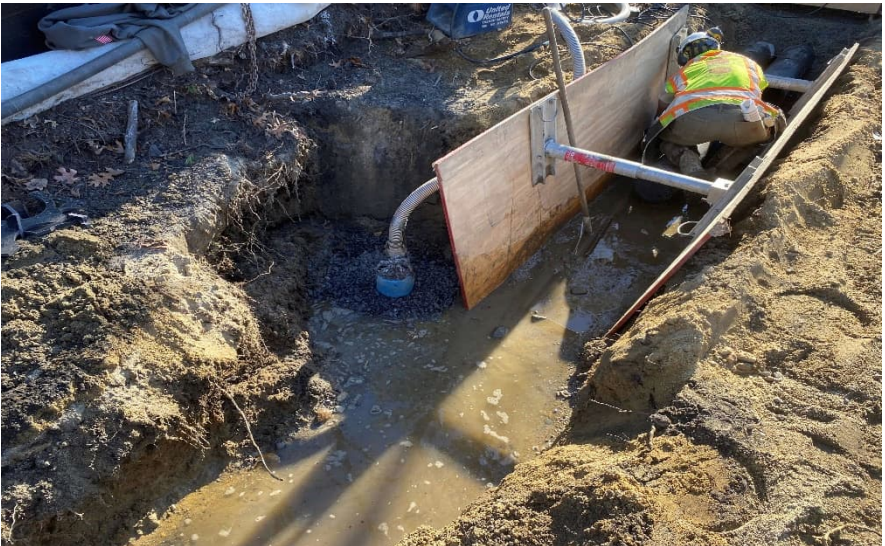
Description: View of pumping operation at Segment 2. This is the location of dewatering water prior to treatment. Water appeared to be slightly turbid.
