Weekly Environmental Compliance Summary

Sudbury to Hudson Transmission Reliability Project (USEPA Tracking # MAR1003UW)

Week of: April 10 to April 14, 2023

CONSTRUCTION MONITORING REPORT

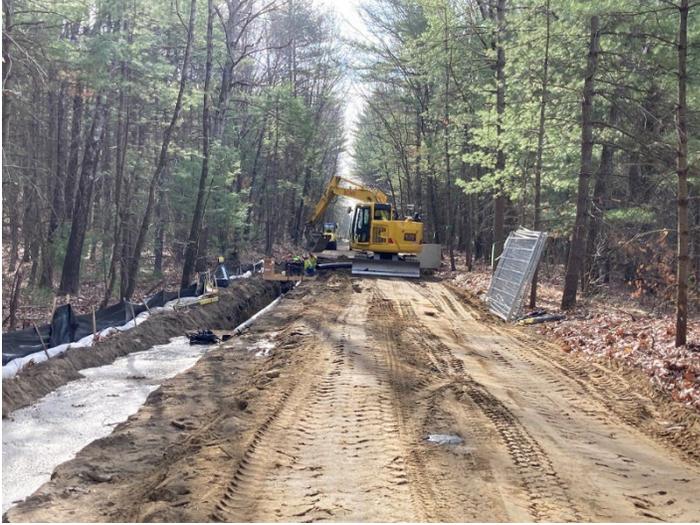
PHOTOGRAPHIC LOG	
Client Name: Eversource		Site Location: Sudbury to Hudson Transmission Reliability Project	Town: Hudson
Photo No.: 1	Date: 4/11/2023

Description: View of Bond performing conduit installation in segment 5. Facing east.

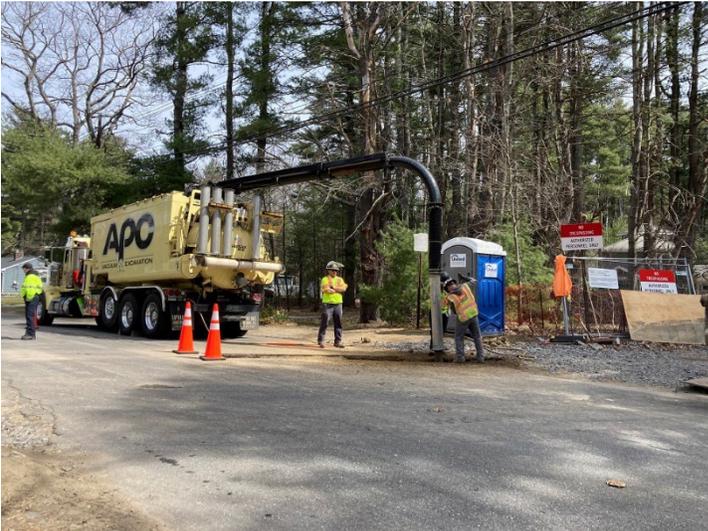
PHOTOGRAPHIC LOG	
Client Name: Eversource		Site Location: Sudbury to Hudson Transmission Reliability Project	Town: Hudson
Photo No.: 2	Date: 4/11/2023

Description: View of Bond working in roadway on Parmenter. Facing northeast.

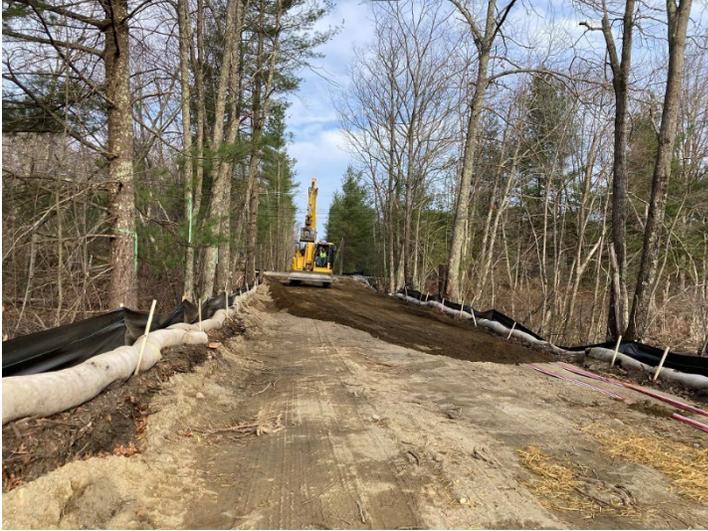
PHOTOGRAPHIC LOG	
Client Name: Eversource		Site Location: Sudbury to Hudson Transmission Reliability Project	Town: Hudson
Photo No.: 3	Date: 4/11/2023

Description: View of Bond working in segment 2. Facing west.

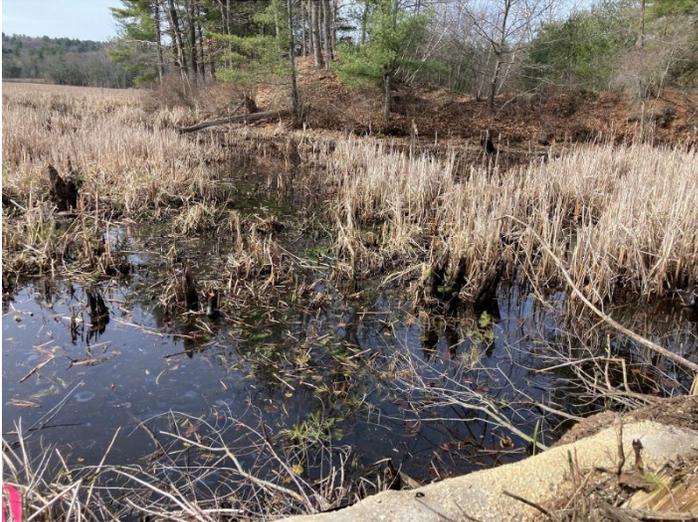
PHOTOGRAPHIC LOG	
Client Name: Eversource		Site Location: Sudbury to Hudson Transmission Reliability Project	Town: Hudson
Photo No.: 4	Date: 4/11/2023

Description: View of Hop Meadow Brook where fallen trees and debris were removed. Facing south.

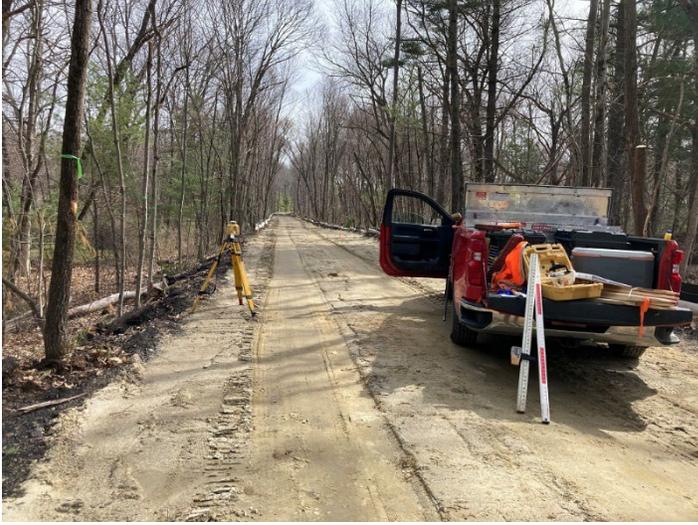
<p>PHOTOGRAPHIC LOG</p>	
<p>Client Name: Eversource</p>		<p>Site Location: Sudbury to Hudson Transmission Reliability Project</p>	<p>Town: Hudson</p>
<p>Photo No.: 5</p>	<p>Date: 4/11/2023</p>

<p>Description: View of ET&L performing layout in segment 1. Facing east.</p>

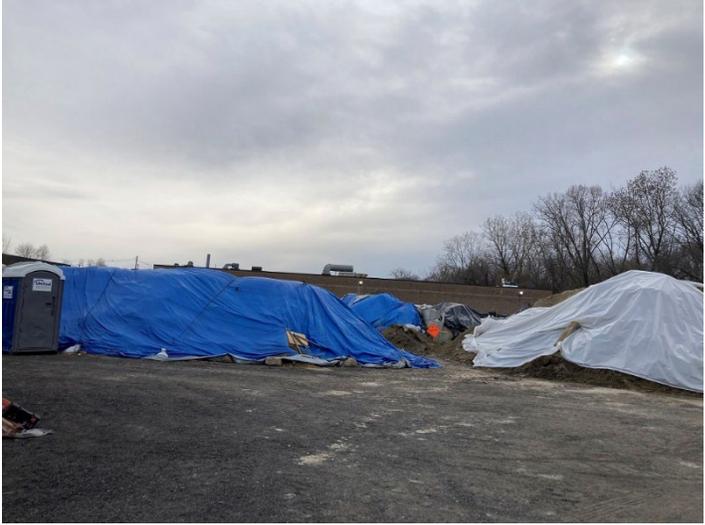
<p>PHOTOGRAPHIC LOG</p>	
<p>Client Name: Eversource</p>		<p>Site Location: Sudbury to Hudson Transmission Reliability Project</p>	<p>Town: Hudson</p>
<p>Photo No.: 6</p>	<p>Date: 4/11/2023</p>

<p>Description: View of laydown yard at Robert Bonazzoli Ave. Facing southwest.</p>

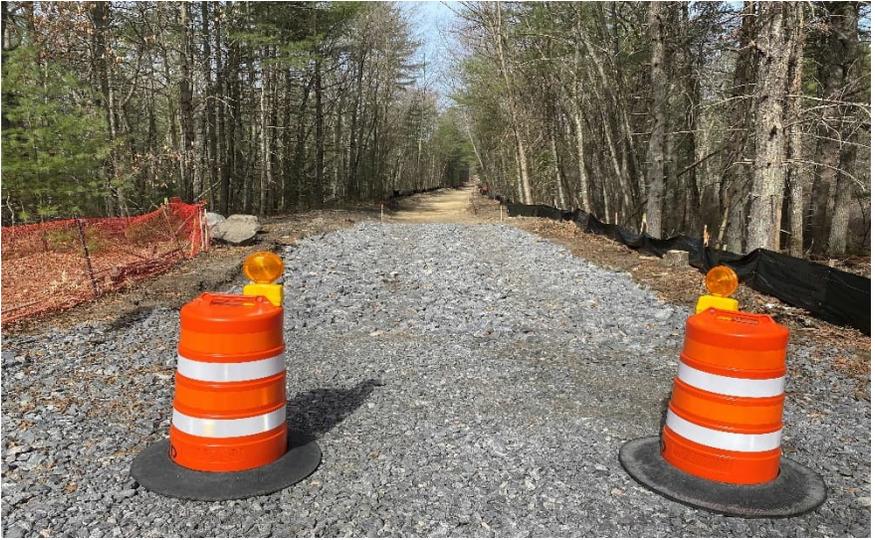
<p>PHOTOGRAPHIC LOG</p>	
<p>Client Name: Eversource</p>		<p>Site Location: Sudbury to Hudson Transmission Reliability Project</p>	<p>Town: Sudbury</p>
<p>Photo No.: 1</p>	<p>Date: 4-11-23</p>

<p>Description:</p> <p>Right-of-way within Segment 9, existing erosion control & barrels noting vernal pool monitoring area, looking westward.</p>

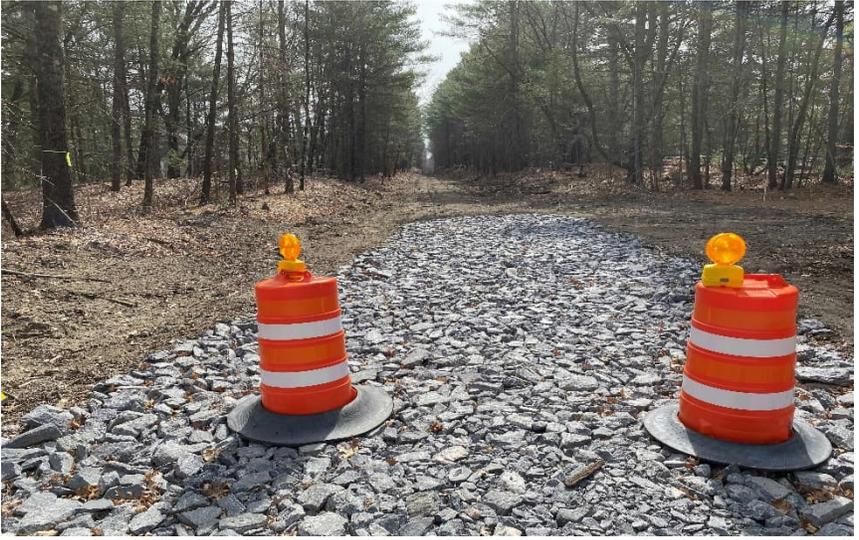
<p>PHOTOGRAPHIC LOG</p>	
<p>Client Name: Eversource</p>		<p>Site Location: Sudbury to Hudson Transmission Reliability Project</p>	<p>Town: Sudbury</p>
<p>Photo No.: 2</p>	<p>Date: 4-11-23</p>

<p>Description:</p> <p>Right-of-way within Segment 10, barrels noting vernal pool monitoring area, looking eastward.</p>

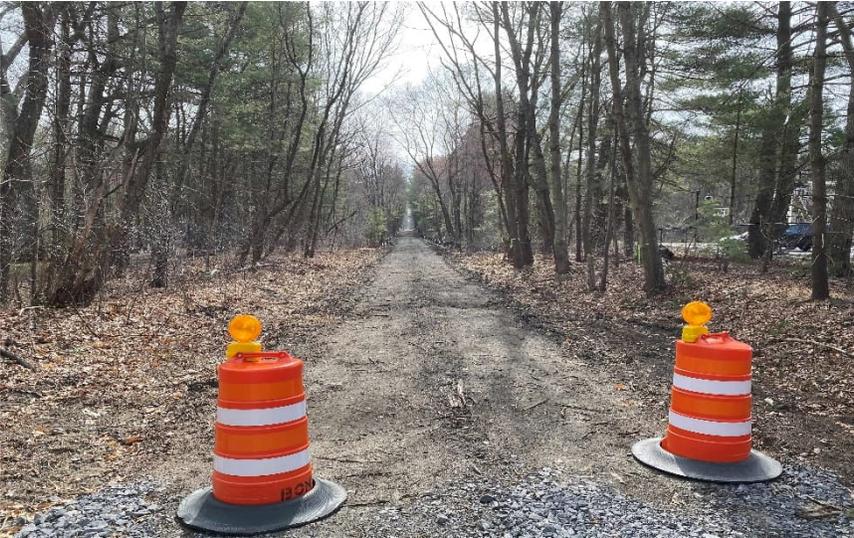
<p>PHOTOGRAPHIC LOG</p>	
<p>Client Name: Eversource</p>		<p>Site Location: Sudbury to Hudson Transmission Reliability Project</p>	<p>Town: Sudbury</p>
<p>Photo No.: 3</p>	<p>Date: 4-11-23</p>

<p>Description:</p> <p>Right-of-way within Segment 11, barrels noting vernal pool monitoring area, looking eastward.</p>

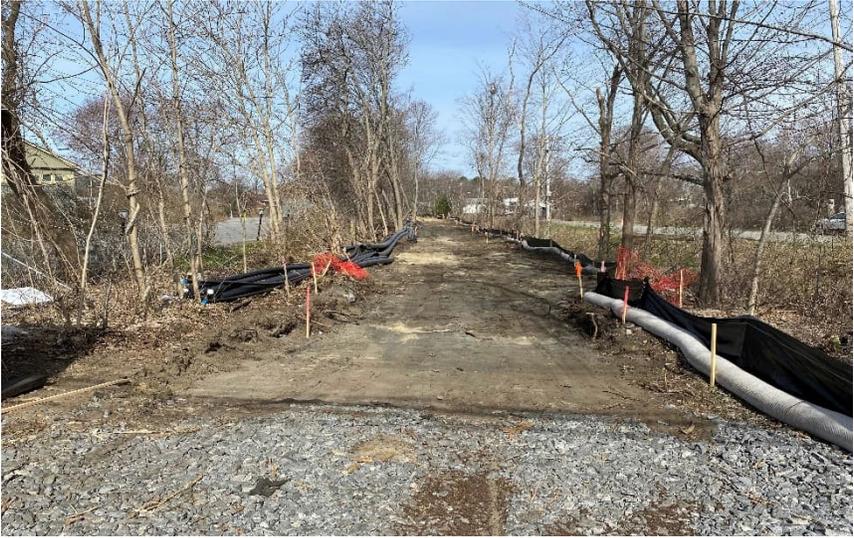
<p>PHOTOGRAPHIC LOG</p>	
<p>Client Name: Eversource</p>		<p>Site Location: Sudbury to Hudson Transmission Reliability Project</p>	<p>Town: Sudbury</p>
<p>Photo No.: 4</p>	<p>Date: 4-11-23</p>

<p>Description:</p> <p>Right-of-way within Segment 12, existing erosion control, looking westward.</p>

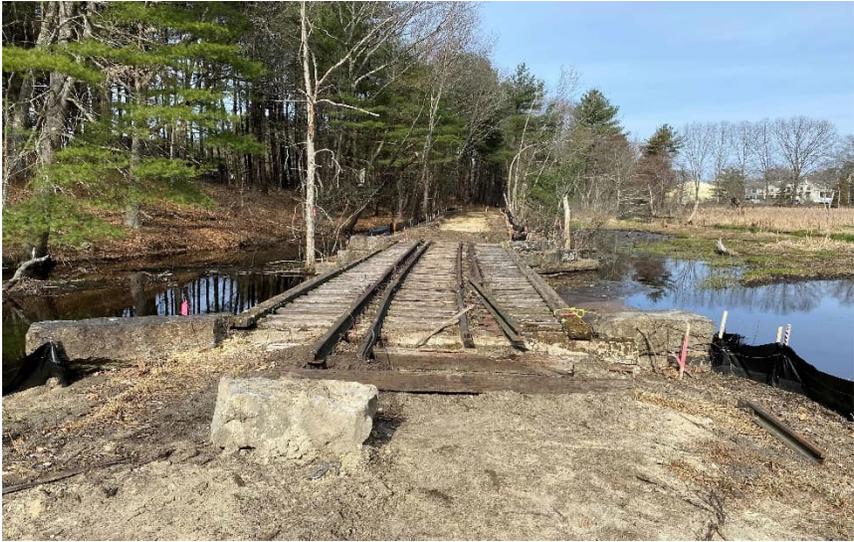
<p>PHOTOGRAPHIC LOG</p>	
<p>Client Name: Eversource</p>		<p>Site Location: Sudbury to Hudson Transmission Reliability Project</p>	<p>Town: Sudbury</p>
<p>Photo No.: 5</p>	<p>Date: 4-11-23</p>

<p>Description:</p> <p>Bridge 127 at Segments 13/14, looking westward.</p>

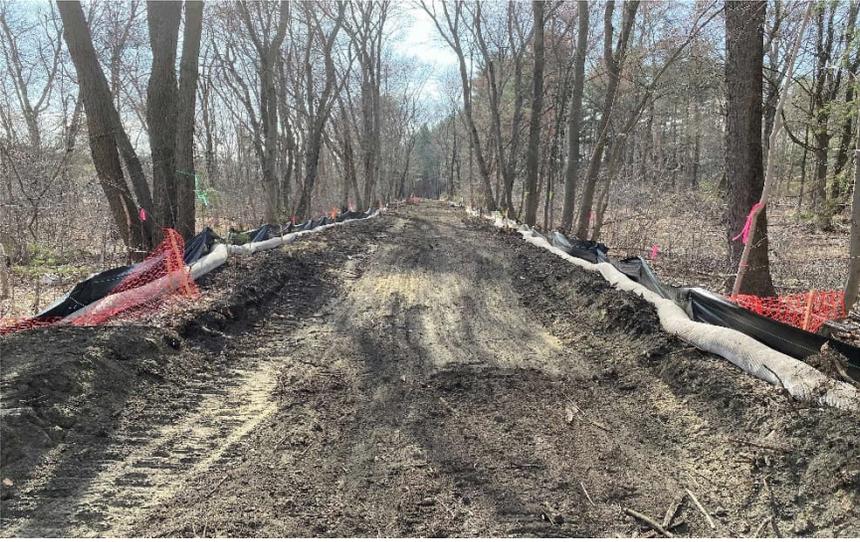
<p>PHOTOGRAPHIC LOG</p>	
<p>Client Name: Eversource</p>		<p>Site Location: Sudbury to Hudson Transmission Reliability Project</p>	<p>Town: Sudbury</p>
<p>Photo No.: 6</p>	<p>Date: 4-11-23</p>

<p>Description:</p> <p>Right-of-way within Segment 13, existing erosion control, looking eastward.</p>

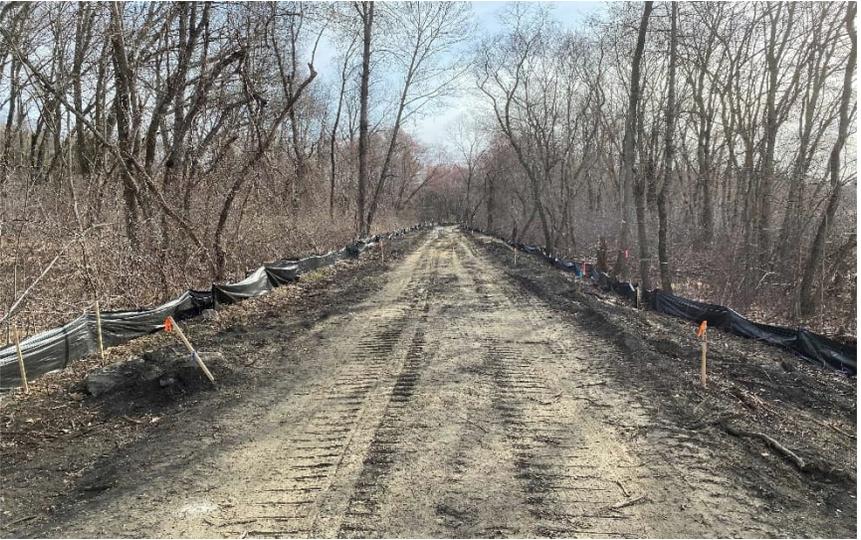
<p>PHOTOGRAPHIC LOG</p>	
<p>Client Name: Eversource</p>		<p>Site Location: Sudbury to Hudson Transmission Reliability Project</p>	<p>Town: Sudbury</p>
<p>Photo No.: 7</p>	<p>Date: 4-11-23</p>

<p>Description: Right-of-way within Segment 14, existing erosion control, looking eastward.</p>

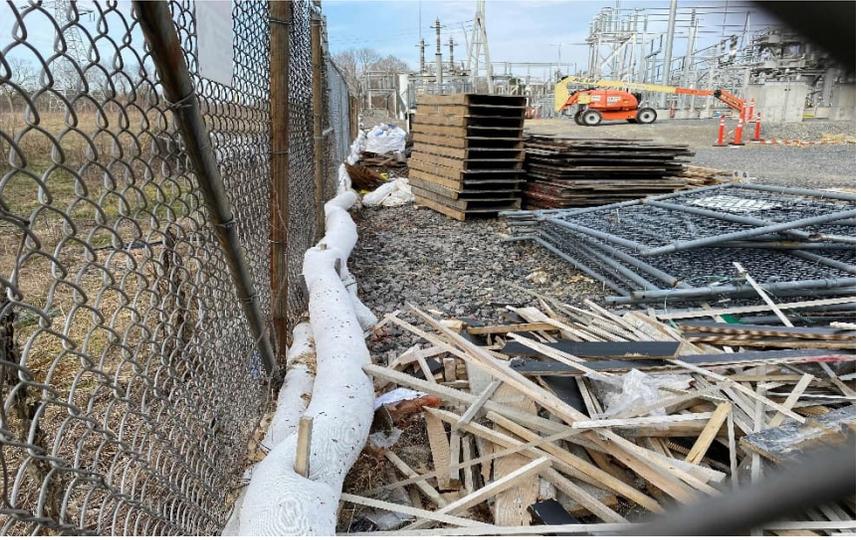
<p>PHOTOGRAPHIC LOG</p>	
<p>Client Name: Eversource</p>		<p>Site Location: Sudbury to Hudson Transmission Reliability Project</p>	<p>Town: Sudbury</p>
<p>Photo No.: 8</p>	<p>Date: 4-11-23</p>

<p>Description: Compost filter tubes within substation, installed & functioning, looking westward.</p>

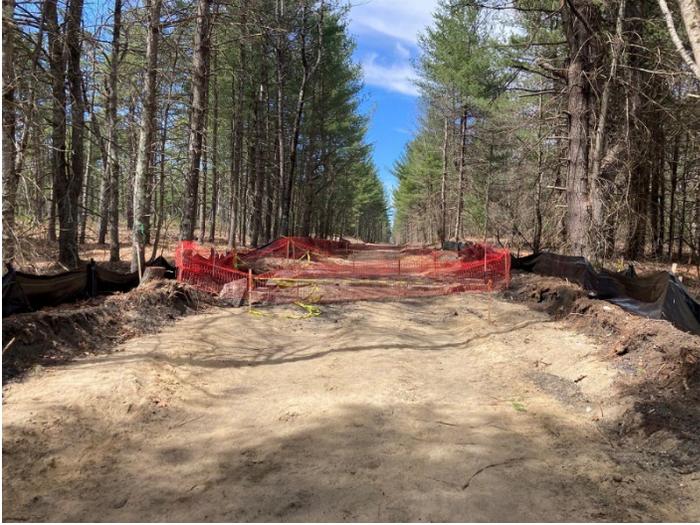
PHOTOGRAPHIC LOG	
Client Name: Eversource		Site Location: Sudbury to Hudson Transmission Reliability Project	Town: Hudson
Photo No.: 1	Date: 4/12/2023

Description: View of orange fence installed around recently discovered cattle crossing in segment 7. Facing west.

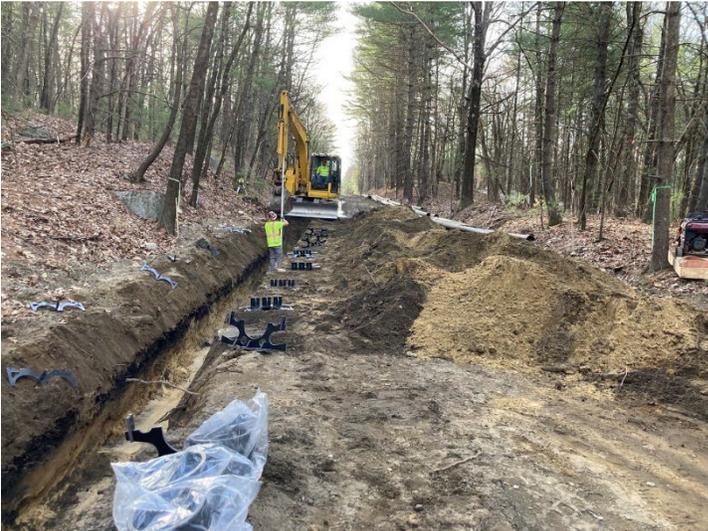
PHOTOGRAPHIC LOG	
Client Name: Eversource		Site Location: Sudbury to Hudson Transmission Reliability Project	Town: Hudson
Photo No.: 2	Date: 4/12/2023

Description: View of Bond performing conduit installation in segment 5. Facing east.

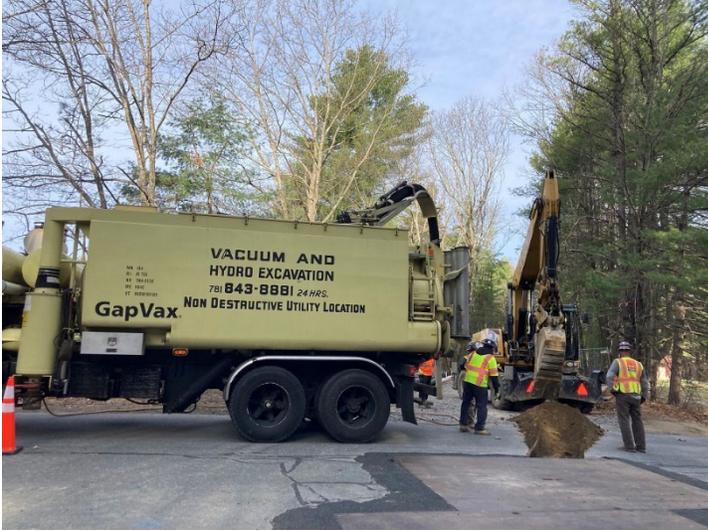
<p align="right">PHOTOGRAPHIC LOG</p>	
<p>Client Name: Eversource</p>		<p>Site Location: Sudbury to Hudson Transmission Reliability Project</p>	
<p>Town: Hudson</p>			
<p>Photo No.: 3</p>	<p>Date: 4/12/2023</p>		
<p>Description: View of Bond working in roadway on Parmenter. Facing west.</p>

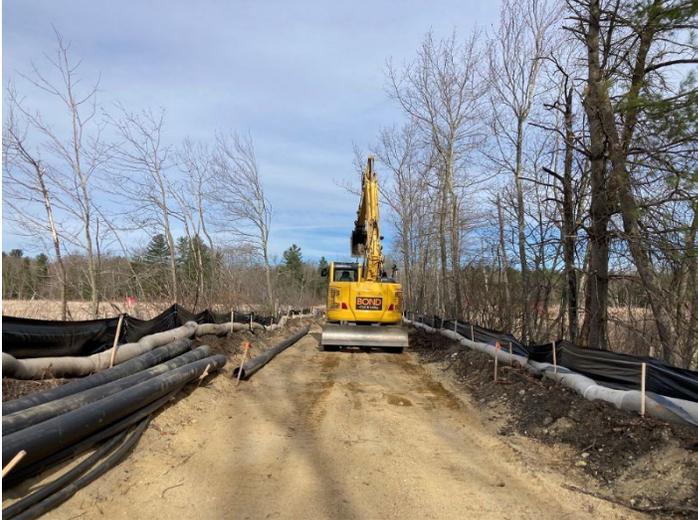
<p align="right">PHOTOGRAPHIC LOG</p>	
<p>Client Name: Eversource</p>		<p>Site Location: Sudbury to Hudson Transmission Reliability Project</p>	
<p>Town: Hudson</p>			
<p>Photo No.: 4</p>	<p>Date: 4/12/2023</p>		
<p>Description: View of Bond's work area in segment 3 near bridge 130. Facing west.</p>

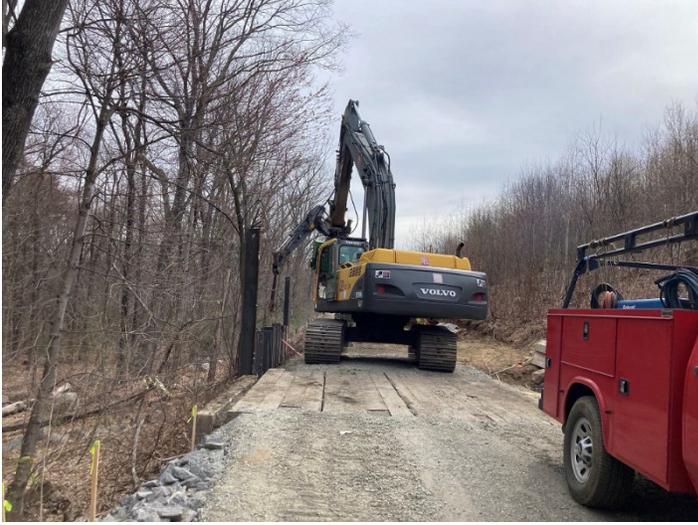
PHOTOGRAPHIC LOG	
Client Name: Eversource		Site Location: Sudbury to Hudson Transmission Reliability Project	
Town: Hudson			
Photo No.: 5	Date: 4/12/2023

Description: View of ET&L installing sheetwall in segment 1. Facing east.

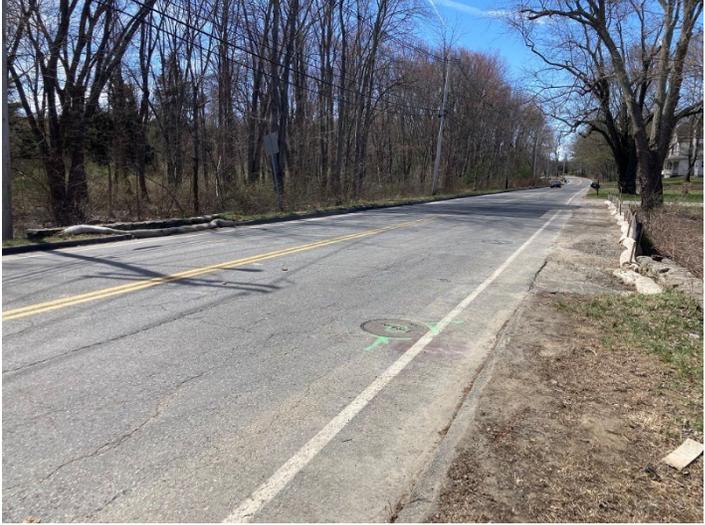
PHOTOGRAPHIC LOG	
Client Name: Eversource		Site Location: Sudbury to Hudson Transmission Reliability Project	
Town: Hudson			
Photo No.: 6	Date: 4/12/2023

Description: View of MH #4 area on Forest Ave. Facing southwest.

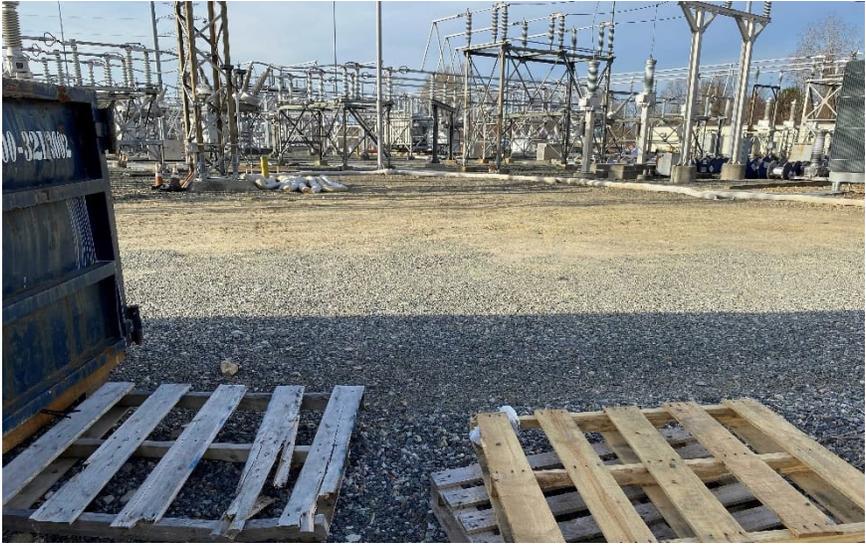
<p>PHOTOGRAPHIC LOG</p>	
<p>Client Name: Eversource</p>		<p>Site Location: Sudbury to Hudson Transmission Reliability Project</p>	<p>Town: Sudbury</p>
<p>Photo No.: 1</p>	<p>Date: 4-12-23</p>

<p>Description:</p> <p>Sudbury substation, looking southward.</p>

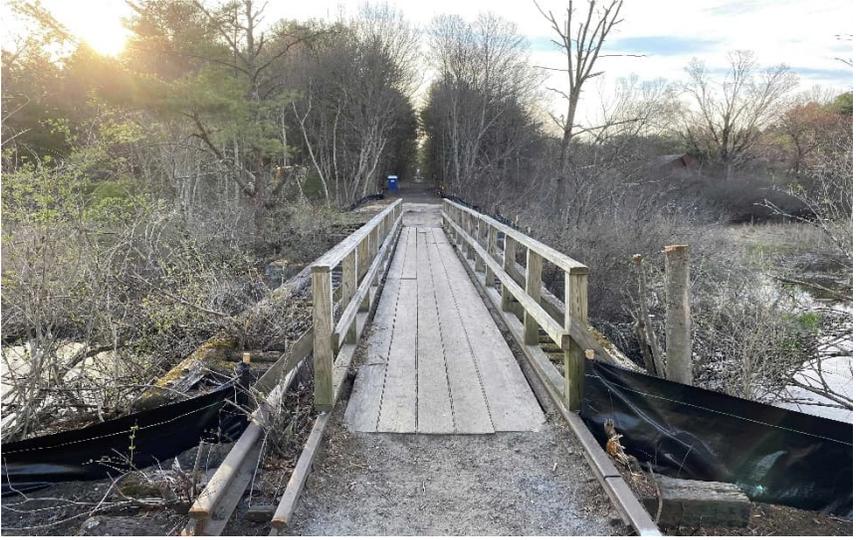
<p>PHOTOGRAPHIC LOG</p>	
<p>Client Name: Eversource</p>		<p>Site Location: Sudbury to Hudson Transmission Reliability Project</p>	<p>Town: Sudbury</p>
<p>Photo No.: 2</p>	<p>Date: 4-12-23</p>

<p>Description:</p> <p>Bridge 128 at Segments 7/8, looking eastward.</p>

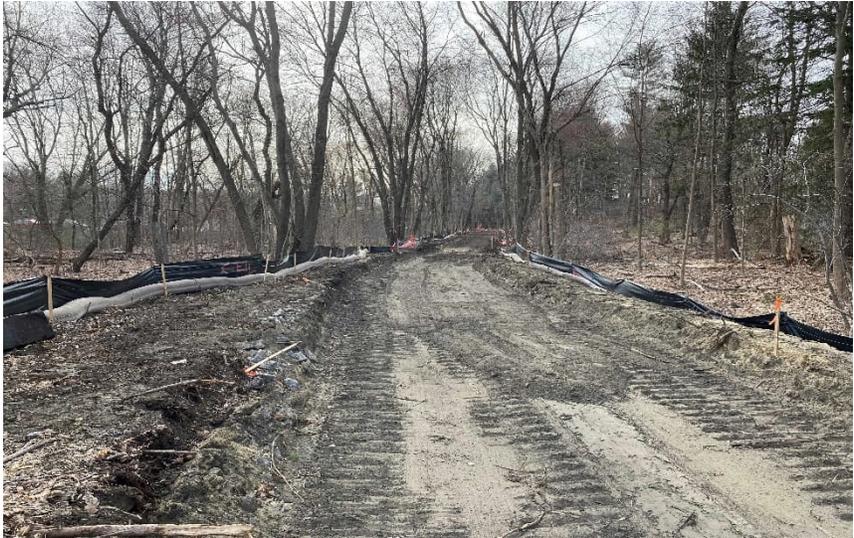
<p>PHOTOGRAPHIC LOG</p>	
<p>Client Name: Eversource</p>		<p>Site Location: Sudbury to Hudson Transmission Reliability Project</p>	<p>Town: Sudbury</p>
<p>Photo No.: 3</p>	<p>Date: 4-12-23</p>

<p>Description: Right-of-way within Segment 14, looking westward.</p>

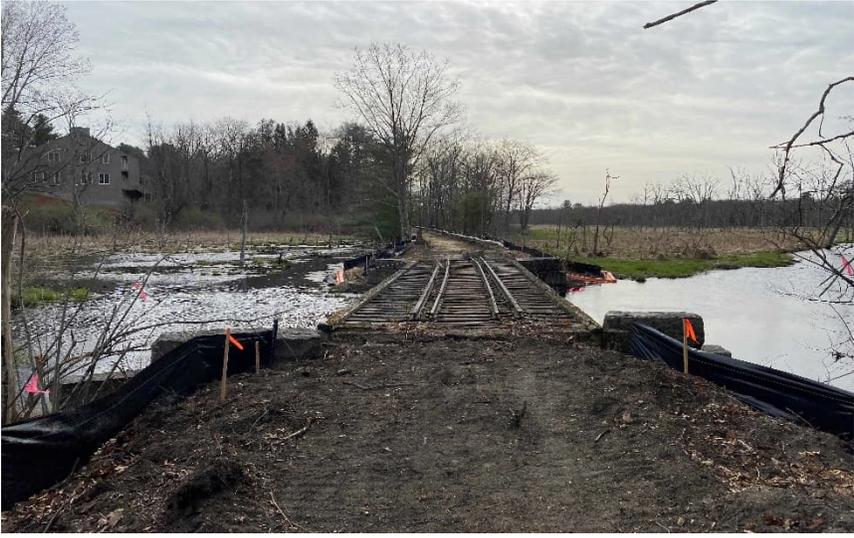
<p>PHOTOGRAPHIC LOG</p>	
<p>Client Name: Eversource</p>		<p>Site Location: Sudbury to Hudson Transmission Reliability Project</p>	<p>Town: Sudbury</p>
<p>Photo No.: 4</p>	<p>Date: 4-12-23</p>

<p>Description: Bridge 127 at Segments 13/14, looking westward.</p>

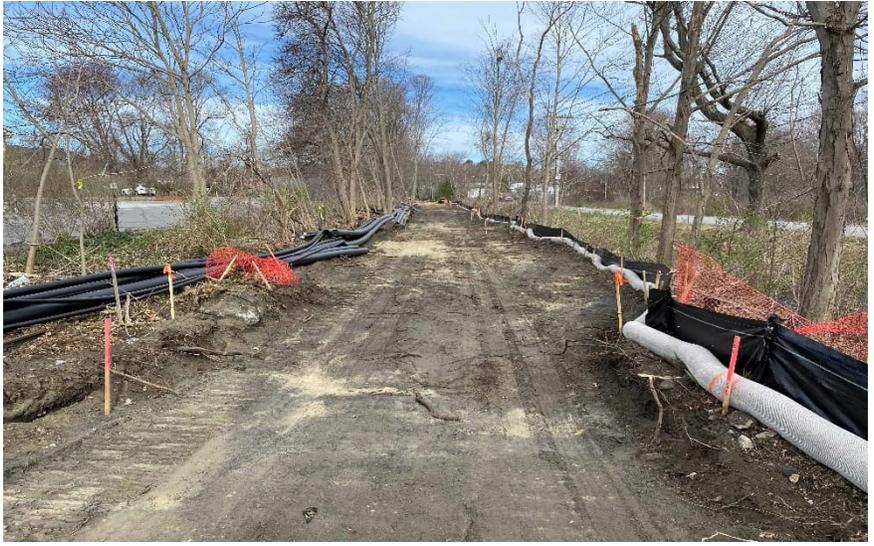
<p>PHOTOGRAPHIC LOG</p>	
<p>Client Name: Eversource</p>		<p>Site Location: Sudbury to Hudson Transmission Reliability Project</p>	<p>Town: Sudbury</p>
<p>Photo No.: 5</p>	<p>Date: 4-12-23</p>

<p>Description:</p> <p>Right-of-way within Segment 12, looking westward.</p>

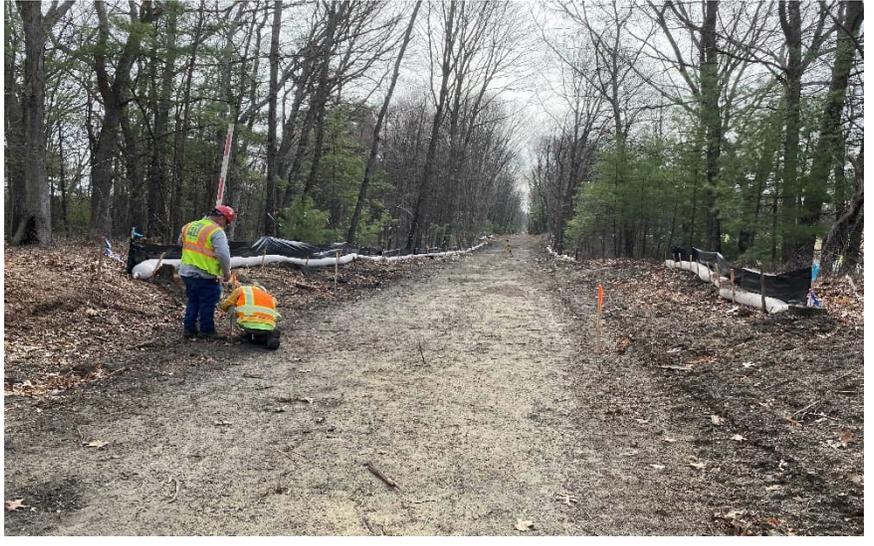
<p>Description:</p> <p>Right-of-way within Segment 11, ET&L conducting survey for cut-fill work, existing erosion control, looking eastward.</p>

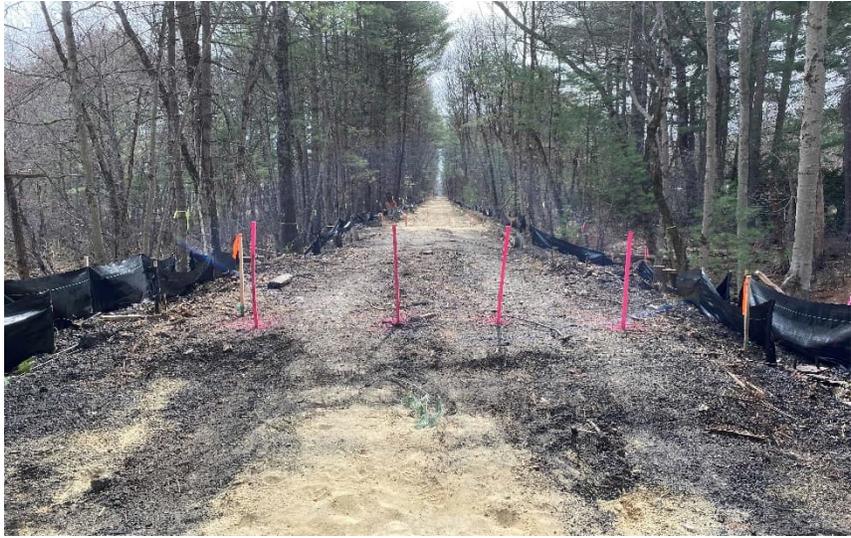
<p>Description:</p> <p>Right-of-way within Segment 11 at approximate Sta# 539+40, Dudley Brook crossing, existing erosion control, looking eastward.</p>

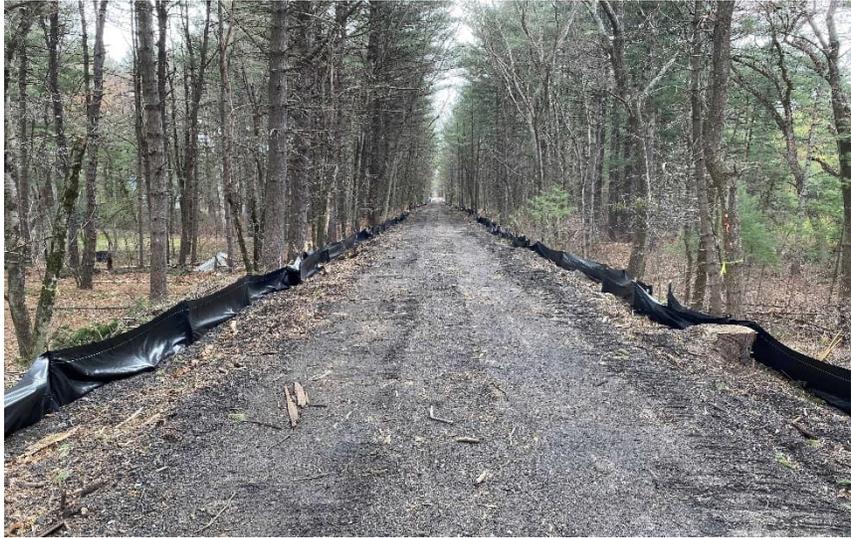
<p>Description:</p> <p>Right-of-way within Segment 9, existing erosion control, looking eastward.</p>

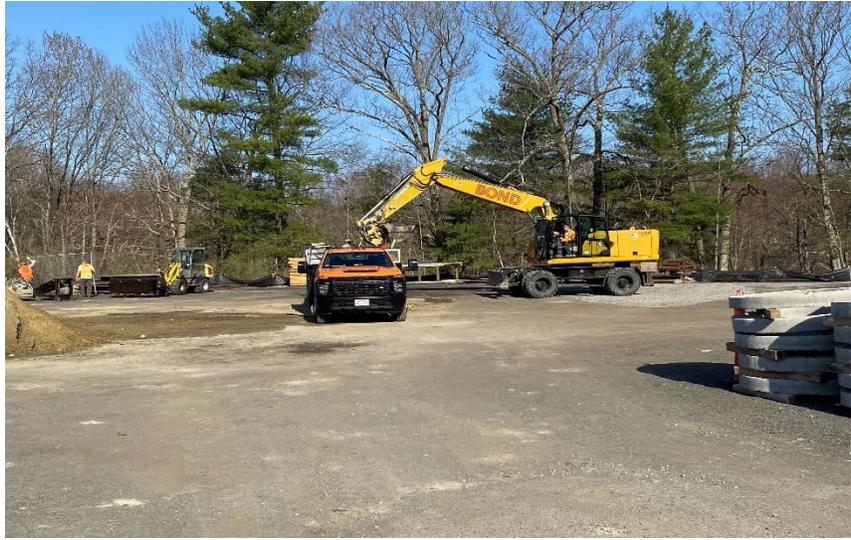
<p>Description:</p> <p>Bond conducting work within Bonazzoli laydown yard, looking northward.</p>

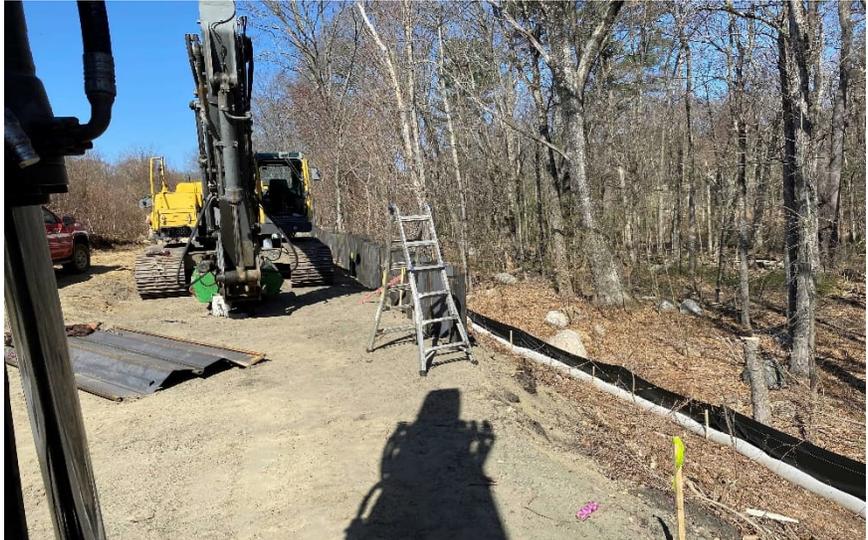
<p>Description:</p> <p>Right-of-way within Segment 1, ET&L installing sheeting, looking westward.</p>

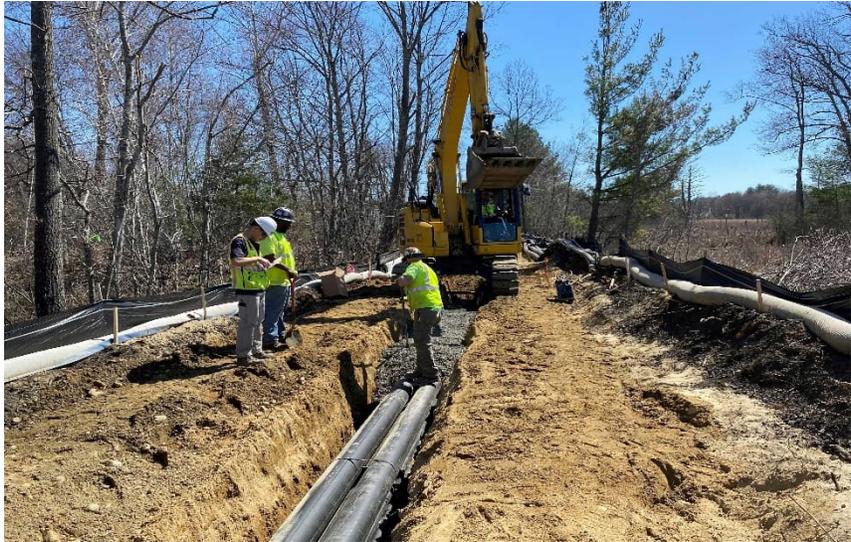
<p>Description: Conduit work within Segment 3, looking eastward.</p>

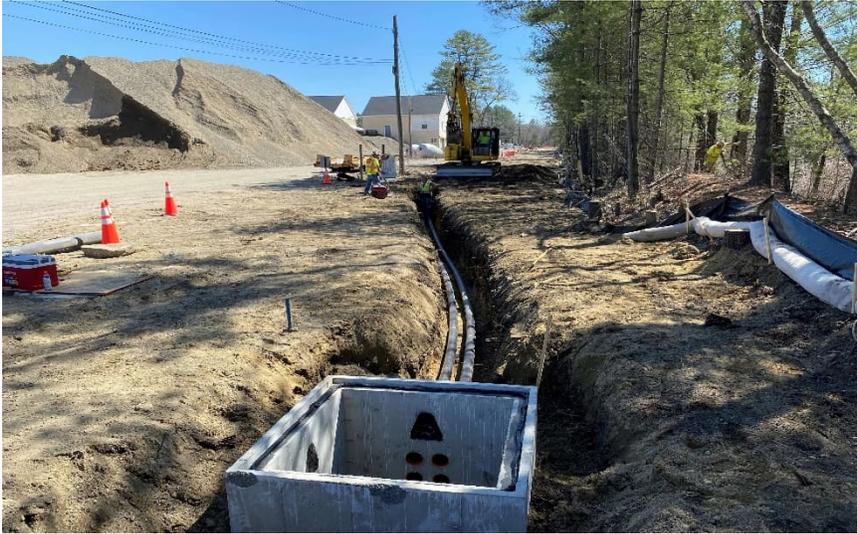
<p>Description: Site work within Segment 3 at MH#8, looking eastward.</p>

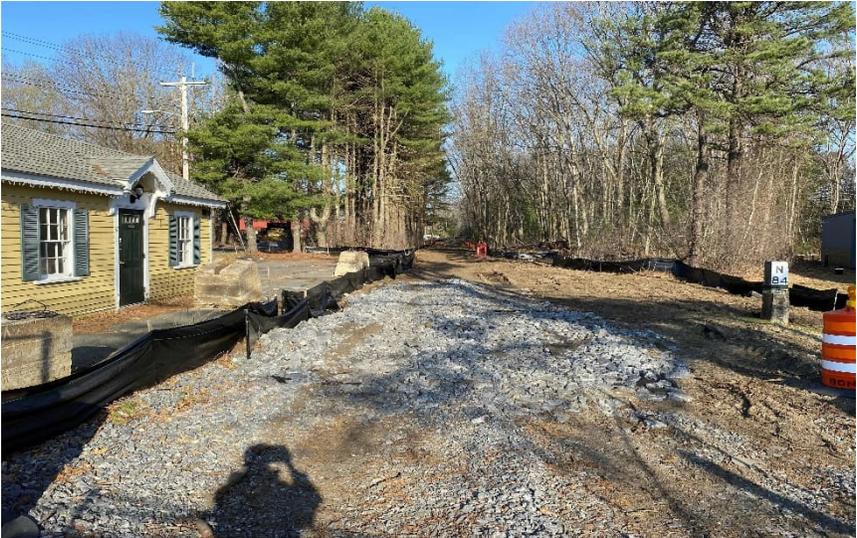
<p>Description:</p> <p>Right-of-way within Segment 11, current erosion control, just off Union Avenue, looking westward.</p>

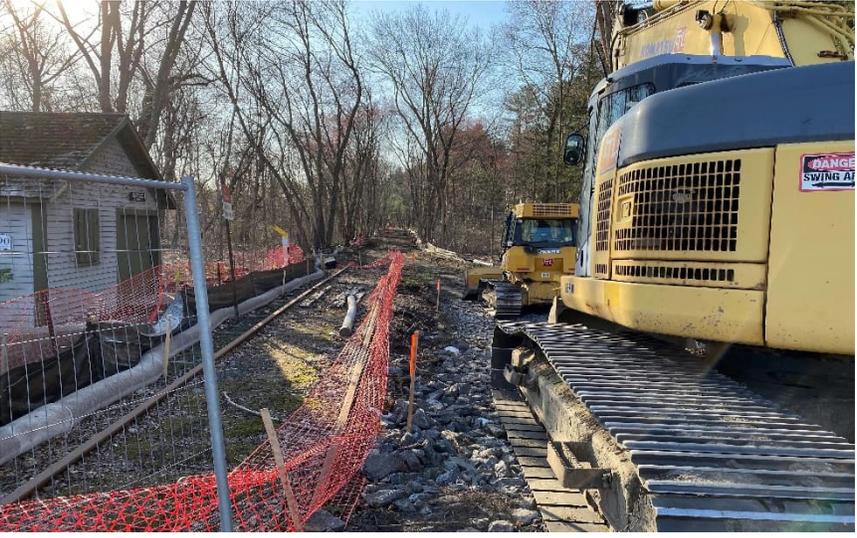
<p>Description:</p> <p>Right-of-way within Segment 13, just off Boston Post Road, current erosion control, looking eastward.</p>

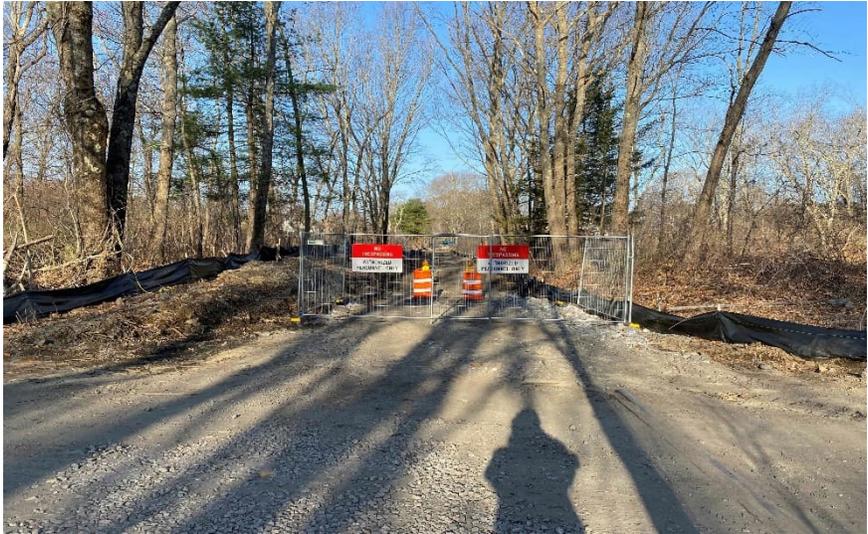
<p>Description:</p> <p>Right-of-way to Segment 14, current erosion control, just off Sudbury Substation Road, looking westward.</p>

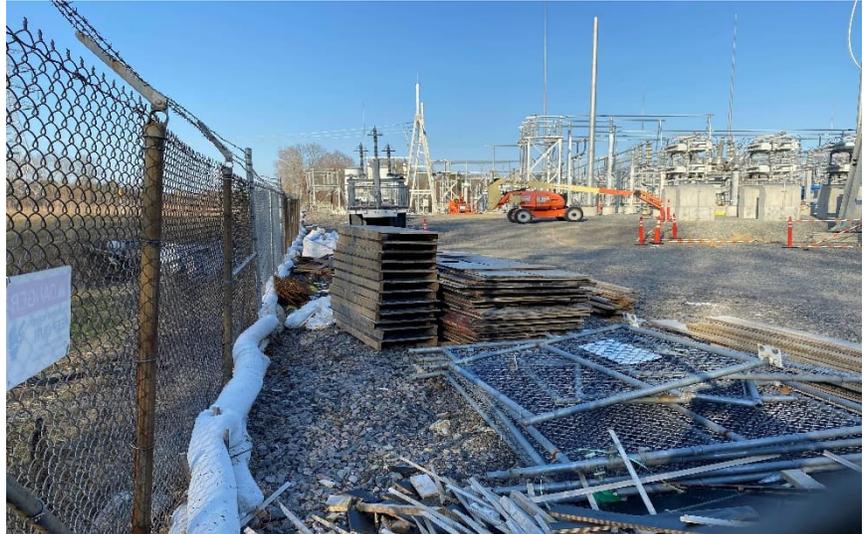
<p>Description:</p> <p>Sudbury substation, compost filter tubes, looking westward.</p>

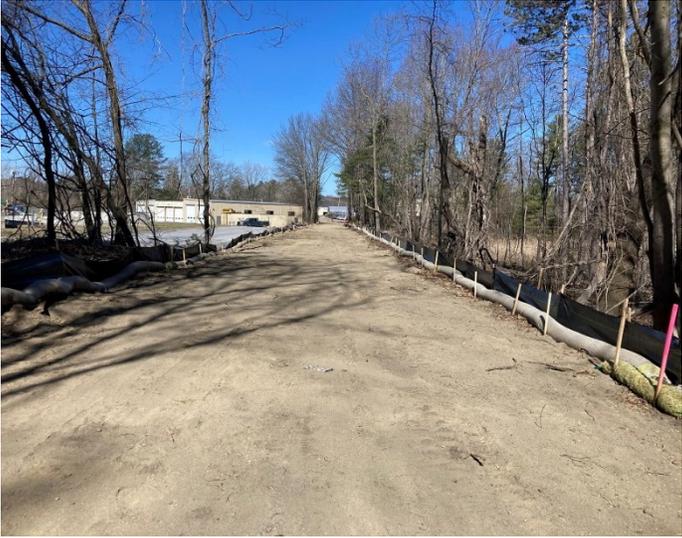
PHOTOGRAPHIC LOG	
Client Name: Eversource		Site Location: Sudbury to Hudson Transmission Reliability Project	Town: Hudson
Photo No.: 1	Date: 4-10-2023

Description: View of segment 3. E&S controls are in good condition. It is recommended that straw wattles with plastic netting be replaced with biodegradable compost filter tubes (per Eversource requirement). Facing west.

5. Straw Wattles in Hudson	<input type="checkbox"/> Yes <input checked="" type="checkbox"/> No	N/A	<input type="checkbox"/> Yes <input checked="" type="checkbox"/> No	N/A	Straw wattles are operating properly. It is recommended that straw wattles with plastic netting be replaced with biodegradable compost filter tubes (per Eversource requirement).

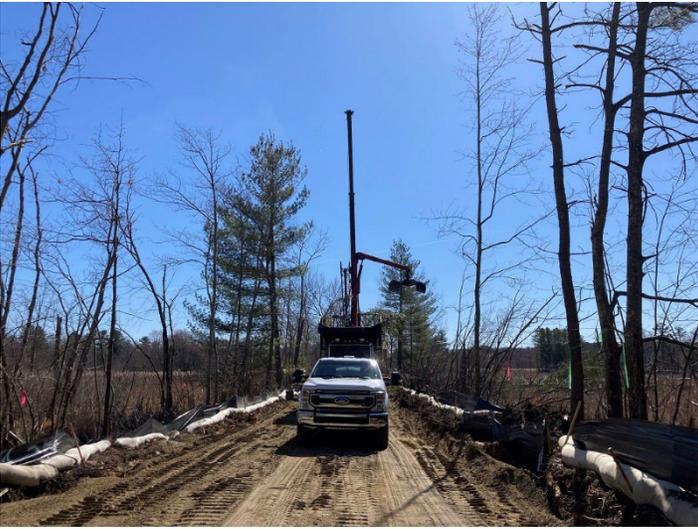
Description: View of Moosehead removing fallen trees from Fort Meadow Brook in segment 2. Facing east.

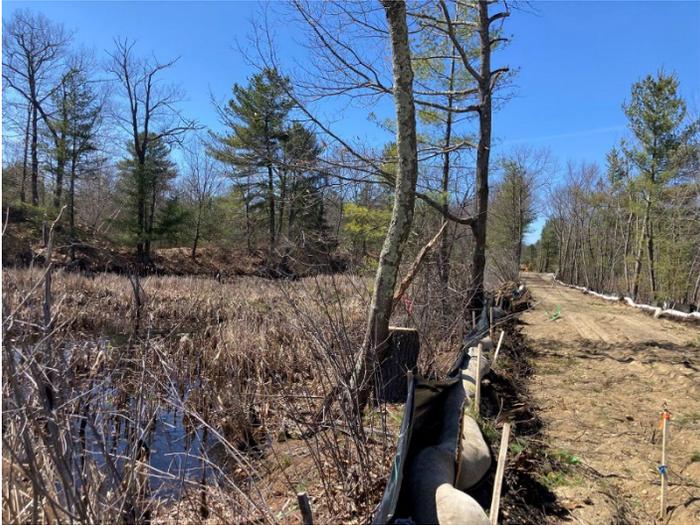
Description: View of area where fallen trees were removed from Fort Meadow Brook in segment 2. Facing west.

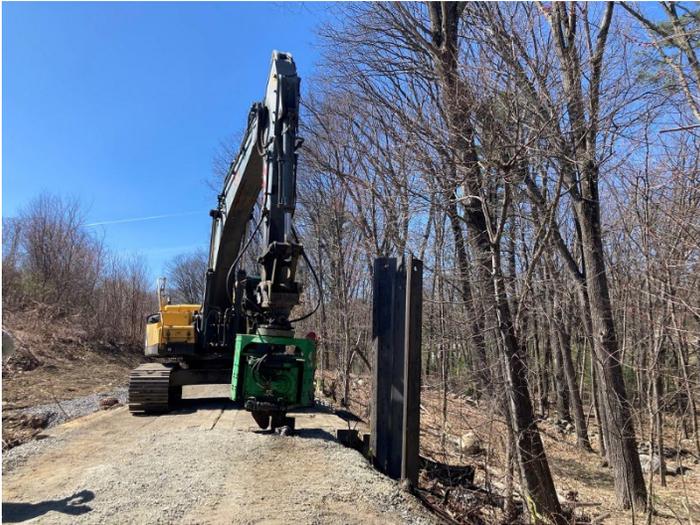
Description: View of ET&L installing sheetwall in segment 1. Facing west.

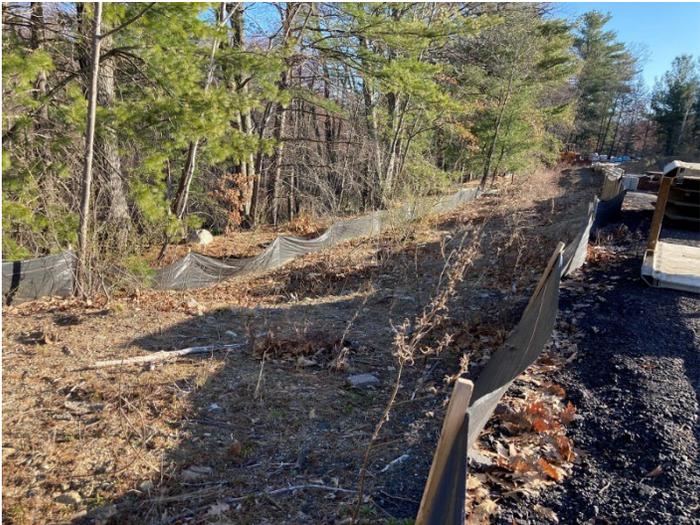
Description: View of silt fence at laydown yard at Robert Bonazzoli Ave. Controls are in good condition. Facing northeast.

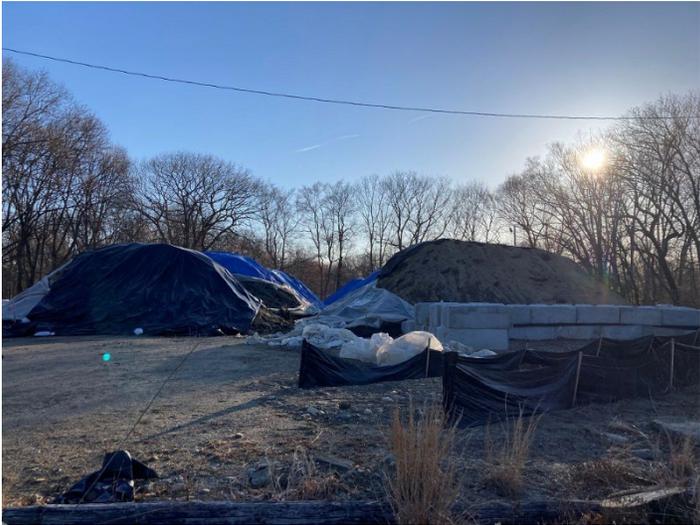
Description: View of laydown yard at Stowe Ct. Stockpile covers are in need of maintenance. Facing northeast.

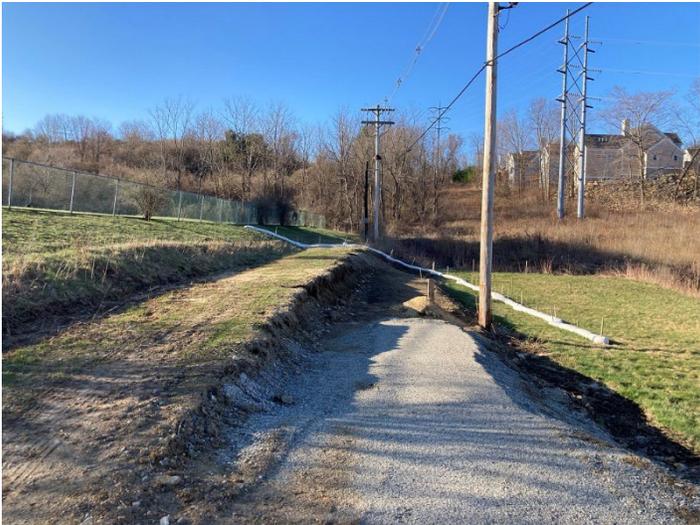
Description: View of E&S controls at MH #1 area. Facing south.

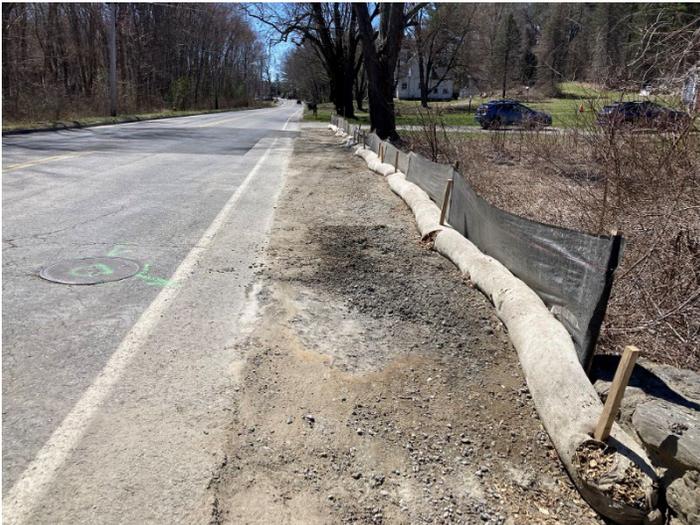
Description: View of E&S controls at MH #4 area. Facing southwest.

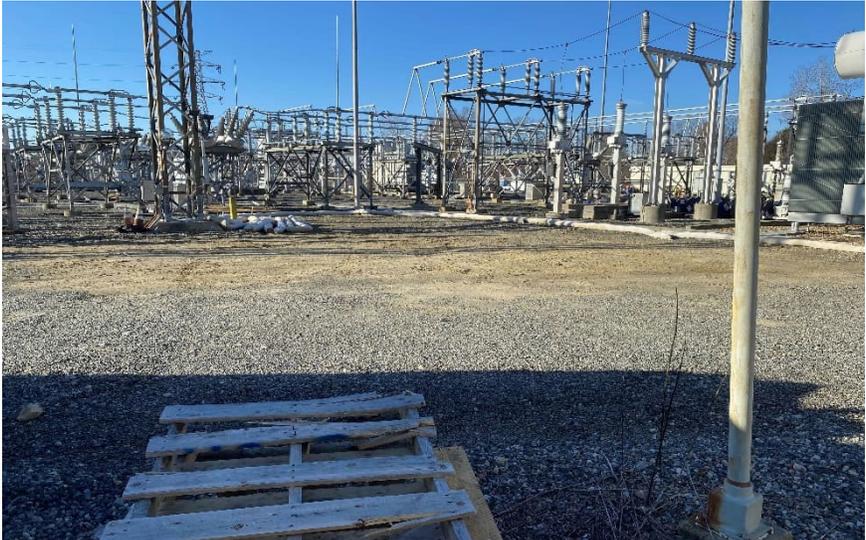
Description: Sudbury Substation, looking southward.

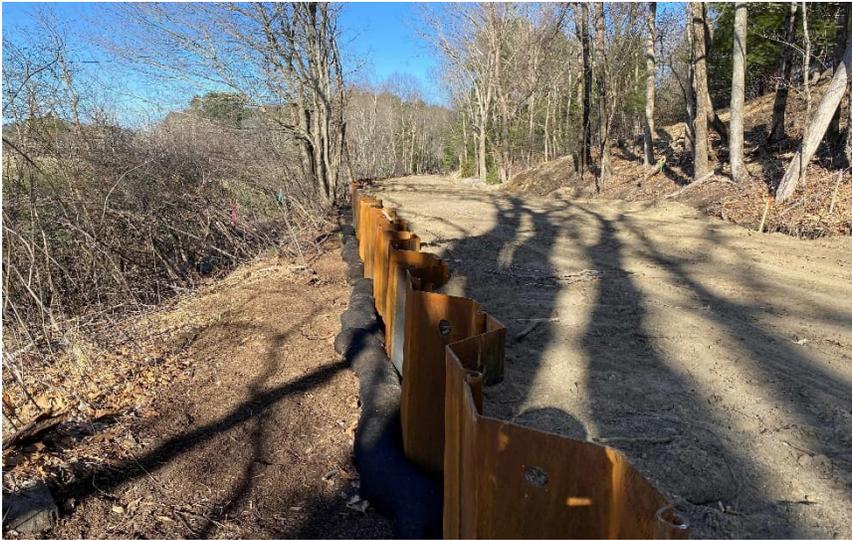
Description: Installed sheeting within Segment 14, looking westward.

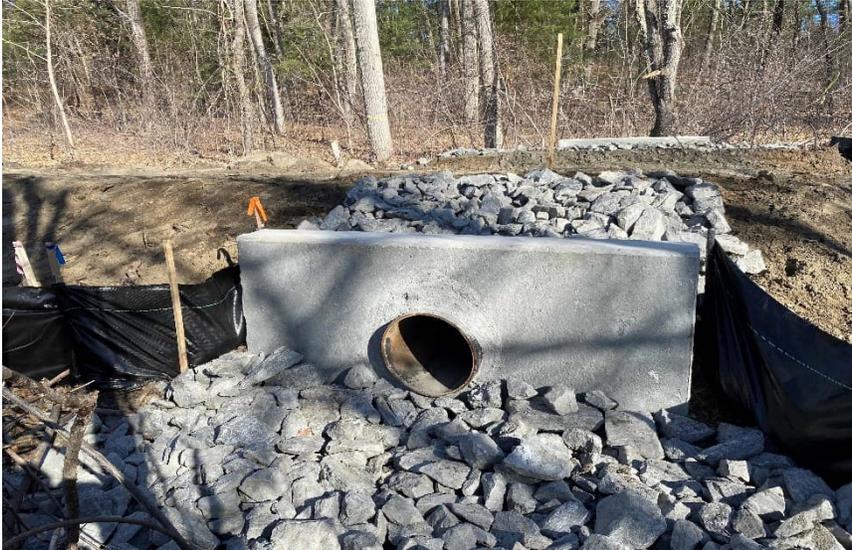
Description: New headwall in Segment 14 at approximate Sta# 738+81, looking northward.

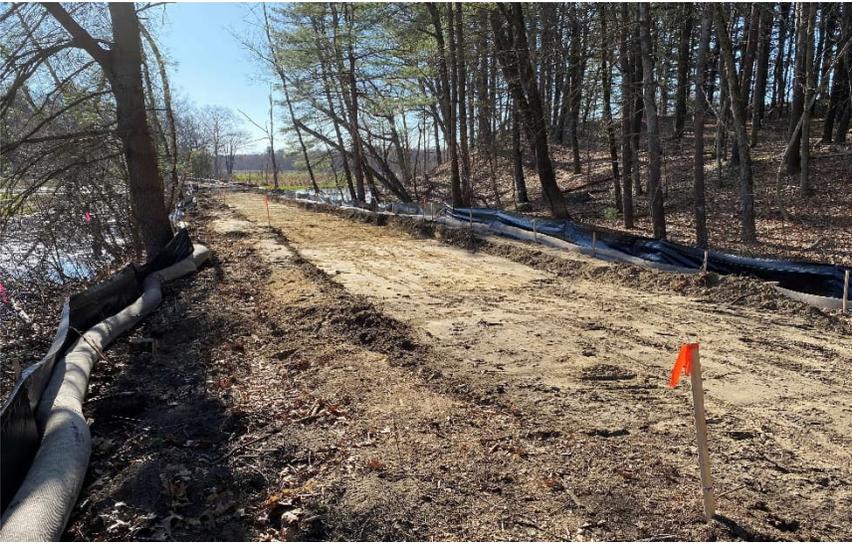
Description: Right-of-way within Segment 13, looking eastward.
