Weekly Environmental Compliance Summary

Sudbury to Hudson Transmission Reliability Project (USEPA Tracking # MAR1003UW)

Week of: April 10 to April 14, 2023

CONSTRUCTION MONITORING REPORT

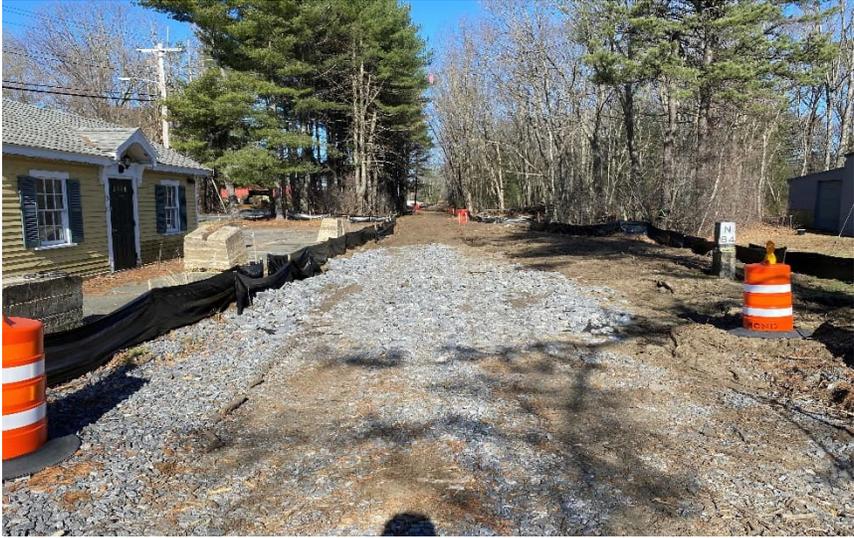
Description: Right-of-way within Segment 11 off Union Street, looking westward.

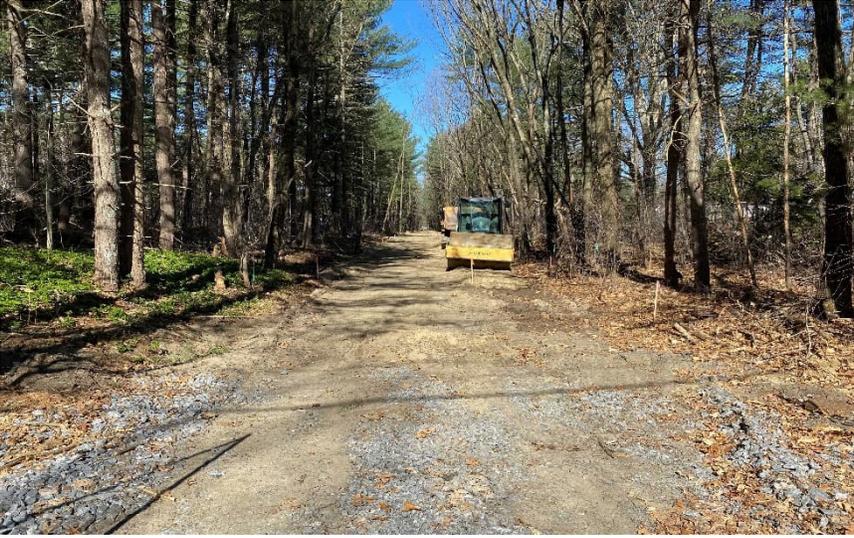
Description: Right-of-way within Segment 10 off Horse Pond Road, looking westward.

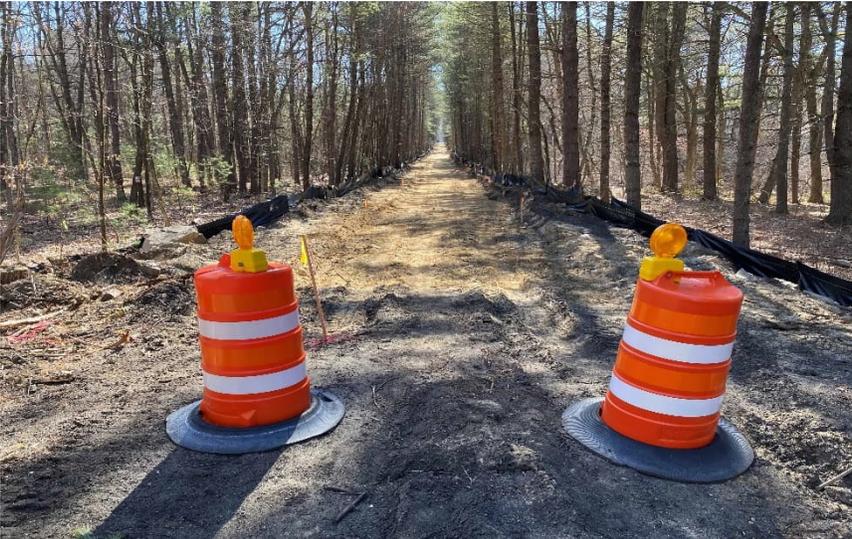
Description: Right-of-way within Segment 10 off Peakham Road, looking eastward.

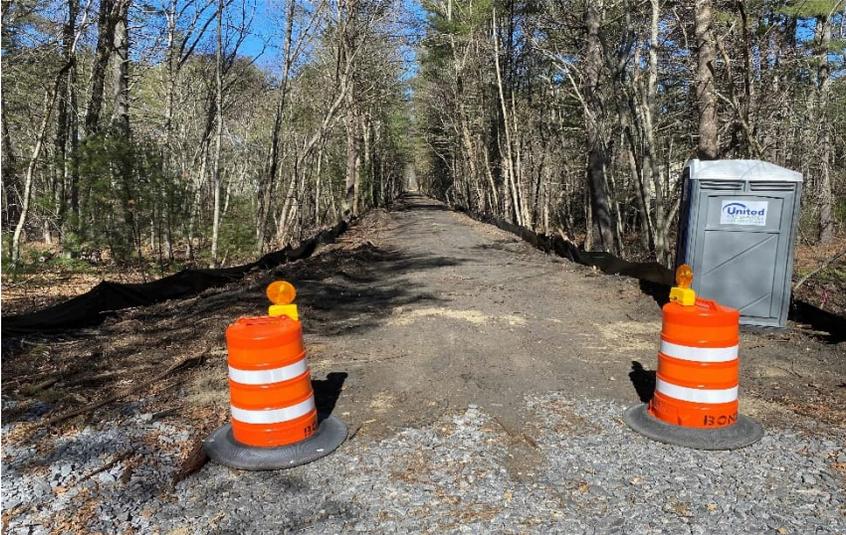
Description: Right-of-way within Segment 9 off Peakham Road, looking westward.

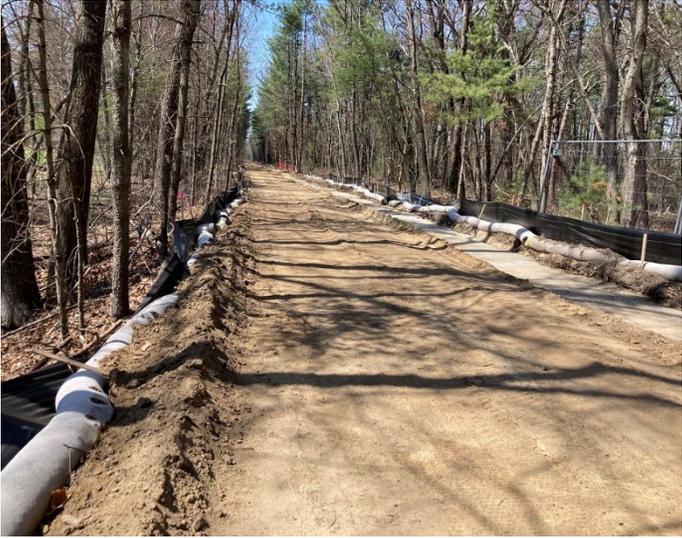
Description: View of segment 4 near culvert. Repair E&S controls where needed in segments 2 and 4 (routine maintenance). Facing west.

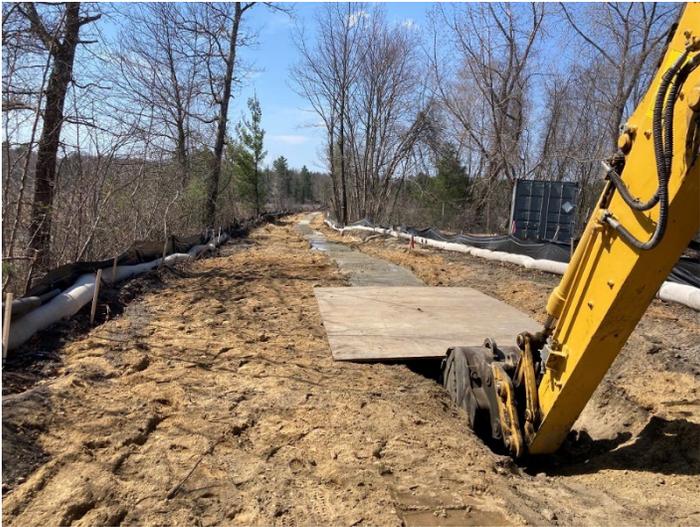
Description: View of Bond's work area in segment 3 near bridge 130. Facing west.

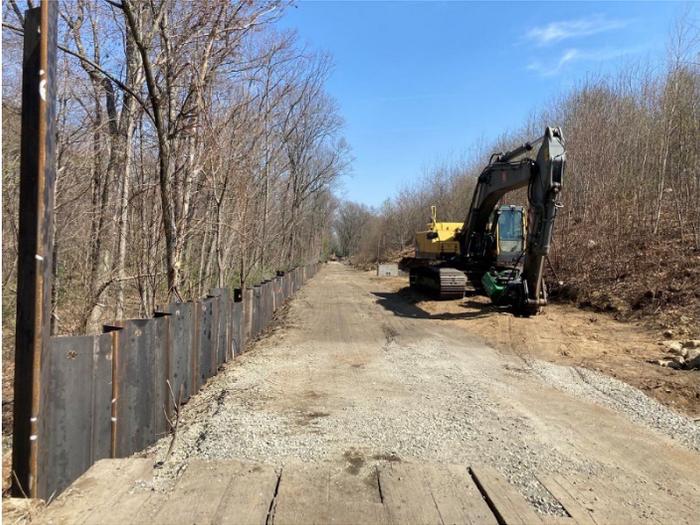
Description: View of sheetwall installation area in segment 1. Facing east.

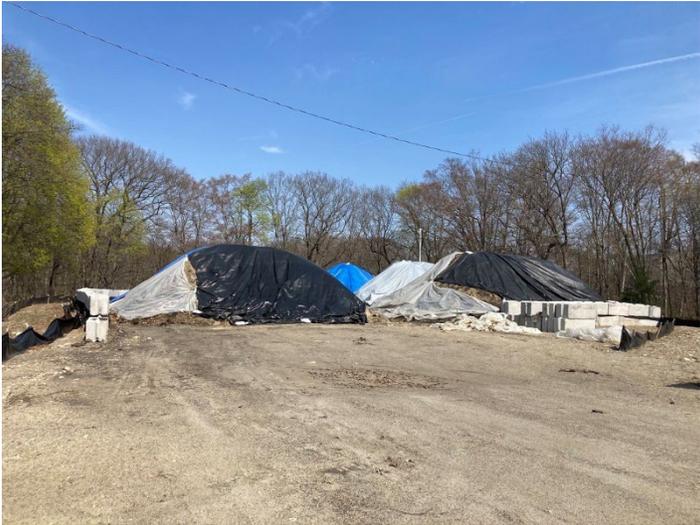
Description: View of laydown yard at Stowe Ct. Maintenance to stockpile covers has been completed. Facing northeast.

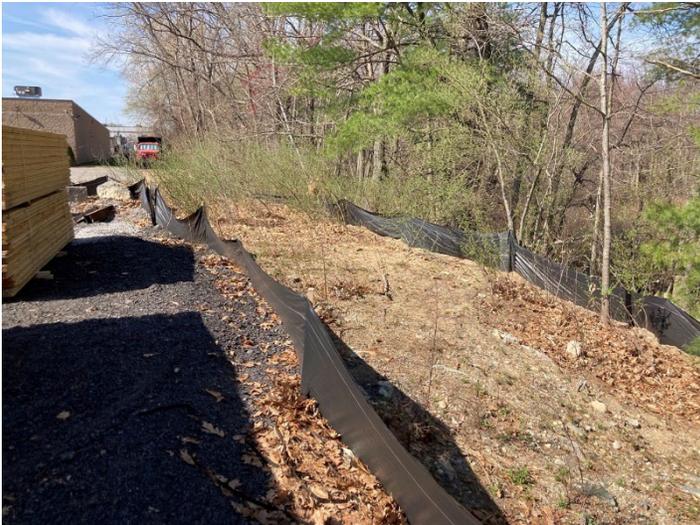
Description: View of silt fence at laydown yard at Robert Bonazzoli Ave. Controls are in good condition. Facing southwest.

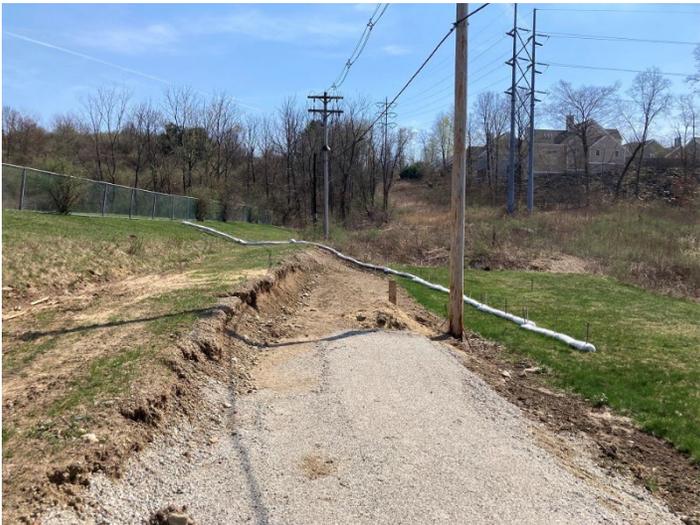
Description: View of E&S controls at MH #1 area. Facing south.

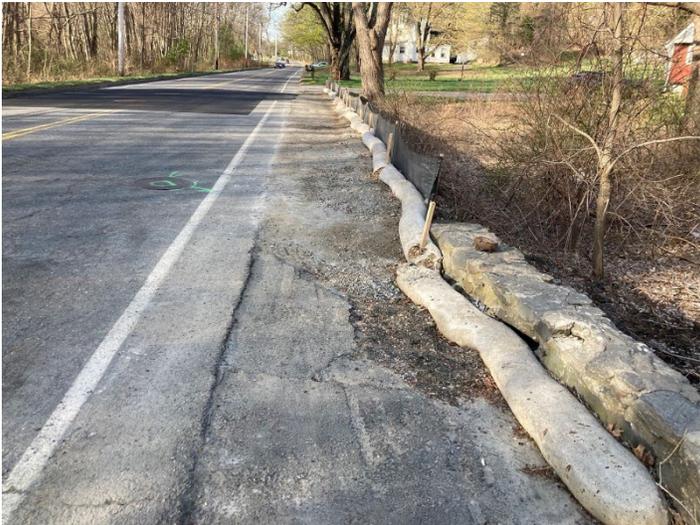
Description: View of E&S controls at MH#4 area. Facing southwest.

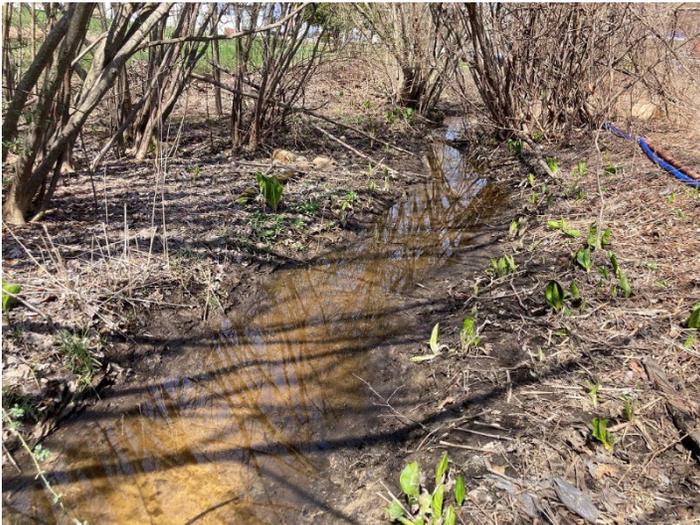
Description: View of stream below culvert south of intersection of Forest Ave and Glendale Street after restoration was completed. Facing west.

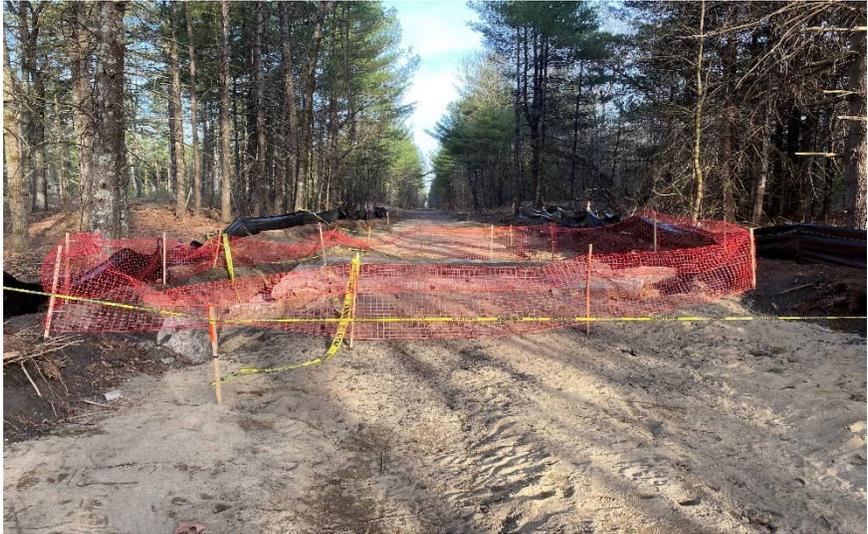
Description: Historic cattle guard within Segment 7, looking westward.

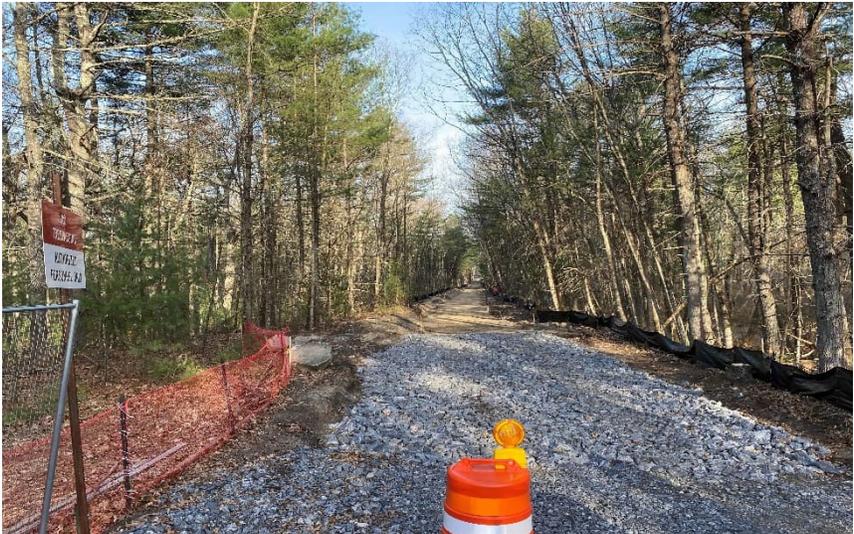
Description: Right-of-way within Segment 8 off Dutton Road, looking westward.

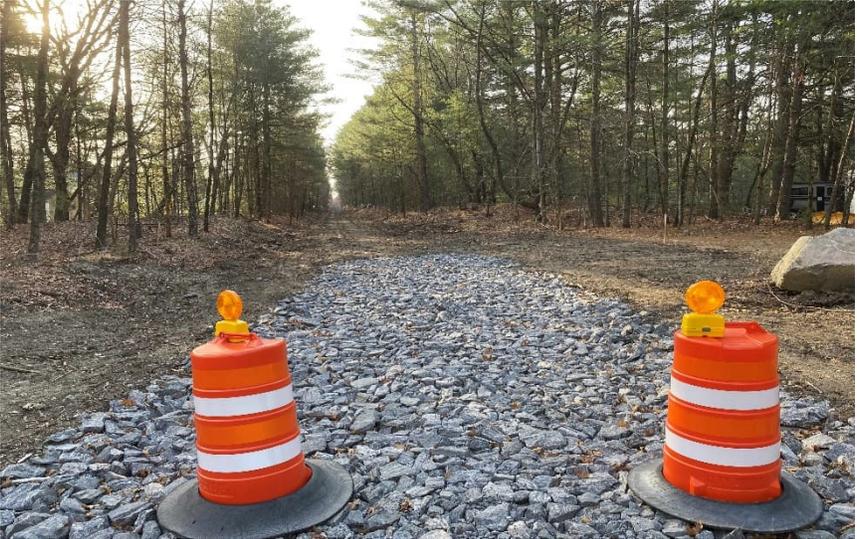
Description: Right-of-way within Segment 9 off Dutton Road, looking eastward.

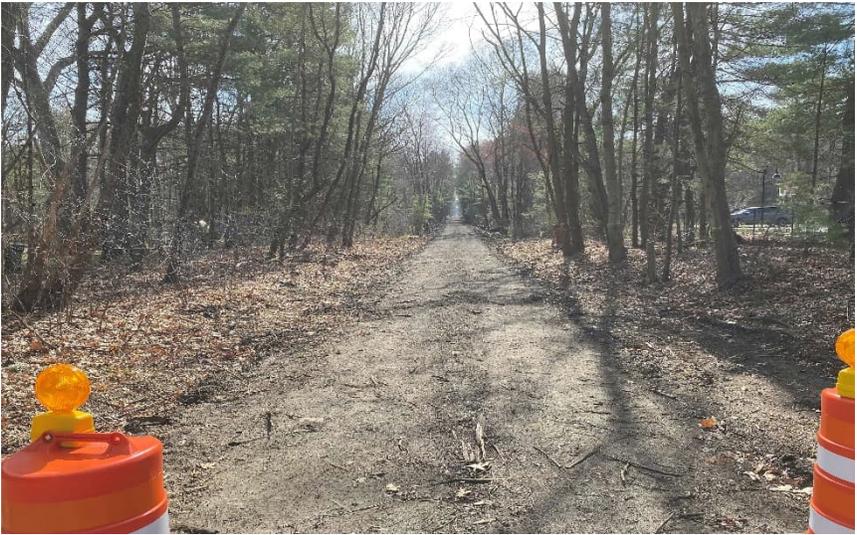
Description: Right-of-way within Segment 11, looking eastward.

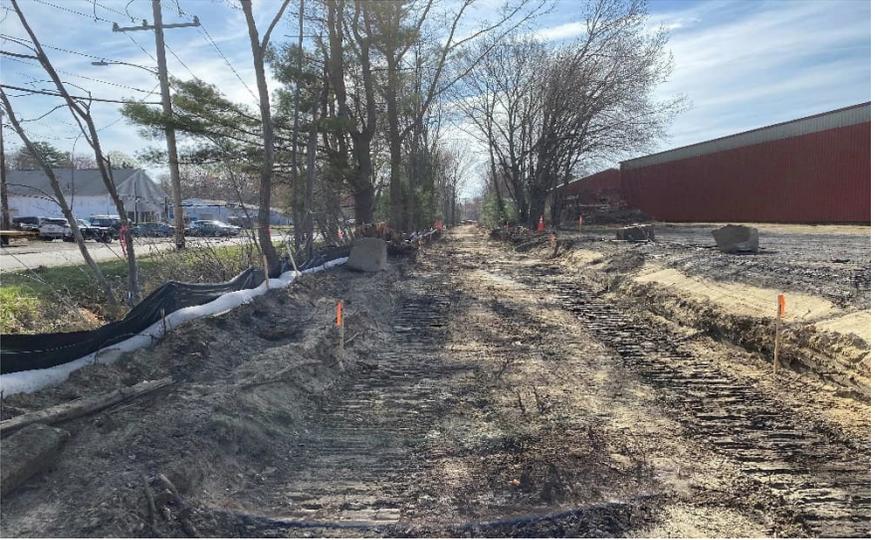
Description: Right-of-way within Segment 12 off Union Street, looking eastward.

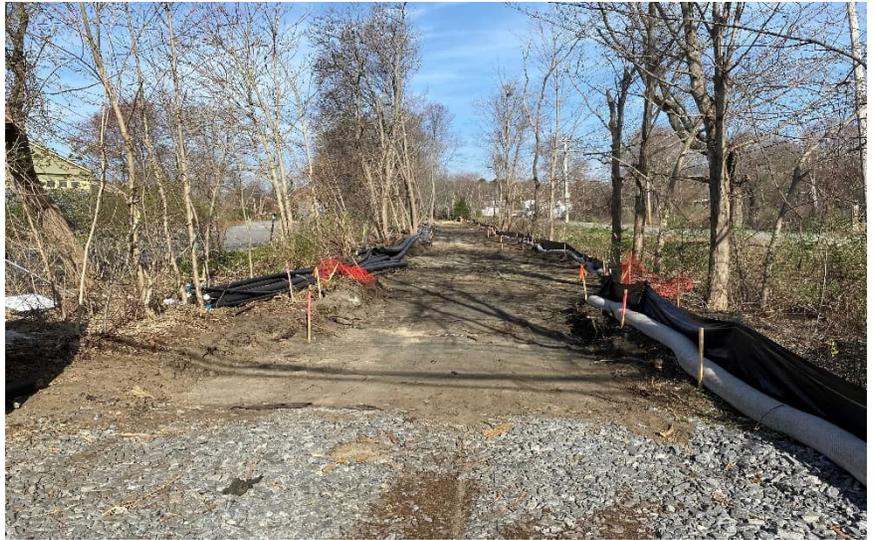
Description: Right-of-way within Segment 12 off Boston Post Road, looking westward.

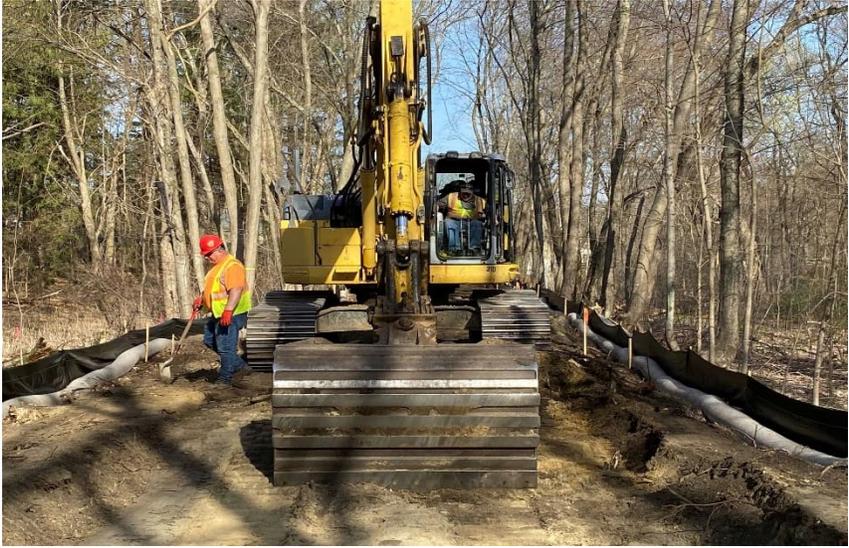
Description: ET&L conducting grading within Segment 13, looking westward.

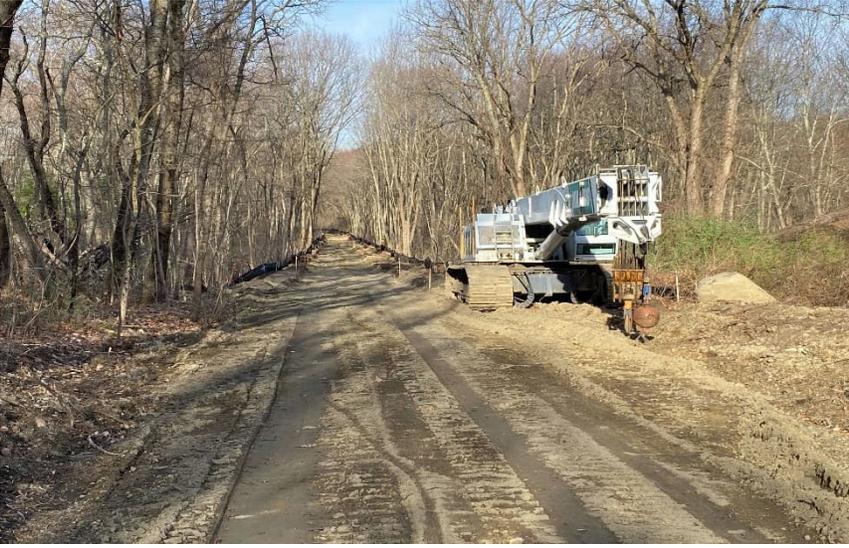
Description: Right-of-way within Segment 14 with stored crane at approximate Sta# 750+00, looking westward.
