Weekly Environmental Compliance Summary

Sudbury to Hudson Transmission Reliability Project (USEPA Tracking # MAR1003UW)

Week of: April 17 to April 21, 2023

CONSTRUCTION MONITORING REPORT

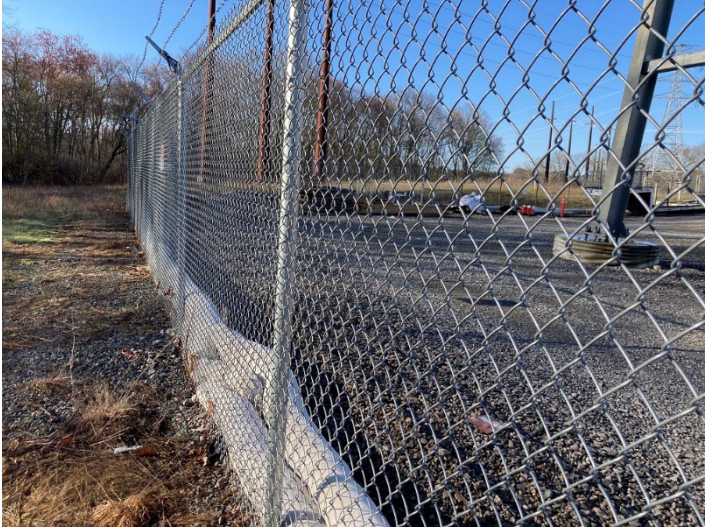
<p align="center">PHOTOGRAPHIC LOG</p>	
Client Name: Eversource		Site Location: Sudbury to Hudson Transmission Reliability Project	Town: Sudbury
Photo No.: 1	Date: 4/18/2023

Description: View of filter tubes at Sudbury Substation. Controls are operating properly. Facing southwest.

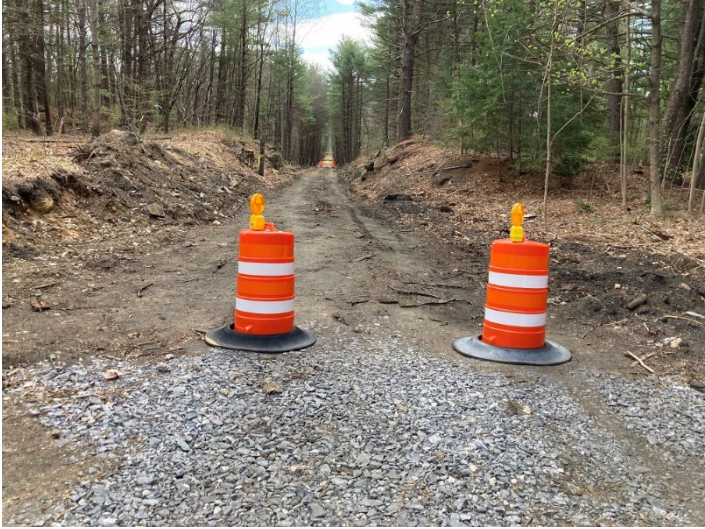
<p align="right">PHOTOGRAPHIC LOG</p>	
<p>Client Name: Eversource</p>		<p>Site Location: Sudbury to Hudson Transmission Reliability Project</p>	<p>Town: Sudbury</p>
<p>Photo No.: 1</p>	<p>Date: 4/19/2023</p>

<p>Description: View of entrance to segment 10 off Peakham Rd. Barrels are in place to indicate vernal pool areas. Facing east.</p>

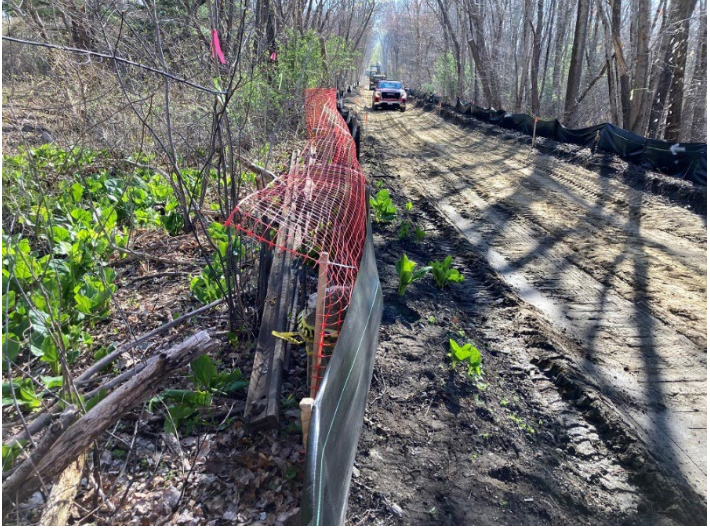
PHOTOGRAPHIC LOG	
Client Name: Eversource		Site Location: Sudbury to Hudson Transmission Reliability Project	Town: Sudbury
Photo No.: 6	Date: 4/19/2023

Description: View of rails that were placed next to rail rests at approximately Sta. #744/Sta. #452 in segment 14. Orange fence was installed along historic area after rails were placed. Facing east.

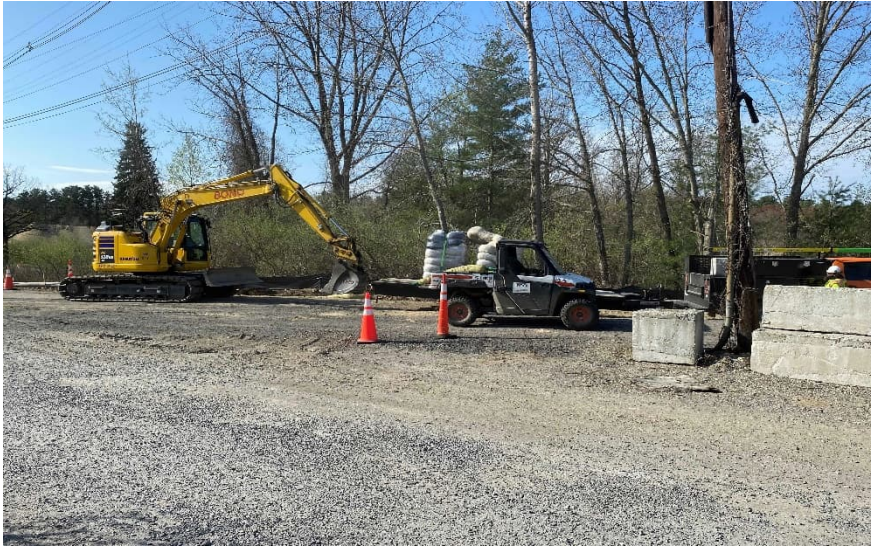
<p>PHOTOGRAPHIC LOG</p>	
<p>Client Name: Eversource</p>		<p>Site Location: Sudbury to Hudson Transmission Reliability Project</p>	<p>Town: Hudson</p>
<p>Photo No.: 3</p>	<p>Date: 4-21-23</p>

<p>Description: Bond conducting erosion control work within Segment 3, looking westward.</p>

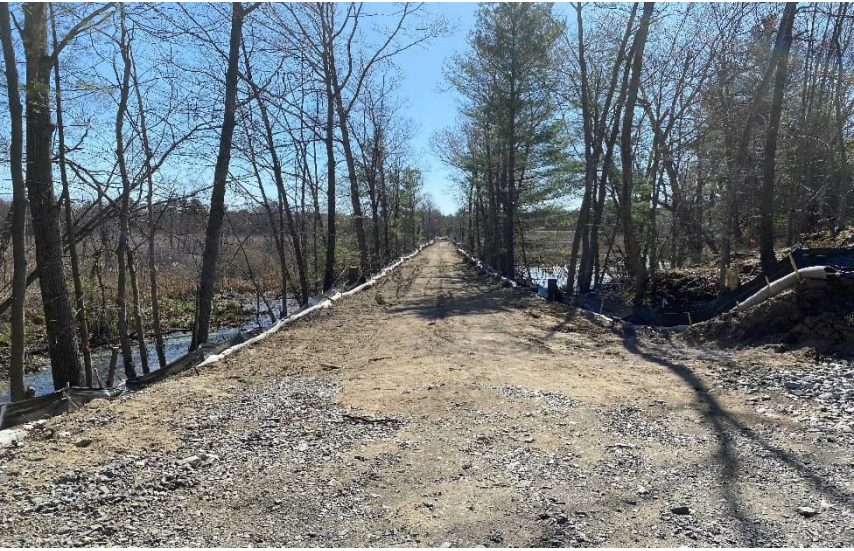
PHOTOGRAPHIC LOG	
Client Name: Eversource		Site Location: Sudbury to Hudson Transmission Reliability Project	Town: Hudson
Photo No.: 7	Date: 4-20-23

Description: Right-of-way within Segment 2, existing erosion control, looking eastward

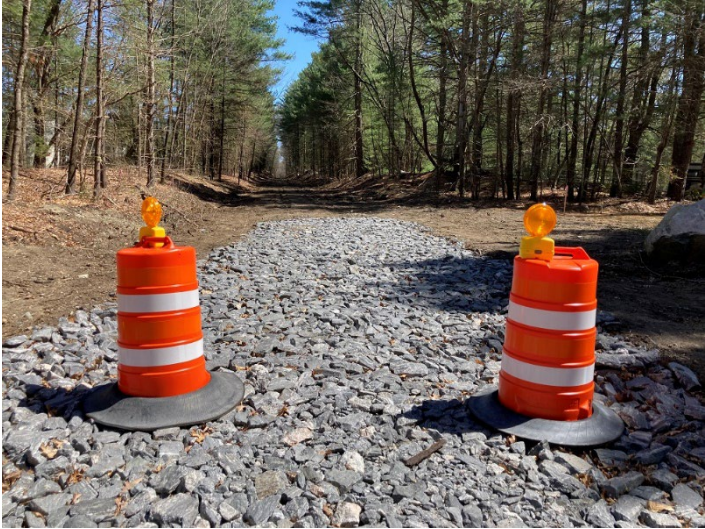
Description: View of entrance to segment 9 from Dutton Rd. Barrels are in place to indicate vernal pool area. Facing east.

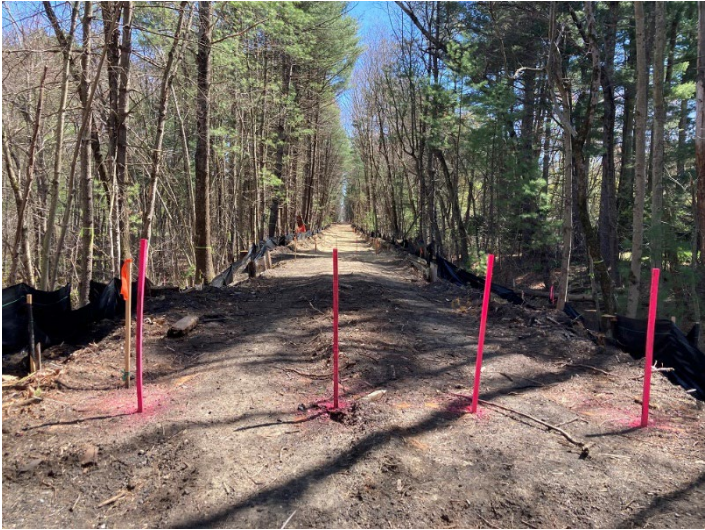
Description: View of Dudley Brook culvert area in segment 10. Stakes are in place to prevent travel or work over culvert. Facing east.

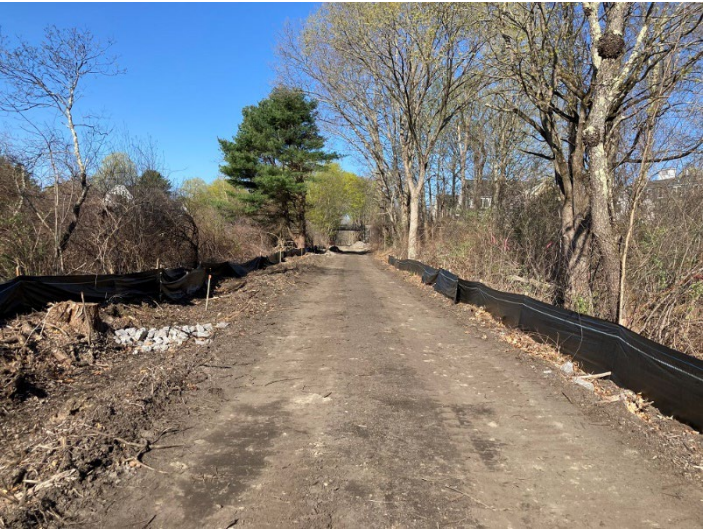
Description: View of syncopated silt fence and swale with check dams at east end of segment 14. Facing west.

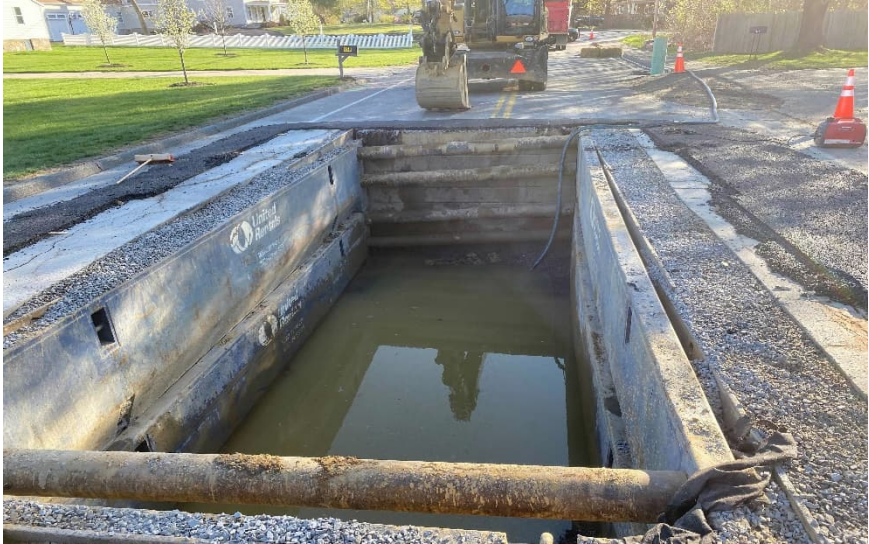
Description: View of area being pumped at work operation at MH#3, in Forest Avenue, looking northward. Water appeared slightly turbid.

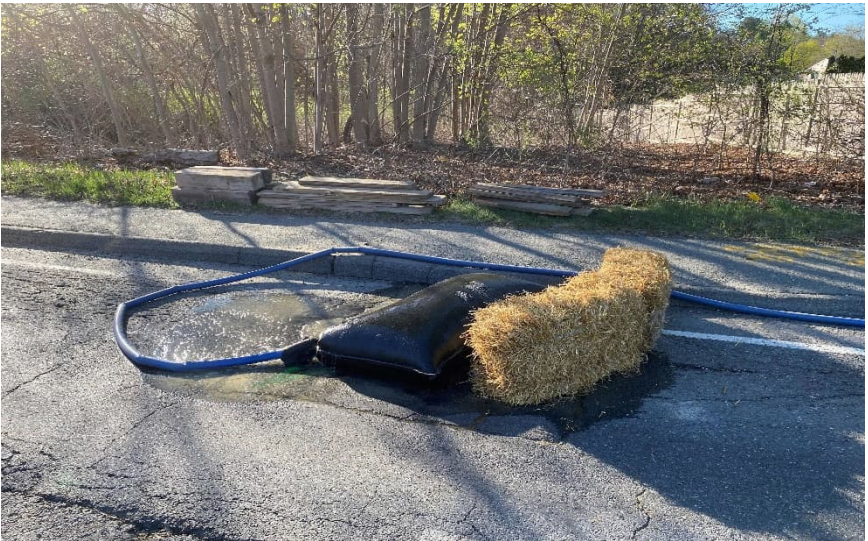
Description: MH#3. View of discharge bag/bales, looking eastward. Water appeared to be clear.

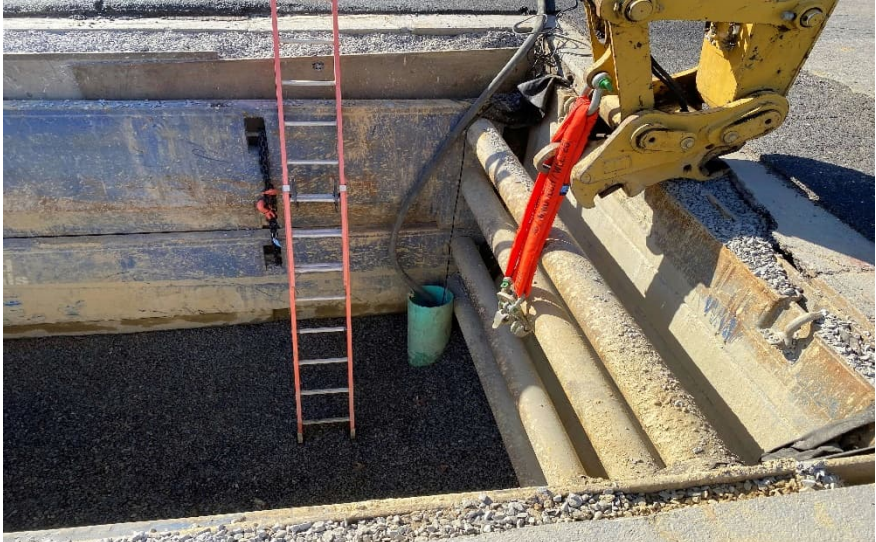
Description: View of area being pumped at work operation at MH#3, in Forest Avenue. Water appeared slightly turbid.
