Weekly Environmental Compliance Summary

Sudbury to Hudson Transmission Reliability Project (USEPA Tracking # MAR1003UW)

Week of: April 24 to April 28, 2023

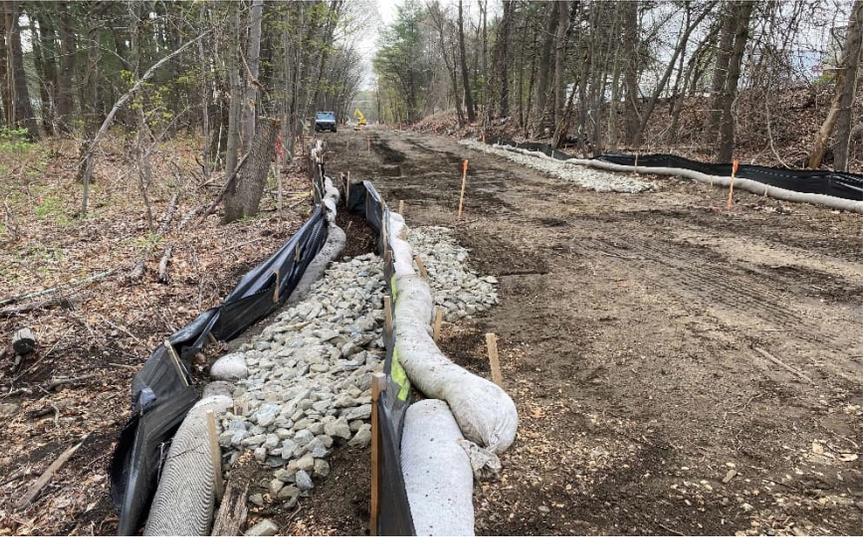
<p>PHOTOGRAPHIC LOG</p>	
<p>Client Name: Eversource</p>		<p>Site Location: Sudbury to Hudson Transmission Reliability Project</p>	<p>Town: Hudson</p>
<p>Photo No.: 6</p>	<p>Date: 4-25-23</p>

Erosion issue previously noted in my 4-24-23 (segment 3 at approximate Sta#174+50) report corrected (see photo 6).

<p>Description: Segment 3 (at approximate Sta# 174+50) erosion control repairs - adding stone berms (foreground) & rock lined swale (opposite side of row), looking eastward</p>

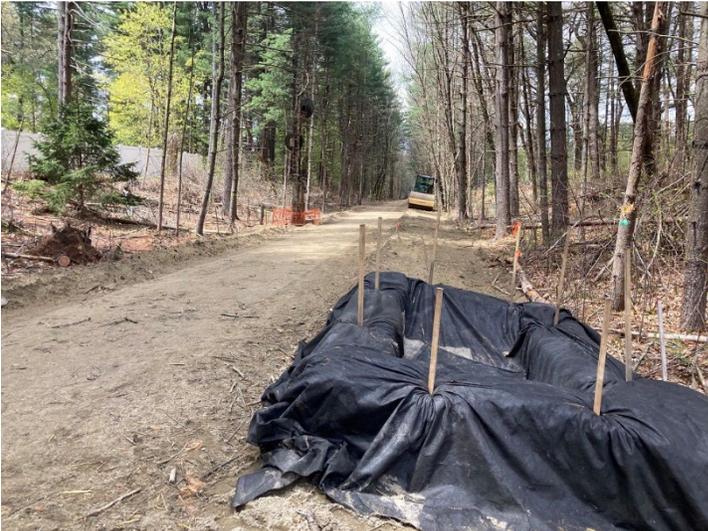
PHOTOGRAPHIC LOG	
Client Name: Eversource		Site Location: Sudbury to Hudson Transmission Reliability Project	Town: Sudbury
Photo No.: 2	Date: 4/25/2023

Description: View of straw bale corral that has been installed in segment 10 in anticipation of dewatering activities at MH #21. Facing west.

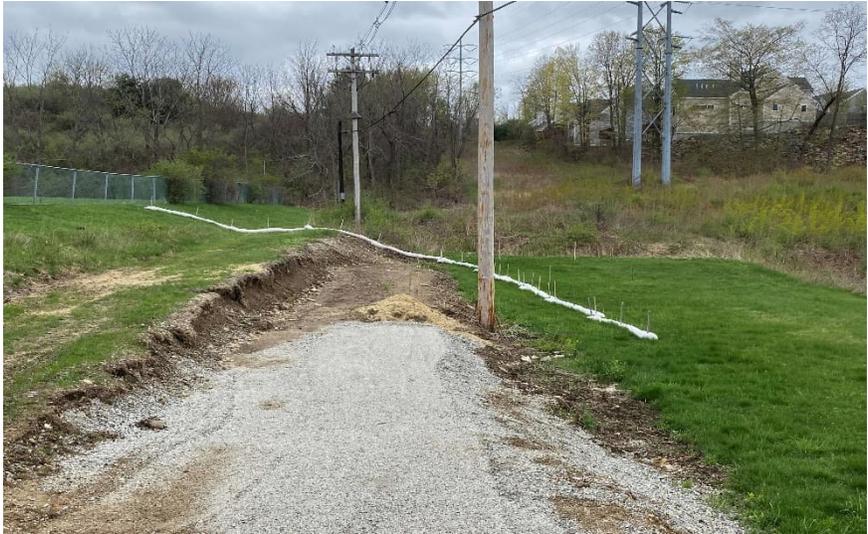
<p>PHOTOGRAPHIC LOG</p>	
<p>Client Name: Eversource</p>		<p>Site Location: Sudbury to Hudson Transmission Reliability Project</p>	<p>Town: Hudson</p>
<p>Photo No.: 1</p>	<p>Date: 4-26-23</p>

<p>Description:</p> <p>Compost filter tubes at MH#1 area (installed & functioning correctly), looking eastward.</p>

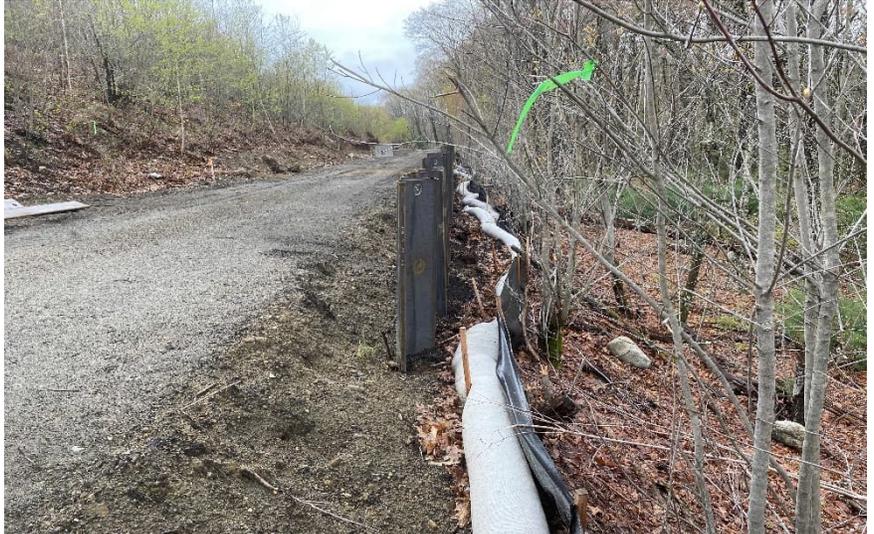
Description: Segment 1, newly installed sheeting with erosion control on the "wetland" side, looking westward.

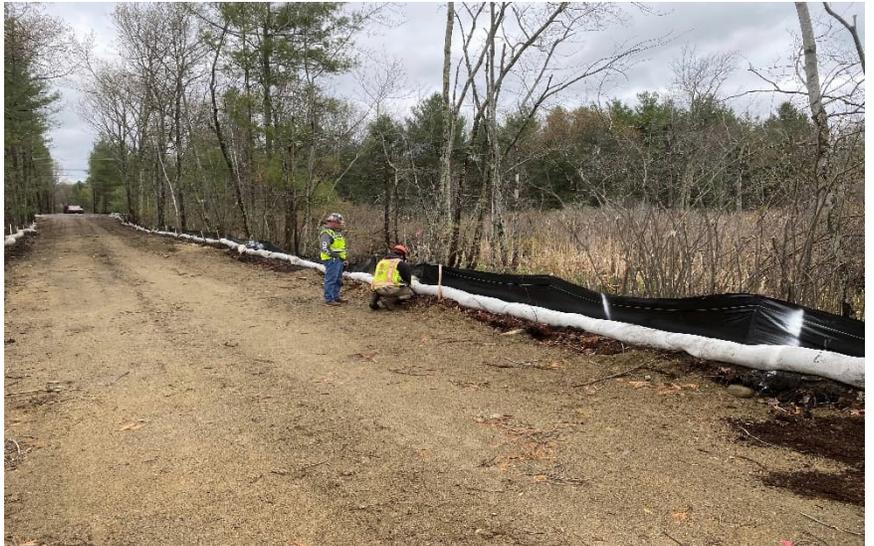
Description: Bond conducting erosion control repairs within Segment 2, looking westward.

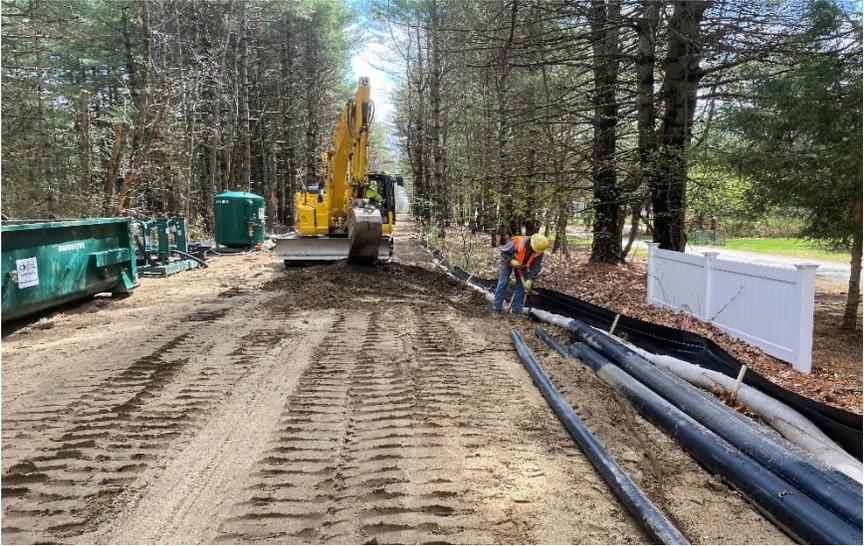
Description: Bond conducting erosion control repairs within Segment 5, looking eastward.

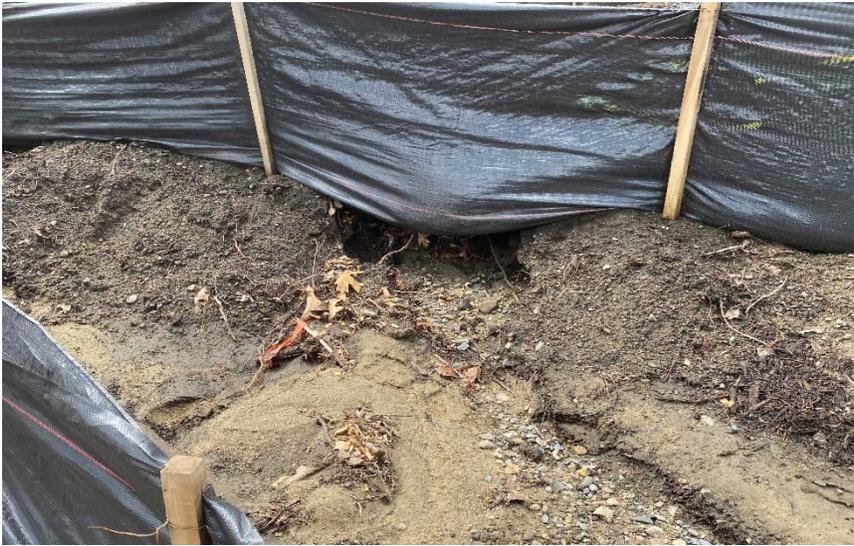
Discharge Location	Observations
1. Hudson within Segment 3 at approximate Sta# 174+50	Actual runoff not observed, but in the end because of the rain event & extensive undercutting of the erosion control (2 rows of silt fencing & compost filter tubes - see photo 8) on-site it is surmised that runoff did exit the site.
2.	
3.	
4.	
5.

Description: Silt fencing undermined by storm event within Segment 3 at approximate Sta# 174+50, looking eastward.

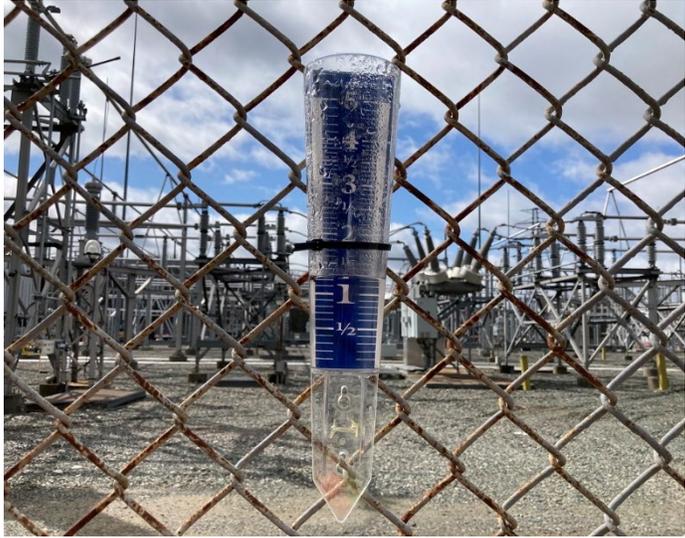
Description: View of rain gauge at Sudbury Substation. 1.25" noted in gauge at 10am. Facing south.

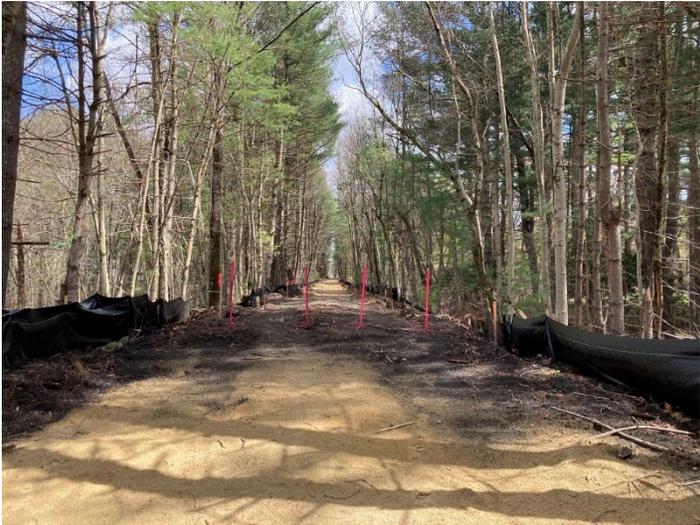
Description: View of Dudley Brook culvert area in segment 10. Stakes are in place to prevent travel or work over culvert. Facing east.

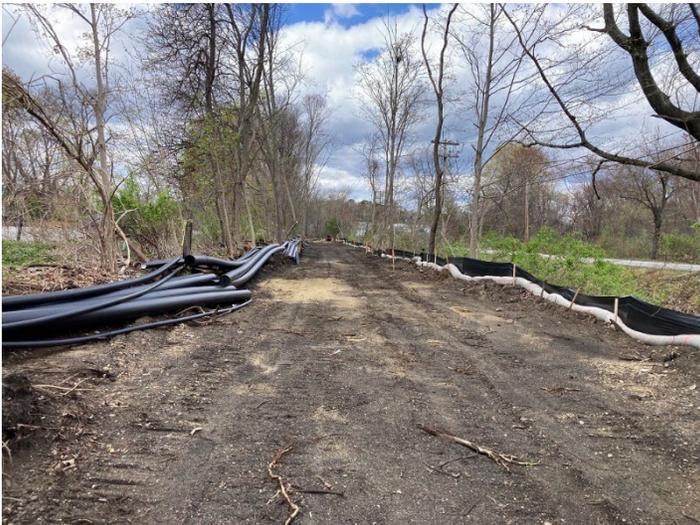
Description: View of segment 12. E&S controls are operating properly. Facing west.

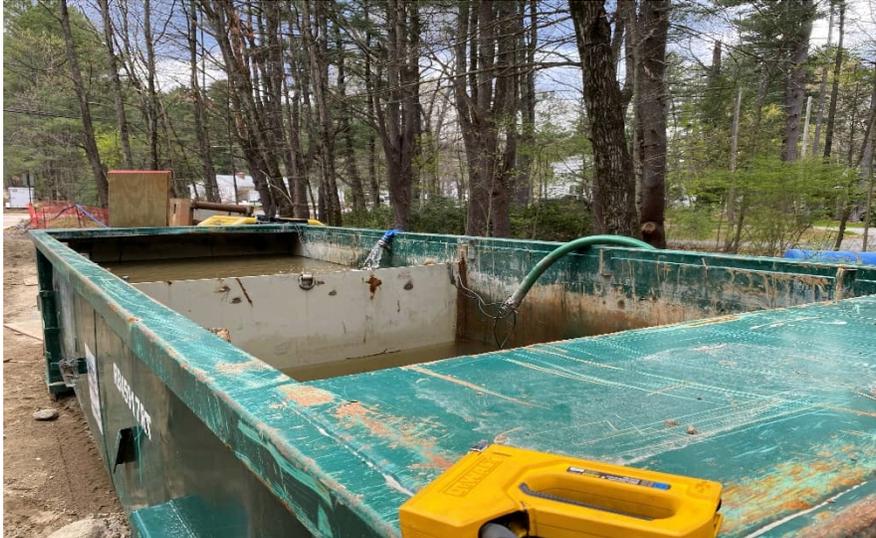
Description: View of area being pumped at work operation within Segment 5 at approximate Sta# 300+50 (accumulated water in frac tank), off Parmenter Road. Water appeared slightly turbid.

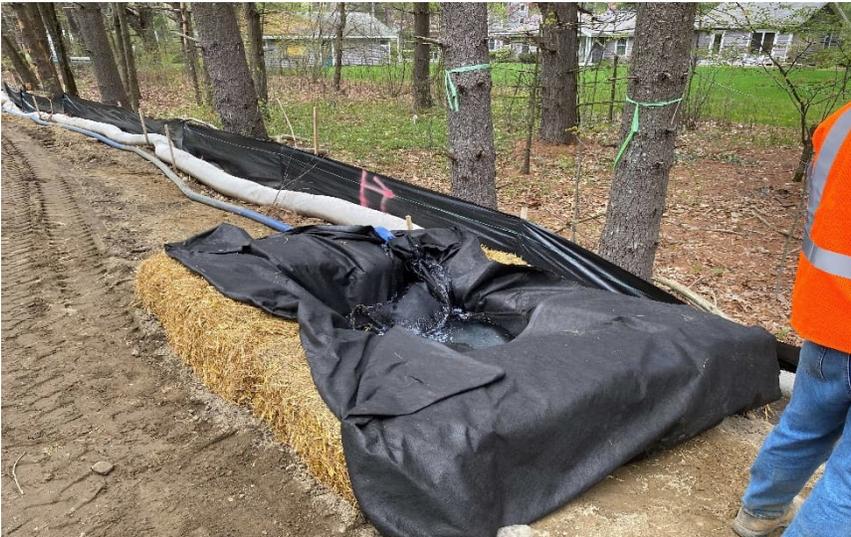
Description: Segment 5 at approximate Sta# 300+50. View of discharge bag/bales, looking westward. Water appeared to be clear.

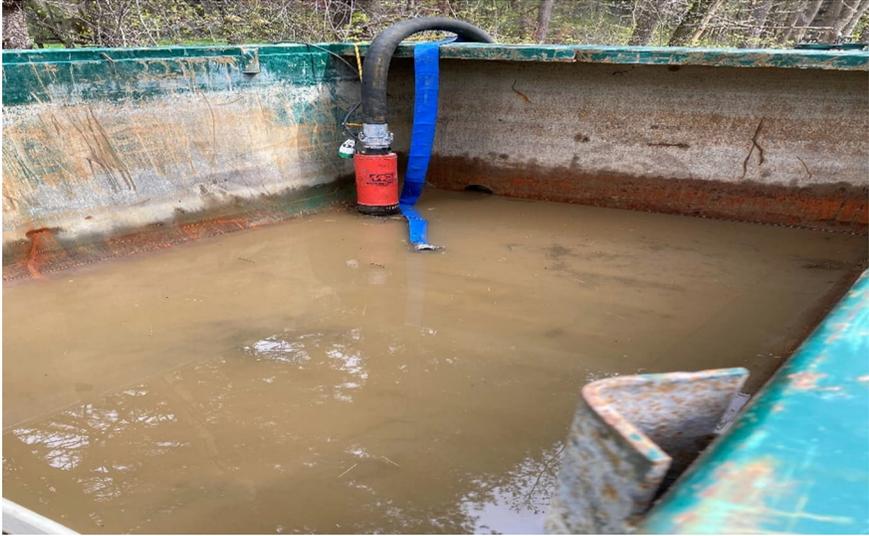
Description: View of area being pumped at work operation within Segment 5 at approximate Sta# 300+50 (accumulated water in frac tank), off Parmenter Road. Water appeared slightly turbid.

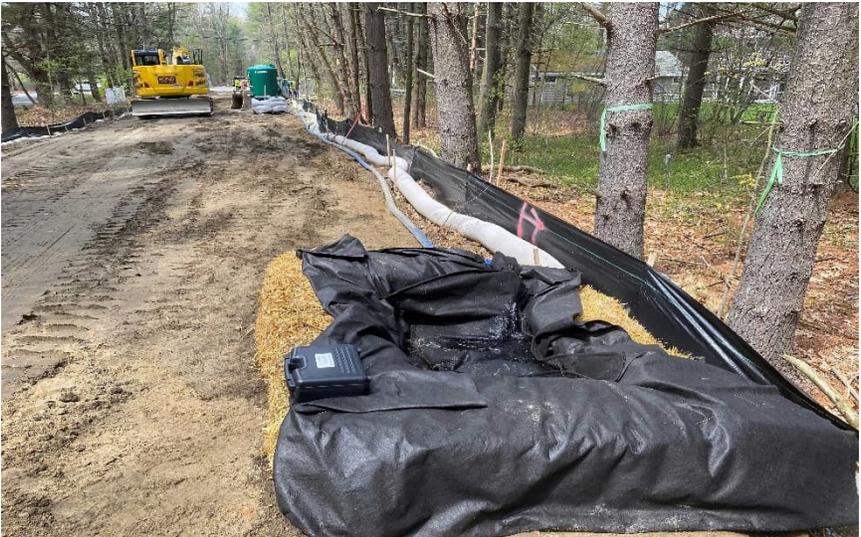
Description: Segment 5 at approximate Sta# 300+50. View of discharge bag/bales, looking westward. Water appeared to be clear.

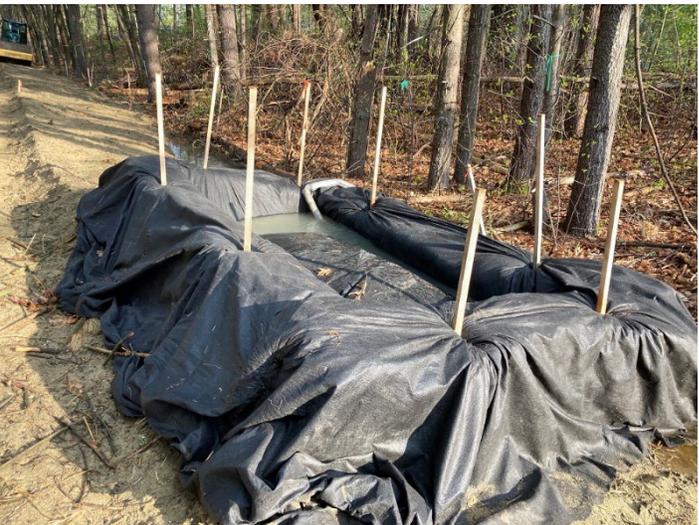
Description: View of dewatering controls (straw bale corral with filter fabric and silt bag). Facing northwest.
