Weekly Environmental Compliance Summary

Sudbury to Hudson Transmission Reliability Project (USEPA Tracking # MAR1003UW)

Week of: May 1 to May 5, 2023

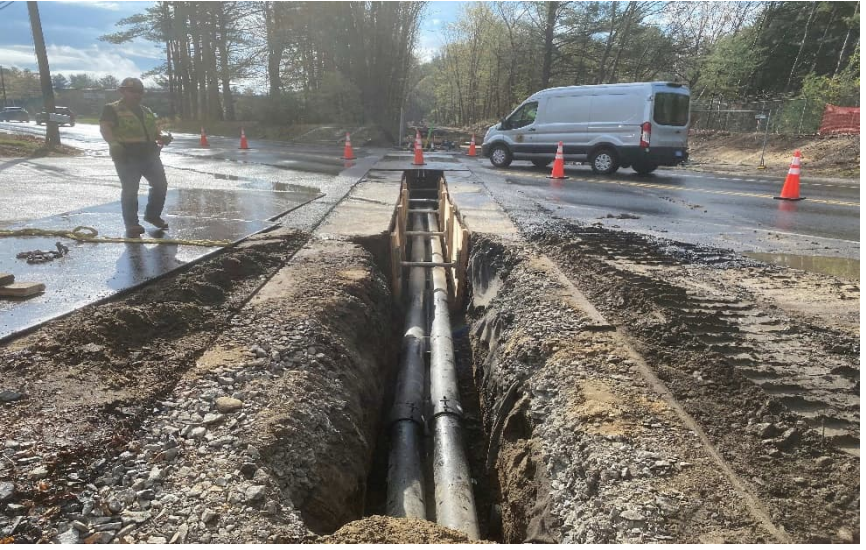
| <p>Photo No.: 1</p> | <p>Date: 5-2-23</p> | | |

| <p>Description:</p> <p>Conduit work, across Main Street, looking eastward.</p> | | | |

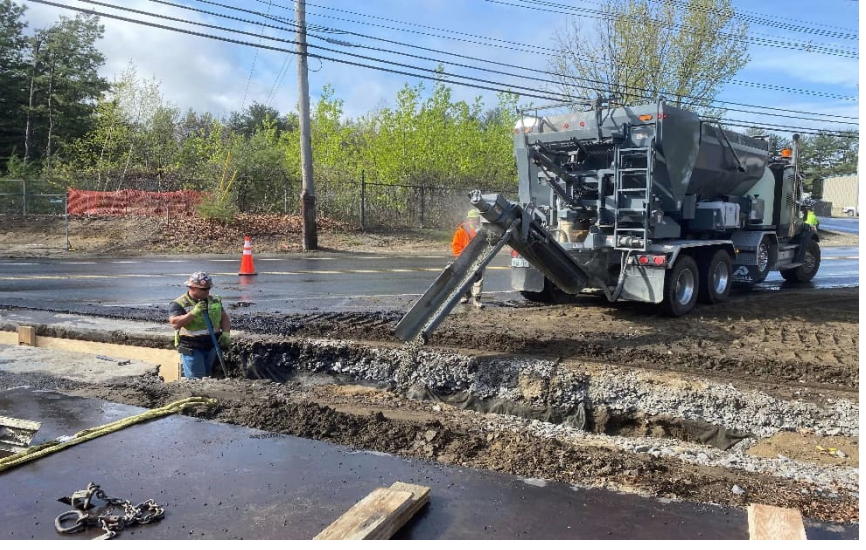
| <p>Photo No.: 2</p> | <p>Date: 5-2-23</p> | | |

| <p>Description:</p> <p>Conduit work, within segment 3, off Main Street, setting flowable fill, looking westward.</p> | | | |

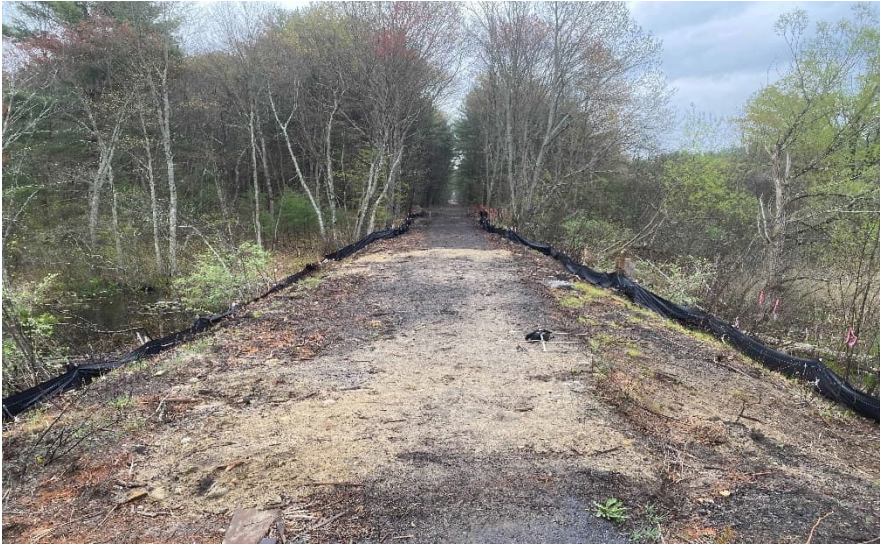
| <p>Photo No.: 3</p> | <p>Date: 5-2-23</p> | | |

| <p>Description:</p> <p>Right-of-way within segment 8 from bridge 128, existing erosion control, looking eastward.</p> | | | |

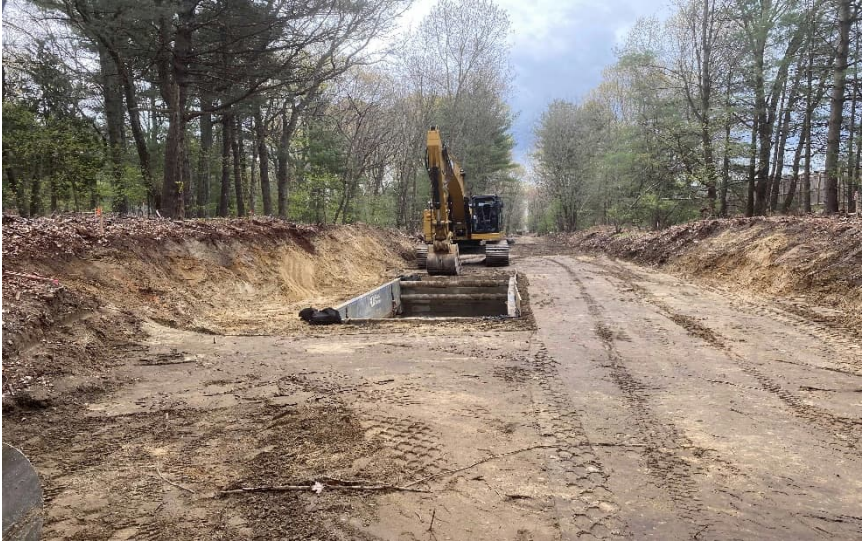
| <p>Photo No.: 4</p> | <p>Date: 5-2-23</p> | | |

| <p>Description:</p> <p>Manhole #22, within segment 11, looking eastward.</p> | | | |

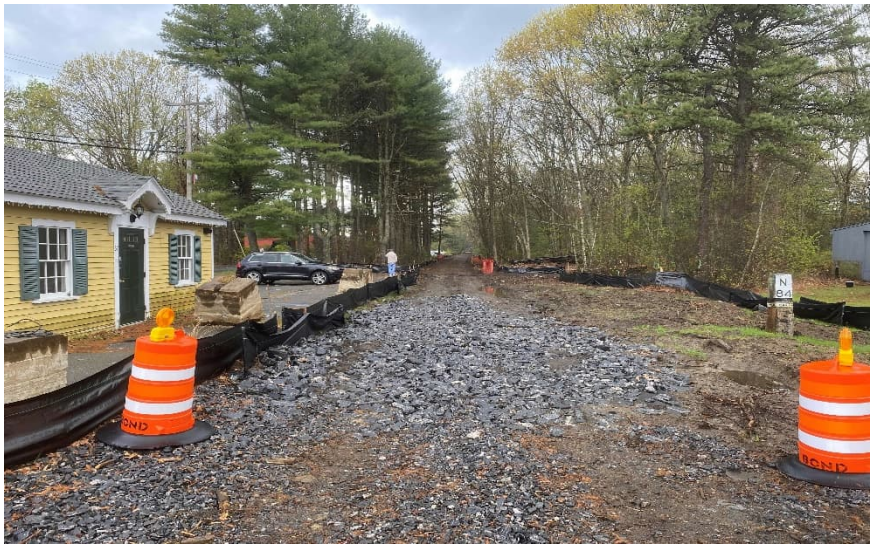
| <p>Photo No.: 6</p> | <p>Date: 5-2-23</p> | | |

| <p>Description: Right-of-way within segment 11, existing erosion control, looking westward.</p> | | | |

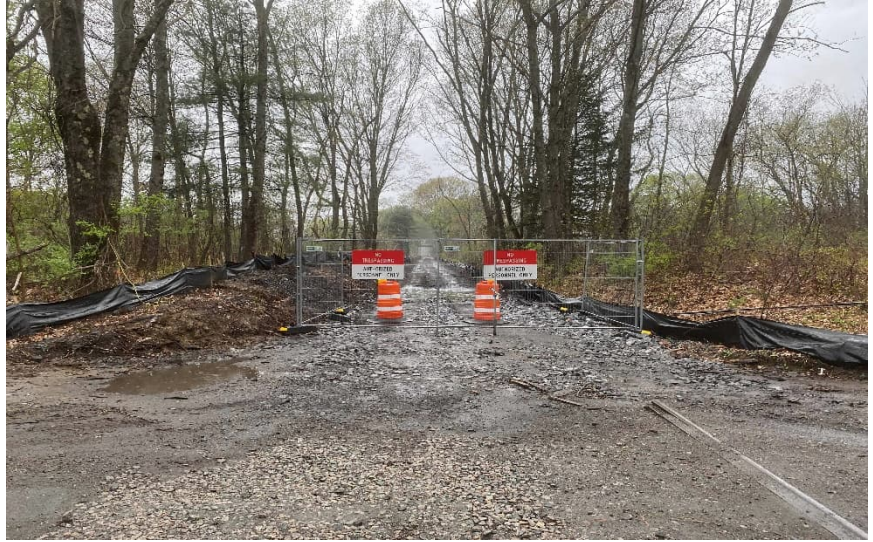
| <p>Photo No.: 8</p> | <p>Date: 5-2-23</p> | | |

| <p>Description: Segment 14 entrance near Sudbury substation, existing erosion control, looking westward.</p> | | | |

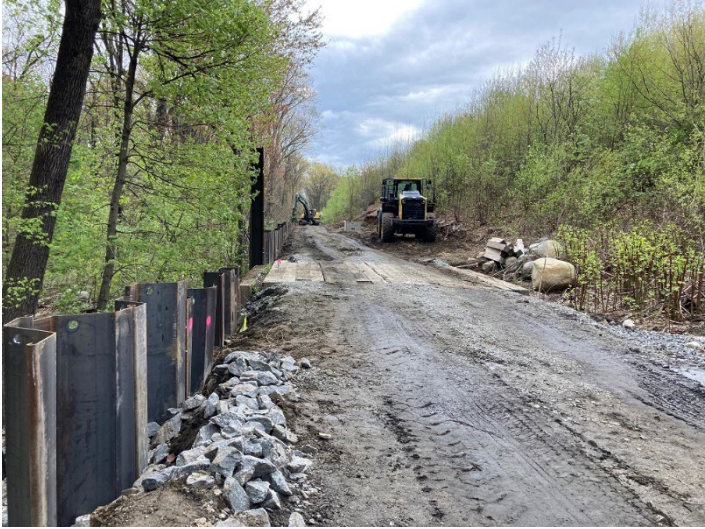
| Photo No.: 1 | Date: 5/03/2023 | | |

| Description: View of ET&L performing sheet wall installation in segment 1. Facing east. | | | |

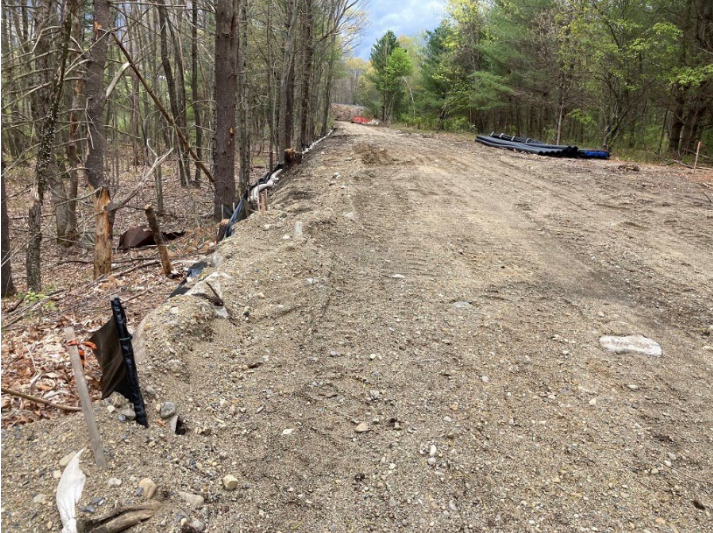
| Photo No.: 2 | Date: 5/03/2023 | | |

| Description: View of segment 2. Erosion control repairs needed in segments 2 and 4 (routine maintenance). Facing west. | | | |

-Repair to E&S controls (routine maintenance) needed in segments 2 and 4.

| Type and Location of E&S Control | Conditions Requiring Routine Maintenance? ¹ | If "Yes," How Many Times (Including This Occurrence) Has This Condition Been Identified? | Conditions Requiring Corrective Action? ^{2, 3} | Date on Which Condition First Observed (If Applicable)? | Description of Conditions Observed |
|---|---|--|---|---|--|
| 6. Silt Fencing on ROW in Hudson | <input checked="" type="checkbox"/> Yes <input type="checkbox"/> No | 1 | <input type="checkbox"/> Yes <input checked="" type="checkbox"/> No | 5/01/2023 | Repair silt fence and filter tubes where needed in segments 2 and 4 (routine maintenance). |
| 8. Filter Tubes in Hudson | <input checked="" type="checkbox"/> Yes <input type="checkbox"/> No | 1 | <input type="checkbox"/> Yes <input checked="" type="checkbox"/> No | 5/01/2023 | Repair silt fence and filter tubes where needed in segments 2 and 4 (routine maintenance). |

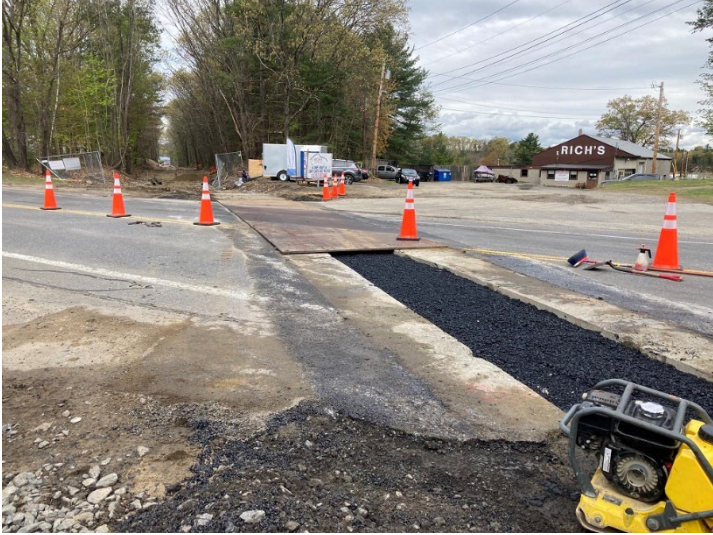
| Photo No.: 3 | Date: 5/03/2023 | | |

| Description: View of blacktop activities at Main St between segments 3 and 4. Facing west. | | | |

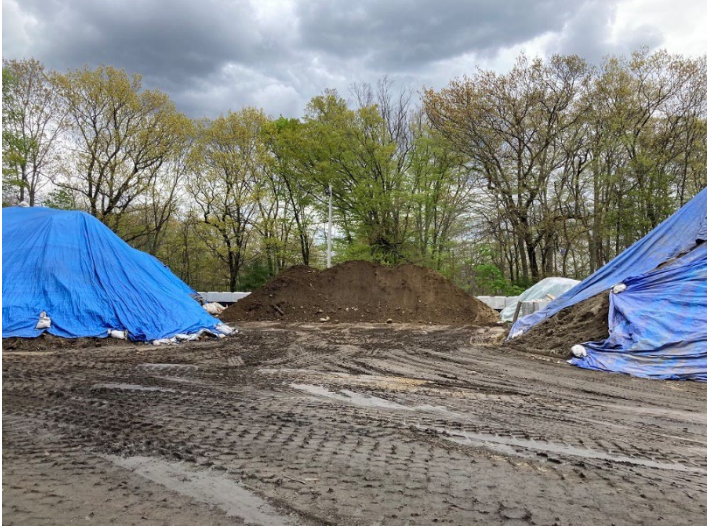
| Photo No.: 6 | Date: 5/03/2023 | | |

| Description: View of laydown yard at Stowe Ct. Uncovered pile is active. Facing northeast. | | | |

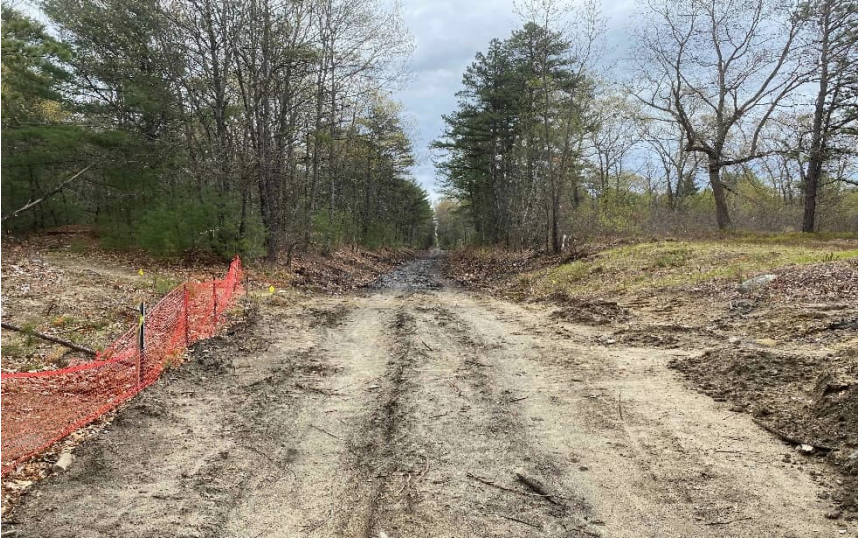
| <p>Photo No.: 2</p> | <p>Date: 5-3-23</p> | | |

| <p>Description:</p> <p>Right-of-way at town line, existing erosion control within segment 7, looking eastward.</p> | | | |

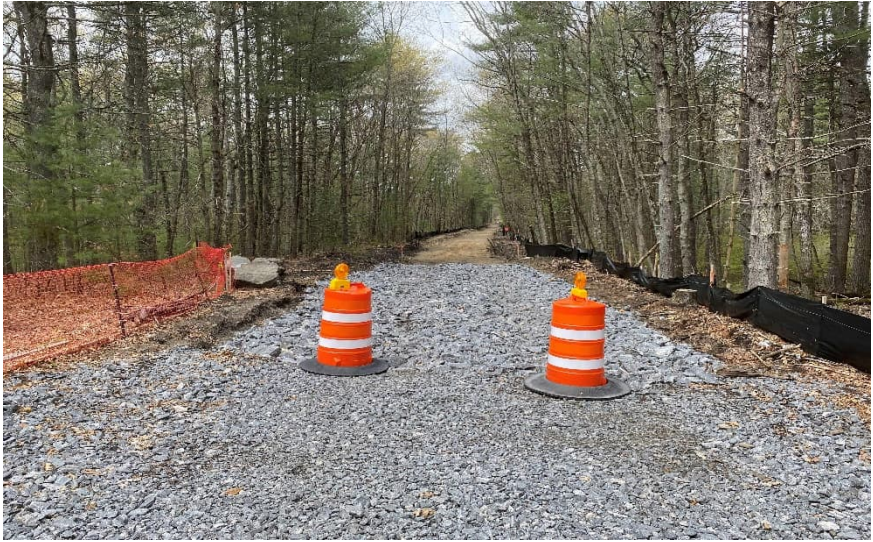
| <p>Photo No.: 3</p> | <p>Date: 5-3-23</p> | | |

| <p>Description:</p> <p>Right-of-way, existing erosion control within segment 8, looking eastward.</p> | | | |

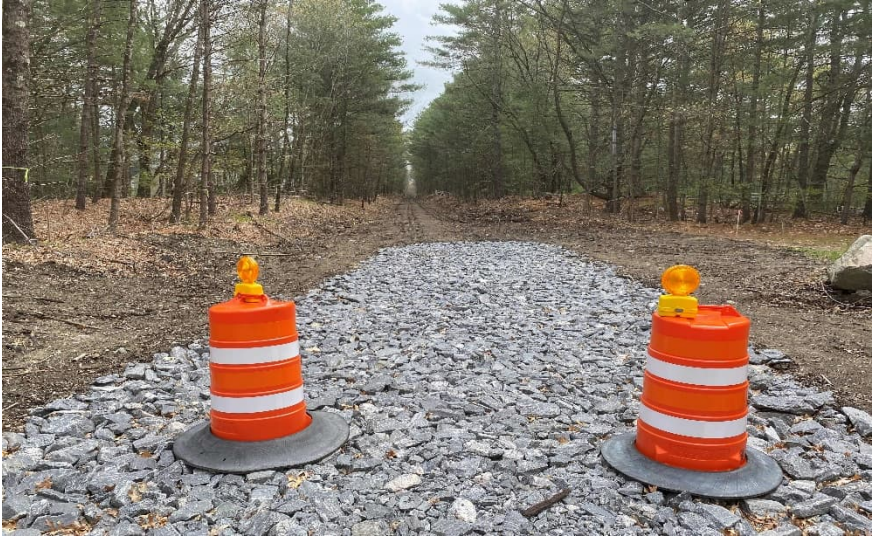
| <p>Photo No.: 4</p> | <p>Date: 5-3-23</p> | | |

| <p>Description:</p> <p>Right-of-way, existing erosion control within segment 9, looking eastward.</p> | | | |

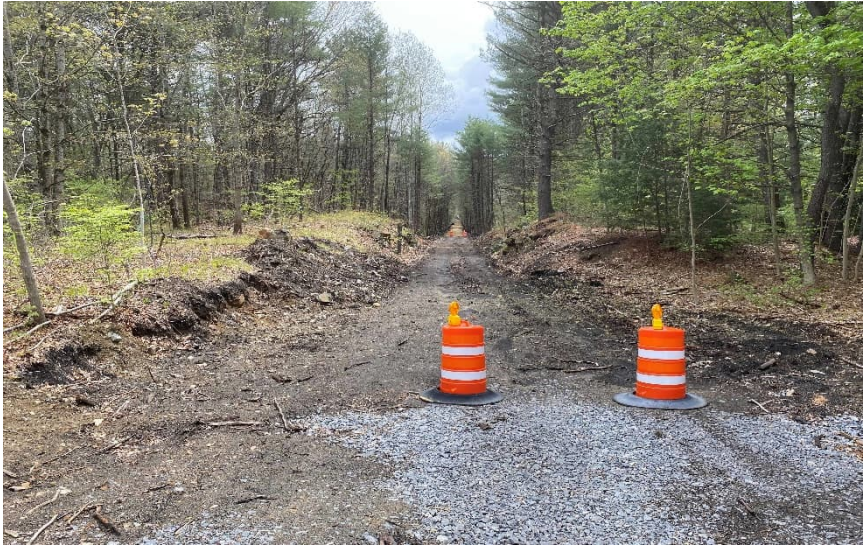
| <p>Photo No.: 5</p> | <p>Date: 5-3-23</p> | | |

| <p>Description: Right-of-way, existing erosion control, segment 10, looking eastward.</p> | | | |

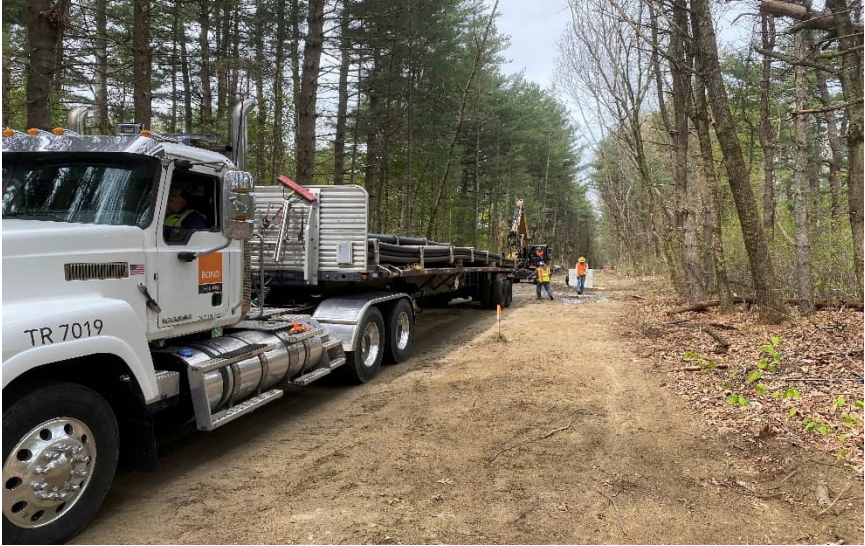
| <p>Photo No.: 6</p> | <p>Date: 5-3-23</p> | | |

| <p>Description: Bond staging conduit within segment 10, looking westward.</p> | | | |

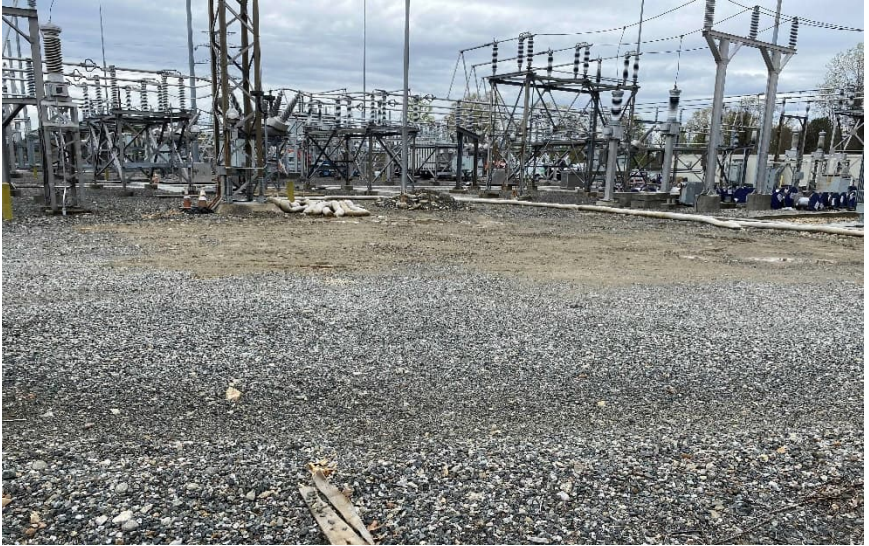
| <p>Photo No.: 8</p> | <p>Date: 5-3-23</p> | | |

| <p>Description:</p> <p>Sudbury substation, new spoil pile, looking southward.</p> | | | |

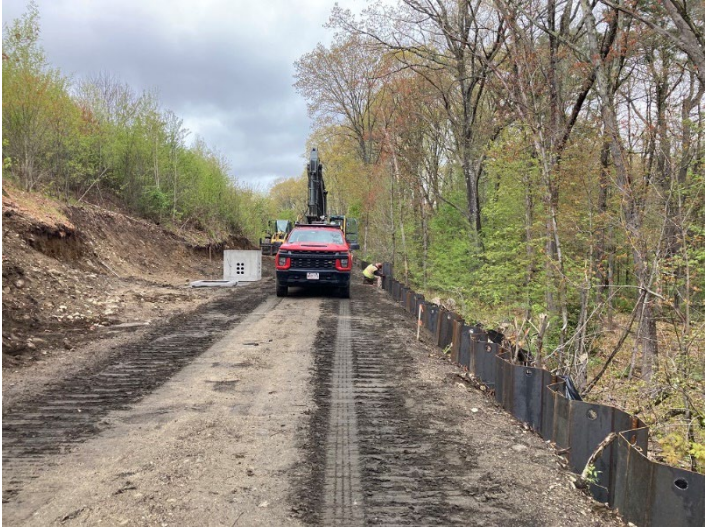
| Photo No.: 1 | Date: 5/04/2023 | | |

| Description: View of ET&L performing sheet wall installation in segment 1. Facing west. | | | |

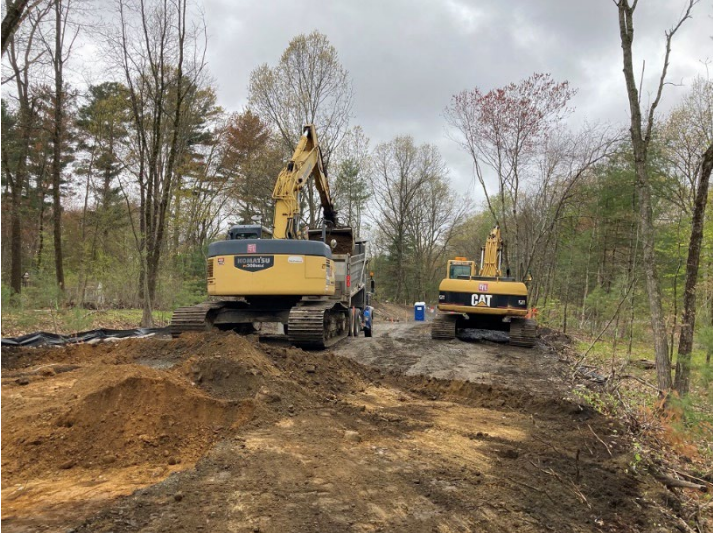
| Photo No.: 2 | Date: 5/04/2023 | | |

| Description: View of ET&L performing cut & fill activities in segment 1. Facing west. | | | |

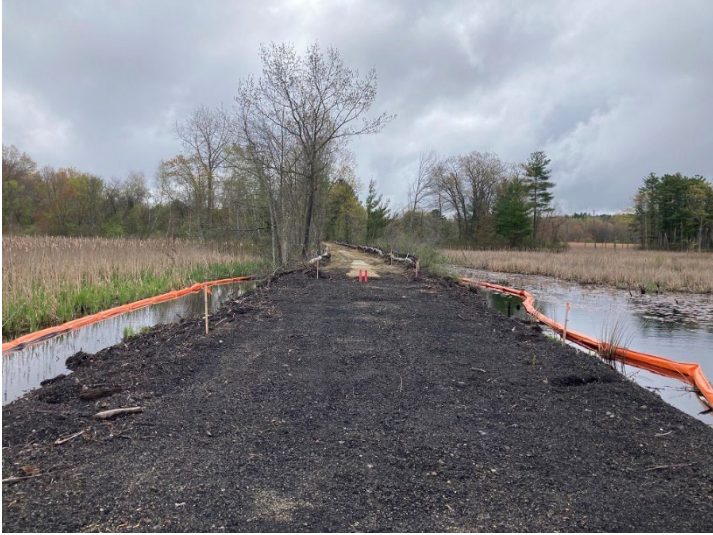
| Photo No.: 3 | Date: 5/04/2023 | | |

| Description: View of segment 3 from bridge 130. Facing east. | | | |

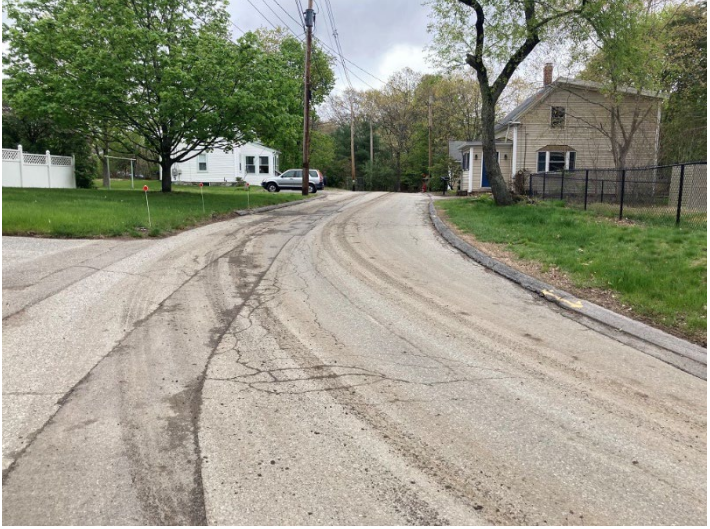
| <p>Photo No.: 6</p> | <p>Date: 5/04/2023</p> | | |

| <p>Description: Sediment tracking observed on Stowe Ct from laydown yard. Street sweeping is scheduled for Friday. Facing northeast.</p> | | | |

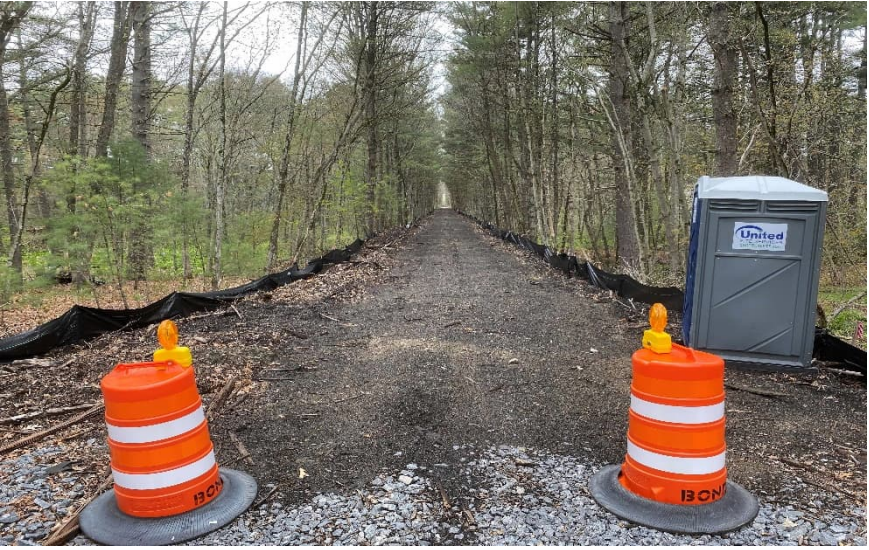
| <p>Photo No.: 1</p> | <p>Date: 5-4-23</p> | | |

| <p>Description: Right-of-way, existing erosion control within segment 9, looking westward.</p> | | | |

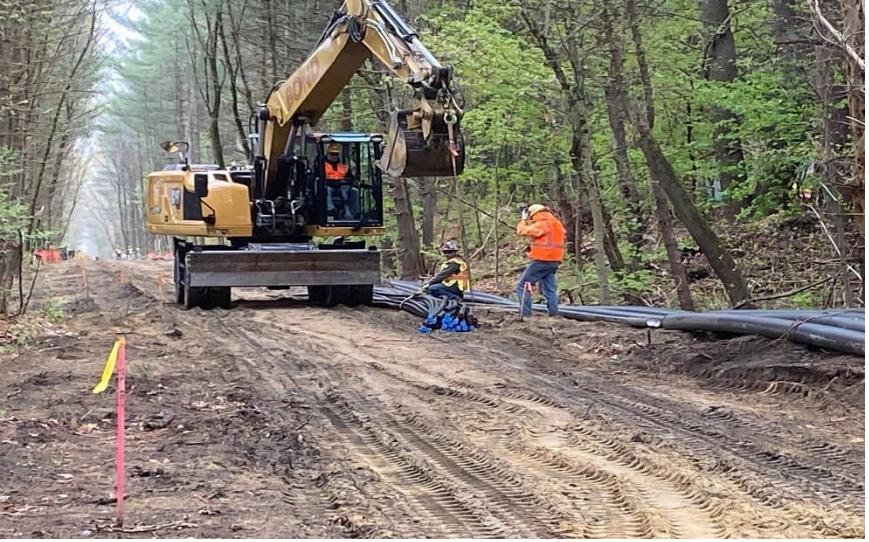
| <p>Photo No.: 2</p> | <p>Date: 5-4-23</p> | | |

| <p>Description: Bond staging conduit within segment 10, looking eastward.</p> | | | |

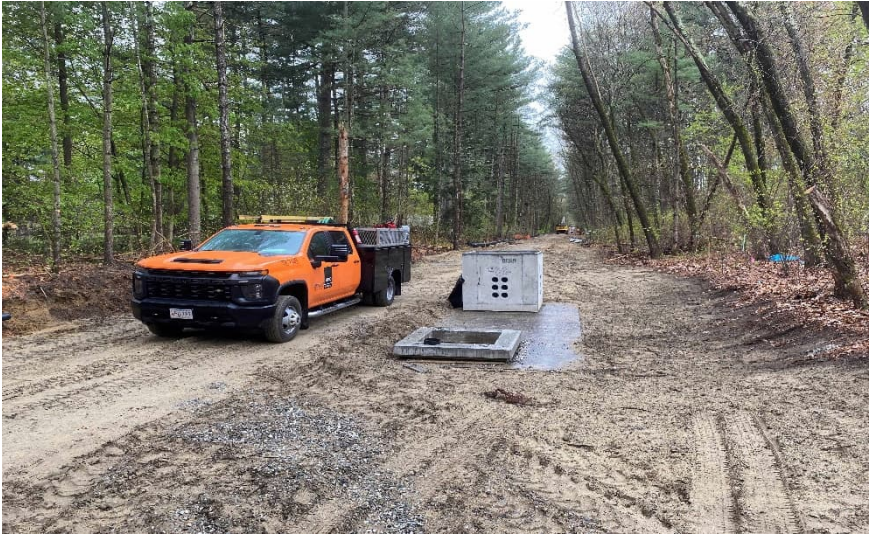
| <p>Photo No.: 3</p> | <p>Date: 5-4-23</p> | | |

| <p>Description:</p> <p>Right-of-way, MH#21 within segment 10, looking westward.</p> | | | |

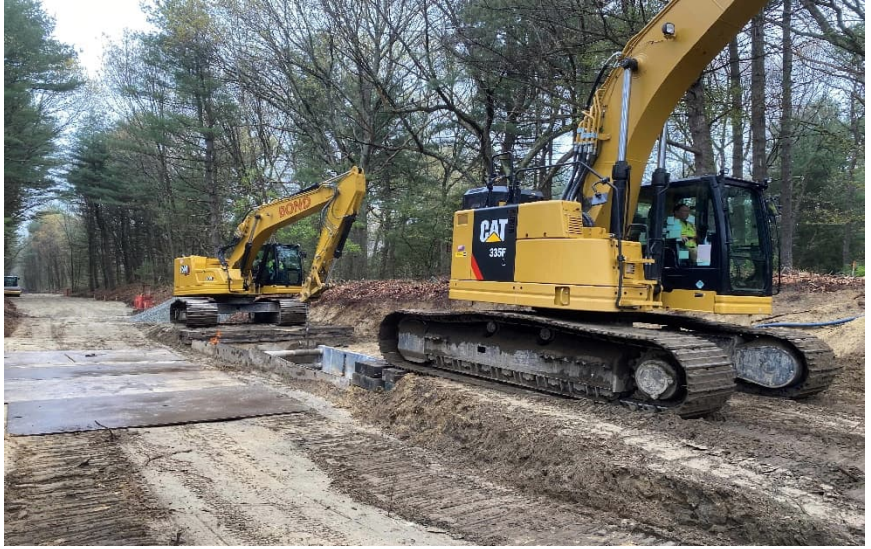
| <p>Photo No.: 4</p> | <p>Date: 5-4-23</p> | | |

| <p>Description:</p> <p>Right-of-way, MH#22 within segment 11, looking westward.</p> | | | |

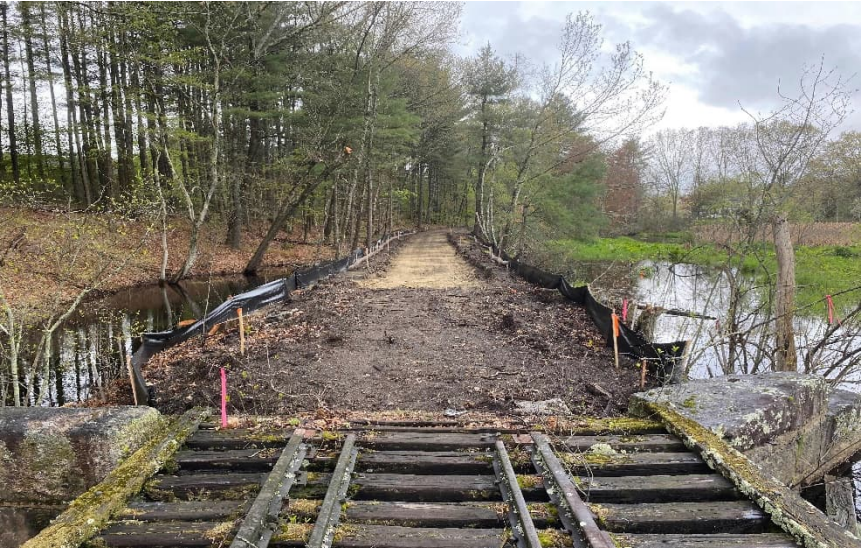
| <p>Photo No.: 5</p> | <p>Date: 5-4-23</p> | | |

| <p>Description:</p> <p>Bridge 130 looking into segment 13, existing erosion control, looking westward.</p> | | | |

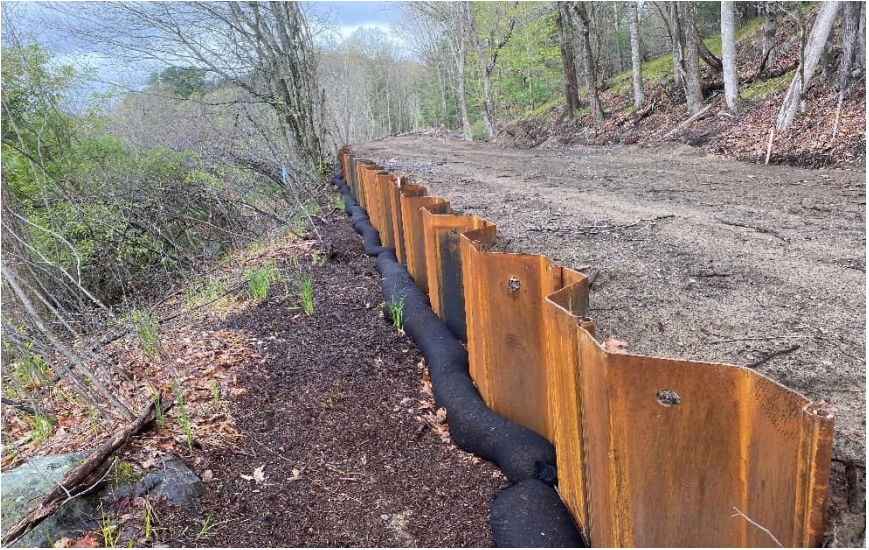
| <p>Photo No.: 7</p> | <p>Date: 5-4-23</p> | | |

| <p>Description:</p> <p>Sheeting within segment 14, existing erosion control, looking westward.</p> | | | |

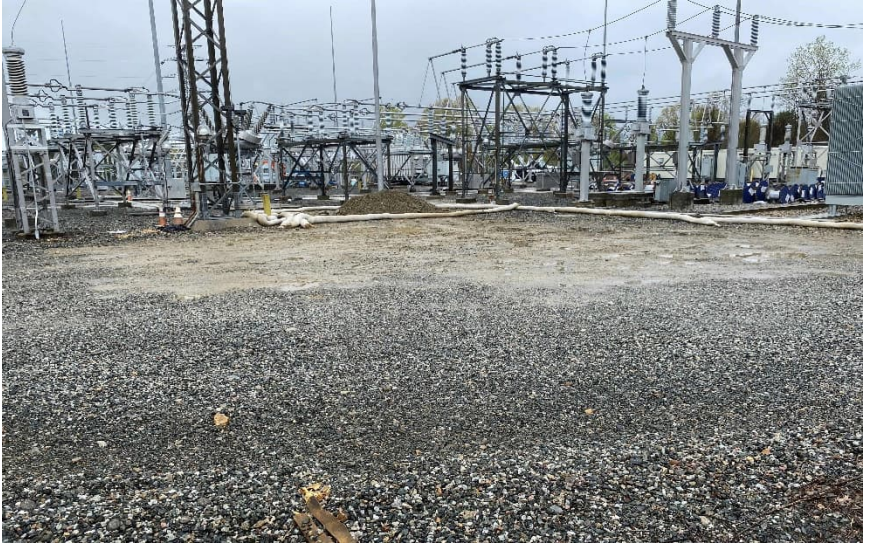
| <p>Photo No.: 8</p> | <p>Date: 5-4-23</p> | | |

| <p>Description:</p> <p>Sudbury substation, new stockpile with compost filter tubes surrounding pile, looking southward.</p> | | | |

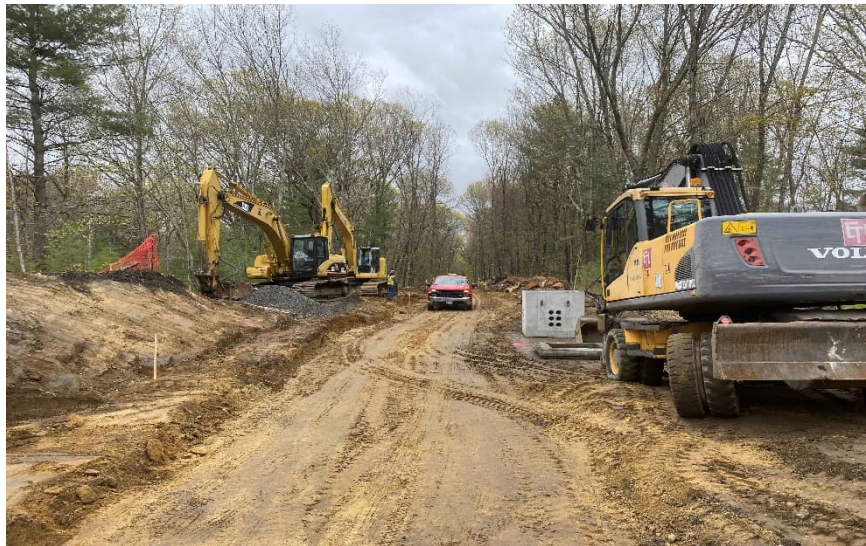
| <p>Photo No.: 2</p> | <p>Date: 5-5-23</p> | | |

| <p>Description:</p> <p>ET&L conducting site work within segment 1, near manhole #5, off Wilkins Street, looking eastward.</p> | | | |

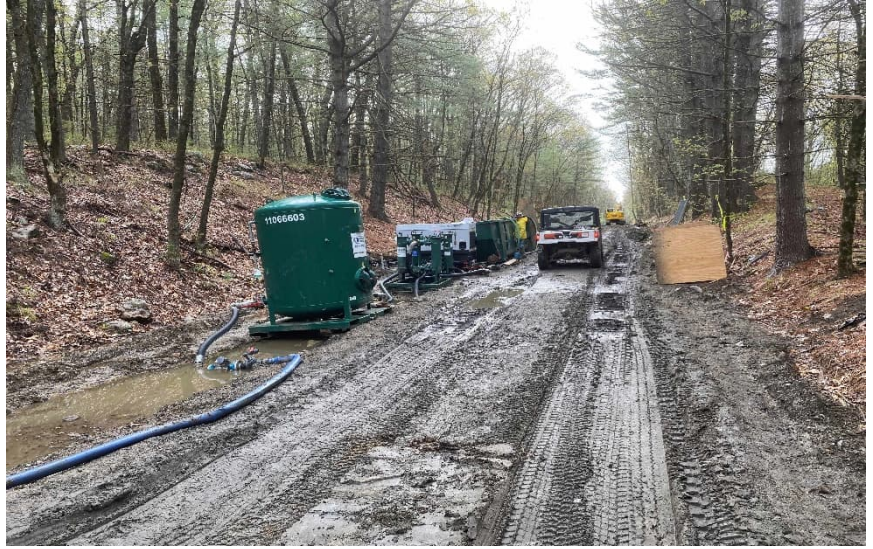
| <p>Photo No.: 4</p> | <p>Date: 5-5-23</p> | | |

| <p>Description:</p> <p>Dewatering operation within segment 5, looking eastward.</p> | | | |

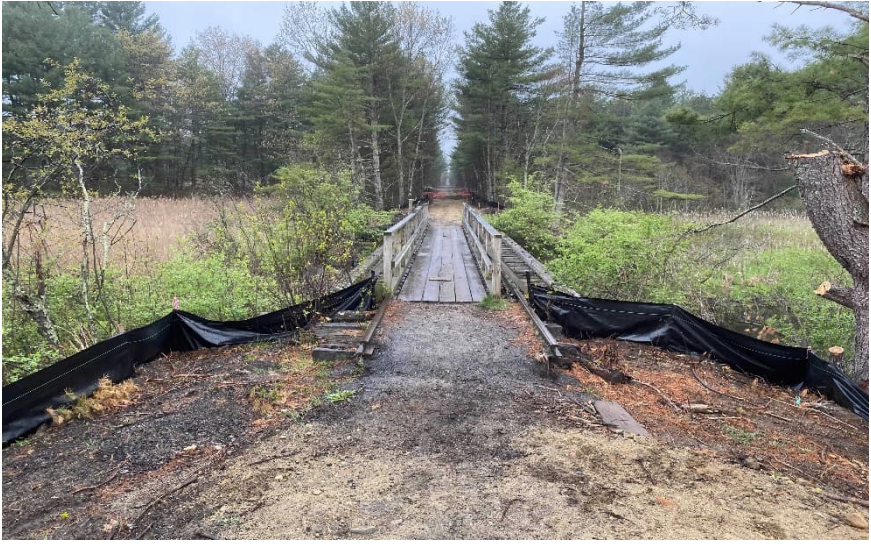
| <p>Photo No.: 5</p> | <p>Date: 5-5-23</p> | | |

| <p>Description:</p> <p>Bridge 128 at segment 7/8 boundary looking into segment 7, existing erosion control, looking westward.</p> | | | |

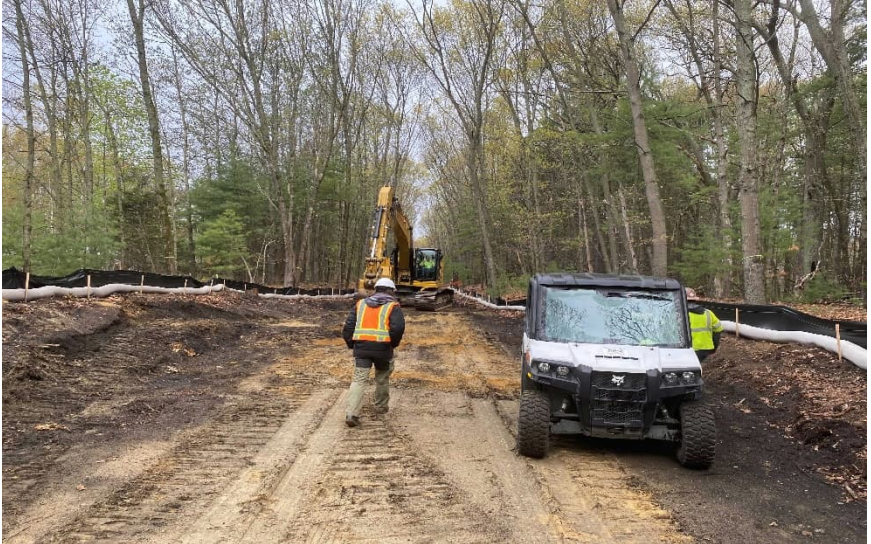
| <p>Photo No.: 6</p> | <p>Date: 5-5-23</p> | | |

| <p>Description:</p> <p>Right-of-way within segment 11, repurposing spoil materials, vernal pool monitor escorting equipment, looking westward.</p> | | | |

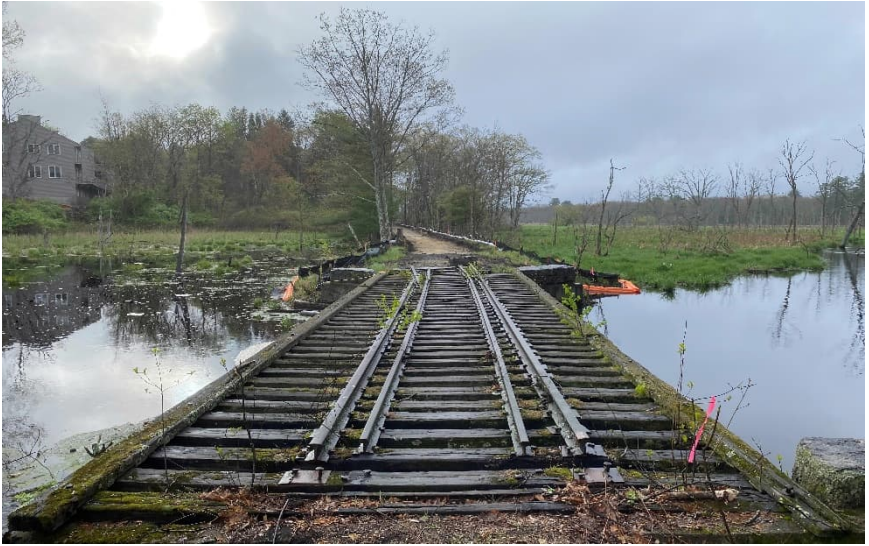
| <p>Photo No.: 7</p> | <p>Date: 5-5-23</p> | | |

| <p>Description:</p> <p>Bridge 127 at segment 13/14 boundary looking into segment 14, existing erosion control, looking eastward.</p> | | | |

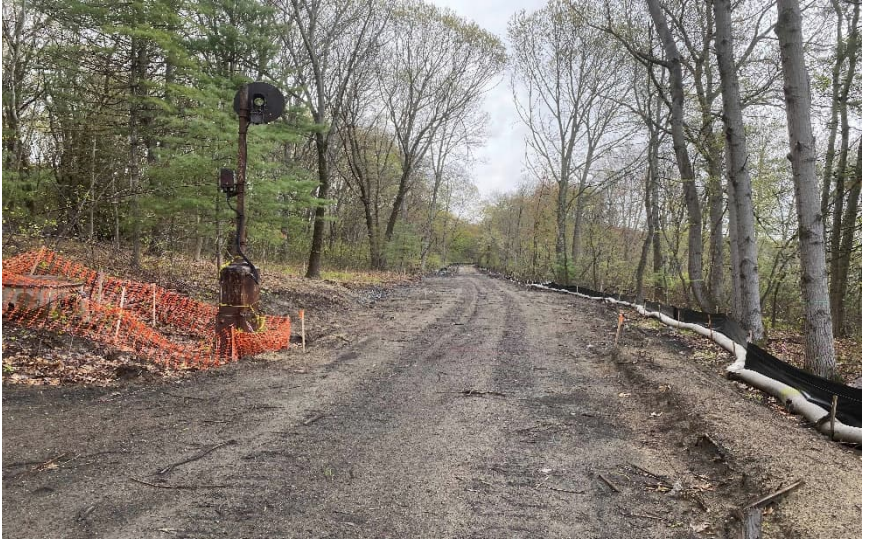
| <p>Photo No.: 8</p> | <p>Date: 5-5-23</p> | | |

| <p>Description:</p> <p>Segment 14, existing erosion control, at approximate Sta#736+50, historic railroad feature within orange fencing, looking eastward.</p> | | | |

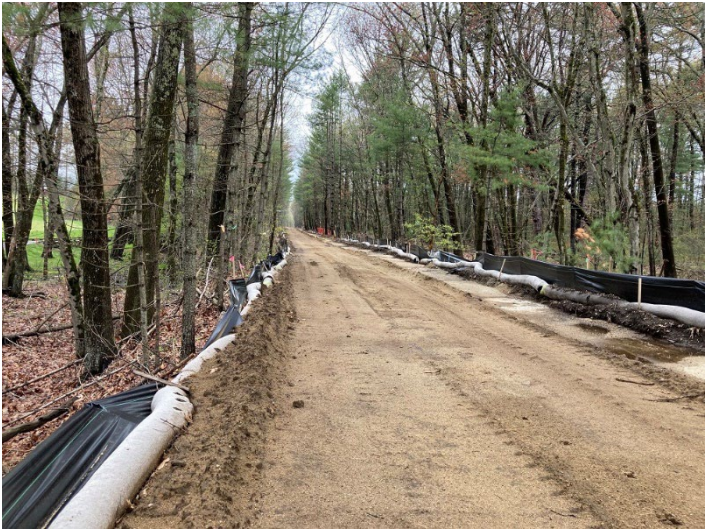
| Photo No.: 4 | Date: 5-01-2023 | | |

| Description: View of E&S controls near culvert in segment 4. Repair controls in segments 2 and 4 where needed (routine maintenance). Facing west. | | | |

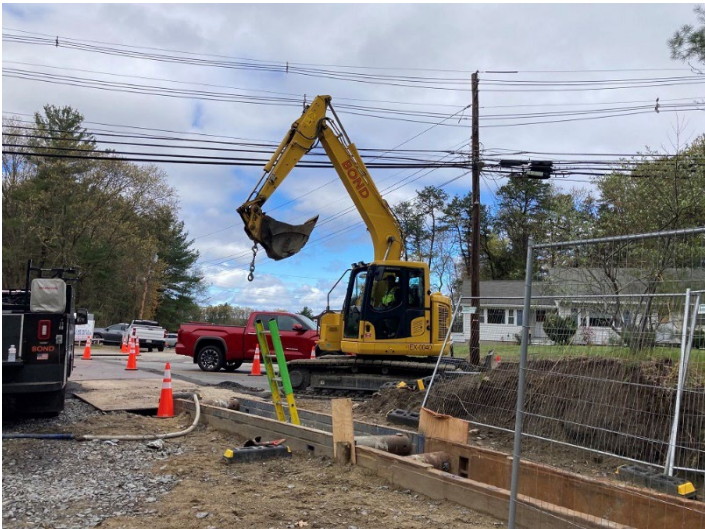
| Photo No.: 5 | Date: 5-01-2023 | | |

| Description: View of Bond working at Main St road crossing. See additional dewatering inspection report for this location. Facing northwest. | | | |

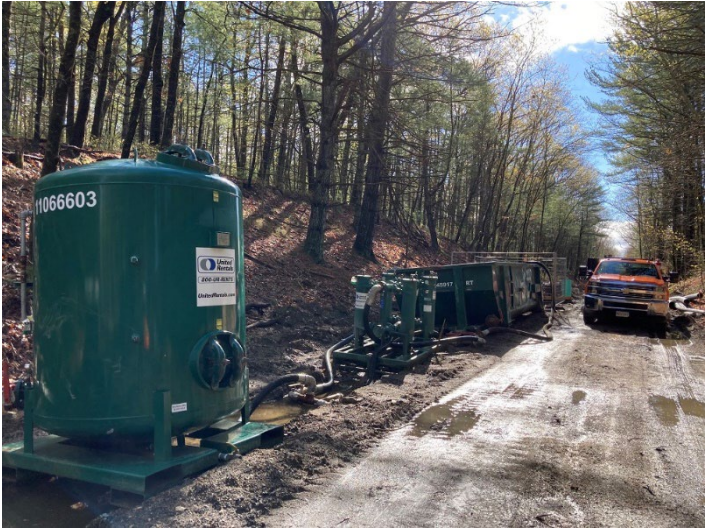
| Photo No.: 6 | Date: 5-01-2023 | | |

| Description: View of Bond conducting dewatering operation in segment 5. See additional dewatering inspection report. Facing northeast. | | | |

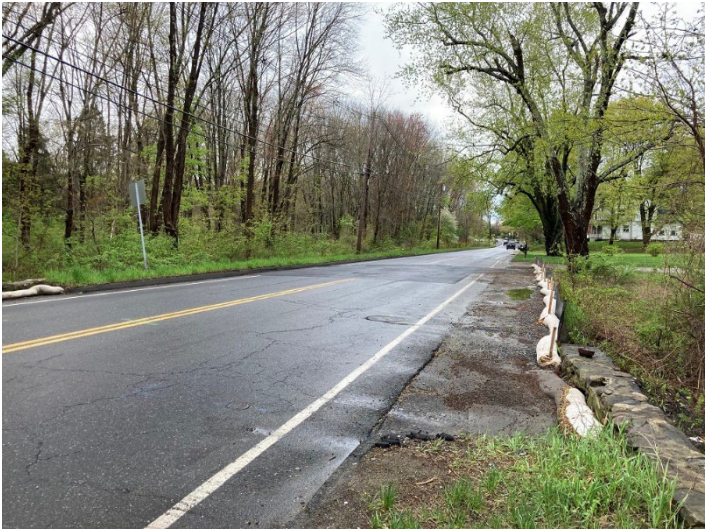
| Photo No.: 7 | Date: 5-01-2023 | | |

| Description: View of MH#4 area. E&S controls are in good condition. Facing southwest. | | | |

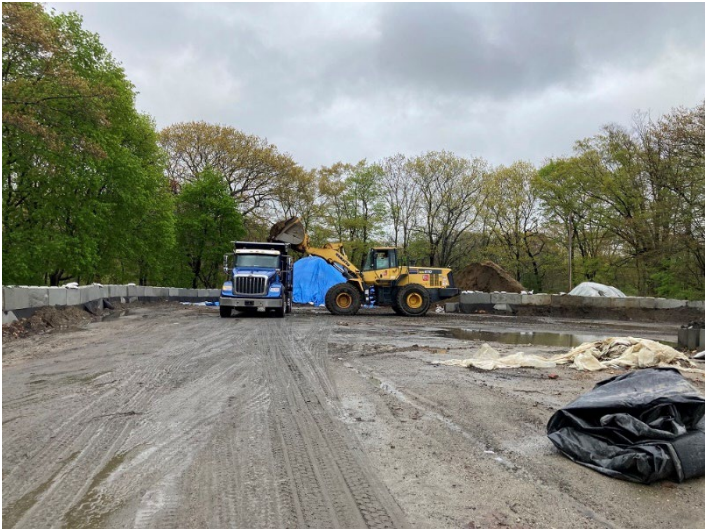
| Photo No.: 8 | Date: 5-01-2023 | | |

| Description: View of load out of stockpiles at Stowe Ct laydown yard. Facing northeast. | | | |

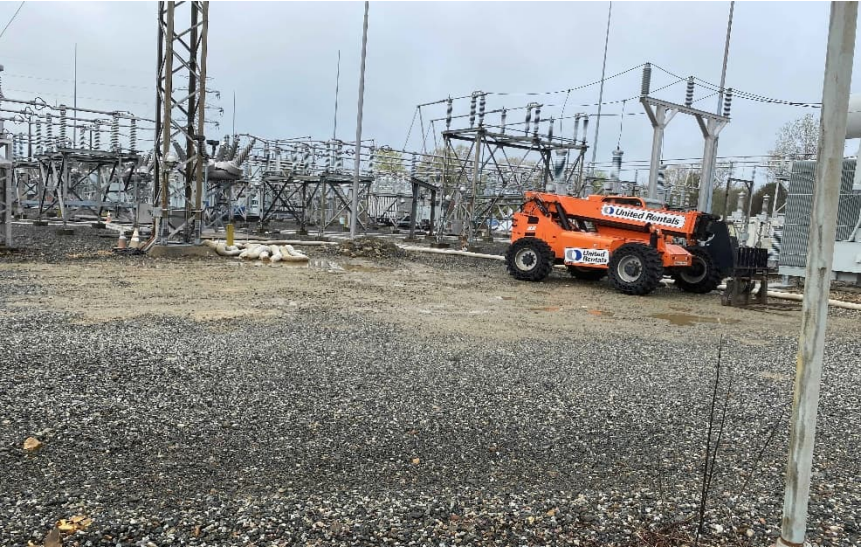
| Photo No.: 1 | Date: 5-1-23 | | |

| Description: Sudbury Substation, new spoil pile, looking southward. | | | |

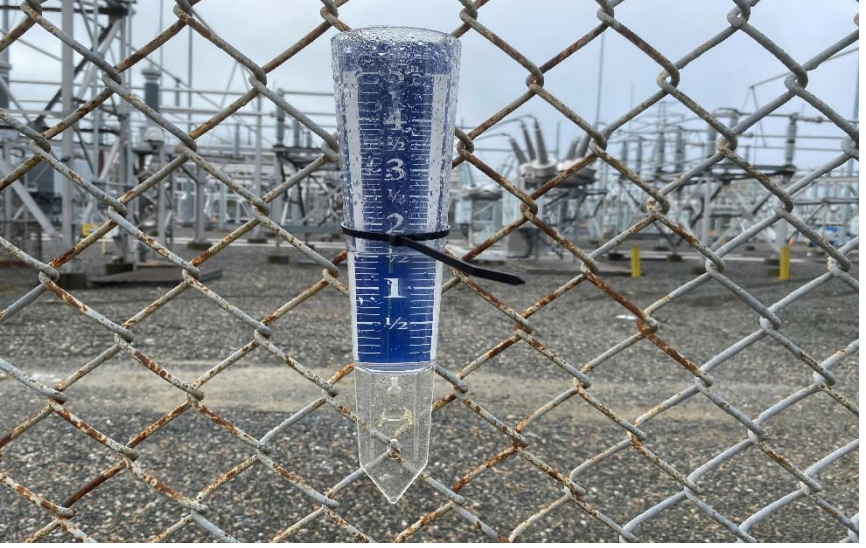
| Photo No.: 2 | Date: 5-1-23 | | |

| Description: Rain gauge at substation, containing 1.55" of rainfall, looking southward. | | | |

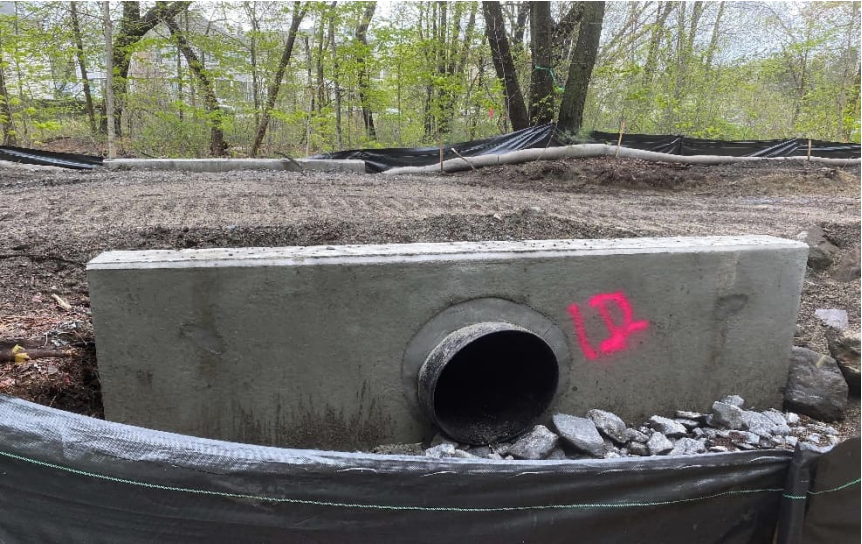
| Photo No.: 3 | Date: 5-1-23 | | |

| Description: Recently installed new headwall within Segment 13, looking eastward. | | | |

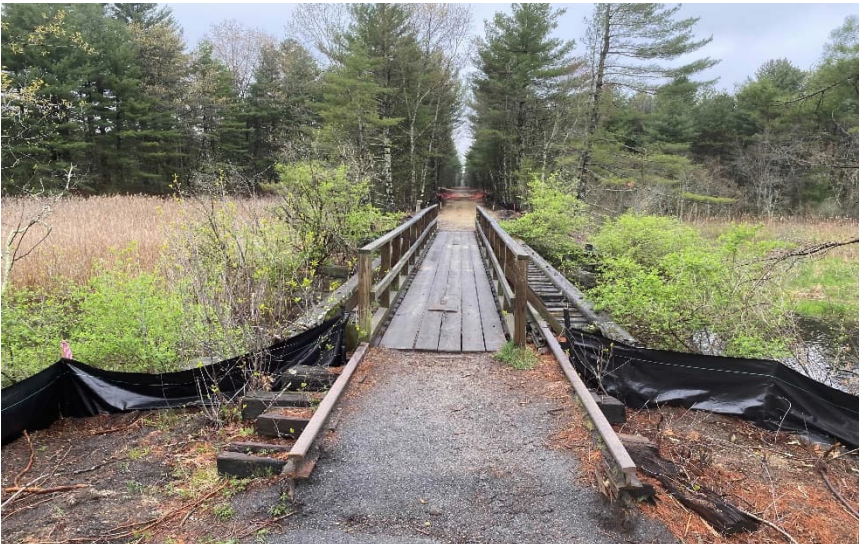
| Photo No.: 4 | Date: 5-1-23 | | |

| Description: Bridge 128 at segments 7/8 boundary, existing erosion control, looking westward. | | | |

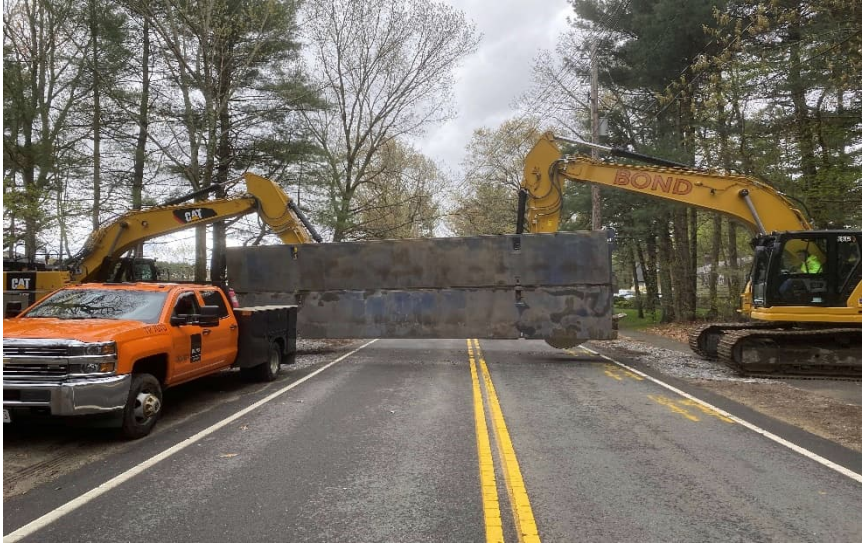
| Photo No.: 6 | Date: 5-1-23 | | |

| Description: Bond moving trench box across Horse Pond Road from Segment 10 into Segment 11, looking westward. | | | |

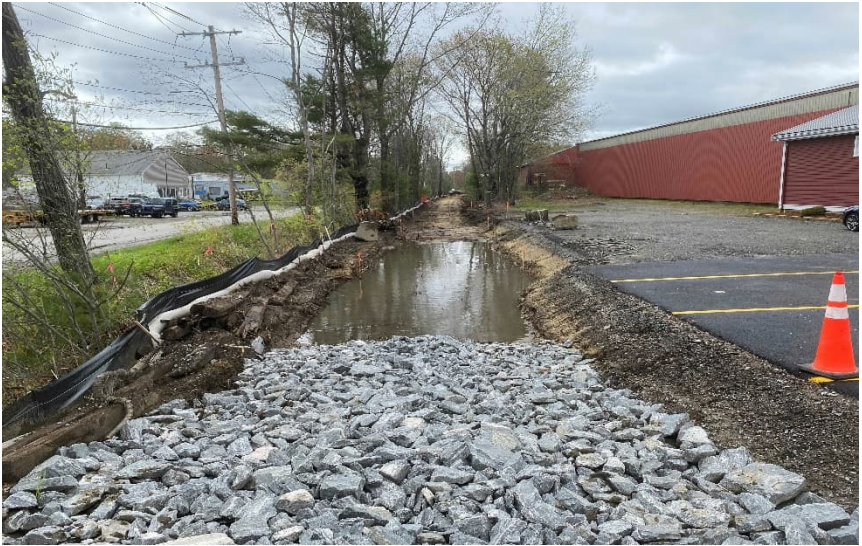
| Photo No.: 7 | Date: 5-1-23 | | |

| Description: Right-of-way within Segment 12 off Union Avenue Road, existing erosion control, pooled water from storm, looking eastward. | | | |

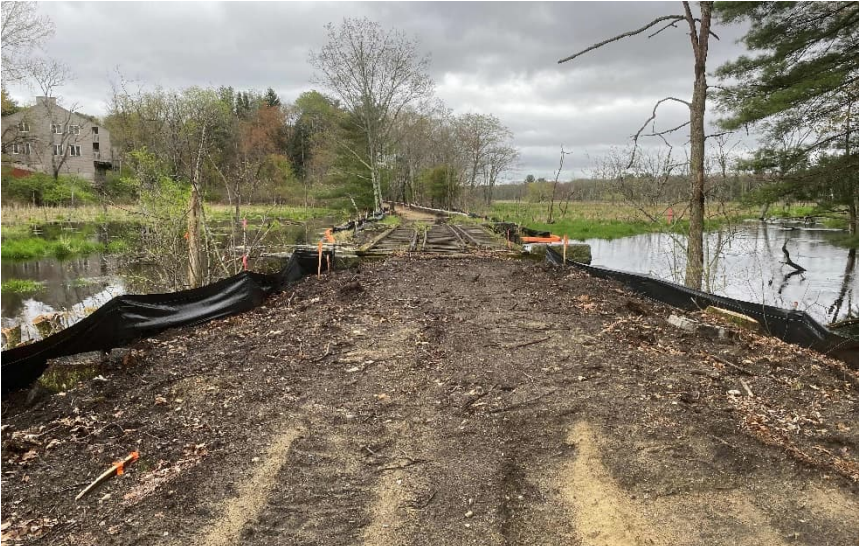
| Photo No.: 8 | Date: 5-1-23 | | |

| Description: Bridge 127 at segments 13/14 boundary, existing erosion control, looking eastward. | | | |

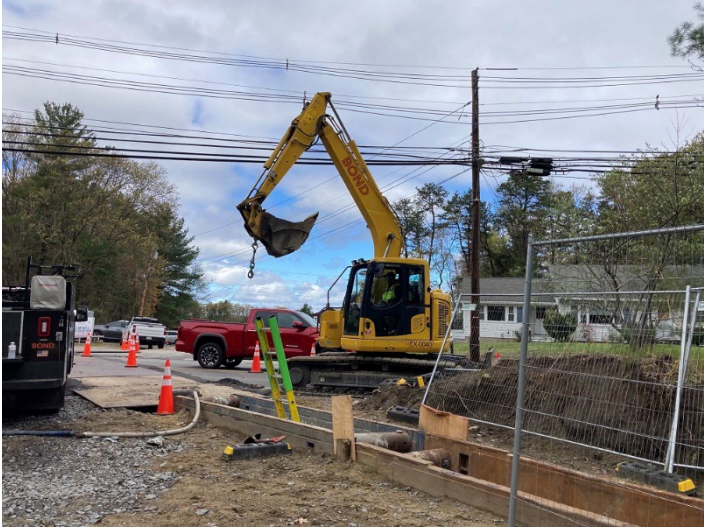
| Photo No.: 1 | Date: 5/01/2023 | | | |

| Description: View of trench work with pumping operation in segment 4 just off Main St. Facing northwest. | | | | |

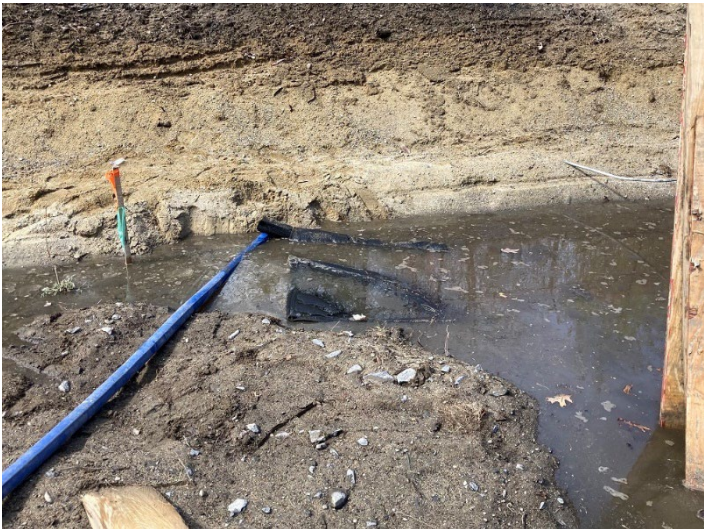
| Photo No.: 4 | Date: 5/01/2023 | | | |

| Description: View of dewatering controls (sediment bag in shallow basin) and discharge. Water appeared turbid. Facing south. | | | | |
