Weekly Environmental Compliance Summary

Sudbury to Hudson Transmission Reliability Project (USEPA Tracking # MAR1003UW)

Week of: May 1 to May 5, 2023

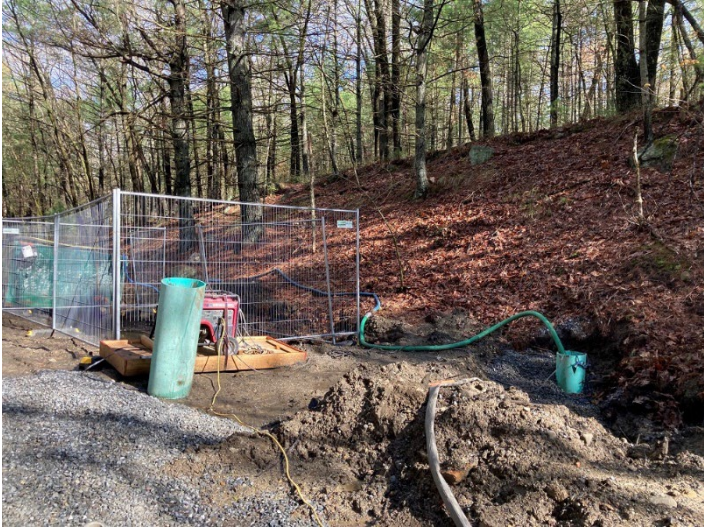
| Photo No.: 1 | Date: 5/01/2023 | | |

| Description: View of pumping operation in segment 5. Facing northwest. | | | |

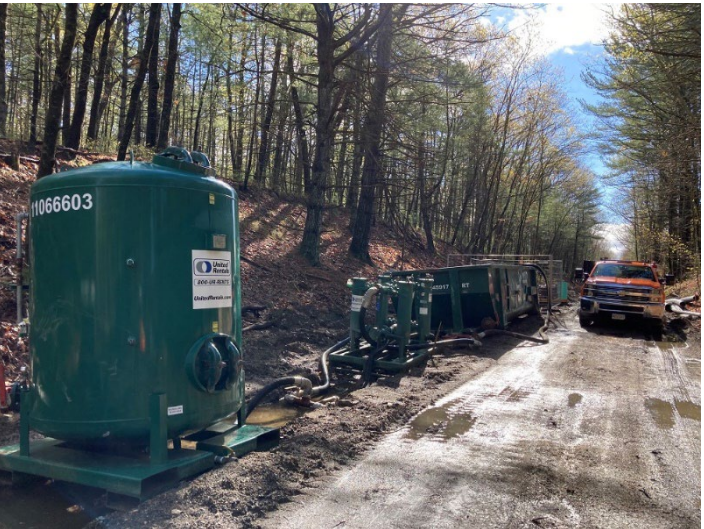
| Photo No.: 2 | Date: 5/01/2023 | | |

| Description: View of frac tank and filtration system. Facing northeast. | | | |

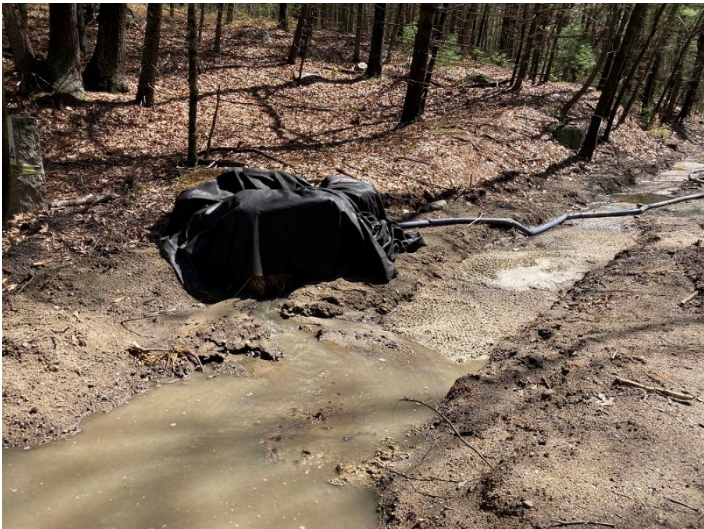
| Photo No.: 4 | Date: 5/01/2023 | | | |

| Description: View of discharge from straw bale corral. Facing northeast. | | | | |

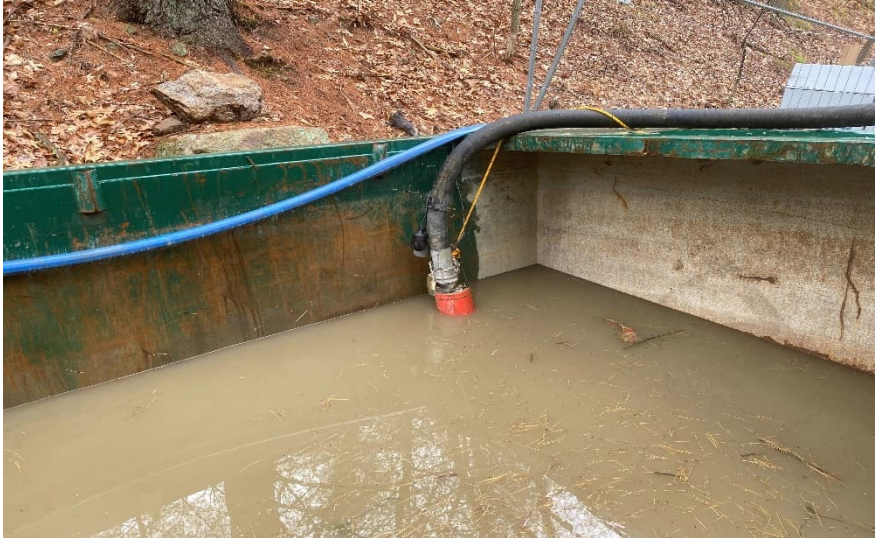
| Photo No.: 1 | Date: 5/2/2023 | | |

| Description: View of area being pumped at work operation within Segment 5 at approximate Sta# 307+00 (accumulated water in frac tank), off Parmenter Road. Water appeared slightly turbid. | | | |

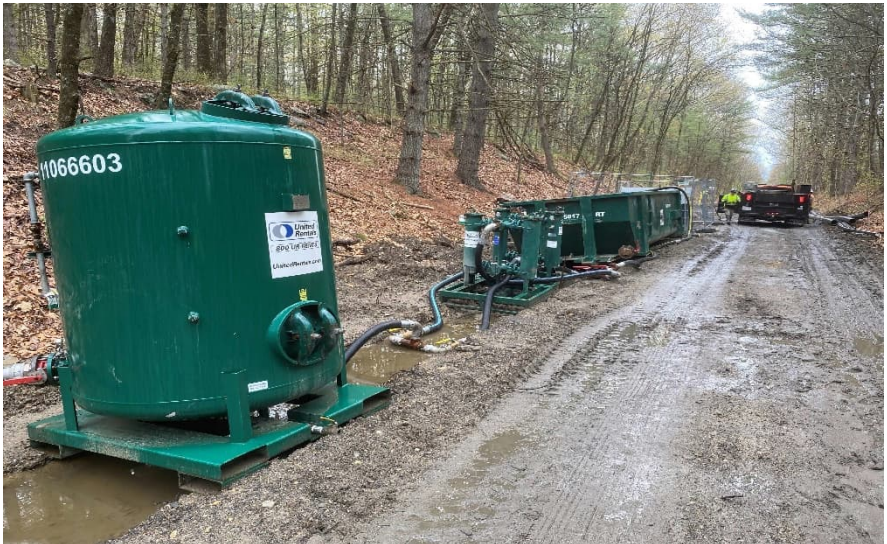
| Photo No.: 2 | Date: 5/2/2023 | | |

| Description: View of pumping operation at Segment 5 at approximate Sta# 307+00 (frac tank to filtration system to dewatering bag within bale corral), looking westward. | | | |

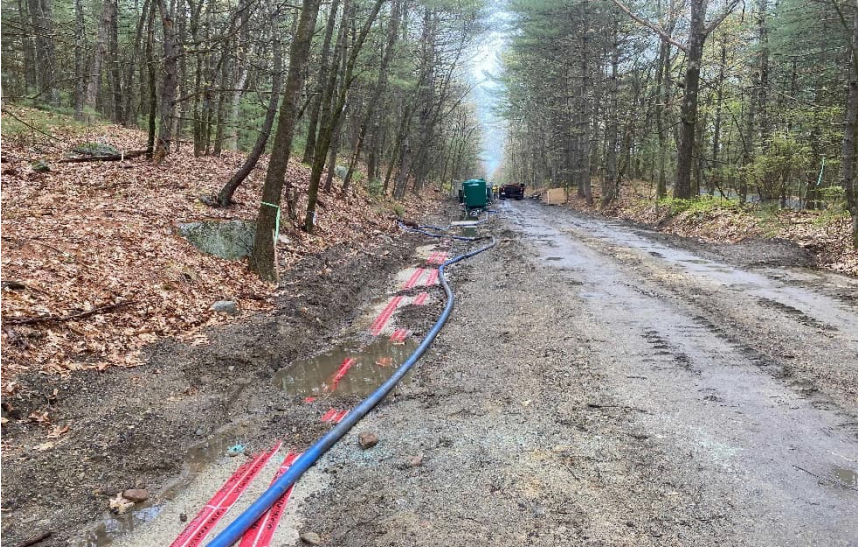
| Photo No.: 3 | Date: 5/2/2023 | | |

| Description: Segment 5 at approximate Sta# 307+00. View of dewatering operation, looking westward. | | | |

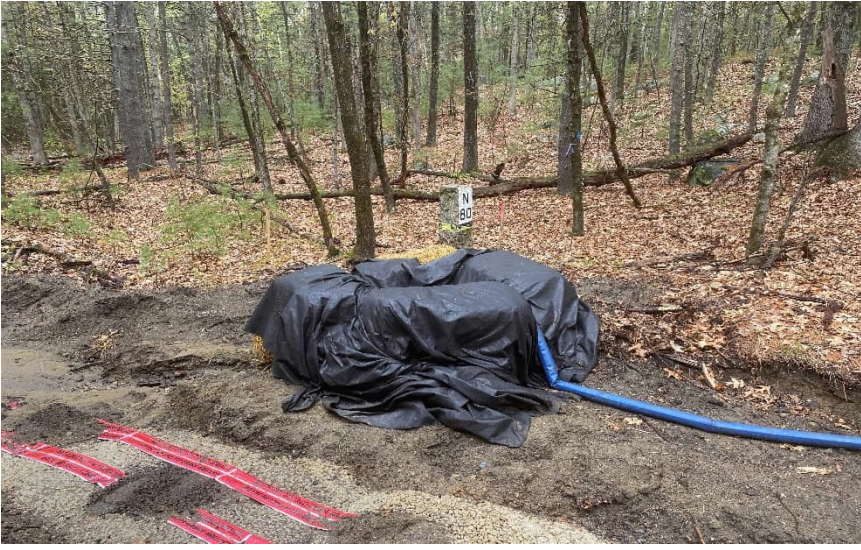
| Photo No.: 4 | Date: 5/2/2023 | | |

| Description: Segment 5 at approximate Sta# 307+00. View of discharge bag/bales, looking westward. Water appeared to be clear. | | | |

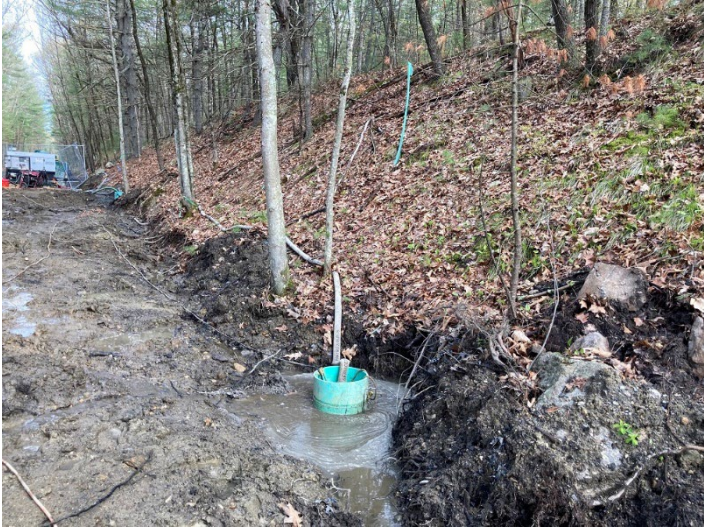
| Photo No.: 1 | Date: 5/03/2023 | | | |

| Description: View of pumping/dewatering water prior to treatment in segment 5. Water appeared slightly turbid. Facing northwest. | | | | |

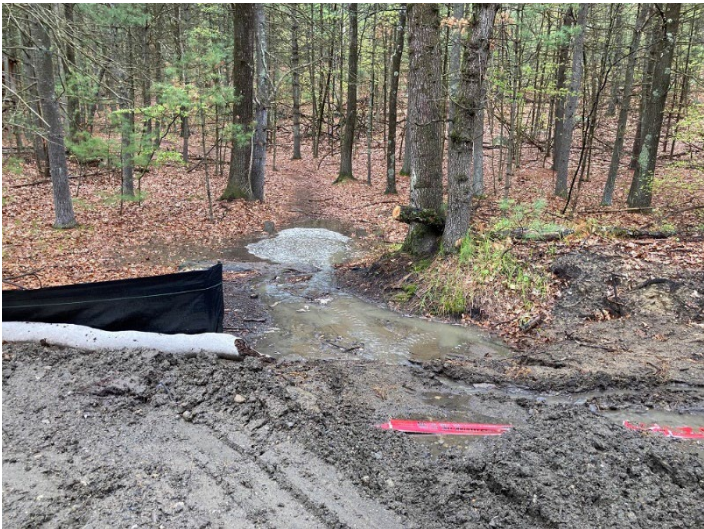
| Photo No.: 4 | Date: 5/03/2023 | | | |

| Description: View of discharge from project ROW. Facing north. | | | | |

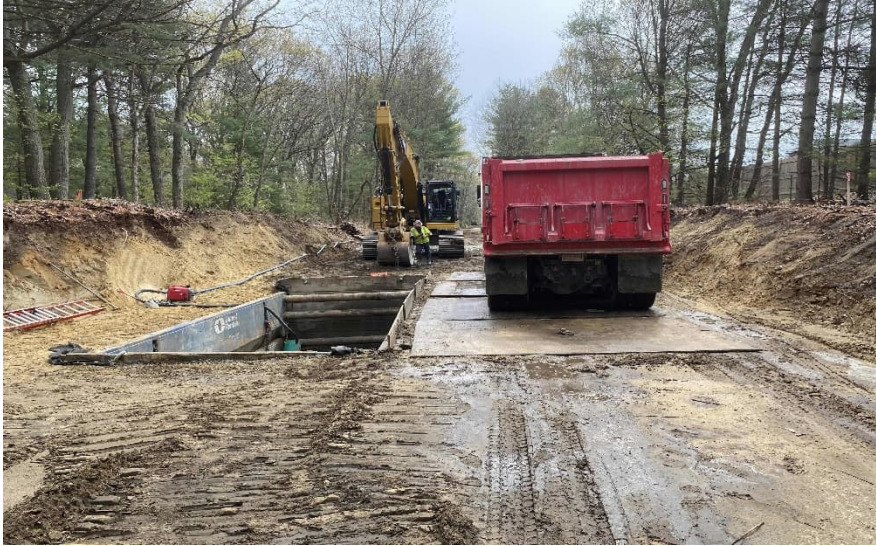
| Photo No.: 1 | Date: 5/3/2023 | | |

| Description: View of area being pumped at work operation within Segment 11 at MH#22, off Horse Pond Road. Water appeared slightly turbid. | | | |

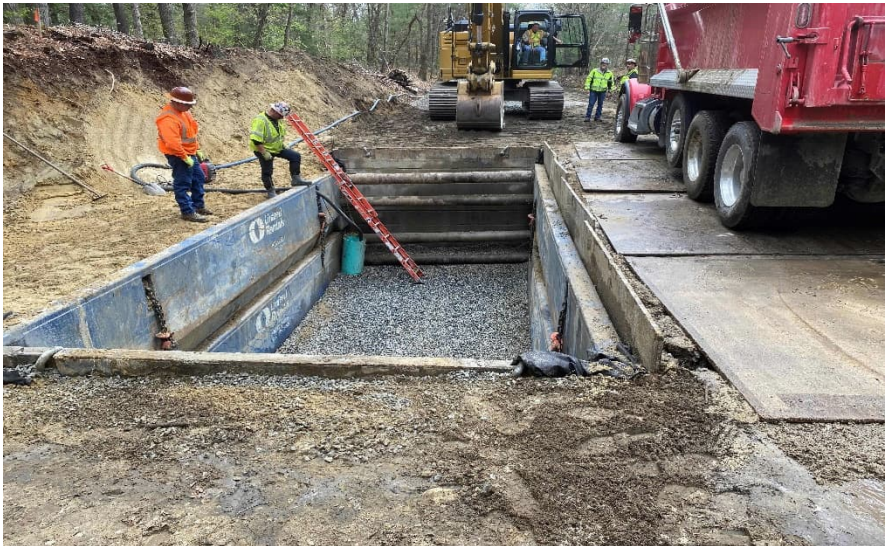
| Photo No.: 2 | Date: 5/3/2023 | | |

| Description: View of pumping operation within Segment 11 at MH#22, looking eastward. | | | |

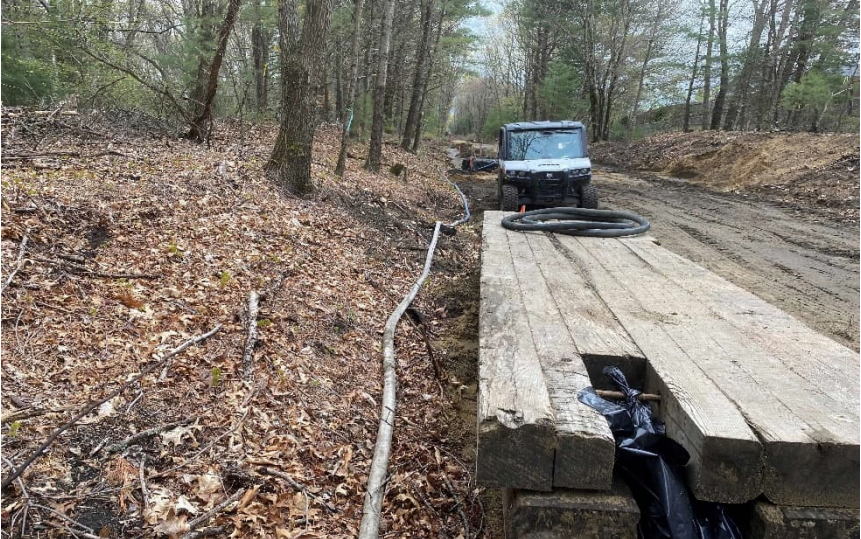
| Photo No.: 3 | Date: 5/3/2023 | | |

| Description: Segment 11 at MH#22. View of dewatering operation, looking eastward. | | | |

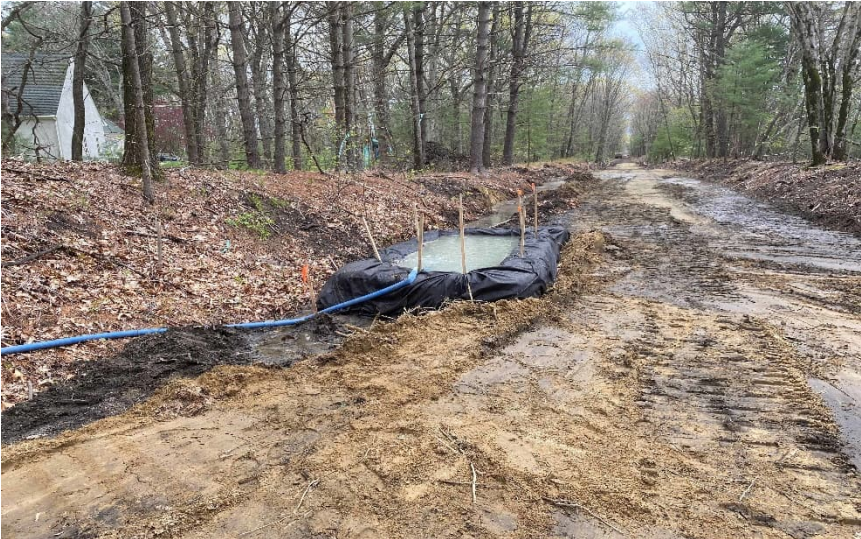
| Photo No.: 4 | Date: 5/3/2023 | | |

| Description: Segment 11 near MH#22. View of discharge bag/bales, looking eastward. Water appeared to be slightly turbid. | | | |

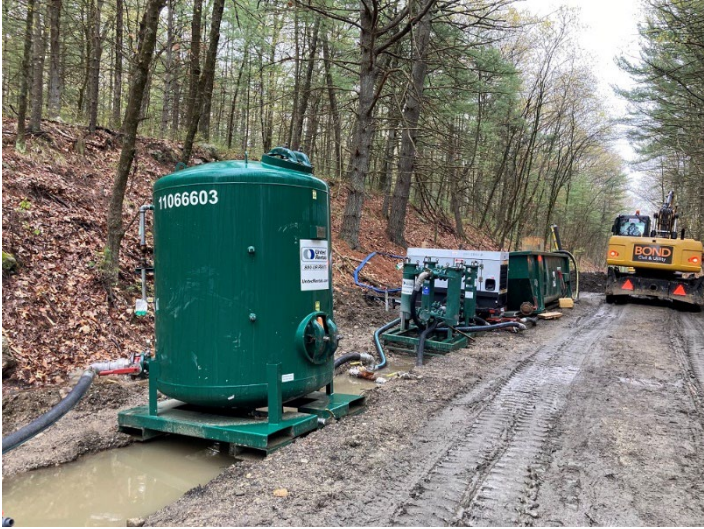
| Photo No.: 1 | Date: 5/04/2023 | | | |

| Description: View of pumping operation in segment 5, specifically frac tank and filtration system. Facing northeast. | | | | |

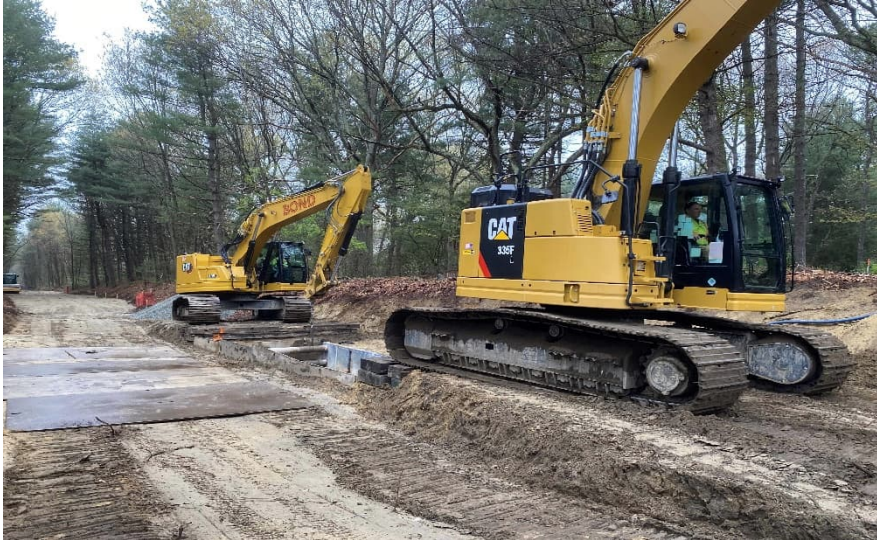
| Photo No.: 1 | Date: 5/4/2023 | | |

| Description: View of area being pumped at work operation within Segment 11 at MH#22, off Horse Pond Road. Water appeared clear. | | | |

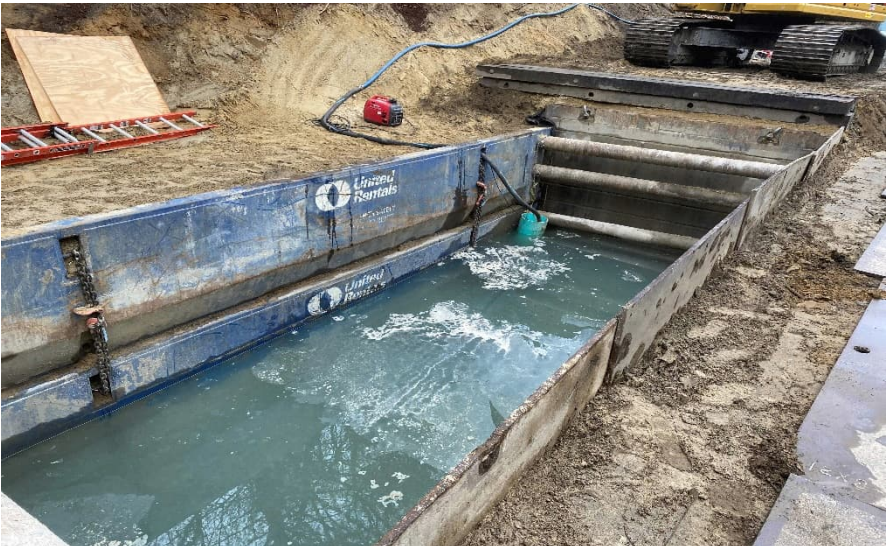
| Photo No.: 2 | Date: 5/4/2023 | | |

| Description: View of pumping operation within Segment 11 at MH#22, looking eastward. | | | |

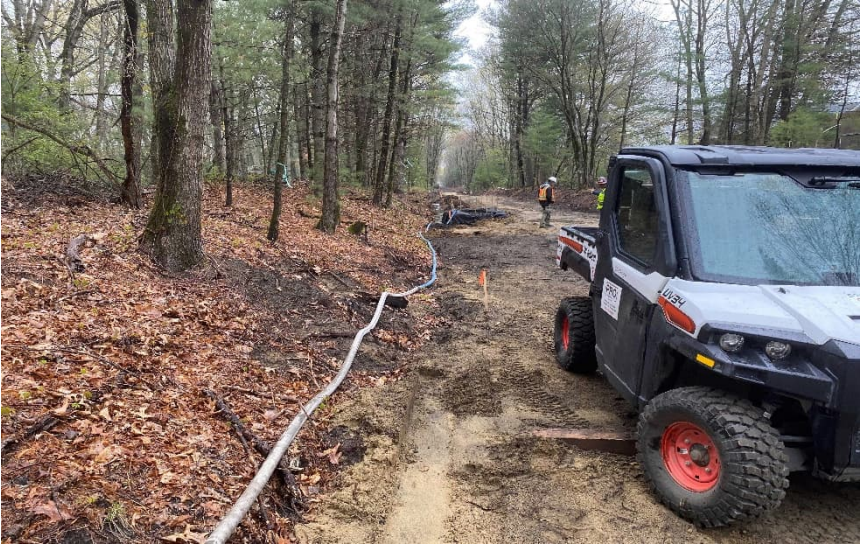
| Photo No.: 3 | Date: 5/4/2023 | | |

| Description: Segment 11 at MH#22. View of dewatering operation, looking eastward. | | | |

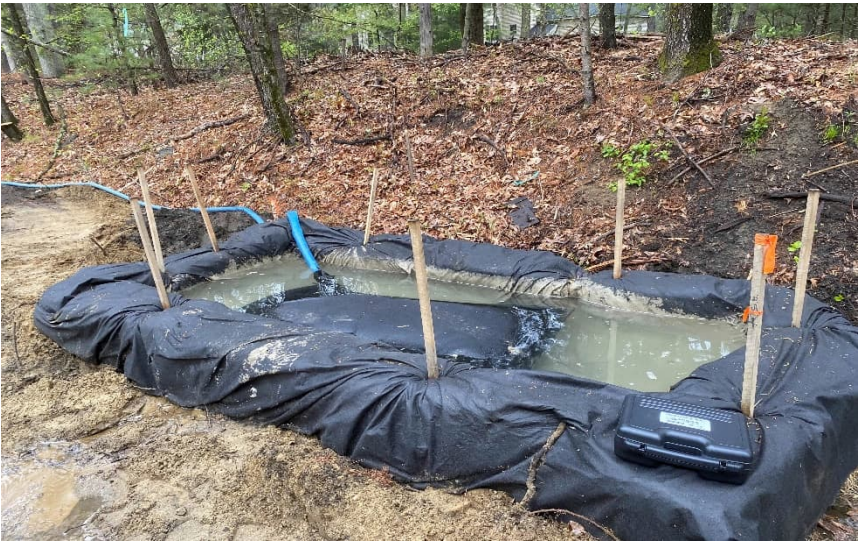
| Photo No.: 4 | Date: 5/4/2023 | | |

| Description: Segment 11 near MH#22. View of discharge bag/bales, looking eastward. Water appeared to be clear. | | | |

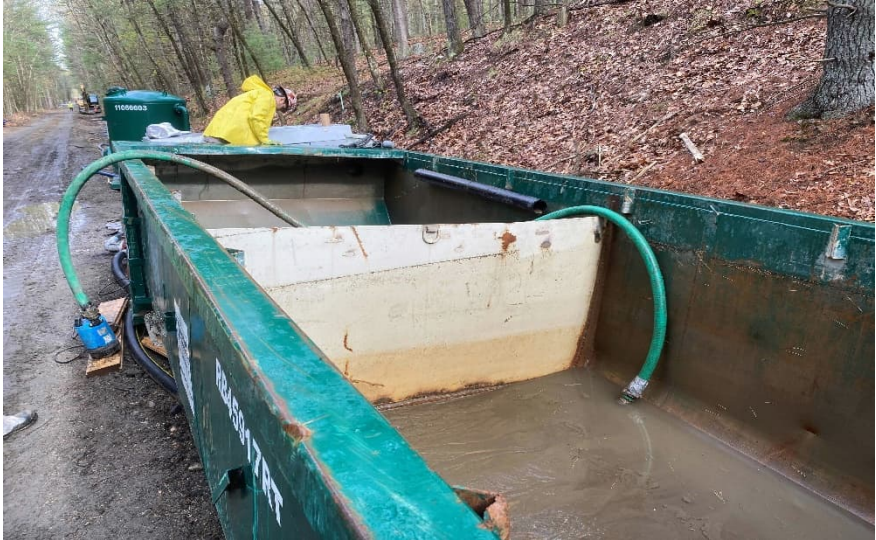
| Photo No.: 1 | Date: 5/5/2023 | | |

| Description: View of area being pumped at work operation within Segment 5 at approximate Sta# 307+00 (accumulated water in frac tank), off Parmenter Road. Water appeared slightly turbid. | | | |

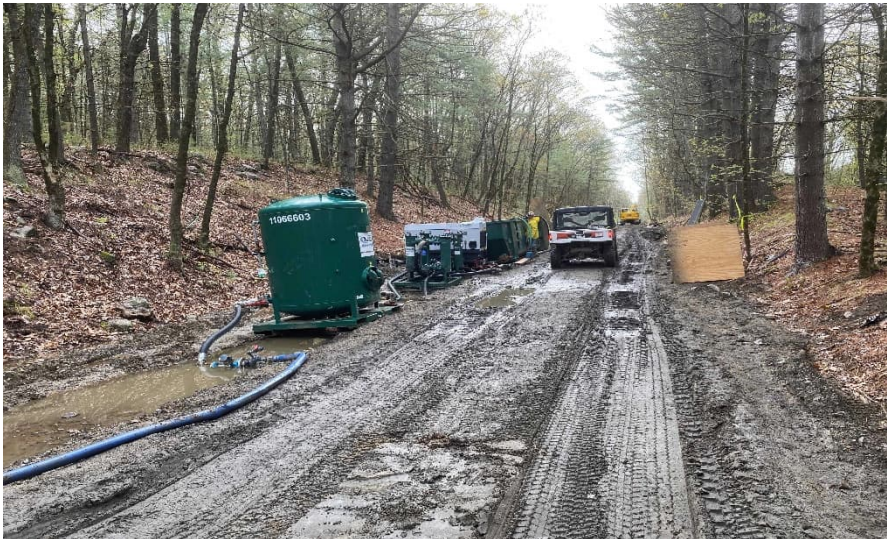
| Photo No.: 2 | Date: 5/5/2023 | | |

| Description: View of pumping operation at Segment 5 at approximate Sta# 307+00 (frac tank to filtration system to dewatering bag within bale corral), looking eastward. | | | |

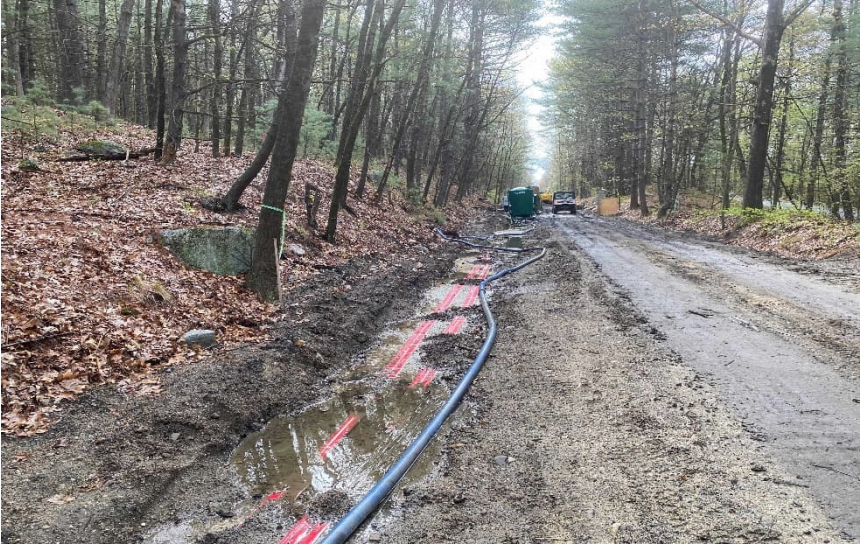
| Photo No.: 3 | Date: 5/5/2023 | | |

| Description: Segment 5 at approximate Sta# 307+00. View of dewatering operation, looking eastward. | | | |

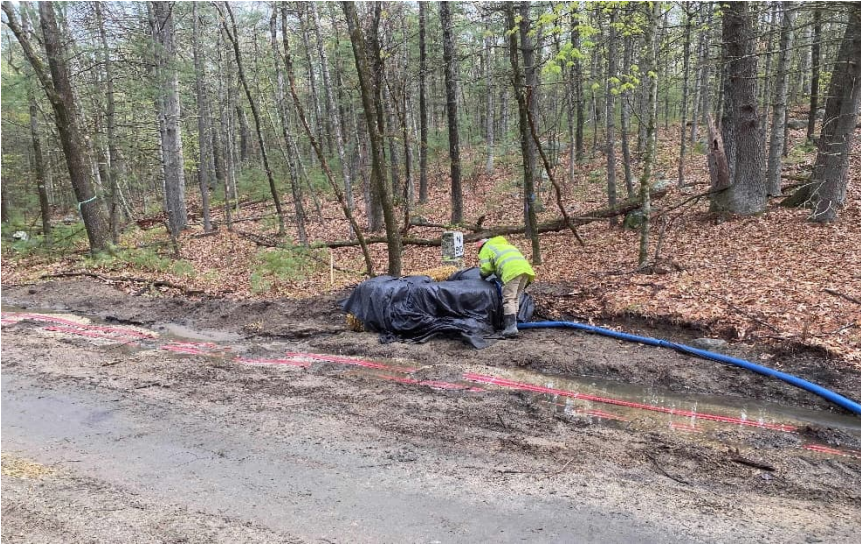
| Photo No.: 4 | Date: 5/5/2023 | | |

| Description: Segment 5 at approximate Sta# 307+00. View of discharge bag/bales, looking eastward. Water appeared to be clear. | | | |
