## Weekly Environmental Compliance Summary

**Sudbury to Hudson Transmission Reliability Project (USEPA Tracking # MAR1003UW)**

Week of: May 15 to May 19, 2023

# CONSTRUCTION MONITORING REPORT

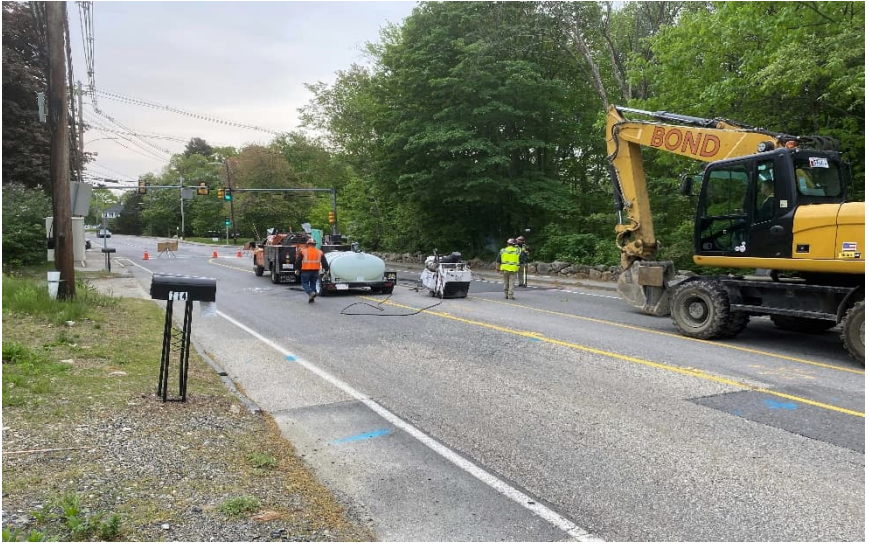
<b>PHOTOGRAPHIC LOG</b>	
Client Name: Eversource		Site Location: Sudbury to Hudson Transmission Reliability Project	Town: Hudson
Photo No.: 1	Date: 5-16-23

Description:  Bond working (cutting concrete) within Forest Avenue, at manhole #2, looking westward.

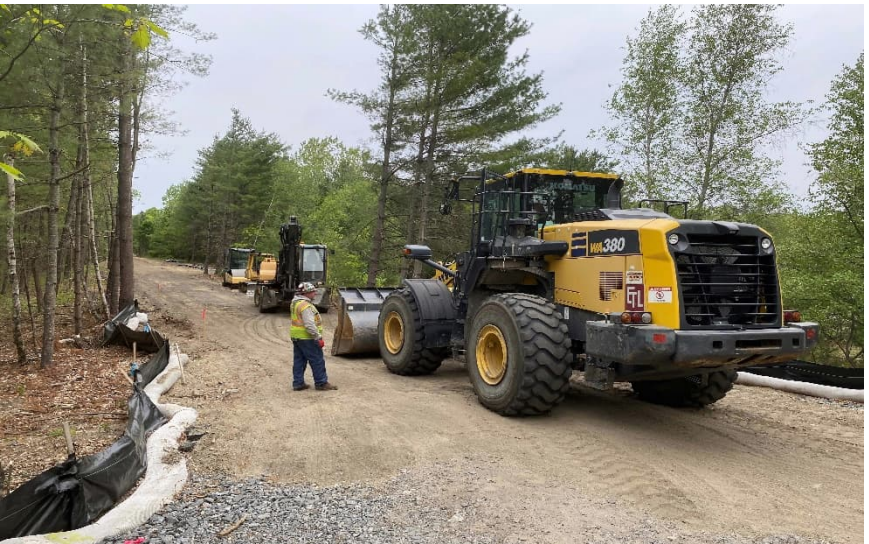
<b>PHOTOGRAPHIC LOG</b>	
Client Name: Eversource		Site Location: Sudbury to Hudson Transmission Reliability Project	Town: Hudson
Photo No.: 2	Date: 5-16-23

Description:  ET&L conducting site work (grading) within segment 2, looking westward.

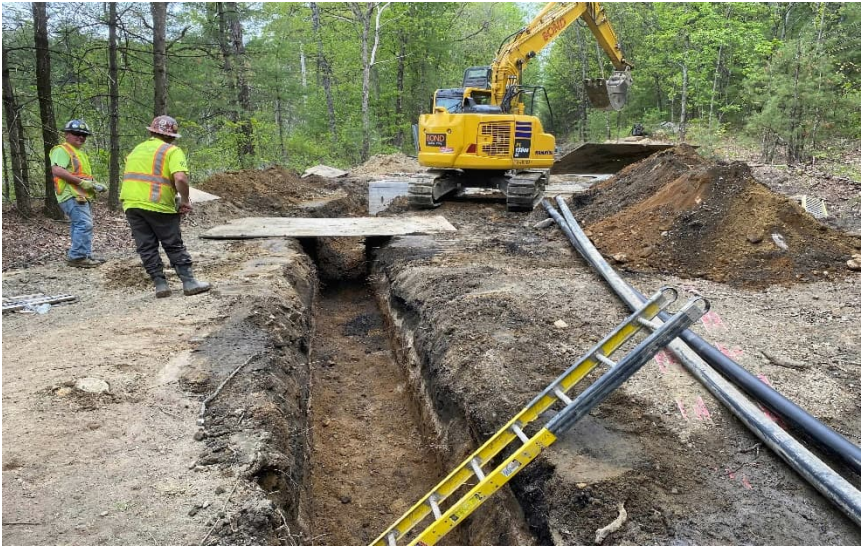
<b>PHOTOGRAPHIC LOG</b>	
Client Name: Eversource		Site Location: Sudbury to Hudson Transmission Reliability Project	Town: Hudson
Photo No.: 3	Date: 5-16-23

Description:  Bond conducting conduit work near manhole#12, within segment 5, looking westward.

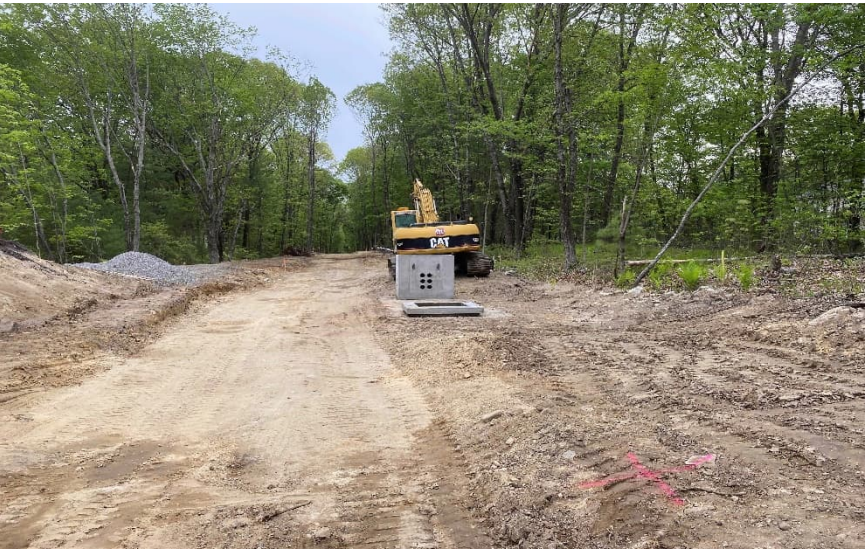
<b>PHOTOGRAPHIC LOG</b>	
Client Name: Eversource		Site Location: Sudbury to Hudson Transmission Reliability Project	Town: Hudson
Photo No.: 4	Date: 5-16-23

Description:  Manhole #5, within Segment 1, looking eastward.

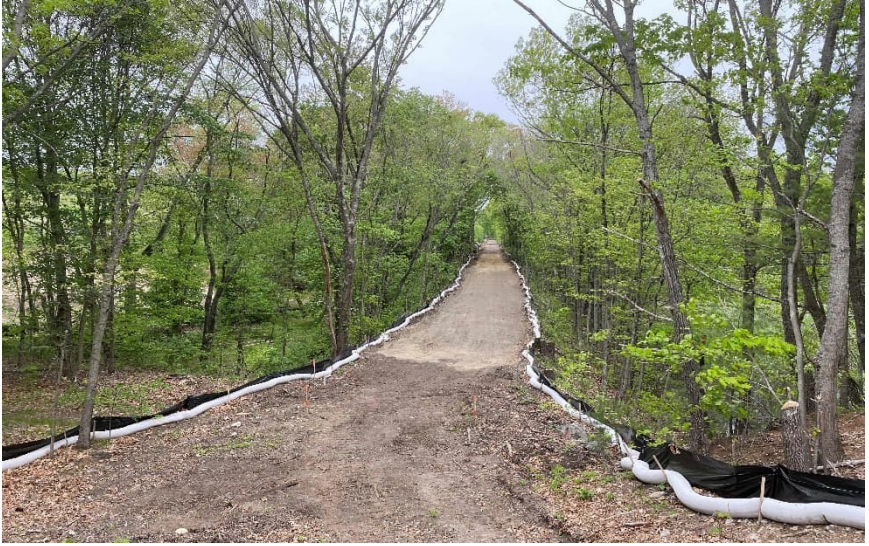
<b>PHOTOGRAPHIC LOG</b>		
Client Name: Eversource		Site Location: Sudbury to Hudson Transmission Reliability Project		Town: Hudson
Photo No.: 5	Date: 5-16-23

Description:  Right-of-way within Segment 1, existing erosion control, looking westward

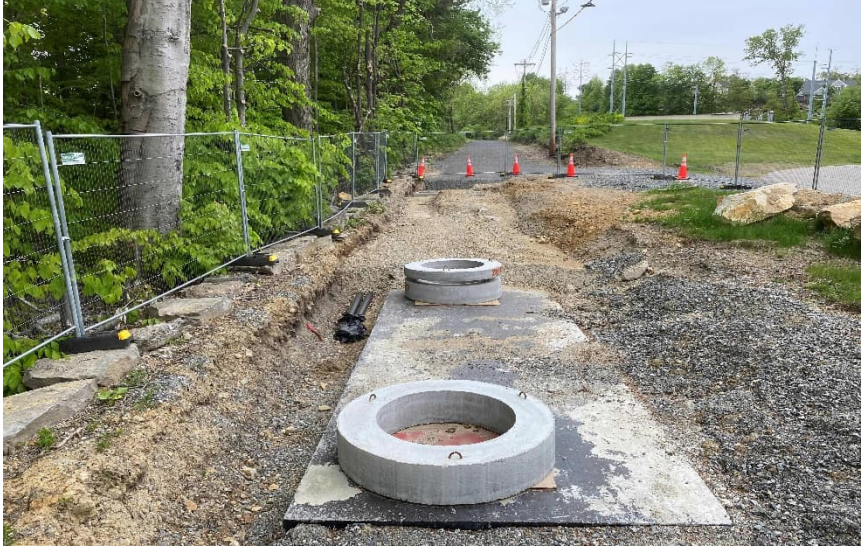
<b>PHOTOGRAPHIC LOG</b>	
Client Name: Eversource		Site Location: Sudbury to Hudson Transmission Reliability Project	Town: Hudson
Photo No.: 8	Date: 5-16-23

Description:  MH#1 area, off Forest Avenue, looking eastward.

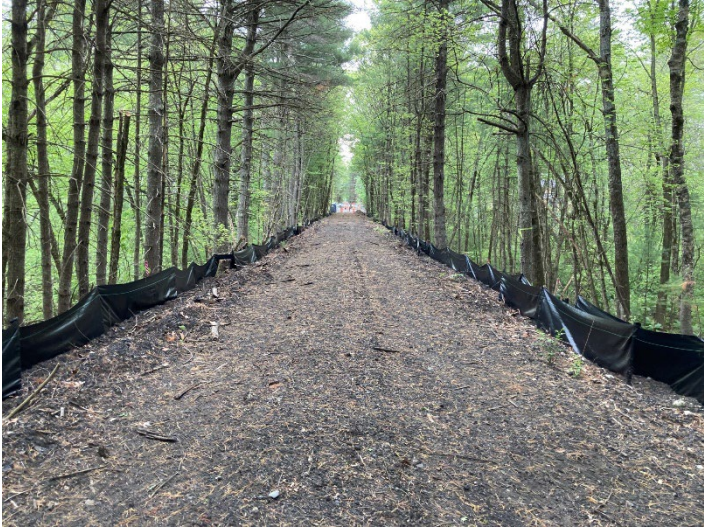
<b>PHOTOGRAPHIC LOG</b>	
<b>Client Name:</b> Eversource		<b>Site Location:</b> Sudbury to Hudson Transmission Reliability Project	<b>Town:</b> Sudbury
<b>Photo No.:</b> 1	<b>Date:</b> 5/16/2023

<b>Description:</b> View of syncopated silt fence in segment 9. Facing east.

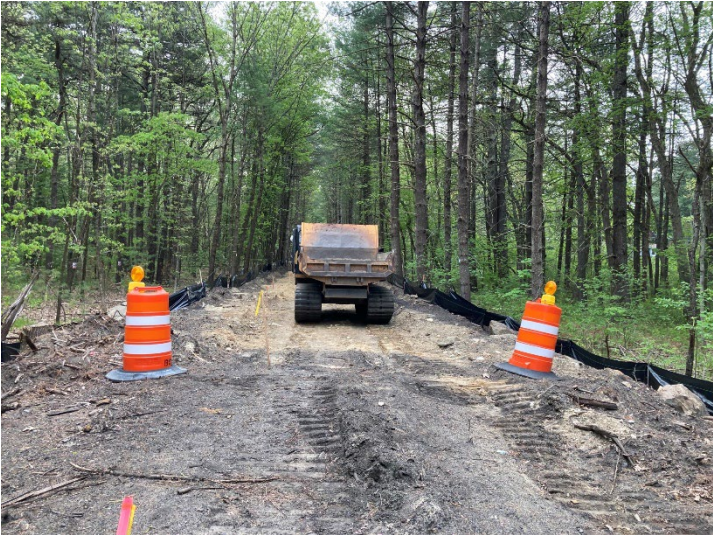
<b>PHOTOGRAPHIC LOG</b>	
<b>Client Name:</b> Eversource		<b>Site Location:</b> Sudbury to Hudson Transmission Reliability Project	<b>Town:</b> Sudbury
<b>Photo No.:</b> 2	<b>Date:</b> 5/16/2023

<b>Description:</b> View of west end of segment 10. ET&L was escorted through vernal pool TOY restricted area to stage equipment. Facing east.

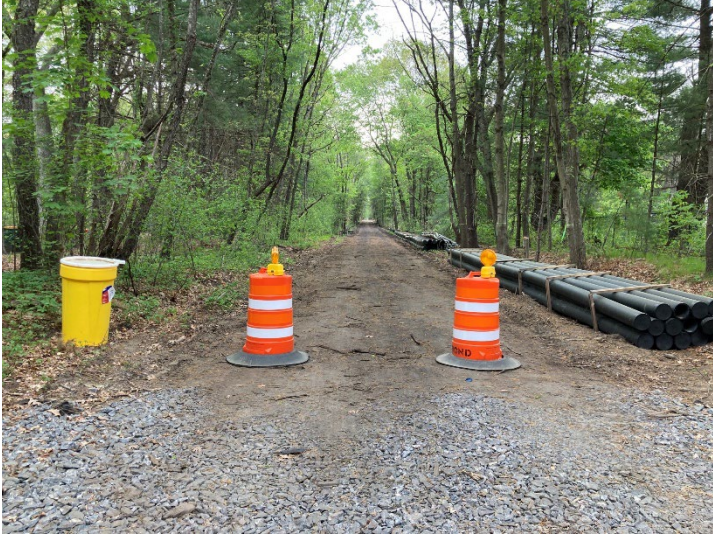
<b>PHOTOGRAPHIC LOG</b>	
<b>Client Name:</b> Eversource		<b>Site Location:</b> Sudbury to Hudson Transmission Reliability Project	<b>Town:</b> Sudbury
<b>Photo No.:</b> 3	<b>Date:</b> 5/16/2023

<b>Description:</b> View of construction entrance to segment 11 at Horse Pond Rd. Barrels are in place to demarcate vernal pool TOY restricted area. Spill kit also pictured. Facing east.

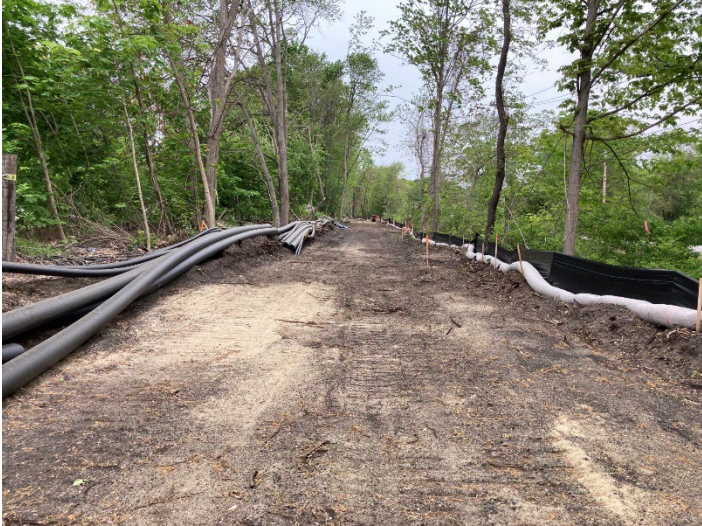
<b>PHOTOGRAPHIC LOG</b>	
<b>Client Name:</b> Eversource		<b>Site Location:</b> Sudbury to Hudson Transmission Reliability Project	<b>Town:</b> Sudbury
<b>Photo No.:</b> 4	<b>Date:</b> 5/16/2023

<b>Description:</b> View of segment 12. Facing west.

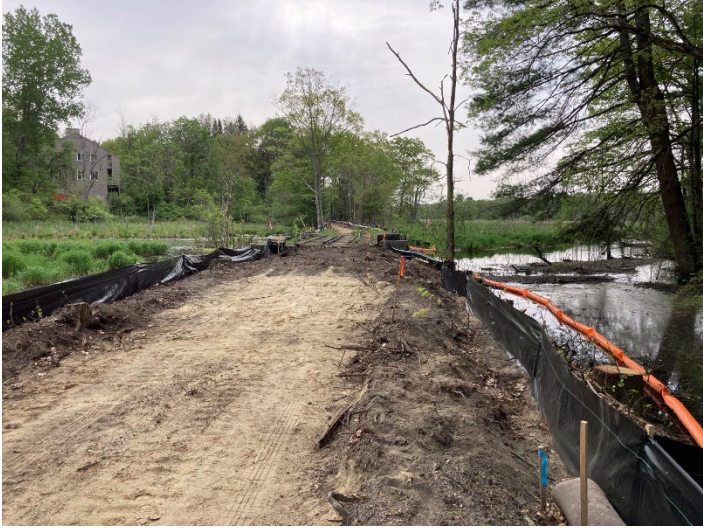
<b>PHOTOGRAPHIC LOG</b>	
<b>Client Name:</b> Eversource		<b>Site Location:</b> Sudbury to Hudson Transmission Reliability Project	<b>Town:</b> Sudbury
<b>Photo No.:</b> 5	<b>Date:</b> 5/16/2023

<b>Description:</b> View of segment 13 near bridge 127. Turbidity curtains have been installed on north and south sides of ROW. Facing east.

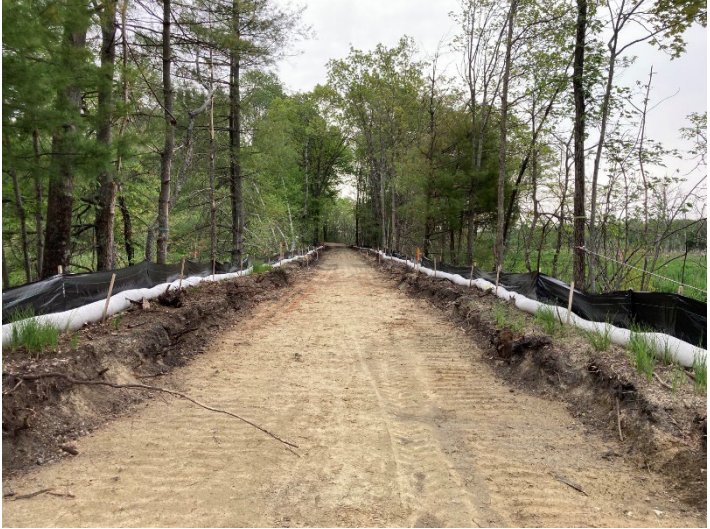
<b>PHOTOGRAPHIC LOG</b>	
<b>Client Name:</b> Eversource		<b>Site Location:</b> Sudbury to Hudson Transmission Reliability Project	<b>Town:</b> Sudbury
<b>Photo No.:</b> 6	<b>Date:</b> 5/16/2023

<b>Description:</b> View of Type A E&S controls in segment 14. Facing east.

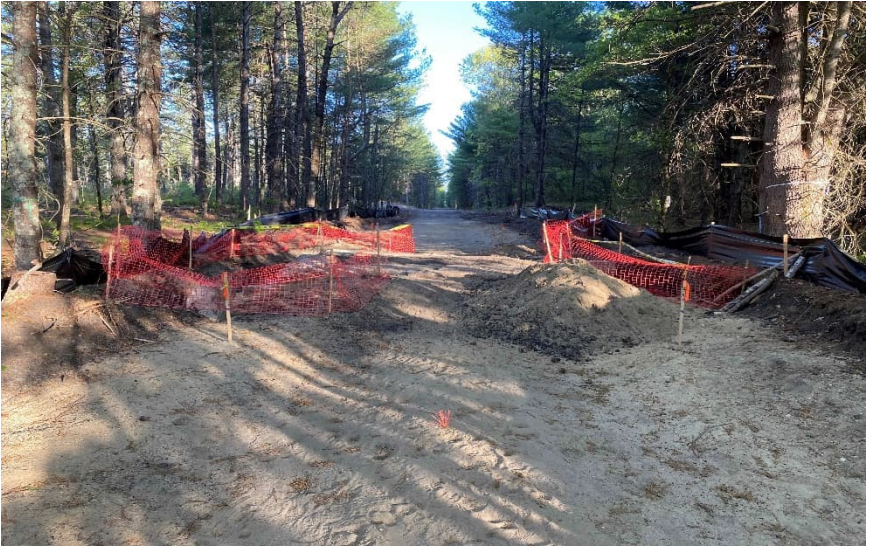
<b>PHOTOGRAPHIC LOG</b>	
Client Name: Eversource		Site Location: Sudbury to Hudson Transmission Reliability Project	Town: Sudbury
Photo No.: 1	Date: 5-17-23

Description:  Right-of-way within segment 7 at historic cattle guard area, existing erosion control, looking westward.

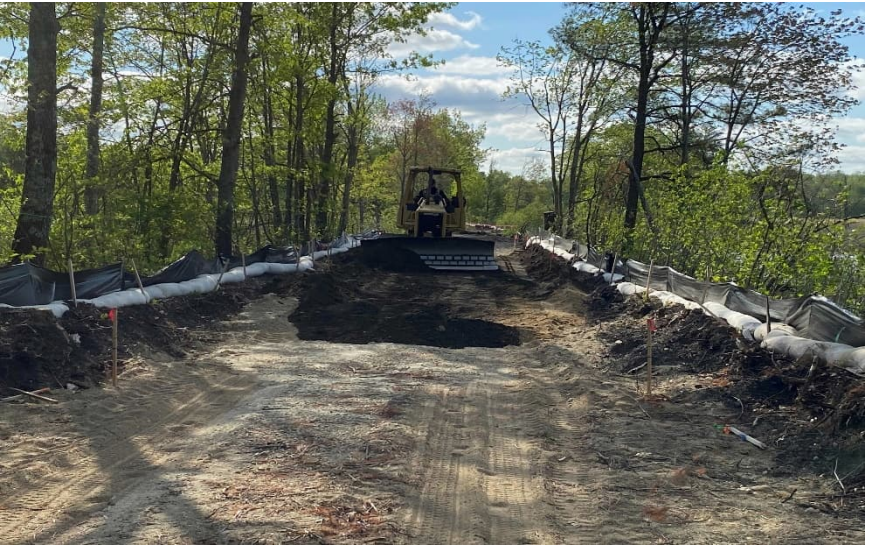
<b>PHOTOGRAPHIC LOG</b>	
Client Name: Eversource		Site Location: Sudbury to Hudson Transmission Reliability Project	Town: Hudson
Photo No.: 2	Date: 5-17-23

Description:  ET&L conducting site work (grading) within segment 2, looking eastward.

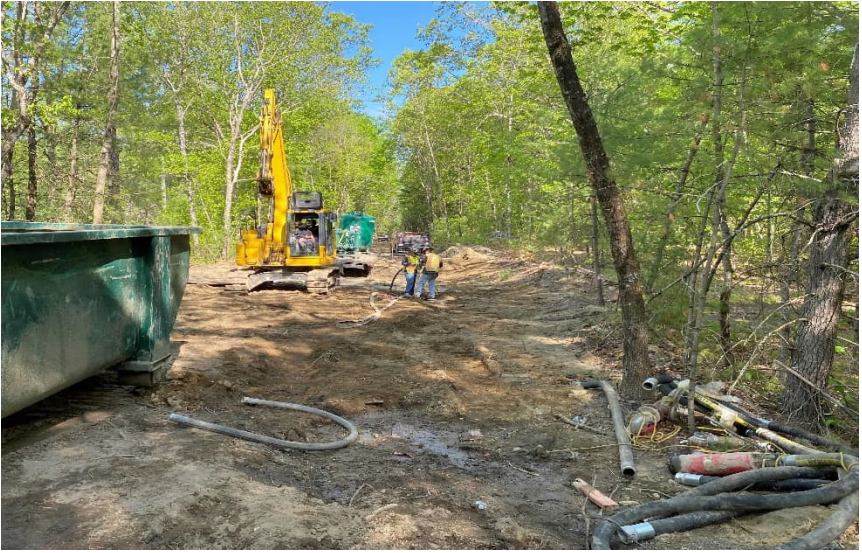
<b>PHOTOGRAPHIC LOG</b>	
Client Name: Eversource		Site Location: Sudbury to Hudson Transmission Reliability Project	Town: Hudson
Photo No.: 3	Date: 5-17-23

Description:  Bond demobilizing from near manhole#12, within segment 5, looking westward.

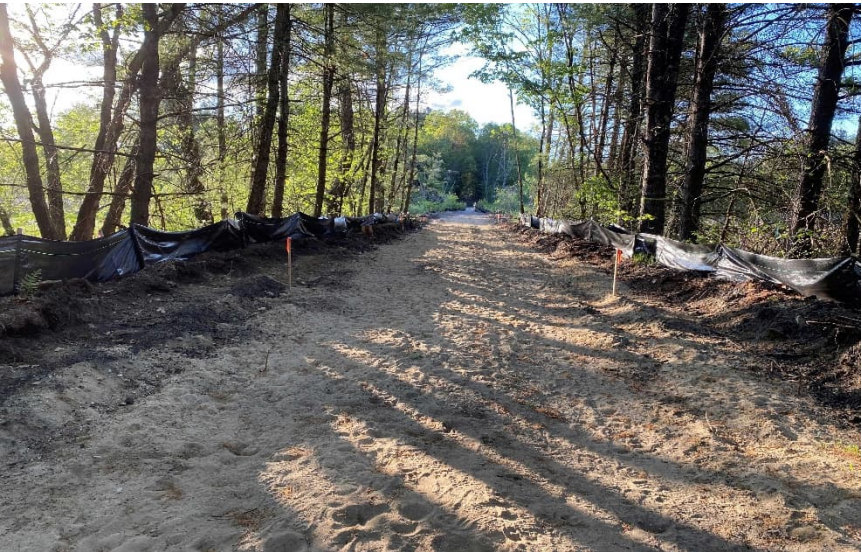
<b>PHOTOGRAPHIC LOG</b>	
Client Name: Eversource		Site Location: Sudbury to Hudson Transmission Reliability Project	Town: Sudbury
Photo No.: 4	Date: 5-17-23

Description:  Right-of-way, within segment 7, looking toward Bridge 128, looking eastward.

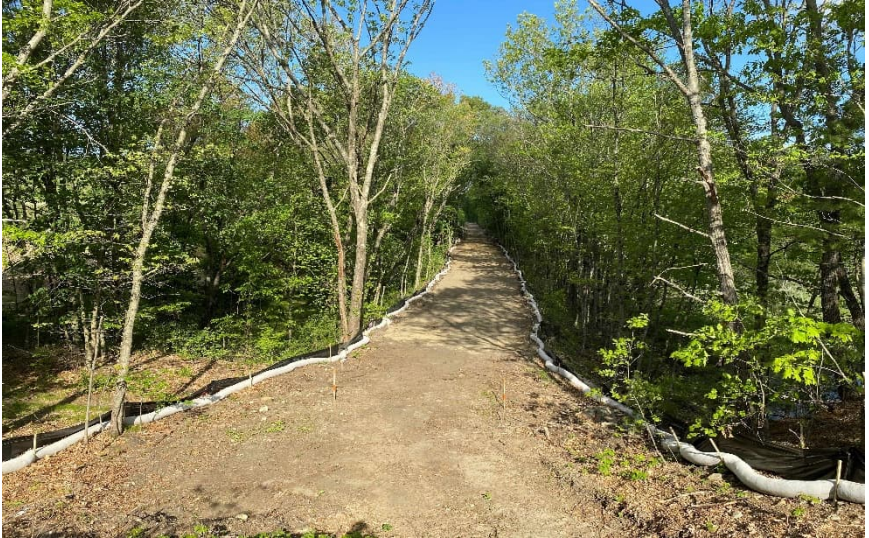
<b>PHOTOGRAPHIC LOG</b>	
Client Name: Eversource		Site Location: Sudbury to Hudson Transmission Reliability Project	Town: Hudson
Photo No.: 5	Date: 5-17-23

Description:  Right-of-way, within Segment 1, existing erosion control, looking westward

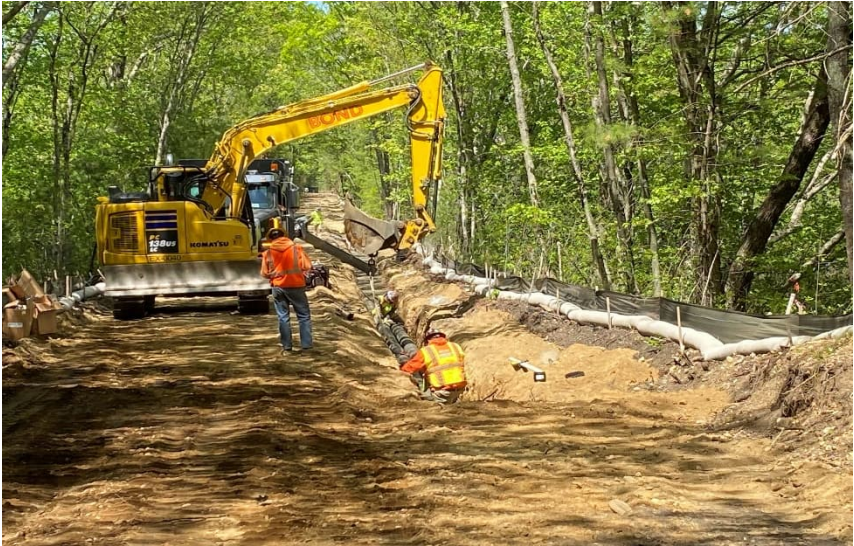
<b>PHOTOGRAPHIC LOG</b>	
Client Name: Eversource		Site Location: Sudbury to Hudson Transmission Reliability Project	Town: Hudson
Photo No.: 8	Date: 5-17-23

Description:  Bond conducting conduit work, within segment 5, looking westward.

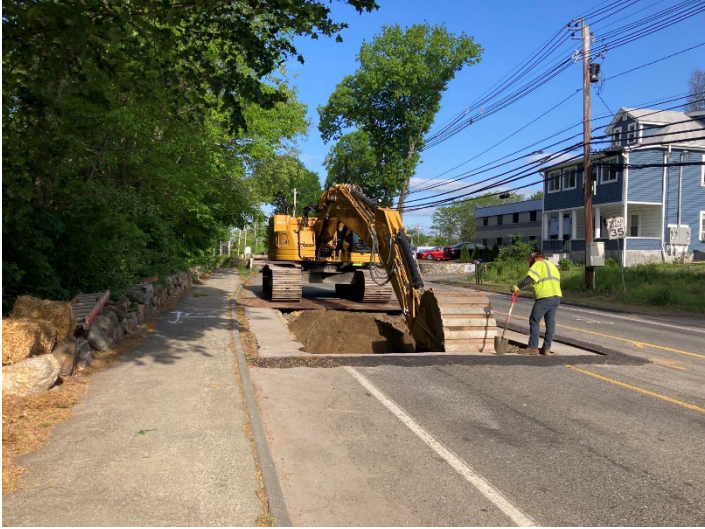
<p align="center"><b>PHOTOGRAPHIC LOG</b></p>	
<p><b>Client Name:</b> Eversource</p>		<p><b>Site Location:</b> Sudbury to Hudson Transmission Reliability Project</p>	<p><b>Town:</b> Hudson</p>
<p><b>Photo No.:</b> 1</p>	<p><b>Date:</b> 5/17/2023</p>

<p><b>Description:</b> View of Bond working at MH #2 on Forest Ave. Facing west.</p>

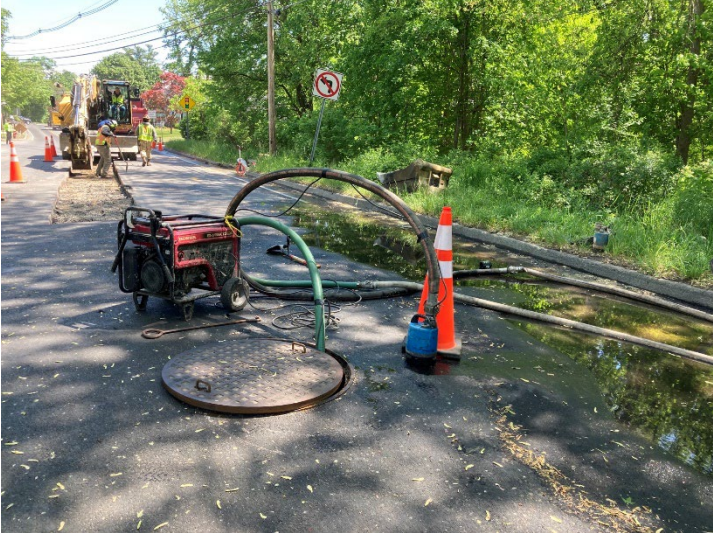
<p align="center"><b>PHOTOGRAPHIC LOG</b></p>	
<p><b>Client Name:</b> Eversource</p>		<p><b>Site Location:</b> Sudbury to Hudson Transmission Reliability Project</p>	<p><b>Town:</b> Hudson</p>
<p><b>Photo No.:</b> 2</p>	<p><b>Date:</b> 5/17/2023</p>

<p><b>Description:</b> View of work and dewatering operation at MH #4 on Forest Ave. See additional dewatering inspection report. Facing northeast.</p>

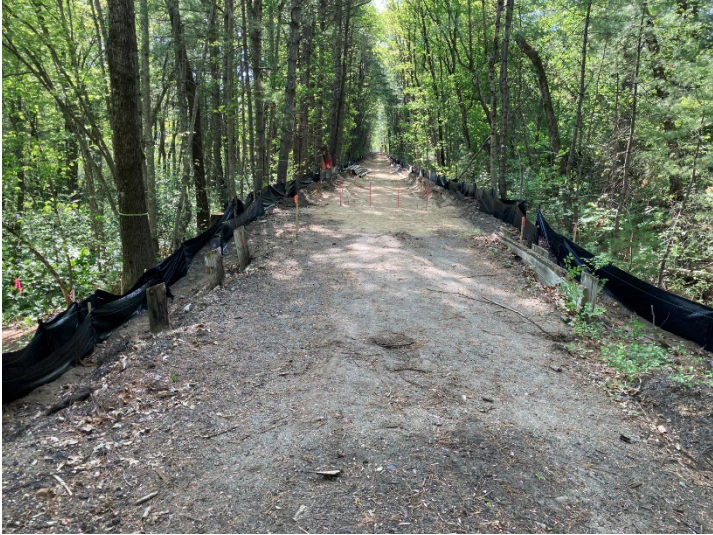
<b>PHOTOGRAPHIC LOG</b>	
<b>Client Name:</b> Eversource		<b>Site Location:</b> Sudbury to Hudson Transmission Reliability Project	
<b>Town:</b> Sudbury			
<b>Photo No.:</b> 3	<b>Date:</b> 5/17/2023

<b>Description:</b> View of Dudley Brook culvert area in segment 10. Facing east.

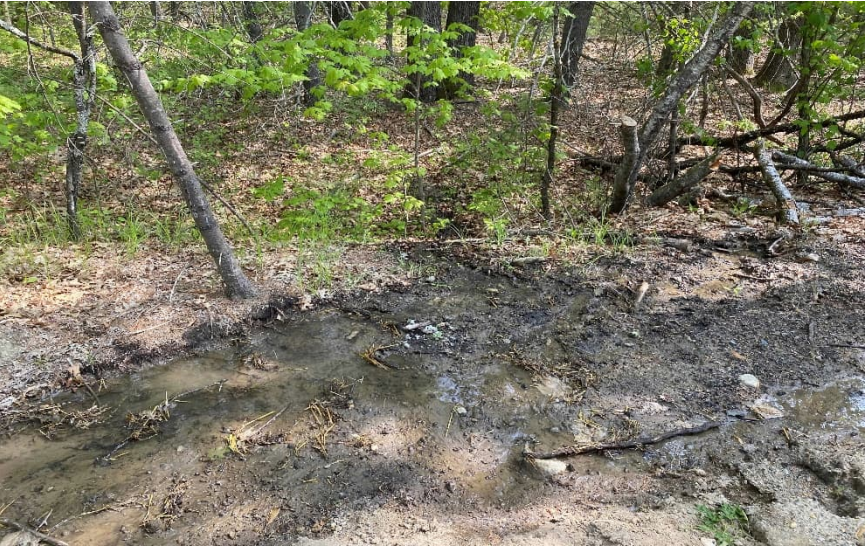
Discharge Location	Observations
1. Hudson within Segment 5 at approximate Sta# 317+50.	Actual runoff observed, as a result of dewatering activities. Water appeared clear. Water sampled for turbidity & results <50 NTUs (see photo 8).
2.	
3.	
4.	
5.

Description:  Runoff from right-of-way, within segment 5 at approximate Sta# 317+50, from dewatering activities, looking eastward.

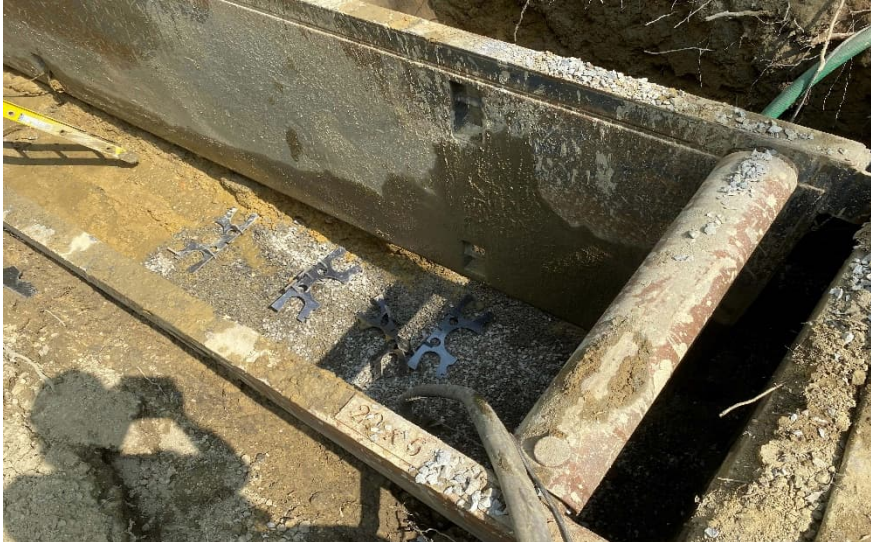
Description: View of area being pumped at work operation within Segment 5 at manhole #12 (accumulated water in frac tank). Water appeared slightly turbid.

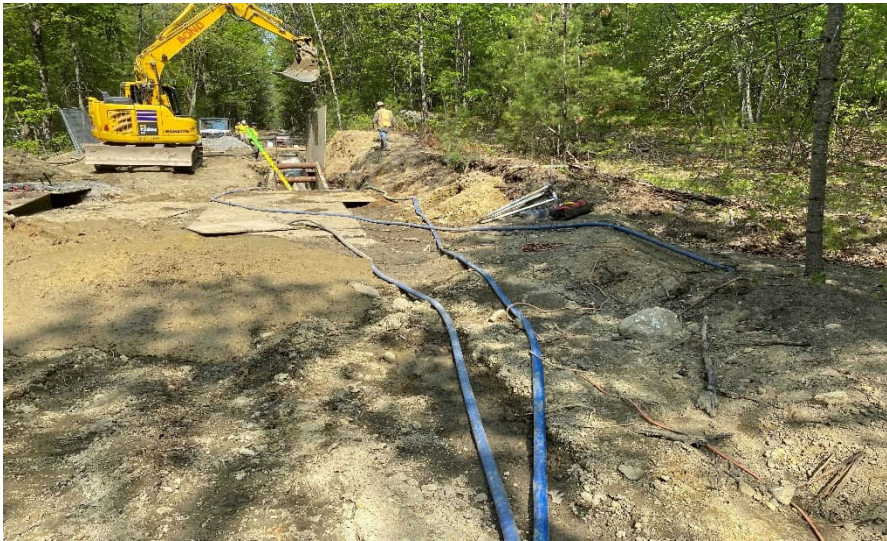
Description: View of pumping operation at Segment 5 at manhole #12 (manhole to frac tank to filtration system to dewatering bag within bale corral), looking westward.

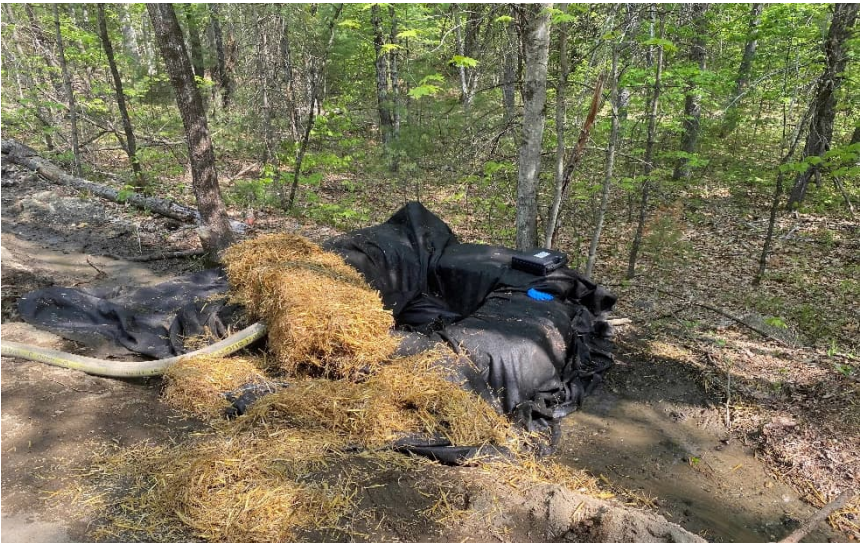
Description: Segment 5 at manhole #12. View of discharge bag/bales, looking westward. Water appeared to be clear.

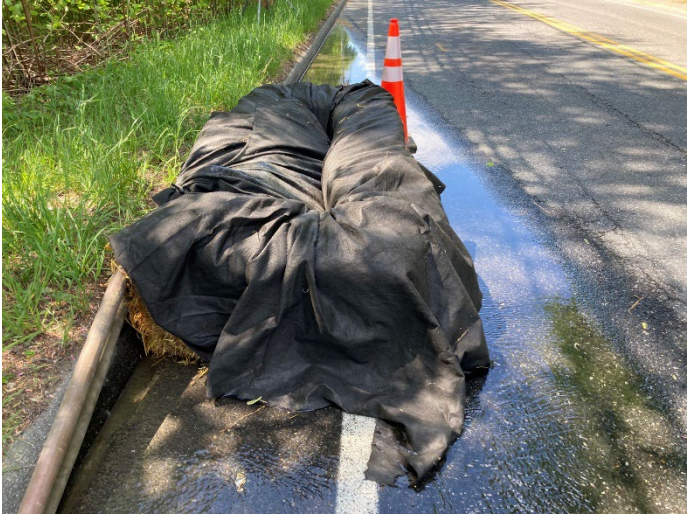
<b>Description:</b> View of dewatering controls (straw bale corral with filter fabric and silt bag). Facing southwest.

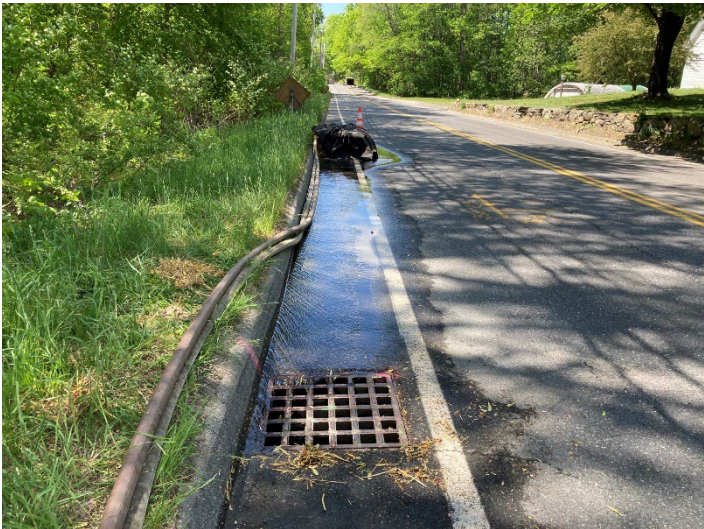
<b>Description:</b> View of discharge point from project (catch basin below hay bale corral on Forest Ave). Discharge appeared clear and turbidity reading was less than 50 NTUs. Facing southwest.

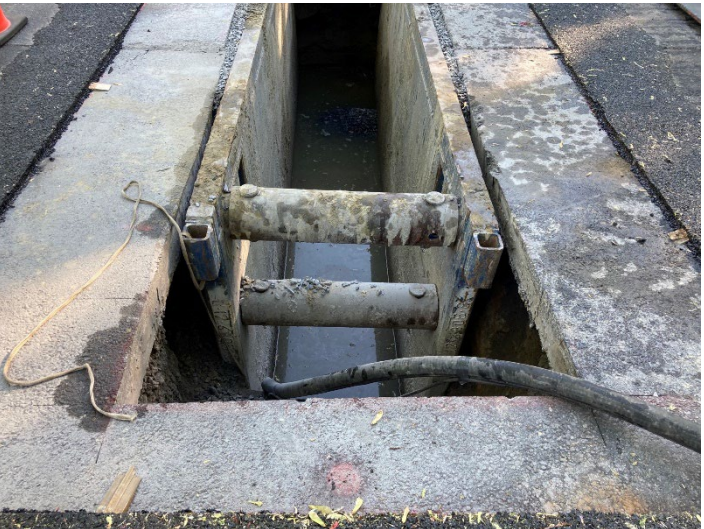
<b>Description:</b> View of dewatering water in trench prior to treatment. Water appeared slightly turbid.

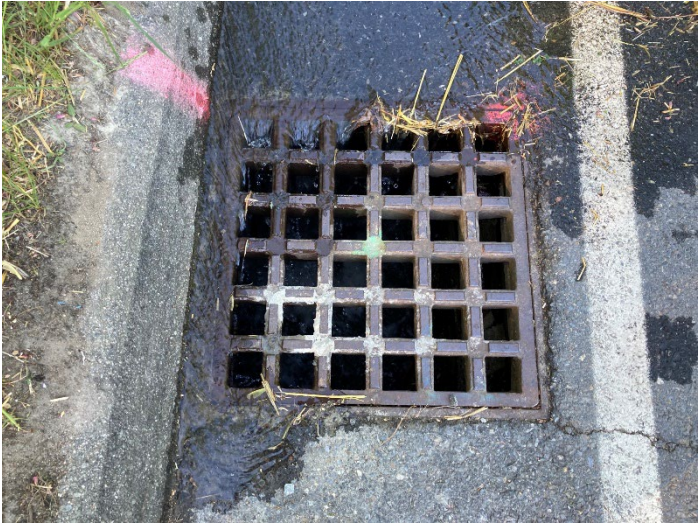
<b>Description:</b> View of discharge point from project (catch basin below hay bale corral on Forest Ave). Discharge appeared clear and turbidity reading was less than 50 NTUs.

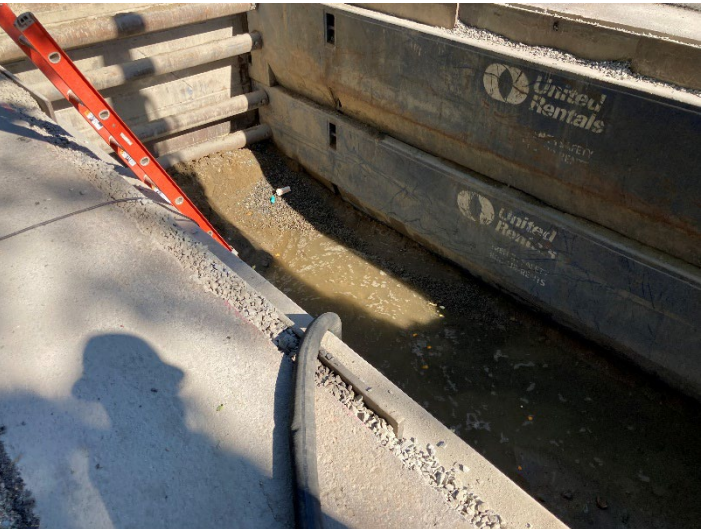
<b>Description:</b> View of dewatering water in trench prior to treatment. Water appeared slightly turbid.

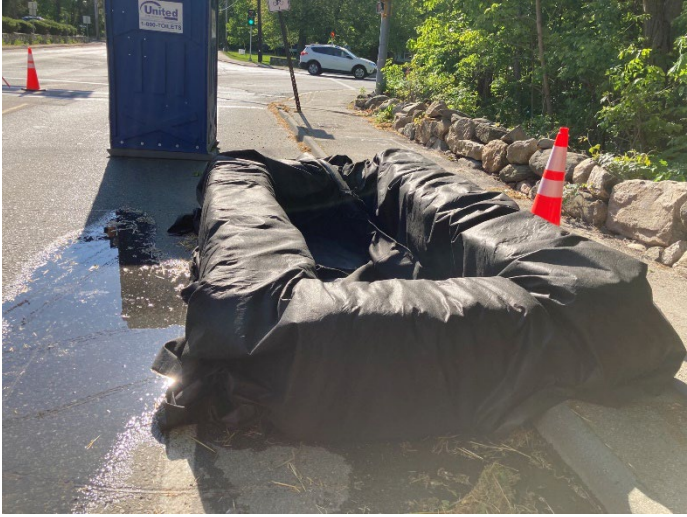
<b>Photo No.:</b> 3	<b>Date:</b> 5/18/2023		
<b>Description:</b> View of dewatering controls (straw bale corral with filter fabric and silt bag). Facing east.

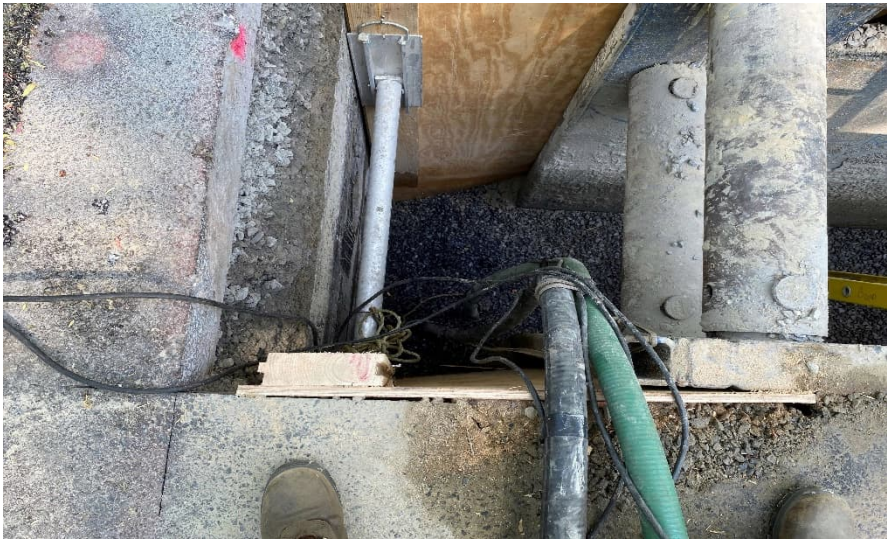
Description: View of pumping operation at MH#4. This is the location of dewatering water prior to treatment. Water appeared to be clear.

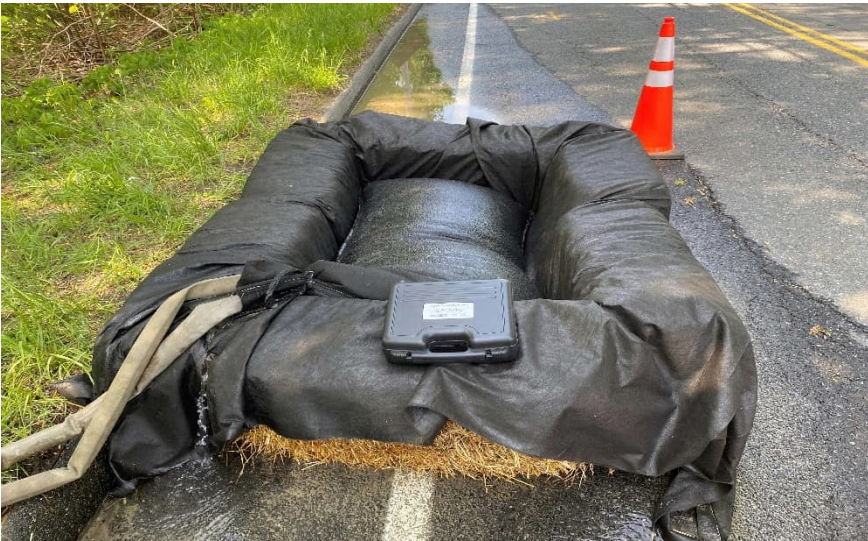
Description: MH#4. View of discharge bag/bales, looking southward. Water appeared to be clear.
