**Weekly Environmental Compliance Summary**

**Sudbury to Hudson Transmission Reliability Project (USEPA Tracking # MAR1003UW)**

Week of: May 22 to May 26, 2023

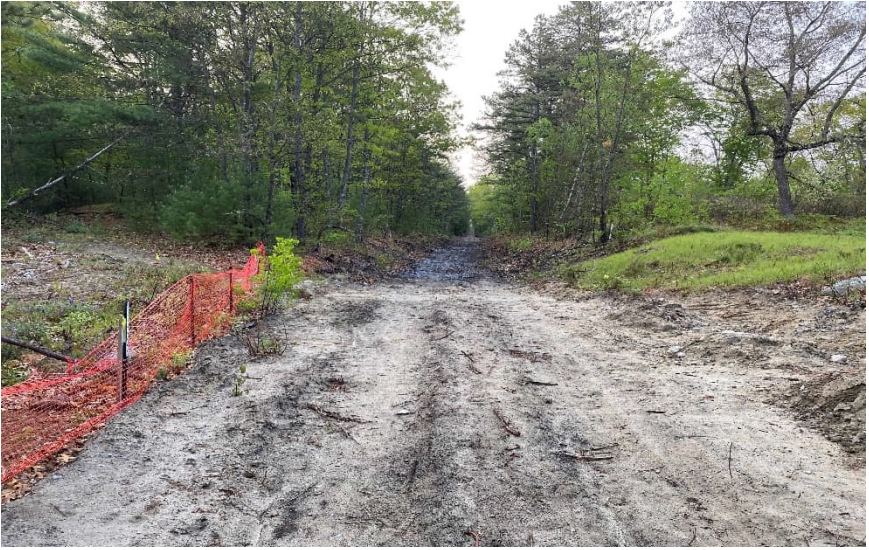
<b>PHOTOGRAPHIC LOG</b>	
Client Name: Eversource		Site Location: Sudbury to Hudson Transmission Reliability Project	Town: Sudbury
Photo No.: 1	Date: 5-23-23

Description:  Right-of-way within segment 7, existing erosion control, looking eastward.

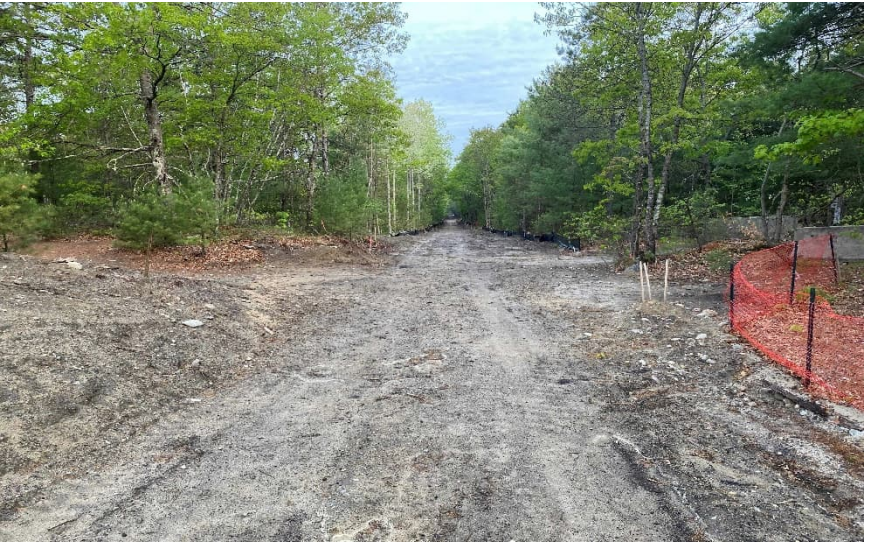
<b>PHOTOGRAPHIC LOG</b>	
Client Name: Eversource		Site Location: Sudbury to Hudson Transmission Reliability Project	Town: Hudson
Photo No.: 2	Date: 5-23-23

Description:  Right-of-way within segment 6, existing erosion control, looking westward.

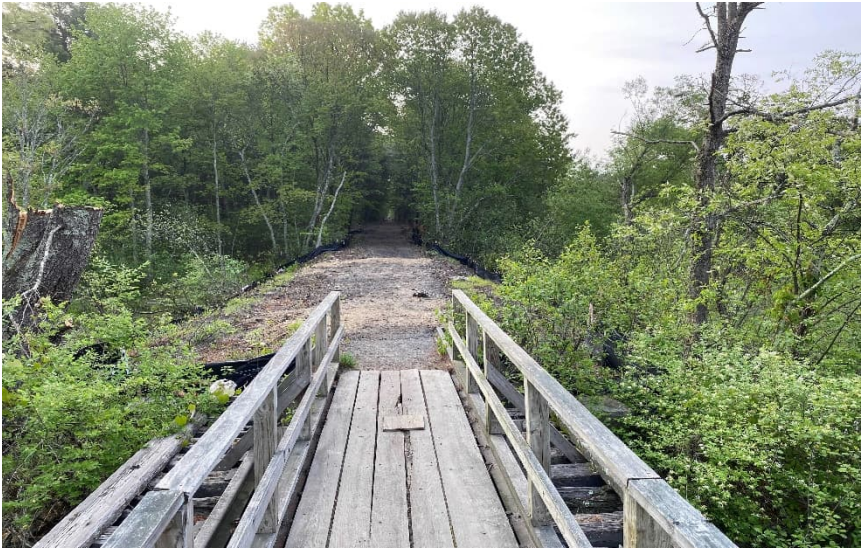
<b>PHOTOGRAPHIC LOG</b>	
Client Name: Eversource		Site Location: Sudbury to Hudson Transmission Reliability Project	Town: Sudbury
Photo No.: 3	Date: 5-23-23

Description:  Right-of-way from bridge 128 looking into segment 8, existing erosion control, looking eastward.

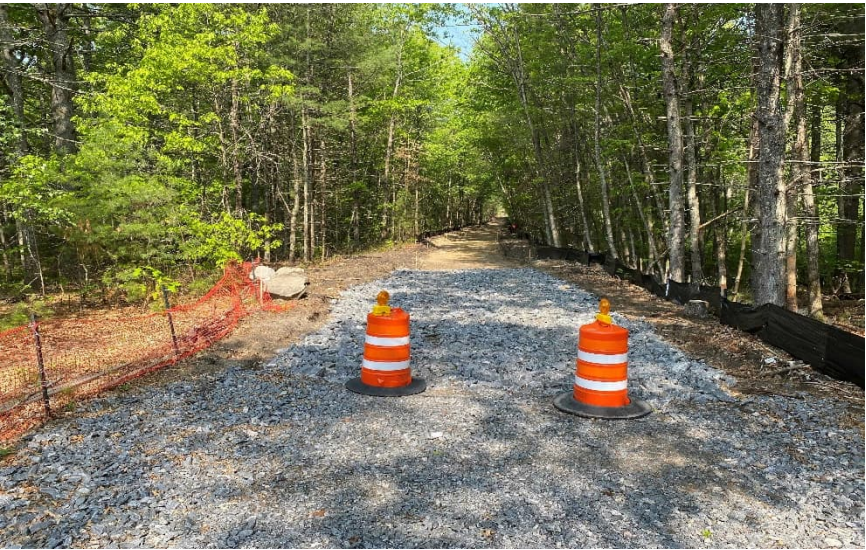
<b>PHOTOGRAPHIC LOG</b>	
Client Name: Eversource		Site Location: Sudbury to Hudson Transmission Reliability Project	Town: Sudbury
Photo No.: 4	Date: 5-23-23

Description:  Right-of-way within segment 8 off Dutton Road, existing erosion control, looking westward.

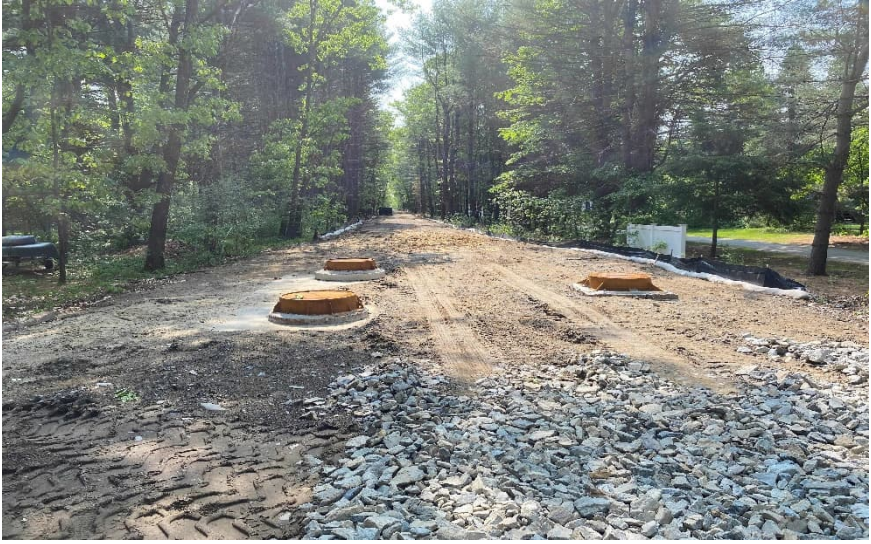
<b>PHOTOGRAPHIC LOG</b>	
Client Name: Eversource		Site Location: Sudbury to Hudson Transmission Reliability Project	Town: Hudson
Photo No.: 5	Date: 5-23-23

Description:  Right-of-way, within Segment 5 – manhole 11, existing erosion control, looking eastward

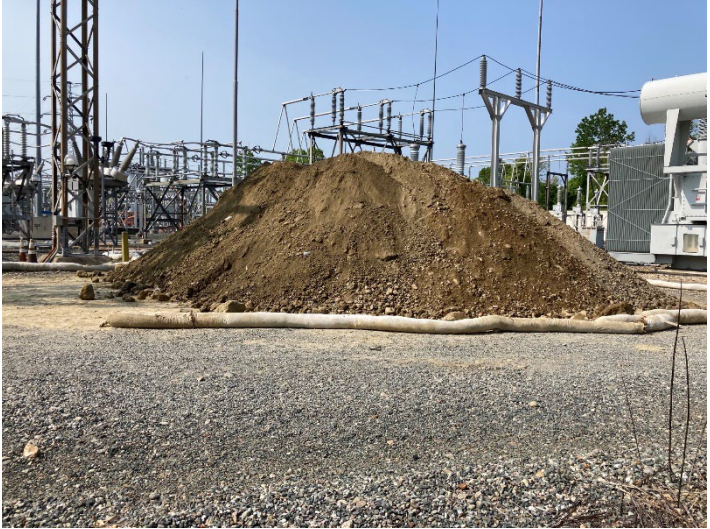
<b>PHOTOGRAPHIC LOG</b>	
<b>Client Name:</b> Eversource		<b>Site Location:</b> Sudbury to Hudson Transmission Reliability Project	<b>Town:</b> Sudbury
<b>Photo No.:</b> 6	<b>Date:</b> 5/23/2023

<b>Description:</b> View of stockpile at Sudbury Substation (located behind Eversource trailer). Facing south.

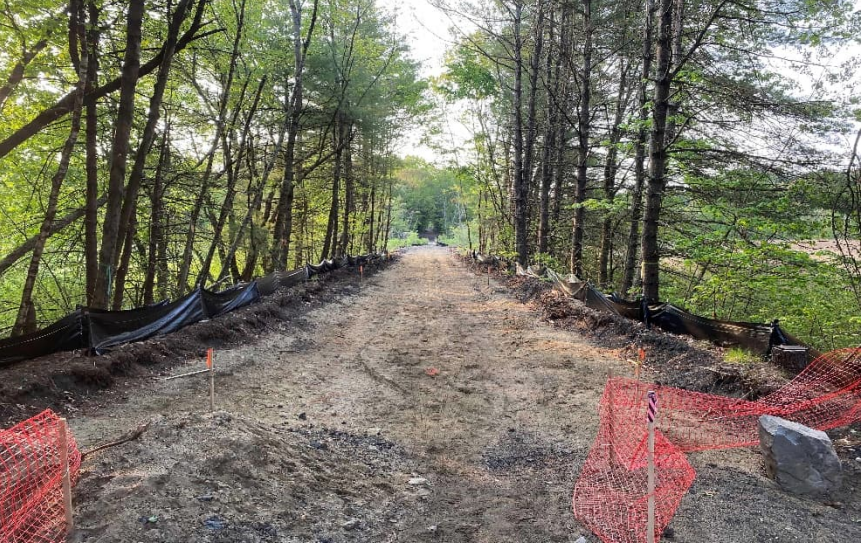
<b>PHOTOGRAPHIC LOG</b>	
Client Name: Eversource		Site Location: Sudbury to Hudson Transmission Reliability Project	Town: Sudbury
Photo No.: 2	Date: 5-24-23

Description:  Right-of-way within segment 7, existing erosion control, looking eastward.

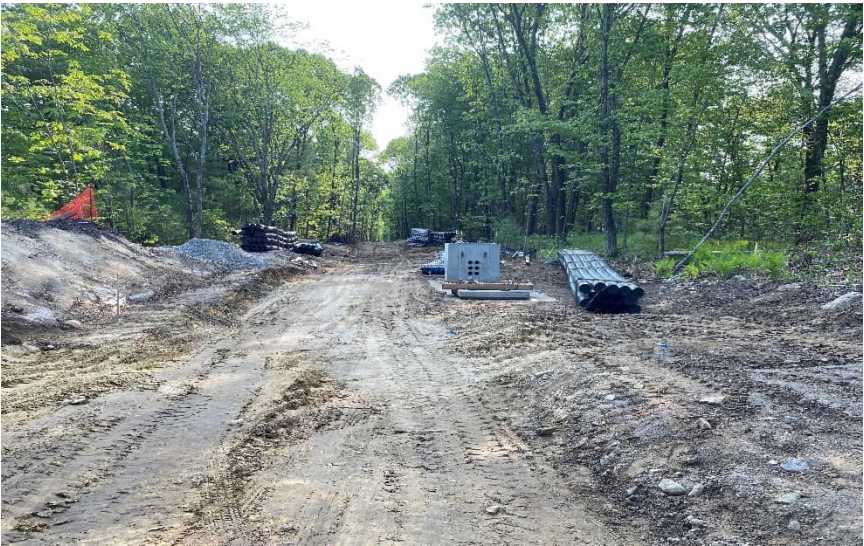
<b>PHOTOGRAPHIC LOG</b>	
Client Name: Eversource		Site Location: Sudbury to Hudson Transmission Reliability Project	Town: Hudson
Photo No.: 4	Date: 5-24-23

Description:  Right-of-way within segment 1, manhole #5, existing erosion control, looking eastward.

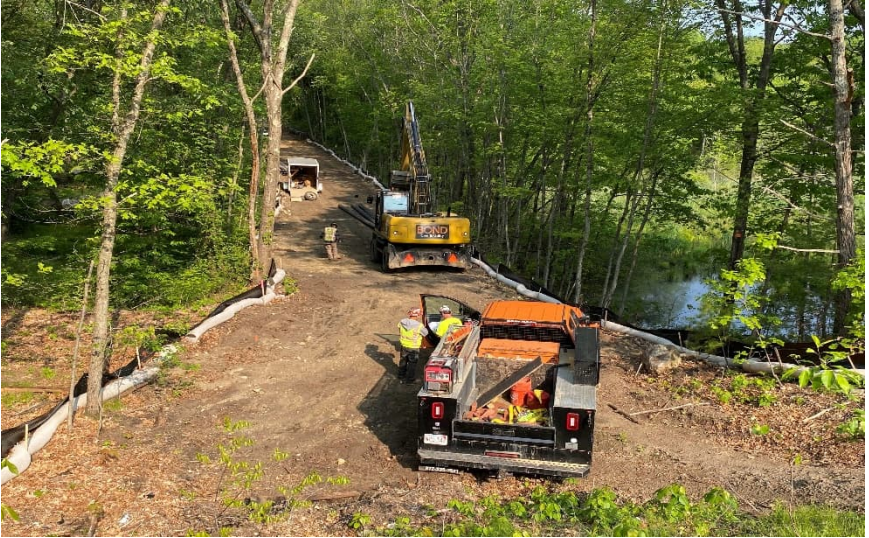
<b>PHOTOGRAPHIC LOG</b>	
Client Name: Eversource		Site Location: Sudbury to Hudson Transmission Reliability Project	Town: Hudson
Photo No.: 5	Date: 5-24-23

Description:  Right-of-way, within Segment 1 – from Chestnut Street, Bond starting conduit work, existing erosion control, looking westward

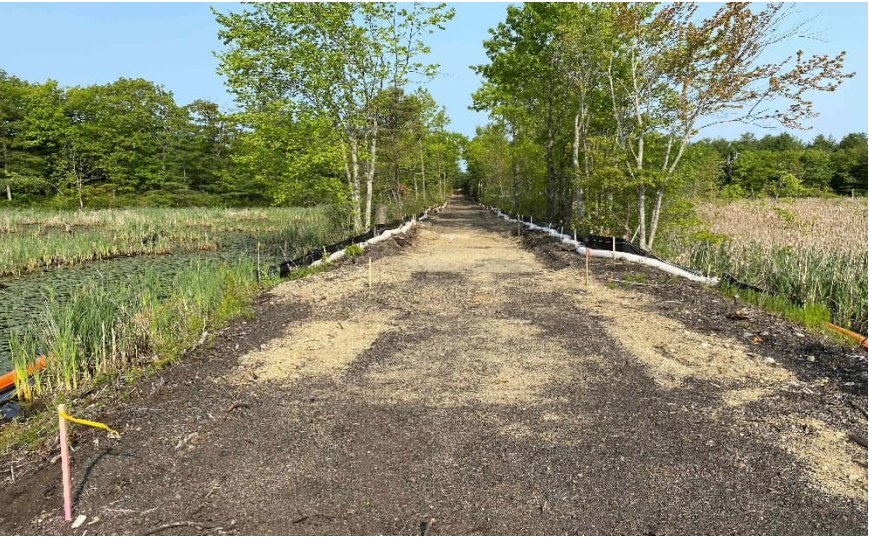
<b>PHOTOGRAPHIC LOG</b>	
Client Name: Eversource		Site Location: Sudbury to Hudson Transmission Reliability Project	Town: Hudson
Photo No.: 6	Date: 5-24-23

Description:  Right-of-way, within Segment 2 – from Bridge 130, existing erosion control, looking westward

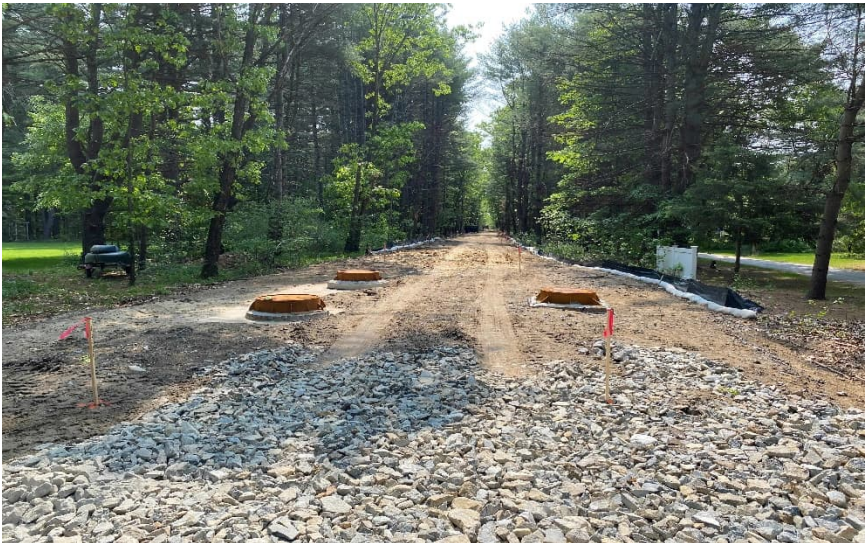
<b>PHOTOGRAPHIC LOG</b>	
Client Name: Eversource		Site Location: Sudbury to Hudson Transmission Reliability Project	Town: Hudson
Photo No.: 8	Date: 5-24-23

Description:  Right-of-way, within Segment 5 – manhole 11, existing erosion control, looking eastward

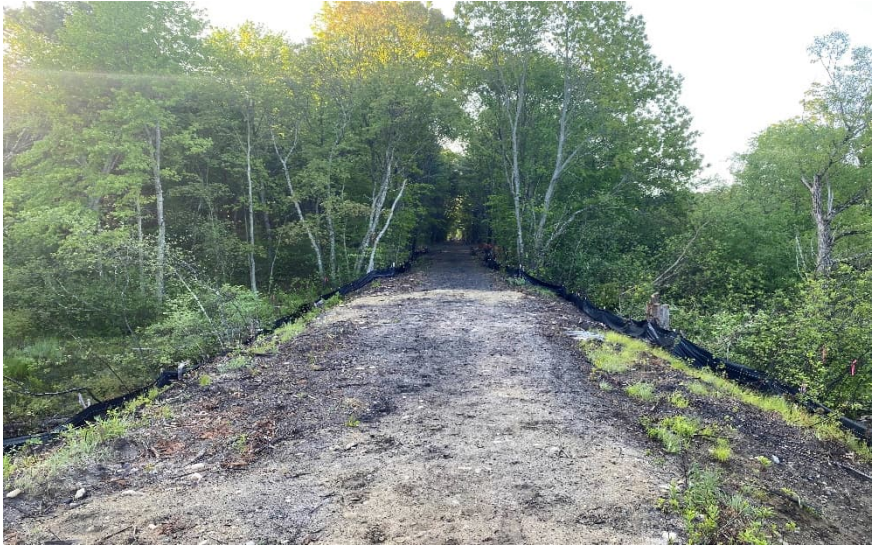
<p>Description:                  Right-of-way within segment 8, existing erosion control, looking eastward.</p>

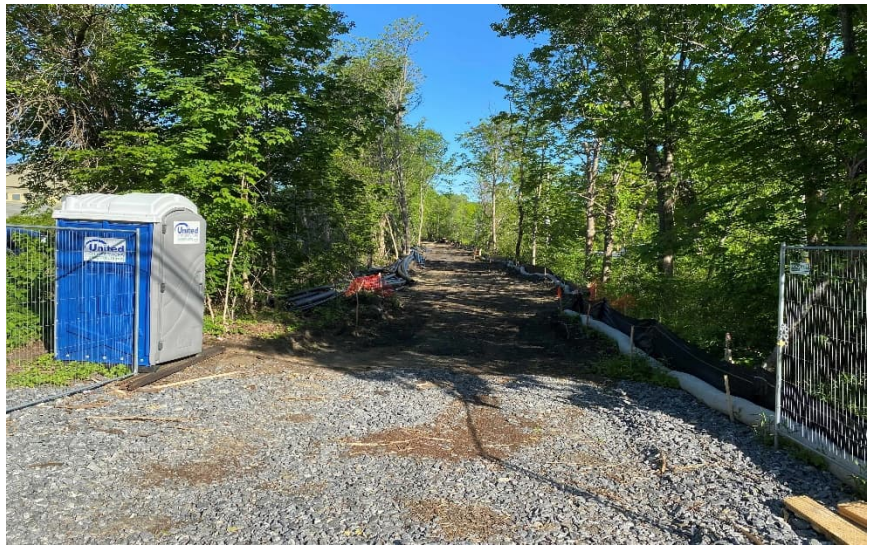
<p>Description:                  Right-of-way within segment 12, existing erosion control, looking westward.</p>

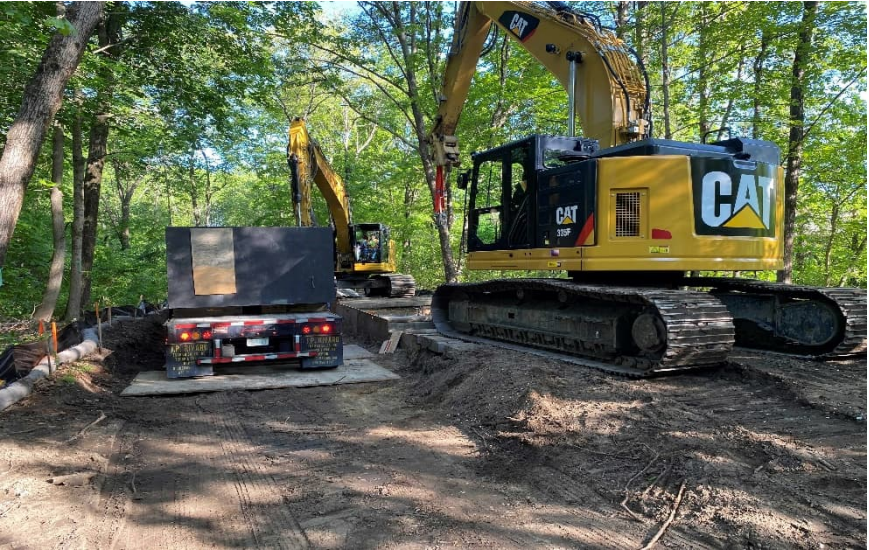
<p>Description:                  Manhole #25 placement within segment 13, existing erosion control, looking westward.</p>

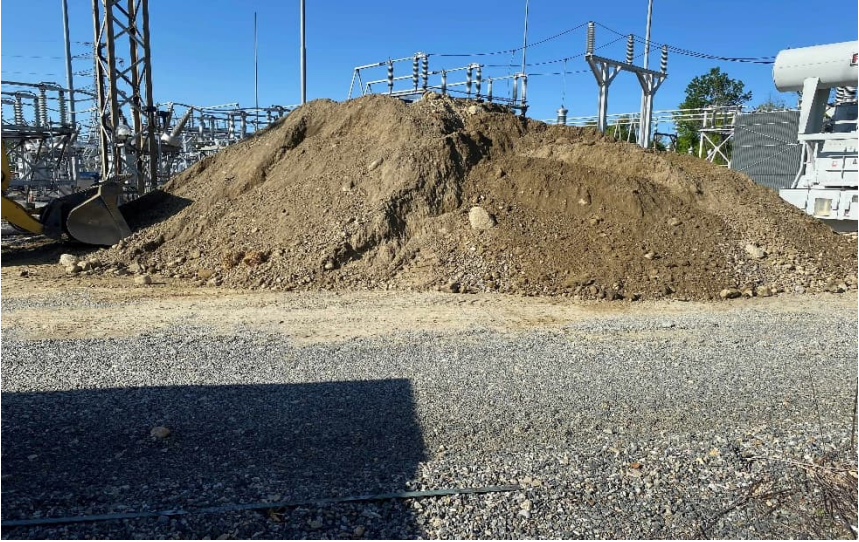
<p>Description:                  Active new spoil pile within substation, looking westward.</p>

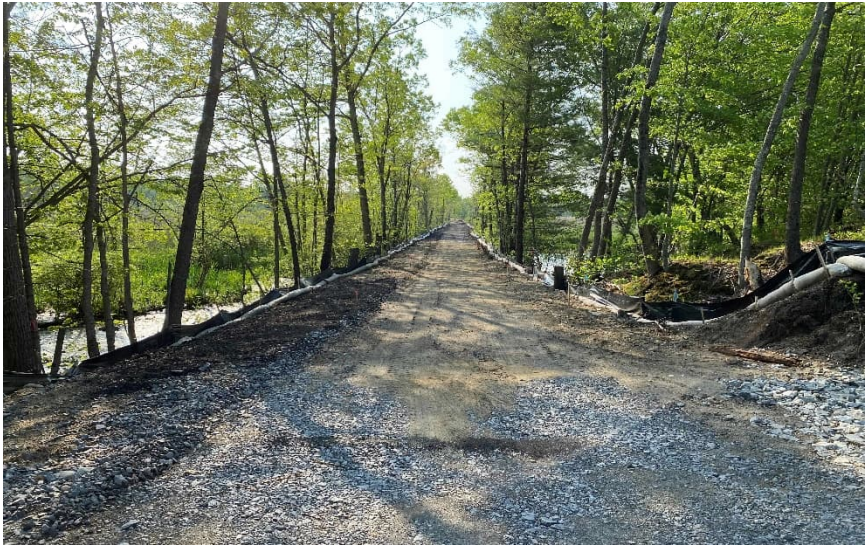
Description:  Right-of-way within segment 2 from approximate Sta# 142+00, existing erosion control, looking eastward.

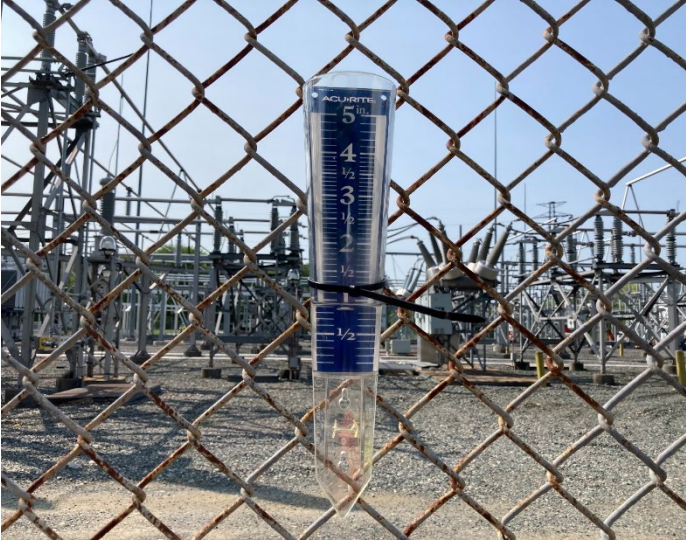
<b>Description:</b> View of rain gauge at Sudbury Substation. 0.90" observed in gauge at 9:30am. Facing south.

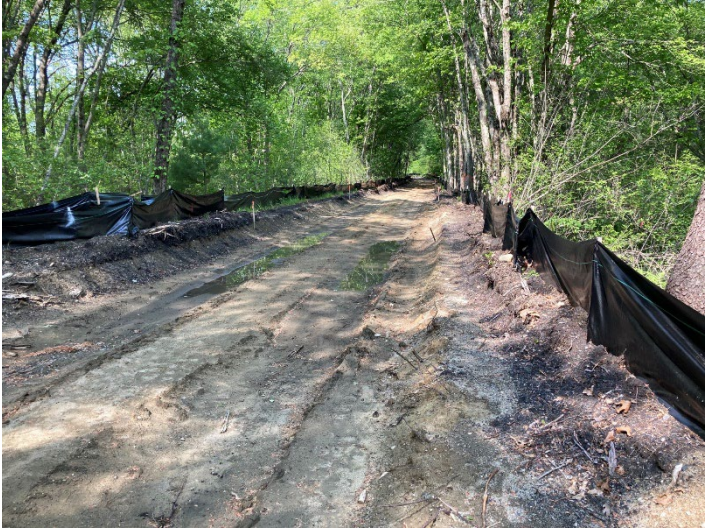
<b>Description:</b> View of syncopated silt fence in segment 14. Facing west.

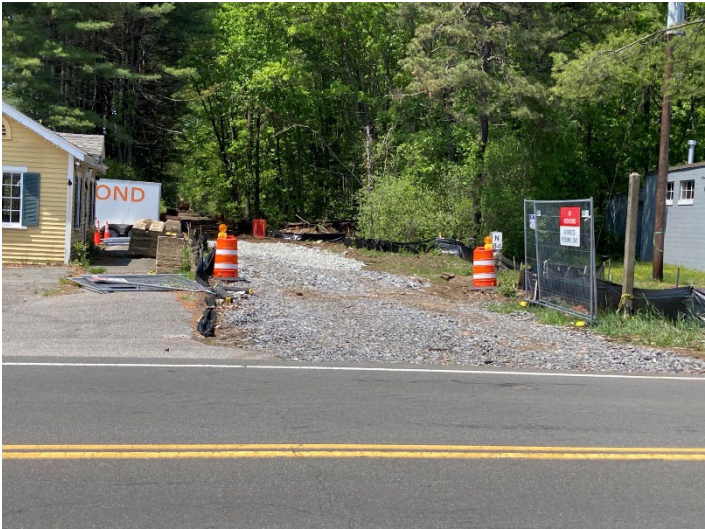
<b>Description:</b> View of construction entrance to segment 11 at Union Ave. Silt fence has been laid down on south side of entrance to allow for truck traffic. Silt fence will be repaired once truck traffic ceases. Facing west.

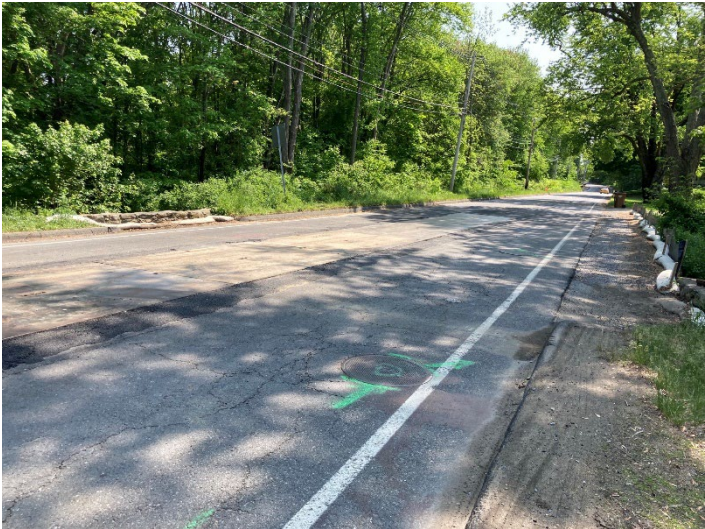
<b>Description:</b> View of E&S controls at MH #4 area on Forest Ave. Controls are operating properly. Facing southwest.

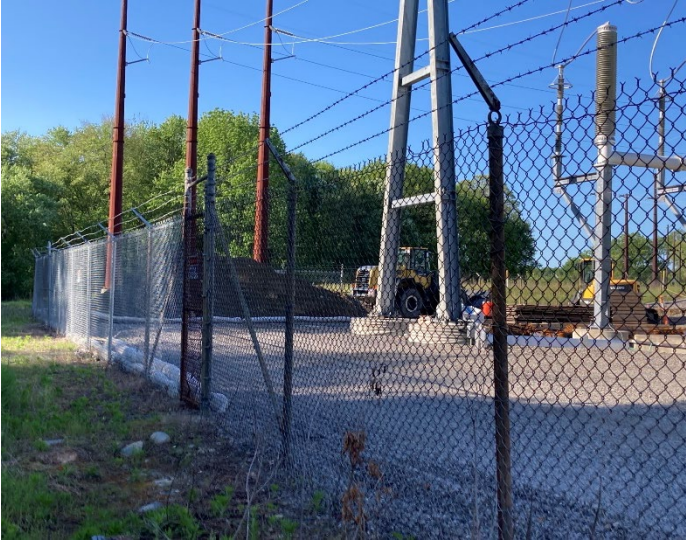
**-Stockpile noted in northeast corner of Sudbury Substation. This pile appears to be within the buffer zone for nearby wetlands and should be relocated. Eversource CMs were informed.**

<b>Description:</b> View of construction area and stockpile in northeast corner of Sudbury Substation. This stockpile appears to be within the buffer zone for nearby wetlands and should be relocated. Facing northwest.

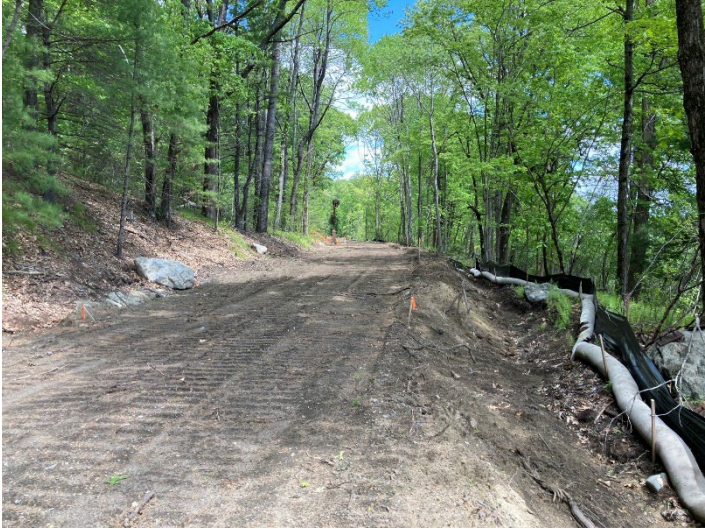
<b>Description:</b> View of Type A E&S controls in segment 14. Facing east.

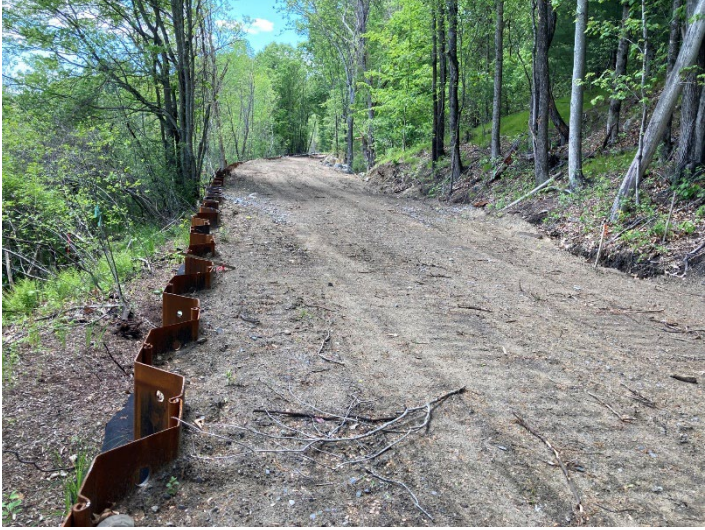
<b>Description:</b> View of sheetwall in segment 14. Filter tubes behind sheetwall are in good condition. Facing west.

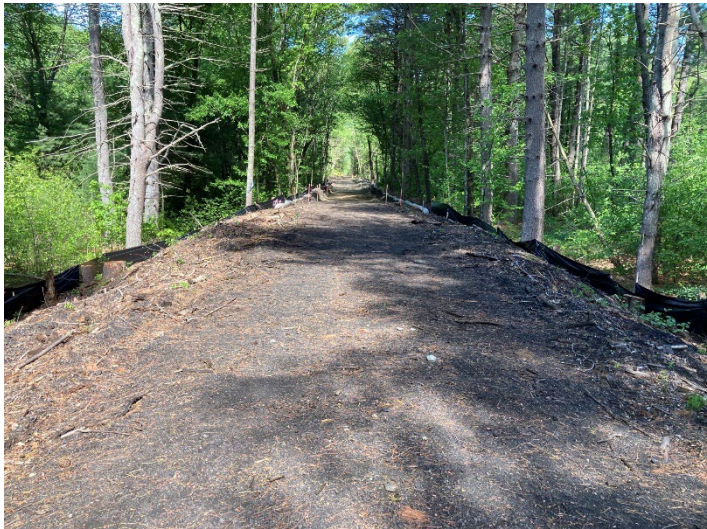
<b>Description:</b> View of Type A and Type B E&S controls in segment 9. Controls are operating properly. Facing west.

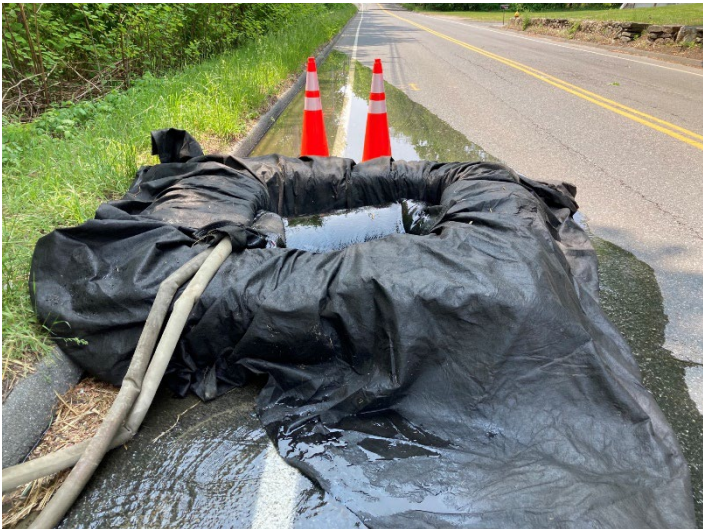
<b>Description:</b> View of dewatering controls (straw bale corral with filter fabric and silt bag). Facing south.

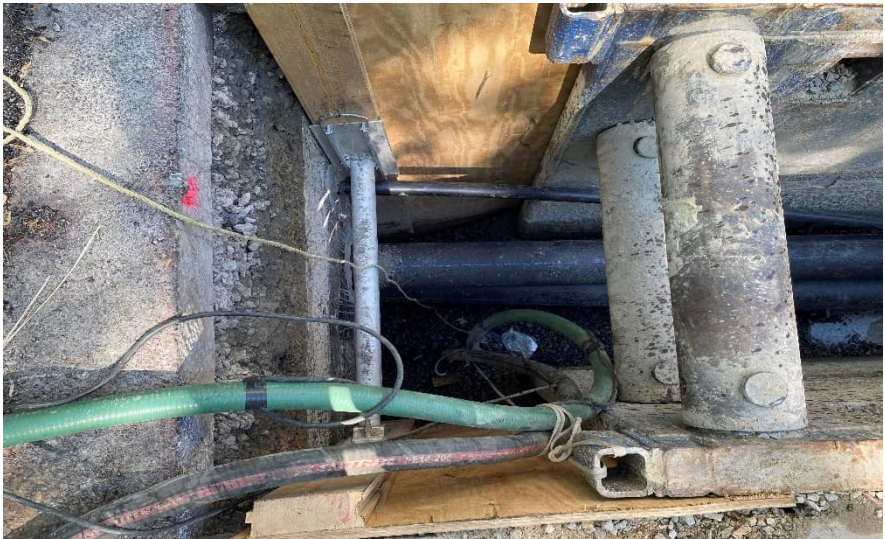
Description: View of pumping operation at MH#4. This is the location of dewatering water prior to treatment. Water appeared to be clear.

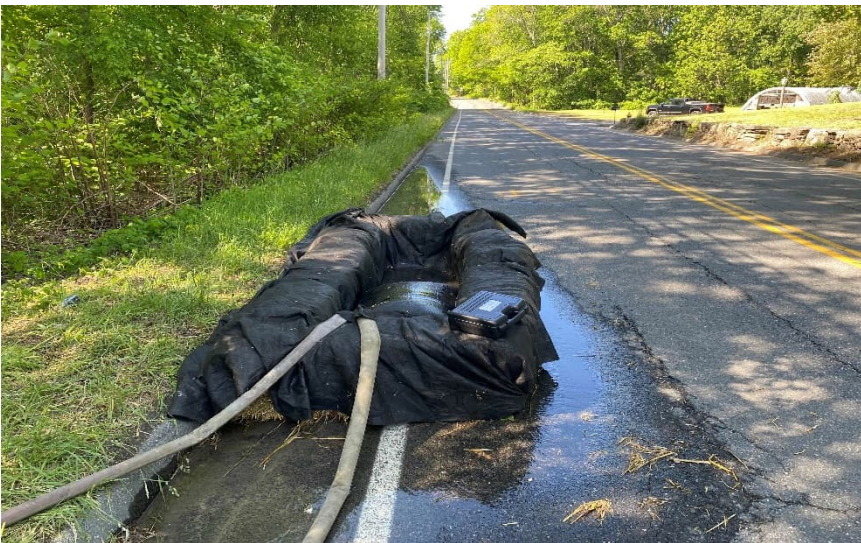
Description: MH#4. View of discharge bag/bales, looking southward. Water appeared to be clear.
