Weekly Environmental Compliance Summary

Sudbury to Hudson Transmission Reliability Project (USEPA Tracking # MAR1003UW)

Week of: May 29 to June 2, 2023

CONSTRUCTION MONITORING REPORT

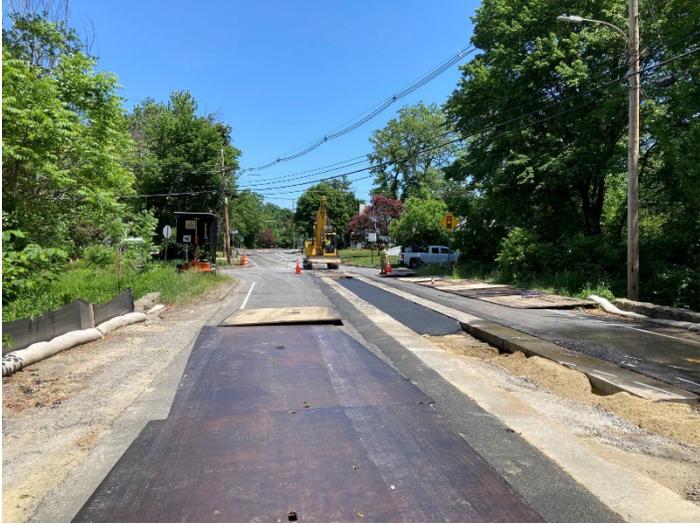
<p>PHOTOGRAPHIC LOG</p>	
<p>Client Name: Eversource</p>		<p>Site Location: Sudbury to Hudson Transmission Reliability Project</p>	<p>Town: Hudson</p>
<p>Photo No.: 1</p>	<p>Date: 5/30/2023</p>

<p>Description: View of Bond working near MH #4 on Forest Ave. Facing north.</p>

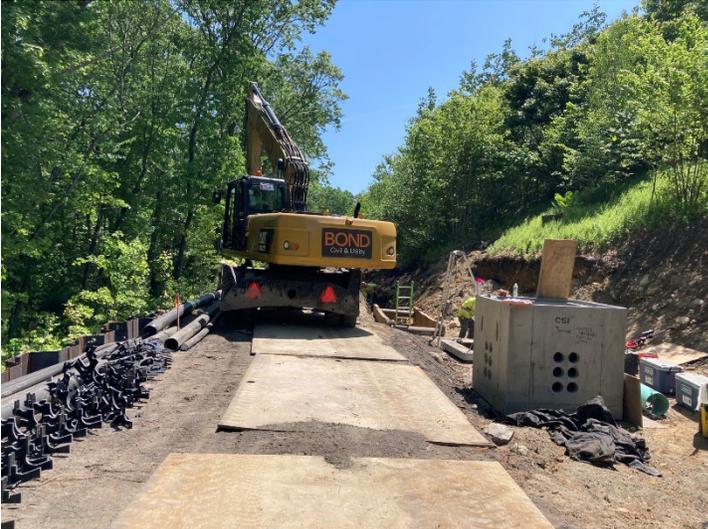
<p>PHOTOGRAPHIC LOG</p>	
<p>Client Name: Eversource</p>		<p>Site Location: Sudbury to Hudson Transmission Reliability Project</p>	<p>Town: Hudson</p>
<p>Photo No.: 2</p>	<p>Date: 5/30/2023</p>

<p>Description: View of Bond installing conduit in segment 1. Facing east.</p>

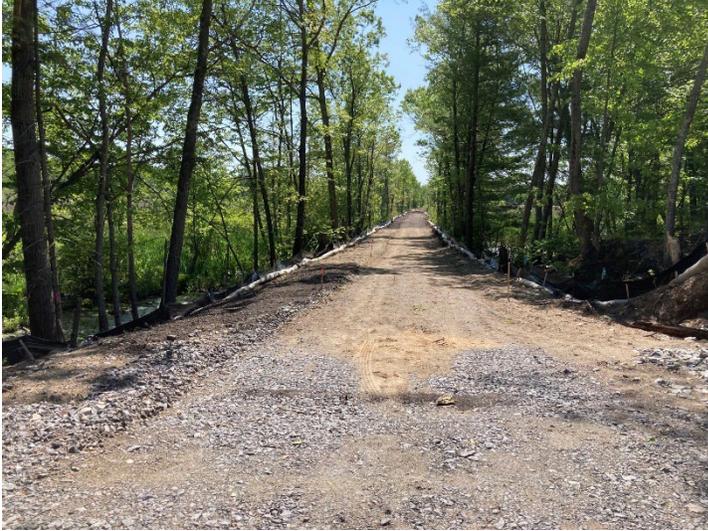
PHOTOGRAPHIC LOG	
Client Name: Eversource		Site Location: Sudbury to Hudson Transmission Reliability Project	Town: Hudson
Photo No.: 3	Date: 5/30/2023

Description: View of segment 2 from water supply road. Facing east.

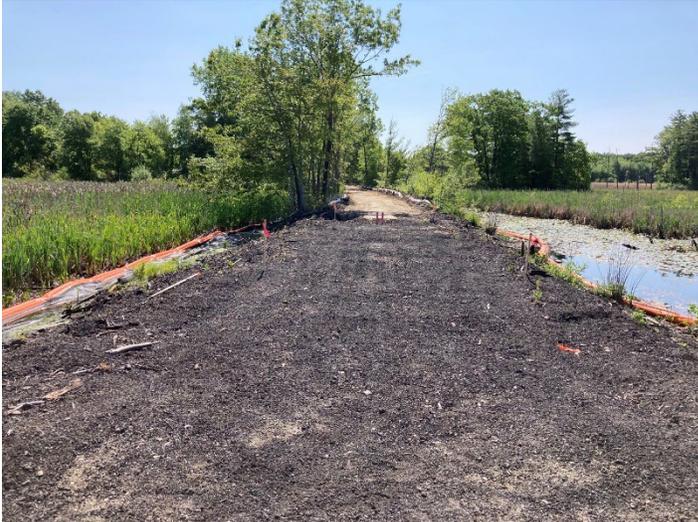
PHOTOGRAPHIC LOG	
Client Name: Eversource		Site Location: Sudbury to Hudson Transmission Reliability Project	Town: Hudson
Photo No.: 4	Date: 5/30/2023

Description: View of segment 3 from bridge 130. Facing east.

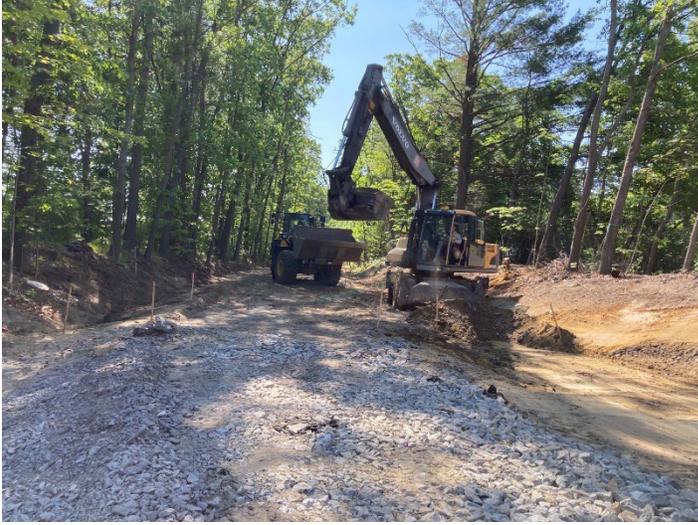
PHOTOGRAPHIC LOG	
Client Name: Eversource		Site Location: Sudbury to Hudson Transmission Reliability Project	Town: Hudson
Photo No.: 5	Date: 5/30/2023

Description: View of ET&L performing final grading activities in segment 4. Facing east.

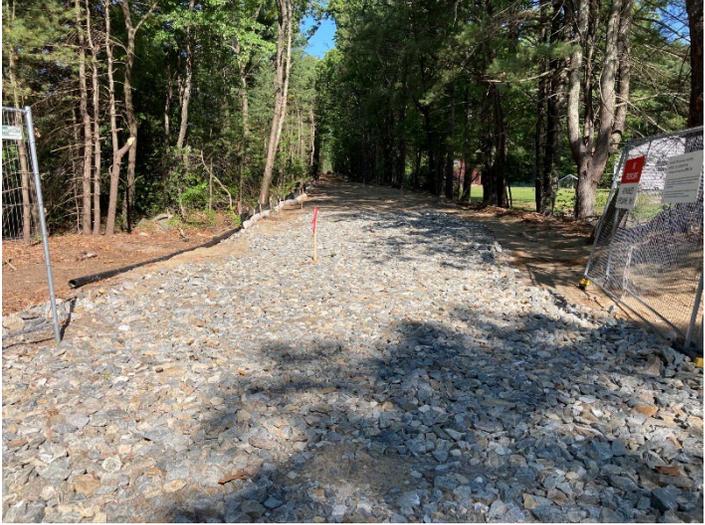
PHOTOGRAPHIC LOG	
Client Name: Eversource		Site Location: Sudbury to Hudson Transmission Reliability Project	Town: Hudson
Photo No.: 6	Date: 5/30/2023

Description: View of entrance to segment 4 at Parmenter Rd. Construction entrance pad is in good condition and operating properly. Facing west.

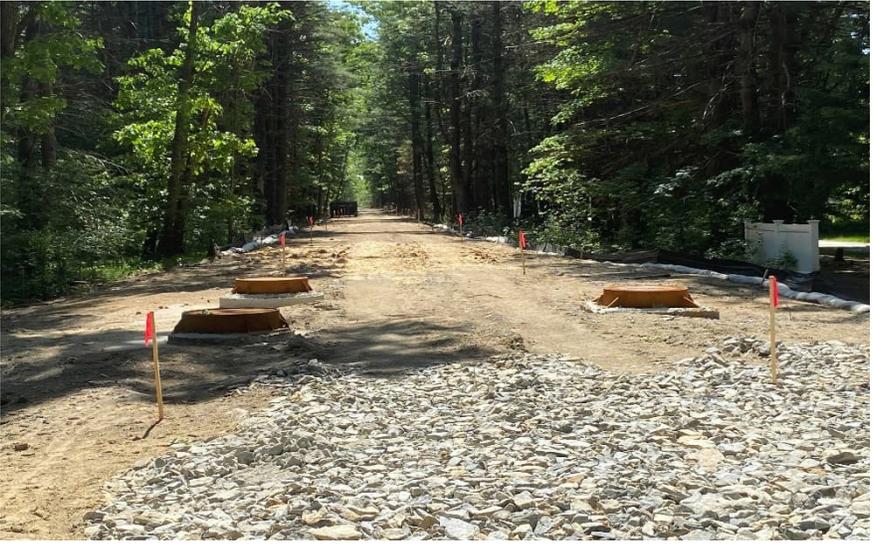
PHOTOGRAPHIC LOG	
Client Name: Eversource		Site Location: Sudbury to Hudson Transmission Reliability Project	Town: Hudson
Photo No.: 1	Date: 5-30-23

Description: Right-of-way within segment 5, manhole 11, existing erosion control, looking eastward.

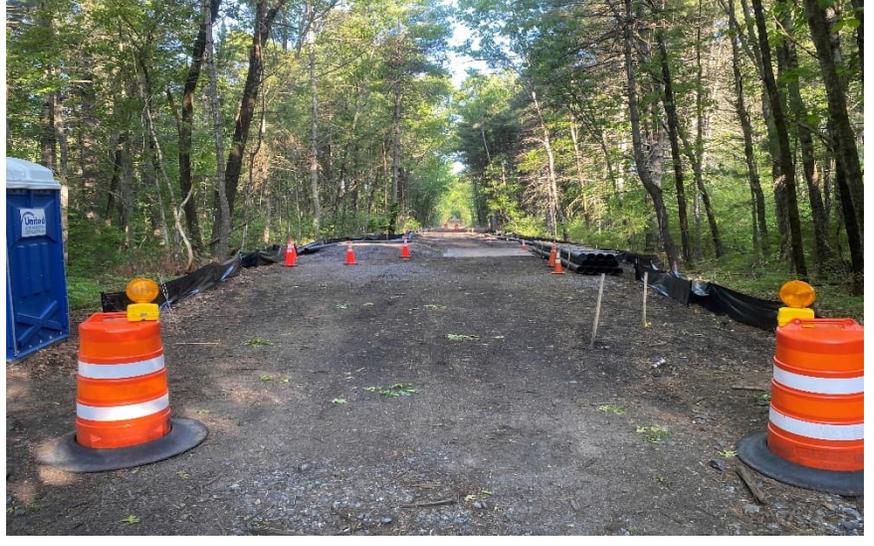
PHOTOGRAPHIC LOG	
Client Name: Eversource		Site Location: Sudbury to Hudson Transmission Reliability Project	Town: Hudson
Photo No.: 2	Date: 5-30-23

Description: Right-of-way within segment 5, existing erosion control, looking westward.

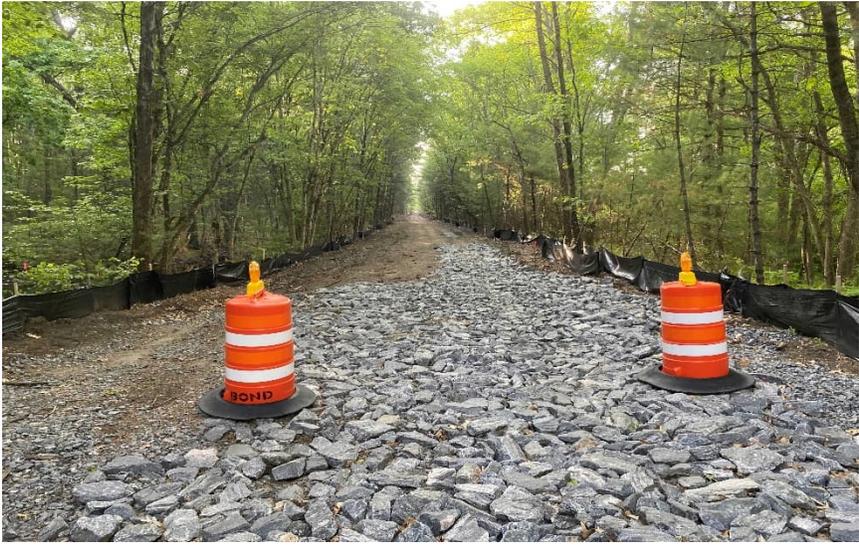
PHOTOGRAPHIC LOG	
Client Name: Eversource		Site Location: Sudbury to Hudson Transmission Reliability Project	Town: Hudson
Photo No.: 3	Date: 5-30-23

Description: Right-of-way within segment 6, existing erosion control, looking eastward.

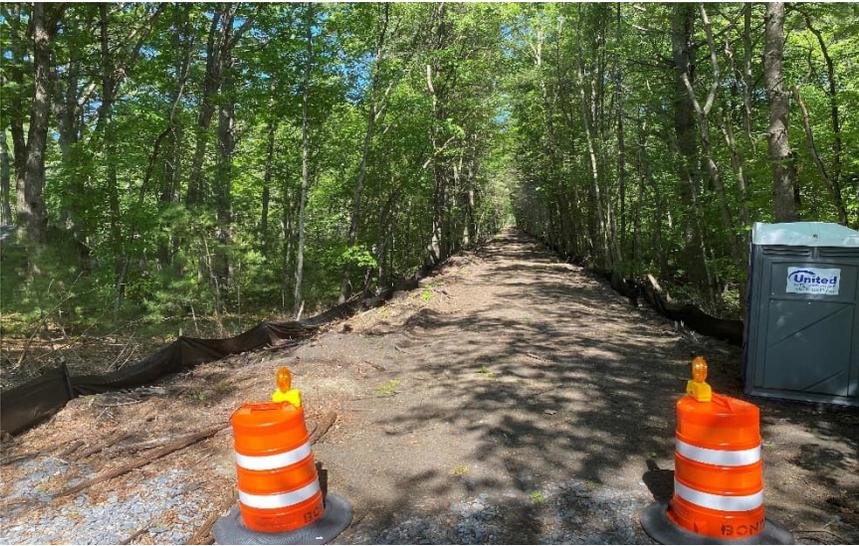
PHOTOGRAPHIC LOG	
Client Name: Eversource		Site Location: Sudbury to Hudson Transmission Reliability Project	Town: Sudbury
Photo No.: 4	Date: 5-30-23

Description: Right-of-way within Segment 9, existing erosion control, looking westward.

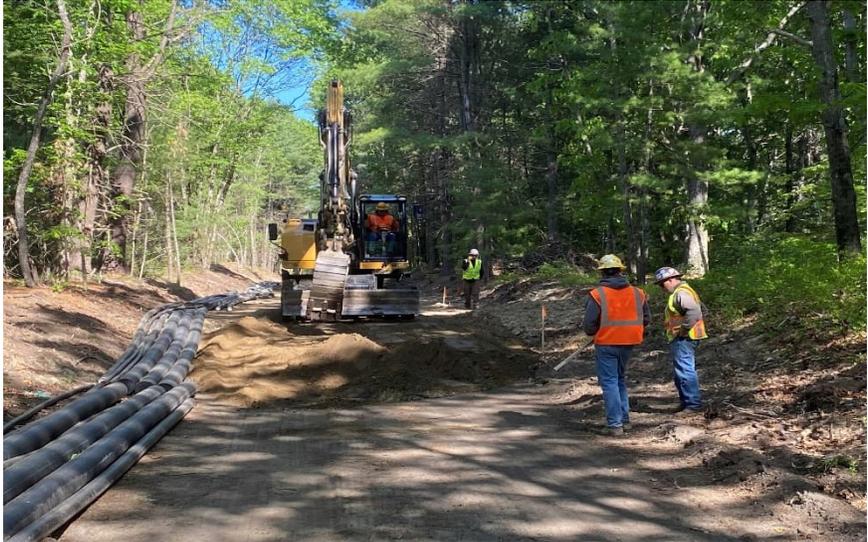
PHOTOGRAPHIC LOG	
Client Name: Eversource		Site Location: Sudbury to Hudson Transmission Reliability Project	Town: Sudbury
Photo No.: 5	Date: 5-30-23

Description: Bond conducting site work within Segment 11, looking westward.

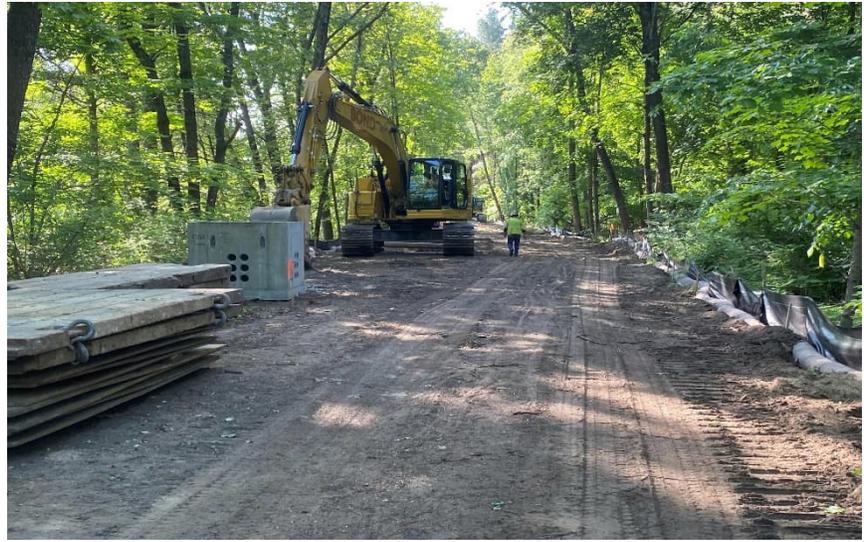
PHOTOGRAPHIC LOG	
Client Name: Eversource		Site Location: Sudbury to Hudson Transmission Reliability Project	Town: Sudbury
Photo No.: 6	Date: 5-30-23

Description: Bond conducting site work within Segment 13, at manhole #25, looking eastward.

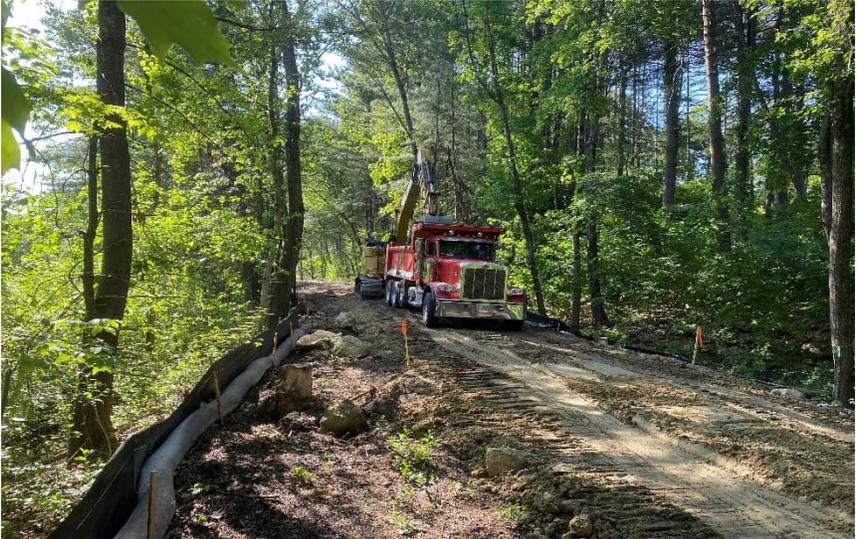
PHOTOGRAPHIC LOG	
Client Name: Eversource		Site Location: Sudbury to Hudson Transmission Reliability Project	Town: Sudbury
Photo No.: 7	Date: 5-30-23

Description: Bond conducting site work (grading cuts) within Segment 13, looking eastward.

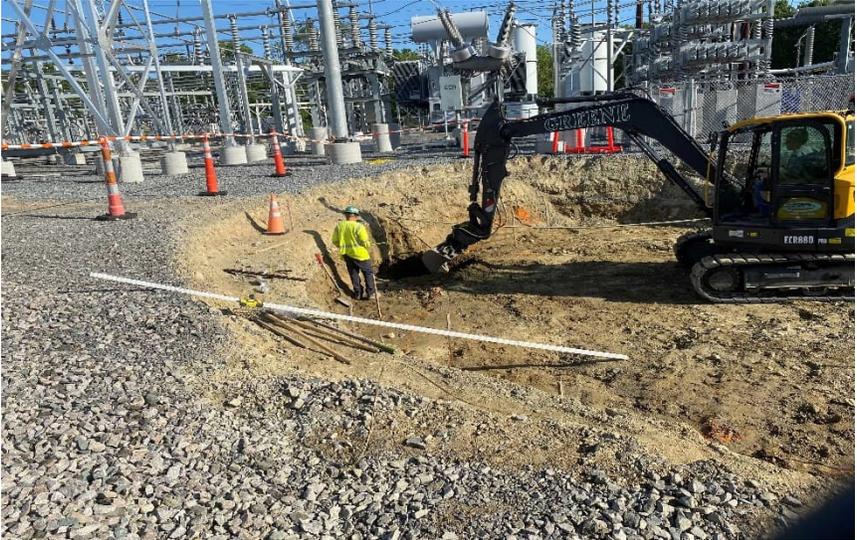
PHOTOGRAPHIC LOG	
Client Name: Eversource		Site Location: Sudbury to Hudson Transmission Reliability Project	Town: Sudbury
Photo No.: 8	Date: 5-30-23

Description: Site work (excavation) within substation, looking northward.

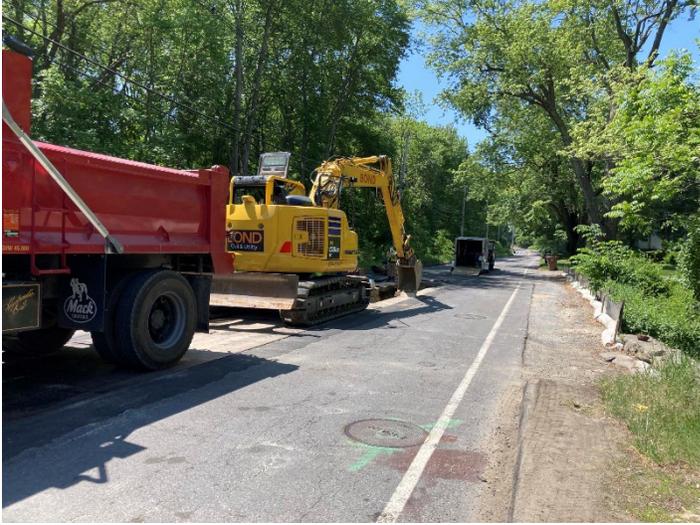
PHOTOGRAPHIC LOG	
Client Name: Eversource		Site Location: Sudbury to Hudson Transmission Reliability Project	Town: Hudson
Photo No.: 1	Date: 5/31/2023

Description: View of Bond working near MH #4 on Forest Ave. Facing south.

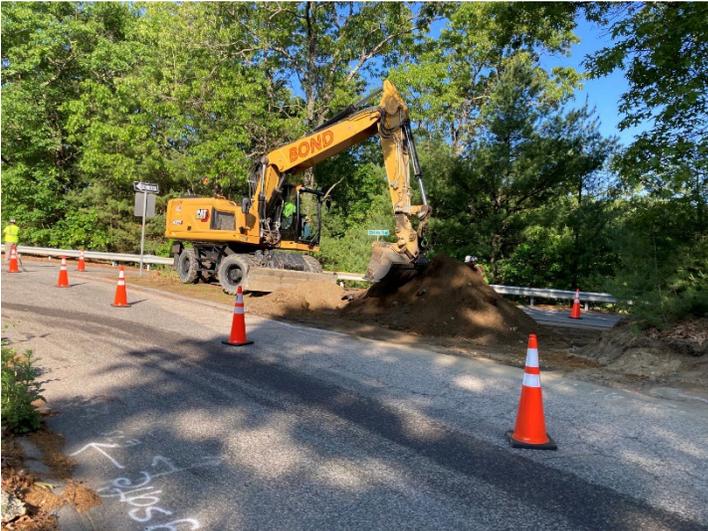
PHOTOGRAPHIC LOG	
Client Name: Eversource		Site Location: Sudbury to Hudson Transmission Reliability Project	Town: Hudson
Photo No.: 2	Date: 5/31/2023

Description: View of Bond removing "peninsula" on Chestnut St for firetruck turn around. Facing west.

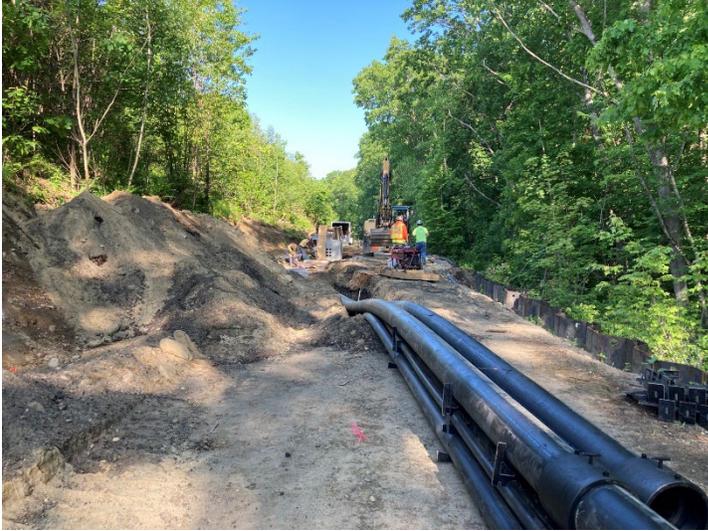
PHOTOGRAPHIC LOG	
Client Name: Eversource		Site Location: Sudbury to Hudson Transmission Reliability Project	Town: Hudson
Photo No.: 3	Date: 5/31/2023

Description: View of Bond installing conduit in segment 1. Facing west.

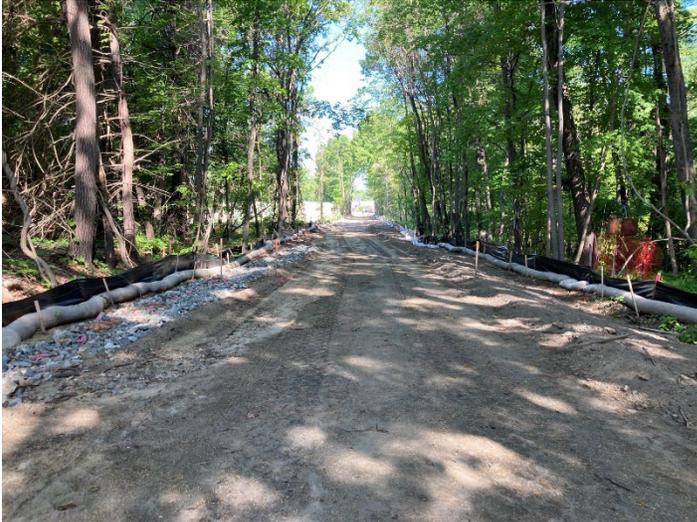
PHOTOGRAPHIC LOG	
Client Name: Eversource		Site Location: Sudbury to Hudson Transmission Reliability Project	Town: Hudson
Photo No.: 4	Date: 5/31/2023

Description: View of E&S controls in segment 3. Facing west.

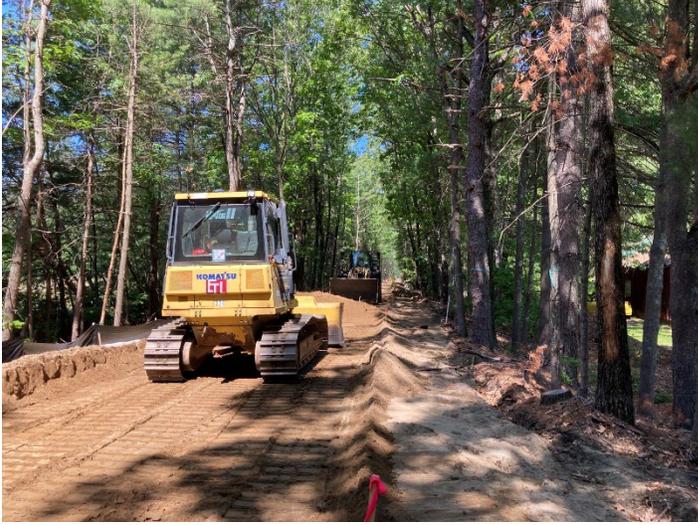
<p align="center">PHOTOGRAPHIC LOG</p>	
<p>Client Name: Eversource</p>		<p>Site Location: Sudbury to Hudson Transmission Reliability Project</p>	
<p>Photo No.: 5 Date: 5/31/2023</p>

<p>Description: View of ET&L performing final grading activities in segment 4. Facing west.</p>

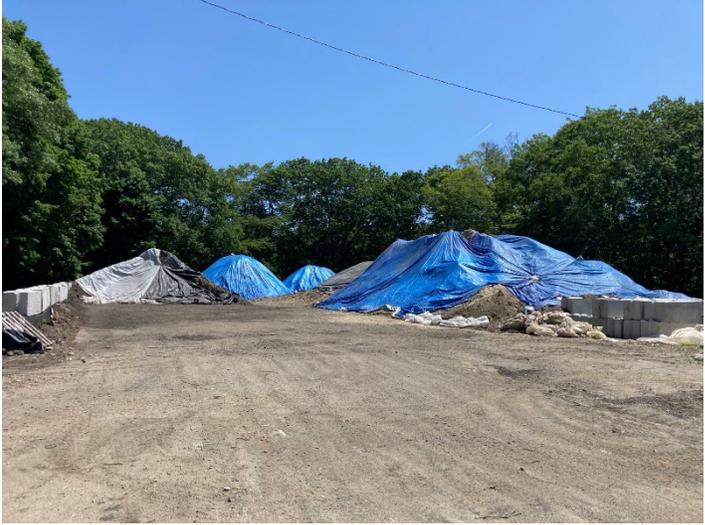
<p align="center">PHOTOGRAPHIC LOG</p>	
<p>Client Name: Eversource</p>		<p>Site Location: Sudbury to Hudson Transmission Reliability Project</p>	
<p>Photo No.: 6 Date: 5/31/2023</p>

<p>Description: View of laydown yard at Stowe Ct. Facing west.</p>

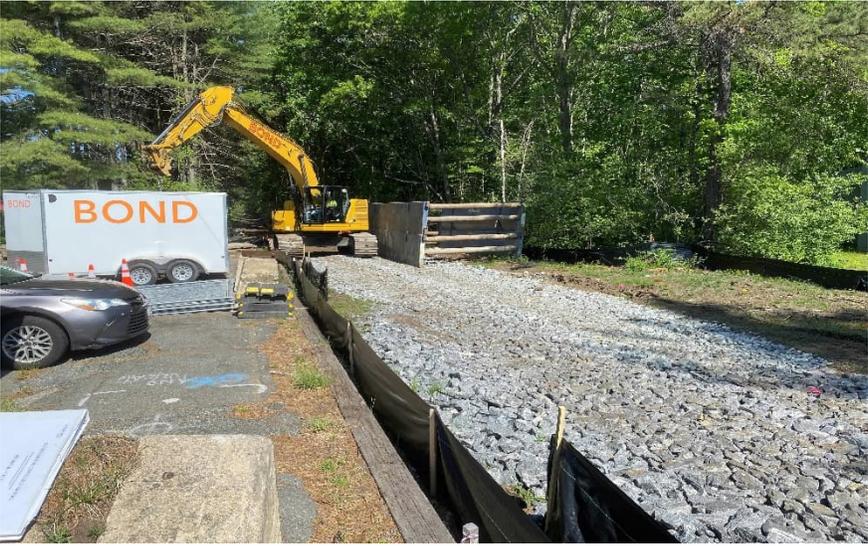
PHOTOGRAPHIC LOG	
Client Name: Eversource		Site Location: Sudbury to Hudson Transmission Reliability Project	Town: Sudbury
Photo No.: 1	Date: 5-31-23

Description: Bond mobilizing to conduct manhole #24 work within segment 11, looking westward.

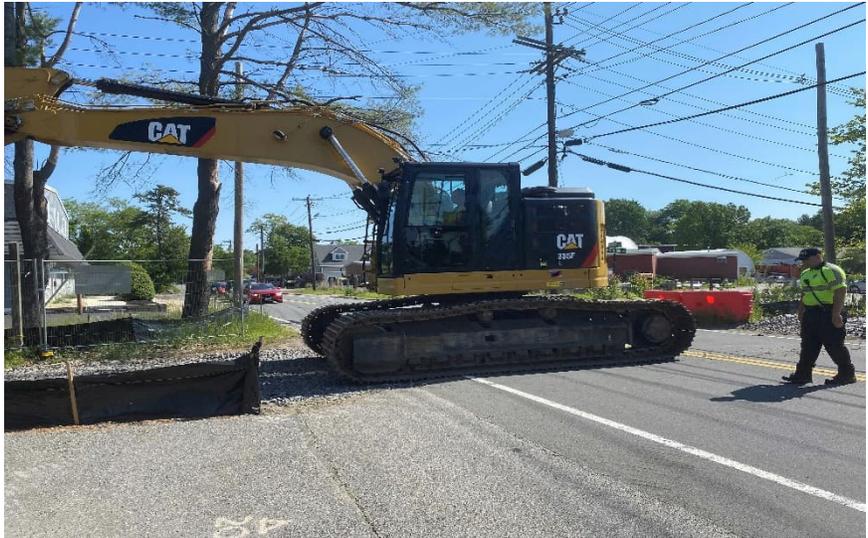
PHOTOGRAPHIC LOG	
Client Name: Eversource		Site Location: Sudbury to Hudson Transmission Reliability Project	Town: Sudbury
Photo No.: 2	Date: 5-31-23

Description: Bond moving equipment into segment 11 to work on manhole #24, looking eastward.

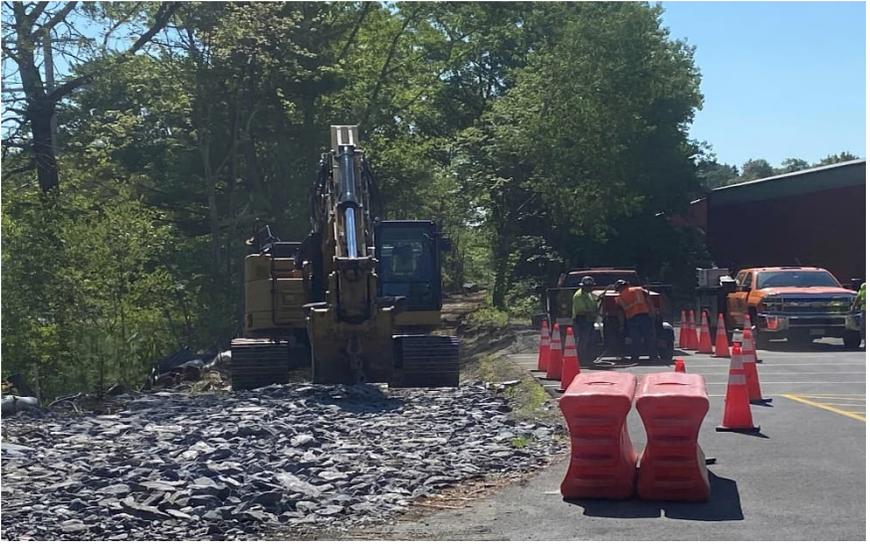
PHOTOGRAPHIC LOG	
Client Name: Eversource		Site Location: Sudbury to Hudson Transmission Reliability Project	Town: Sudbury
Photo No.: 3	Date: 5-31-23

Description: Bond cleaning equipment prior to entering segment 11, existing erosion control, looking eastward.

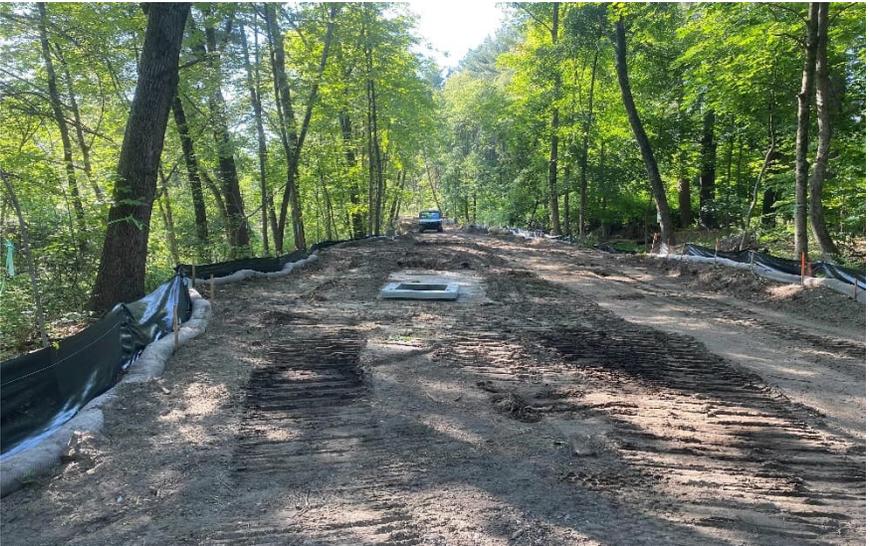
PHOTOGRAPHIC LOG	
Client Name: Eversource		Site Location: Sudbury to Hudson Transmission Reliability Project	Town: Sudbury
Photo No.: 4	Date: 5-31-23

Description: Right-of-way within Segment 13 (manhole #25), existing erosion control, looking eastward.

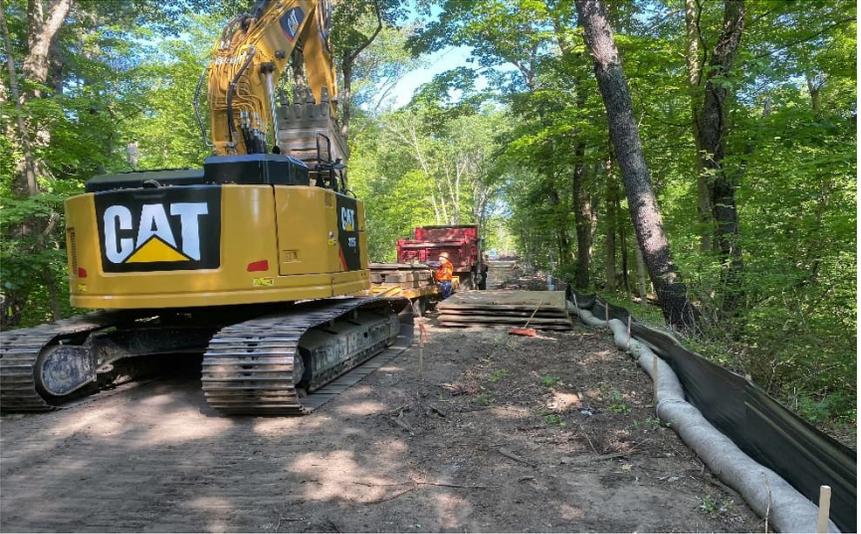
PHOTOGRAPHIC LOG	
Client Name: Eversource		Site Location: Sudbury to Hudson Transmission Reliability Project	Town: Sudbury
Photo No.: 5	Date: 5-31-23

Description: Bond de-mobing from Segment 13, looking westward.

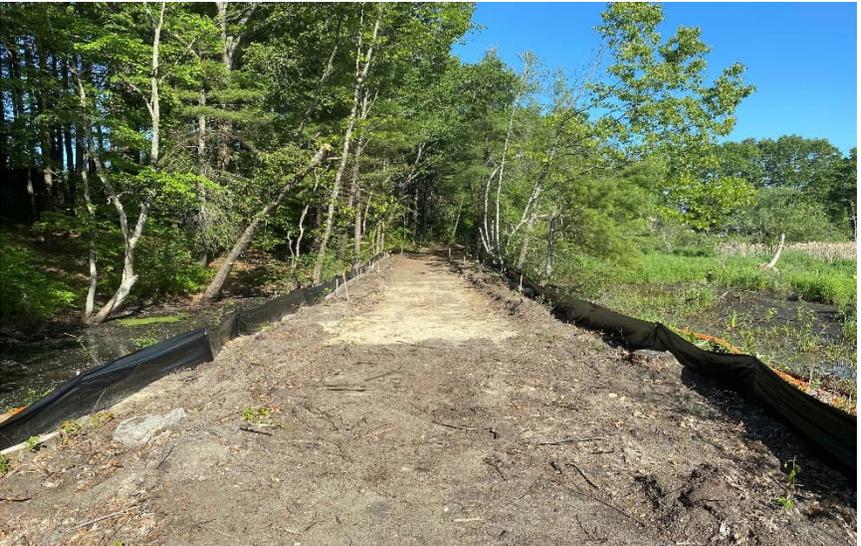
PHOTOGRAPHIC LOG	
Client Name: Eversource		Site Location: Sudbury to Hudson Transmission Reliability Project	Town: Sudbury
Photo No.: 6	Date: 5-31-23

Description: Right-of-way within Segment 13, existing erosion control, looking westward.

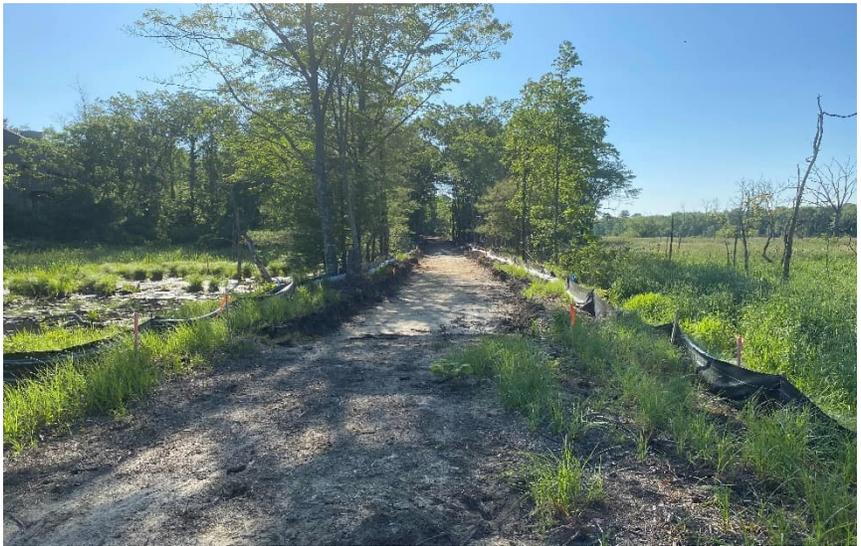
PHOTOGRAPHIC LOG	
Client Name: Eversource		Site Location: Sudbury to Hudson Transmission Reliability Project	Town: Sudbury
Photo No.: 7	Date: 5-31-23

Description: Right-of-way within Segment 14, existing erosion control, looking eastward.

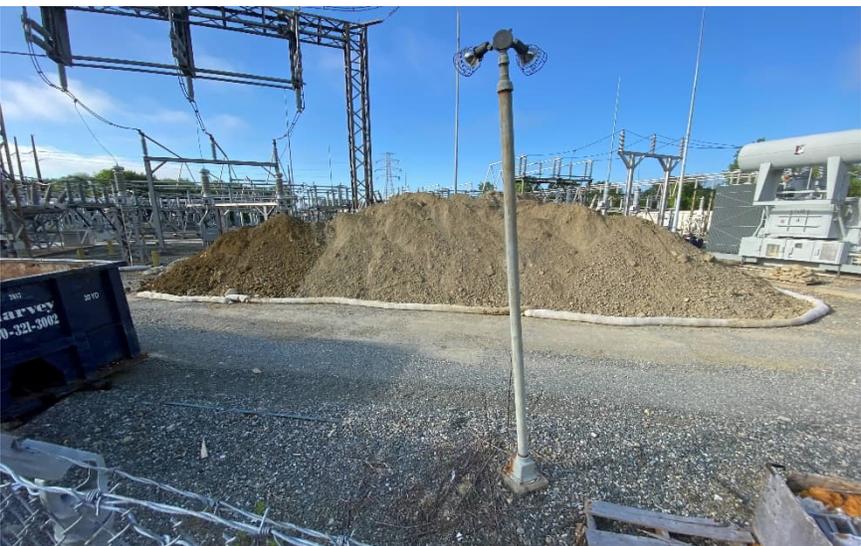
PHOTOGRAPHIC LOG	
Client Name: Eversource		Site Location: Sudbury to Hudson Transmission Reliability Project	Town: Sudbury
Photo No.: 8	Date: 5-31-23

Description: Spoil pile within substation, erosion control (compost filter tube) installed correctly & functioning properly, looking southward.

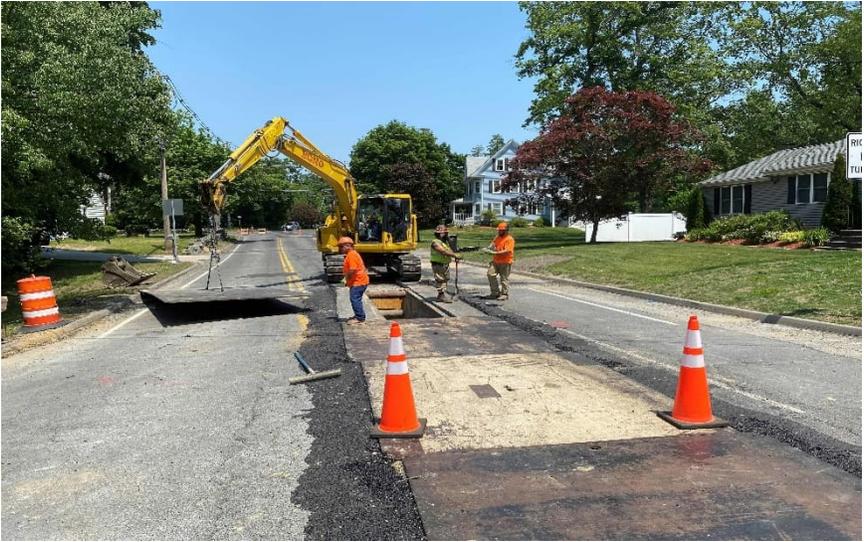
<p>PHOTOGRAPHIC LOG</p>	
<p>Client Name: Eversource</p>		<p>Site Location: Sudbury to Hudson Transmission Reliability Project</p>	<p>Town: Hudson</p>
<p>Photo No.: 1</p>	<p>Date: 6-2-23</p>

<p>Description:</p> <p>Conduit work within Forest Avenue, north of manhole #4, looking northward.</p>

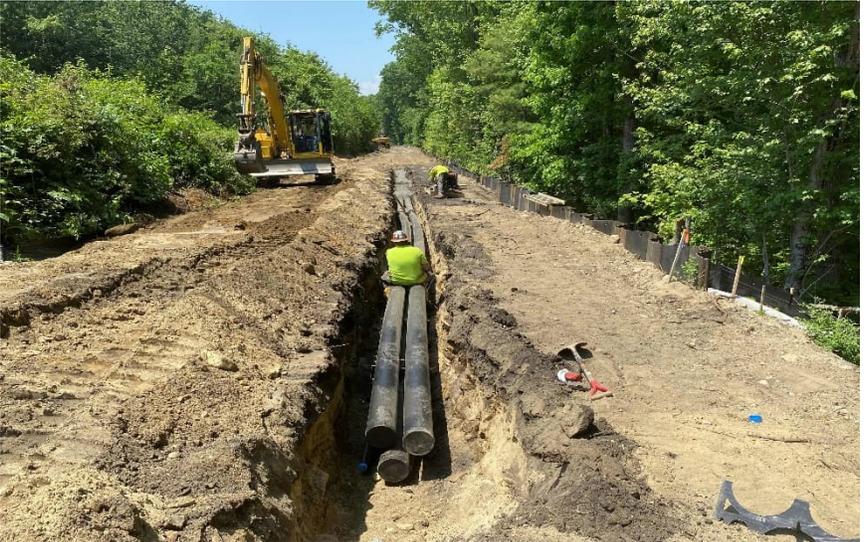
<p>PHOTOGRAPHIC LOG</p>	
<p>Client Name: Eversource</p>		<p>Site Location: Sudbury to Hudson Transmission Reliability Project</p>	<p>Town: Hudson</p>
<p>Photo No.: 2</p>	<p>Date: 6-2-23</p>

<p>Description:</p> <p>Bond conducting conduit work within Segment 1, looking westward.</p>

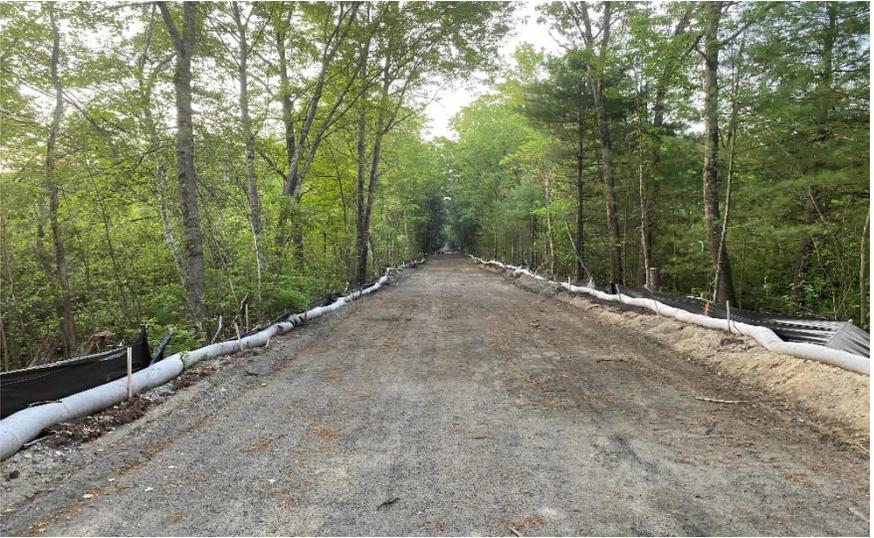
<p>PHOTOGRAPHIC LOG</p>	
<p>Client Name: Eversource</p>		<p>Site Location: Sudbury to Hudson Transmission Reliability Project</p>	<p>Town: Hudson</p>
<p>Photo No.: 3</p>	<p>Date: 6-2-23</p>

<p>Description:</p> <p>Right-of-way within segment 5, existing erosion control, looking eastward.</p>

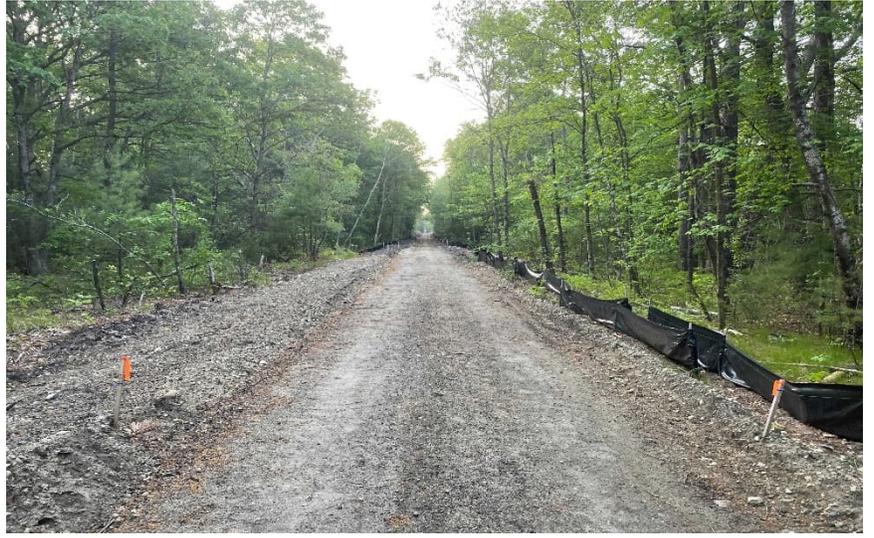
<p>PHOTOGRAPHIC LOG</p>	
<p>Client Name: Eversource</p>		<p>Site Location: Sudbury to Hudson Transmission Reliability Project</p>	<p>Town: Hudson</p>
<p>Photo No.: 4</p>	<p>Date: 6-2-23</p>

<p>Description:</p> <p>Right-of-way within segment 6, existing erosion control, looking eastward.</p>

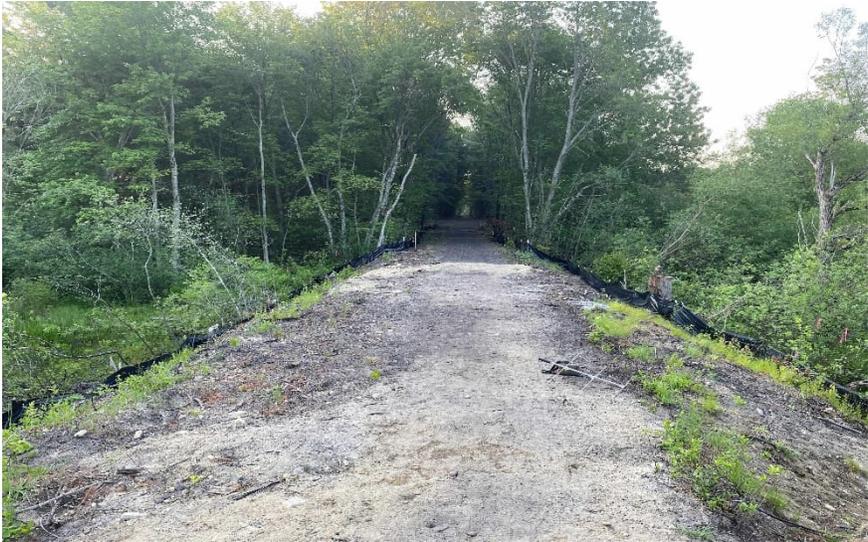
<p>PHOTOGRAPHIC LOG</p>	
<p>Client Name: Eversource</p>		<p>Site Location: Sudbury to Hudson Transmission Reliability Project</p>	<p>Town: Sudbury</p>
<p>Photo No.: 5</p>	<p>Date: 6-2-23</p>

<p>Description:</p> <p>Right-of-way within segment 8, existing erosion control, looking eastward.</p>

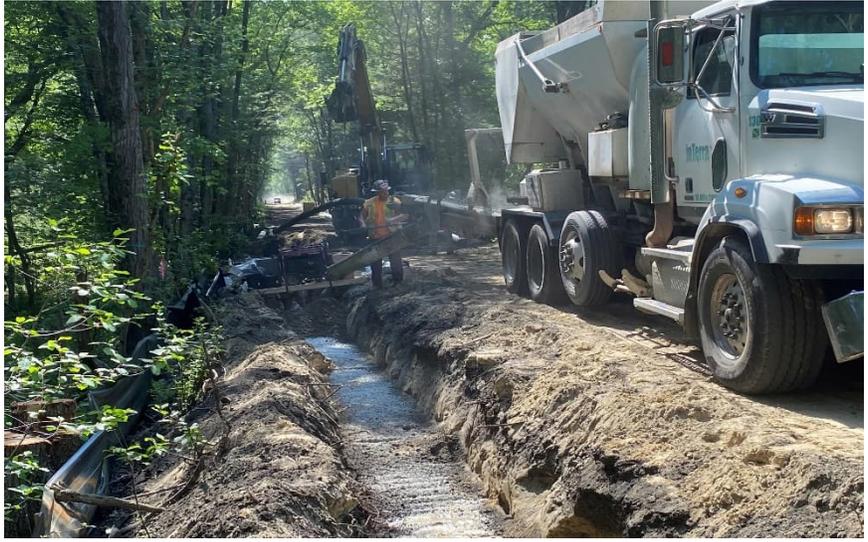
<p>PHOTOGRAPHIC LOG</p>	
<p>Client Name: Eversource</p>		<p>Site Location: Sudbury to Hudson Transmission Reliability Project</p>	<p>Town: Sudbury</p>
<p>Photo No.: 6</p>	<p>Date: 6-2-23</p>

<p>Description:</p> <p>Bond conducting conduit work within Segment 11, looking eastward.</p>

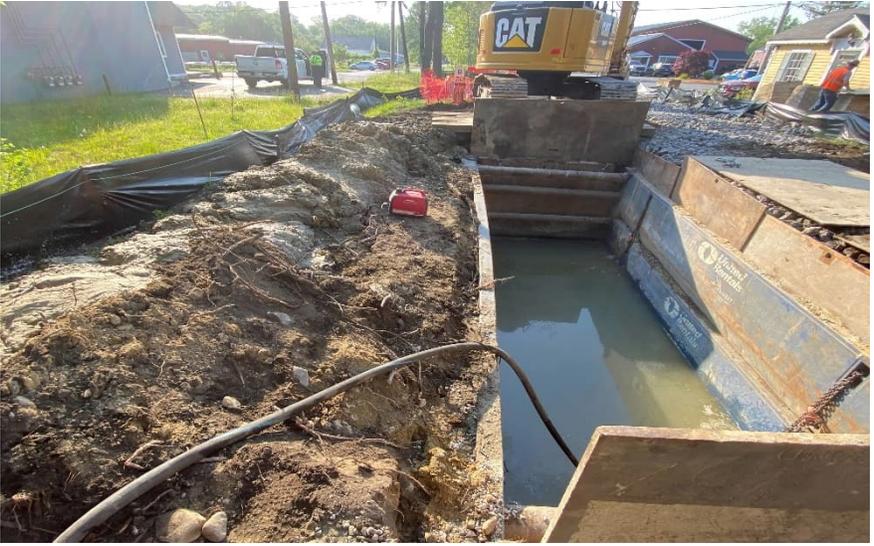
<p align="center">PHOTOGRAPHIC LOG</p>	
<p>Client Name: Eversource</p>		<p>Site Location: Sudbury to Hudson Transmission Reliability Project</p>	<p>Town: Sudbury</p>
<p>Photo No.: 7</p>	<p>Date: 6-2-23</p>

<p>Description:</p> <p>Bond conducting manhole work (dewatering) for Manhole #24, off Union Avenue, looking eastward.</p>

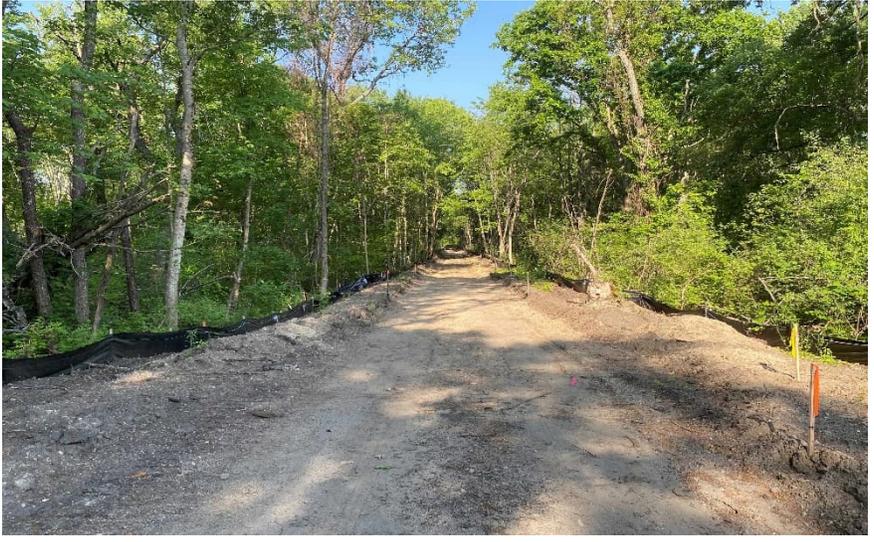
<p align="center">PHOTOGRAPHIC LOG</p>	
<p>Client Name: Eversource</p>		<p>Site Location: Sudbury to Hudson Transmission Reliability Project</p>	<p>Town: Sudbury</p>
<p>Photo No.: 8</p>	<p>Date: 6-2-23</p>

<p>Description:</p> <p>Right-of-way within segment 14, existing erosion control, looking westward.</p>

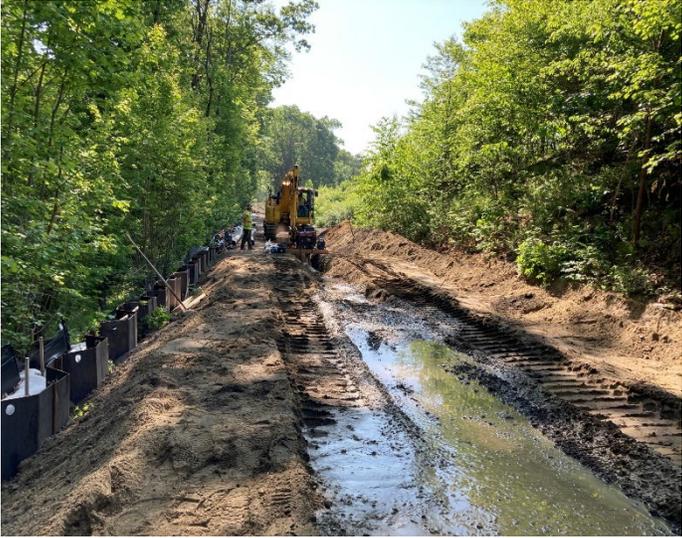
Description: View of Bond installing conduit/ductbank in segment 1. Facing east.

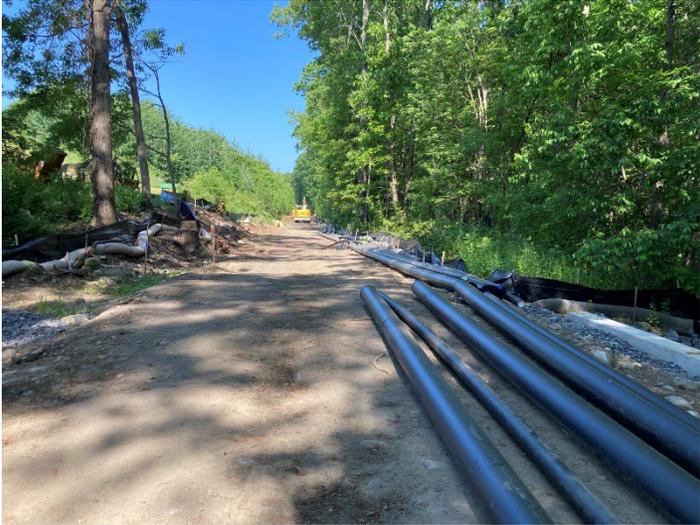
Description: View of Stow portion of project in segment 1. Facing west.

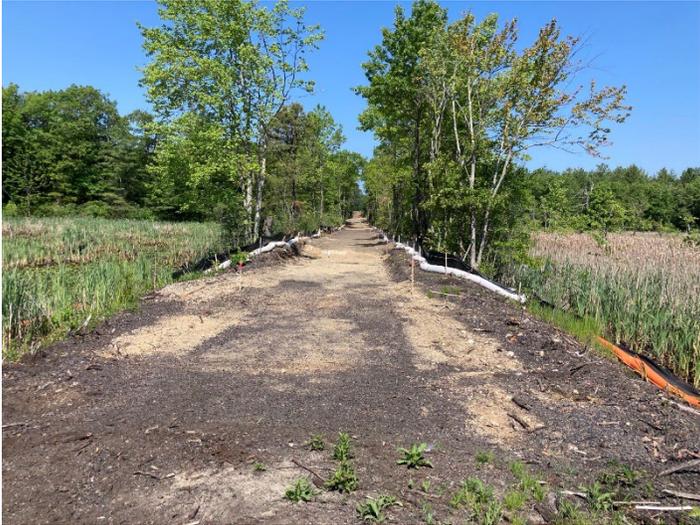
Description: View of E&S controls in segment 2 near bridge 130. Facing west.

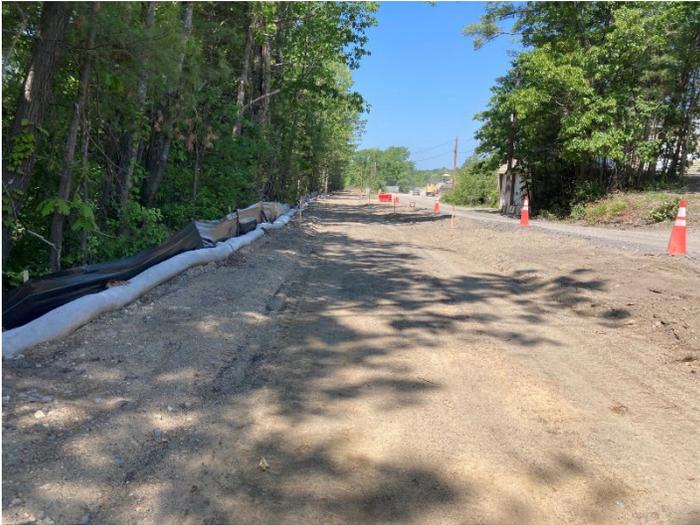
Description: View of Type A E&S controls in segment 3. Facing west.

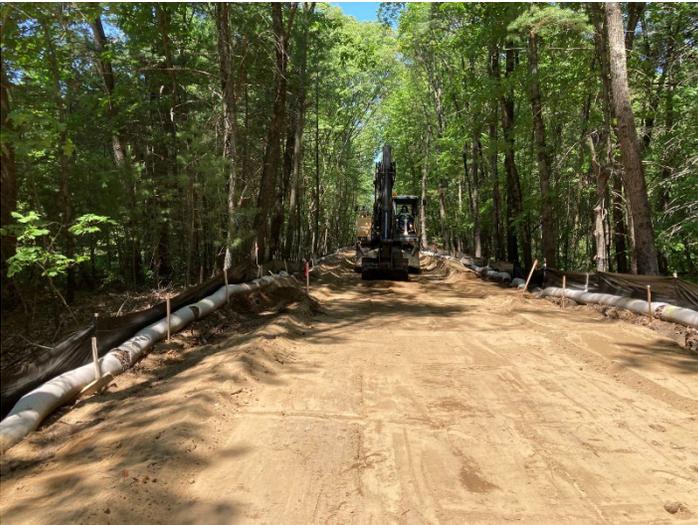
Description: View of ET&L performing final grading activities in segment 4. Facing west.

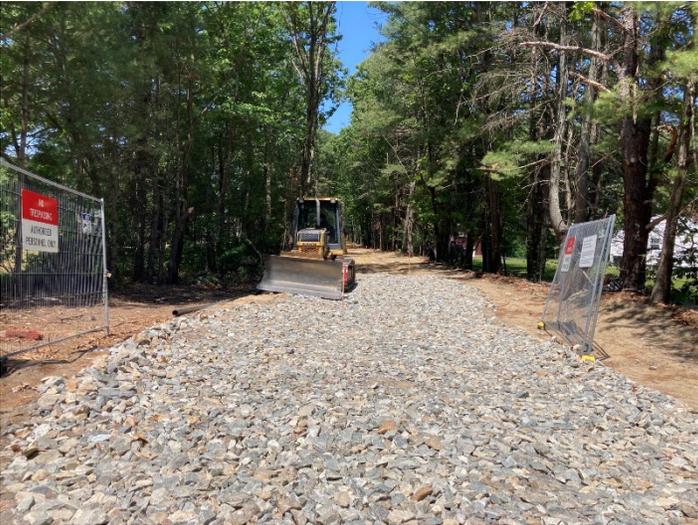
Description: View of entrance to segment 4 at Parmenter Rd. Construction entrance pad is in good condition and operating properly. Facing west.

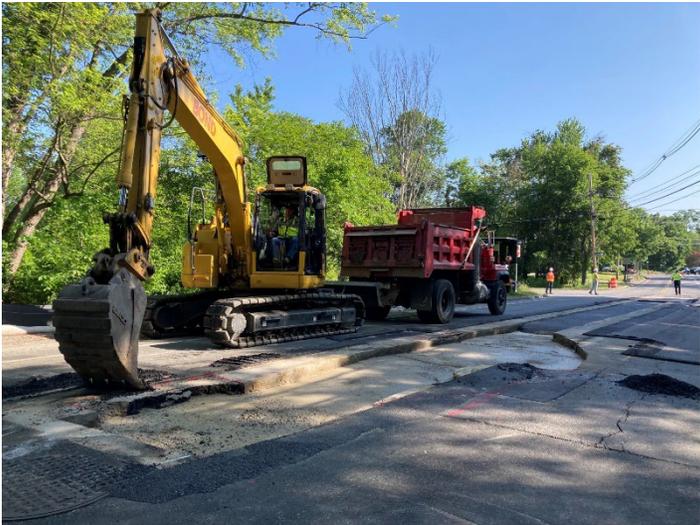
Description: View of Bond working near MH #4 on Forest Ave. Facing northwest.

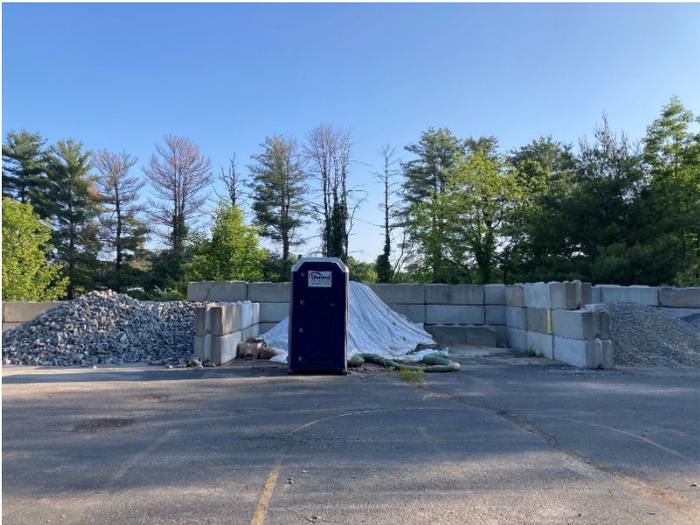
Description: View of Main St laydown yard. Facing north.

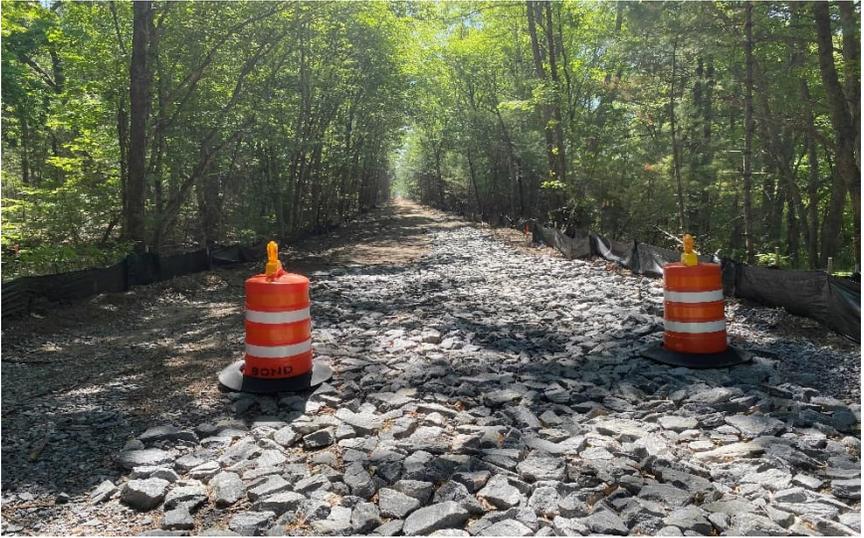
Description: Right-of-way within segment 6, existing erosion control, looking eastward.

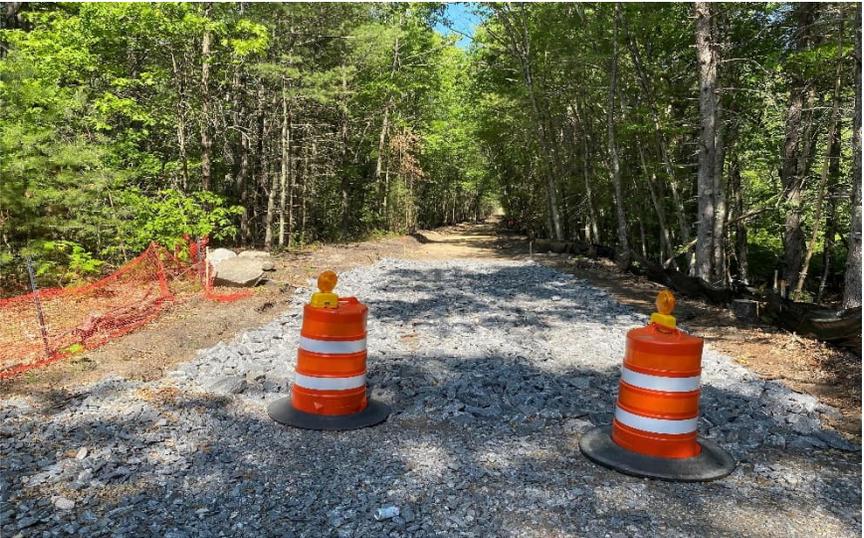
Description: Right-of-way within segment 8, existing erosion control, looking westward.

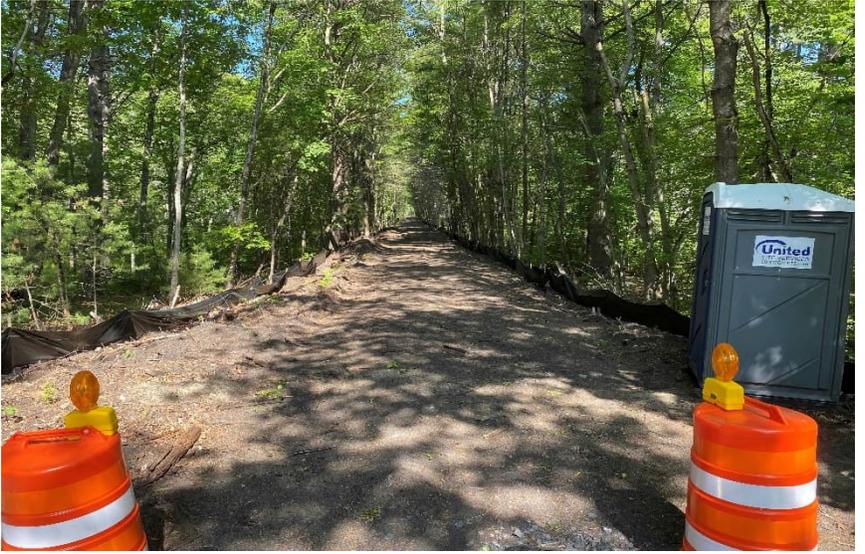
Description: Right-of-way within segment 9, existing erosion control, looking westward.
