Weekly Environmental Compliance Summary

Sudbury to Hudson Transmission Reliability Project (USEPA Tracking # MAR1003UW)

Week of: May 29 to June 2, 2023

CONSTRUCTION MONITORING REPORT

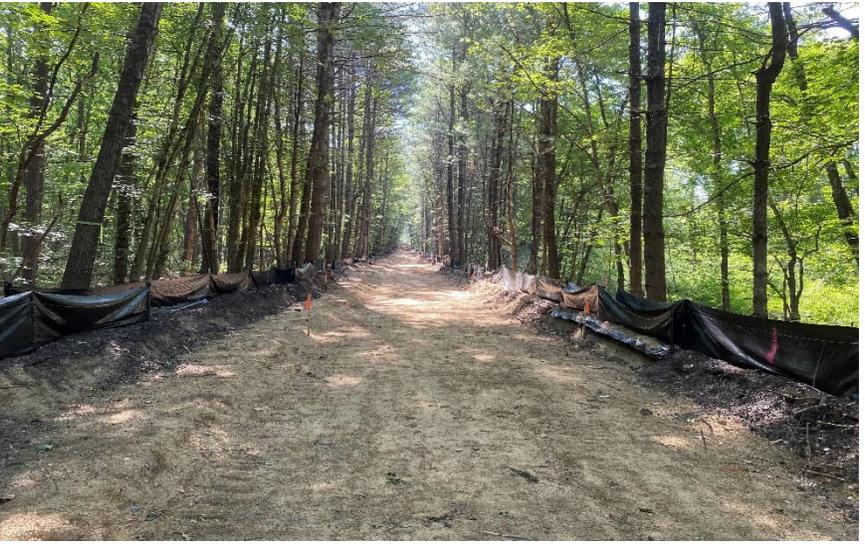
Description: Right-of-way within segment 10, existing erosion control, looking eastward.

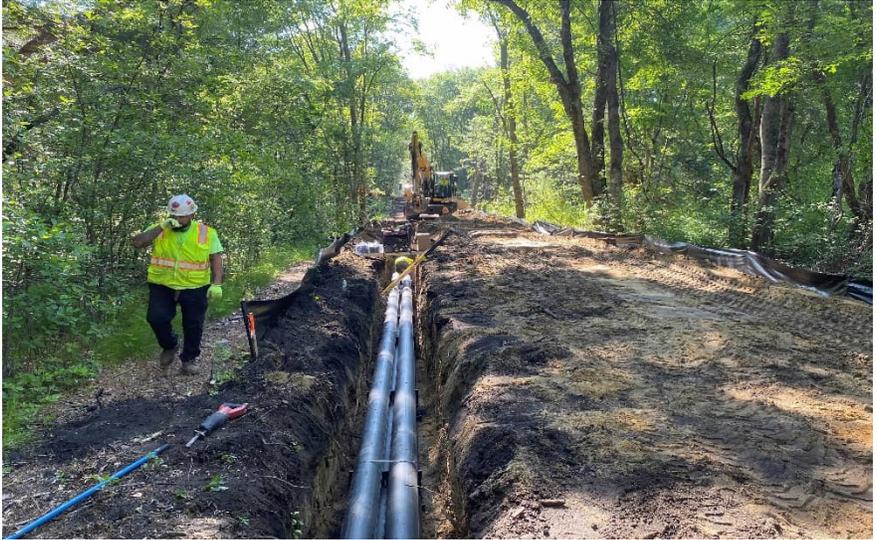
Description: Bond conducting conduit work within segment 11, looking eastward.

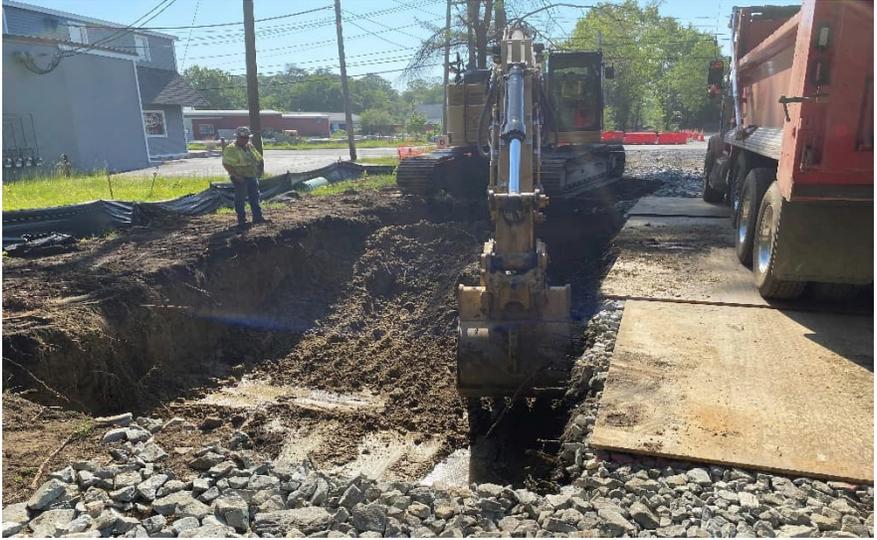
Description: Bond conducting excavation for manhole #24 within Segment 11, looking eastward.

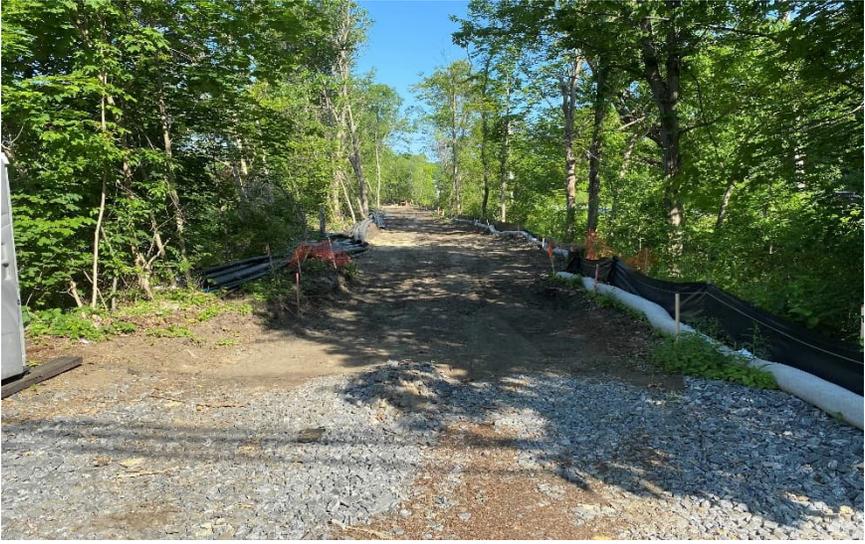
Description: Right-of-way within Segment 12, existing erosion control, looking westward.

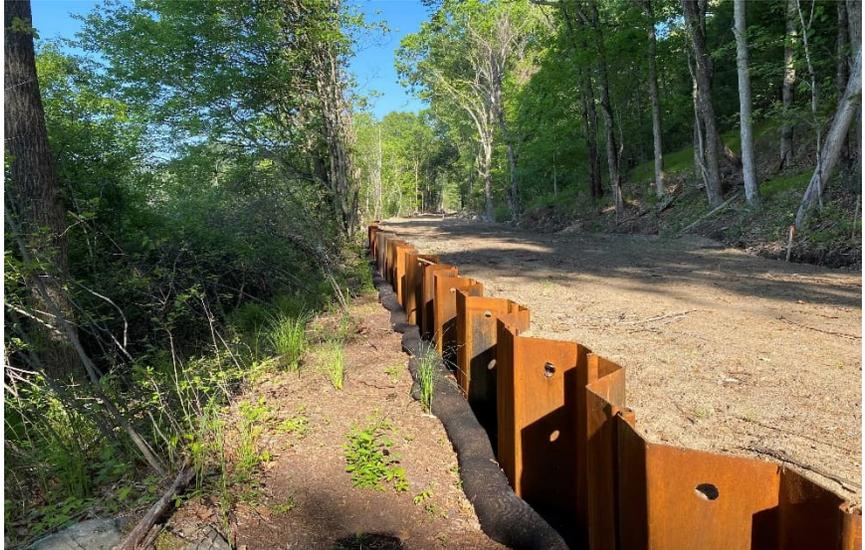
Description: New sheeting within segment 14, existing erosion control, looking westward.

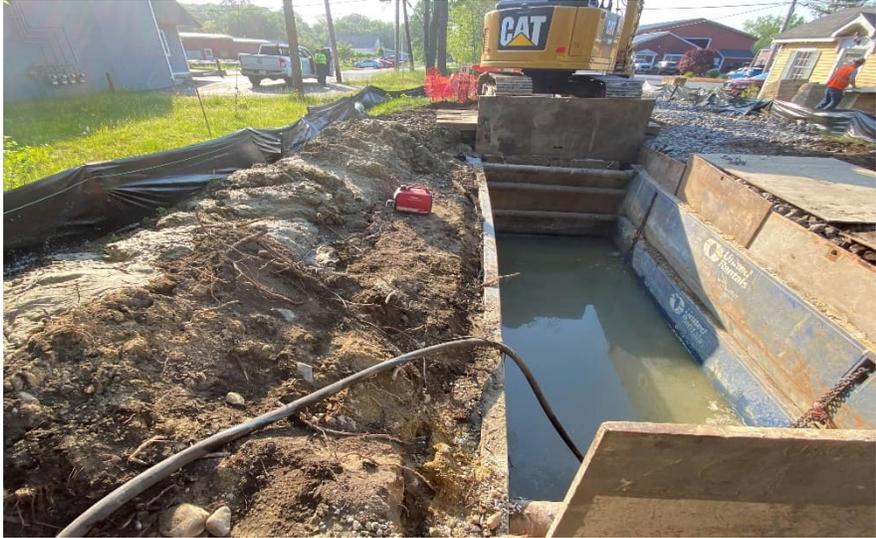
Description: View of area being pumped at work operation at MH#24, off Union Avenue, looking eastward.

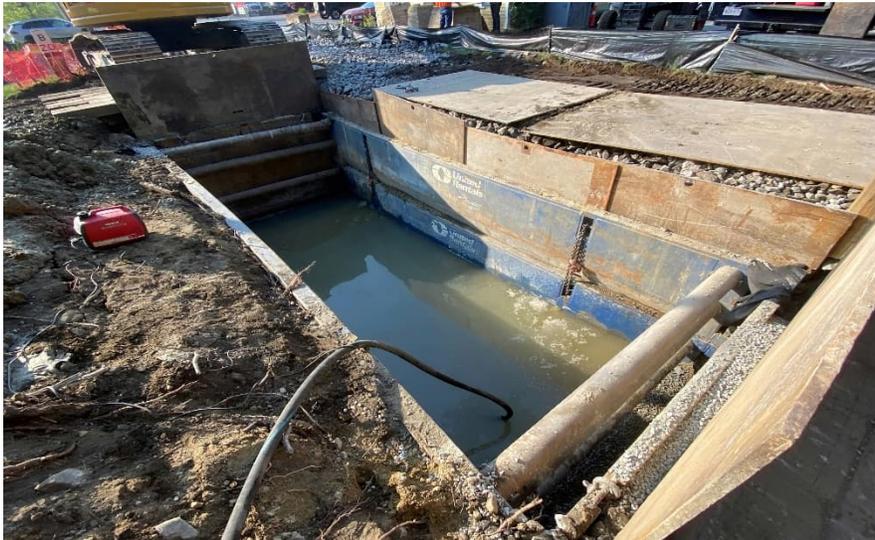
Description: View of pumping operation at MH#24. This is the location of dewatering water prior to treatment. Water appeared to be slightly turbid.

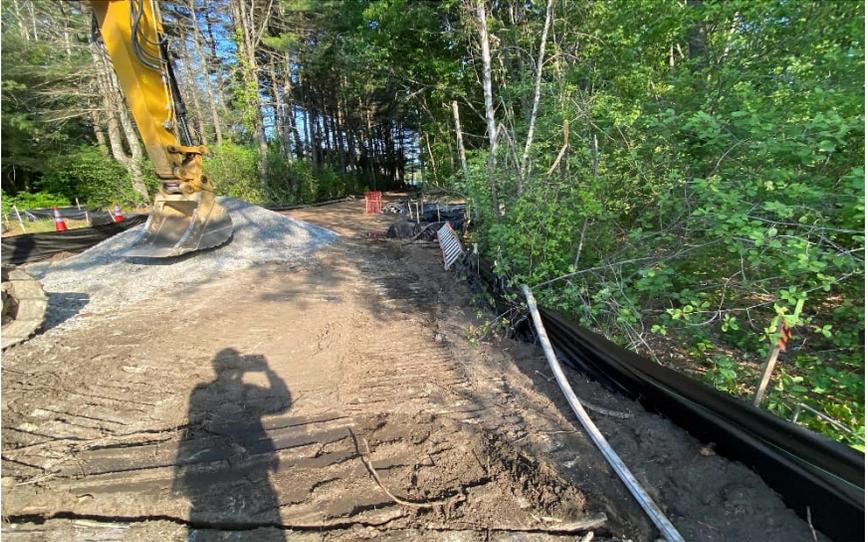
Description: MH#24. View of dewatering operation, looking westward.

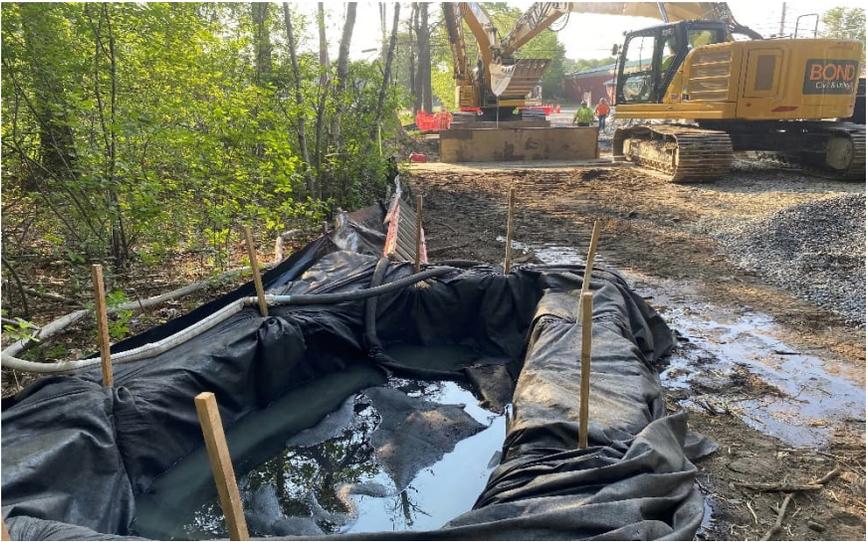
Description: MH#24. View of discharge bag/bales, looking eastward. Water appeared to be clear.
