Weekly Environmental Compliance Summary

Sudbury to Hudson Transmission Reliability Project (USEPA Tracking # MAR1003UW)

Week of: June 5 to June 9, 2023

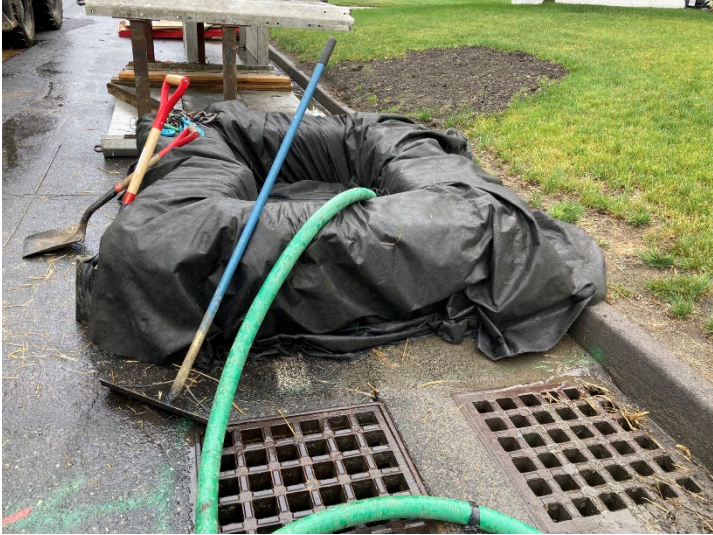
<p>PHOTOGRAPHIC LOG</p>	
<p>Client Name: Eversource</p>		<p>Site Location: Sudbury to Hudson Transmission Reliability Project</p>	<p>Town: Hudson</p>
<p>Photo No.: 3</p>	<p>Date: 6/05/2023</p>

<p>Description: View of dewatering controls near MH #4 on Forest Ave. See additional dewatering inspection report. Facing north.</p>

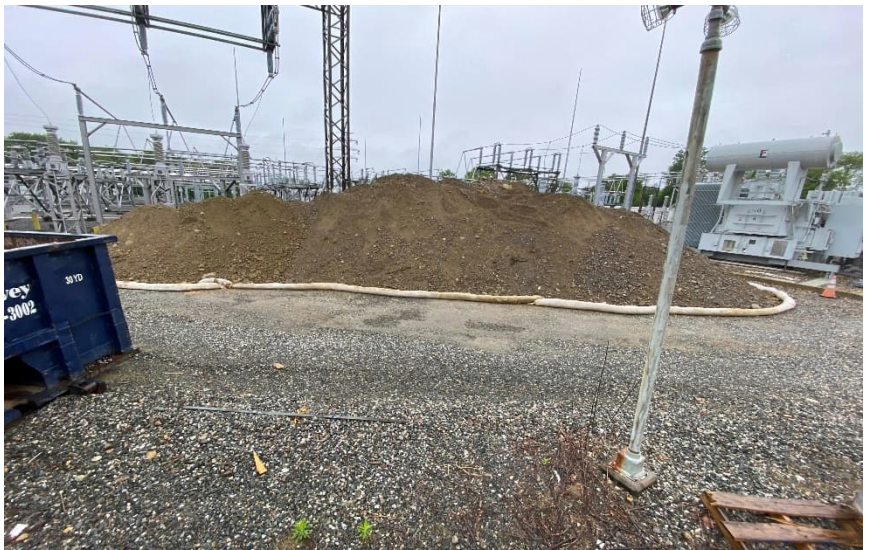
PHOTOGRAPHIC LOG	
Client Name: Eversource		Site Location: Sudbury to Hudson Transmission Reliability Project	Town: Sudbury
Photo No.: 8	Date: 6-5-23

Description: Spoil pile within substation, erosion control (compost filter tube) installed correctly & functioning properly, looking southward.

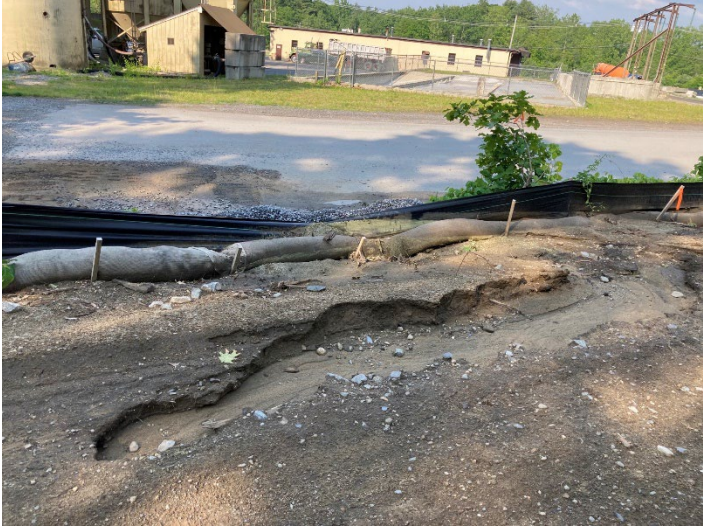
PHOTOGRAPHIC LOG	
Client Name: Eversource		Site Location: Sudbury to Hudson Transmission Reliability Project	Town: Hudson
Photo No.: 5	Date: 6/07/2023

-As noted on reports in the past, stormwater from adjacent property flows onto project ROW in segment 3 during heavy rains. During this week's rains, stormwater flow from adjacent property eroded exposed soils and overwhelmed E&S controls at approximately Sta. #173 rt. Stormwater flow and sediment impacted adjacent property. Adjacent property owner made repairs to their property immediately, but repairs are needed on project ROW. Eversource CM was contacted and plan is being developed to control stormwater flow and stabilize this area.

Description: View of erosion and overwhelmed E&S controls at approximately Sta. #173 rt in segment 3. Facing south.

- Repairs are needed to E&S controls at approximately Sta. #173 rt in segment 3. See comments below.**
-
-

-ET&L assessed eroded exposed soils and overwhelmed E&S controls at approximately Sta. #173 rt in segment 3. Repairs are scheduled to begin tomorrow (6/09/2023).

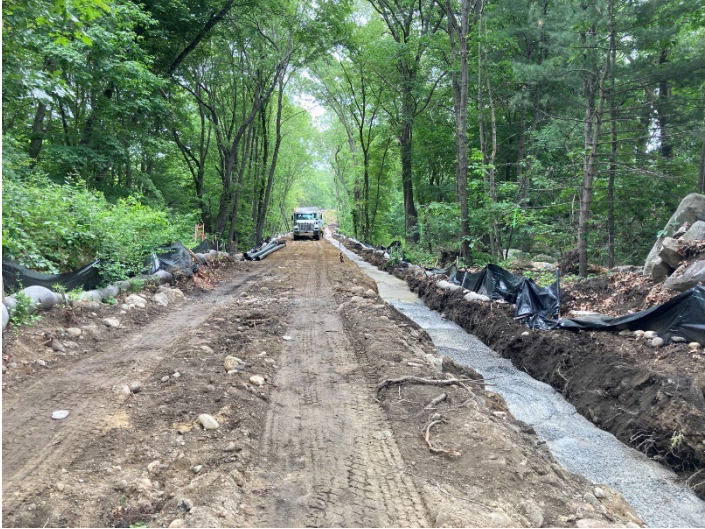
Description: Additional view of Bond's work area in segment 1. Repairs to E&S controls needed along this segment (routine maintenance). Facing east.

-Repairs to E&S controls are needed in segment 1 (routine maintenance). Repairs are scheduled for tomorrow (6/09/2023).

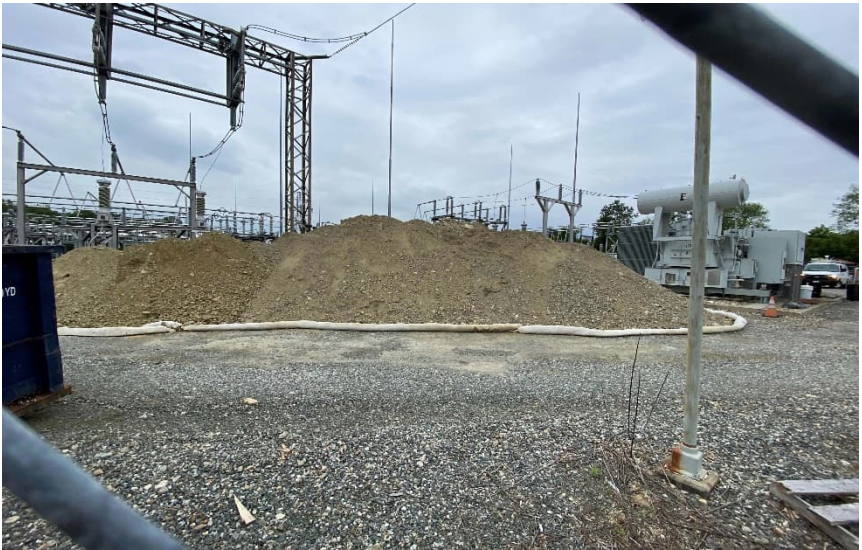
Description: Spoil pile within Sudbury Substation, compound filter tubes installed and functioning correctly, looking westward.

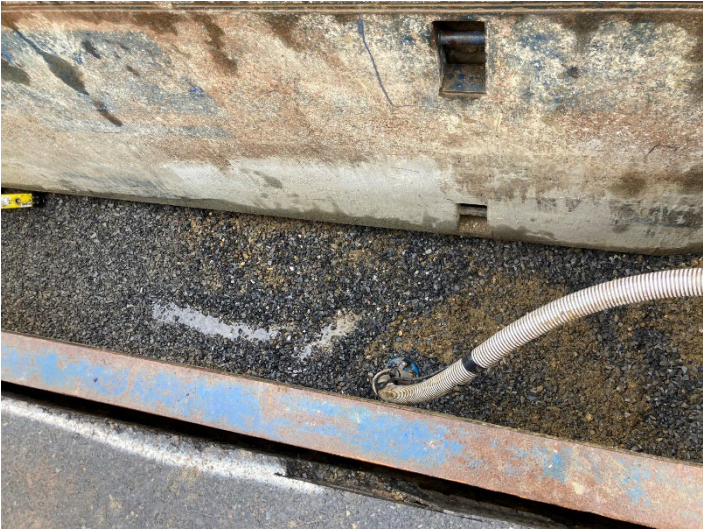
Description: View of dewatering water in trench prior to treatment.

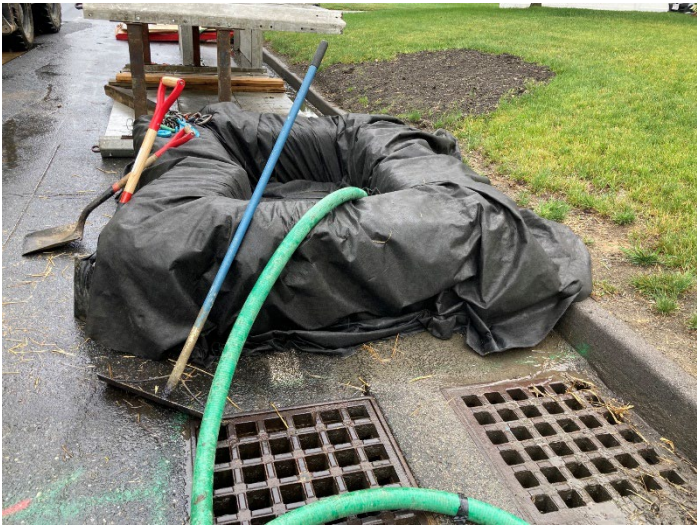
Photo No.: 4	Date: 6/05/2023		
Description: View dewatering controls and discharge point from project (catch basins below hay bale corral on Forest Ave). Discharge appeared slightly turbid. Turbidity reading was higher than 50 NTUs. Facing north.

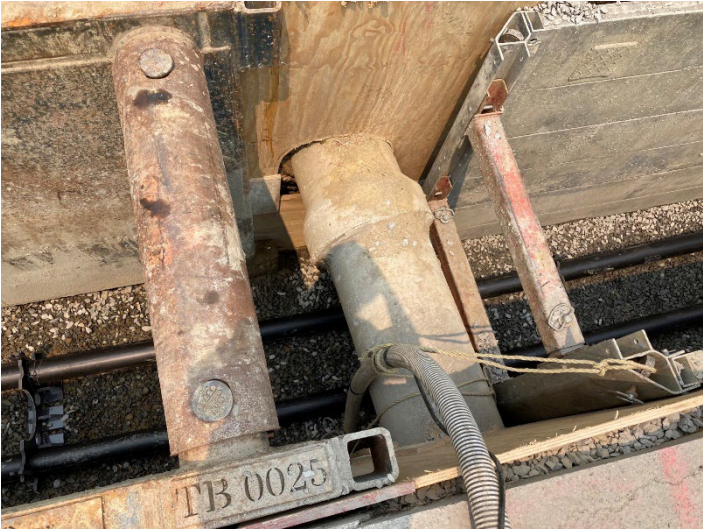
Description: View of trench. Unable to visualize water prior to treatment.
