Weekly Environmental Compliance Summary

Sudbury to Hudson Transmission Reliability Project (USEPA Tracking # MAR1003UW)

Week of: June 12 to June 16, 2023

CONSTRUCTION MONITORING REPORT

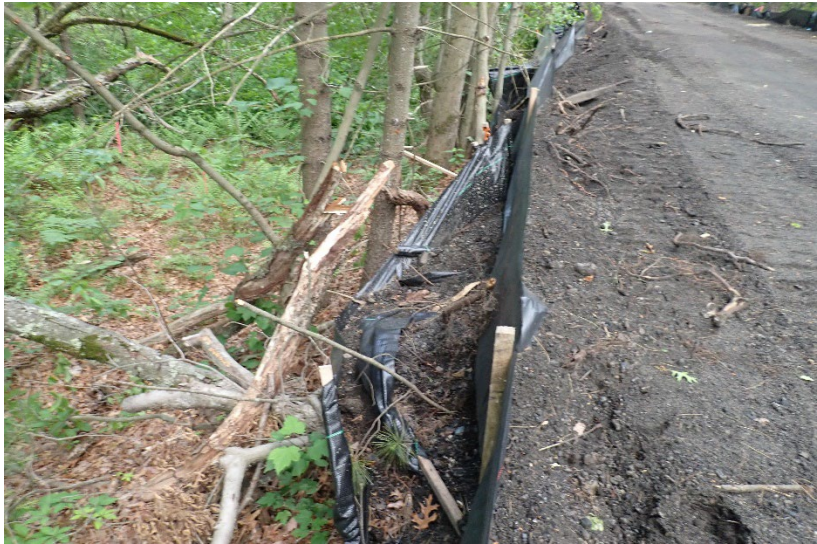
PHOTOGRAPHIC LOG	
Client Name: Eversource		Site Location: Sudbury to Hudson Transmission Reliability Project	Town: Sudbury
Photo No.: 4	Date: 6-12-23

Due to heavy rain on Friday (6/9), a small amount of sediment washed past the silt fence in segment 11, at the northern wetland closest to Horse Pond Road Entrance. Sediment is in the upland, with the wetland located downgradient. Some portions of the silt fence were observed to be leaning from the pressure of the buildup sediment behind it. Crews are aware of this issue and will be addressing the washed-out sediment and silt fencing. (New Routine Maintenance).

Description: View of sediment, located within segment 11, washed out during the rain on Friday past the first silt fence. Secondary silt fence is leaning under the pressure of the built-up sediment. Crews were notified of the issue. Facing eastward.

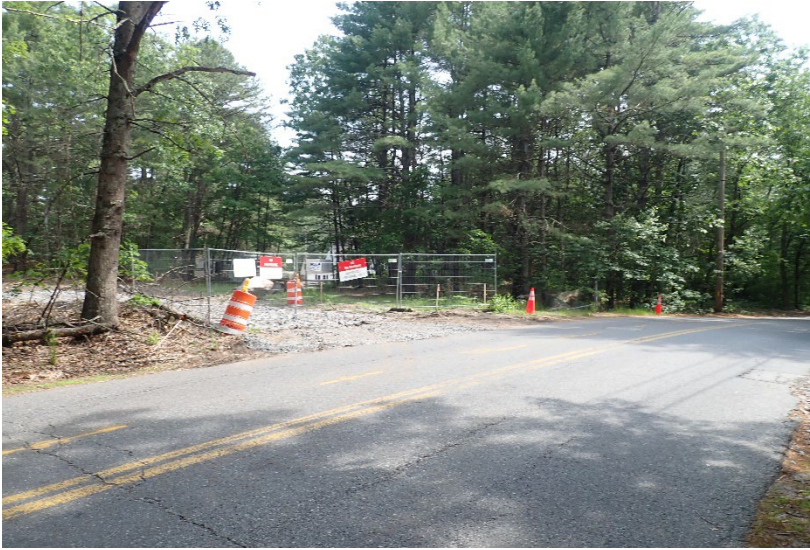
PHOTOGRAPHIC LOG	
Client Name: Eversource		Site Location: Sudbury to Hudson Transmission Reliability Project	Town: Sudbury
Photo No.: 6	Date: 6-12-23

Description: View of construction entrance to segment 9. No sediment tracking observed within roadway. Looking southeast.

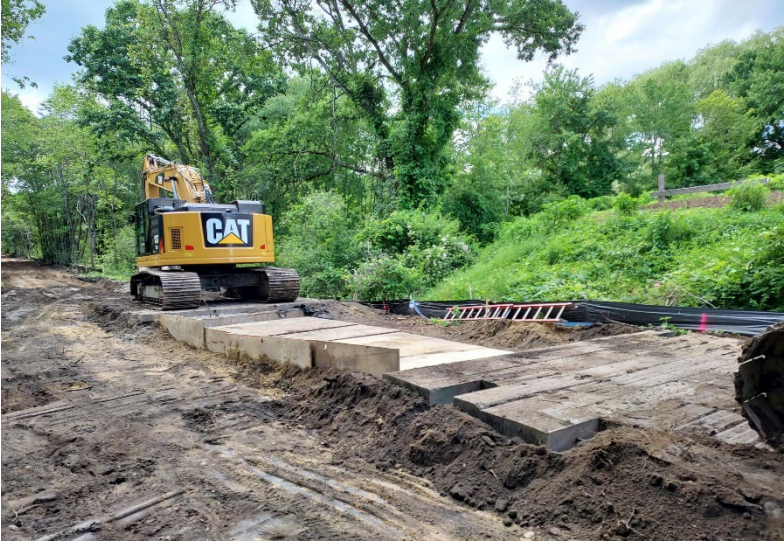
PHOTOGRAPHIC LOG	
Client Name: Eversource		Site Location: Sudbury to Hudson Transmission Reliability Project	
Town: Sudbury			
Photo No.: 1	Date: 6-13-23

Description: View of manhole 27 work and erosion controls within Segment 14. Controls are in good condition. Facing westward.

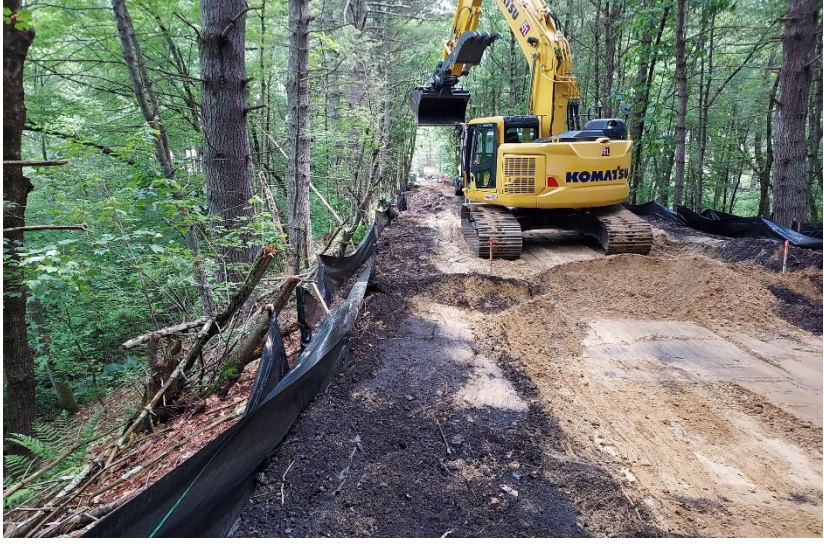
PHOTOGRAPHIC LOG	
Client Name: Eversource		Site Location: Sudbury to Hudson Transmission Reliability Project	
Town: Sudbury			
Photo No.: 2	Date: 6-13-23

Description: View of ET&L conducting grading work within segment 9. Silt fence is in good condition. Facing eastward.

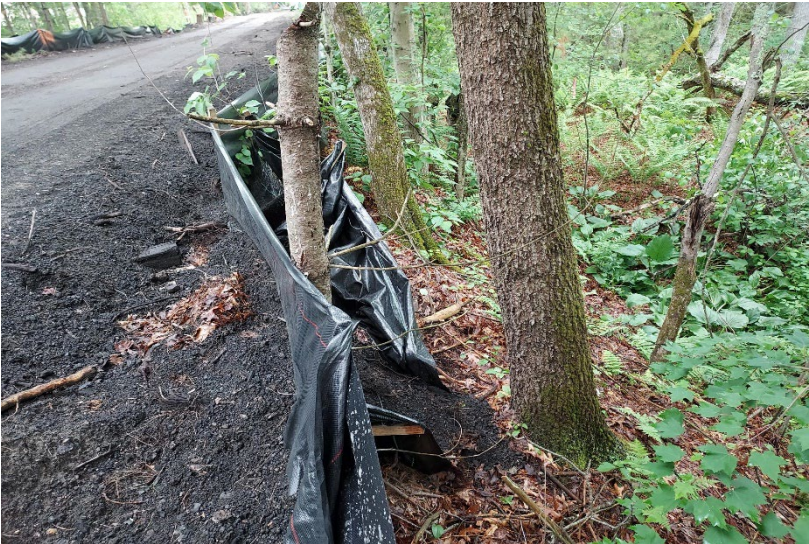
PHOTOGRAPHIC LOG	
Client Name: Eversource		Site Location: Sudbury to Hudson Transmission Reliability Project	Town: Sudbury
Photo No.: 4	Date: 6-13-23

Due to heavy rain on Friday (6/9), a small amount of sediment washed past the silt fence in segment 11, at the northern wetland closest to Horse Pond Road Entrance. Sediment is in the upland, with the wetland located downgradient. Some portions of the silt fence were observed to be leaning from the pressure of the buildup sediment behind it. Crews are aware of this issue and will be addressing the washed-out sediment and silt fencing. (Routine Maintenance).

Description: View of sediment, located within segment 11, washed out during the rain on Friday past the silt fence. Crews were notified of the issue. Facing westward.

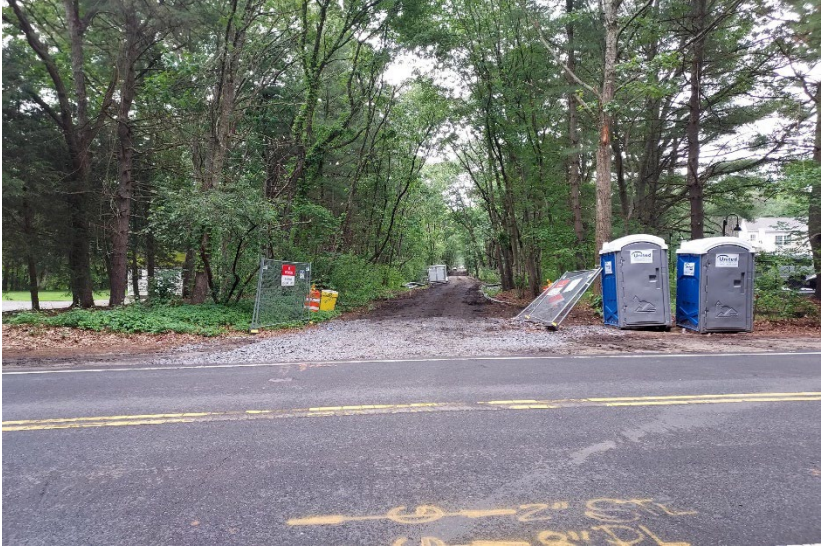
PHOTOGRAPHIC LOG	
Client Name: Eversource		Site Location: Sudbury to Hudson Transmission Reliability Project	Town: Sudbury
Photo No.: 6	Date: 6-13-23

Description: View of construction entrance to segment 11. No sediment tracking observed within roadway. Facing eastward.

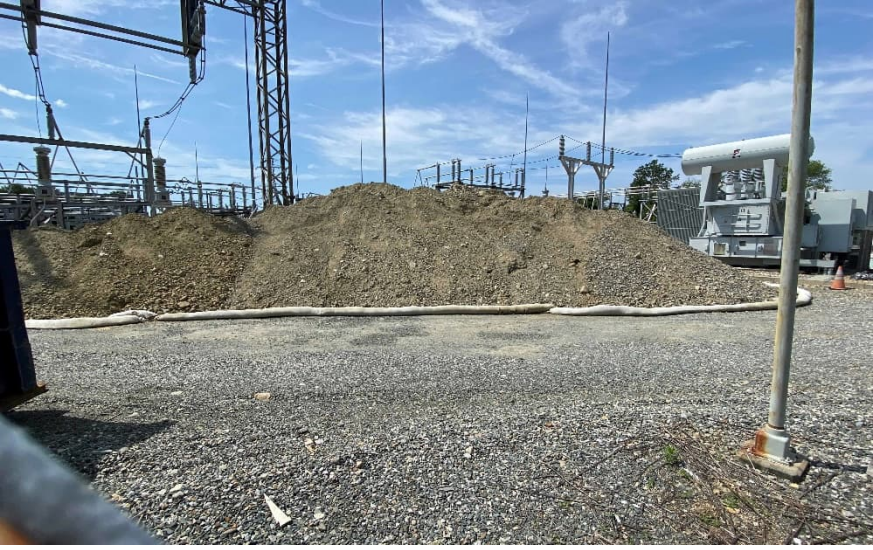
<p>Description:</p> <p>Spoil pile at Sudbury Substation, existing tubes (erosion control) installed & functioning correctly, looking southward.</p>

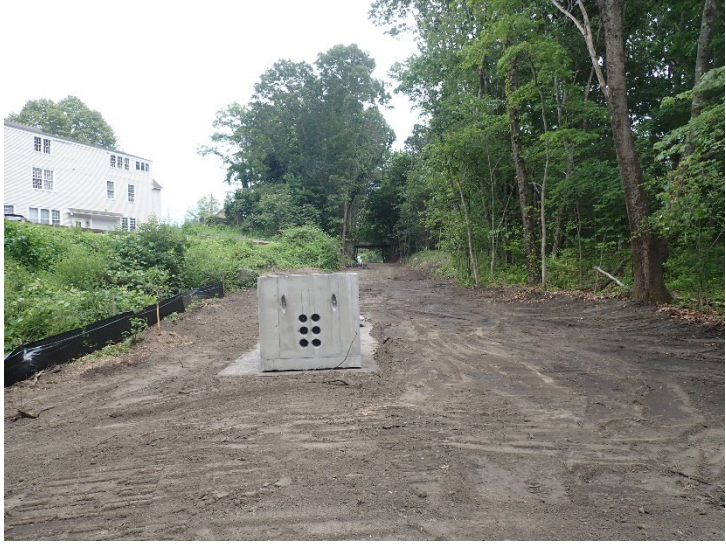
Description: View of manhole 27 and erosion controls within Segment 14. Controls are in good condition. Facing eastward.

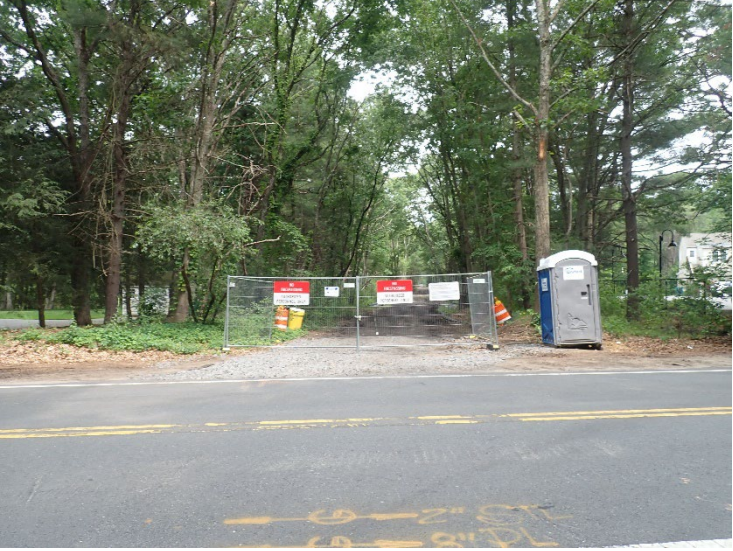
Description: View of construction entrance to segment 11. No sediment tracking observed within roadway. Facing eastward.

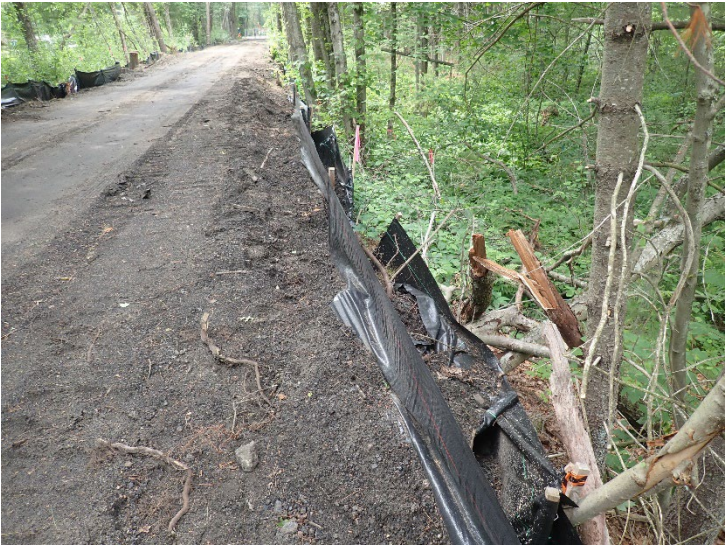
Due to heavy rain on Friday (6/9), a small amount of sediment washed past the silt fence in segment 11, at the northern wetland closest to Horse Pond Road Entrance. Sediment is in the upland, with the wetland located downgradient. Some portions of the silt fence were observed to be leaning from the pressure of the buildup sediment behind it. Crews are aware of this issue and will be addressing the washed-out sediment and silt fencing on Friday (6/16/23). (Routine Maintenance).

Description: View of silt fence in segment 11 near Horse Pond Road. Crews have been actively repairing fencing in this area. Facing westward.

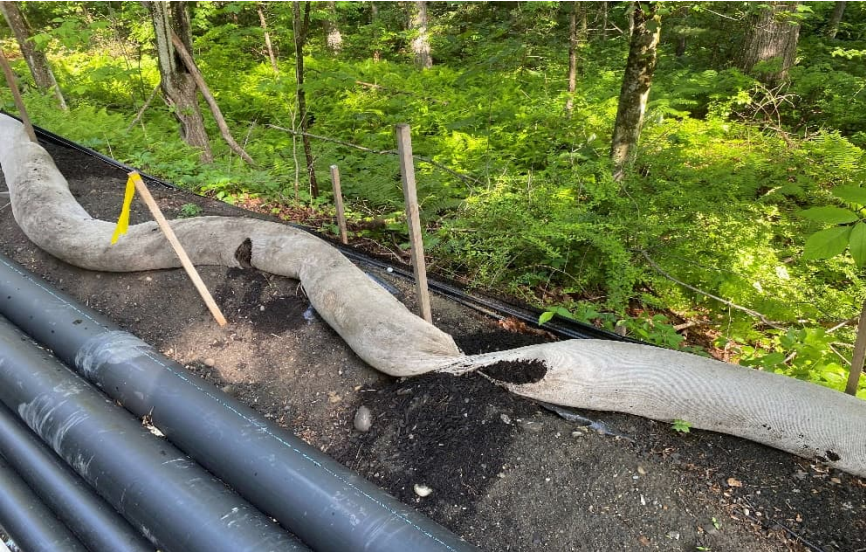
New Routine Maintenance Recommendations? Yes No **Erosion control damaged within Segment 1, needs repairs (see photo 8).**

Description: Example of erosion control within Segment 1 needing repairs (silt fencing down & damaged compost filter tube), looking westward.

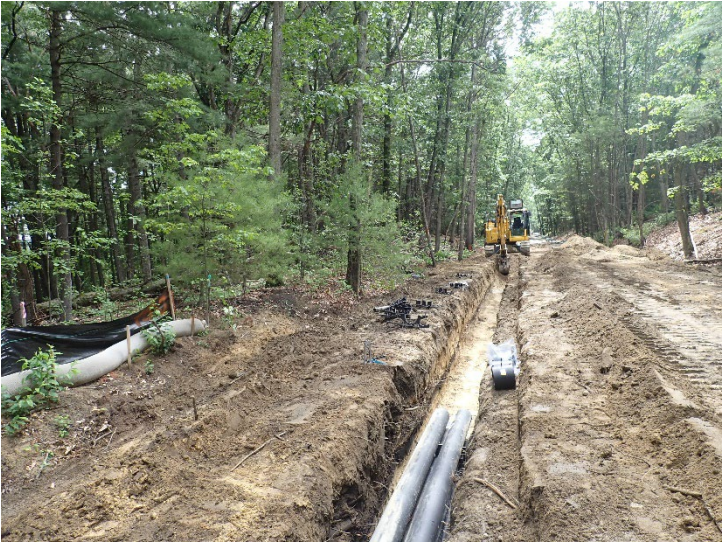
Description: View of Bond conducting conduit work within segment 11, existing erosion control within the active work area are in good condition. Facing eastward.

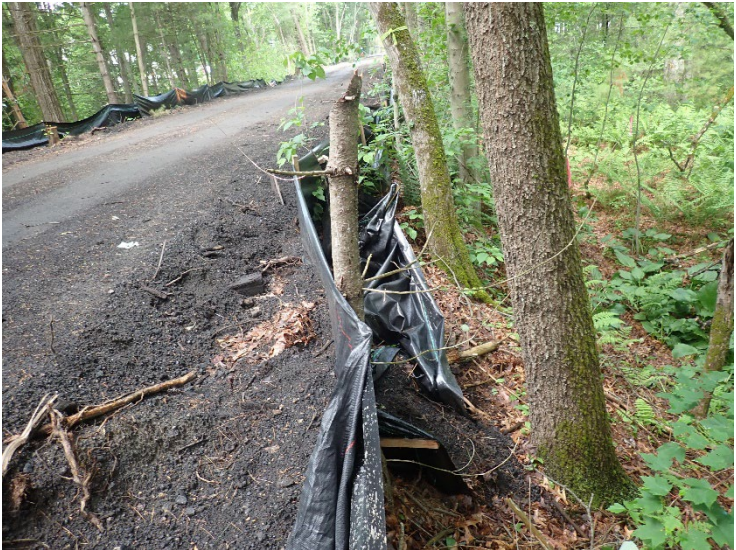
Description: View of erosion controls within segment 11, near Horse Pond Road. Silt fencing needs to be repaired along either side of the Right-of-Way (ROW). Portions of the silt fence are buckling under the weight of collected sediment. Breached sediment should be racked back behind the controls and controls repaired. Facing westward.

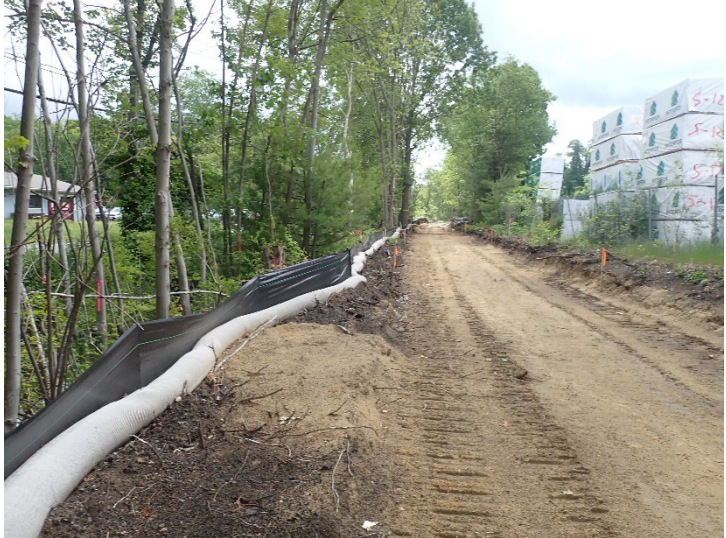
Description: View of ROW within segment 12. Sediment controls appear in good condition. Facing eastward.

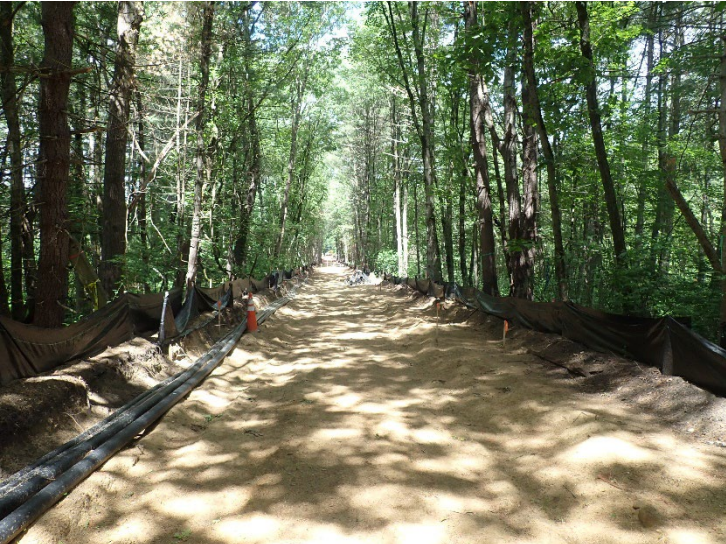
Description: View of ROW within segment 10. Erosion controls appear in good condition. Facing eastward.

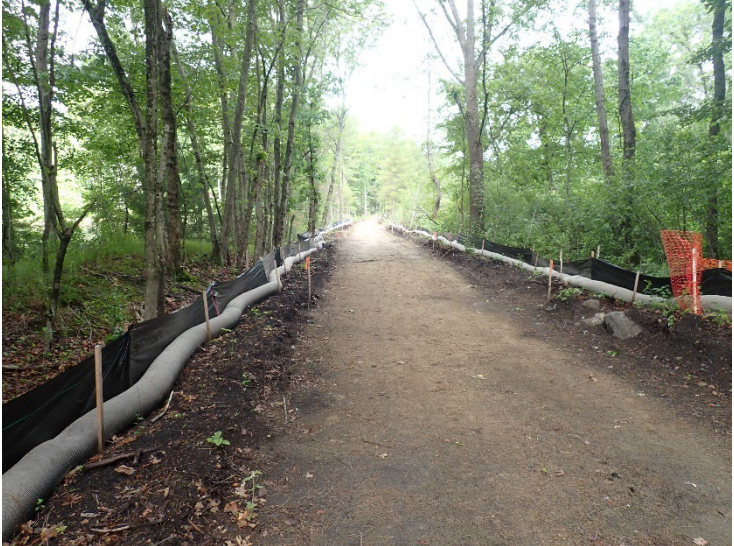
Description: View of erosion controls along segment 14, near bridge 127. Controls appear in good condition. Facing westward.

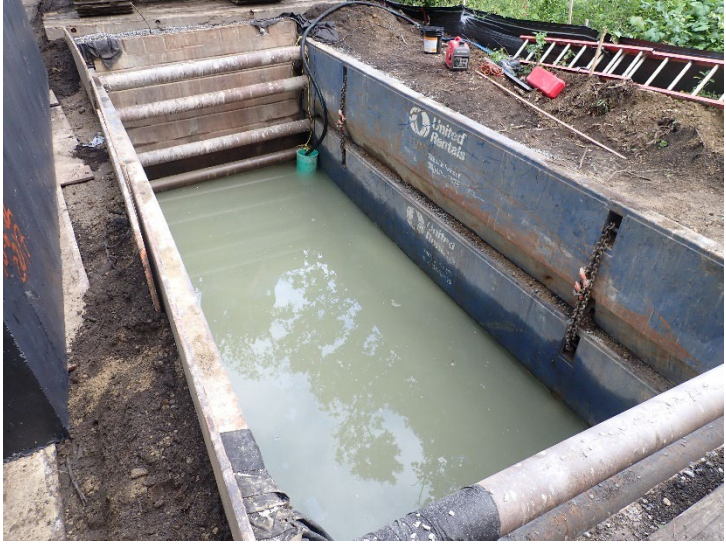
Description: View of area being pumped at work operation at MH#27, off of Boston Post Road in segment 14. This is the location of dewatering water prior to treatment. Water appeared to be slightly turbid. Facing eastward.

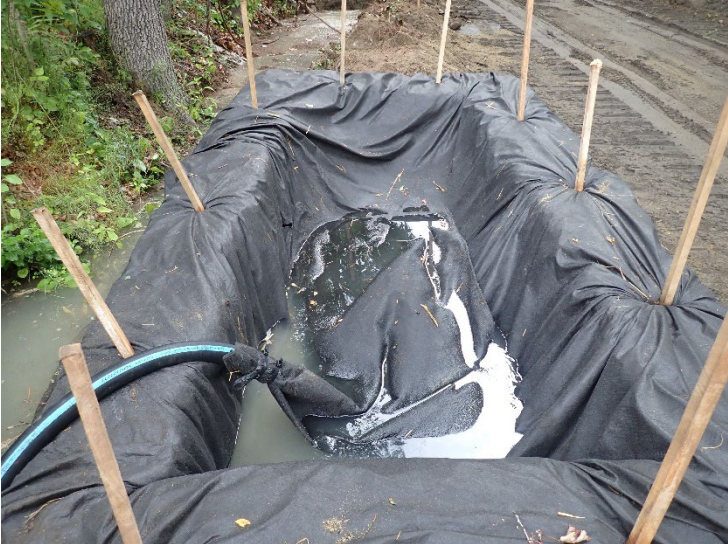
Photo No.: 3	Date: 6/15/2023		
Description: View of dewatering basin for MH#27. Water appears turbid within the basin. Facing eastward.

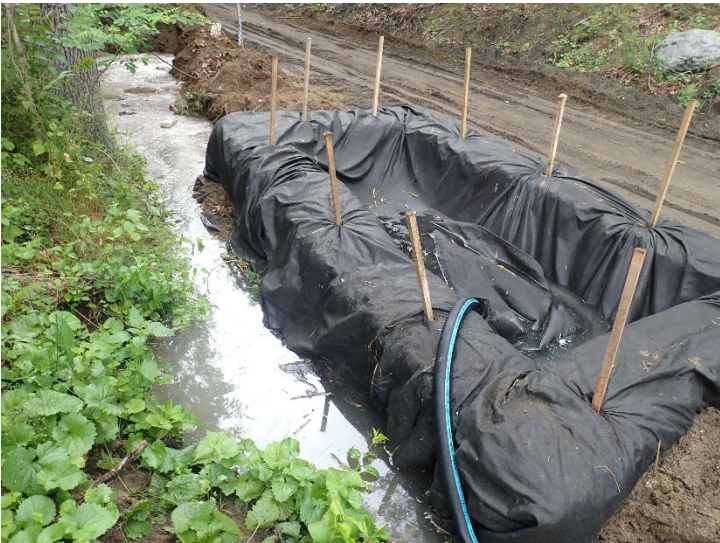
Photo No.: 4	Date: 6/15/2023		
Description: View of water discharging from dewatering basin associated with manhole #27. Water is slightly turbid after treatment, with pollen. Facing eastward.
