Weekly Environmental Compliance Summary

Sudbury to Hudson Transmission Reliability Project (USEPA Tracking # MAR1003UW)

Sudbury, Hudson, and Stow, MA

Week of: June 19 to June 23, 2023

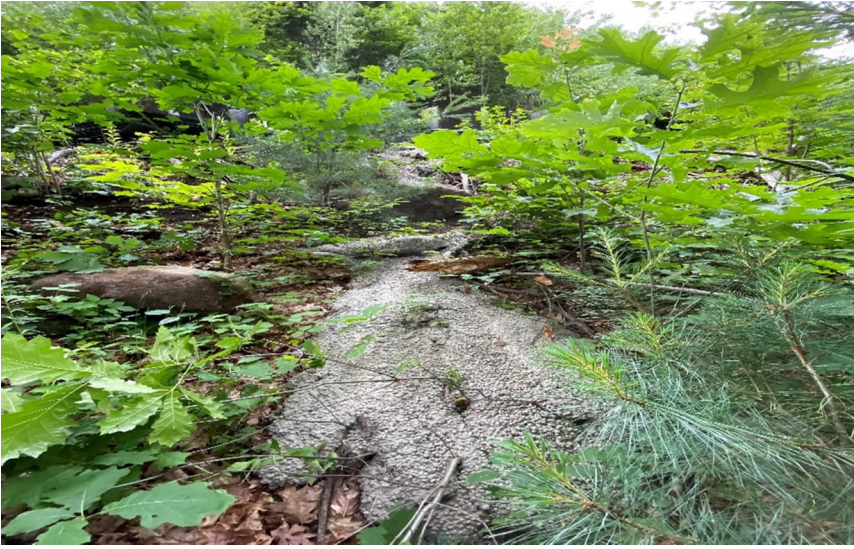
PHOTOGRAPHIC LOG	
Client Name: Eversource		Site Location: Sudbury to Hudson Transmission Reliability Project	Town: Hudson
Photo No.: 3	Date: 6-20-23

New Routine Maintenance Recommendations? Yes No **Erosion control damaged within Segment 1, needs repairs. Spill of concrete/fill material outside of right-of-way within Segment 1 (see photo 3).**

Description: Fill material off right-of-way, within Segment 1 at approximate Sta# 95+45, erosion control (silt fencing, compost filter tubes & sheeting (up slope - upper portion of photo), looking eastward.

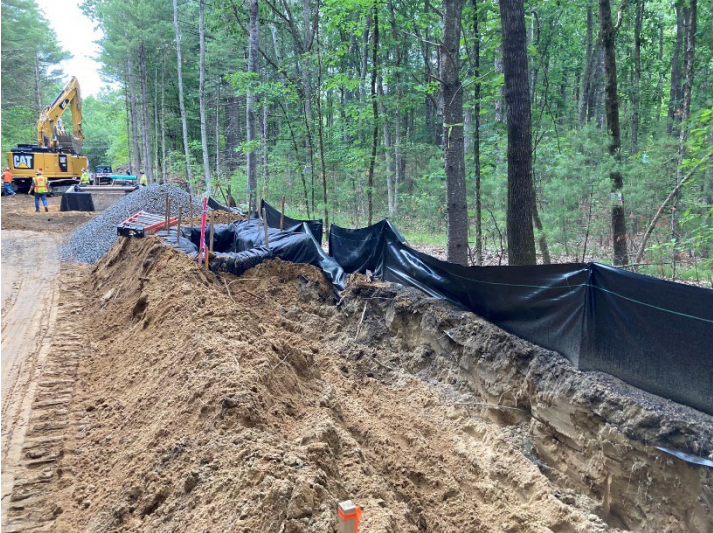
<p align="right">PHOTOGRAPHIC LOG</p>	
<p>Client Name: Eversource</p>		<p>Site Location: Sudbury to Hudson Transmission Reliability Project</p>	<p>Town: Sudbury</p>
<p>Photo No.: 2</p>	<p>Date: 6/20/2023</p>

<p>Description: View of Bond working at MH #20 in segment 10. Dewatering basin has been installed and inspected by Lori Capone (Sudbury CC). Facing west.</p>

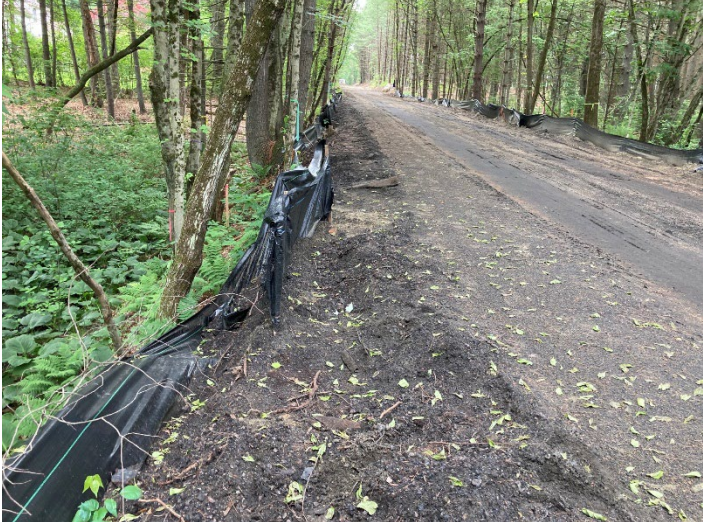
PHOTOGRAPHIC LOG	
Client Name: Eversource		Site Location: Sudbury to Hudson Transmission Reliability Project	Town: Sudbury
Photo No.: 4	Date: 6/20/2023

- Repairs are needed to E&S controls in segment 11 in Sudbury (Routine Maintenance).

Description: Repairs are needed to E&S controls in segment 11 (Routine Maintenance). Facing east.

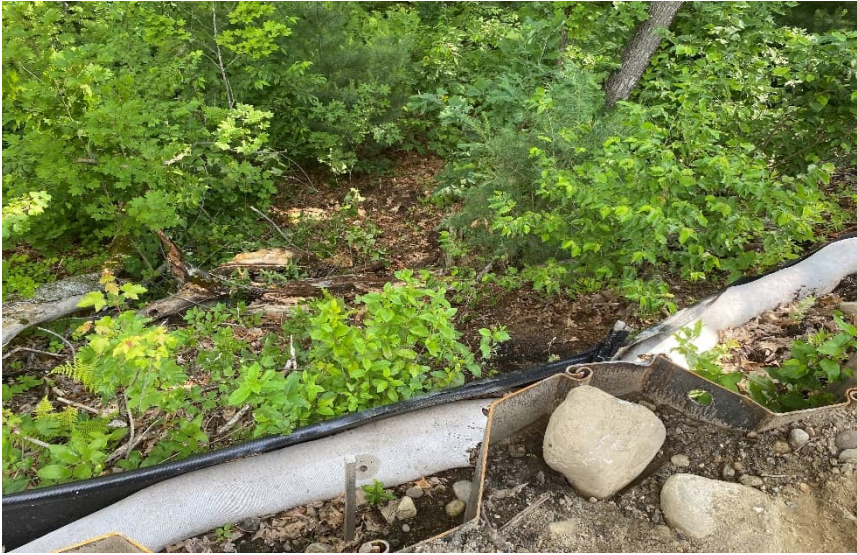
PHOTOGRAPHIC LOG	
Client Name: Eversource		Site Location: Sudbury to Hudson Transmission Reliability Project	Town: Hudson
Photo No.: 3	Date: 6-21-23

New Routine Maintenance Recommendations? Yes No **Erosion control damaged within Segment 1, needs repairs. Spill of concrete/fill material outside of right-of-way within Segment 1, reported 6-20-23 cleaned up (see photo 3).**

Description: Previously reported fill material off right-of-way, within Segment 1 at approximate Sta# 95+45, cleanup, looking westward.

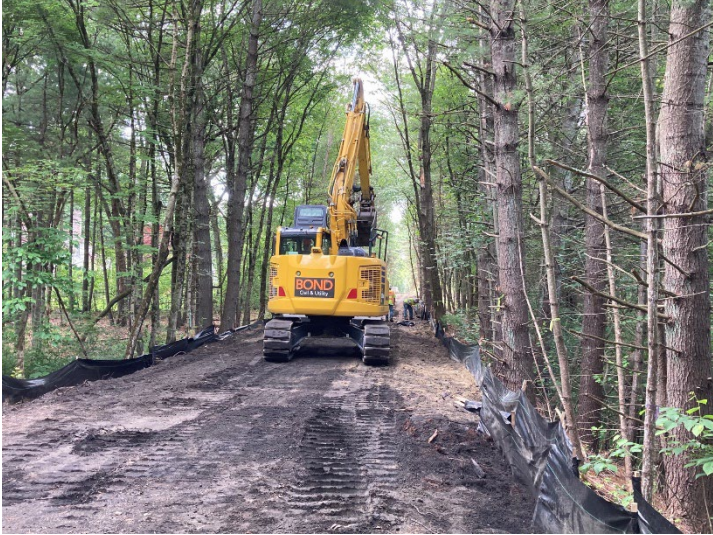
<p>PHOTOGRAPHIC LOG</p>	
<p>Client Name: Eversource</p>		<p>Site Location: Sudbury to Hudson Transmission Reliability Project</p>	
<p>Town: Sudbury</p>			
<p>Photo No.: 3</p>	<p>Date: 6/21/2023</p>

<p>Description: View of Bond conducting E&S repairs in segment 11. Facing east.</p>

Other Comments & Observations
- Repairs to E&S controls in segment 11 were completed.
Authorized Signature
6/21/2023
Date

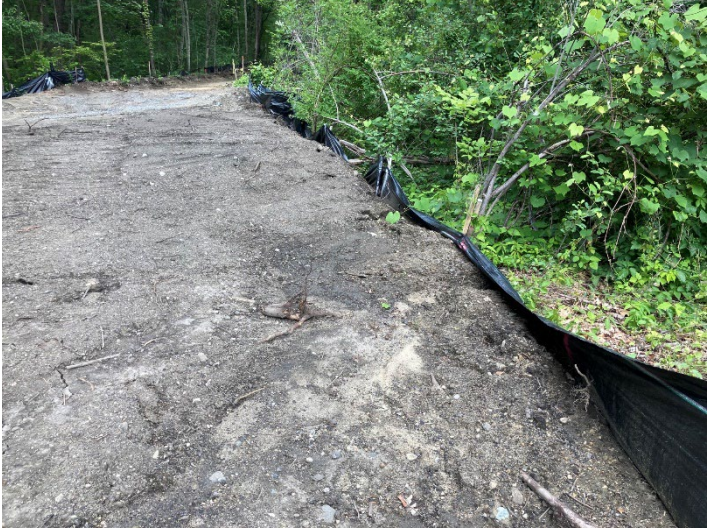
PHOTOGRAPHIC LOG	
Client Name: Eversource		Site Location: Sudbury to Hudson Transmission Reliability Project	Town: Sudbury
Photo No.: 6	Date: 6/21/2023

Description: Repairs to E&S controls are needed in segment 14 near MH #27 (Routine Maintenance). Facing west.

- Repairs are needed to E&S controls in segment 14 near MH #27 (Routine Maintenance).

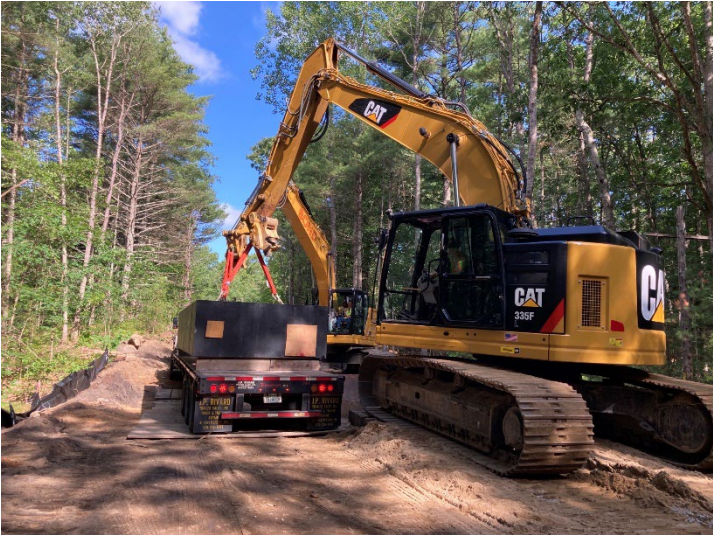
Description: View of Bond installing MH #20 in segment 10. Dewatering was not needed during excavation. Facing west.

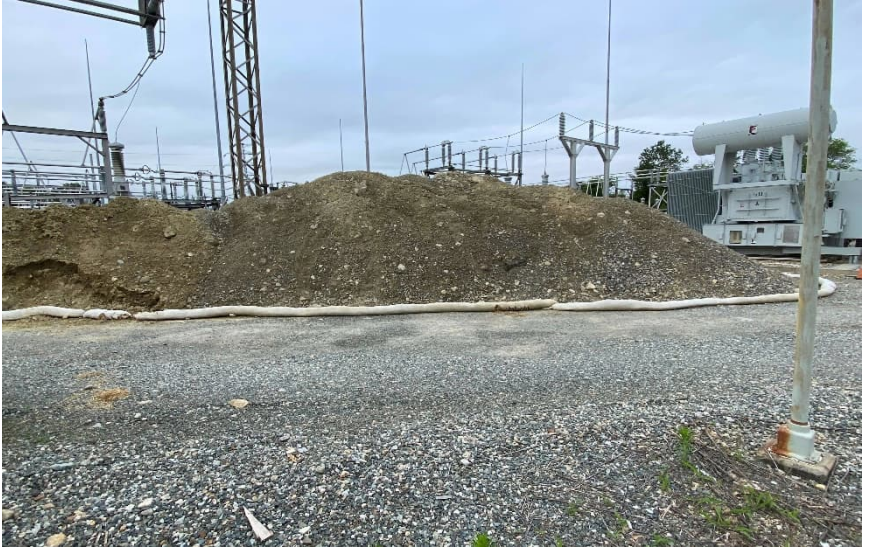
<p>Description:</p> <p>Spoil pile at Sudbury Substation, existing tubes (erosion control) installed & functioning correctly, looking southward.</p>

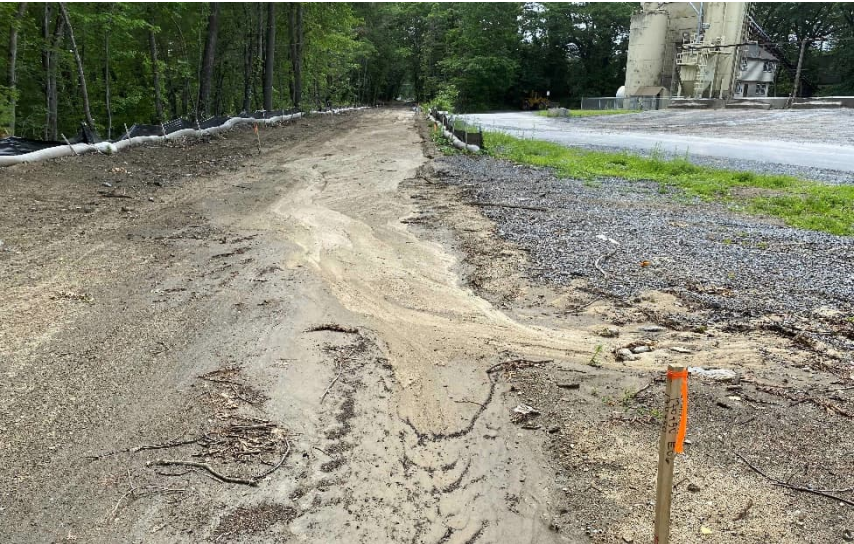
Description: Recent sedimentation off right-of-way within segment 3 at station #170+50, looking eastward.

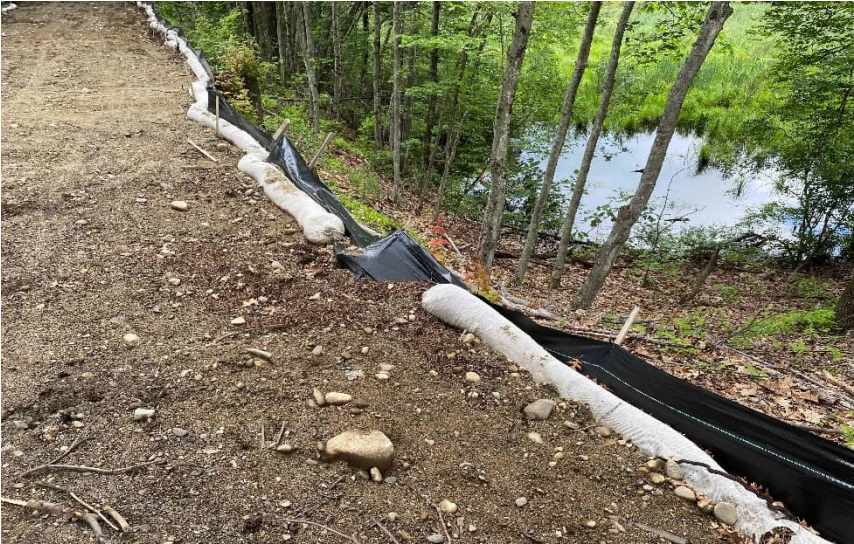
New Routine Maintenance Recommendations? Yes No **Erosion control damaged within Segment 1, needs repairs (see photo 8).**

Description: Example of erosion control within Segment 1 needing repairs (silt fencing down & damaged compost filter tube), looking westward.

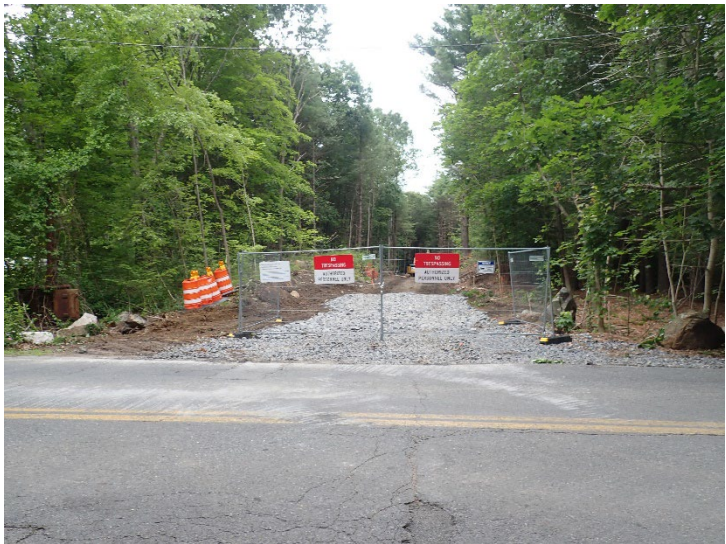
Description: View of construction entrance to segment 10 off Peakham Road. No sediment tracking observed on roadway. Facing westward.

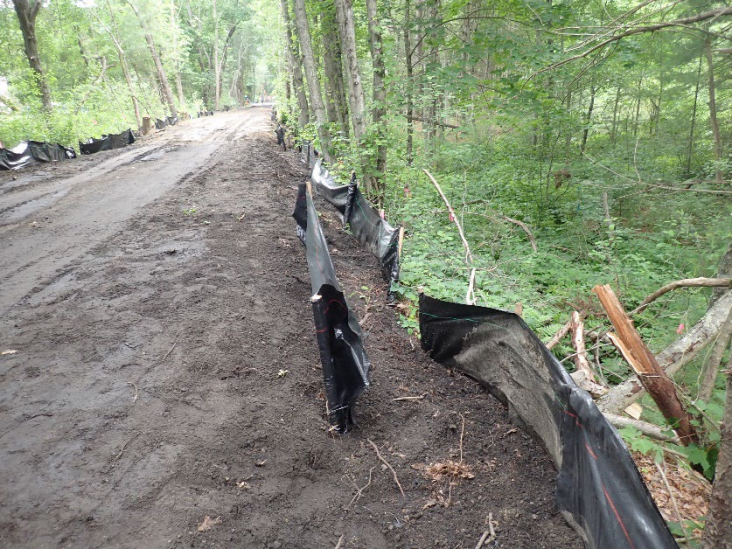
Description: View of erosion controls within segment 11, near Horse Pond Road. Crews were on site repairing the silt fence in this area. Sections of silt fence are pending repairs. Facing westward.

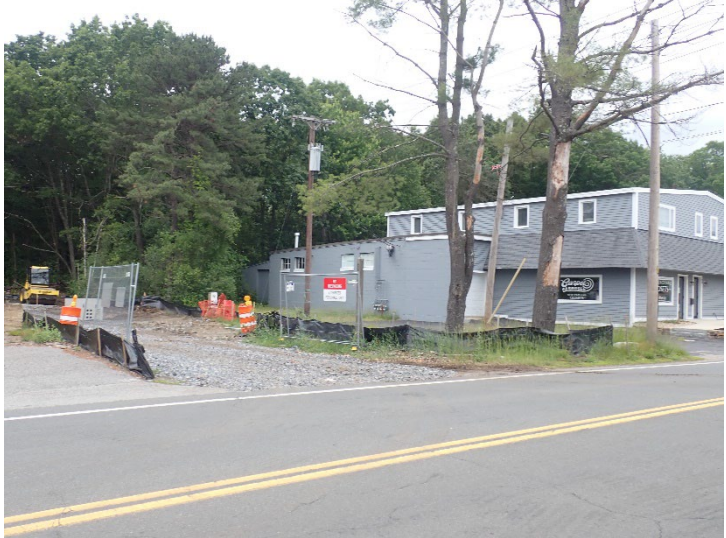
Description: View of construction entrance for segment 11 off Union Street. No sediment tracking observed within roadway. Facing westward.

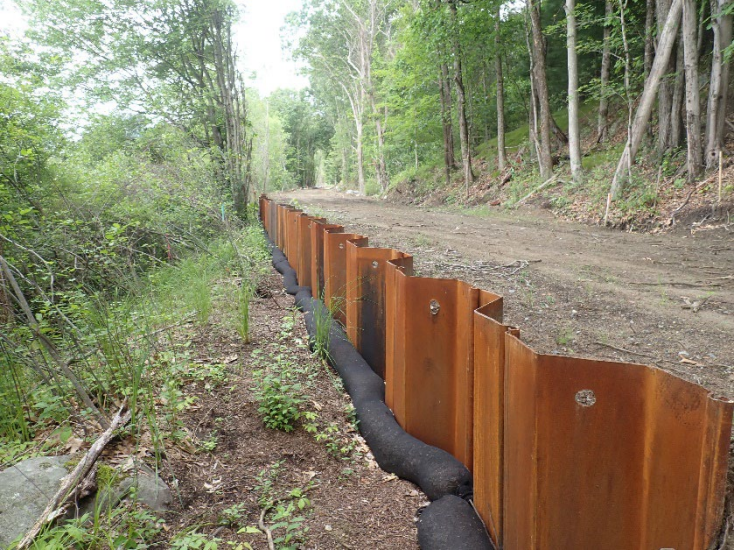
Description: View of erosion controls along segment 14. Controls appear in good condition. Facing westward.

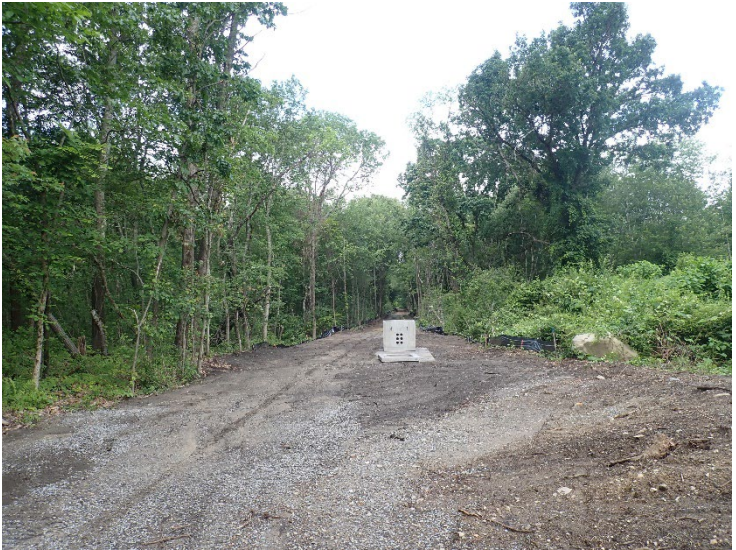
Description: View of manhole #27 and erosion controls in segment 14. Controls appear in good condition. Facing westward.
