Weekly Environmental Compliance Summary

Sudbury to Hudson Transmission Reliability Project (USEPA Tracking # MAR1003UW)

Week of: June 26 to June 30, 2023

CONSTRUCTION MONITORING REPORT

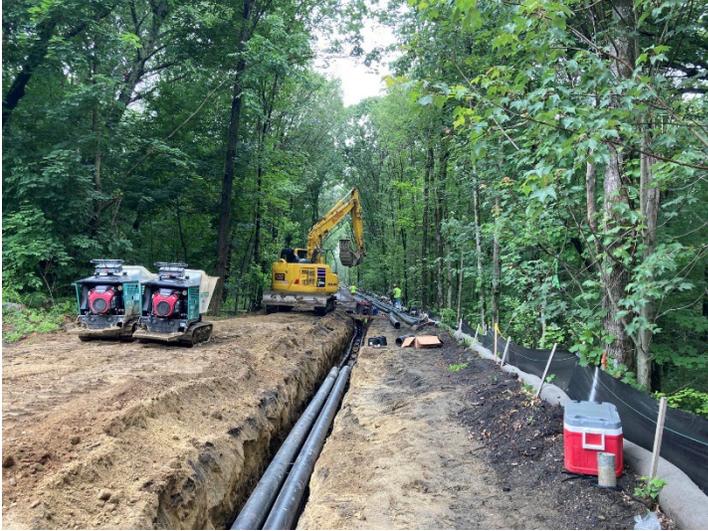
PHOTOGRAPHIC LOG	
Client Name: Eversource		Site Location: Sudbury to Hudson Transmission Reliability Project	Town: Hudson
Photo No.: 3	Date: 6/27/2023

Description: View of Bond installing conduit in segment 1. Repairs to E&S controls are needed in this segment (routine maintenance). Facing west.

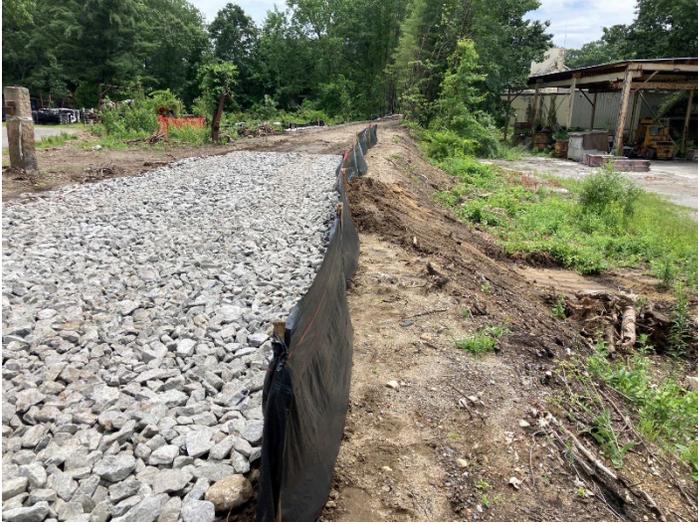
PHOTOGRAPHIC LOG	
Client Name: Eversource		Site Location: Sudbury to Hudson Transmission Reliability Project	Town: Hudson
Photo No.: 5	Date: 6/27/2023

Description: Erosion observed at approximately Sta. #166 in segment 3 has been repaired and additional rip rap stone and silt fence have been installed to prevent further erosion. The sediment that deposited during this incident has been removed. Facing east.

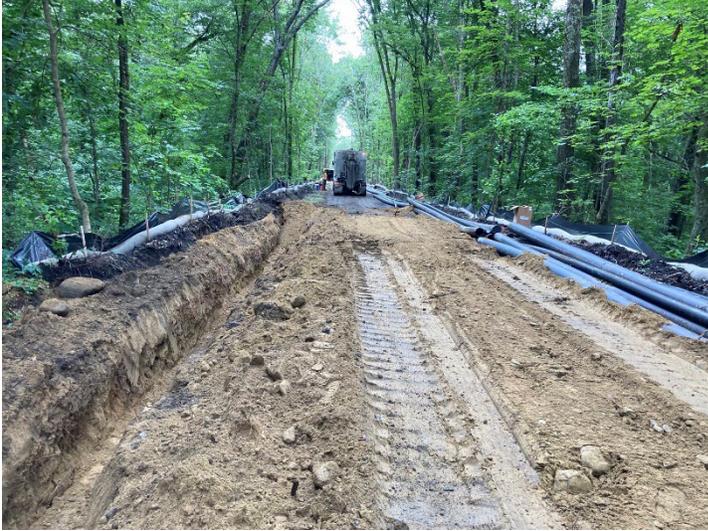
PHOTOGRAPHIC LOG	
Client Name: Eversource		Site Location: Sudbury to Hudson Transmission Reliability Project	Town: Hudson
Photo No.: 3	Date: 6/28/2023

Description: View of Bond installing conduit in segment 1. Repairs to E&S controls are needed in this segment (routine maintenance). Facing west.

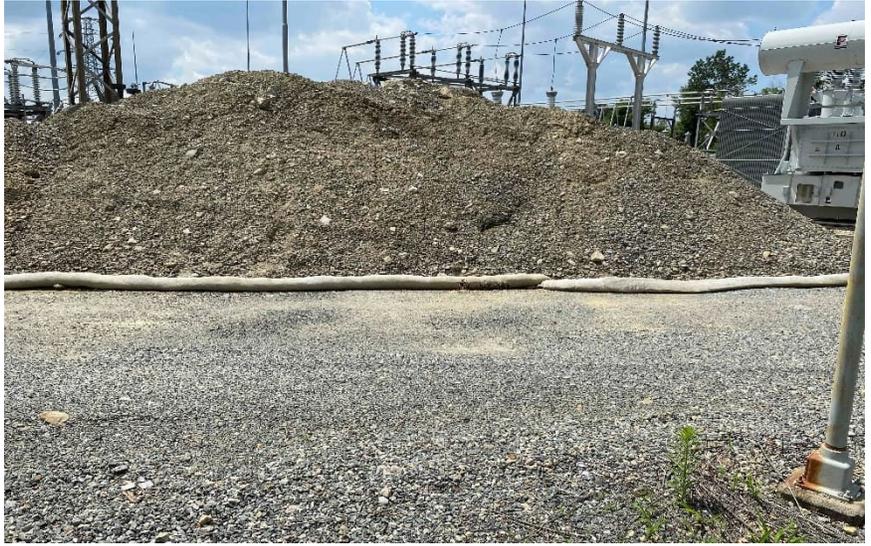
<p>Description:</p> <p>Spoil pile at Sudbury Substation, existing tubes (erosion control) installed & functioning correctly, looking southward.</p>

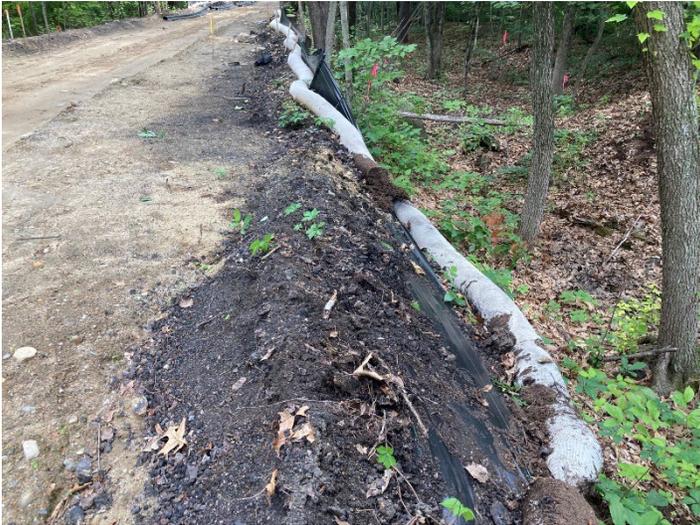
Description: Repairs to E&S controls are needed in segment 1 (routine maintenance). Facing east.

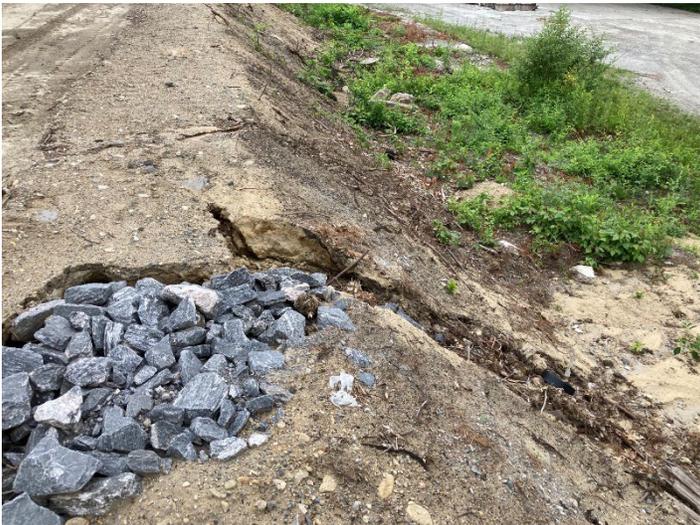
-As noted on reports in the past, stormwater from adjacent property flows onto project ROW in segment 3 during heavy rains. During this week's rains, stormwater flow from adjacent property eroded exposed soils at multiple locations in this segment. Sediment appears to have deposited outside of LOW, but did not impact any jurisdictional areas. Recommend repairing erosion, removing deposited sediment, and considering the installation of additional BMPs in this area.

Description: View of erosion and washout noted at approximately Sta. #166 rt in segment 3. Recommend repairing erosion, removing deposited sediment, and considering the installation of additional BMPs in this area. Facing east.

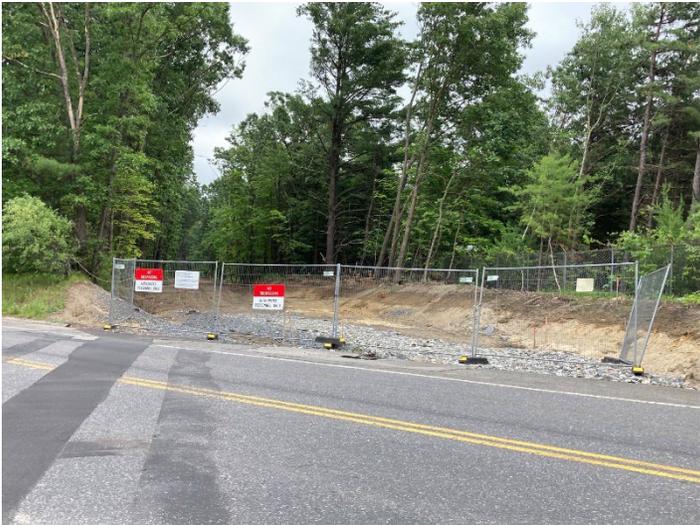
Description: View of construction entrance to segment 4 at Main St. Entrance pad and inlet protection are in good condition and operating properly. Facing east.

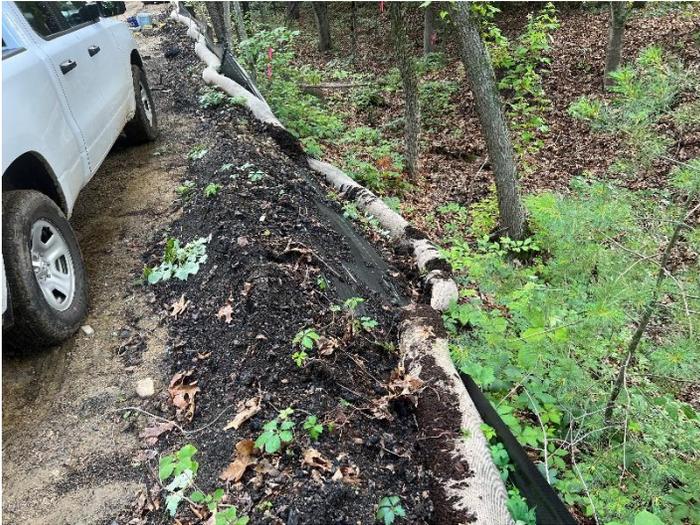
Description: Repairs to E&S controls are needed in segment 1 (routine maintenance). Facing east.

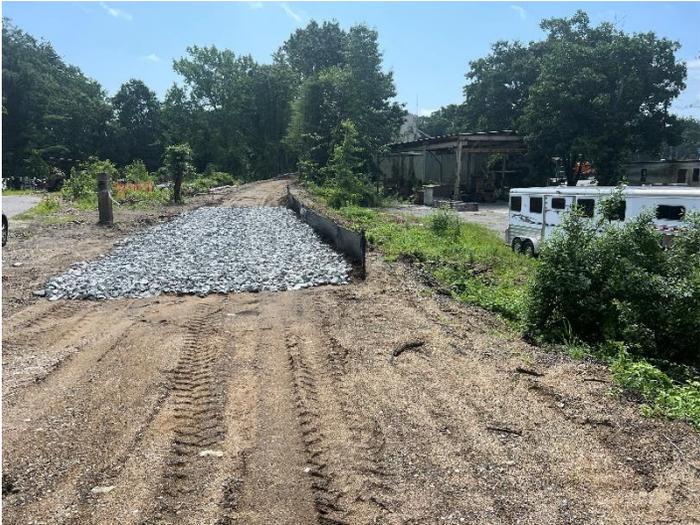
Description: View of area where erosion and washout was noted on previous SWPPP report at approximately Sta. #166 rt in segment 3. Crushed stone and silt fence have been installed, erosion has been repaired, and deposited sediment has been removed. Facing east.

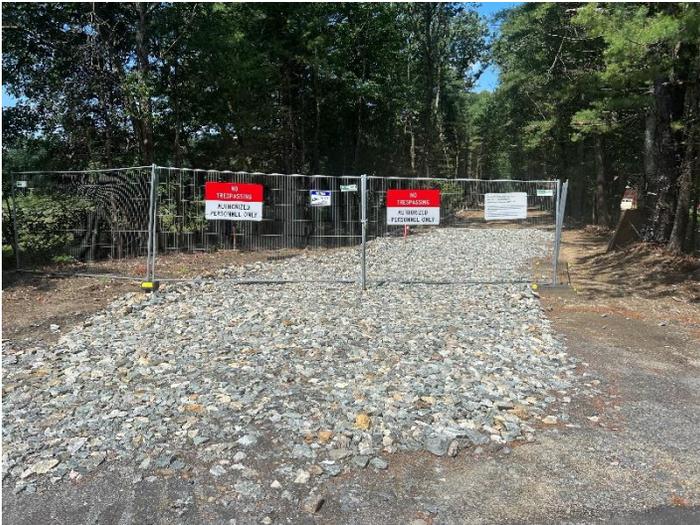
Description: View of construction entrance to segment 4 at Main St. Entrance pad and inlet protection are in good condition and operating properly. Facing east.

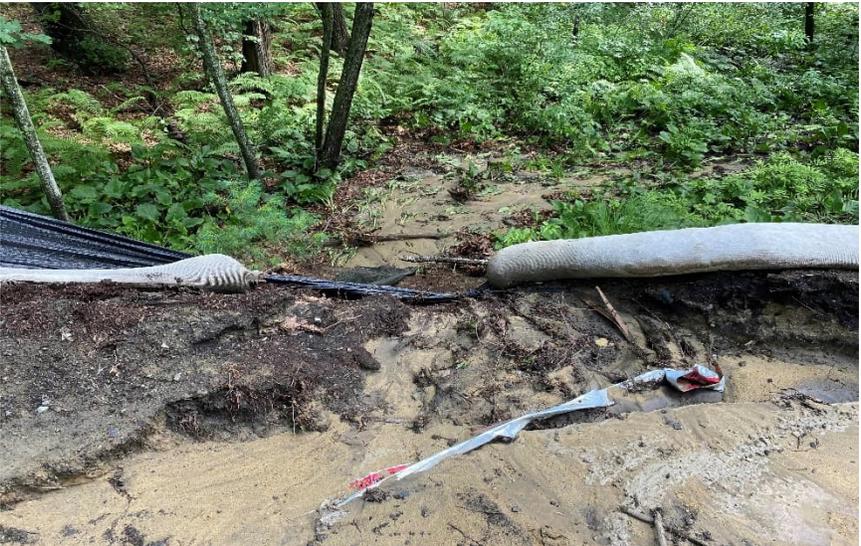
Description: Compromised erosion controls within segment 11 at approximate Sta# 577+25 off the eastern side of the work area, looking eastward.

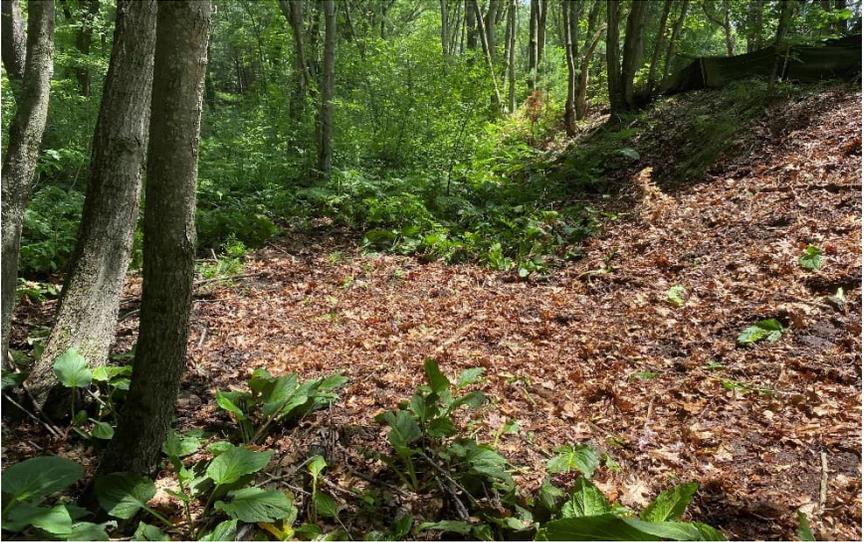
Description: Wetland area off eastern side of work area at approximate Sta# 577+25 following sedimentation removal, looking southward.

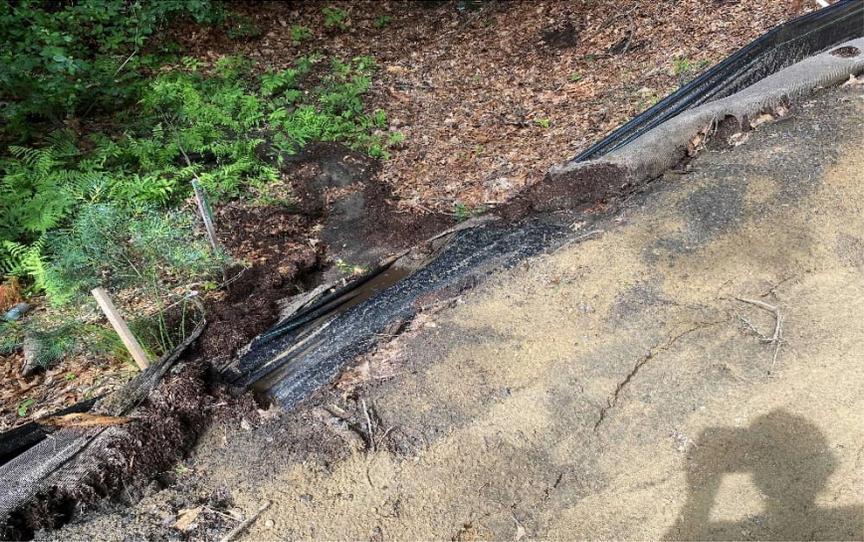
Description: Compromised erosion controls within segment 11 at approximate Sta# 577+25 off the western side of the work area, looking westward.

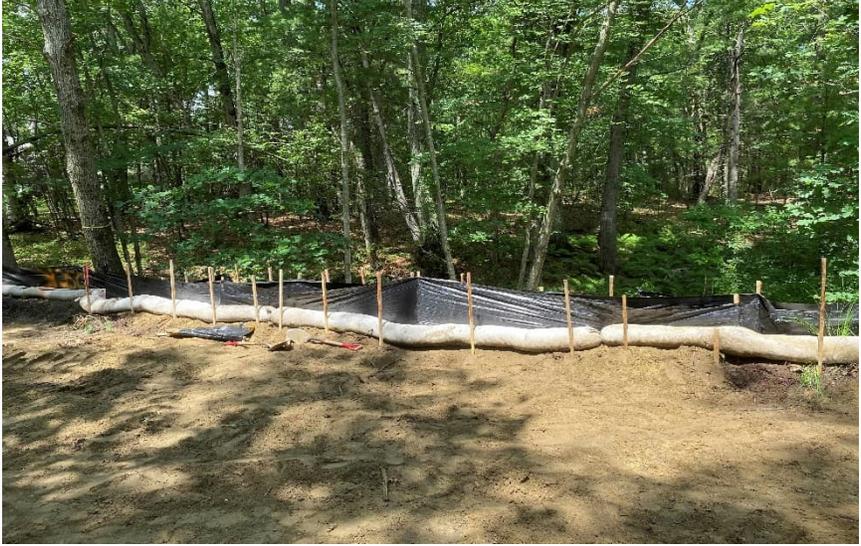
Description: Newly installed erosion control on eastern side of work area at Sta# 577+25 within segment 11, looking eastward.

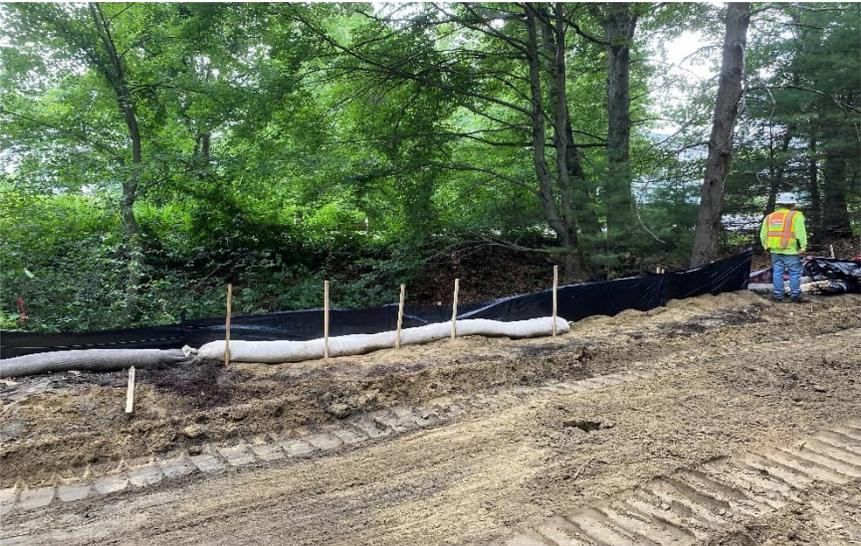
Description: Newly installed erosion control on western side of work area at Sta# 577+25 within segment 11, looking westward. One last compost filter tube to be installed (right of photo) on 6-30-2023.
