Weekly Environmental Compliance Summary

Sudbury to Hudson Transmission Reliability Project (USEPA Tracking # MAR1003UW)

Week of: July 3 to July 7, 2023

CONSTRUCTION MONITORING REPORT

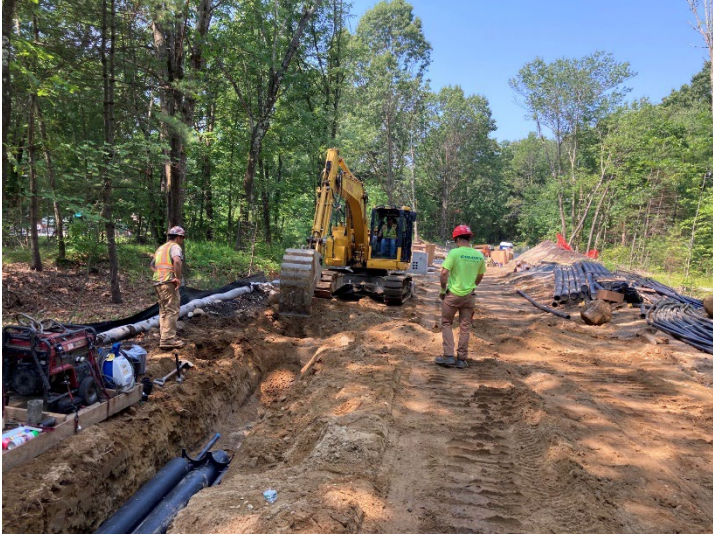
PHOTOGRAPHIC LOG	
Client Name: Eversource		Site Location: Sudbury to Hudson Transmission Reliability Project	Town: Hudson
Photo No.: 3	Date: 7/06/2023

Description: View of Bond installing conduit and ductbank in segment 1. Repairs to E&S controls are needed in this segment. Facing west.

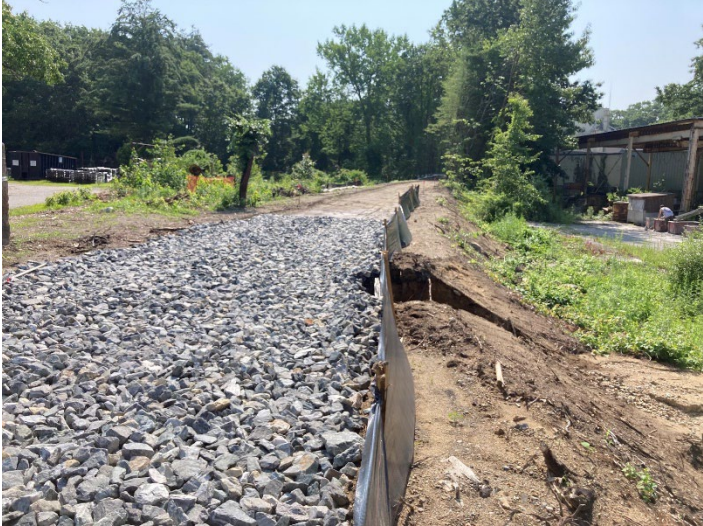
PHOTOGRAPHIC LOG	
Client Name: Eversource		Site Location: Sudbury to Hudson Transmission Reliability Project	Town: Hudson
Photo No.: 4	Date: 7/06/2023

Description: View of segment 3. Two stormwater washouts are in need of repair in this segment. Facing east.

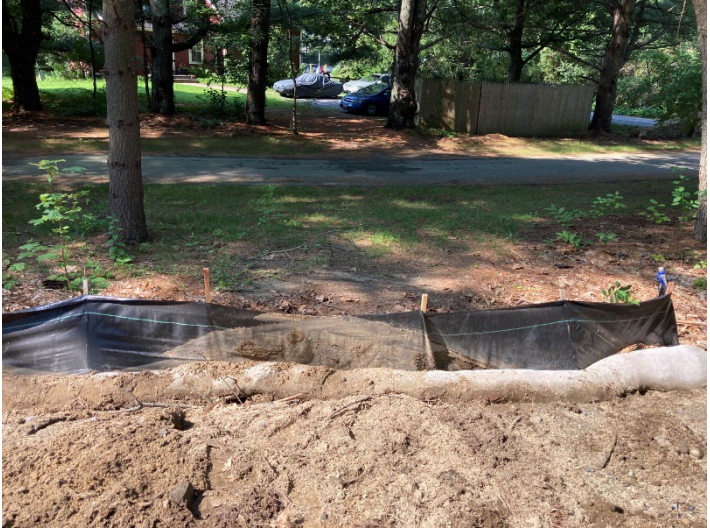
PHOTOGRAPHIC LOG	
Client Name: Eversource		Site Location: Sudbury to Hudson Transmission Reliability Project	
Town: Hudson			
Photo No.: 6	Date: 7/06/2023

Description: E&S controls and washout have been repaired near MH 11 in segment 5 off Parmenter Rd. Facing south.

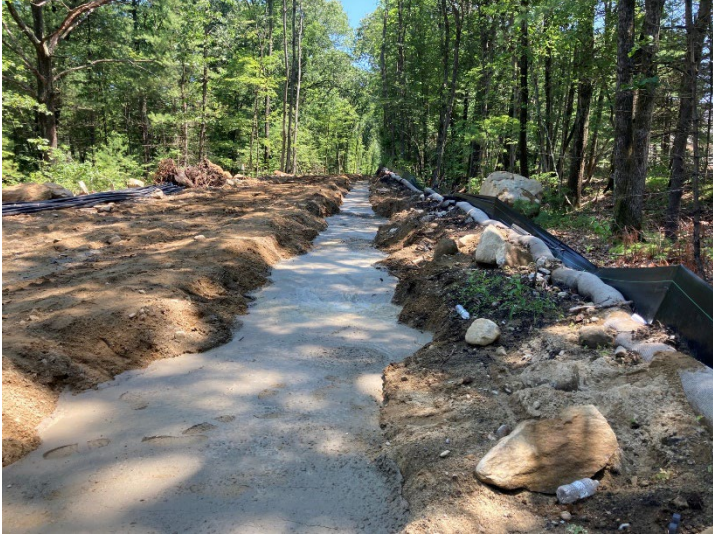
PHOTOGRAPHIC LOG	
Client Name: Eversource		Site Location: Sudbury to Hudson Transmission Reliability Project	
Town: Hudson			
Photo No.: 3	Date: 7/07/2023

Description: View of ductbank in segment 1. Repairs to E&S controls are needed in this segment in addition to segments 2 and 5 (routine maintenance). Facing east.

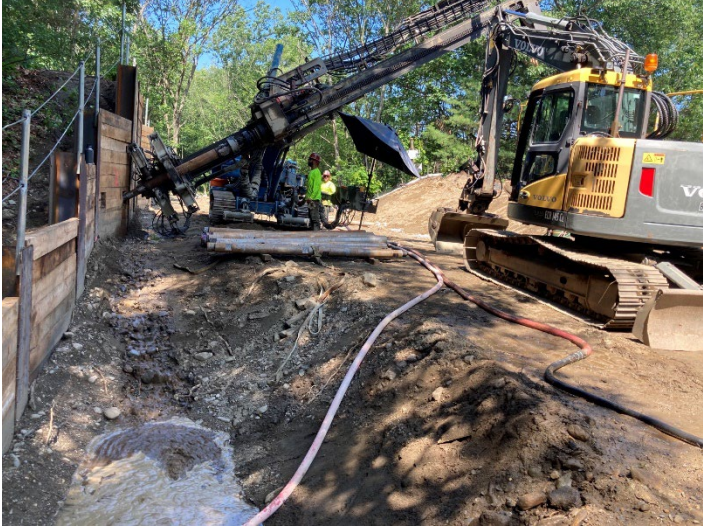
PHOTOGRAPHIC LOG	
Client Name: Eversource		Site Location: Sudbury to Hudson Transmission Reliability Project	
Town: Hudson			
Photo No.: 4	Date: 7/07/2023

Description: View of drilling tie-backs at Chestnut St. Water being used for drilling is contained within infiltration basin and not observed to be discharging off-site. Facing west.

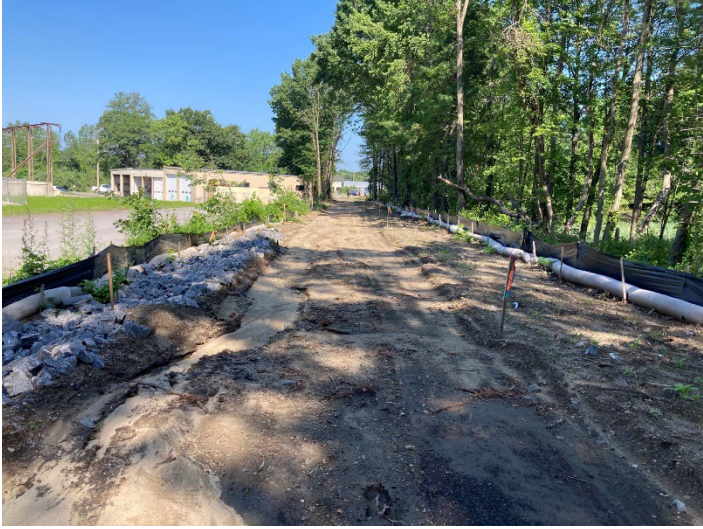
PHOTOGRAPHIC LOG	
Client Name: Eversource		Site Location: Sudbury to Hudson Transmission Reliability Project	
Photo No.: 5		Town: Hudson	
Date: 7/07/2023

Description: View of segment 3. Two stormwater washouts are in need of repair in this segment. Facing west.

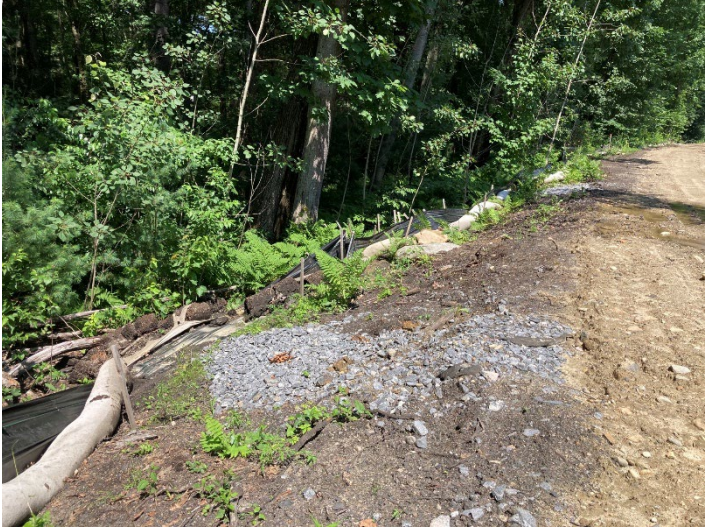
PHOTOGRAPHIC LOG	
Client Name: Eversource		Site Location: Sudbury to Hudson Transmission Reliability Project	Town: Hudson
Photo No.: 3	Date: 7-05-2023

-Swale that was previously installed in segment 1 has been removed due to ductbank installation. From approximately Sta. #115 to Sta. #119, stormwater and groundwater seep is discharging through silt fence instead of entering leaching catch basin #3 as designed. It is recommended that swale is reinstalled when feasible to ensure proper stormwater drainage. Water discharging from project at time of inspection appeared to be clear and free of sediment or pollutants.

Description: View of damaged E&S controls at Sta. #116 left in segment 1 where stormwater discharge is occurring. Repairs to E&S controls are needed throughout this segment (routine maintenance). Facing northeast.

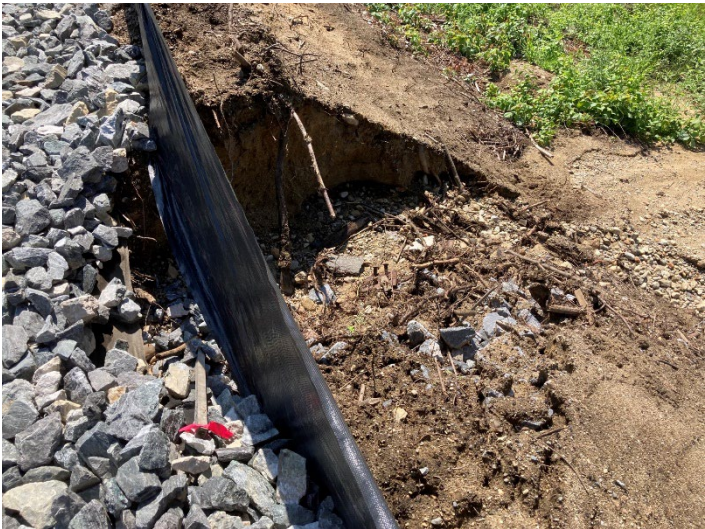
Epsilon ASSOCIATES INC.		PHOTOGRAPHIC LOG	
Client Name: Eversource		Site Location: Sudbury to Hudson Transmission Reliability Project	Town: Hudson
Photo No.: 5	Date: 7-05-2023

-As noted on reports in the past, stormwater from adjacent property flows onto project ROW in segment 3 during heavy rains. During this week's rains, stormwater flow from adjacent property eroded exposed soils at two locations in this segment- approximately Sta. #166 rt and Sta. #170 rt. Sediment appears to have deposited outside of limit of work, but did not impact any jurisdictional areas. Recommend repairing erosion and removing deposited sediment at both locations. Repair silt fence where undermined at Sta. #166 rt (routine maintenance).

Description: View of erosion and washout noted at approximately Sta. #166 rt in segment 3. Recommend repairing erosion and removing deposited sediment. Repair silt fence where undermined (routine maintenance).

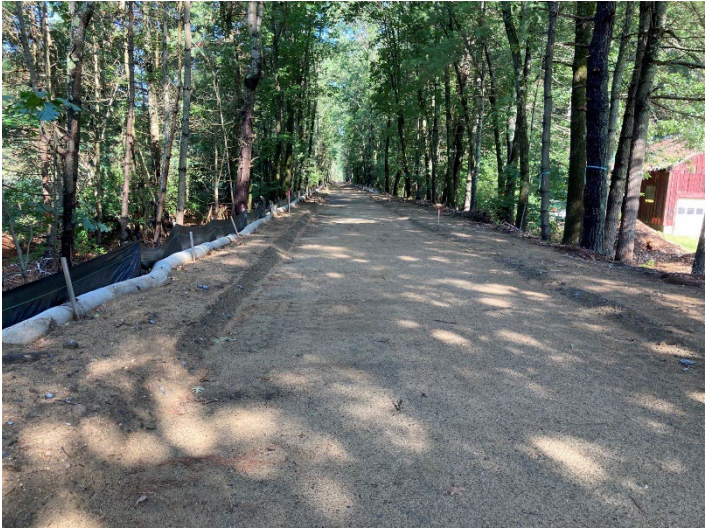
Epsilon ASSOCIATES INC.		PHOTOGRAPHIC LOG	
Client Name: Eversource		Site Location: Sudbury to Hudson Transmission Reliability Project	Town: Hudson
Photo No.: 6	Date: 7-05-2023

Description: View of Type A E&S controls in segment 4. Controls are operating properly. Facing west.

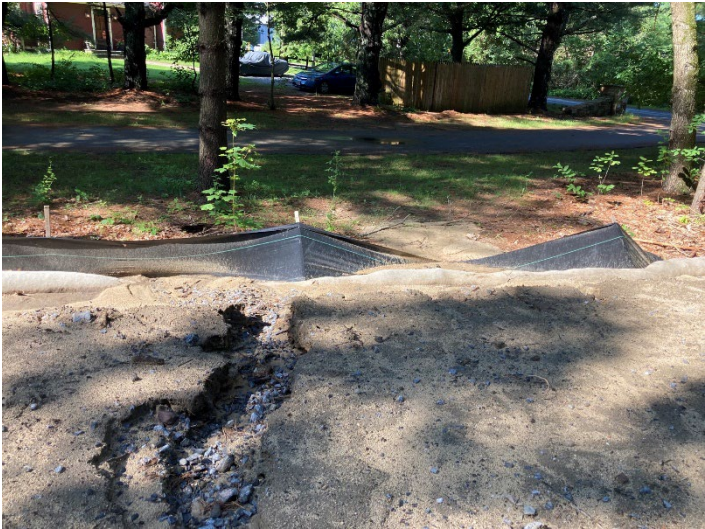
Epsilon ASSOCIATES INC.		PHOTOGRAPHIC LOG	
Client Name: Eversource		Site Location: Sudbury to Hudson Transmission Reliability Project	Town: Hudson
Photo No.: 7	Date: 7-05-2023

-During this week's rains, stormwater flow eroded exposed soils in segment 5. At approximately Sta. #300+40 rt (near MH #11 off Parmenter Rd), E&S controls became overwhelmed and sediment deposited beyond limit of work. Sediment did not impact any jurisdictional areas. Recommend repairing erosion and removing deposited sediment. Repair E&S controls in segment 5 as needed (routine maintenance).

Description: View of Sta. #300+40 rt in segment 5 (near MH #11 off Parmenter Rd). During this week's rains, stormwater flow eroded exposed soils in segment. At this location, E&S controls became overwhelmed and sediment desposited beyond limit of work. Recommend repairing erosion and removing deposited sediment. Repair E&S controls in segment 5 as needed (routine maintenance). Facing south.

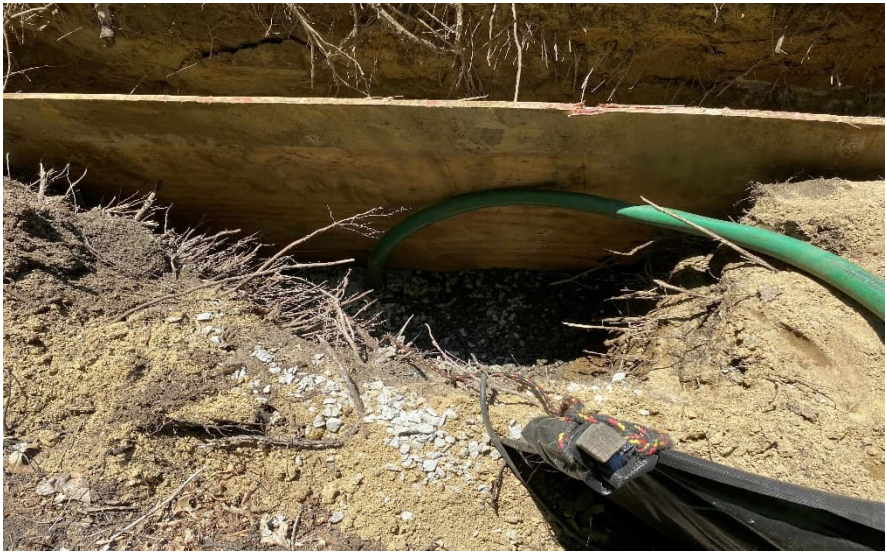
PHOTOGRAPHIC LOG	
Client Name: Eversource		Site Location: Sudbury to Hudson Transmission Reliability Project	Town: Sudbury
Photo No.: 2	Date: 7/7/2023

Description: View of pumping operation at Segment 11. This is the location of dewatering water prior to treatment. Water appeared to be slightly turbid.

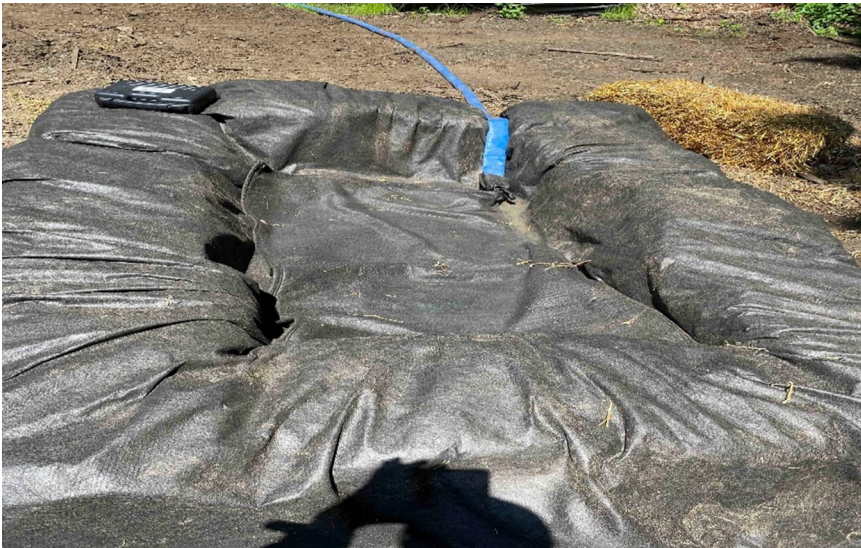
PHOTOGRAPHIC LOG	
Client Name: Eversource		Site Location: Sudbury to Hudson Transmission Reliability Project	Town: Sudbury
Photo No.: 4	Date: 7/7/2023

Description: Segment 11. View of discharge bag/bales, looking westward. Water discharge to bag intermittent and appeared to be slightly turbid.
