**Weekly Environmental Compliance Summary**

**Sudbury to Hudson Transmission Reliability Project (USEPA Tracking # MAR1003UW)**

Sudbury, Hudson, and Stow, MA

Week of: July 17 to July 21, 2023

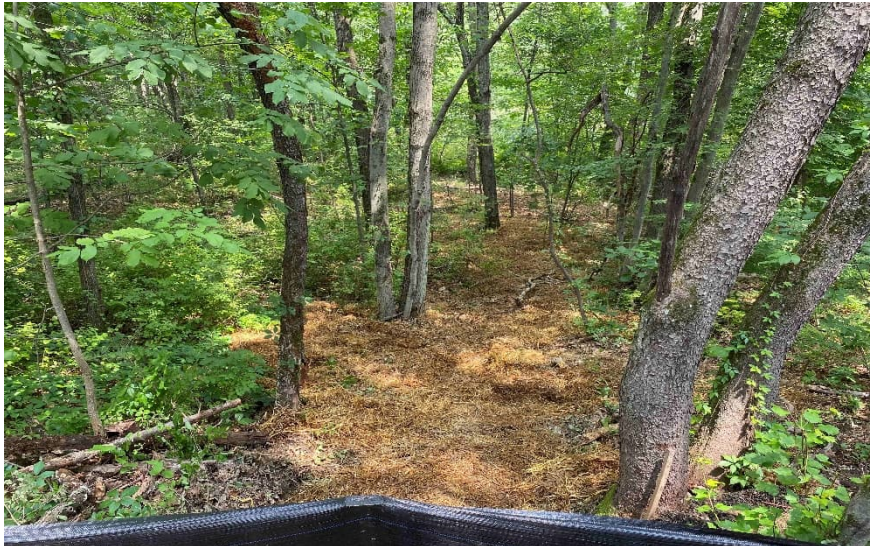
| Photo No.: 2 | Date: 7-18-23 | | |

| Description:<br><br>Erosion control repair area within segment 1 at approximate Sta# 128+50, previously overwhelmed by weekend rainstorm & movement of sedimentation outside the work area, looking eastward. | | | |

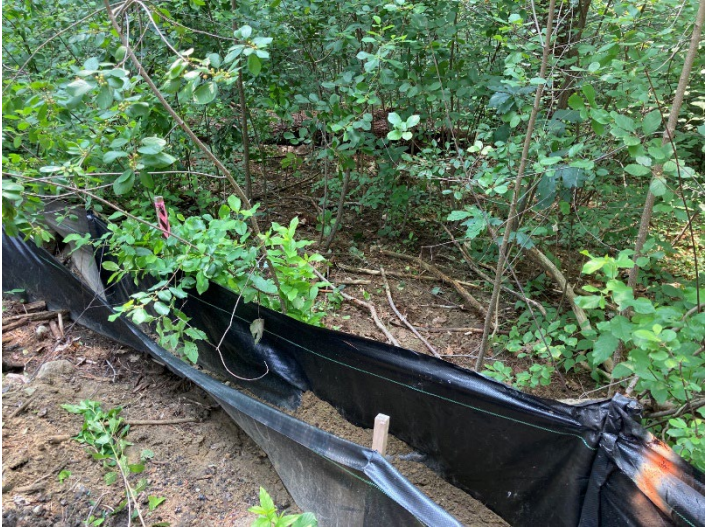
| <b>Photo No.:</b> 1 | <b>Date:</b><br>7/18/2023 | | |

| <b>Description:</b><br>View of silt fence at Sta. 520 rt in segment 9. Sediment that deposited beyond limit of work has been removed. Gap in syncopated silt fence at this location has been closed with permission from Lori Capone (Sudbury CC agent). Facing southeast. | | | |

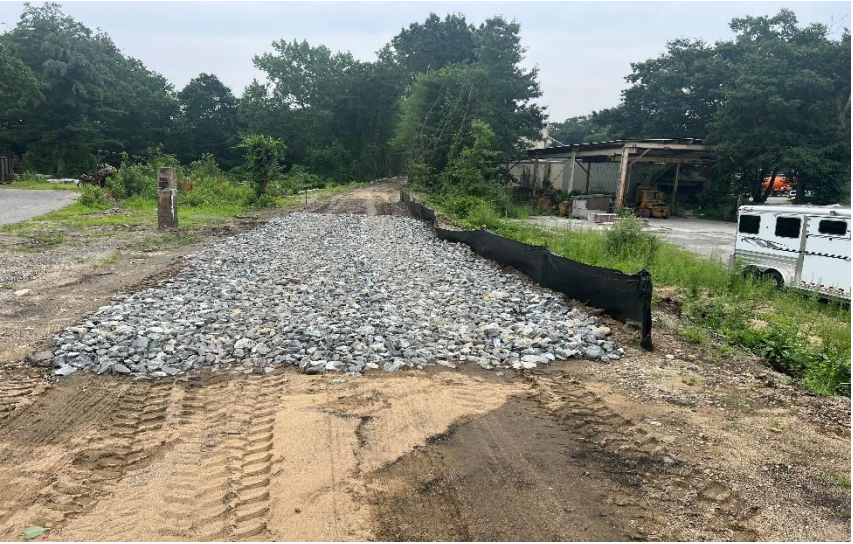
| <b>Photo No.:</b> 6 | <b>Date:</b> 7-19-23 | | |

| <b>Description:</b><br><br>Area where washout had been previously repaired within segment 3. All repairs and erosion controls are in good condition and working properly. Facing East. | | | |

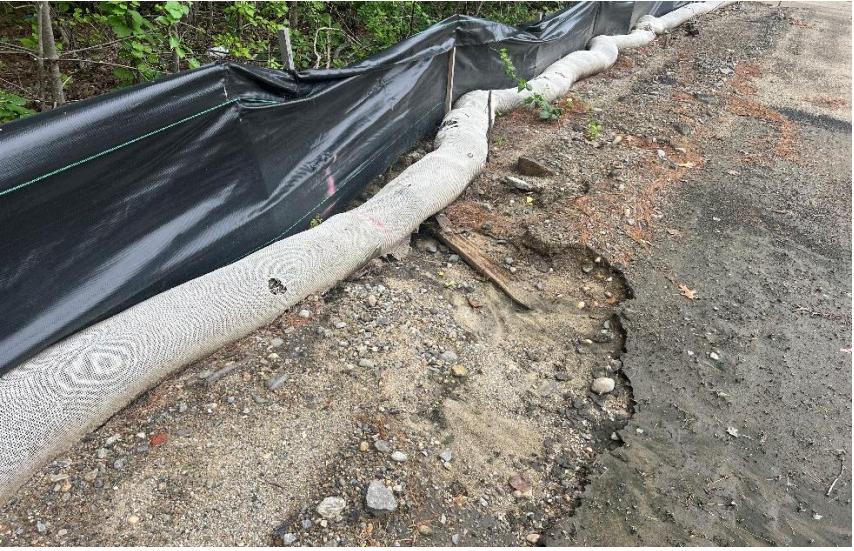
| <b>Photo No.:</b> 7 | <b>Date:</b> 7-19-23 | | |

**-Repairs to erosion controls in segment 1 have been completed.**  
**-Erosion controls in segment 3 near Sta. 160 are in need of repairs (routine maintenance).**

| <b>Description:</b><br><br>Silt fence within segment 3 near Sta# 160+00 that has been undermined by recent storm events. Erosion and erosion controls are in need of repairs. <i>Facing South.</i> | | | |

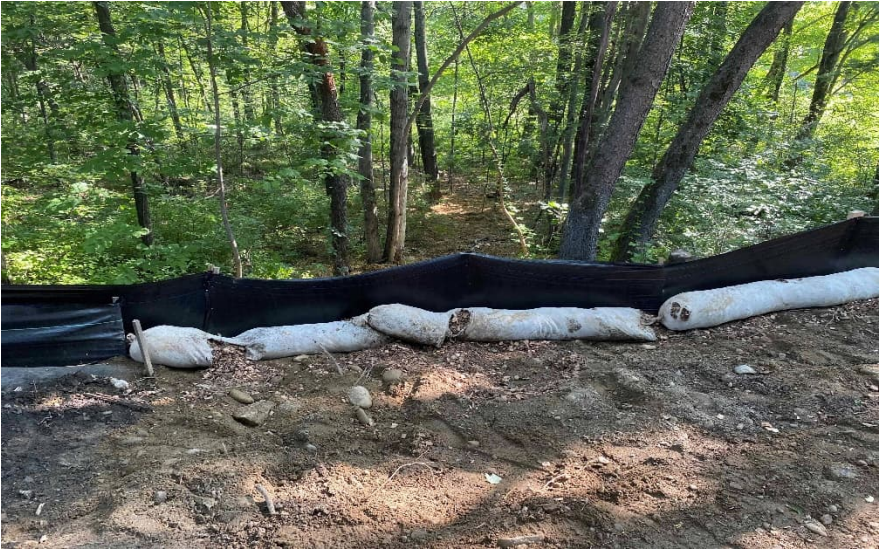
| Photo No.: 1 | Date: 7-20-23 | | |

| Description:<br><br>Work area within segment 1, repaired erosion control at approximate Sta# 128+50, looking eastward. | | | |

Corrective action noted on 7-17-23 (erosion control repairs in segment 1) completed & inspected today.

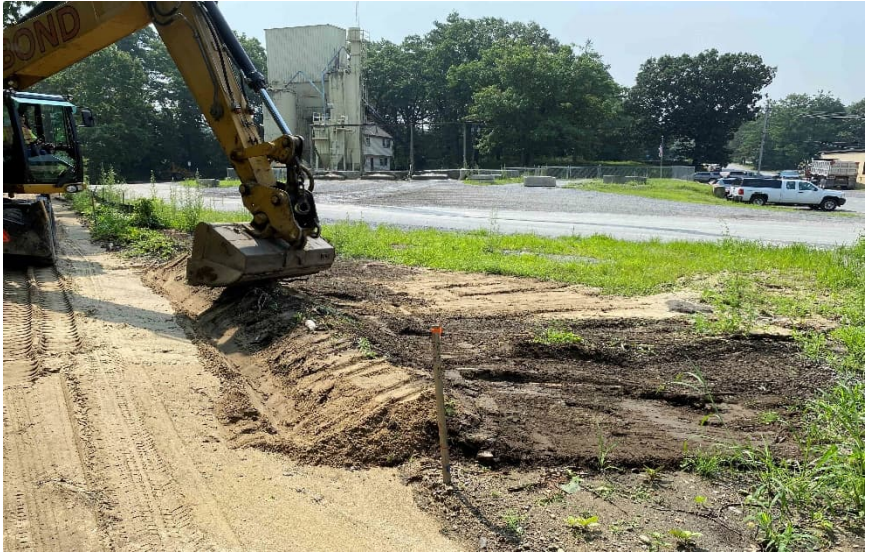
| Photo No.: 7 | Date: 7-17-23 | | |

| Description:<br><br>Historic sedimentation outside work area within segment 3 repaired, looking eastward. | | | |

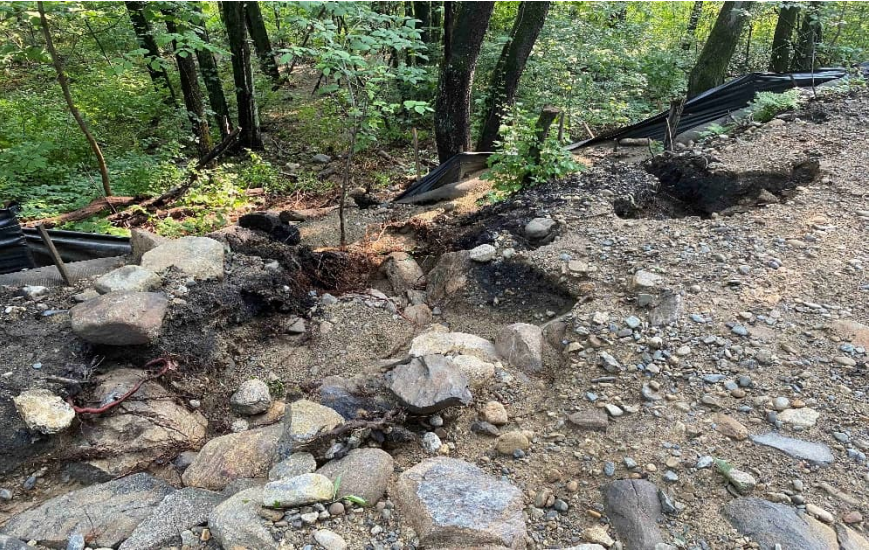
| Photo No.: 8 | Date: 7-17-23 | | |

| New Corrective Action Recommendations <input checked="" type="checkbox"/> Yes <input type="checkbox"/> No <b>Erosion control damaged within Segment 1, needs repairs (see photo 8 below).</b> |

| <b>Corrective Action recommendation for erosion control failures with discharges found outside the work area within Segment 1 as follows: Sta# 128+50 with approximately 5,000 square feet (sqft), Sta# 125+00 with approximately 400 sqft, 119+00 with approximately 100 sqft, Sta# 113+25 with approximately 200 sqft, Sta# 113+00 with approximately 100 sqft, Sta# 89+75 with approximately 400 sqft and Sta# 86+00 with approximately 50 sqft. These discharges were noted within upland areas only.</b> |

| Description:<br><br>Example of erosion control within Segment 1 (approximately Sta# 128+50) overwhelmed, sedimentation outside work area & needing repairs (silt fencing down & damaged compost filter tube), looking eastward. | | | |

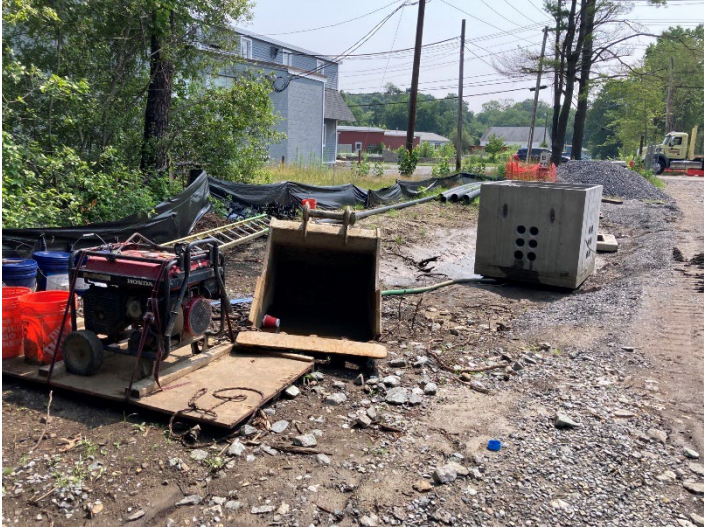
| <b>Photo No.:</b> 1 | <b>Date:</b><br>7/17/2023 | | |

| <b>Description:</b><br>View of pumping/dewatering operation at MH #24 in segment 11. Unable to visualize water prior to treatment. Facing east. | | | |

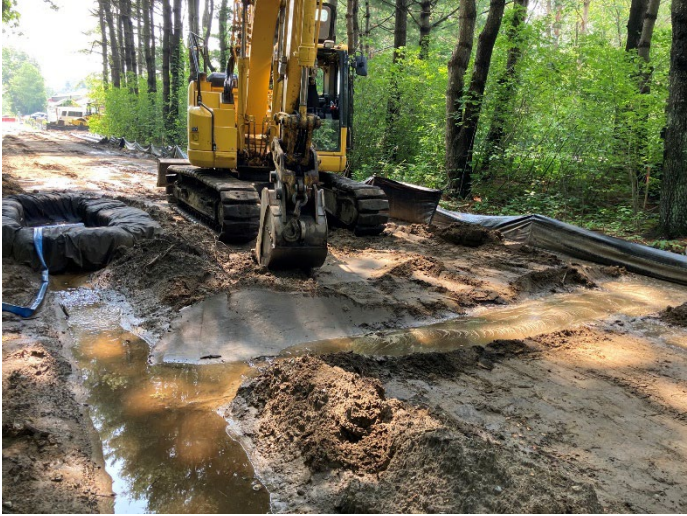
| <b>Photo No.:</b> 3 | <b>Date:</b><br>7/17/2023 | | |

| <b>Description:</b><br>View of discharge from straw bale corral. Trenches were dug in an attempt to keep water onsite and allow for infiltration. Facing east. | | | |

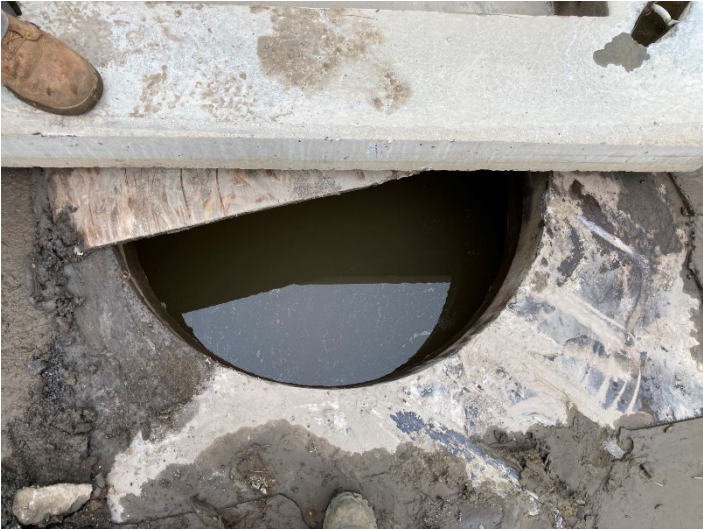
| <b>Photo No.:</b> 2 | <b>Date:</b><br>7/18/2023 | | | |

| <b>Description:</b><br>View of dewatering water prior to treatment. Water appeared slightly turbid. | | | | |

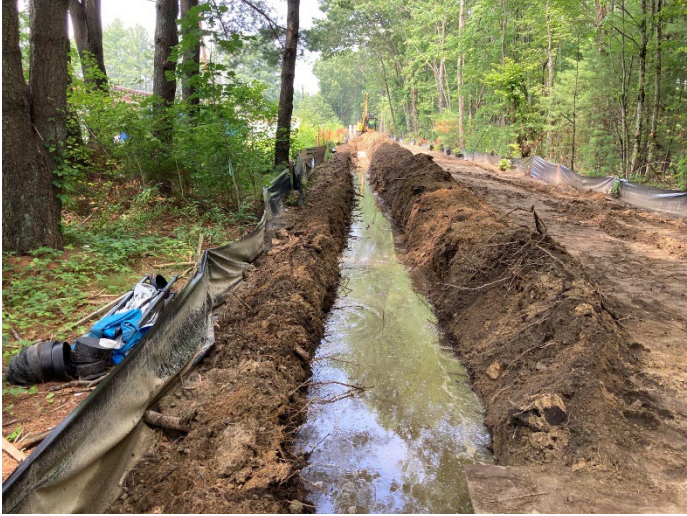
| <b>Photo No.:</b> 5 | <b>Date:</b><br>7/18/2023 | | |

| <b>Description:</b><br>Later in the day, additional trenches were dug to keep water onsite and allow for infiltration. Trenches were successful. Facing west. | | | |

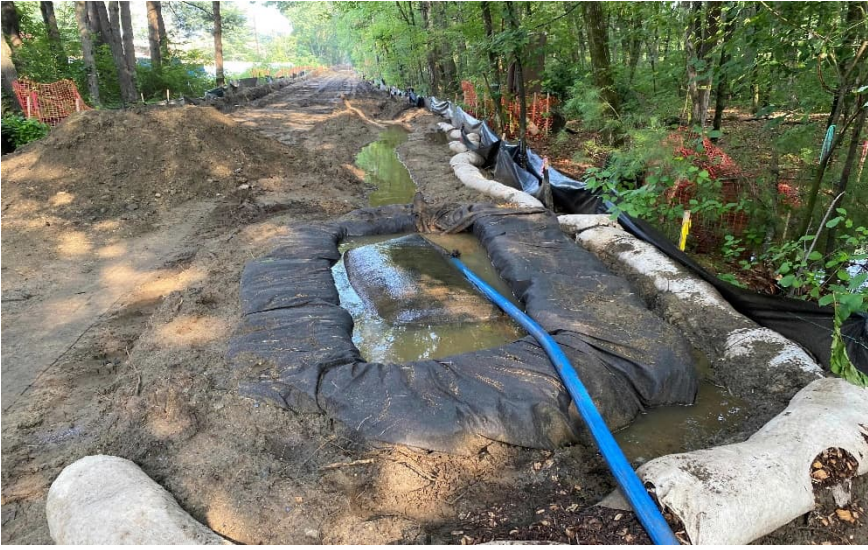
| Photo No.: 4 | Date:<br>7/19/2023 | | |

| Description:<br>Segment 11. View of discharge bag/bales, looking westward. Water discharge to bag intermittent and appeared to be slightly turbid. | | | |

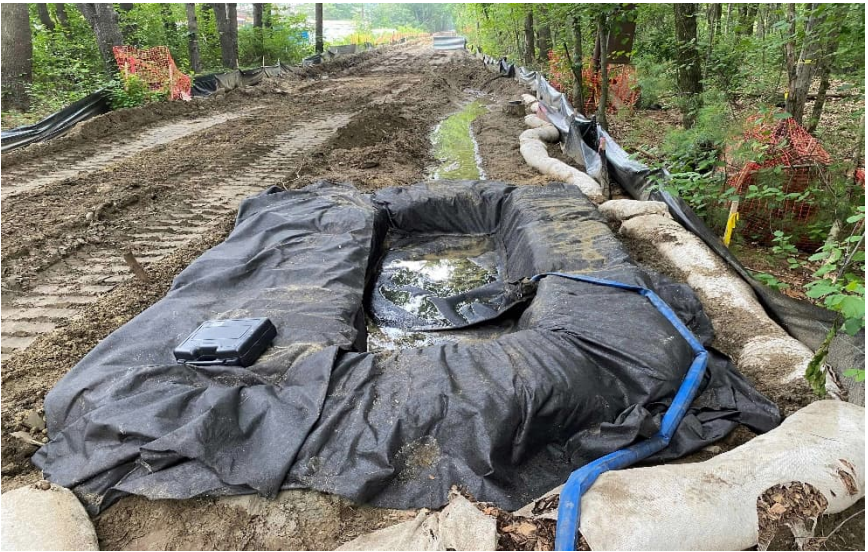
| Photo No.: 4 | Date:<br>7/21/2023 | | |

| Description:<br>Segment 11. View of discharge bag/bales, looking westward. Water discharge to bag intermittent and appeared to be clear. | | | |
