Weekly Environmental Compliance Summary

Sudbury to Hudson Transmission Reliability Project (USEPA Tracking # MAR1003UW)

Week of: July 24 to July 28, 2023

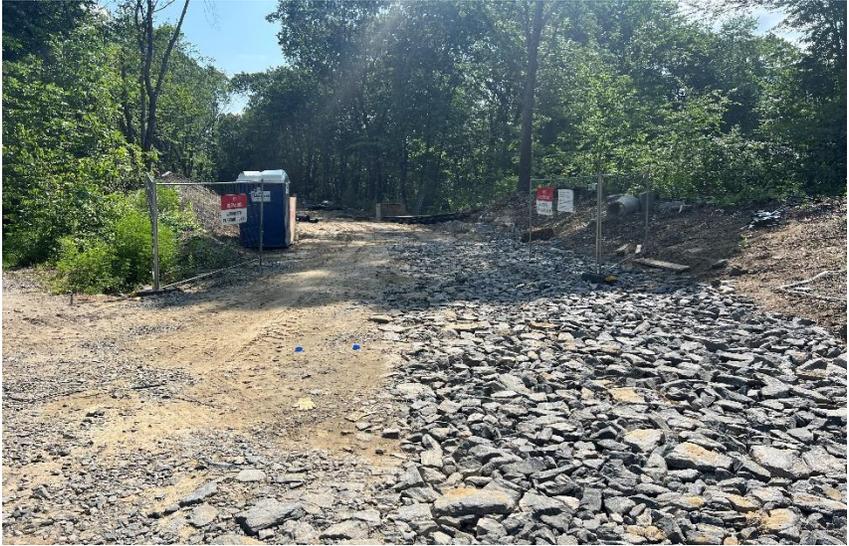
PHOTOGRAPHIC LOG	
Client Name: Eversource		Site Location: Sudbury to Hudson Transmission Reliability Project	Town: Hudson
Photo No.: 3	Date: 7-25-23

Description: The site entrance of segment 1. Erosion controls within segment 1 have been repaired and are in proper working condition. <i>Facing East.</i>

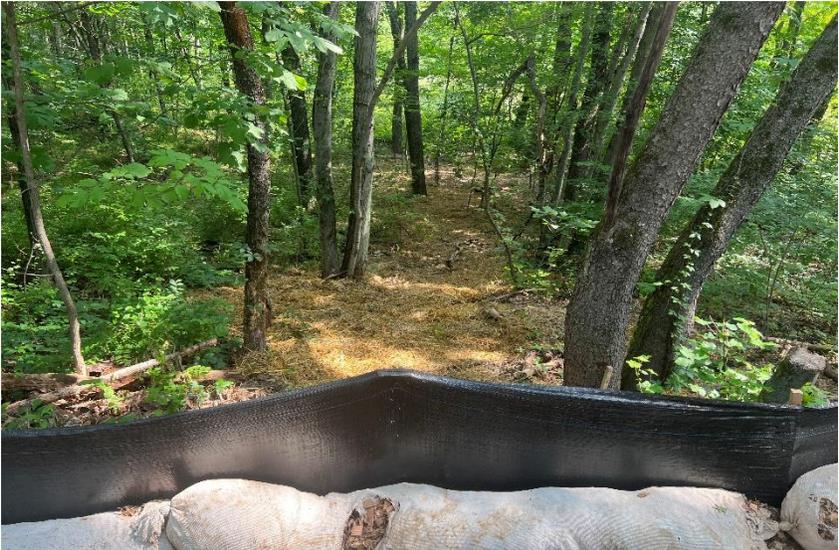
PHOTOGRAPHIC LOG	
Client Name: Eversource		Site Location: Sudbury to Hudson Transmission Reliability Project	Town: Hudson
Photo No.: 4	Date: 7-25-23

Description: Erosion controls have been repaired within segment 1 near Sta# 128+50. <i>Facing North.</i>

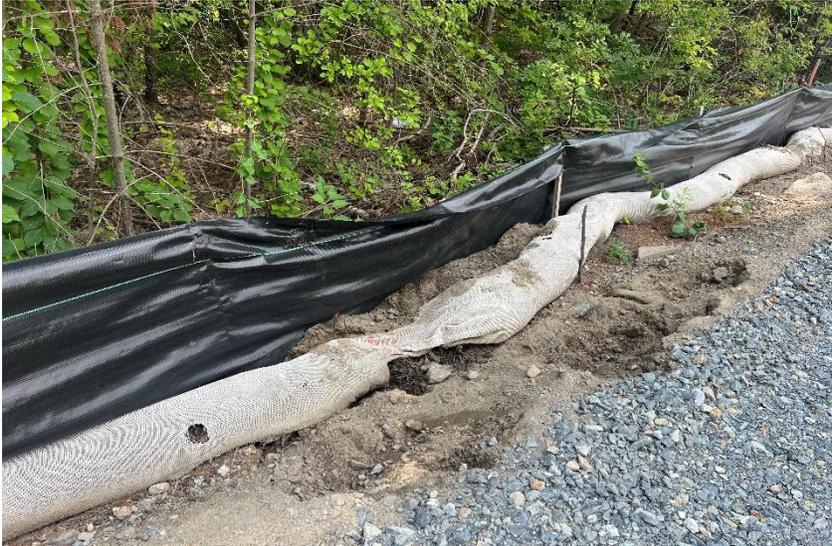
PHOTOGRAPHIC LOG	
Client Name: Eversource		Site Location: Sudbury to Hudson Transmission Reliability Project	Town: Hudson
Photo No.: 7	Date: 7-25-23

Description: Erosion controls in need of repairs within segment 3 near Sta# 161+00 have been repaired and are in working condition. <i>Facing South.</i>

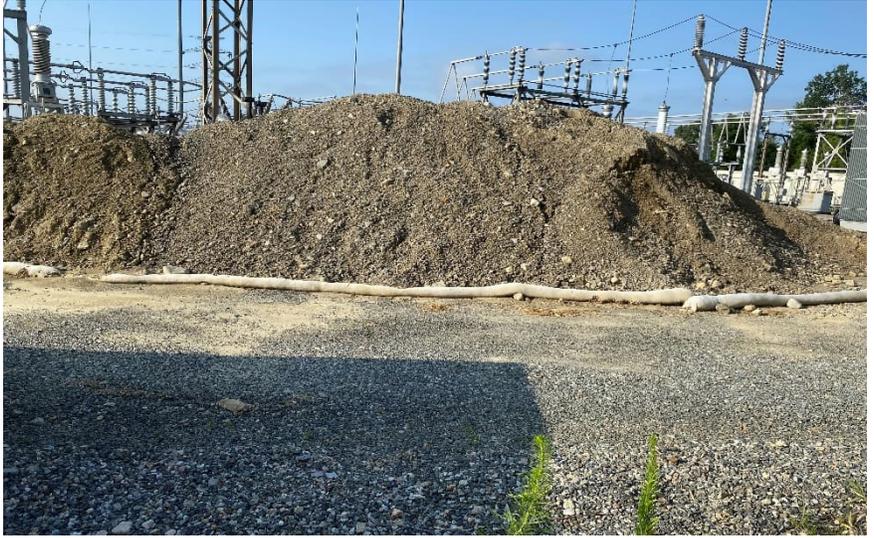
PHOTOGRAPHIC LOG	
Client Name: Eversource		Site Location: Sudbury to Hudson Transmission Reliability Project	Town: Sudbury
Photo No.: 5	Date: 7-25-23

Description: Spoil pile within substation with compost filter tubes surrounding spoils, installed and functioning correctly, looking westward.

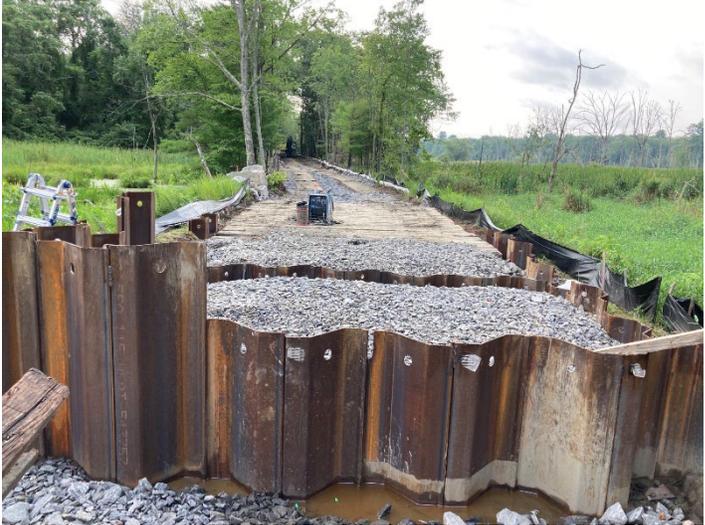
<p>Description: View of sheets at bridge 127 in segment 14. Silt fence is in need of repair in this area (routine maintenance). Facing east.</p>

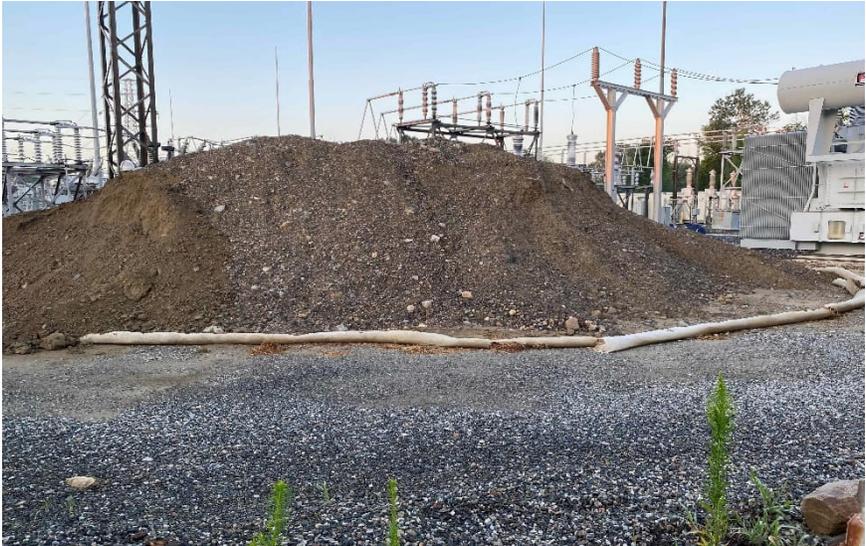
<p>Description:</p> <p>Spoil pile within substation surrounded by compost filter tubes, installed and working properly, looking southward.</p>

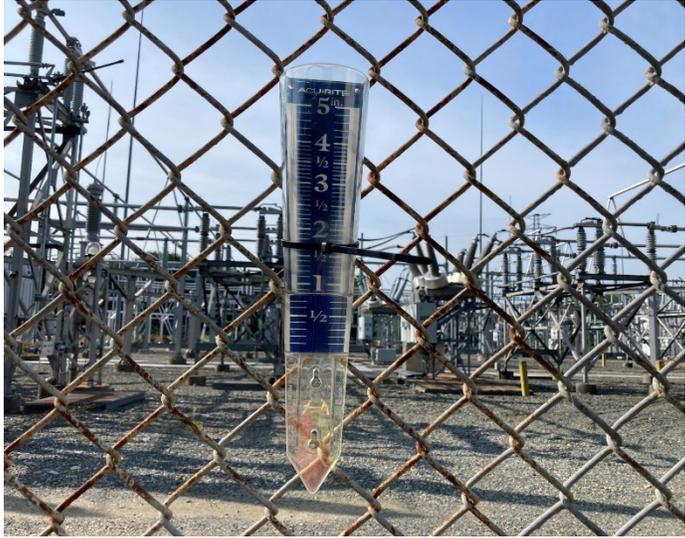
Description: View of rain gauge at Sudbury Substation. 0.80" observed in gauge at 9:00am. Facing south.

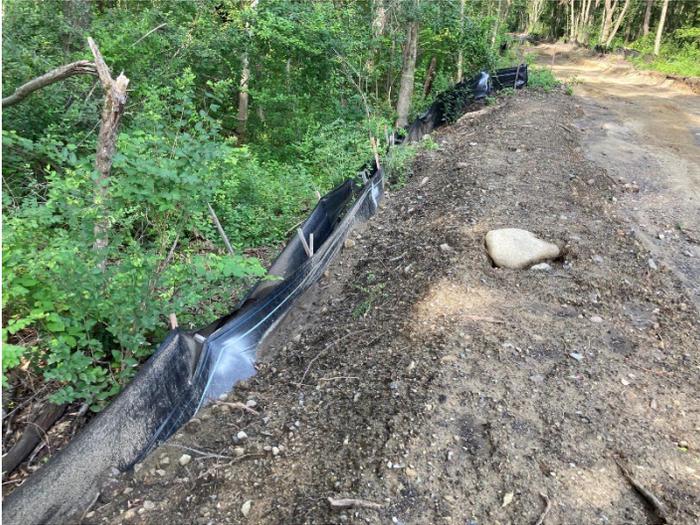
Description: Silt fence is in need of repair at multiple locations in segment 14 (routine maintenance). Facing west.

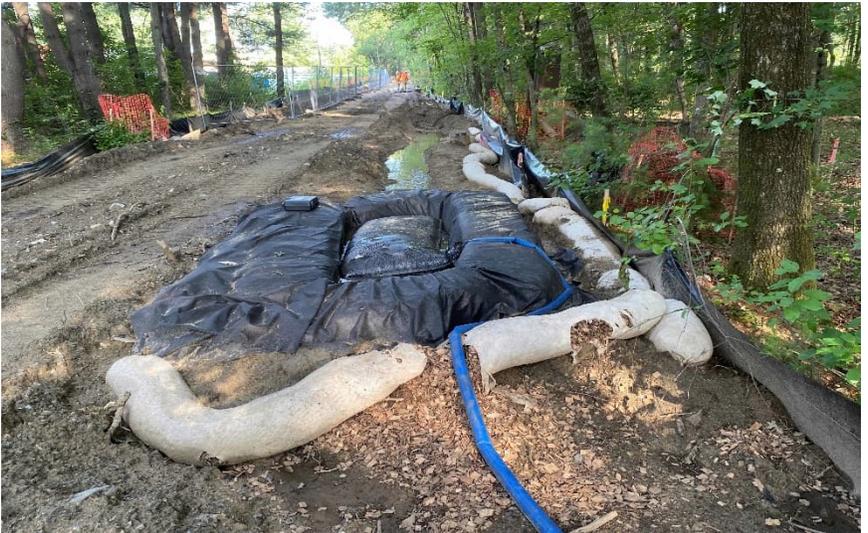
Description: Segment 11. View of discharge bag/bales, looking westward. Water discharge to bag intermittent and appeared to be clear.

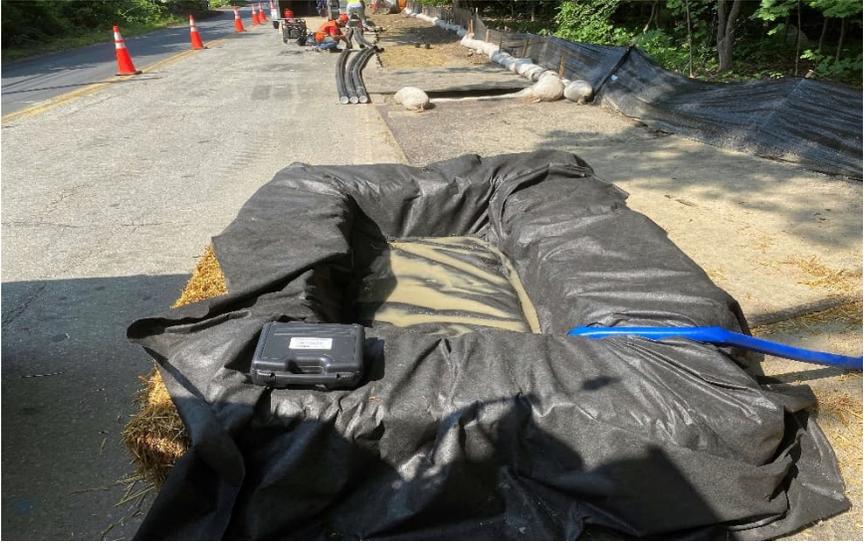
Description: Wilkins Avenue. View of discharge bag/bales, looking westward. Water discharge to bag intermittent and appeared to be turbid.
