Weekly Environmental Compliance Summary

Sudbury to Hudson Transmission Reliability Project (USEPA Tracking # MAR1003UW)

Week of: July 31 to August 4, 2023

CONSTRUCTION MONITORING REPORT
Sudbury to Hudson Transmission Project

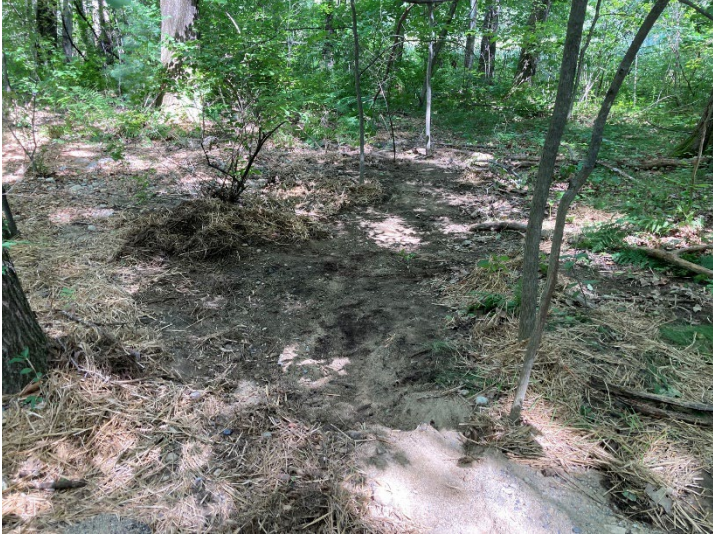
PHOTOGRAPHIC LOG	
Client Name: Eversource		Site Location: Sudbury to Hudson Transmission Reliability Project	
Town: Hudson			
Photo No.: 3	Date: 8/01/2023

Description: View of sediment removal in progress at Sta. #128+50 LT in segment 1. Facing north.

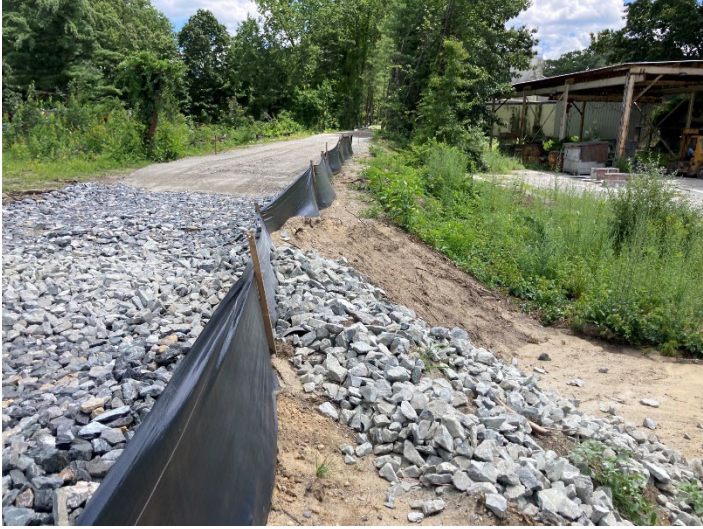
PHOTOGRAPHIC LOG	
Client Name: Eversource		Site Location: Sudbury to Hudson Transmission Reliability Project	Town: Hudson
Photo No.: 5	Date: 8/01/2023

-Silt fence and erosion have been repaired at Sta. #166 RT in segment 3.

Description: Silt fence and erosion have been repaired at Sta. #166 RT in segment 3. Facing east.

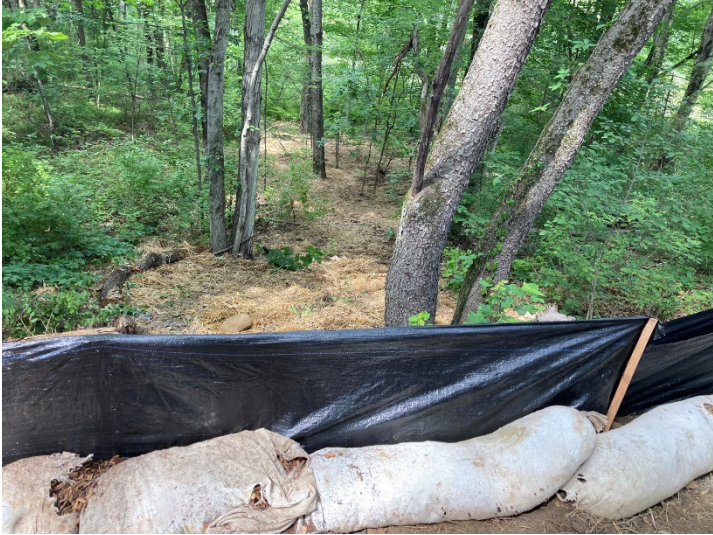
PHOTOGRAPHIC LOG	
Client Name: Eversource		Site Location: Sudbury to Hudson Transmission Reliability Project	Town: Hudson
Photo No.: 3	Date: 8/02/2023

Description: View of Sta. #128+50 LT in segment 1. E&S controls have been repaired. Deposited sediment has been removed from beyond limit of work and groundcover has been applied. Facing north.

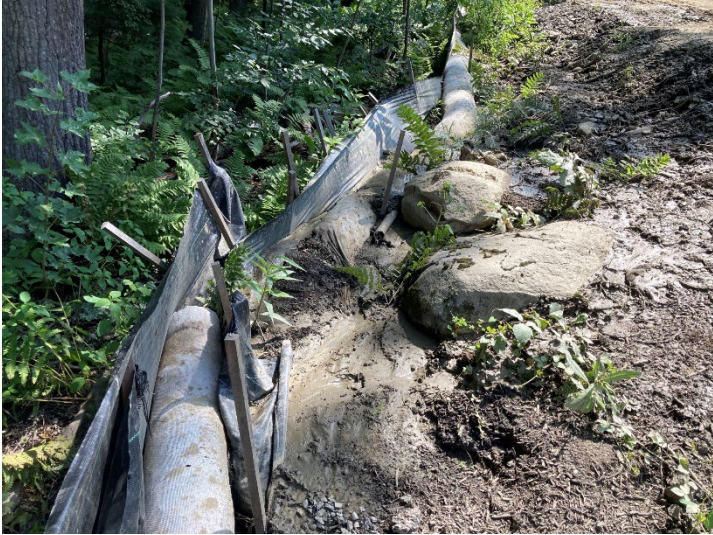
<p>Description: View of Sta. #116 LT in segment 1. E&S controls are in need of repair in multiple locations in this segment. Facing east.</p>

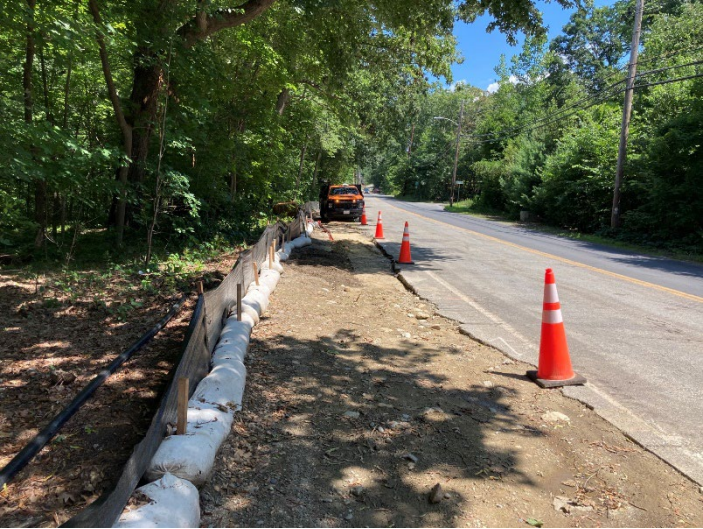
Description: View of Bond working on Wilkins St. E&S controls in this area are in good condition. Facing north.

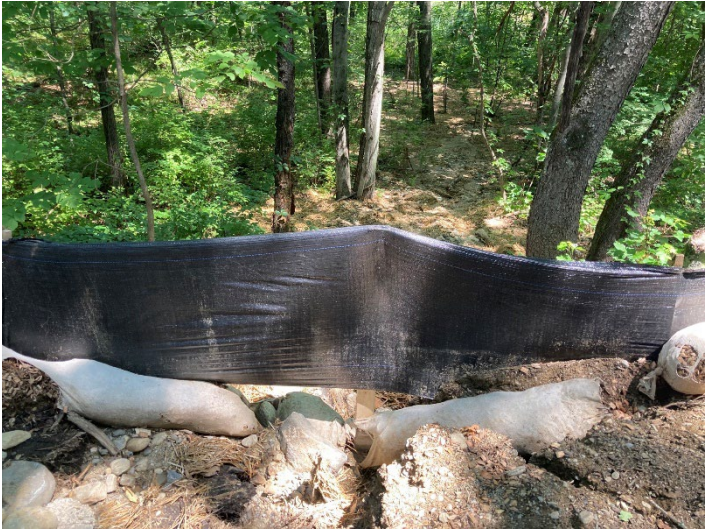
-During heavy rains, storm water overwhelmed existing erosion controls and flowed off the work area at Sta. #128+50 LT. Stormwater discharge was not in progress during inspection. Sediment deposited beyond limit of work, but did not appear to reach any jurisdictional areas. Approximately 3,000 sqft of sediment observed beyond perimeter controls. Repair E&S controls, repair erosion, and remove deposited sediment (corrective action).

Description: View of damaged E&S controls and sedimentation outside of work area at Sta. #128+50 LT in segment 1. Silt fence and filter tube are in need of repair. It is also necessary to repair erosion and remove deposited sediment by hand (corrective action). Facing north.

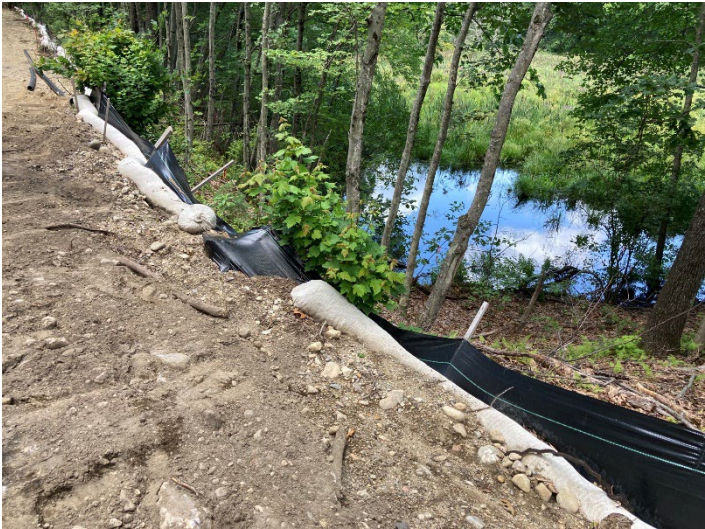
Description: View of damaged E&S controls near Chestnut St in segment 1. Repairs to E&S controls are needed here and throughout this segment (routine maintenance). Facing northwest.

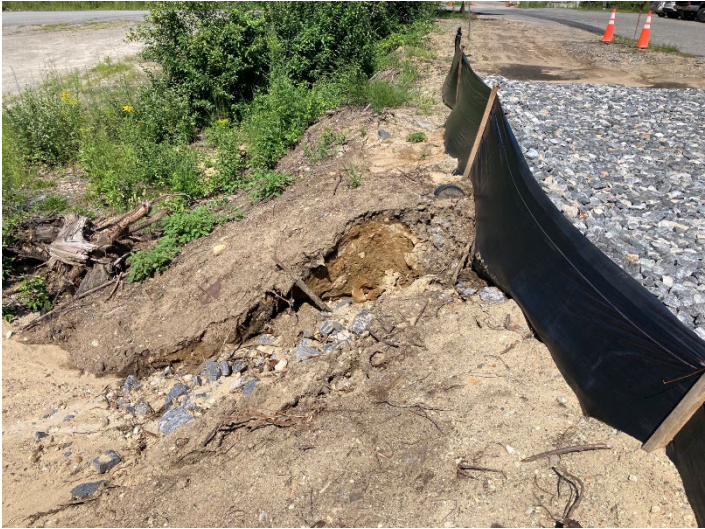
-Erosion and washout noted at approximately Sta. #166 rt in segment 3. Sediment deposited beyond limit of work, but did not reach any jurisdictional areas. Recommend repairing erosion and removing deposited sediment. Repair silt fence where undermined (routine maintenance).

Description: View of erosion and washout noted at approximately Sta. #166 RT in segment 3. Recommend repairing erosion and removing deposited sediment. Repair silt fence where undermined (routine maintenance). Facing west.

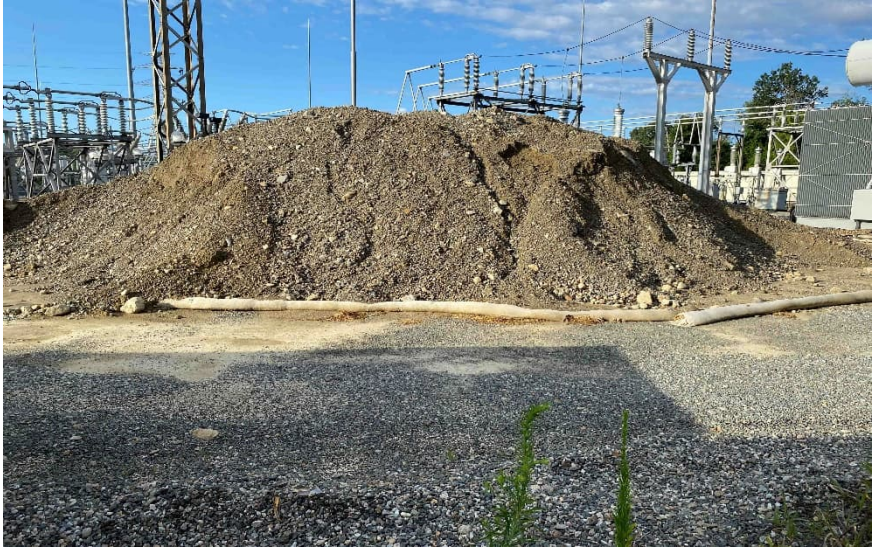
Description: Spoil pile within substation surrounded by compost filter tubes, installed & functioning correctly, looking southward.

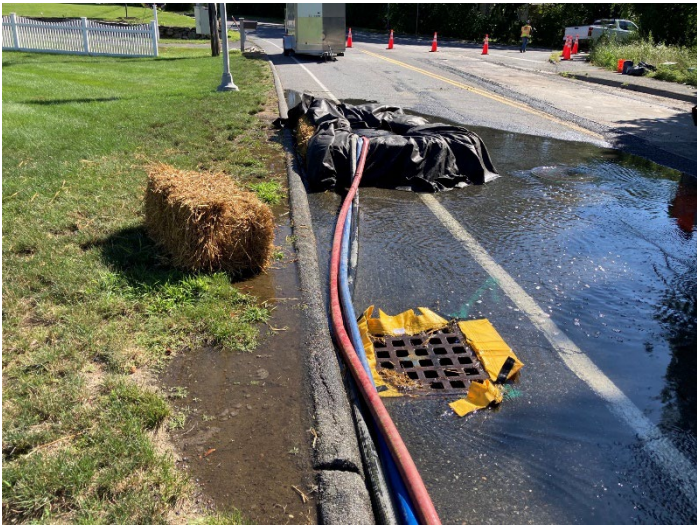
Description: View of dewatering controls (straw bale corral with filter fabric and silt bag) and discharge point from project (catch basin below hay bale corral on Forest Ave). Discharge appeared clear. Turbidity reading was below 50 NTUs. Facing north.

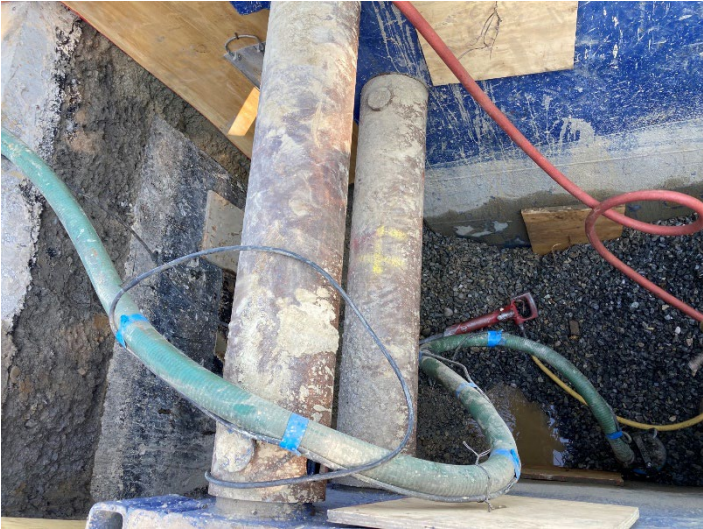
Description: View of water in trench prior to treatment. Water appeared turbid.

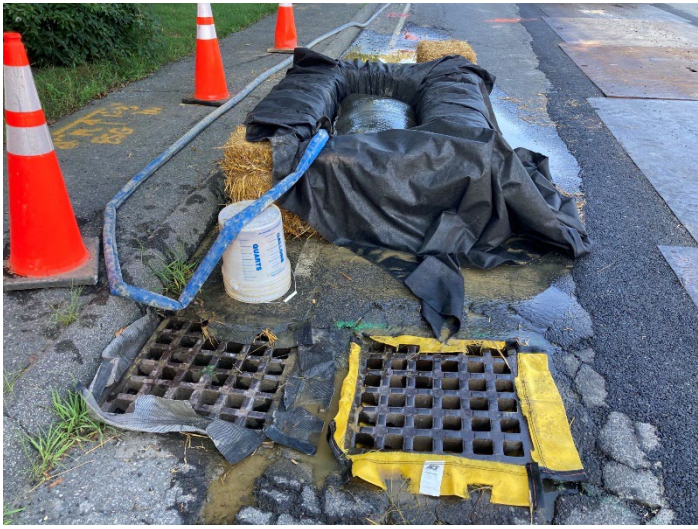
Description: View of dewatering controls (straw bale corral with filter fabric and silt bag) and discharge point from project (catch basins below hay bale corral on Forest Ave). Discharge appeared slightly turbid. Turbidity reading was higher than 50 NTUs. Facing south.

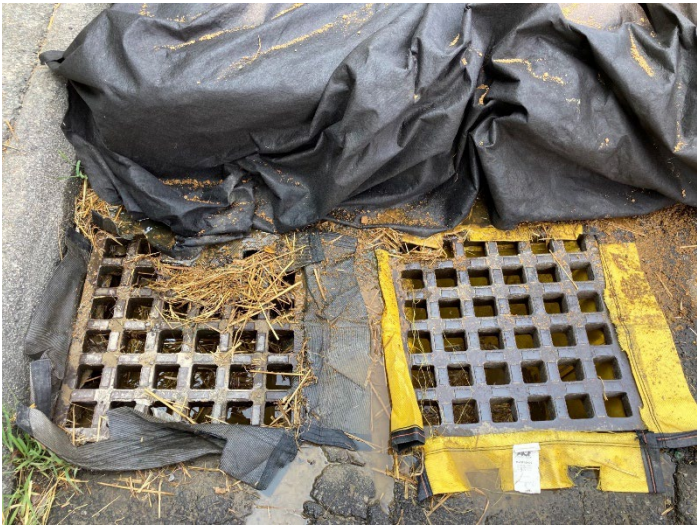
Description: View of discharge point from project (catch basins below hay bale corral on Forest Ave). Discharge appeared slightly turbid. Turbidity reading was higher than 50 NTUs. Facing south.
