Weekly Environmental Compliance Summary

Sudbury to Hudson Transmission Reliability Project (USEPA Tracking # MAR1003UW)

Week of: August 7 to August 11, 2023

CONSTRUCTION MONITORING REPORT

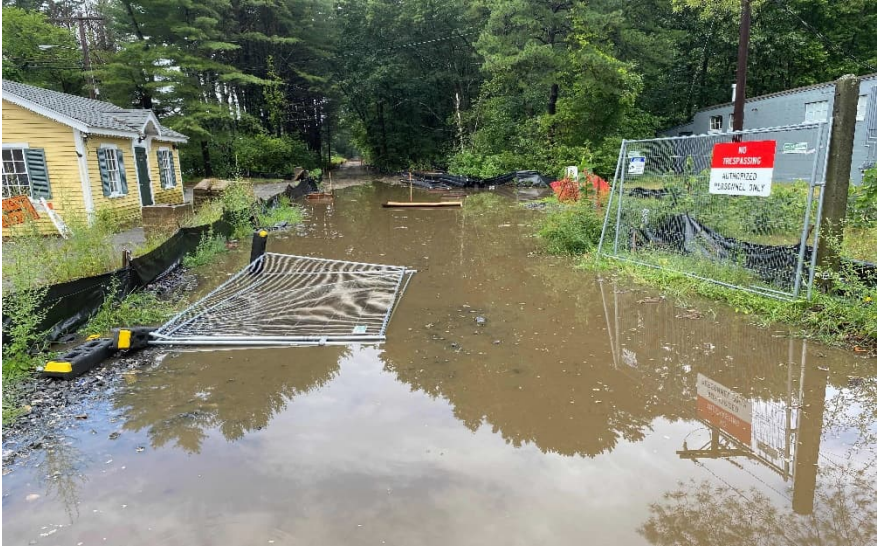
PHOTOGRAPHIC LOG	
Client Name: Eversource		Site Location: Sudbury to Hudson Transmission Reliability Project	Town: Sudbury
Photo No.: 5	Date: 8-8-23

Description: Work area within segment 11, area flooded, existing erosion control, looking westward.

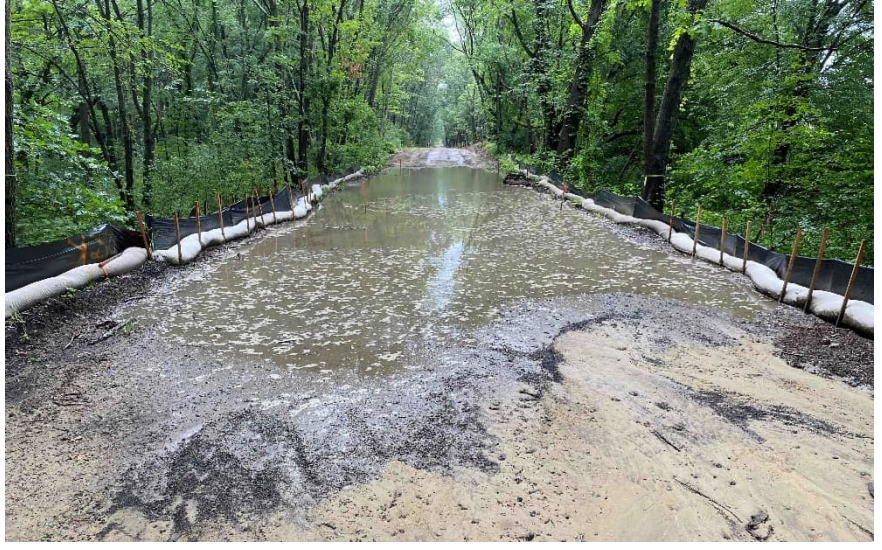
PHOTOGRAPHIC LOG	
Client Name: Eversource		Site Location: Sudbury to Hudson Transmission Reliability Project	Town: Sudbury
Photo No.: 6	Date: 8-8-23

Description: Segment 11, site of previous erosion control failure, but stable today, existing erosion control, looking eastward.

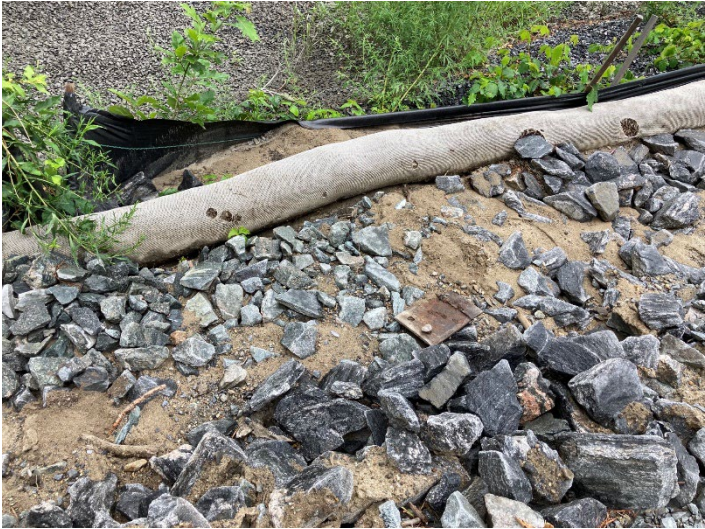
Description: Example of E&S controls in need of repair in segment 3 (routine maintenance). Facing south.

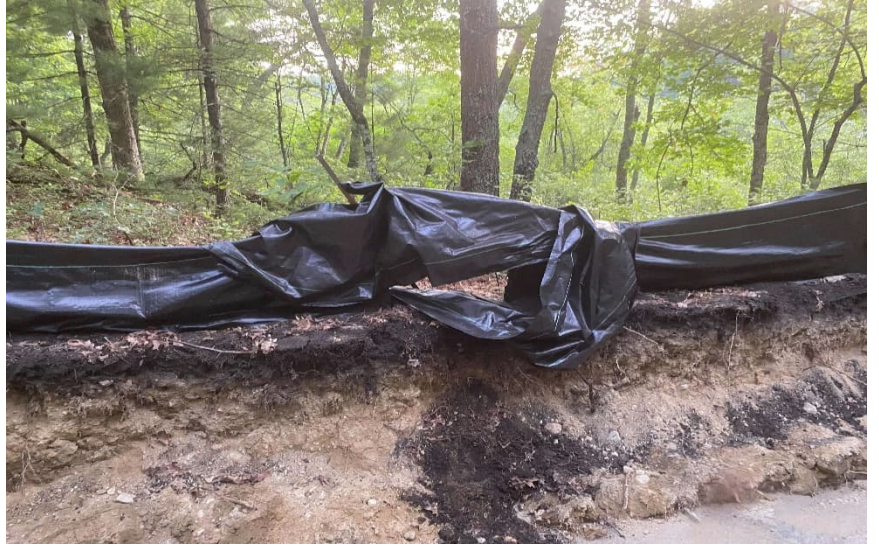
New Corrective Action Recommendations Yes No Erosion control (silt fencing) within segment 8 disturbed as a result of conduit work, needs repairs. See photo 2.

Description: Work area within Segment 8, silt fencing disturbed & needs repairs, looking eastward.

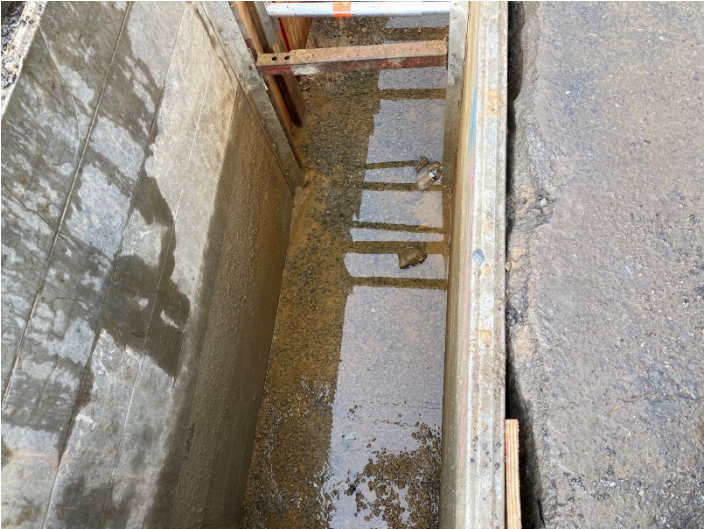
Description: View of trench and water prior to treatment. Water appeared slightly turbid.

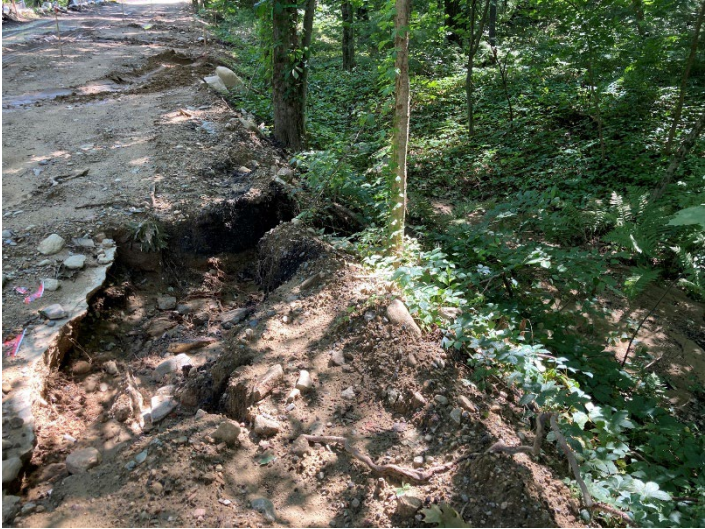
Description: View of erosion/washouts observed between Sta. #110+50 and Sta. #112+50 RT in segment 1. Sediment has deposited beyond limit of work and should be removed. It is recommended that E&S controls be installed in this area although controls are not called for on the plans. Facing east.

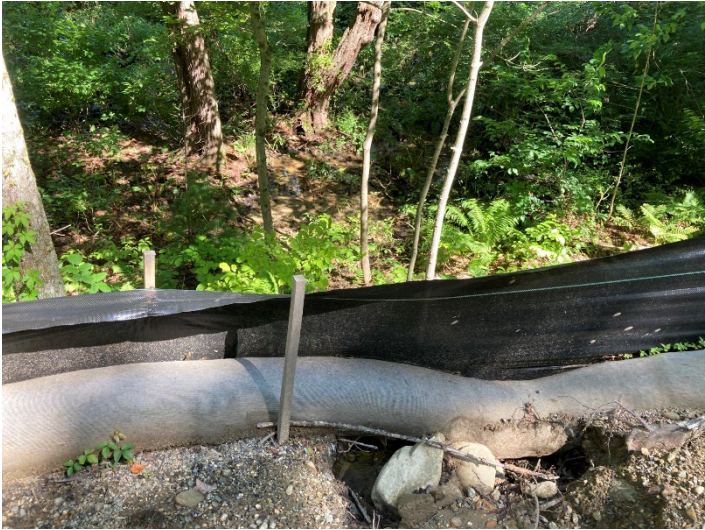
Description: View of approximately Sta. #109 LT in segment 1. E&S controls are undermined and in need of repair. Sediment has deposited beyond limit of work and into adjacent wetland. Sediment should be removed from wetland by hand, per instruction from Hudson CC. Facing north.

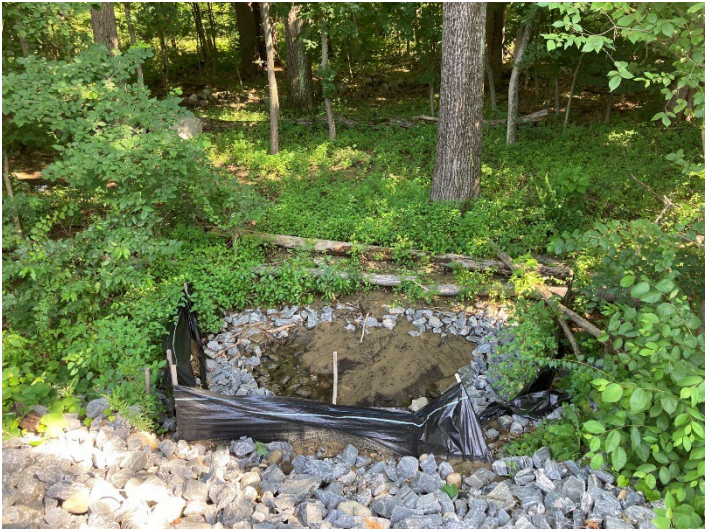
Description: View of Sta. #119+25 LT (concrete headwall/drainage structure 4) in segment 1. Silt fence along rip rap below headwall is in need of repair. Sediment has collected on rip rap and should be removed. Sediment appears to have deposited beyond rip rap and cattle crossing and should be removed. Facing north.

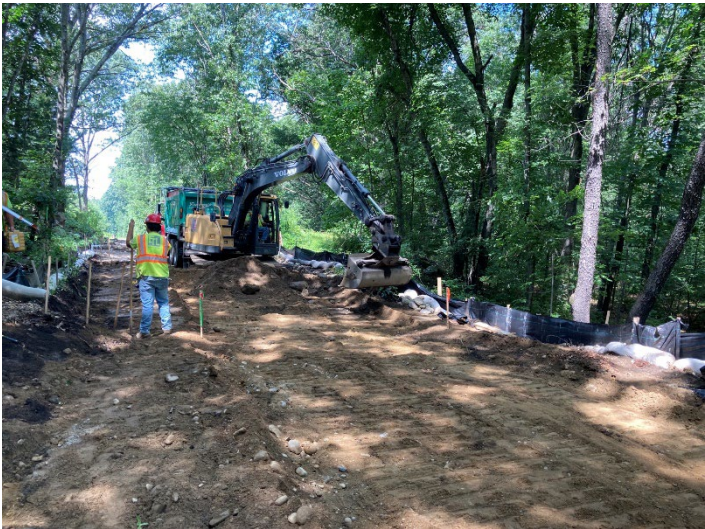
Description: View of ET&L repairing erosion and E&S controls at Sta. #128+50 in segment 1. Facing west.

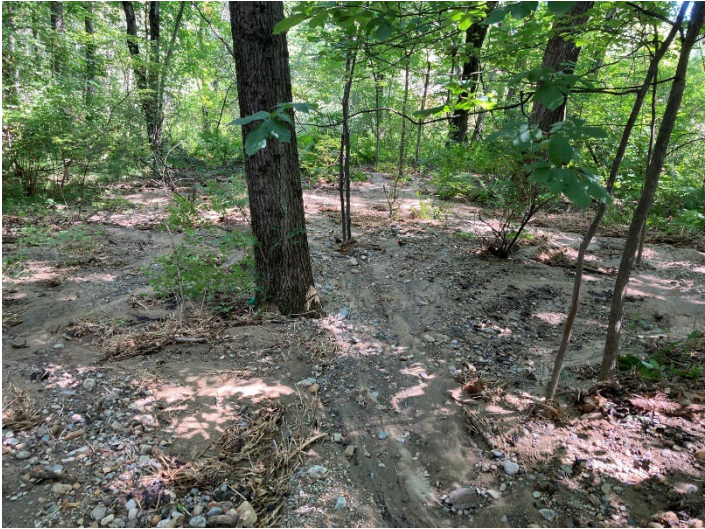
Description: View of sediment that has deposited beyond limit of work at Sta. 128+50 LT in segment 1. Sediment should be removed. E&S controls have been repaired in this area (see photo above). Facing north.

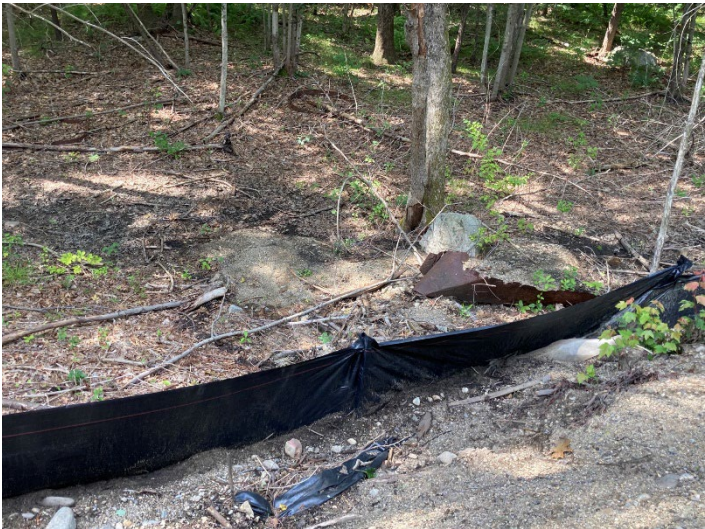
Description: View of Sta. #138 RT in segment 2. Sediment has deposited beyond limit of work and should be removed. Silt fence has been repaired, but new filter tube is needed. Facing south.

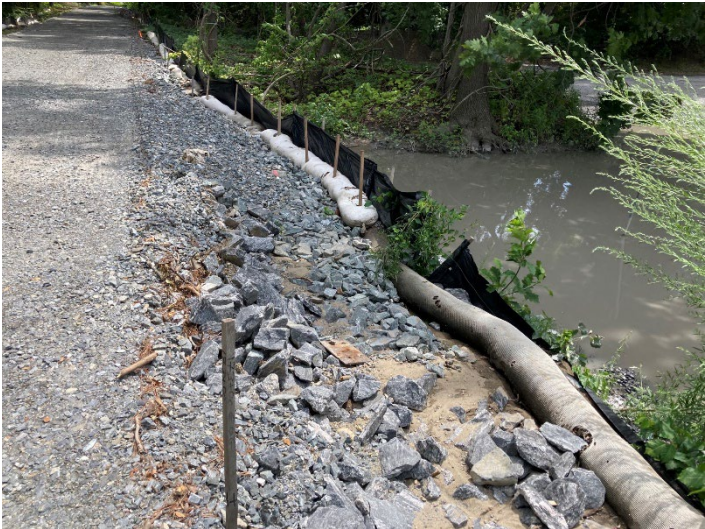
Description: Example of E&S controls in need of repair in segment 3. Facing east.

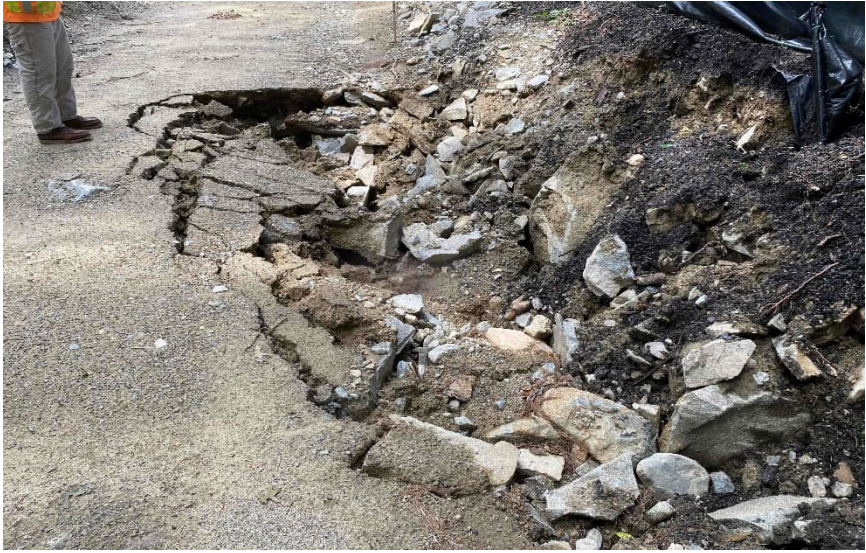
Description: Work area within segment 9, collapse of work area above culvert at Sta# 521+69 (repairs needed), looking westward.

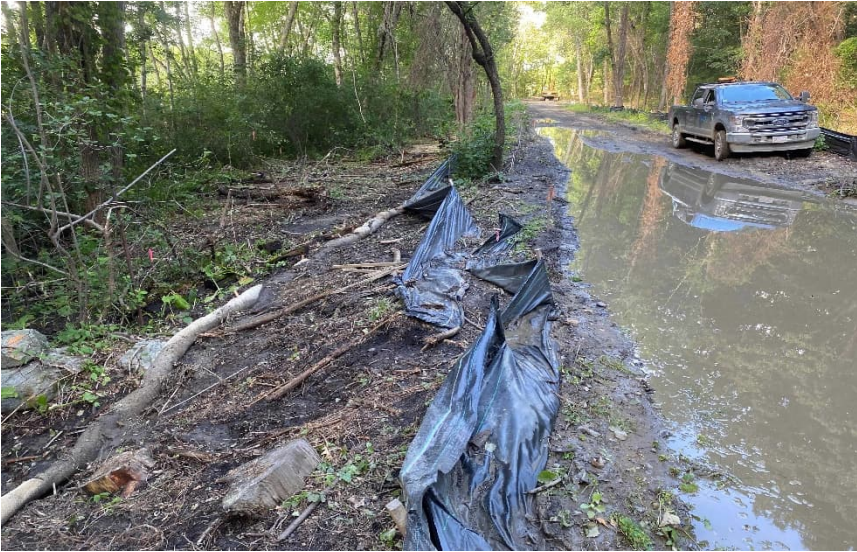
Description: Work area within segment 14 at Sta# 741+75, collapse of erosion control (needing repair), looking westward.
