**Weekly Environmental Compliance Summary**

**Sudbury to Hudson Transmission Reliability Project (USEPA Tracking # MAR1003UW)**

Sudbury, Hudson, and Stow, MA

Week of: August 14 to August 18, 2023

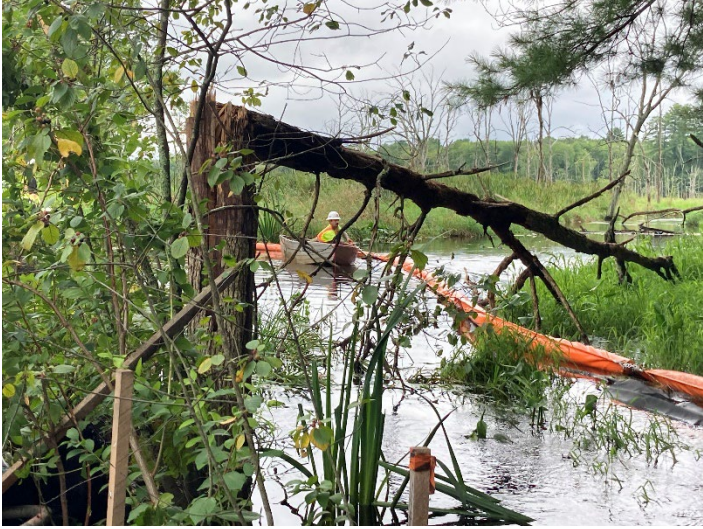
<b>PHOTOGRAPHIC LOG</b>	
<b>Client Name:</b> Eversource		<b>Site Location:</b> Sudbury to Hudson Transmission Reliability Project	<b>Town:</b> Sudbury
<b>Photo No.:</b> 5	<b>Date:</b> 8/15/2023

<b>Description:</b> View of ET&L repairing turbidity curtain and removing debris from water at bridge 127. Facing east.

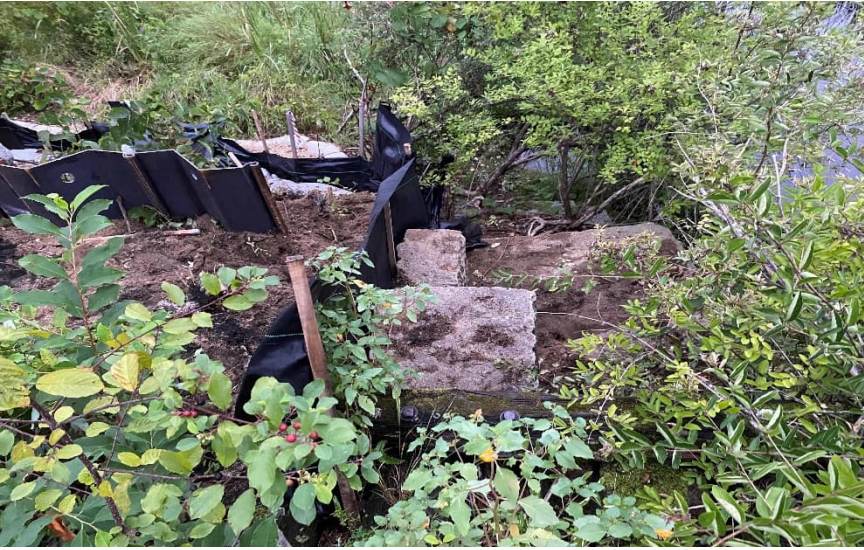
<b>PHOTOGRAPHIC LOG</b>	
Client Name: Eversource		Site Location: Sudbury to Hudson Transmission Reliability Project	Town: Sudbury
Photo No.: 8	Date: 8-17-23

New Corrective Action Recommendations    Yes    No    Corrective action from yesterday (fix silt fencing within segment 7) completed, see photo 8

Description:  Repaired silt fencing within segment 7 at bridge 128, looking northward.

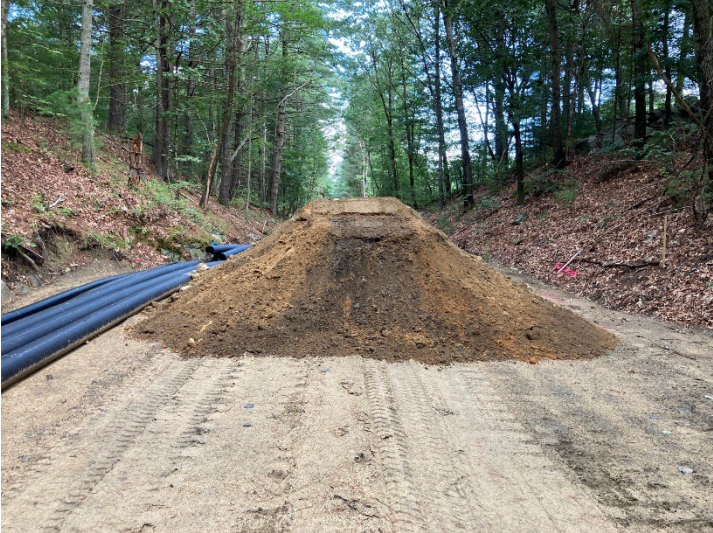
<b>PHOTOGRAPHIC LOG</b>	
<b>Client Name:</b> Eversource		<b>Site Location:</b> Sudbury to Hudson Transmission Reliability Project	<b>Town:</b> Sudbury
<b>Photo No.:</b> 2	<b>Date:</b> 8/17/2023

Identify presence of stockpiles and document when placed and when removed (week maximum for stockpiles)  
**-Stockpile is present behind Eversource trailer in Sudbury Substation. Week maximum does not apply at this location.**  
**-Stockpile noted today (8/17/2023) within ROW in segment 9.**

<b>Description:</b> View of stockpile noted in segment 9. Facing east.

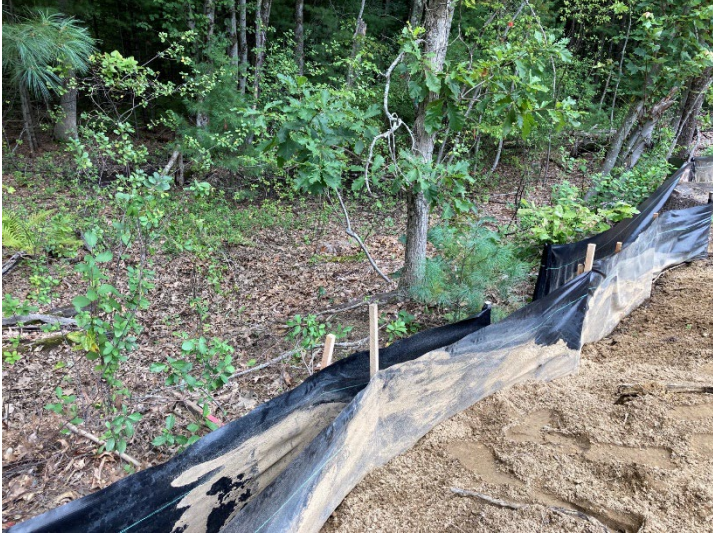
<b>PHOTOGRAPHIC LOG</b>	
<b>Client Name:</b> Eversource		<b>Site Location:</b> Sudbury to Hudson Transmission Reliability Project	<b>Town:</b> Sudbury
<b>Photo No.:</b> 3	<b>Date:</b> 8/17/2023

**-E&S repairs in segment 11 have been completed.**

<b>Description:</b> View of Sta. #595 in segment 11. Silt fence has been repaired and sediment has been removed from beyond limit of work. Facing northeast.

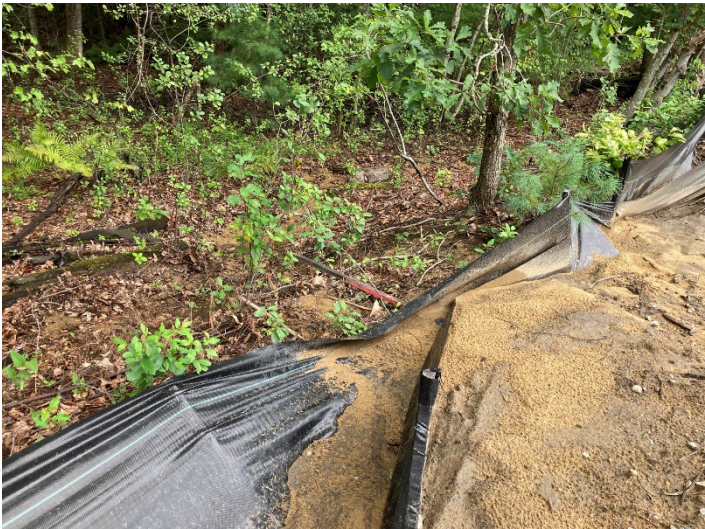
-At Sta. #595 in segment 11, sediment overtopped the silt fence and deposited beyond limit of work. Sediment did not reach a jurisdictional area. Silt fence should be repaired and sediment should be removed (routine maintenance).

<b>Description:</b> View of Sta. #595 in segment 11. During storm event, sediment overtopped the silt fence and deposited beyond limit of work. Sediment did not reach a jurisdictional area. Silt fence should be repaired and sediment should be removed. Facing northeast.

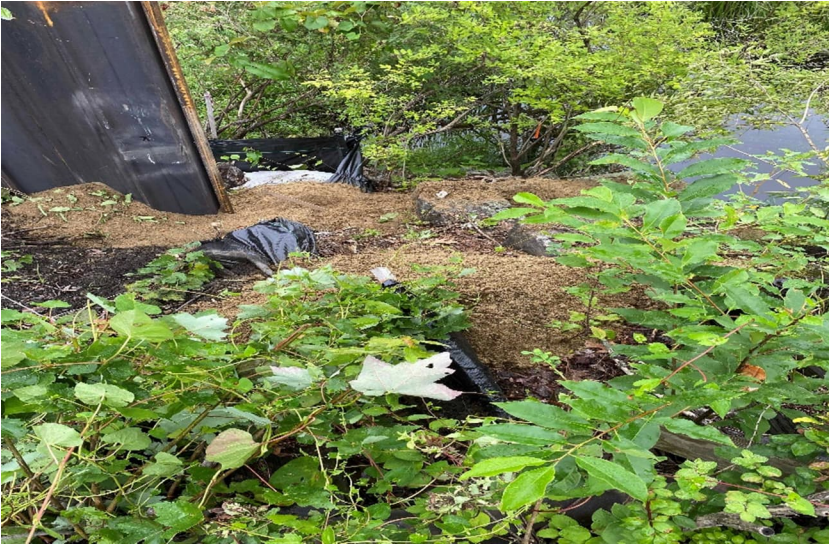
New Corrective Action Recommendations    Yes     No    **Erosion control damaged within segment 7 during sheeting placement for bridge 128 work, see photo 8.**

Description:  Erosion controls (silt fencing) disturbed by sheeting installation activities within segment 7, to be repaired, looking northward.

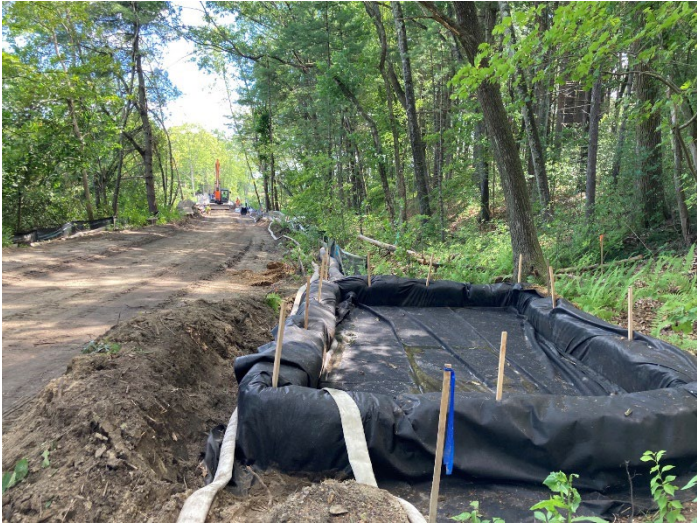
<b>Description:</b> Additional view of dewatering controls. Very little discharge from corral was observed, and therefore turbidity sample was unable to be collected. Facing east.

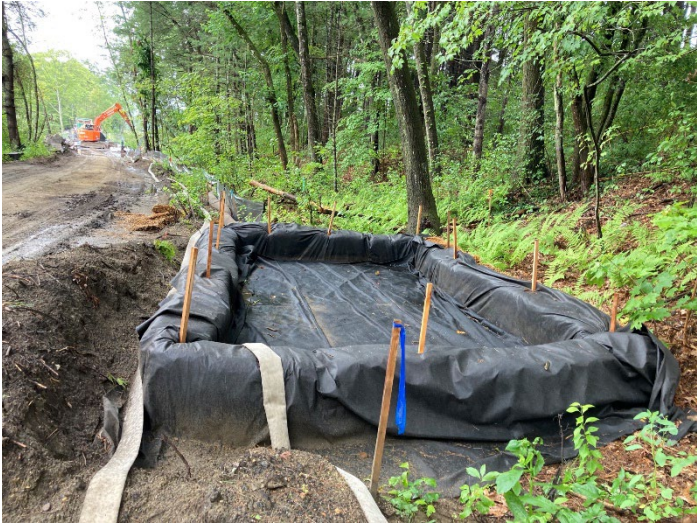
<b>Photo No.:</b> 4	<b>Date:</b> 8/15/2023		
<b>Description:</b> Additional view of dewatering controls. Very little discharge from corral was observed, and therefore turbidity sample was unable to be collected. Facing east.

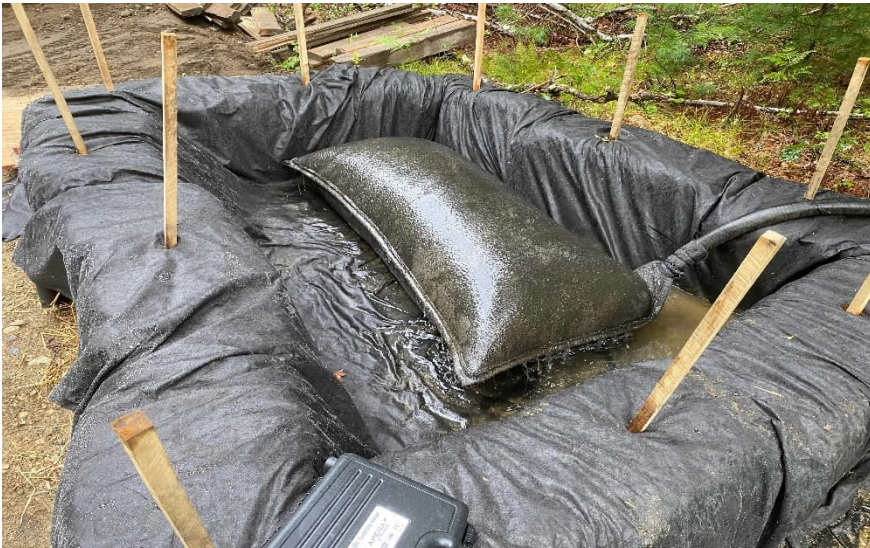
Description: Segment 6. View of discharge bag/bales, looking westward. Water discharge to bag intermittent and appeared to be slightly turbid.

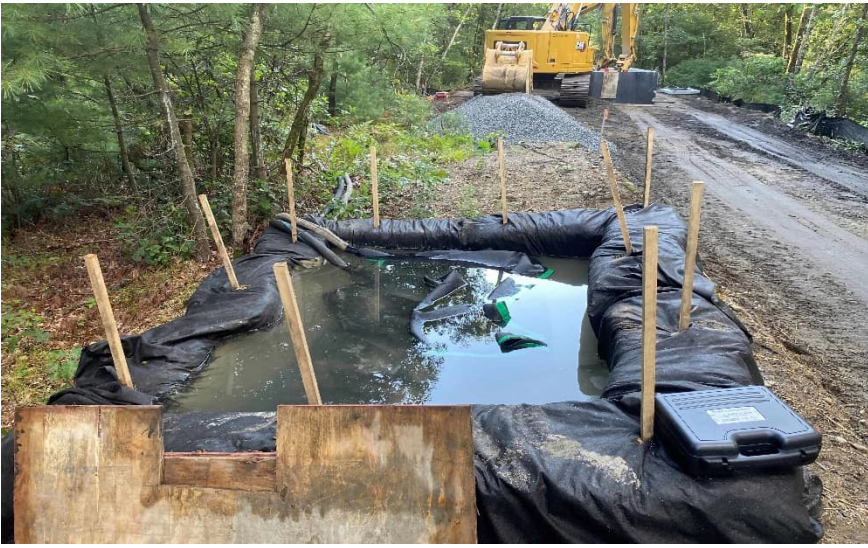
Description: Segment 6. View of discharge bag/bales, looking eastward. Water discharge to bag intermittent and appeared to be slightly turbid.
