| Field | Report | No. | 14 |

| • | | | | | |
|---|---|---|---|---|--|
| | Project Name: | Sudbury-Hudson Transmission Reliability | | | |
| Horsley Witten | Inspection Date: | 9/06/23 | Arrival Time: | 8:00 AM | |

115kV Underground Transmission Line

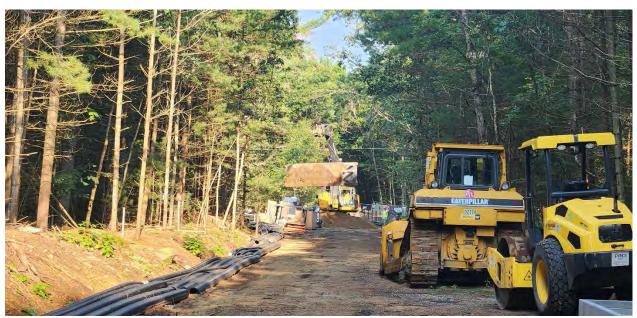
- Silt fence and filter tube are functioning properly along segments 7-9, 12, and 14.
- A manhole was being installed in between segment 8 and segment 9 (Photo 1)
- Silt fence has a broken stake along segment 10 (Photo 2).
- Sediment has tracked into the road from gravel construction entrance STA 361+00 (Photo 3).
- Silt fence has a broken stake along segment 11 in two places (Photo 3).
- Silt fence is under a boulder at a point along segment 13 (Photo 4).
- Silt fence has a broken stake at Bridge 127 along segment 13 (Photo 5)
- Form, rebar, and pour abutment wall was being installed at Bridge 127 (Photo 6).

Photo 1: Manhole installation between segment 8 and segment 9. Photo taken on 9/06/23

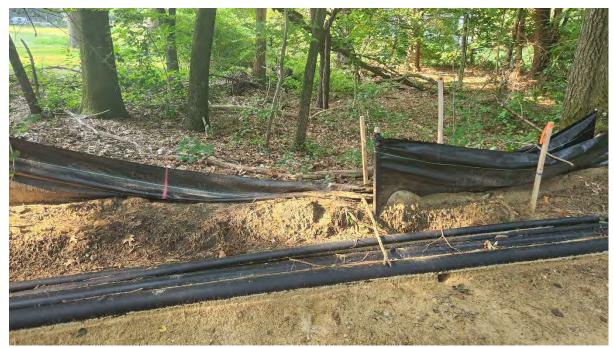
Photo 2: Broken stake in the silt fence along segment 10. Photo taken on 9/06/23

1. Repair silt fence and filter tube as noted above.

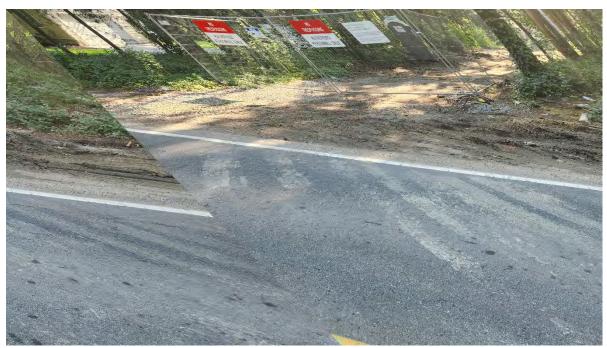
Photo 3: Sediment in the road from gravel construction entrance STA 361+00. Photo taken on 9/06/23

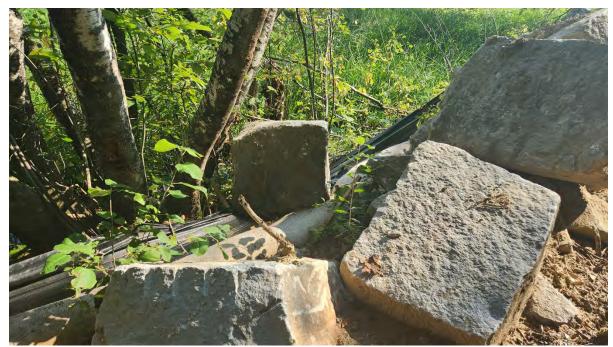
Photo 4: Boulder on the silt fence along segment 13. Photo taken on 9/06/23

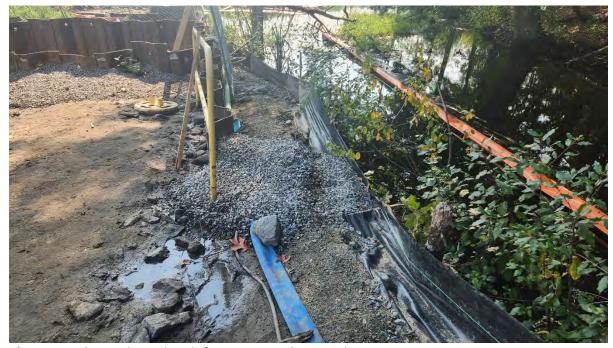
Photo 5: Broken stake in the silt fence near Bridge 127 along segment 13. Photo taken on 9/06/23

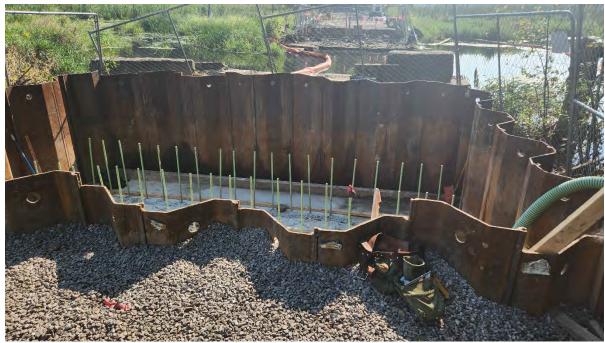
Photo 6: Form, rebar, and pour abutment wall being installed at Bridge 127. Photo taken on 9/06/23
