**Weekly Environmental Compliance Summary**

**Sudbury to Hudson Transmission Reliability Project (USEPA Tracking # MAR1003UW)**

Sudbury, Hudson, and Stow, MA

Week of: August 21 to August 25, 2023

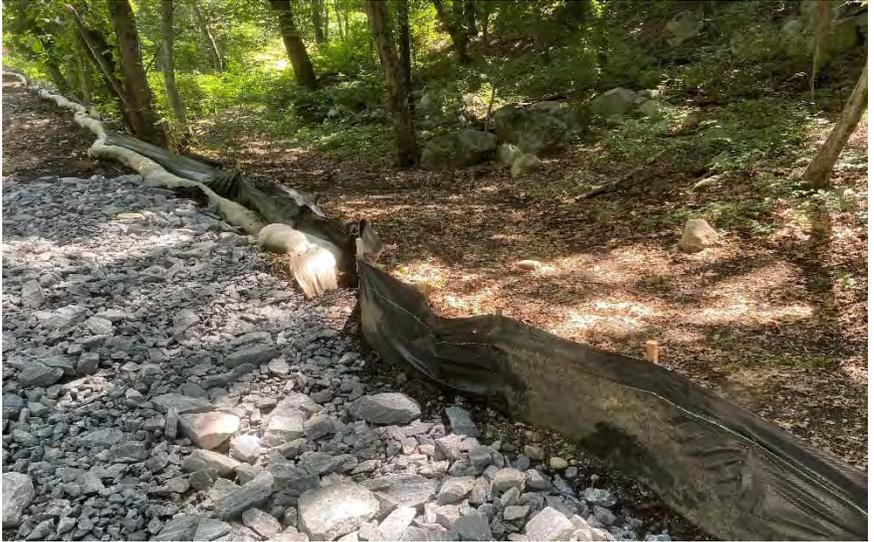
Description:  Erosion control & cleanup completed within segment 1 at Sta# 128+75, looking westward.

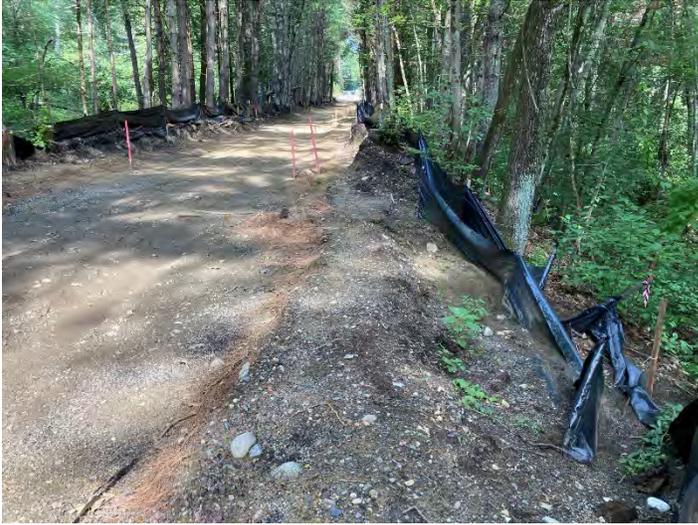
Description: Silt fence is in need of repair at Dudley Brook culvert in segment 10. Facing west.

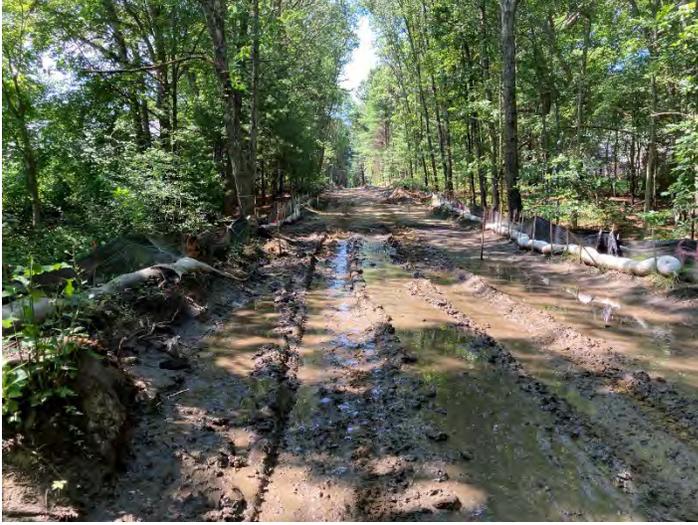
<p>Description: View of segment 11. Erosion controls have been repaired in this area. Facing west.</p>

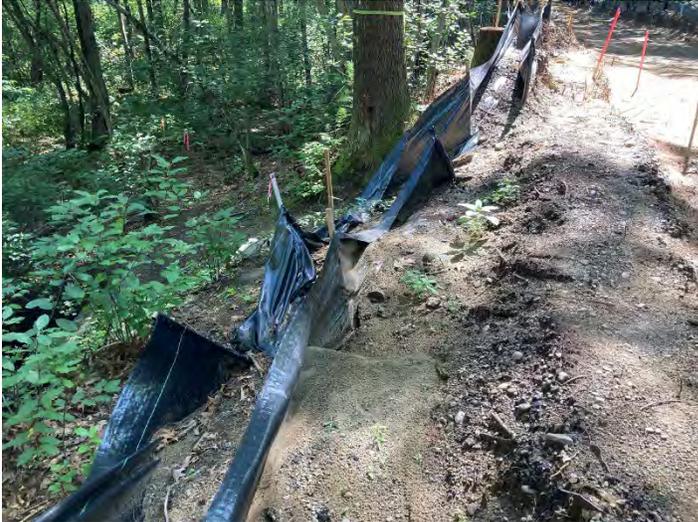
<p>Description: Silt fence is in need of repair at Dudley Brook culvert in segment 10. Facing east.</p>

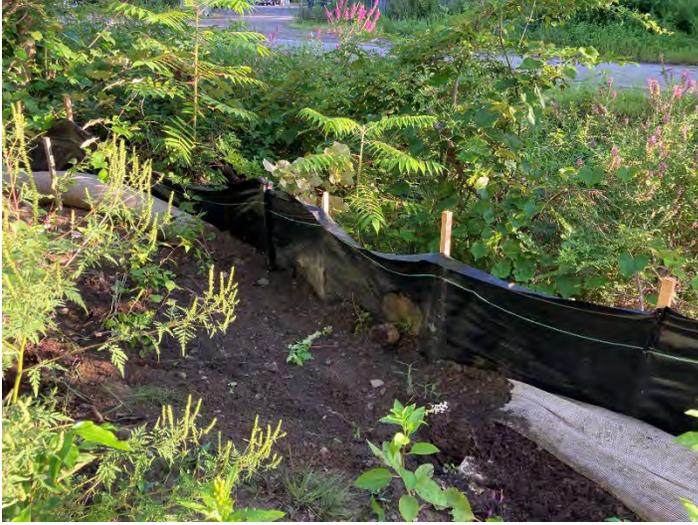
Description: View of Sta. #707 in segment 12. Silt fence has been repaired in this area. It is recommended that new filter tube is also installed. Facing northwest.

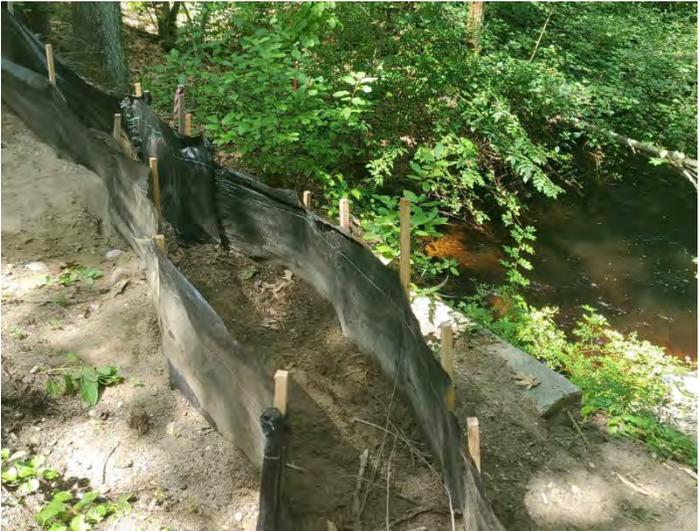
Description: Silt fence has been repaired at Dudley Brook culvert in segment 10. Facing northwest.

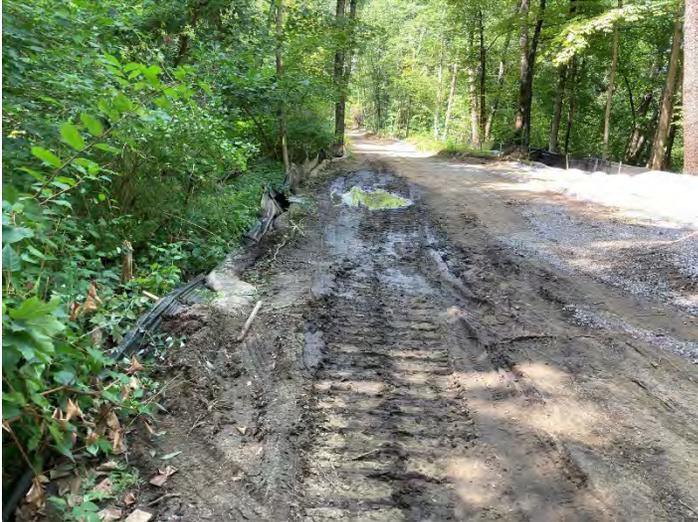
Description: Silt fence is in need of repair in segment 13. Facing west.

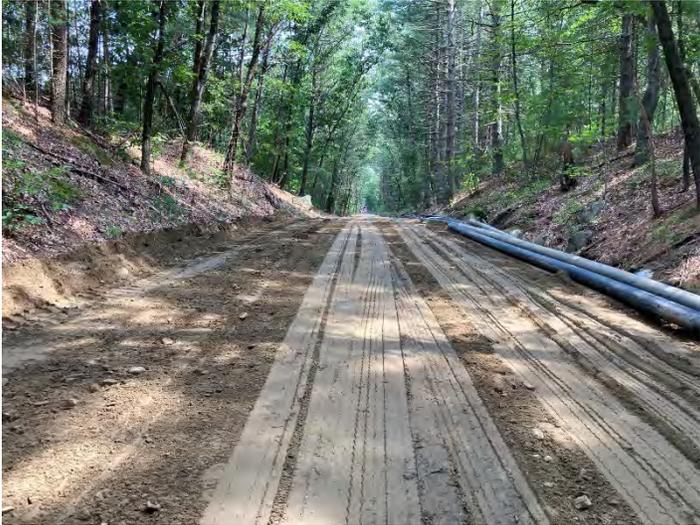
Description: View of west end of segment 9. Stockpile previously noted in this location has been removed. Facing west.

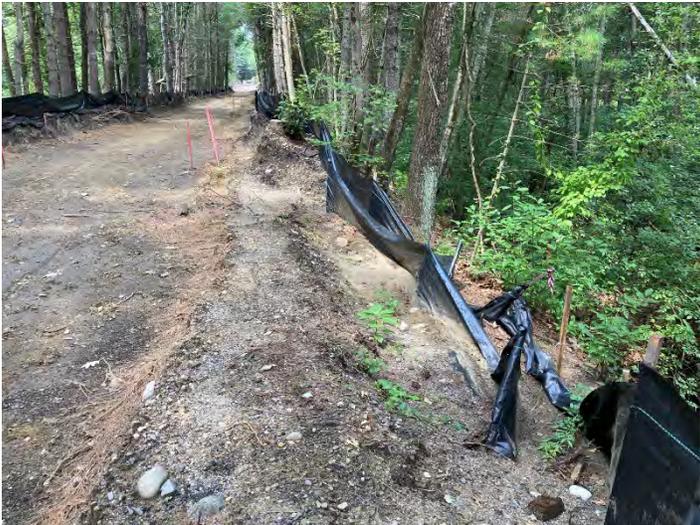
Description: Silt fence is in need of repair at Dudley Brook culvert in segment 10. Facing west.

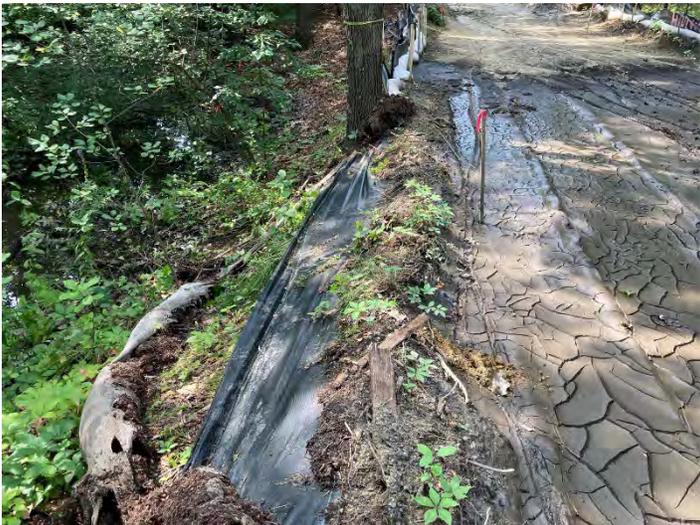
Description: E&S repairs are needed in multiple locations in segment 11. Facing east.

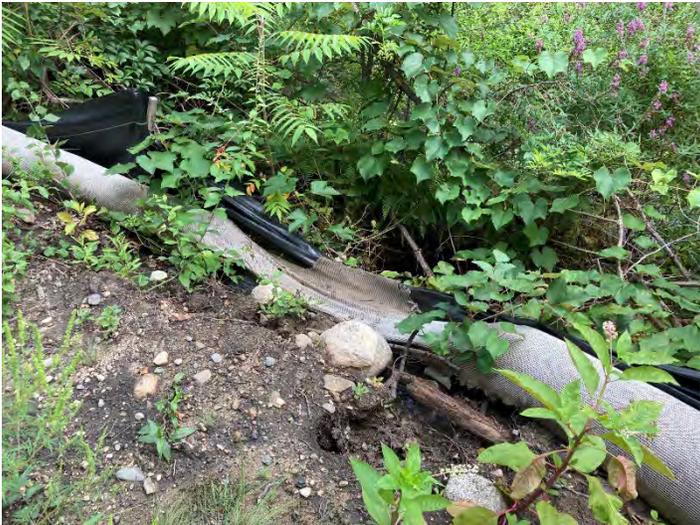
Description: View of damaged E&S controls at approximately Sta. #707 in segment 12. Facing northwest.

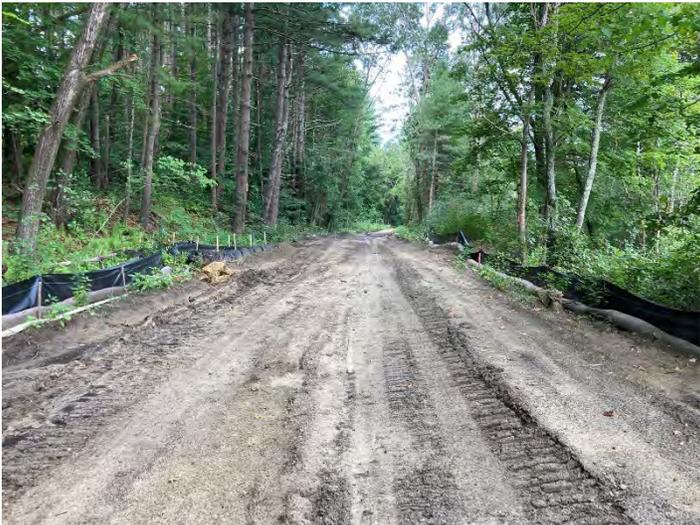
Description: View of Type A E&S controls in segment 13. Controls are in good condition. Facing west.

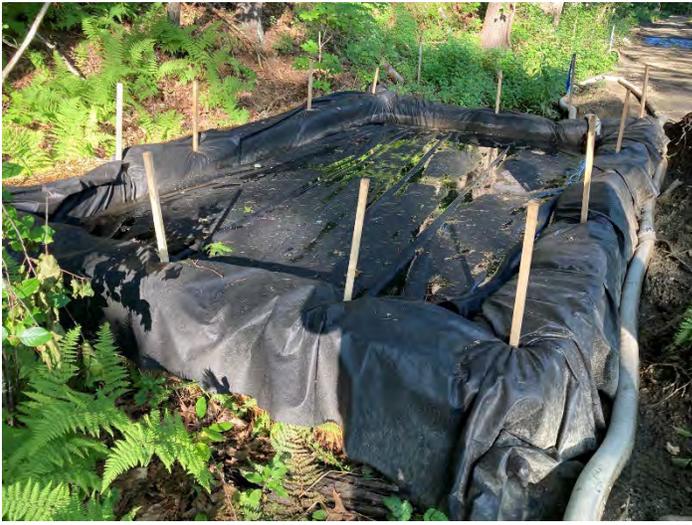
Description: View of dewatering controls (straw bale corral with filter fabric, stone, and silt bag) and discharge from corral. No discharge from corral was observed. Facing west.

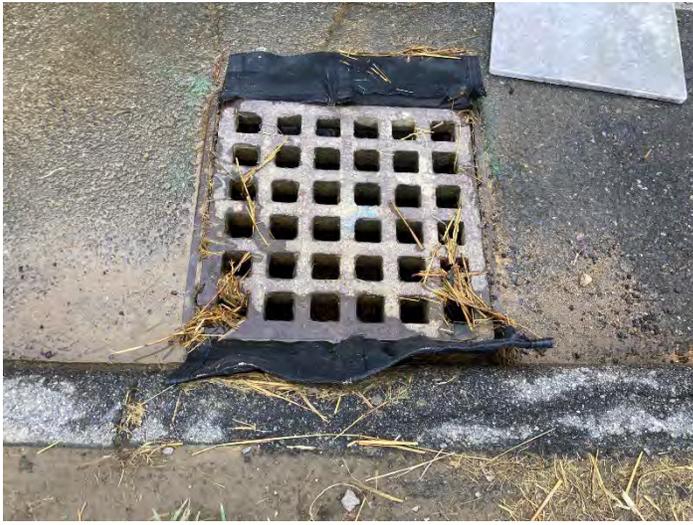
Description: View of discharge point from project (catch basin below hay bale corral on Forest Ave). Very little discharge from corral was observed at time of inspection, and therefore turbidity sample was unable to be collected.
