## Weekly Environmental Compliance Summary

**Sudbury to Hudson Transmission Reliability Project (USEPA Tracking # MAR1003UW)**

Sudbury, Hudson, and Stow, MA

Week of: September 4, 2023 to September 8, 2023

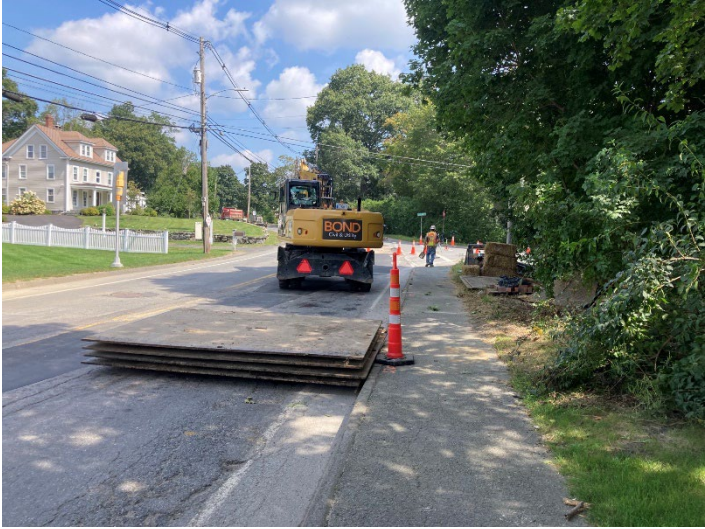
<p><b>PHOTOGRAPHIC LOG</b></p>	
<p><b>Client Name:</b> Eversource</p>		<p><b>Site Location:</b> Sudbury to Hudson Transmission Reliability Project</p>	<p><b>Town:</b> Hudson</p>
<p><b>Photo No.:</b> 1</p>	<p><b>Date:</b> 9/05/2023</p>

<p><b>Description:</b> View of Bond working on Forest Ave. Facing north.</p>

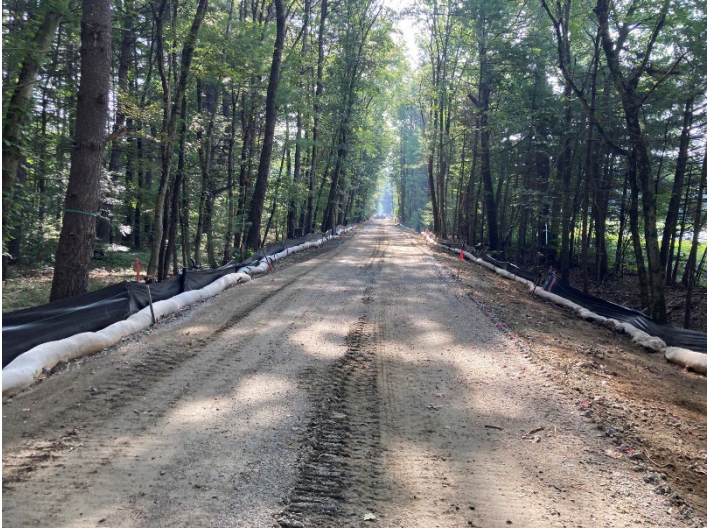
<p><b>PHOTOGRAPHIC LOG</b></p>	
<p><b>Client Name:</b> Eversource</p>		<p><b>Site Location:</b> Sudbury to Hudson Transmission Reliability Project</p>	<p><b>Town:</b> Hudson</p>
<p><b>Photo No.:</b> 6</p>	<p><b>Date:</b> 9/05/2023</p>

<p><b>Description:</b> View of Type A E&amp;S controls in segment 4. Facing east.</p>

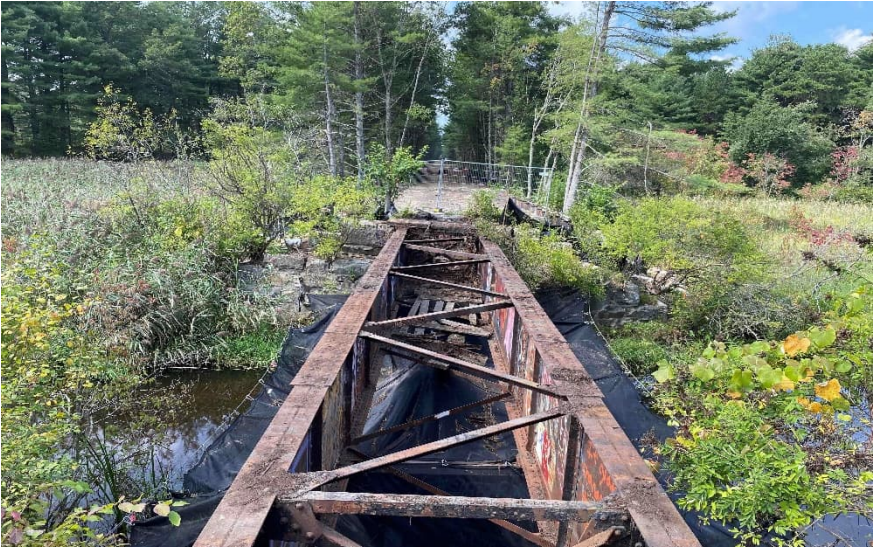
<b>PHOTOGRAPHIC LOG</b>	
Client Name: Eversource		Site Location: Sudbury to Hudson Transmission Reliability Project	Town: Sudbury
Photo No.: 1	Date: 9-5-23

Description:  Work area within segment 8, Bridge 128 area, existing erosion control, looking westward.

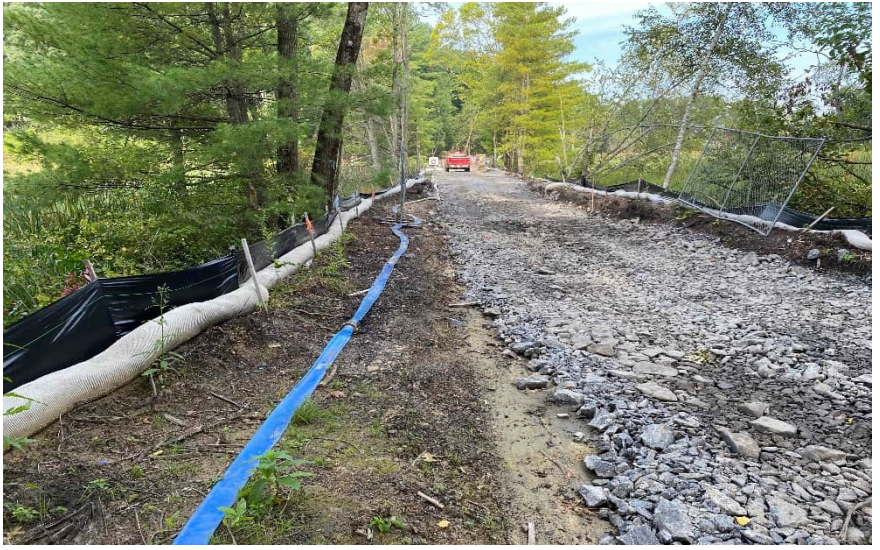
<b>PHOTOGRAPHIC LOG</b>	
Client Name: Eversource		Site Location: Sudbury to Hudson Transmission Reliability Project	Town: Sudbury
Photo No.: 2	Date: 9-5-23

Description:  Work area within segment 14, existing erosion control, looking westward.

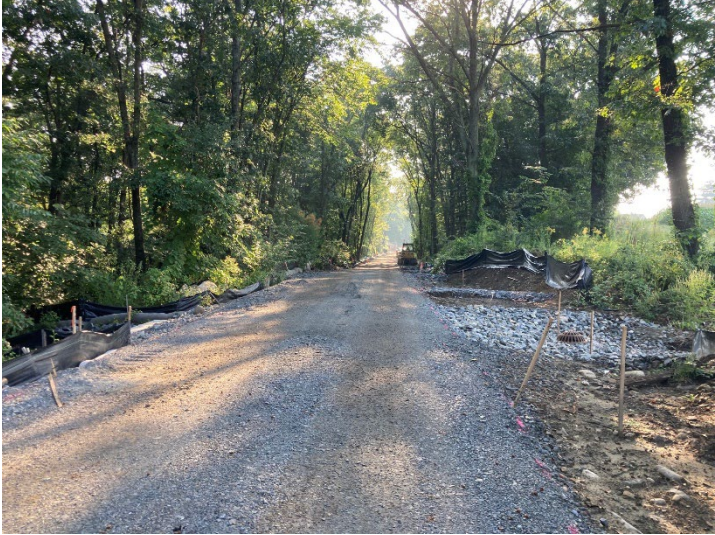
<b>PHOTOGRAPHIC LOG</b>	
<b>Client Name:</b> Eversource		<b>Site Location:</b> Sudbury to Hudson Transmission Reliability Project	<b>Town:</b> Stow
<b>Photo No.:</b> 3	<b>Date:</b> 9/06/2023

<b>Description:</b> View of leaching catch basin in Stow portion of segment 1. Facing east.

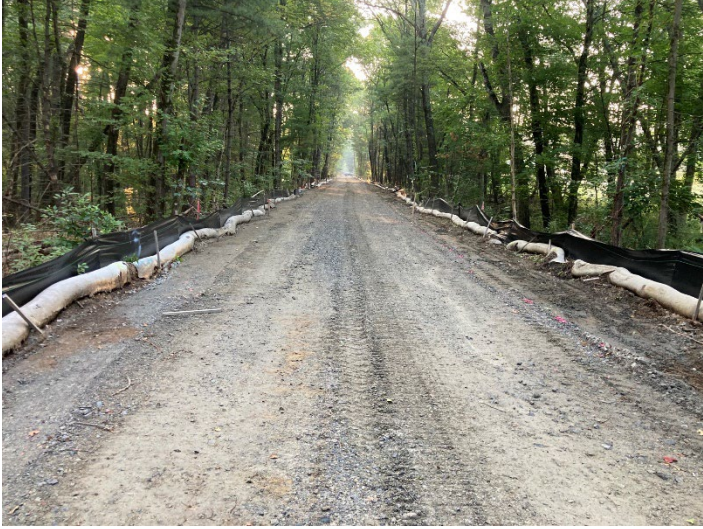
<b>PHOTOGRAPHIC LOG</b>	
<b>Client Name:</b> Eversource		<b>Site Location:</b> Sudbury to Hudson Transmission Reliability Project	<b>Town:</b> Hudson
<b>Photo No.:</b> 5	<b>Date:</b> 9/06/2023

<b>Description:</b> View of Type A E&S controls in segment 4. Facing east.

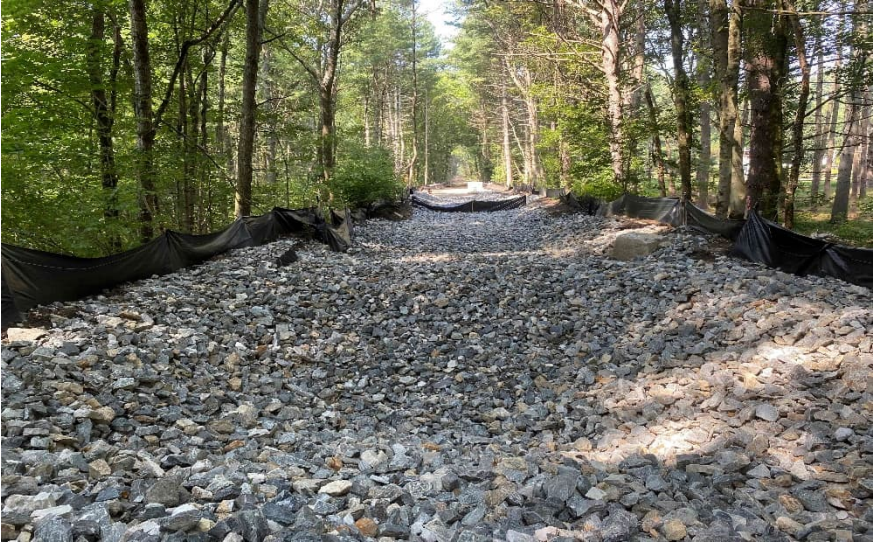
<b>PHOTOGRAPHIC LOG</b>	
Client Name: Eversource		Site Location: Sudbury to Hudson Transmission Reliability Project	Town: Sudbury
Photo No.: 5	Date: 9-6-23

Description:  Work area within segment 9, temporary stabilization of work area, looking westward.

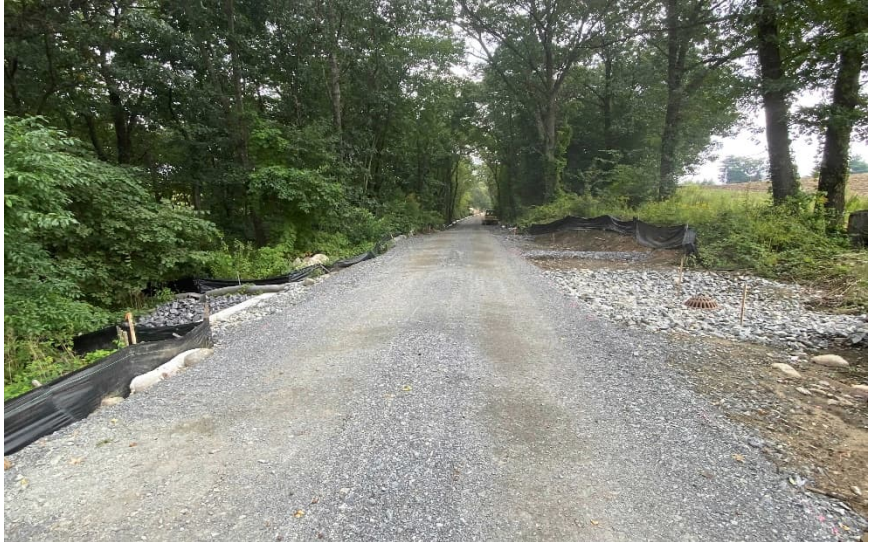
<p>Description:                  Work area within segment 1, existing erosion control, looking eastward.</p>

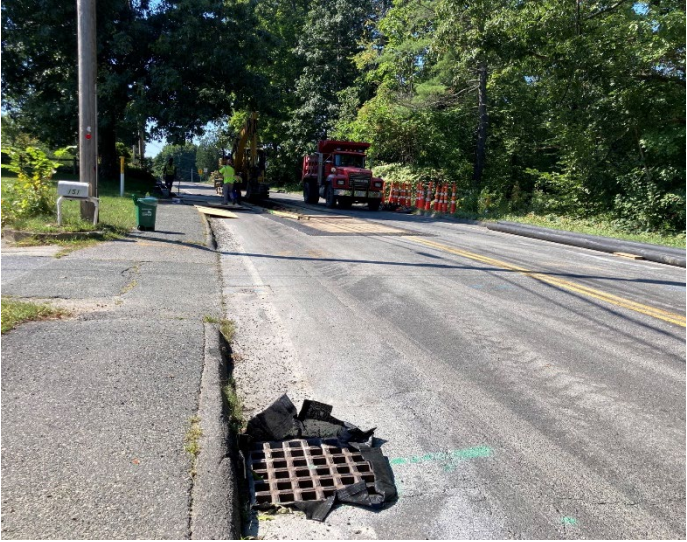
<b>Description:</b> View of Bond crew working between MH #3 and MH #4 on Forest Ave. Silt sack inlet protection has been installed in nearby storm drains. Facing south.

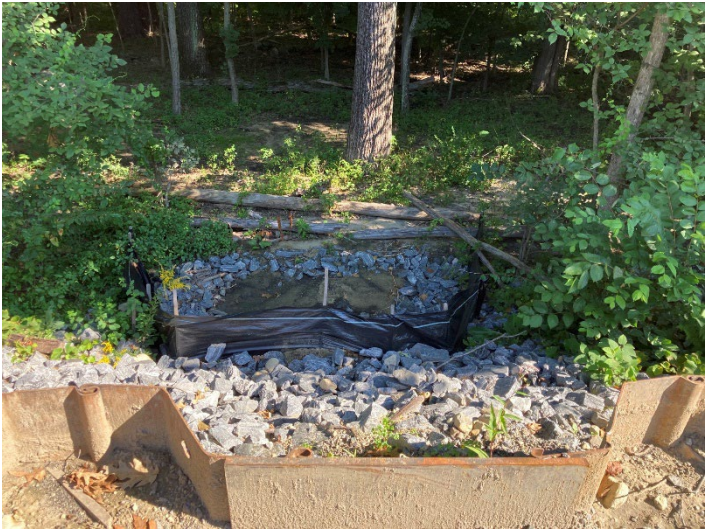
-Sediment has collected on rip rap below concrete headwall/drainage structure 4 at Sta. #119+25 LT in segment 1. It is recommended that the sediment be removed.

<b>Description:</b> View of Sta. #119+25 LT (concrete headwall/drainage structure 4) in segment 1. It is recommended that sediment that has collected on rip rap be removed. Facing north.

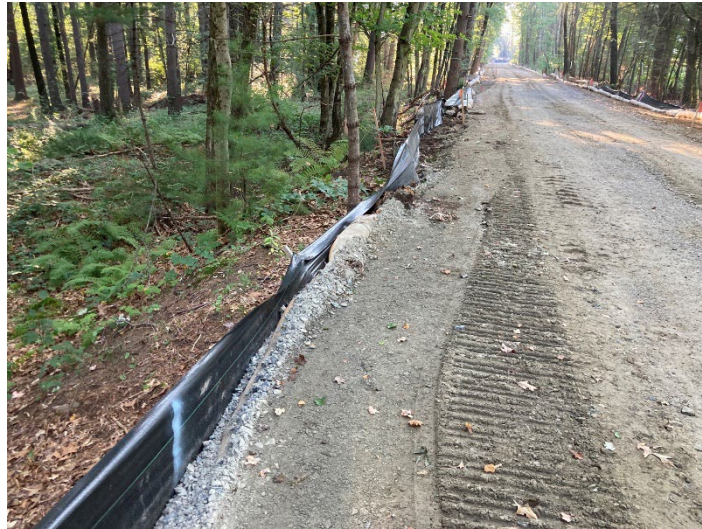
View of Type A E&S controls in segment 4. Minor maintenance is recommended throughout this segment. Facing west.

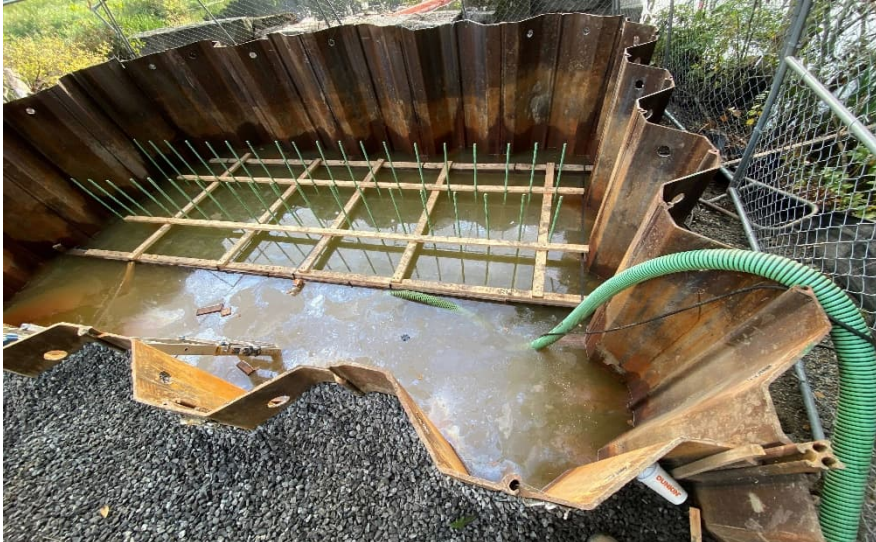
Description: View of area being pumped at Hop Brook (area in cofferdam), looking westward.

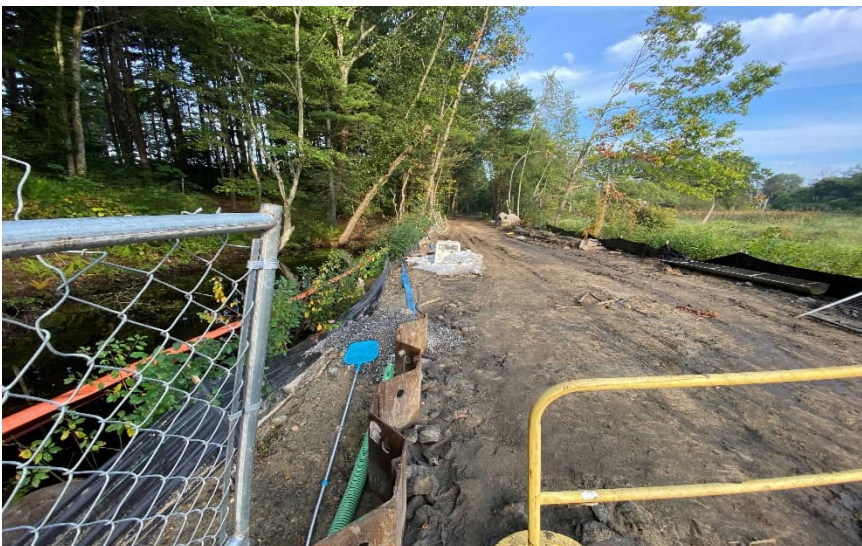
Description: Segment 13. View of dewatering operation (pumping at far end of area), looking westward.
