Weekly Environmental Compliance Summary

Sudbury to Hudson Transmission Reliability Project (USEPA Tracking # MAR1003UW)

Week of: September 11, 2023 to September 15, 2023

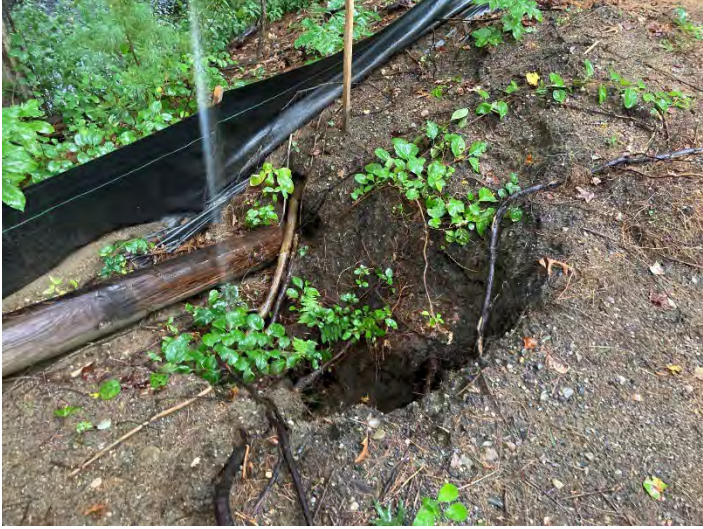
<p align="right">PHOTOGRAPHIC LOG</p>	
Client Name: Eversource		Site Location: Sudbury to Hudson Transmission Reliability Project	Town: Sudbury
Photo No.: 4	Date: 9/13/2023

-Depression observed above Dudley Brook culvert in segment 10. It is recommended that this area be assessed and stabilized as needed.

Description: View of depression above Dudley Brook culvert in segment 10. It is recommended that this area be assessed and stabilized as needed. Facing southwest.

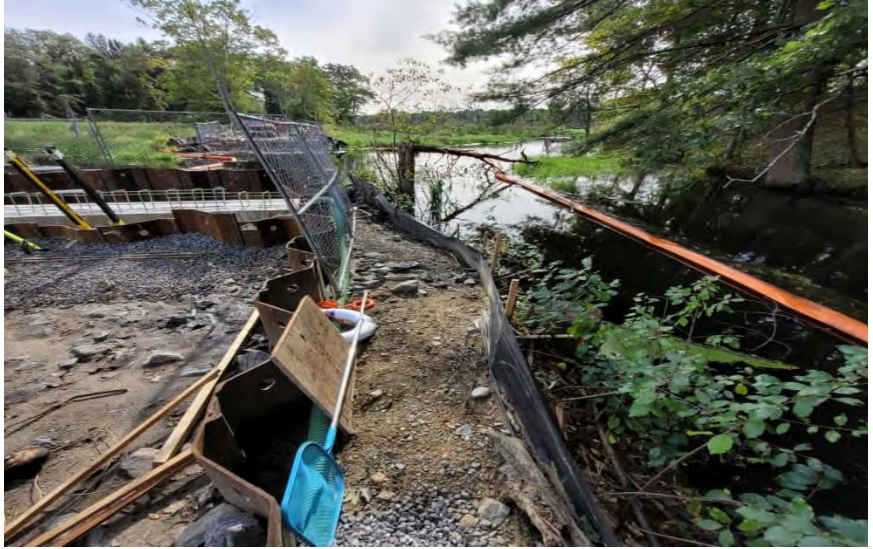
<p>PHOTOGRAPHIC LOG</p>	
<p>Client Name: Eversource</p>		<p>Site Location: Sudbury to Hudson Transmission Reliability Project</p>	<p>Town: Sudbury</p>
<p>Photo No.: 6</p>	<p>Date: 9-15-23</p>

<p>Description:</p> <p>Work area within segment 13, bridge 127 work (repaired erosion control), looking eastward.</p>

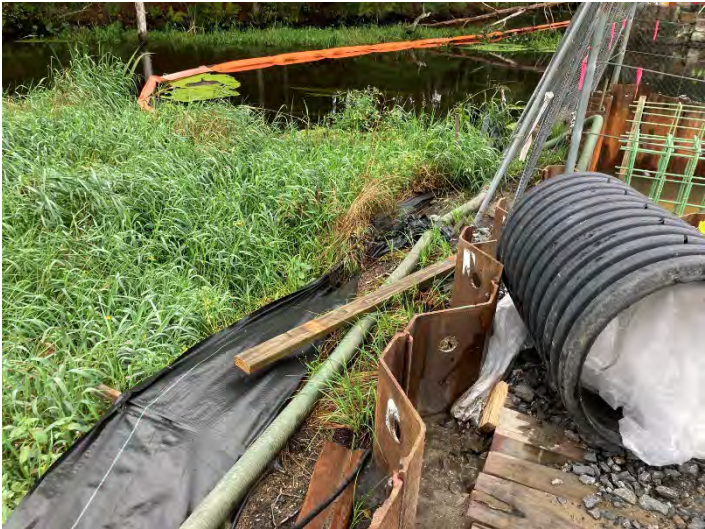
-Silt fence is in need of repair at bridge 127 and in multiple places along segment 14 (routine maintenance).

4. Silt Fencing on ROW in Sudbury	<input checked="" type="checkbox"/> Yes <input type="checkbox"/> No	1	<input type="checkbox"/> Yes <input checked="" type="checkbox"/> No	9/11/2023	-Silt fence is installed in segments 9-14. -Silt fence is in need of repair at bridge 127 and in multiple places along segment 14 (routine maintenance).

Description: Silt fence is in need of repair at bridge 127 and in multiple places along segment 14. Facing west.

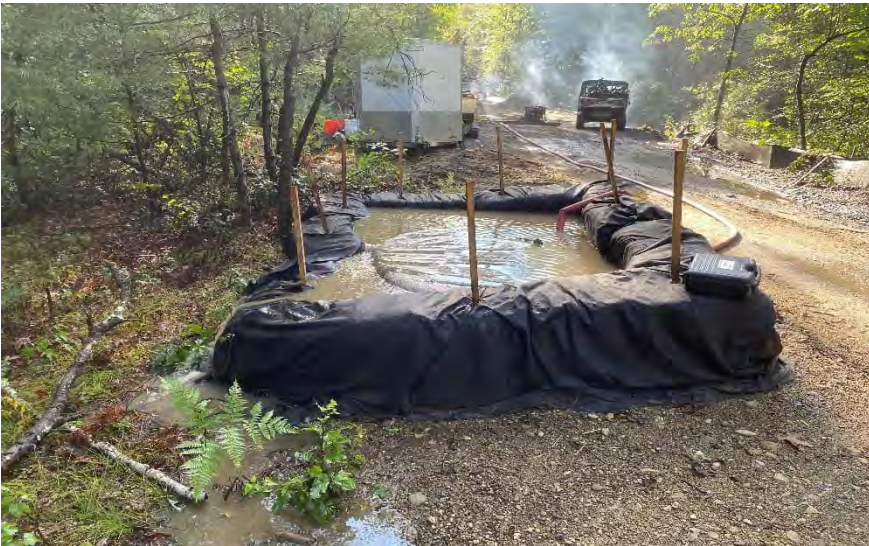
Description: Segment 6. View of discharge bag/bales, looking eastward. Water discharge to bag intermittent and appeared to be slightly turbid.

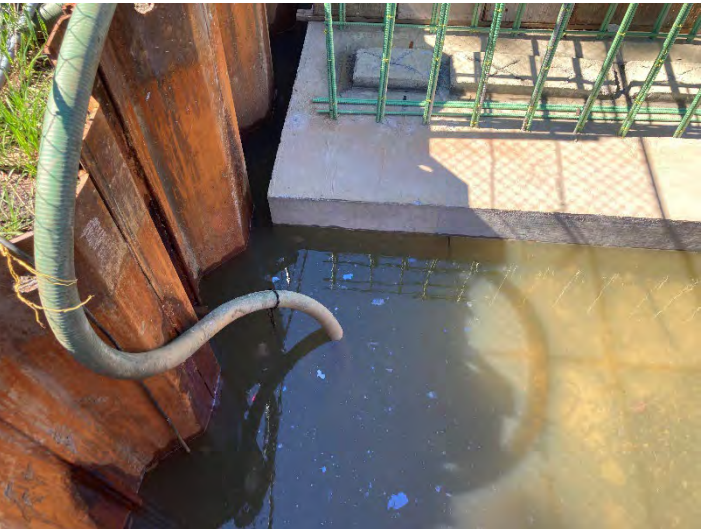
Description: View of water prior to treatment. Water appeared slightly turbid. Possible sheen also observed, but appeared to be minor.
