# Wildlife Habitat Features Report Eversource Sudbury to Hudson Transmission Reliability Project Sudbury, Massachusetts

DECEMBER 2022- MAY 2023

SWCA Project No. 67849

July 2023

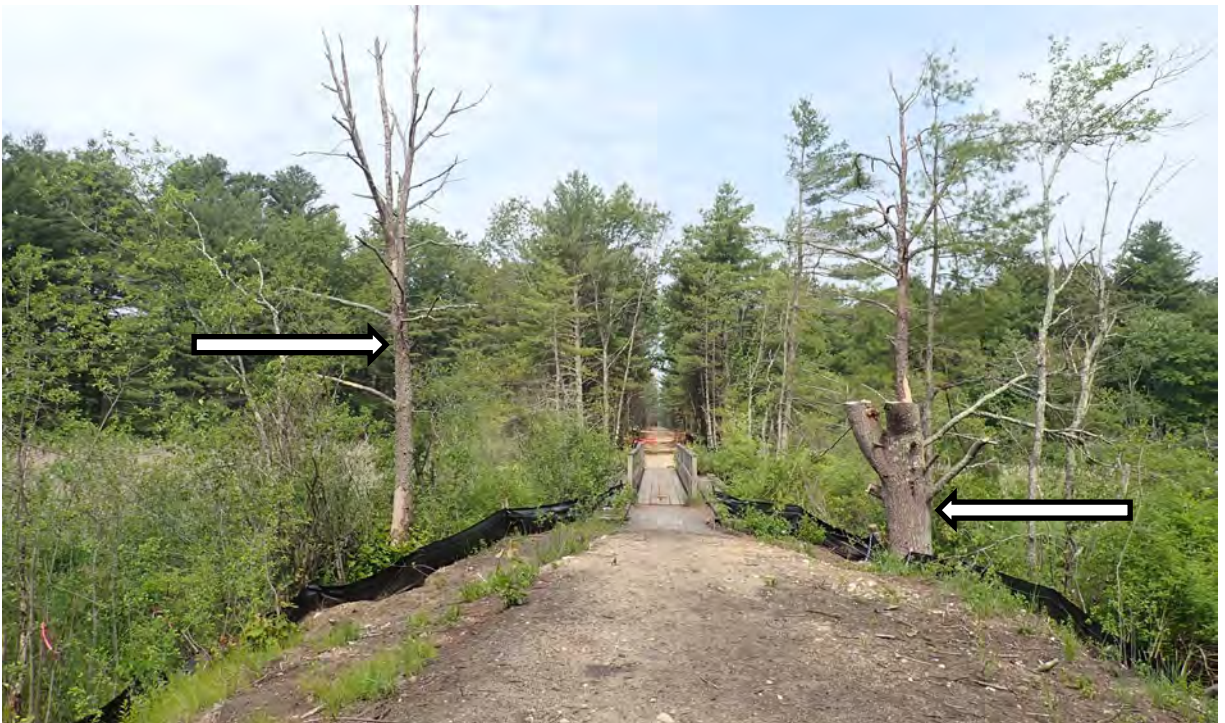
**Photo #8:** View of one snag that was left in place (left) in Impact Area 5, near the bridge crossing. Large pine (right) required removal to allow for bridge repairs. The stump of the pine was left in place. *Facing west.*

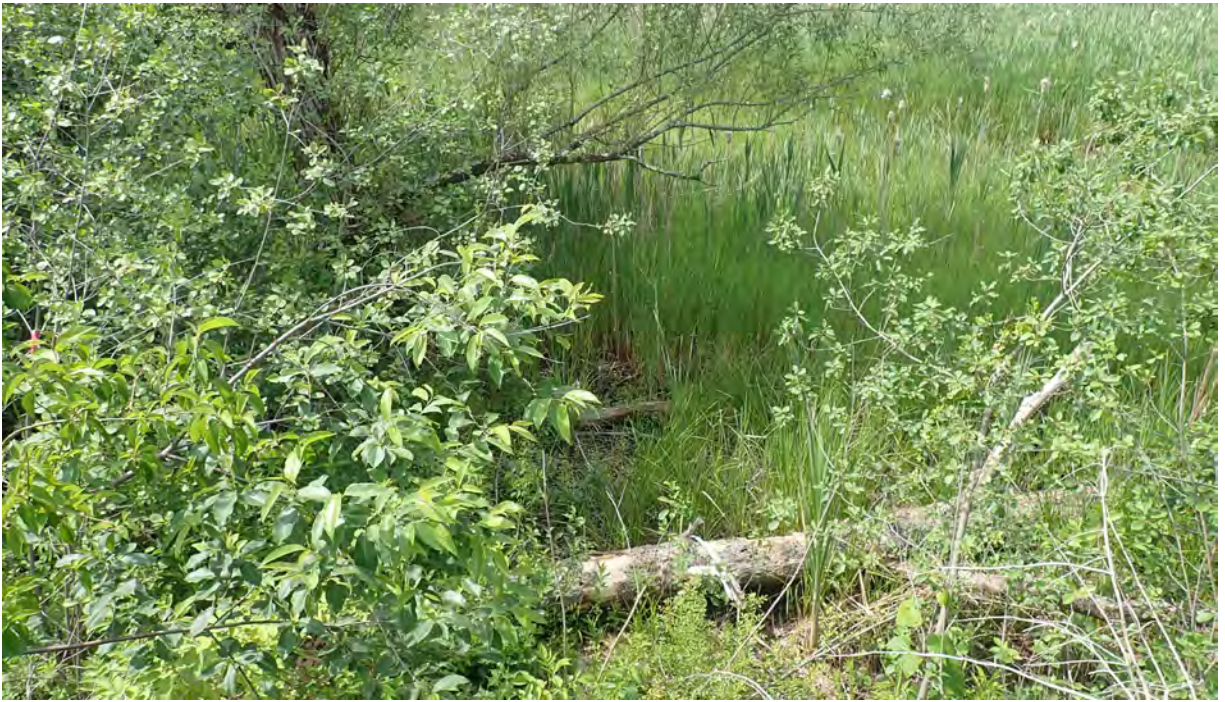
**Photo #9:** View of installed fallen log as a snag in Impact Area 6. An installed fallen log, within Impact Area 5 is located further west (right) and is difficult to see through the vegetation. *Facing south.*

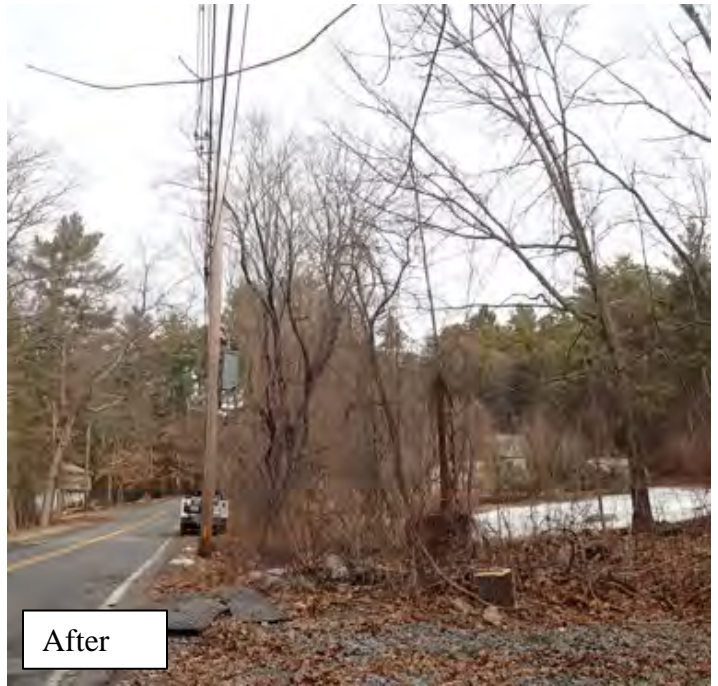
**Photo #13:** View of tree in Impact Area 9 on the eastern side of Peakham Road. Tree was located just beyond the limit of work and in poor condition. Tree branches and thick vines connected the tree extended into the limit of work and onto the power lines. For safety concerns the entire tree was removed and stump left in place. *Facing northeast.*

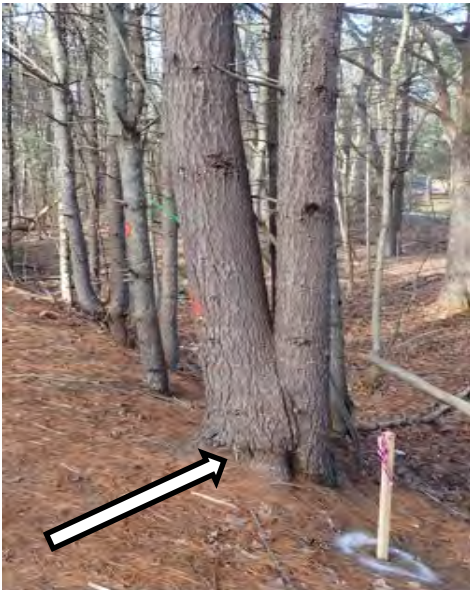
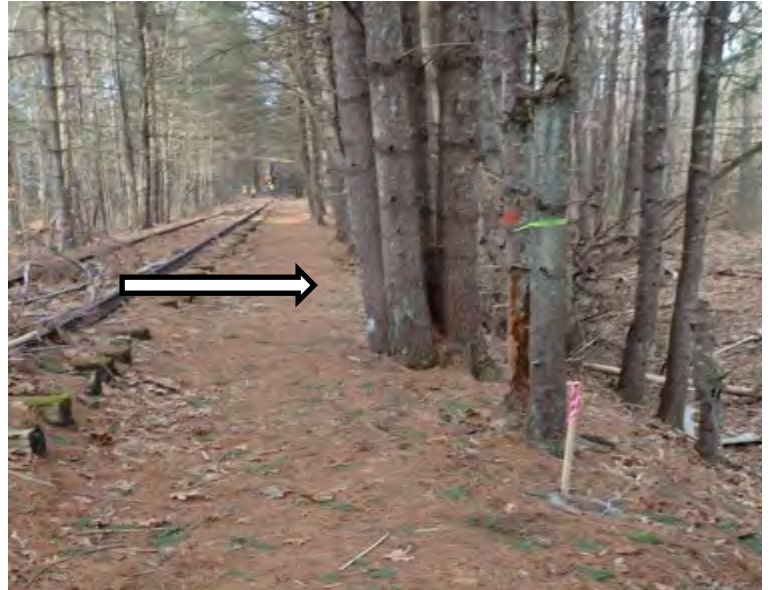
**Photo #14:** View of trees within Impact Area 10. Many of the trees within this section had multiple trunks and were on the boundary of the limit of work. Trees were preserved to the greatest extent possible. When the anticipated grading and trenching, associated with the proposed work, would negatively impact the tree health and stability, trees were removed for safety concerns. *Facing northwest.*

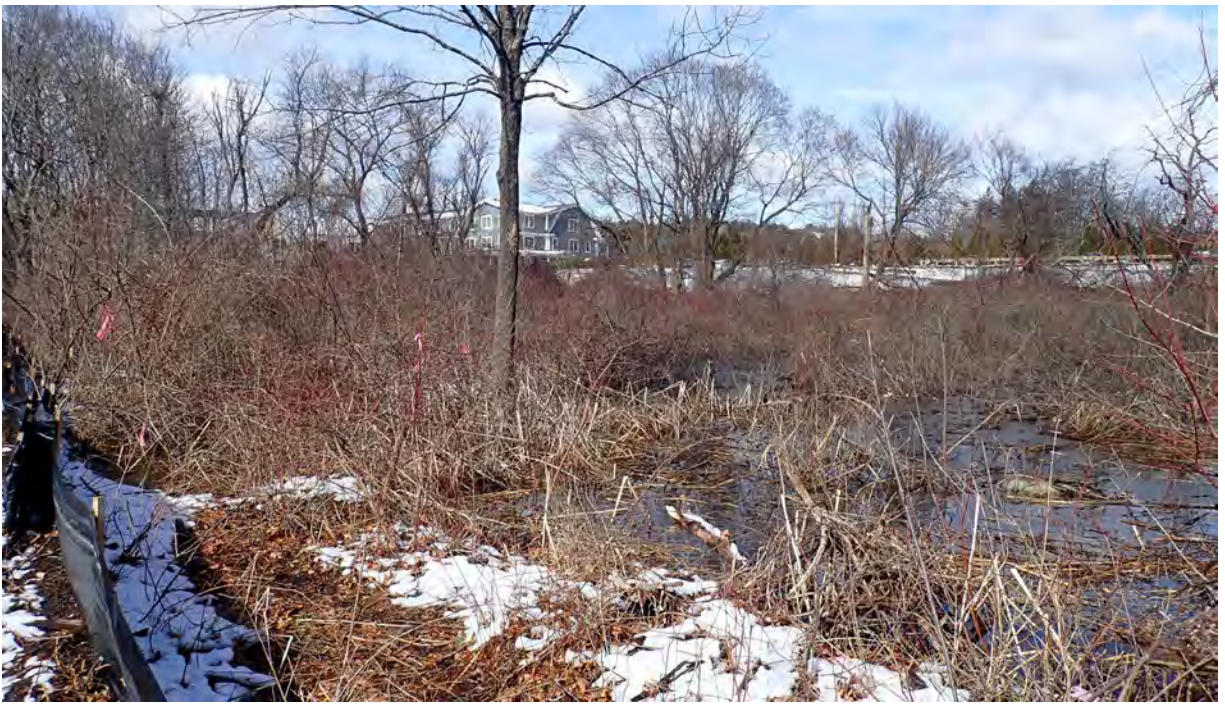
**Photo #1:** View of vernal pool #15 in Segment 14. Silt fence is in good condition here and throughout the project area. No sediment or debris observed within the resource area. *Facing northwest.*

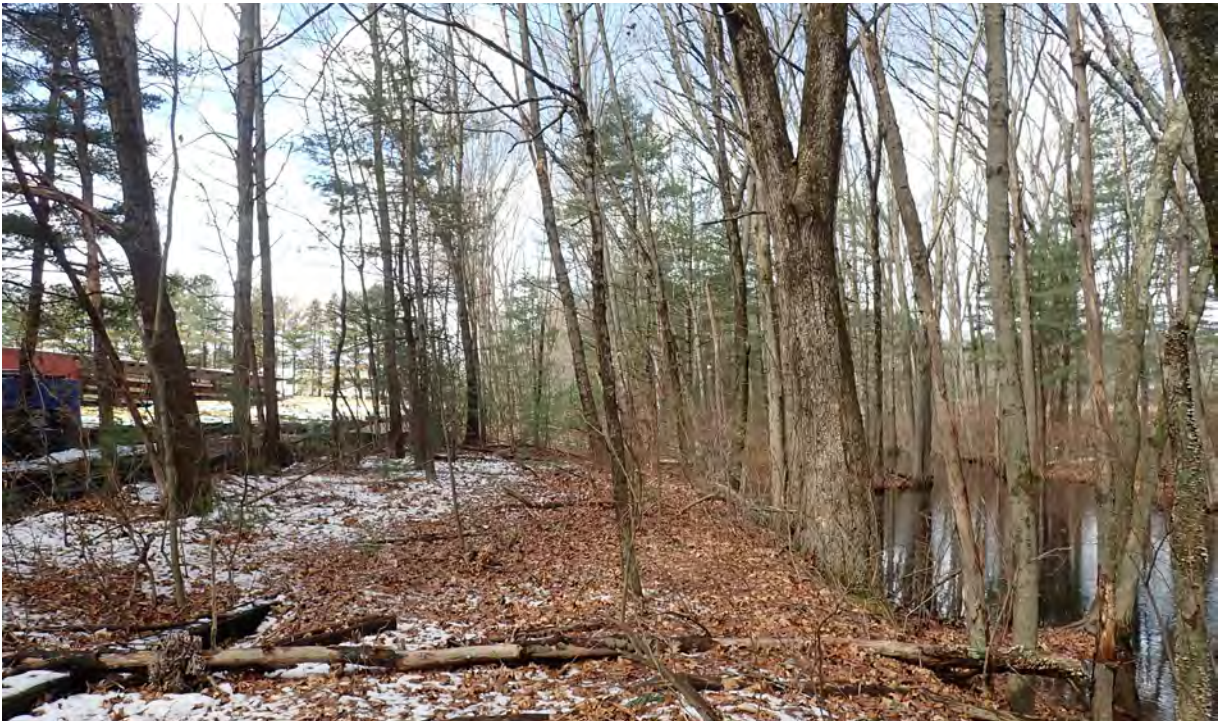
**Photo #2:** View of vernal pool #11 in Segment 11. No sediment or construction debris observed within the resource area or beyond the silt fencing. Silt fence is in good condition. *Facing northwest.*

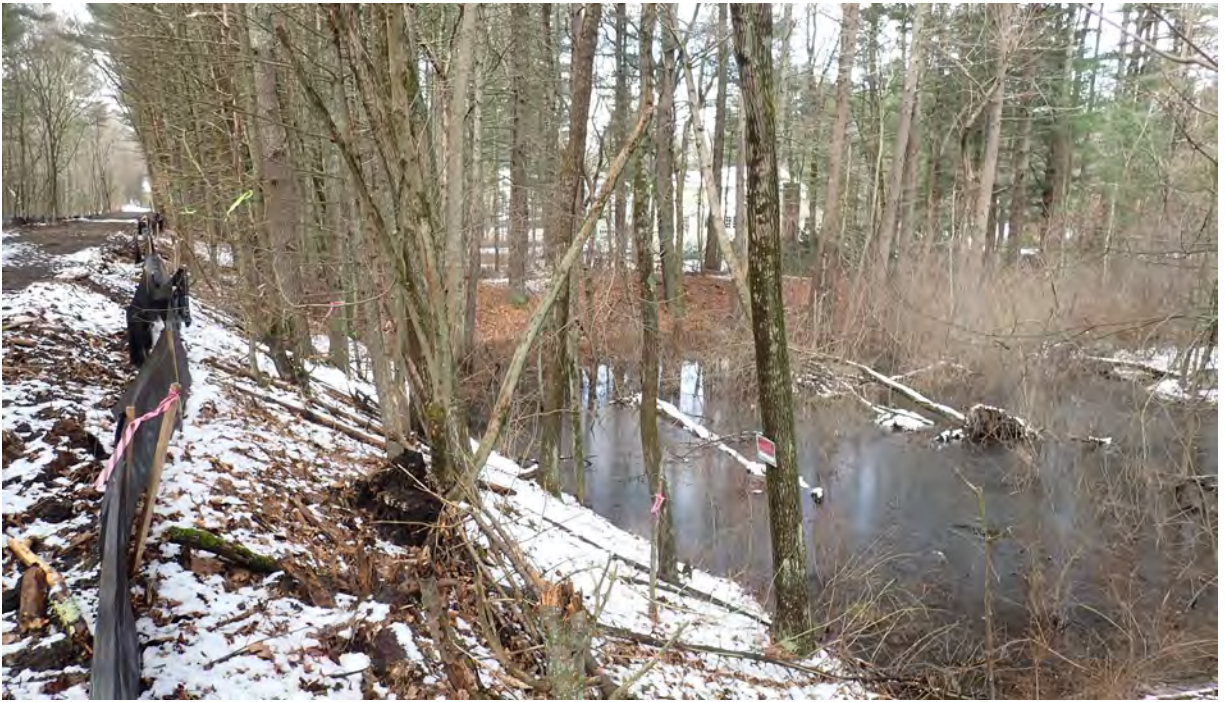
**Photo #3:** View of vernal pool #8 in Segment 9. Silt fence in good condition. No sediment or debris observed in the resource area or associated buffer zones. *Facing northwest.*

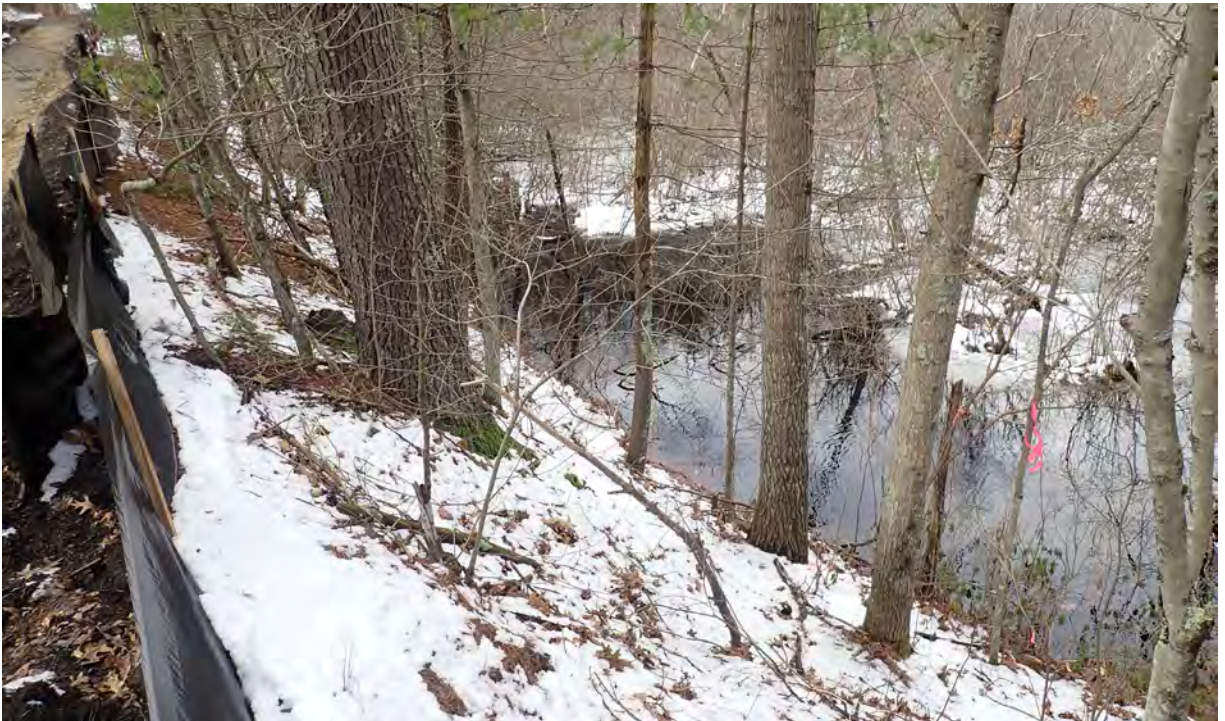
**Photo #4:** View of vernal pool #4 in Segment 8. Silt fence in good condition. No sediment or debris observed in the resource area or associated buffer zones. *Facing northwest.*

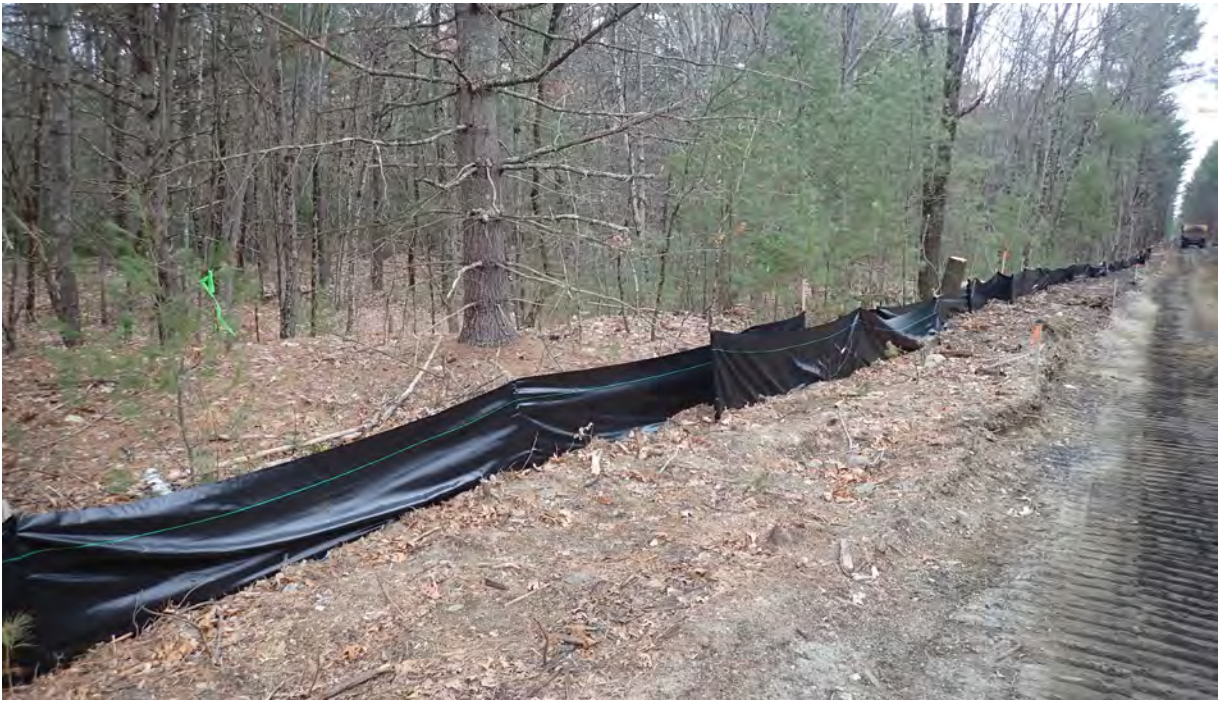
**Photo #1:** View of silt fence separating vernal pool #1 and the limit of work in Segment 7. Silt fence is in good condition. No sediment or debris observed within the resource area. *Facing southeast.*

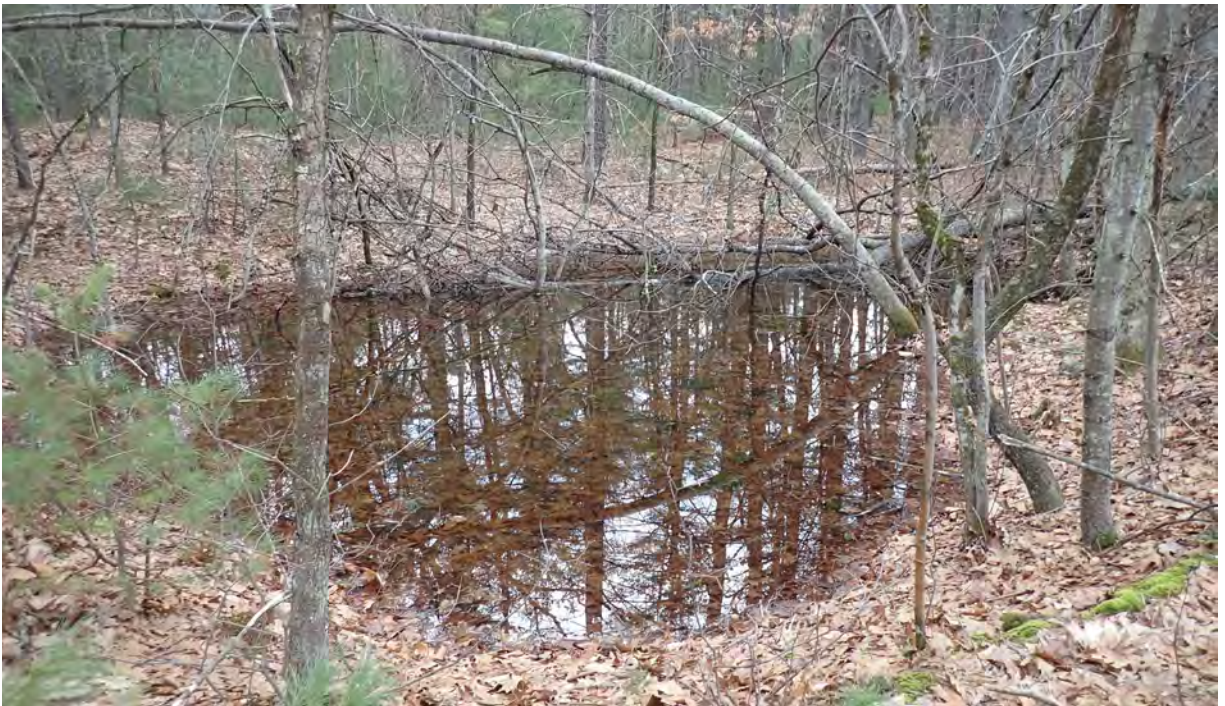
**Photo #2:** View of vernal pool #1 in Segment 7. No sediment or debris observed within the resource area. *Facing north.*

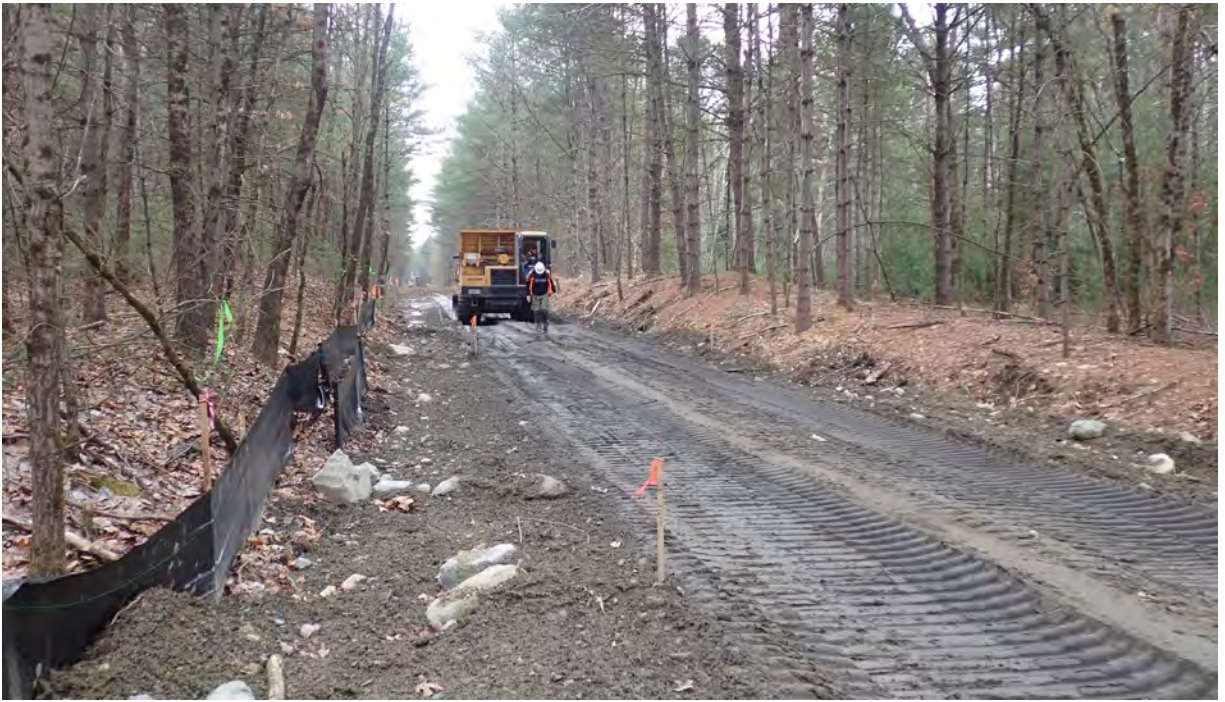
**Photo #3:** View of construction right-of-way near vernal pool #2 in Segment 7. Silt fence in good condition. No sediment or debris observed in the resource area or associated buffer zones. A monitor escorts construction vehicles through a portion of the right-of-way within vernal pool buffer zone. *Facing southeast.*

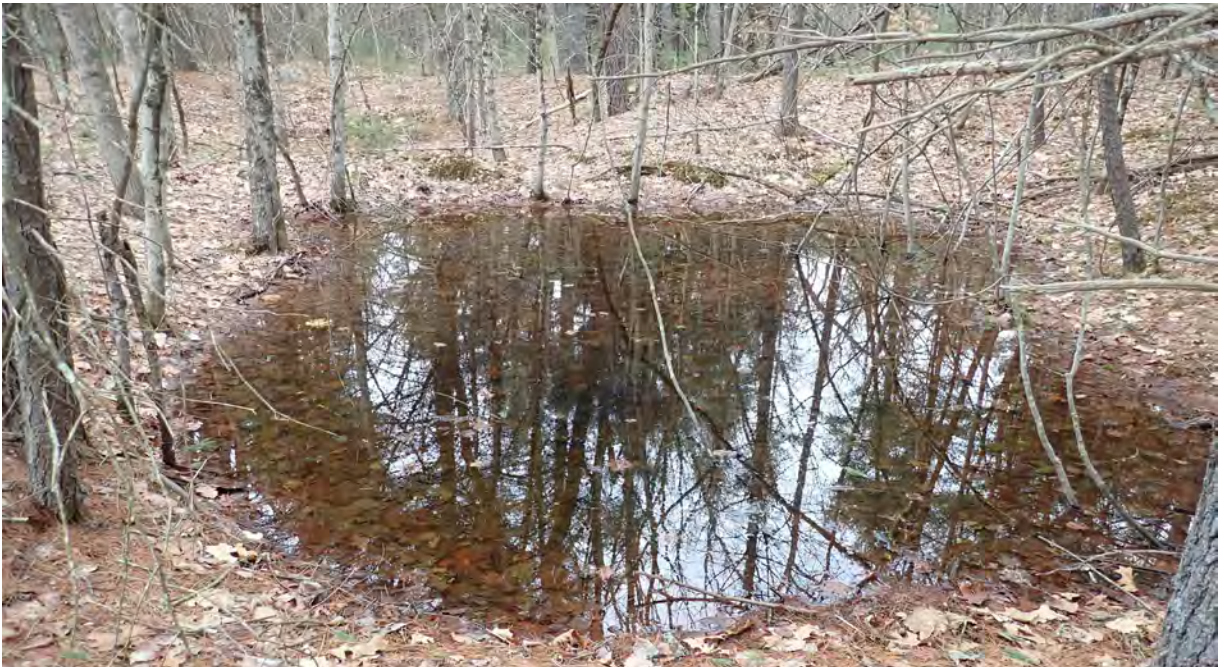
**Photo #4:** View of vernal pool #2 in Segment 7. Silt fence in good condition. No sediment or debris observed in the resource area or associated buffer zones. *Facing north.*

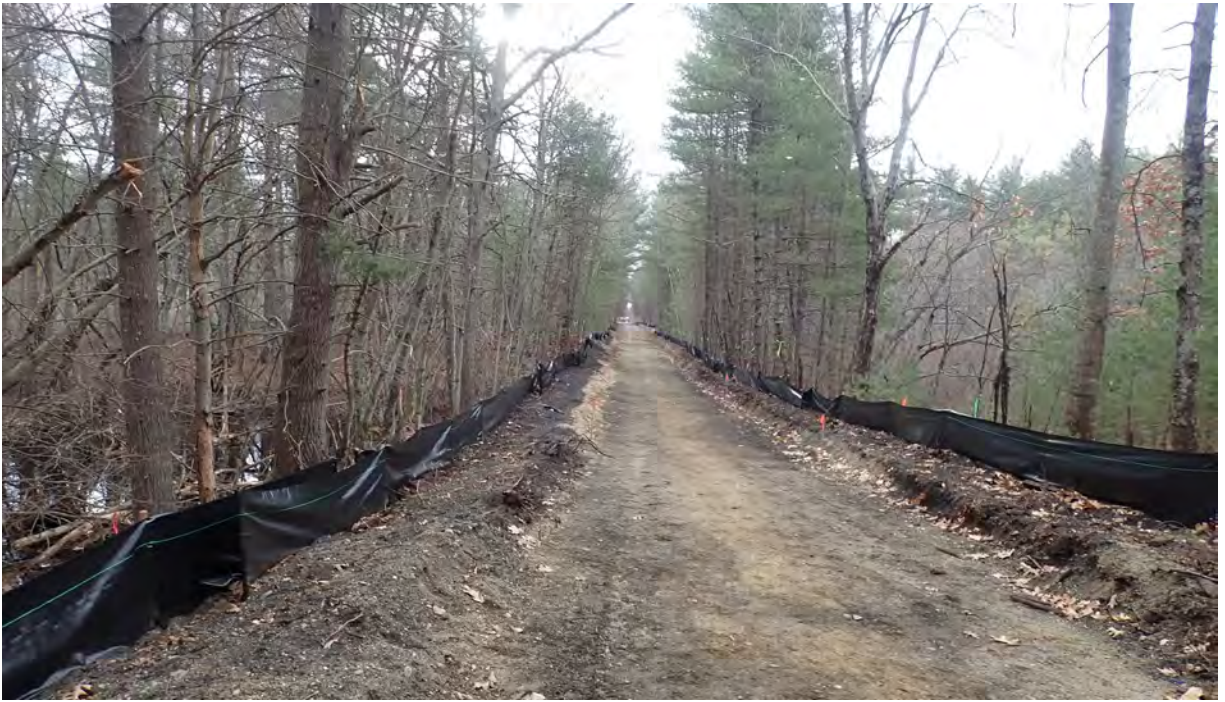
**Photo #5:** View of construction right-of-way with vernal pool #3 on the left and vernal pool #5 on the right in Segment 8. Silt fence in good condition. No sediment or debris observed in the resource area or associated buffer zones. *Facing southeast.*

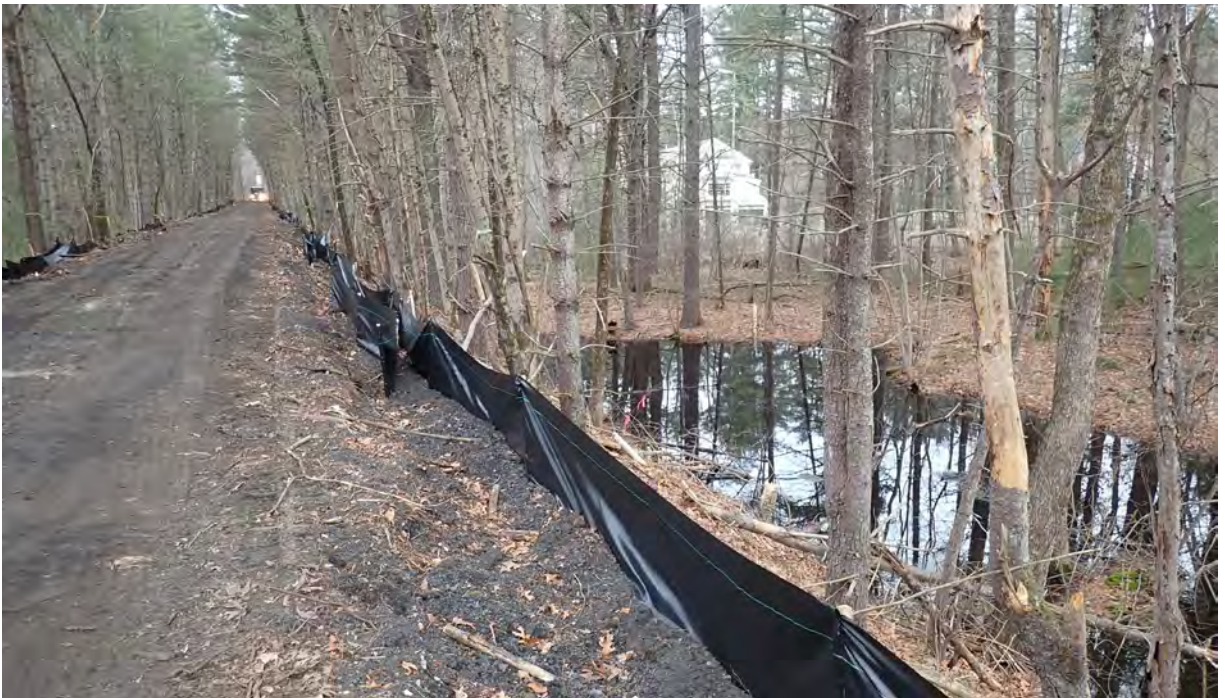
**Photo #6:** View of vernal pool #9 in Segment 9. Silt fence in good condition. No sediment or debris observed in the resource area or associated buffer zones. *Facing northwest.*

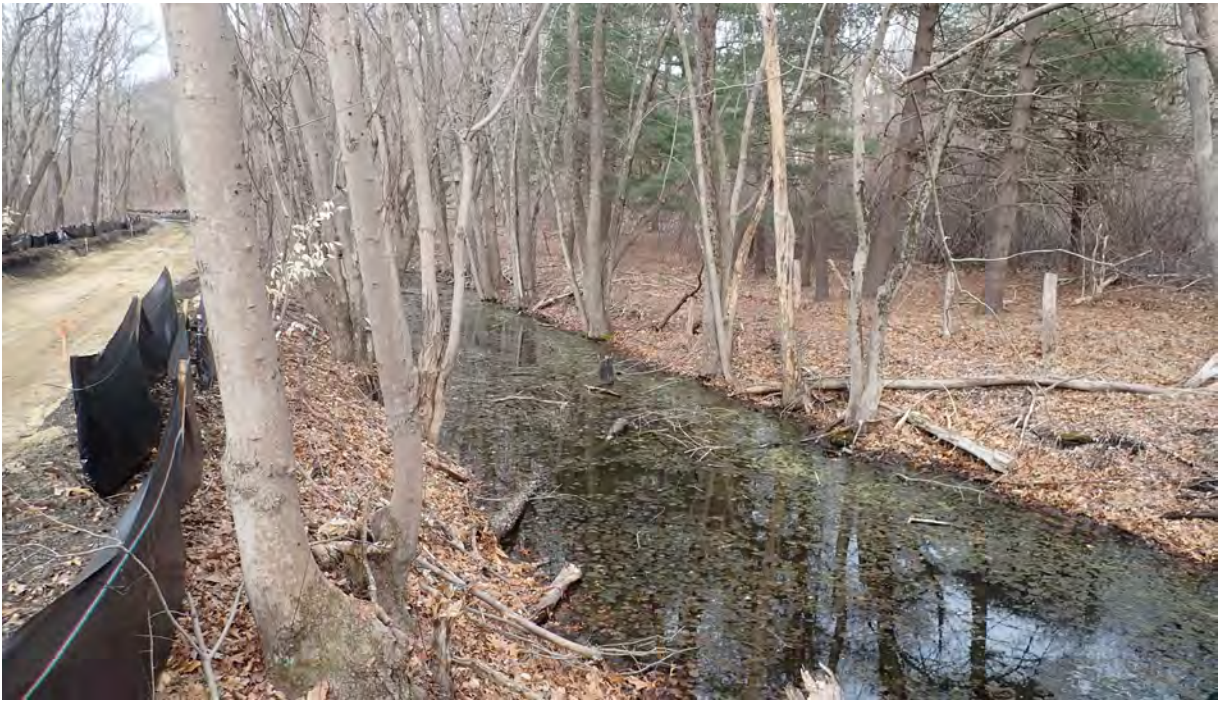
**Photo #7:** View of vernal pool #13 in Segment 14. Silt fence in good condition. No sediment or debris observed in the resource area or associated buffer zones. *Facing west.*

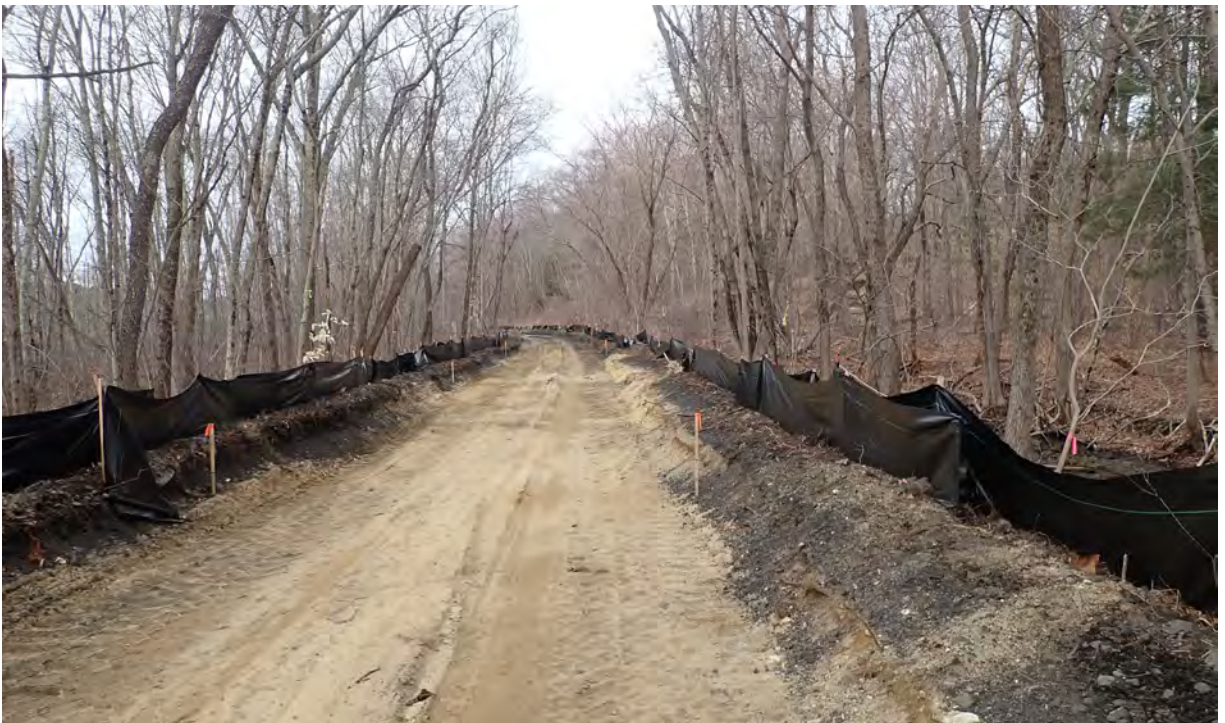
**Photo #8:** View of construction right-of-way with vernal pool #13 on the right and vernal pool #14 on the left in Segment 14. Silt fence in good condition. No sediment or debris observed in the resource area or associated buffer zones. *Facing west.*

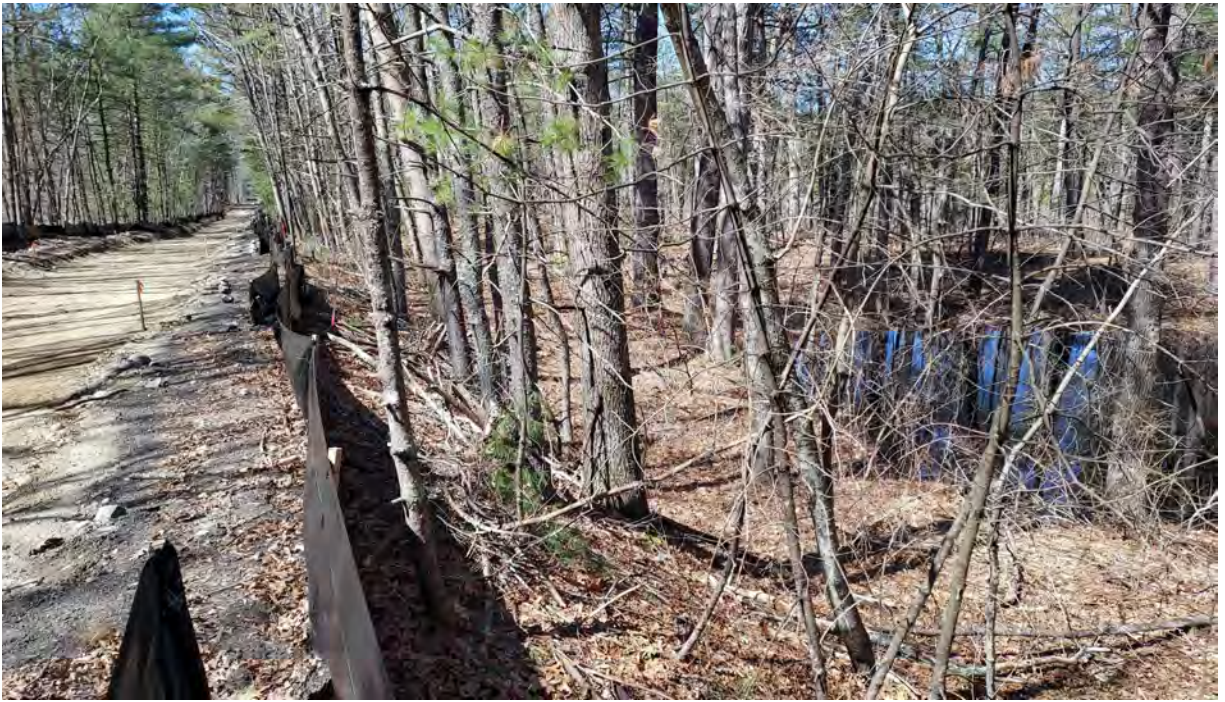
**Photo #1:** View of vernal pool #6 and in Segment 8. Silt fence is in good condition. No sediment or debris observed within the resource area, buffer zone, or project area. *Facing northwest.*

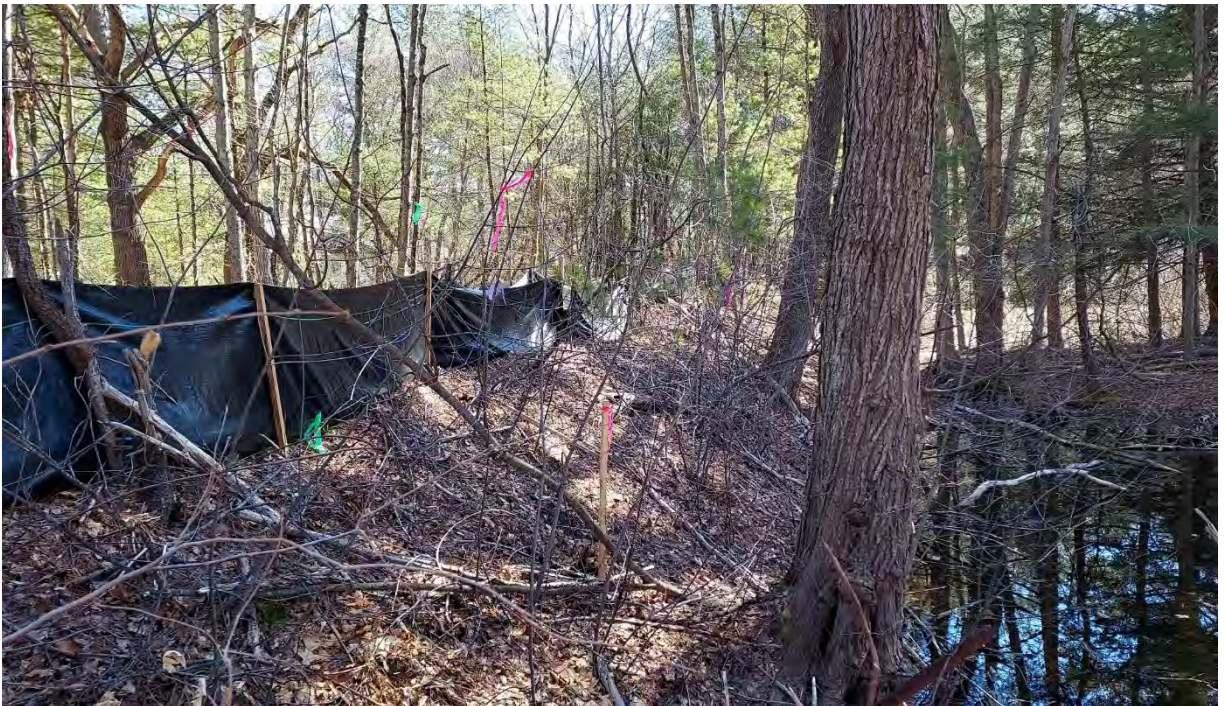
**Photo #2:** View of vernal pool #10 in Segment 11. No sediment or debris observed within the resource area or associated buffer zone. Silt fencing here and throughout the project area is in good condition. *Facing southeast.*

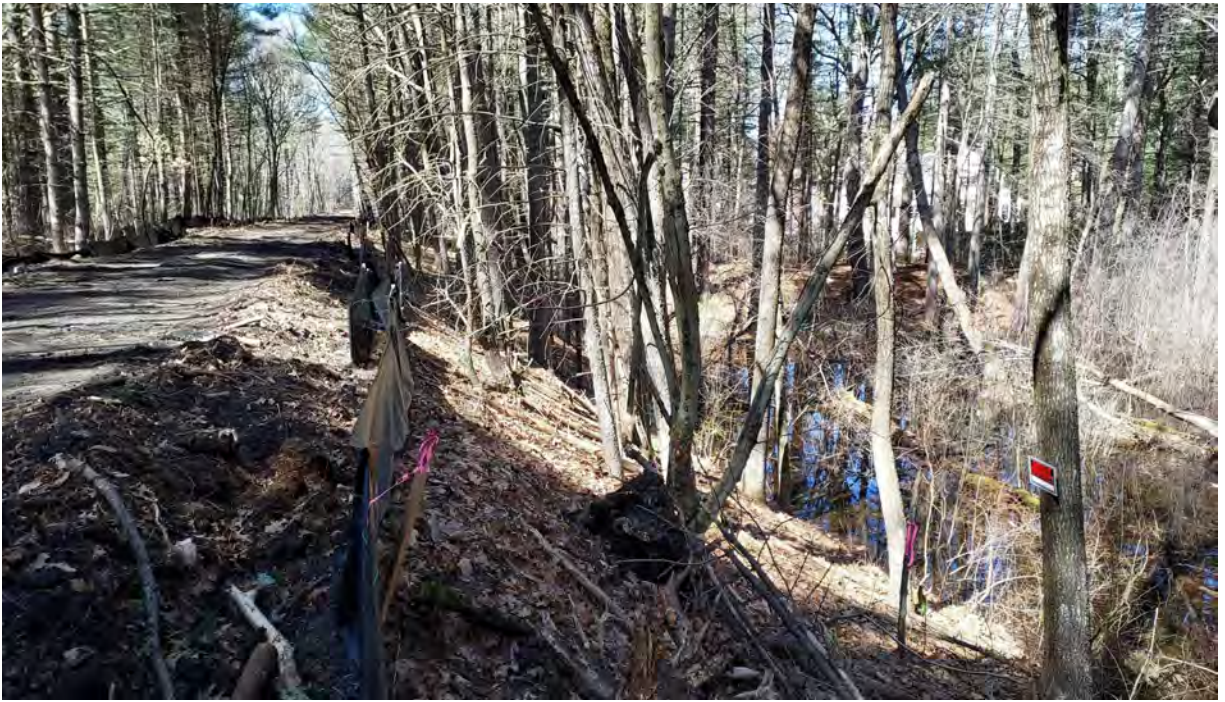
**Photo #3:** View of vernal pool #8 in Segment 10. Silt fence in good condition. No sediment or debris observed in the resource area or associated buffer zones. *Facing northwest.*

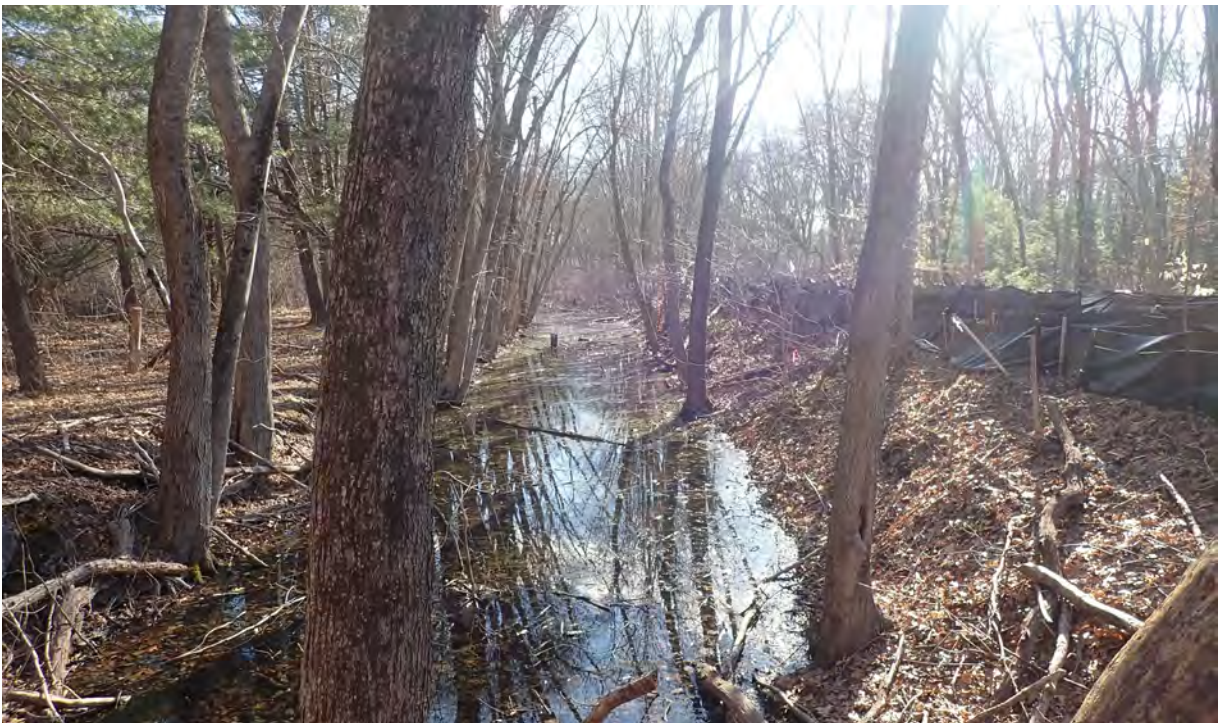
**Photo #4:** View of vernal pool #13 in Segment 14. Silt fence in good condition. No sediment or debris observed in the resource area or associated buffer zones. *Facing east.*

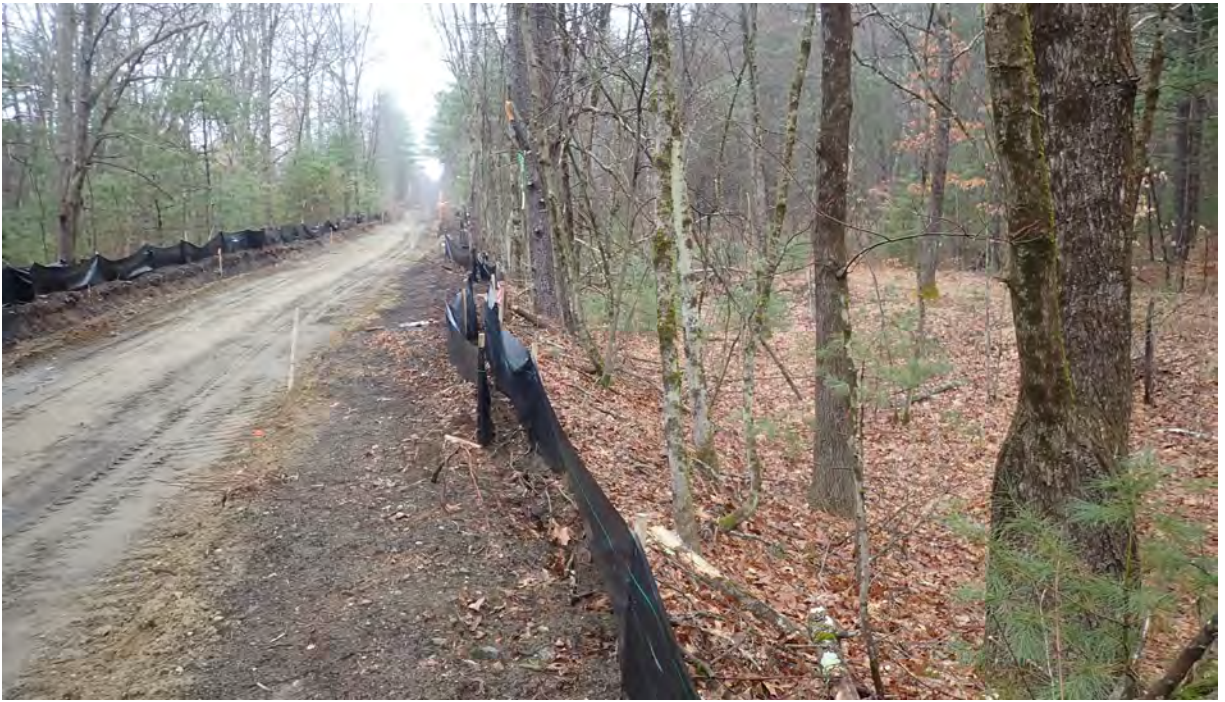
**Photo #1:** View of project area near vernal pool #1 and in Segment 7. Silt fence is in good condition. No sediment or debris observed within the resource area, buffer zone, or project area. *Facing northwest.*

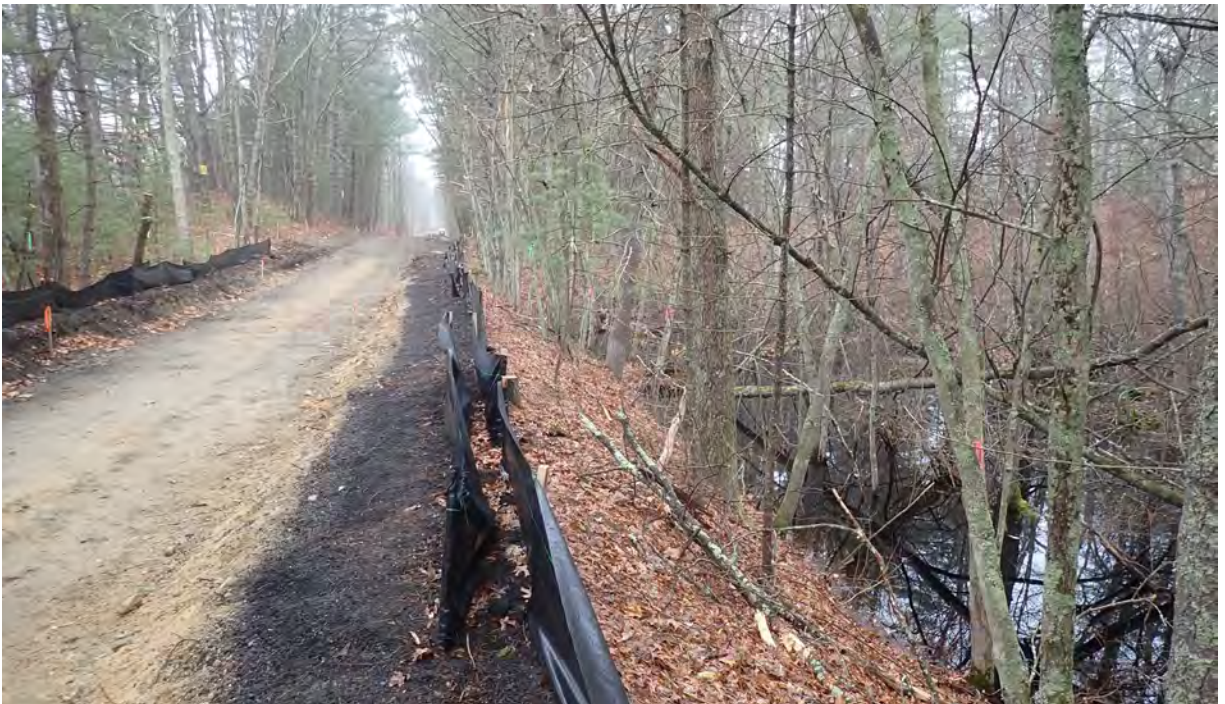
**Photo #2:** View of vernal pool #3 in Segment 8. No sediment or debris observed within the resource area or associated buffer zone. Silt fencing here and throughout the project area is in good condition. *Facing northwest.*

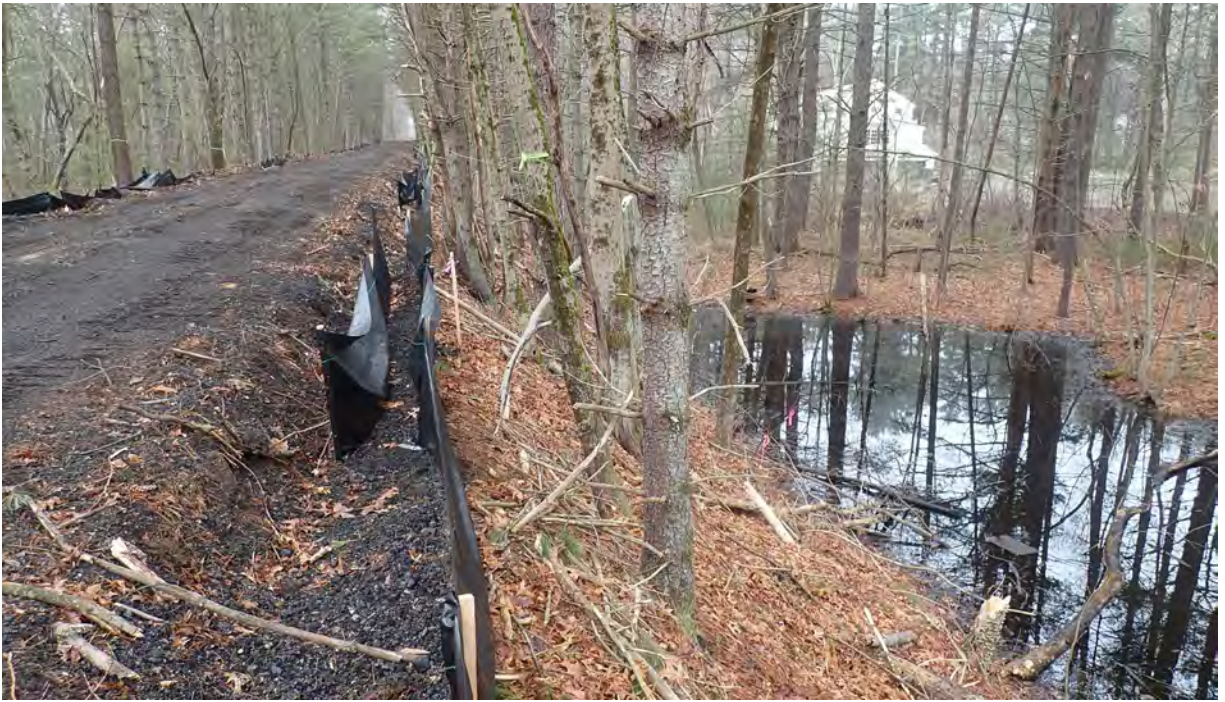
**Photo #3:** View of vernal pool #9 in Segment 10. Silt fence in good condition. No sediment or debris observed in the resource area or associated buffer zone. *Facing northwest.*

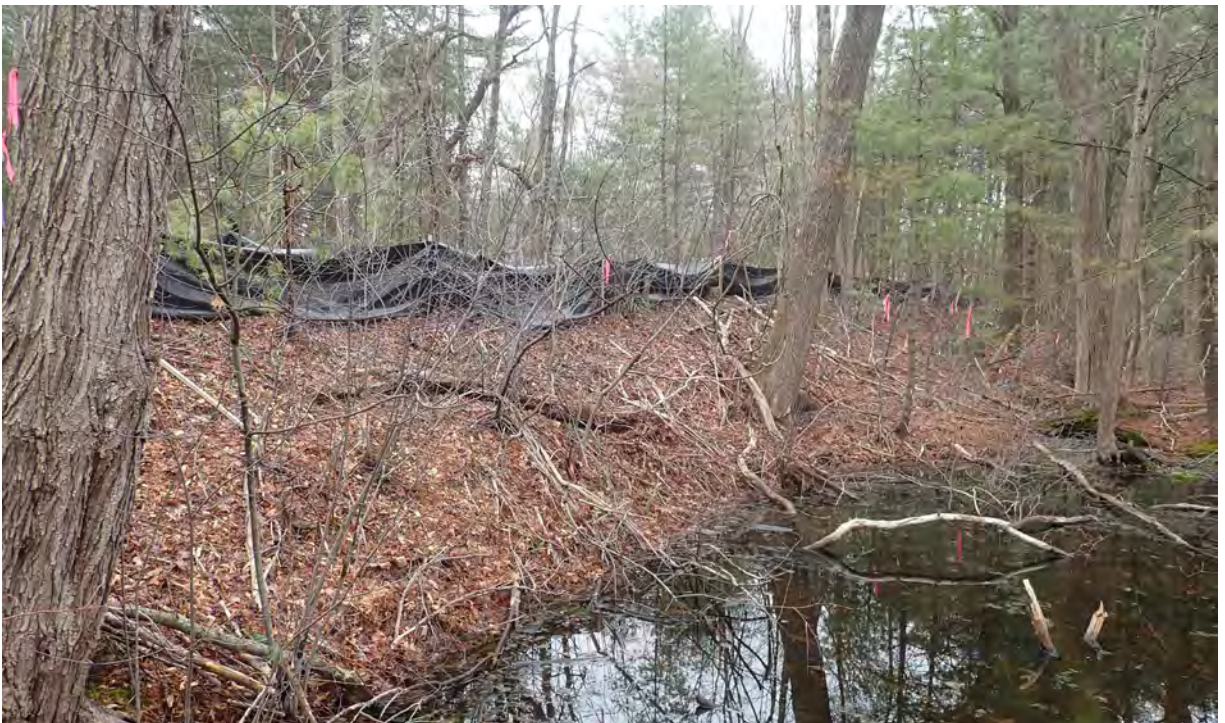
**Photo #4:** View of vernal pool #10 in Segment 11. Silt fence in good condition. No sediment or debris observed in the resource area or associated buffer zone. *Facing southeast.*

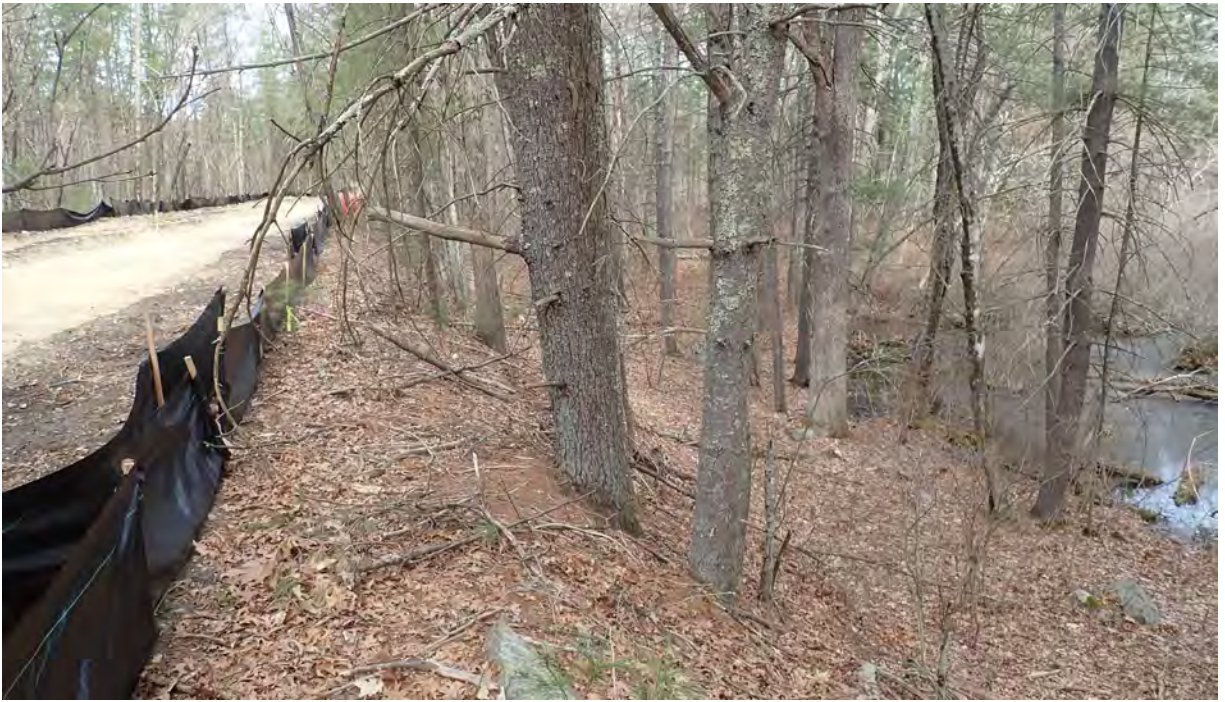
**Photo #1:** View of project area near vernal pool #7 and in Segment 8. Silt fence is in good condition. No sediment or debris observed within the resource area, buffer zone, or project area. *Facing northwest.*
