# Wildlife Habitat Features Report Eversource Sudbury to Hudson Transmission Reliability Project Sudbury, Massachusetts

DECEMBER 2022- MAY 2023

SWCA Project No. 67849

July 2023

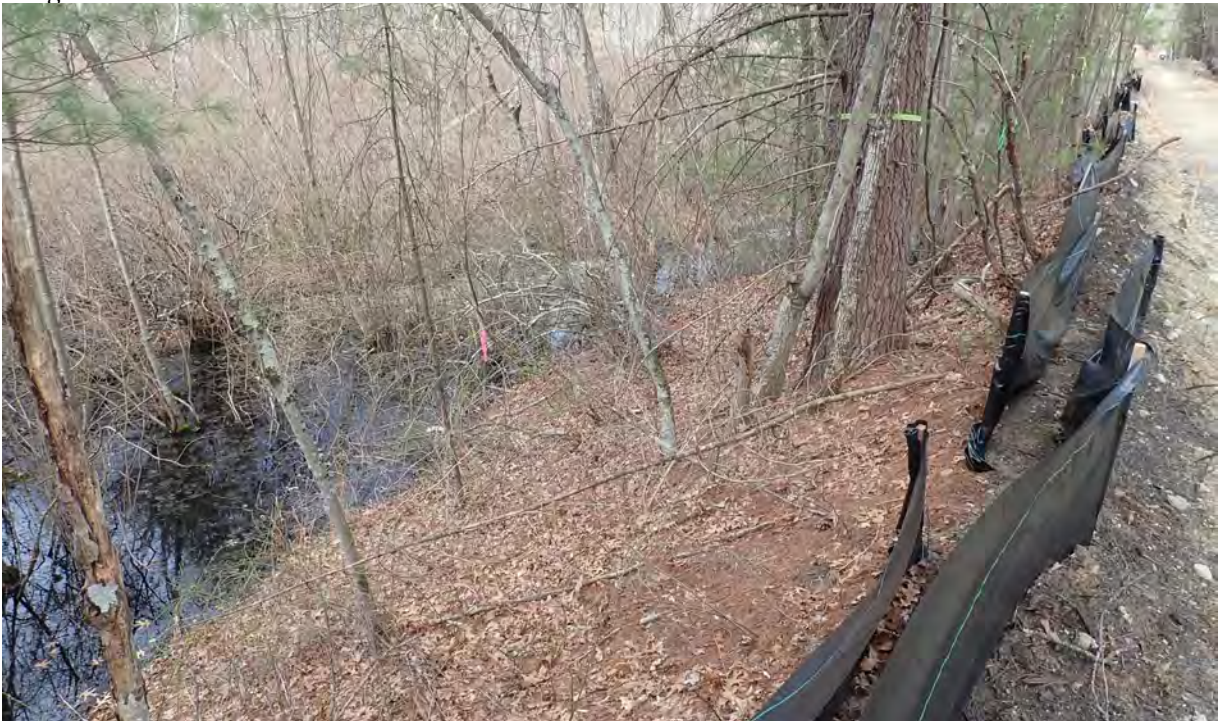
**Photo #2:** View of vernal pool #4 in Segment 8. No sediment or debris observed within the resource area or associated buffer zone. Silt fencing here and throughout the project area is in good condition. *Facing southeast.*

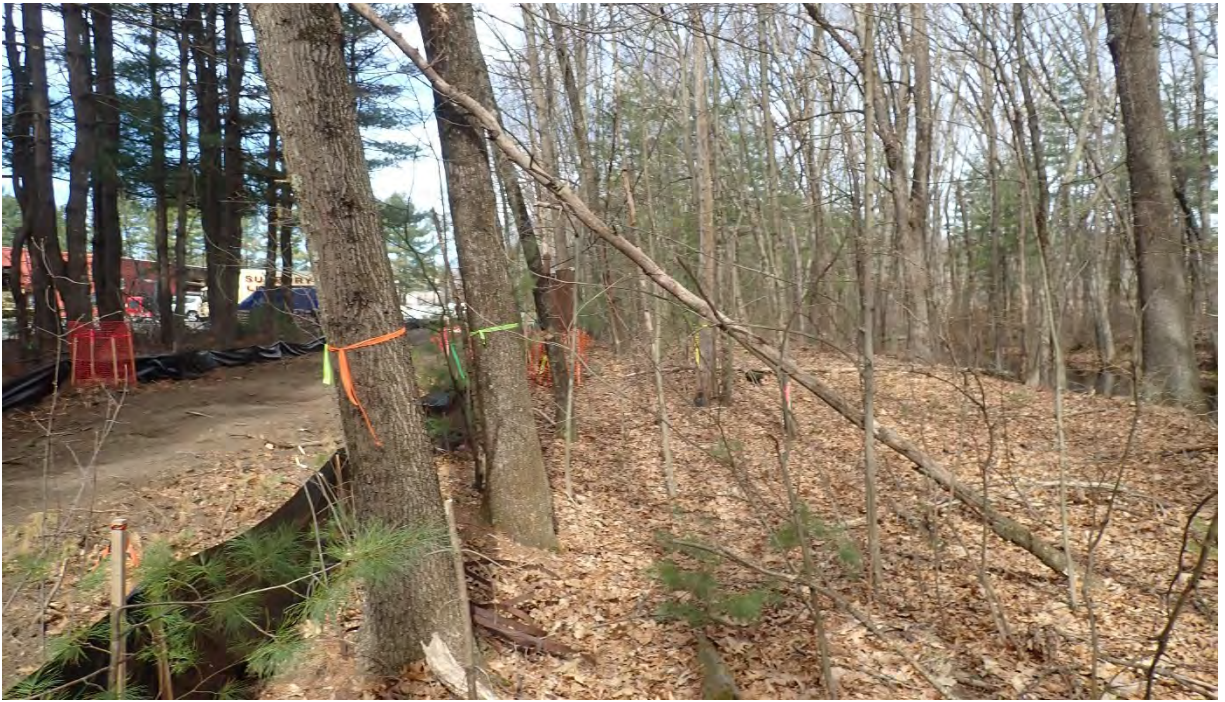
**Photo #3:** View of vernal pool #11 in Segment 11. Silt fence in good condition. No sediment or debris observed in the resource area or associated buffer zone. *Facing northwest.*

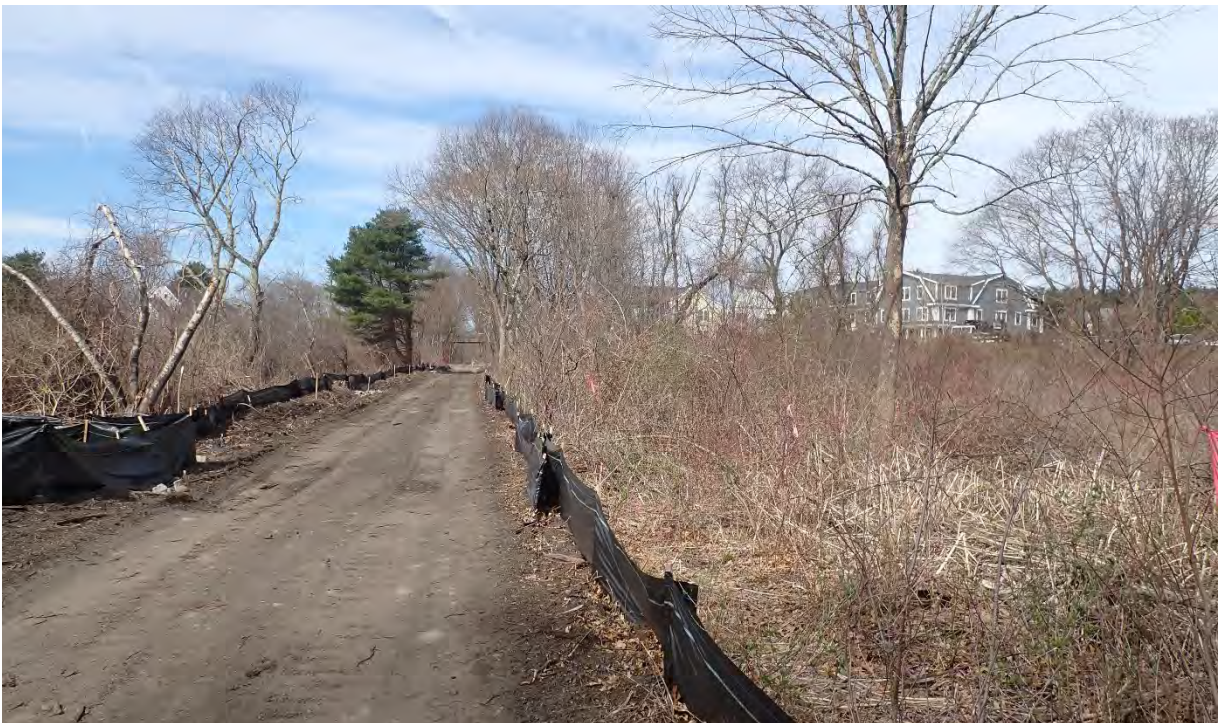
**Photo #4:** View of vernal pool #15 in Segment 14. Silt fence in good condition. No sediment or debris observed in the resource area or associated buffer zone. *Facing east.*

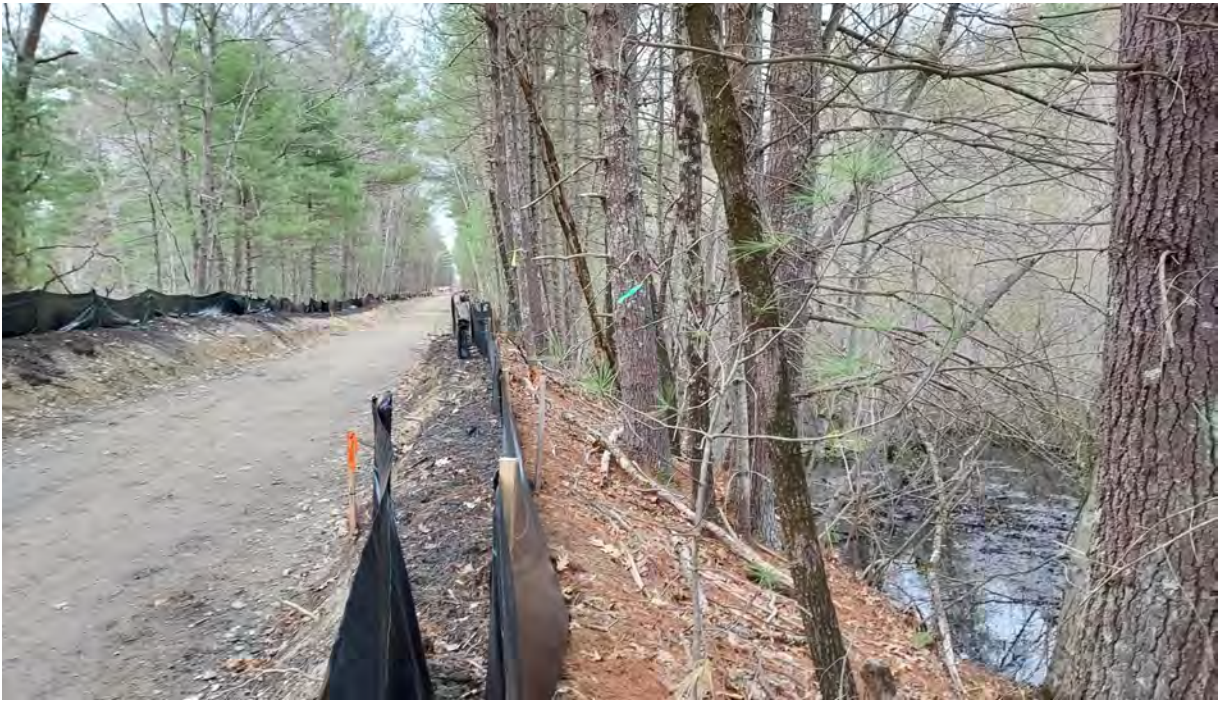
**Photo #1:** View of project area near vernal pool #5 and in Segment 8. Silt fence is in good condition. No sediment or debris observed within the resource area, buffer zone, or project area. *Facing southeast.*

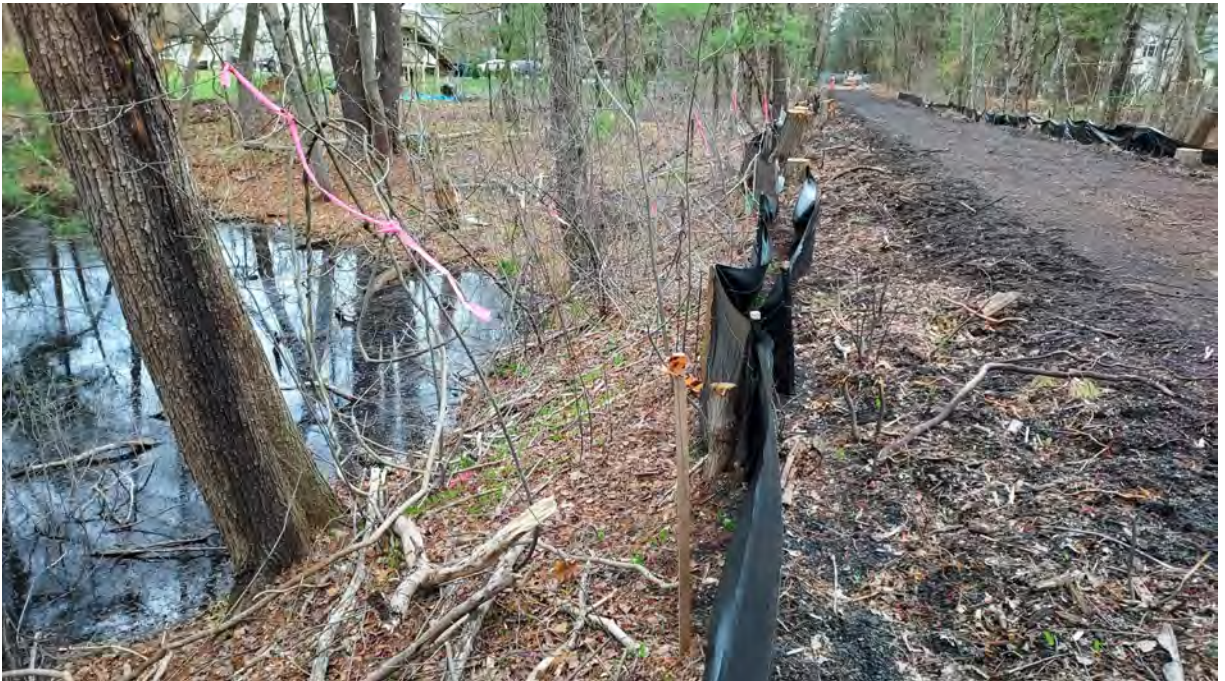
**Photo #2:** View of vernal pool #9 in Segment 10. No sediment or debris observed within the resource area or associated buffer zone. Silt fencing here and throughout the project area is in good condition. Pair of wood ducks observed in the vernal pool. *Facing southeast.*

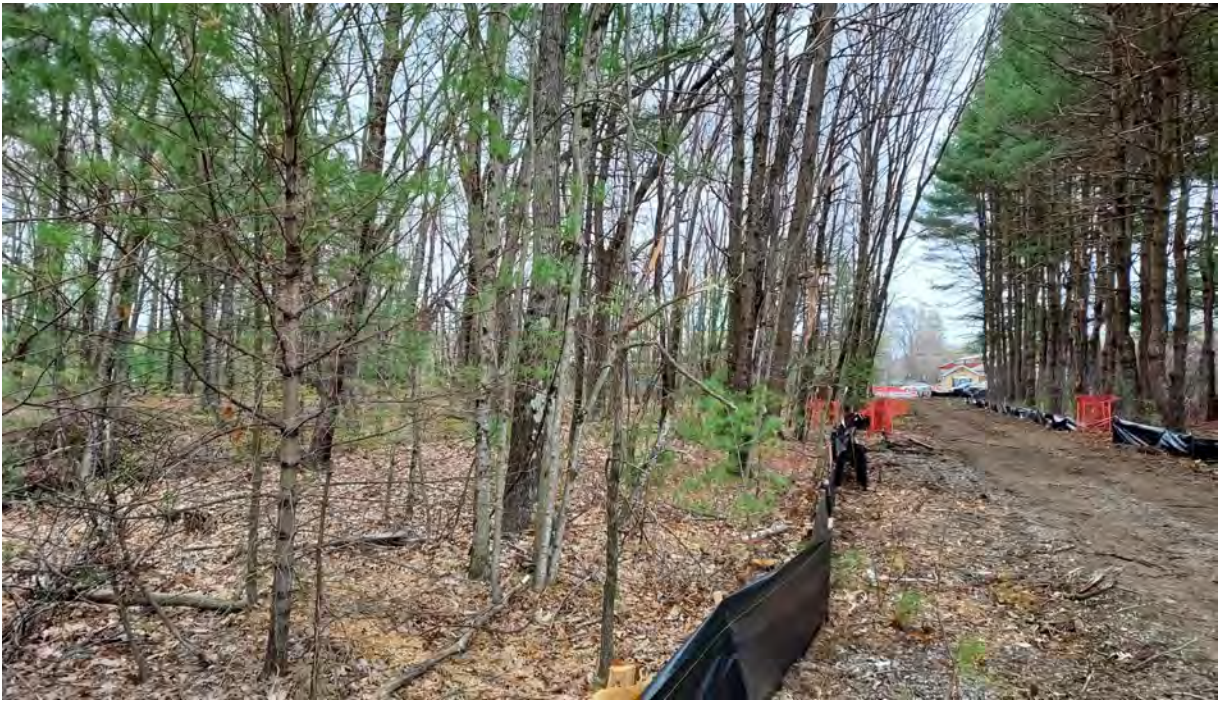
**Photo #3:** View of vernal pool #11 in Segment 11. Silt fence in good condition. No sediment or debris observed in the resource area or associated buffer zone. *Facing southeast.*

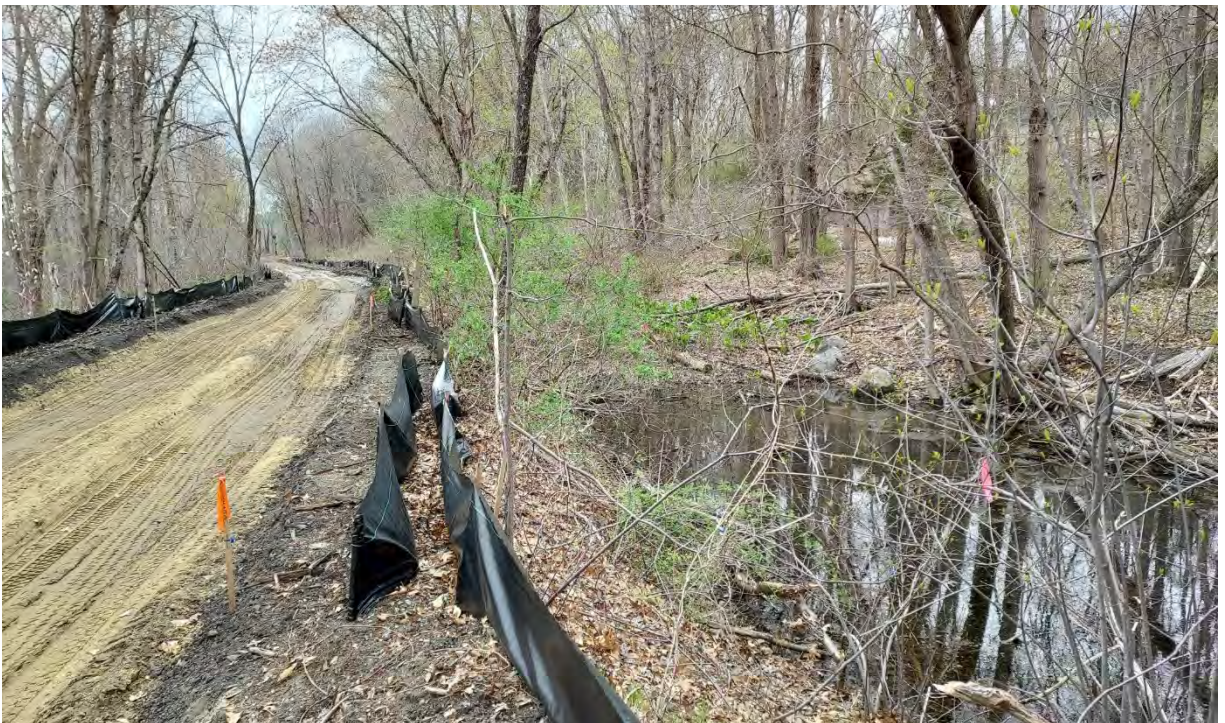
**Photo #4:** View of vernal pool #12 in Segment 14. Silt fence in good condition. No sediment or debris observed in the resource area or associated buffer zone. *Facing west.*

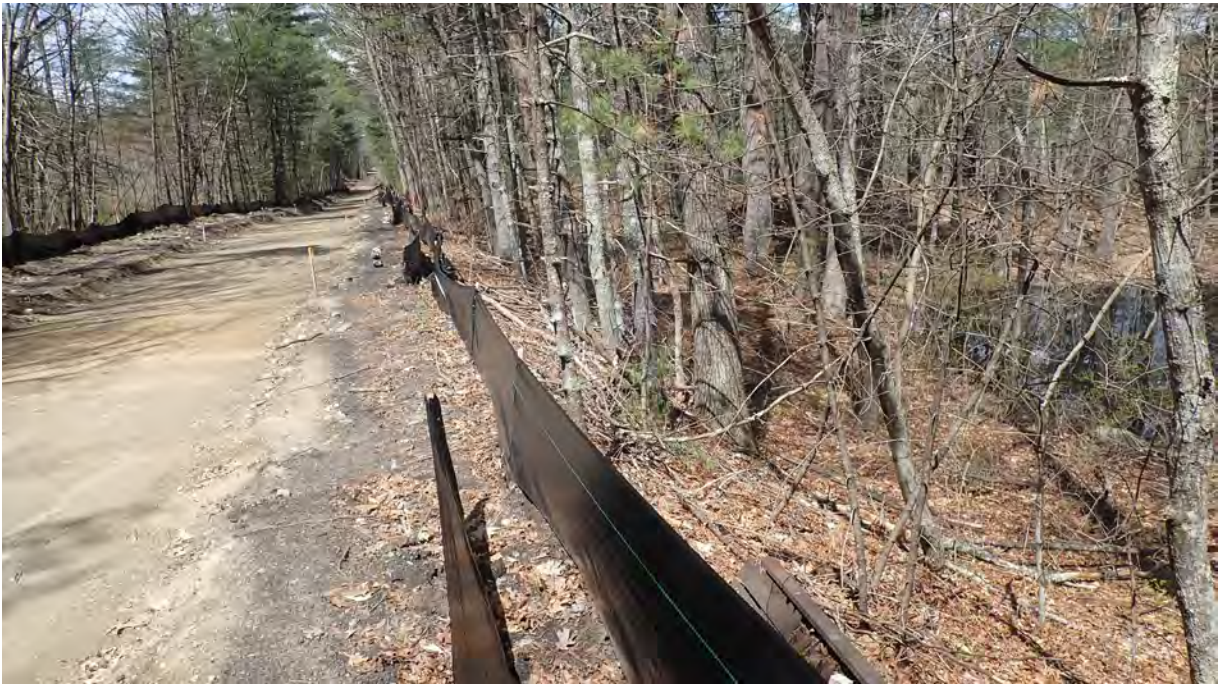
**Photo #1:** View of project area near vernal pool #6 and in Segment 8. Silt fence is in good condition. No sediment or debris observed within the resource area, buffer zone, or project area. *Facing northwest.*

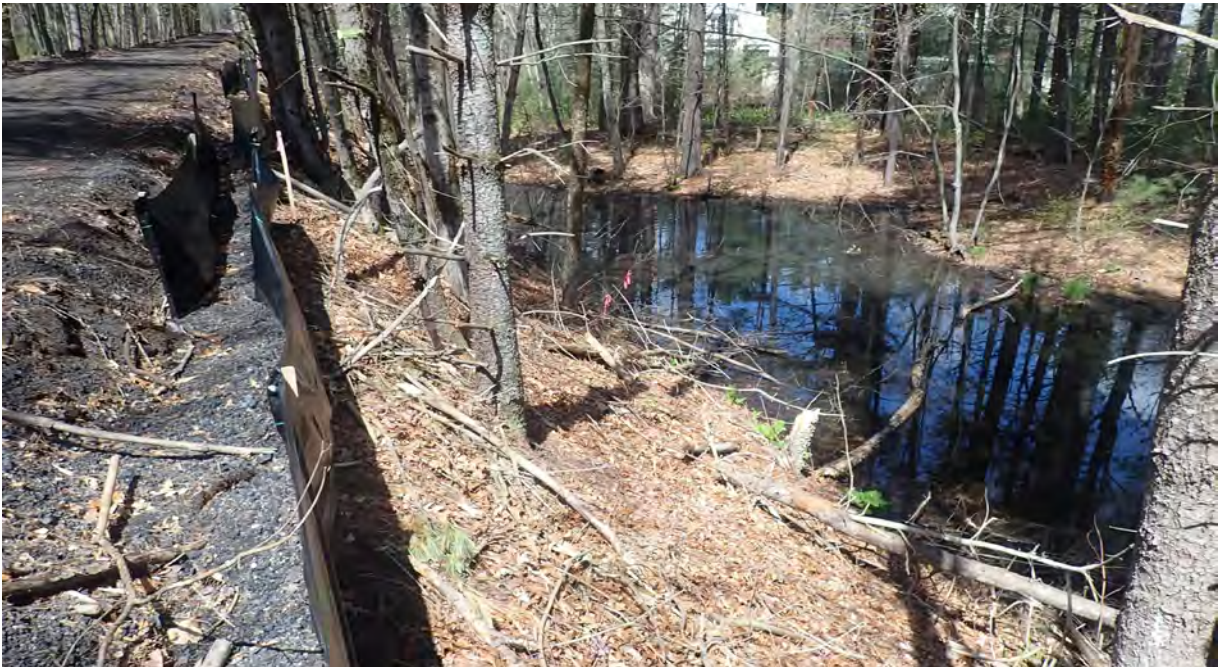
**Photo #2:** View of vernal pool #9 in Segment 10. No sediment or debris observed within the resource area or associated buffer zone. Silt fencing here and throughout the project area is in good condition. Pair of wood ducks and pair of mallard ducks observed in the vernal pool. *Facing northwest.*

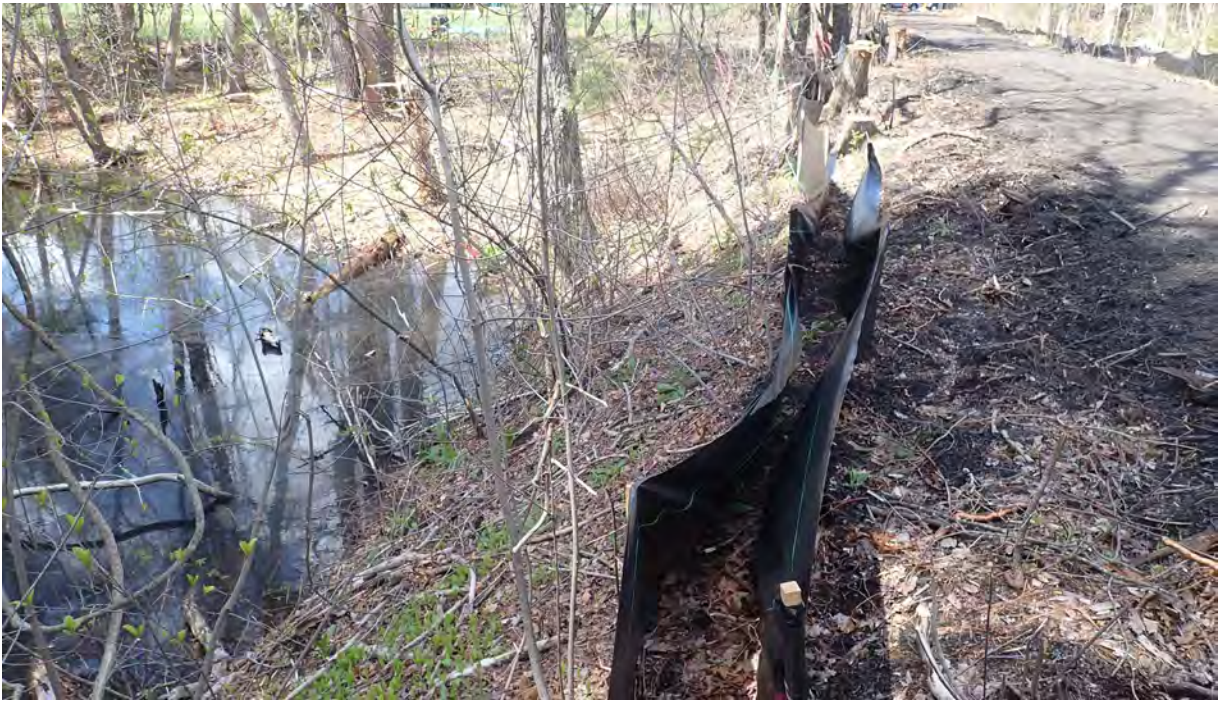
**Photo #3:** View of vernal pool #10 in Segment 11. Silt fence in good condition. No sediment or debris observed in the resource area or associated buffer zone. *Facing southeast.*

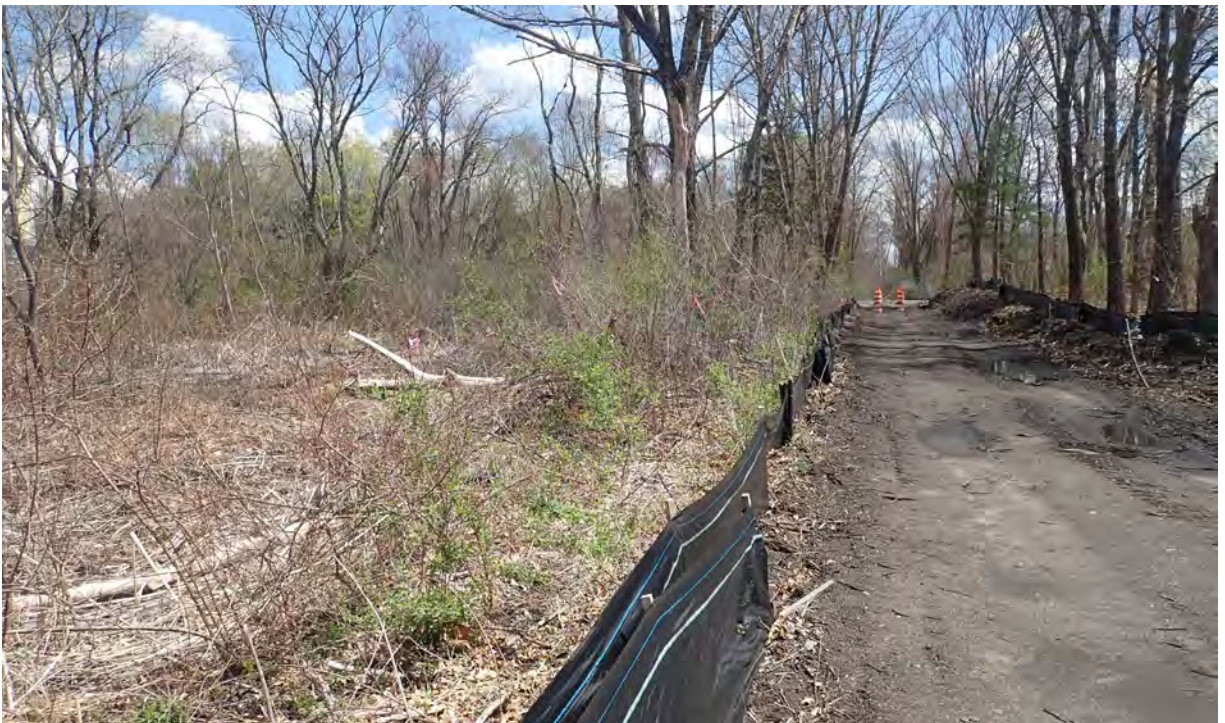
**Photo #4:** View of vernal pool #15 in Segment 14. Silt fence in good condition. No sediment or debris observed in the resource area or associated buffer zone. *Facing east.*

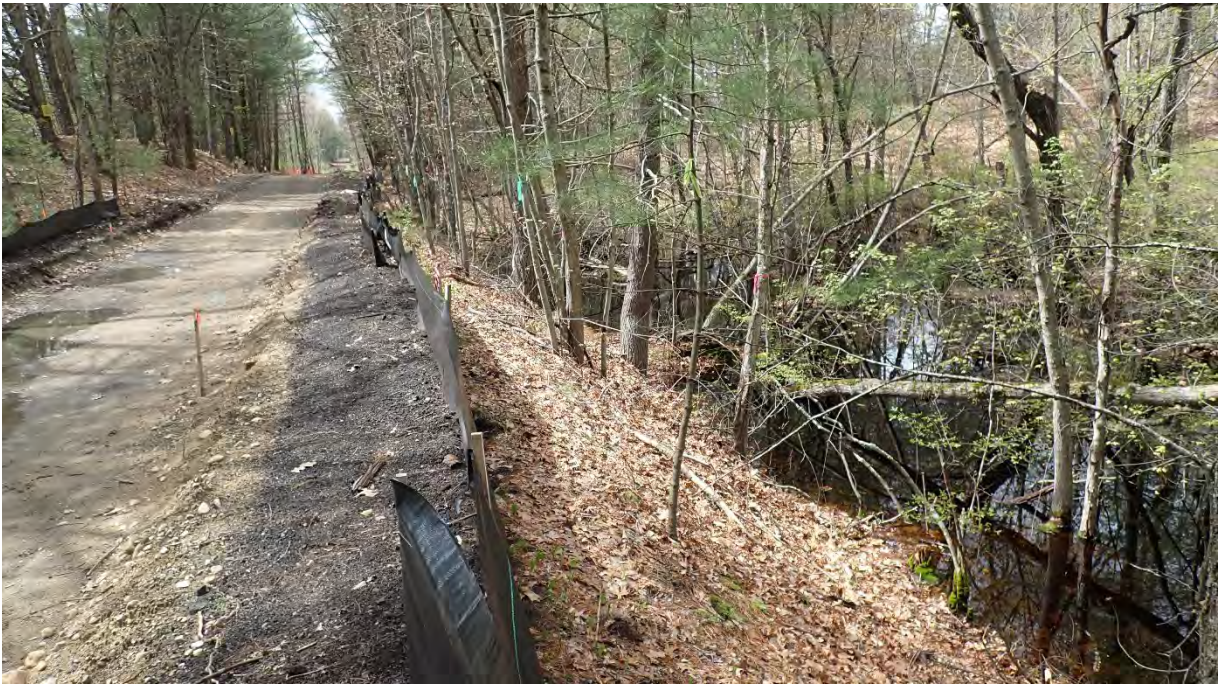
**Photo #1:** View of project area near vernal pool #3 and in Segment 8. Silt fence is in good condition. No sediment or debris observed within the resource area, buffer zone, or project area. *Facing northwest.*

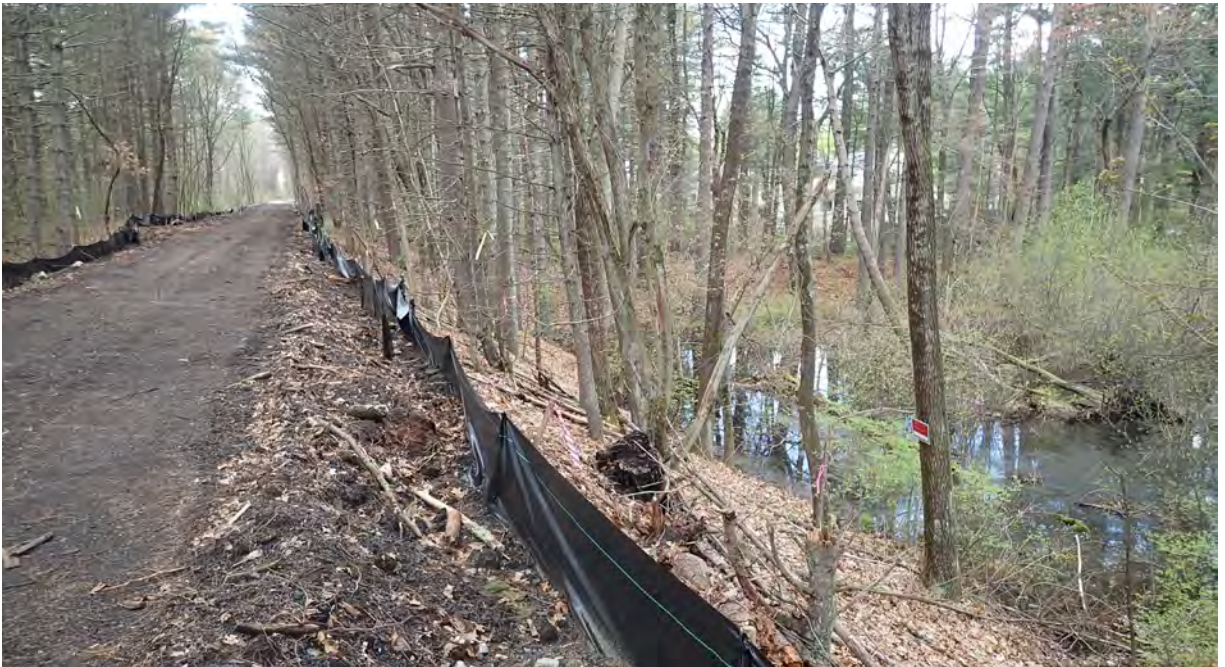
**Photo #2:** View of vernal pool #8 in Segment 10. No sediment or debris observed within the resource area or associated buffer zone. Silt fencing here and throughout the project area is in good condition. *Facing northwest.*

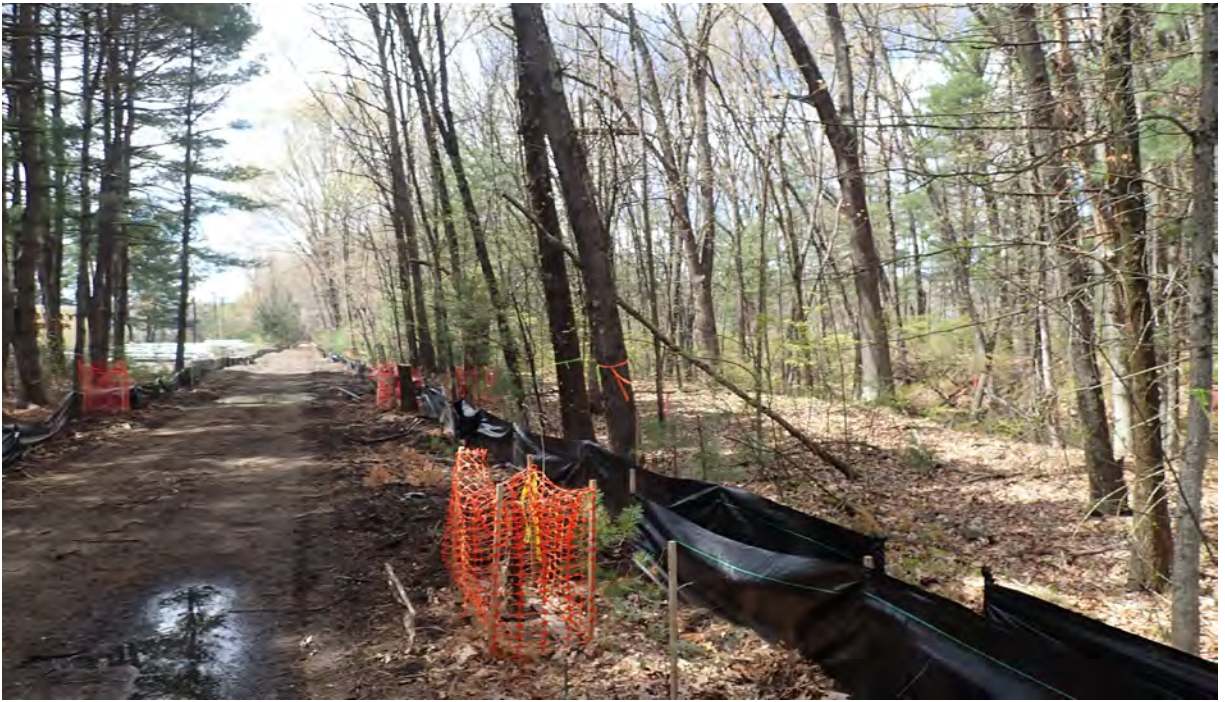
**Photo #3:** View of project area near vernal pool #11 in Segment 11. Silt fence in good condition. No sediment or debris observed in the resource area or associated buffer zone. *Facing northwest.*

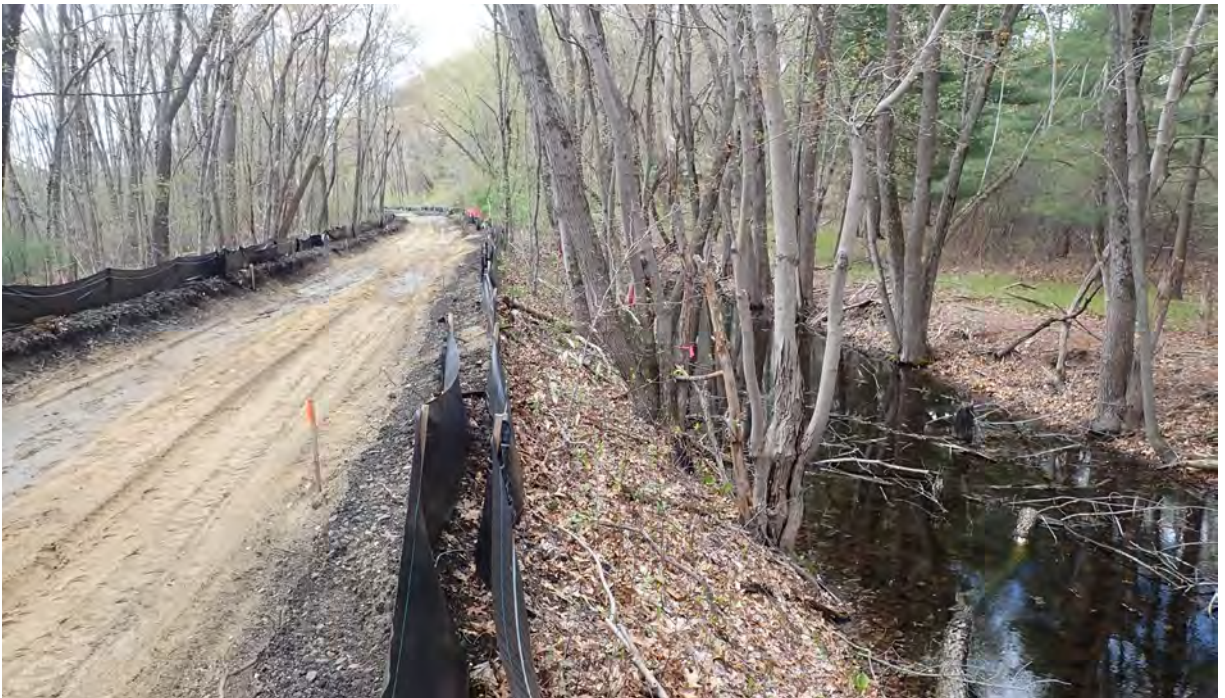
**Photo #4:** View of vernal pool #13 in Segment 14. Silt fence in good condition. No sediment or debris observed in the resource area or associated buffer zone. *Facing west.*

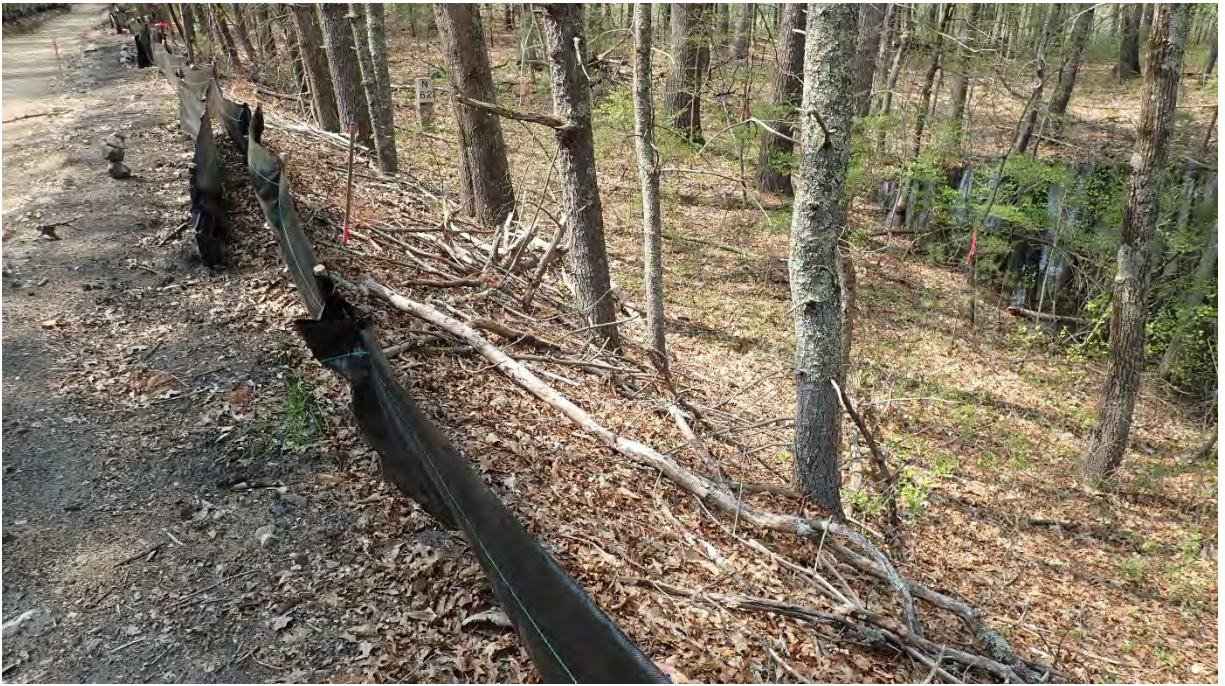
**Photo #1:** View of project area near vernal pools #6 in Segment 8. Silt fence is in good condition. No sediment or debris observed within the resource area, buffer zone, or project area. *Facing north.*

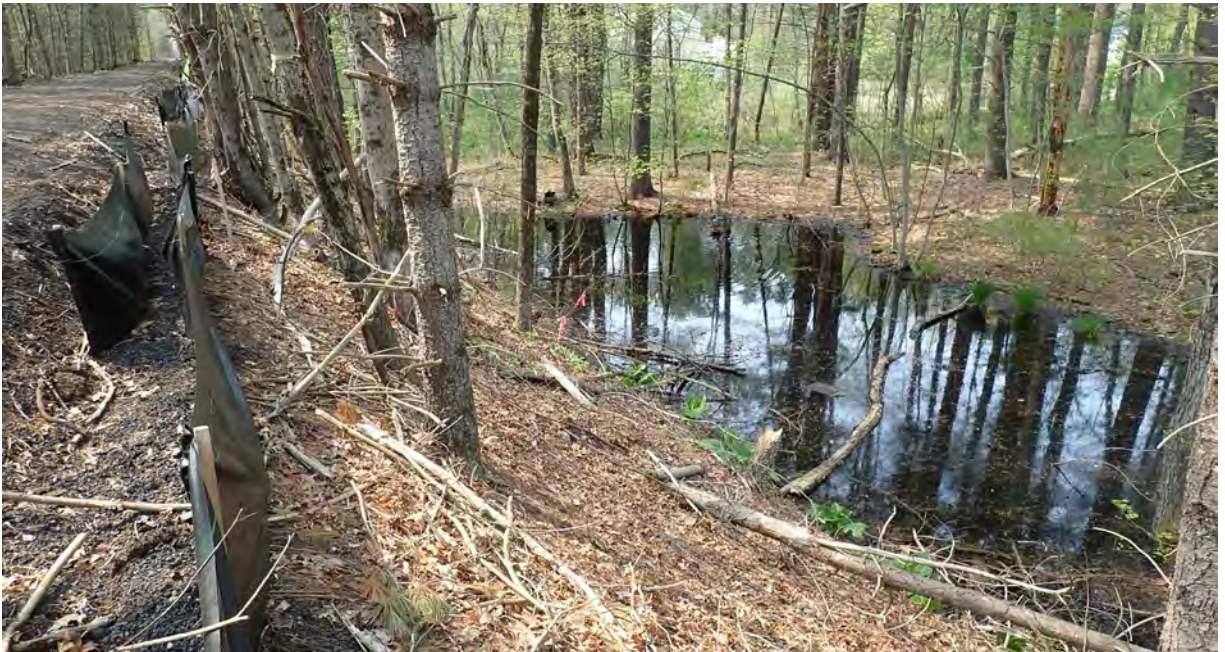
**Photo #2:** View of vernal pool #9 in Segment 10. No sediment or debris observed within the resource area or associated buffer zone. Silt fencing here and throughout the project area is in good condition. Pair of mallard ducks and wood ducks observed within vernal pool. *Facing northwest.*

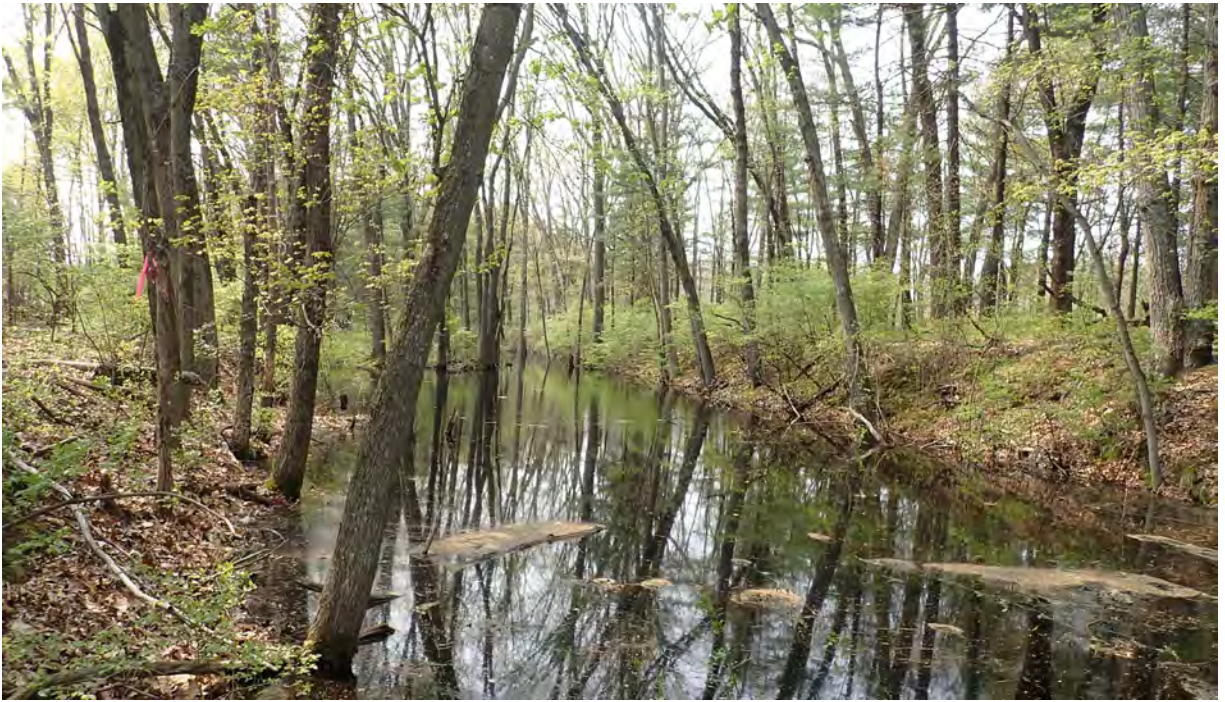
**Photo #3:** View of vernal pool #11 in Segment 11. Silt fence in good condition. No sediment or debris observed in the resource area or associated buffer zone. *Facing northwest.*

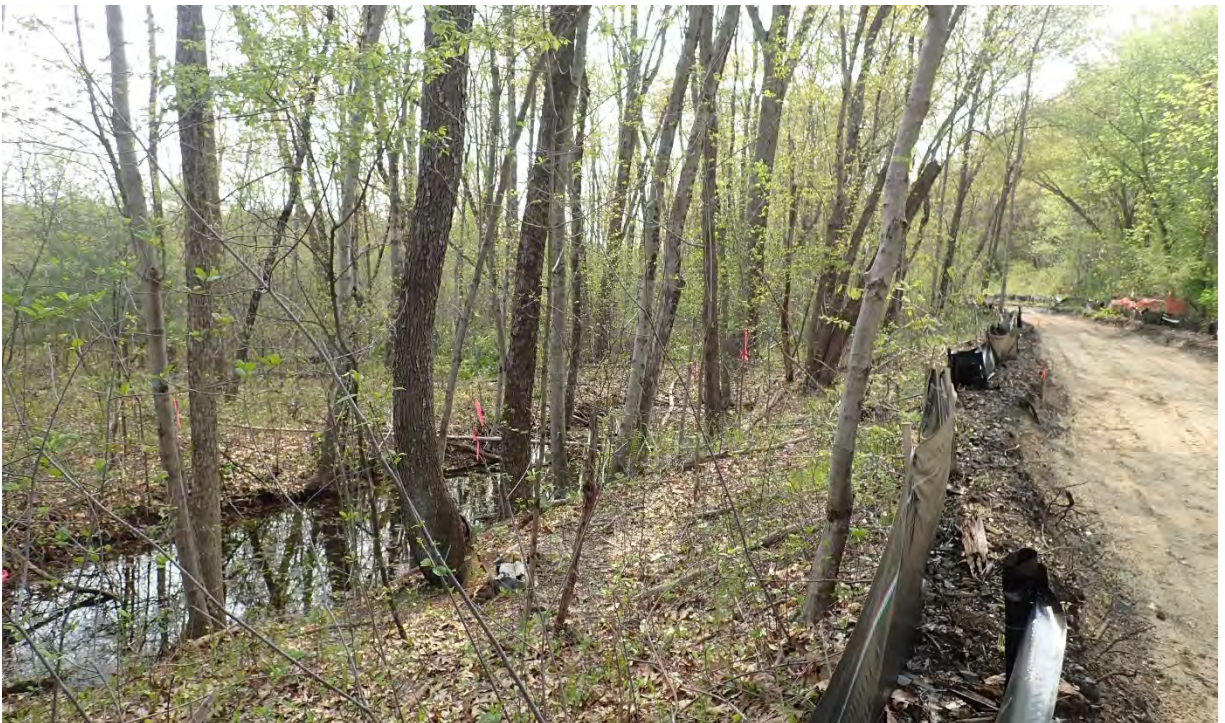
**Photo #4:** View of vernal pool #14 in Segment 14. Silt fence in good condition. No sediment or debris observed in the resource area or associated buffer zone. *Facing west.*

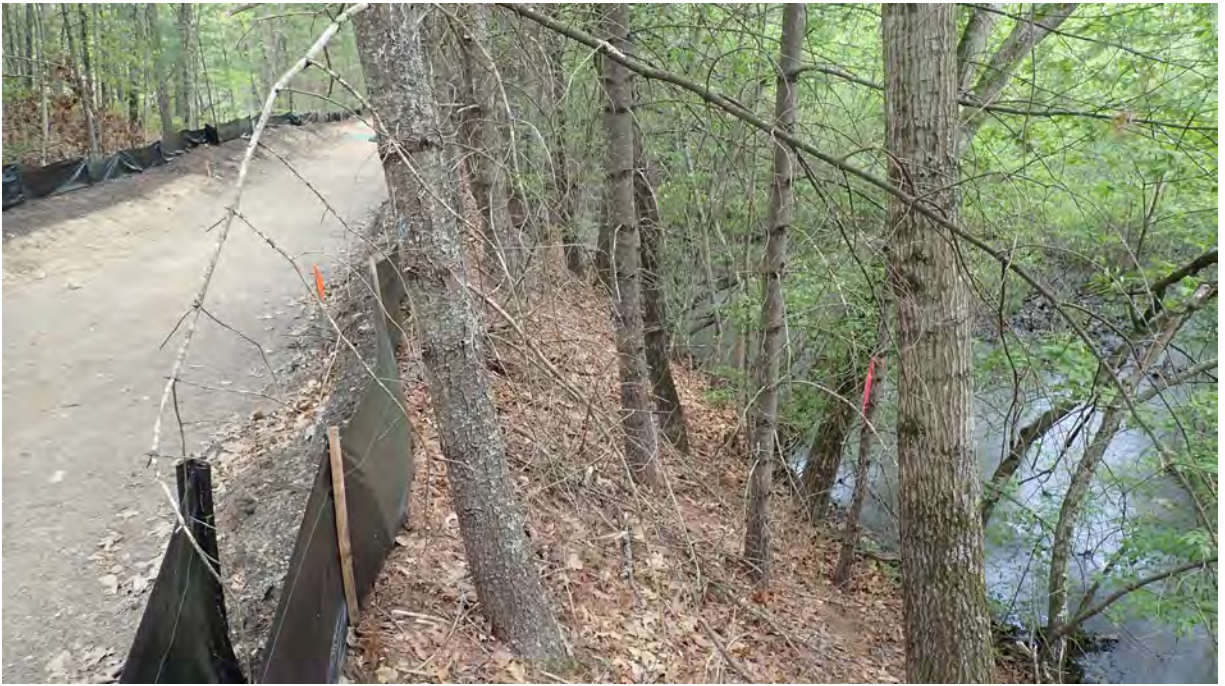
**Photo #1:** View of project area near vernal pools #5 in Segment 8. Silt fence is in good condition. No sediment or debris observed within the resource area, buffer zone, or project area. *Facing southeast.*

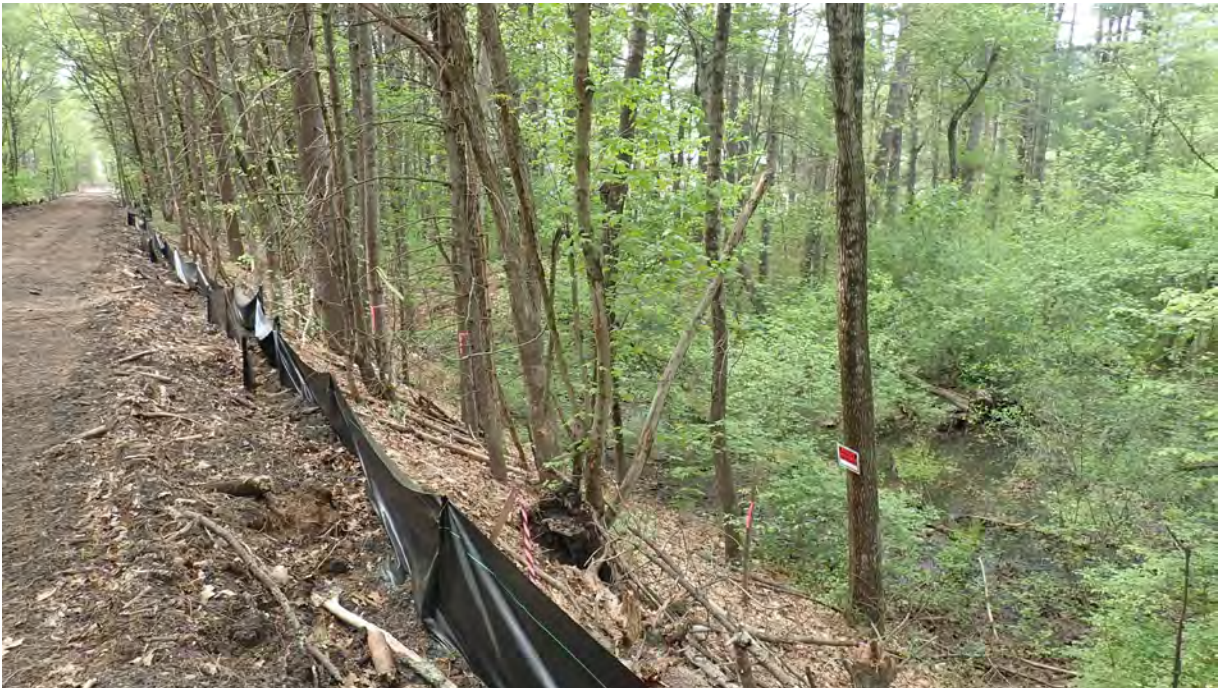
**Photo #2:** View of vernal pool #8 in Segment 10. No sediment or debris observed within the resource area or associated buffer zone. Silt fencing here and throughout the project area is in good condition. *Facing northwest.*

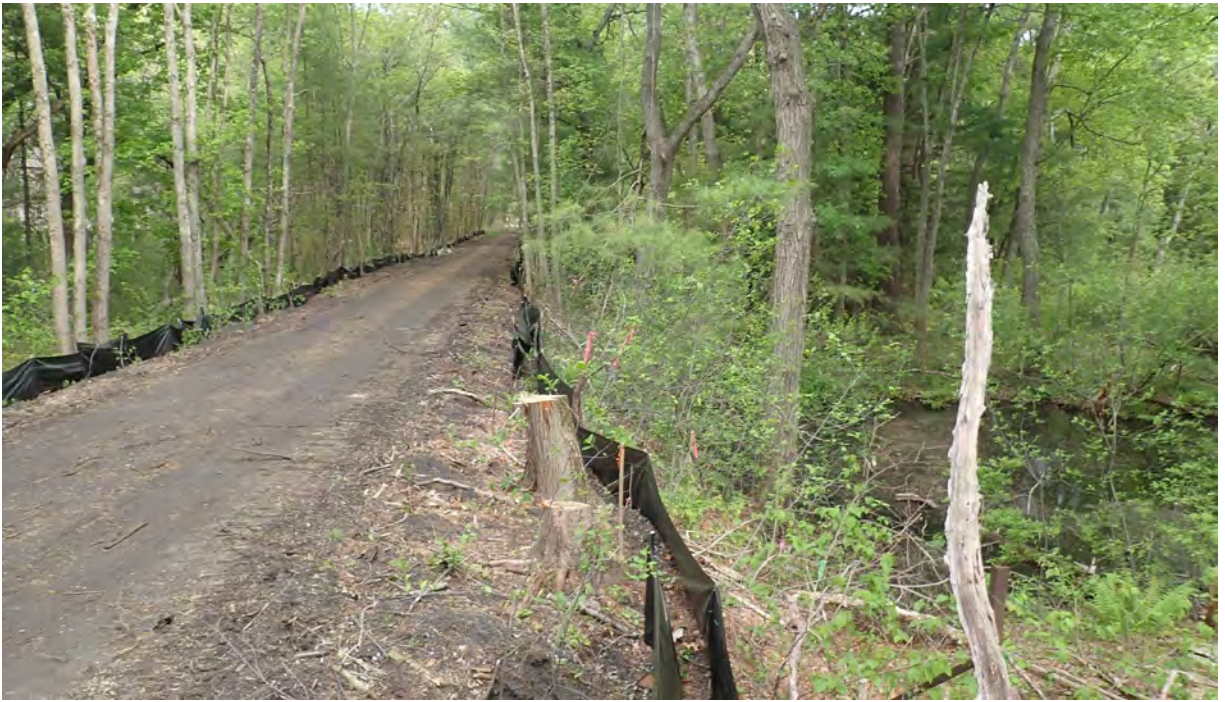
**Photo #3:** View of vernal pool #10 in Segment 11. Silt fence in good condition. No sediment or debris observed in the resource area or associated buffer zone. *Facing northwest.*

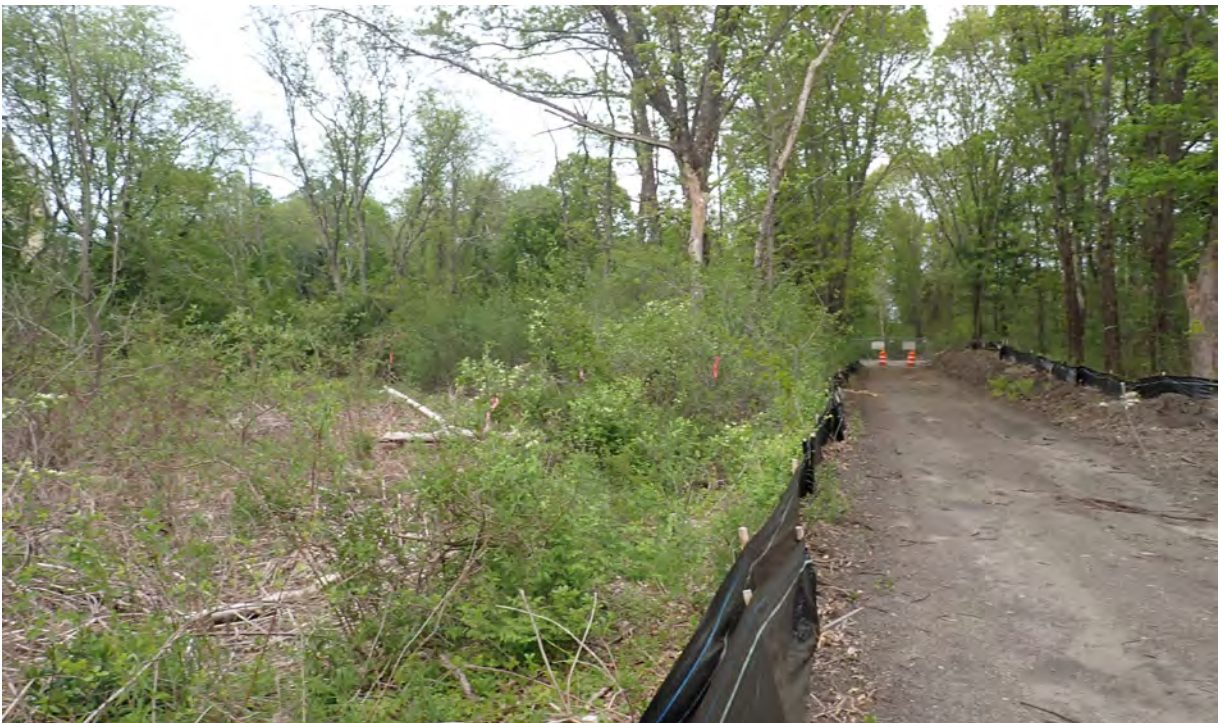
**Photo #4:** View of vernal pool #15 in Segment 14. Silt fence in good condition. No sediment or debris observed in the resource area or associated buffer zone. *Facing east.*

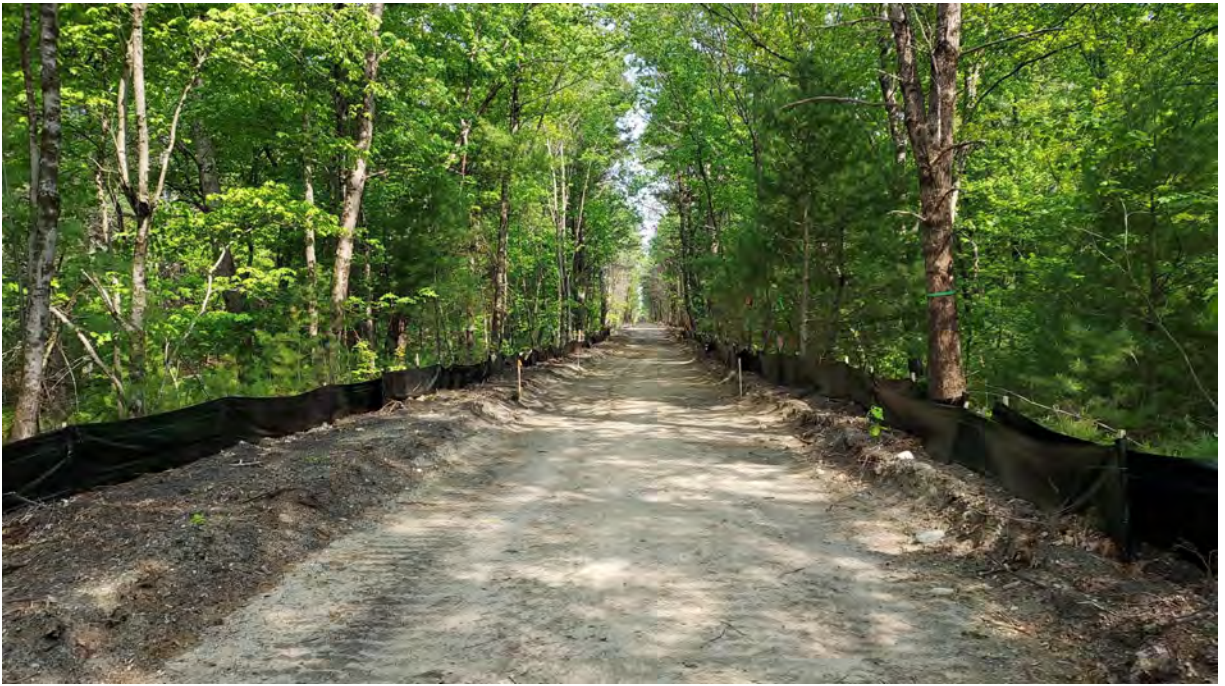
**Photo #1:** View of project area near vernal pools #1 in Segment 7. Silt fence is in good condition. No sediment or debris observed within the resource area, buffer zone, or project area. *Facing northwest.*

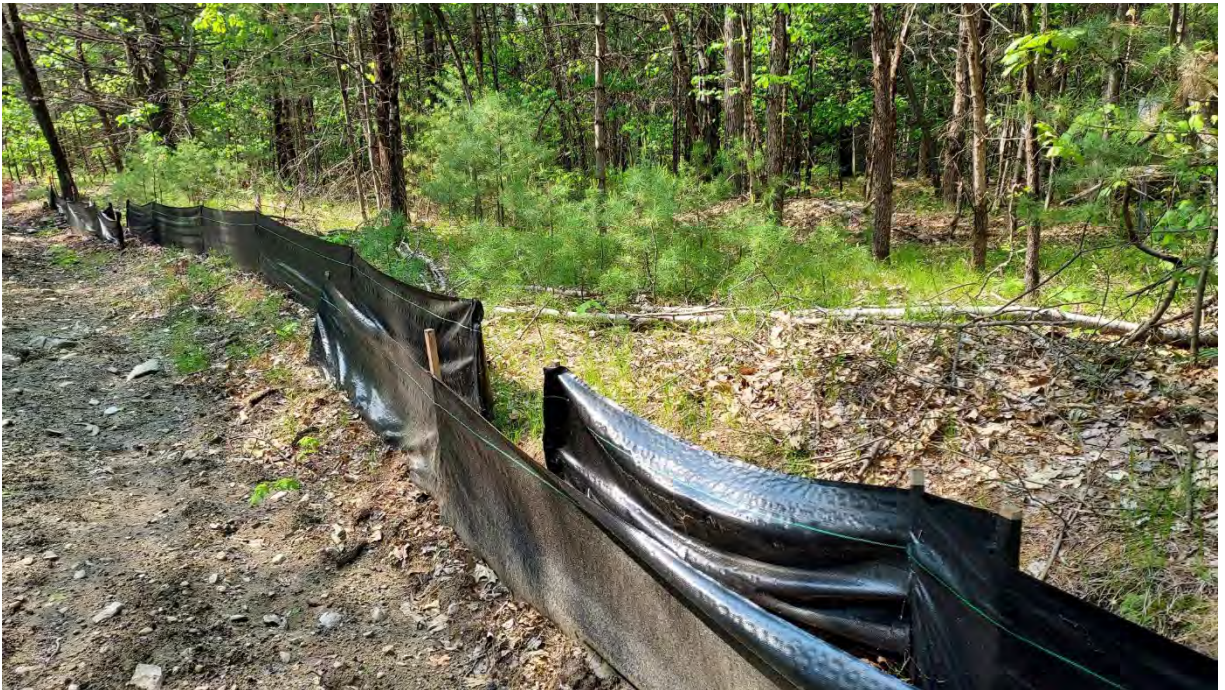
**Photo #2:** View of silt fence near vernal pool #2 in Segment 7. No sediment or debris observed within the resource area or associated buffer zone. Silt fencing here and throughout the project area is in good condition. *Facing north.*
